RPA & Associates, LLC.

JOB	DATE
528 – 530 CALLE CORVO, SANTA FE, NM 87501	09/04/2025

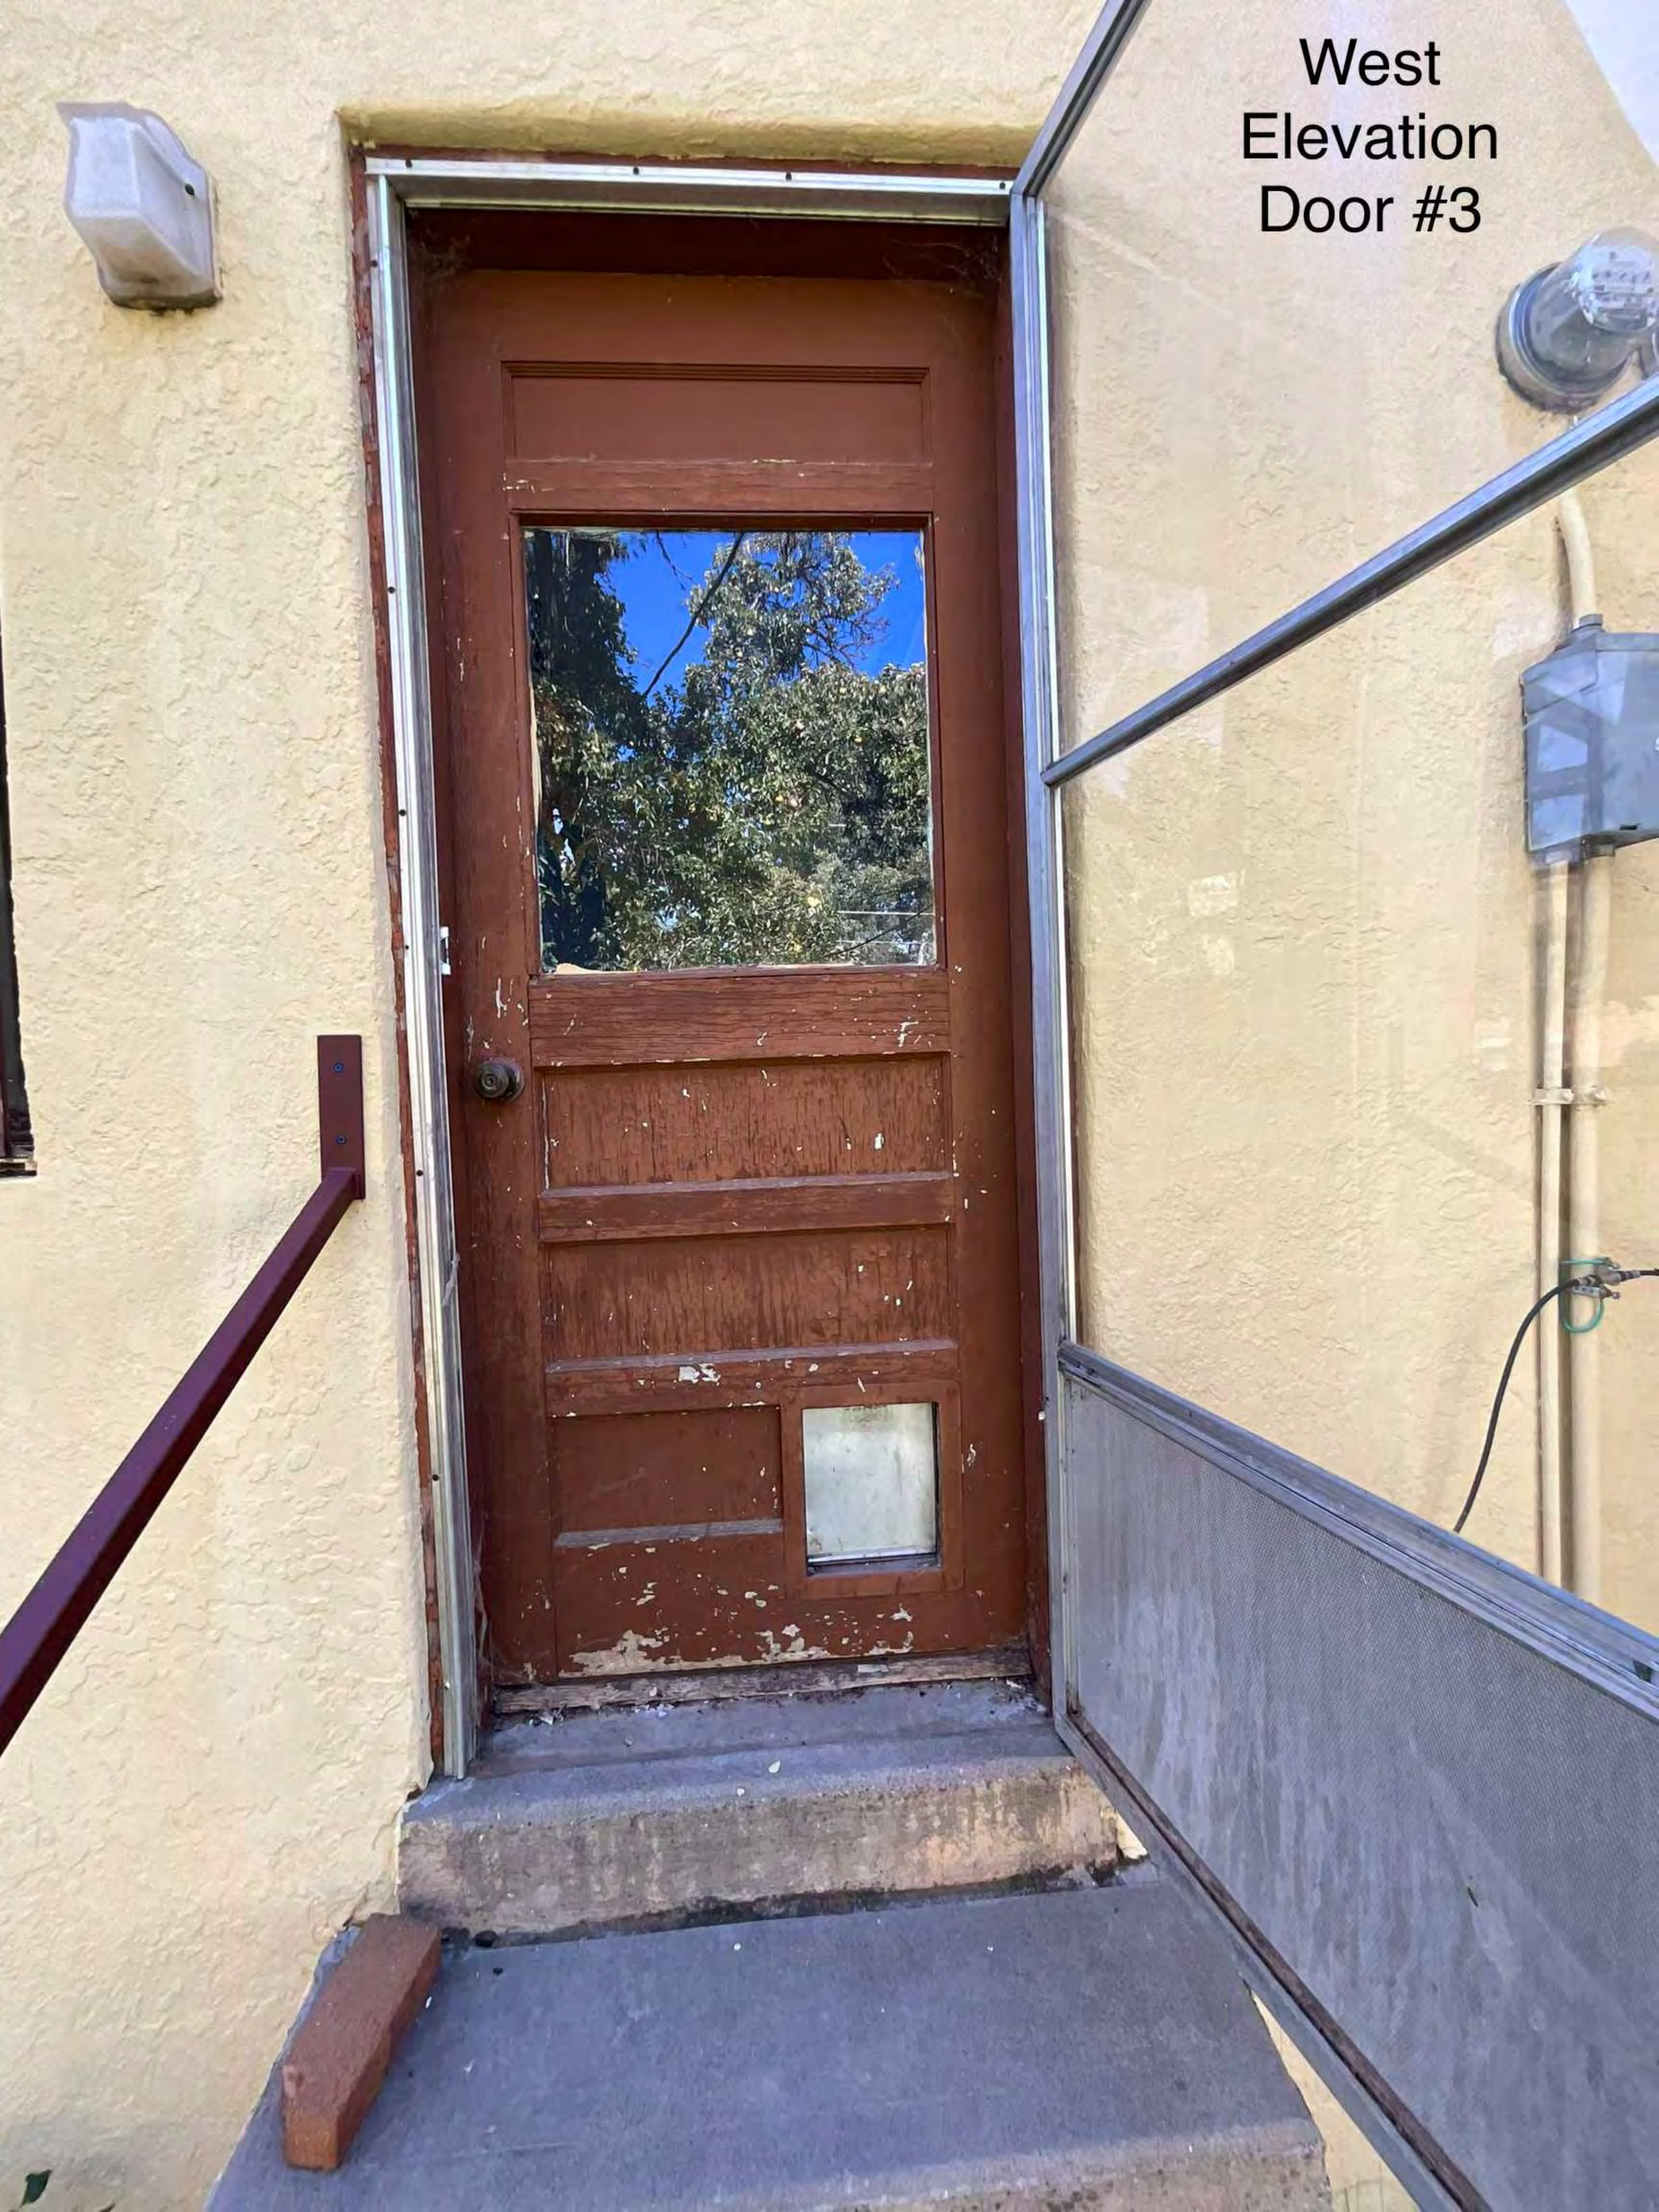
West
Elevation
Door #3

Doors #3 and #4 are historic, however are unrestorable.

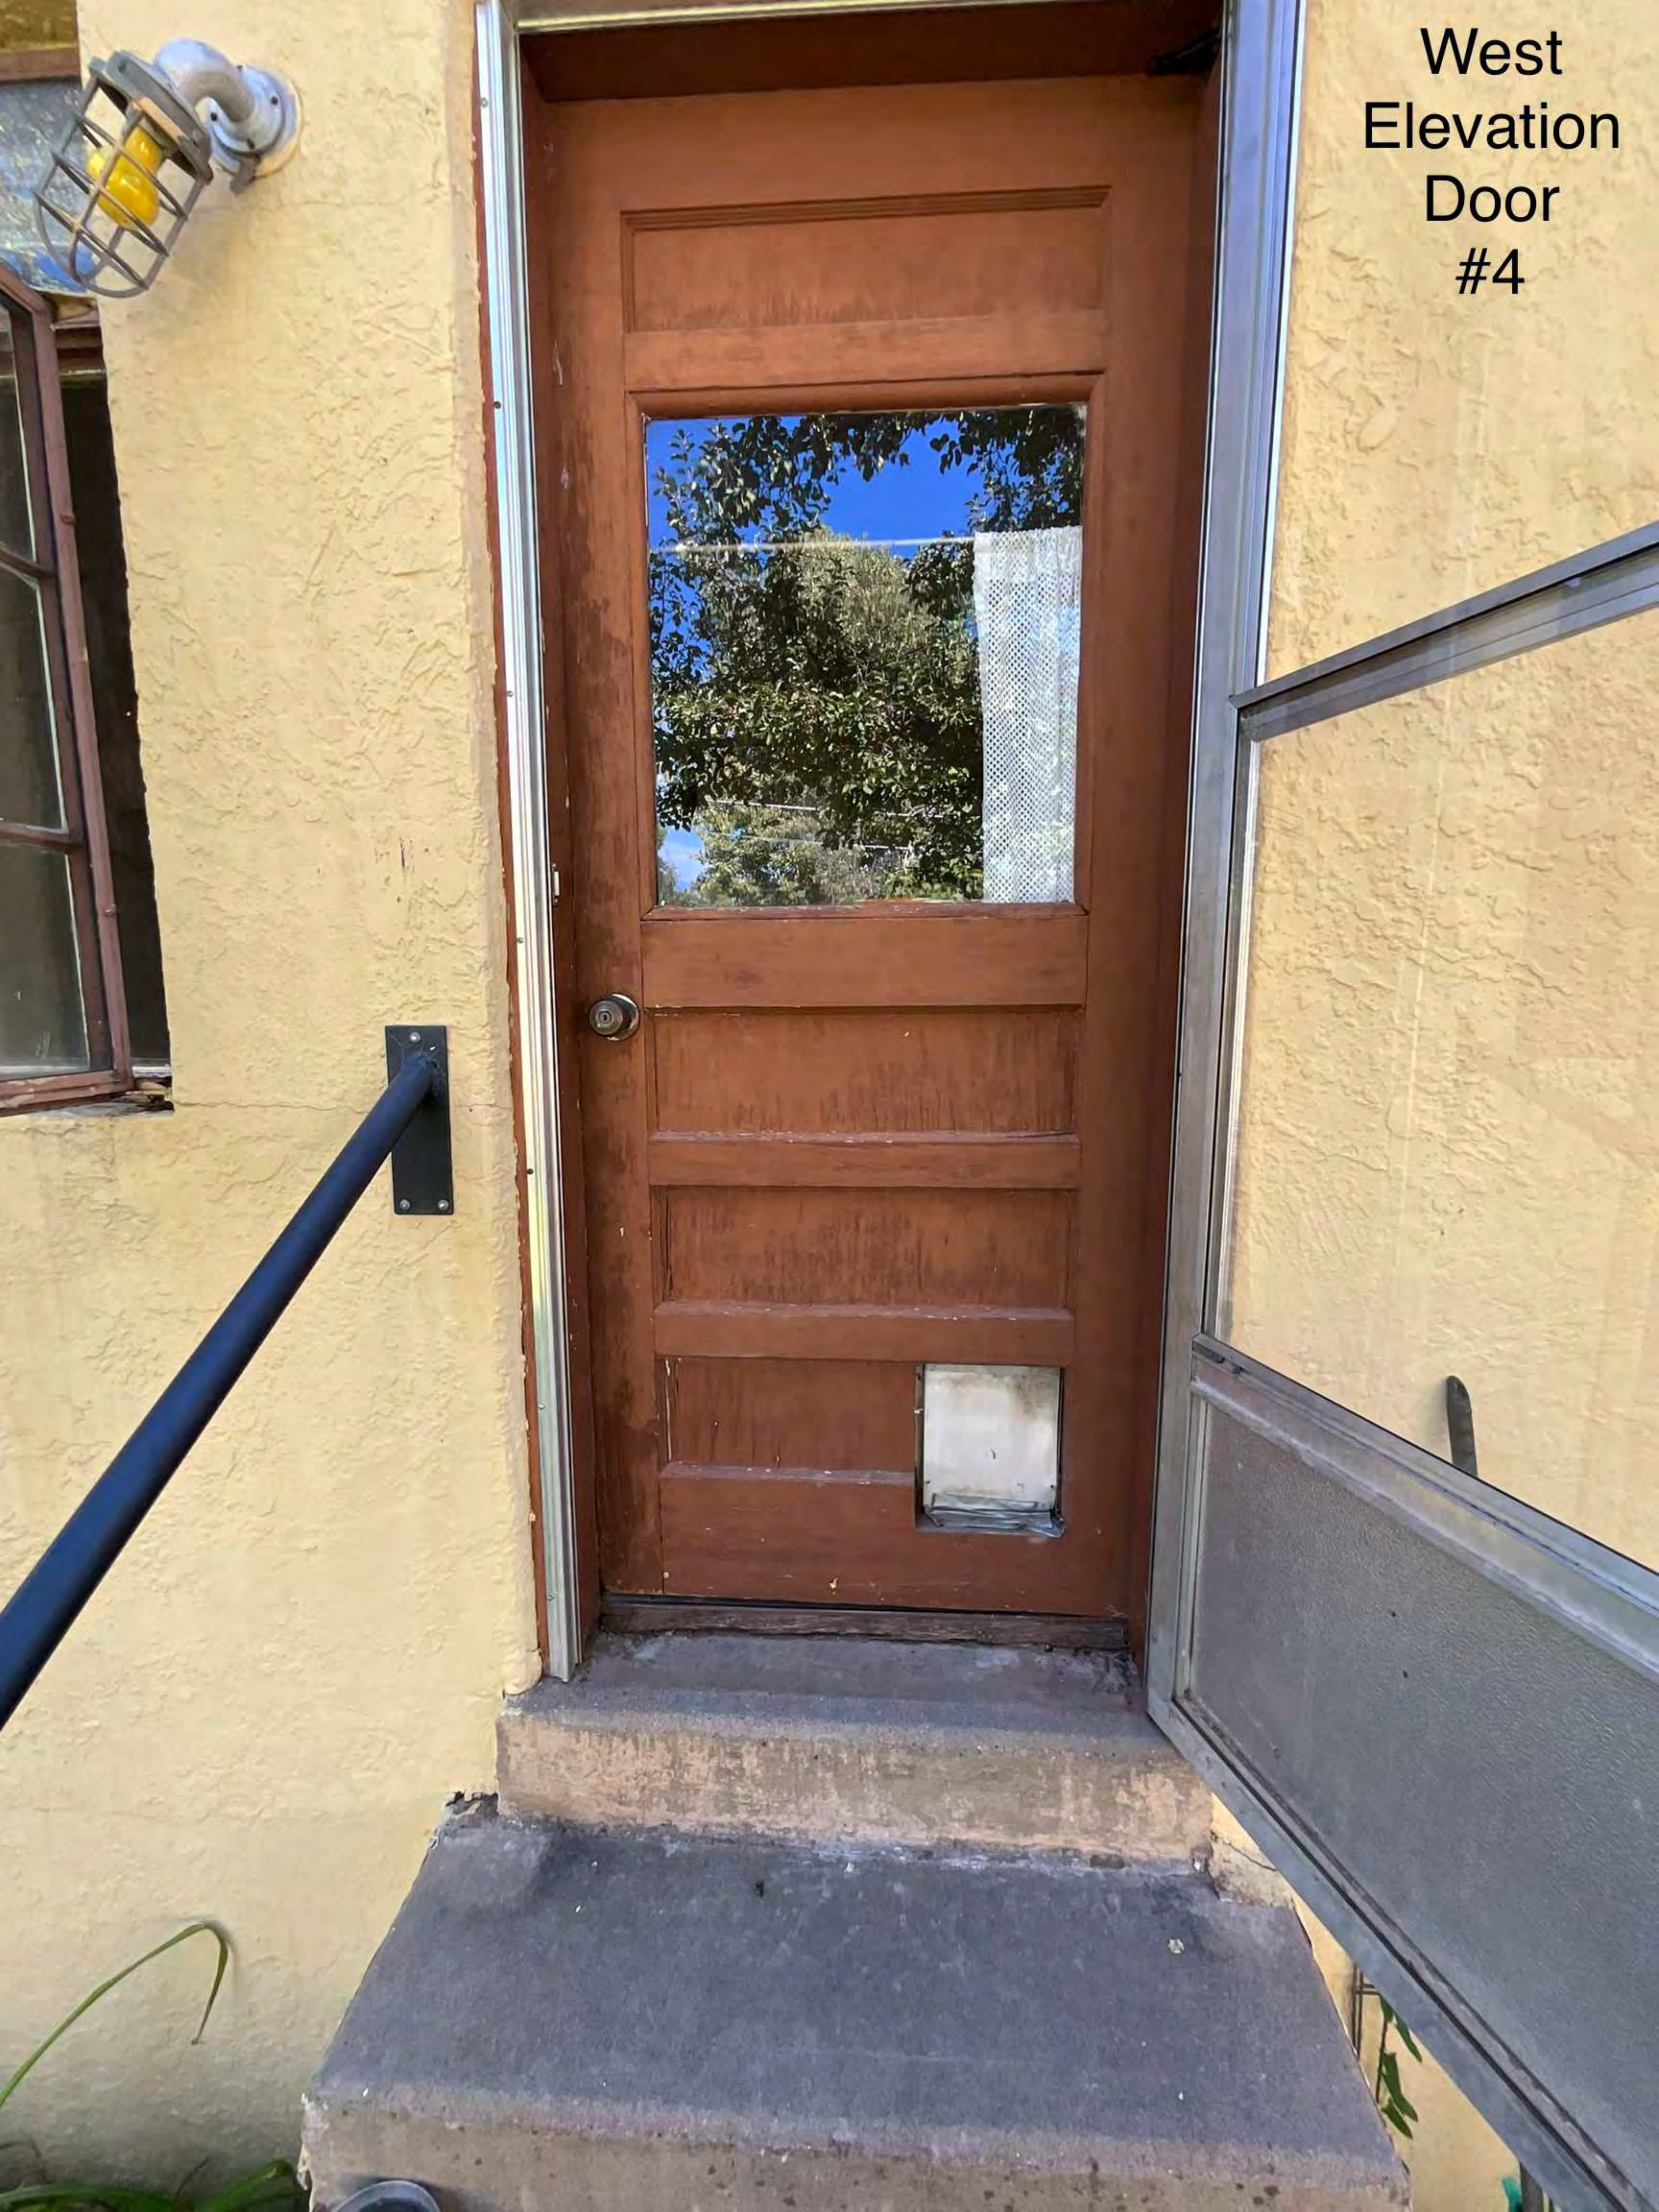
West
Elevation
Door
#4

DR #4	32" x 80" RH ALL WOOD DOOR 1-HORIZONTAL/1-LT/3-HORIZONTAL PANEL		HISTORIC – PANEL CROSS RAILS CUT DOOR, WEAKENING THE STRUCTURE

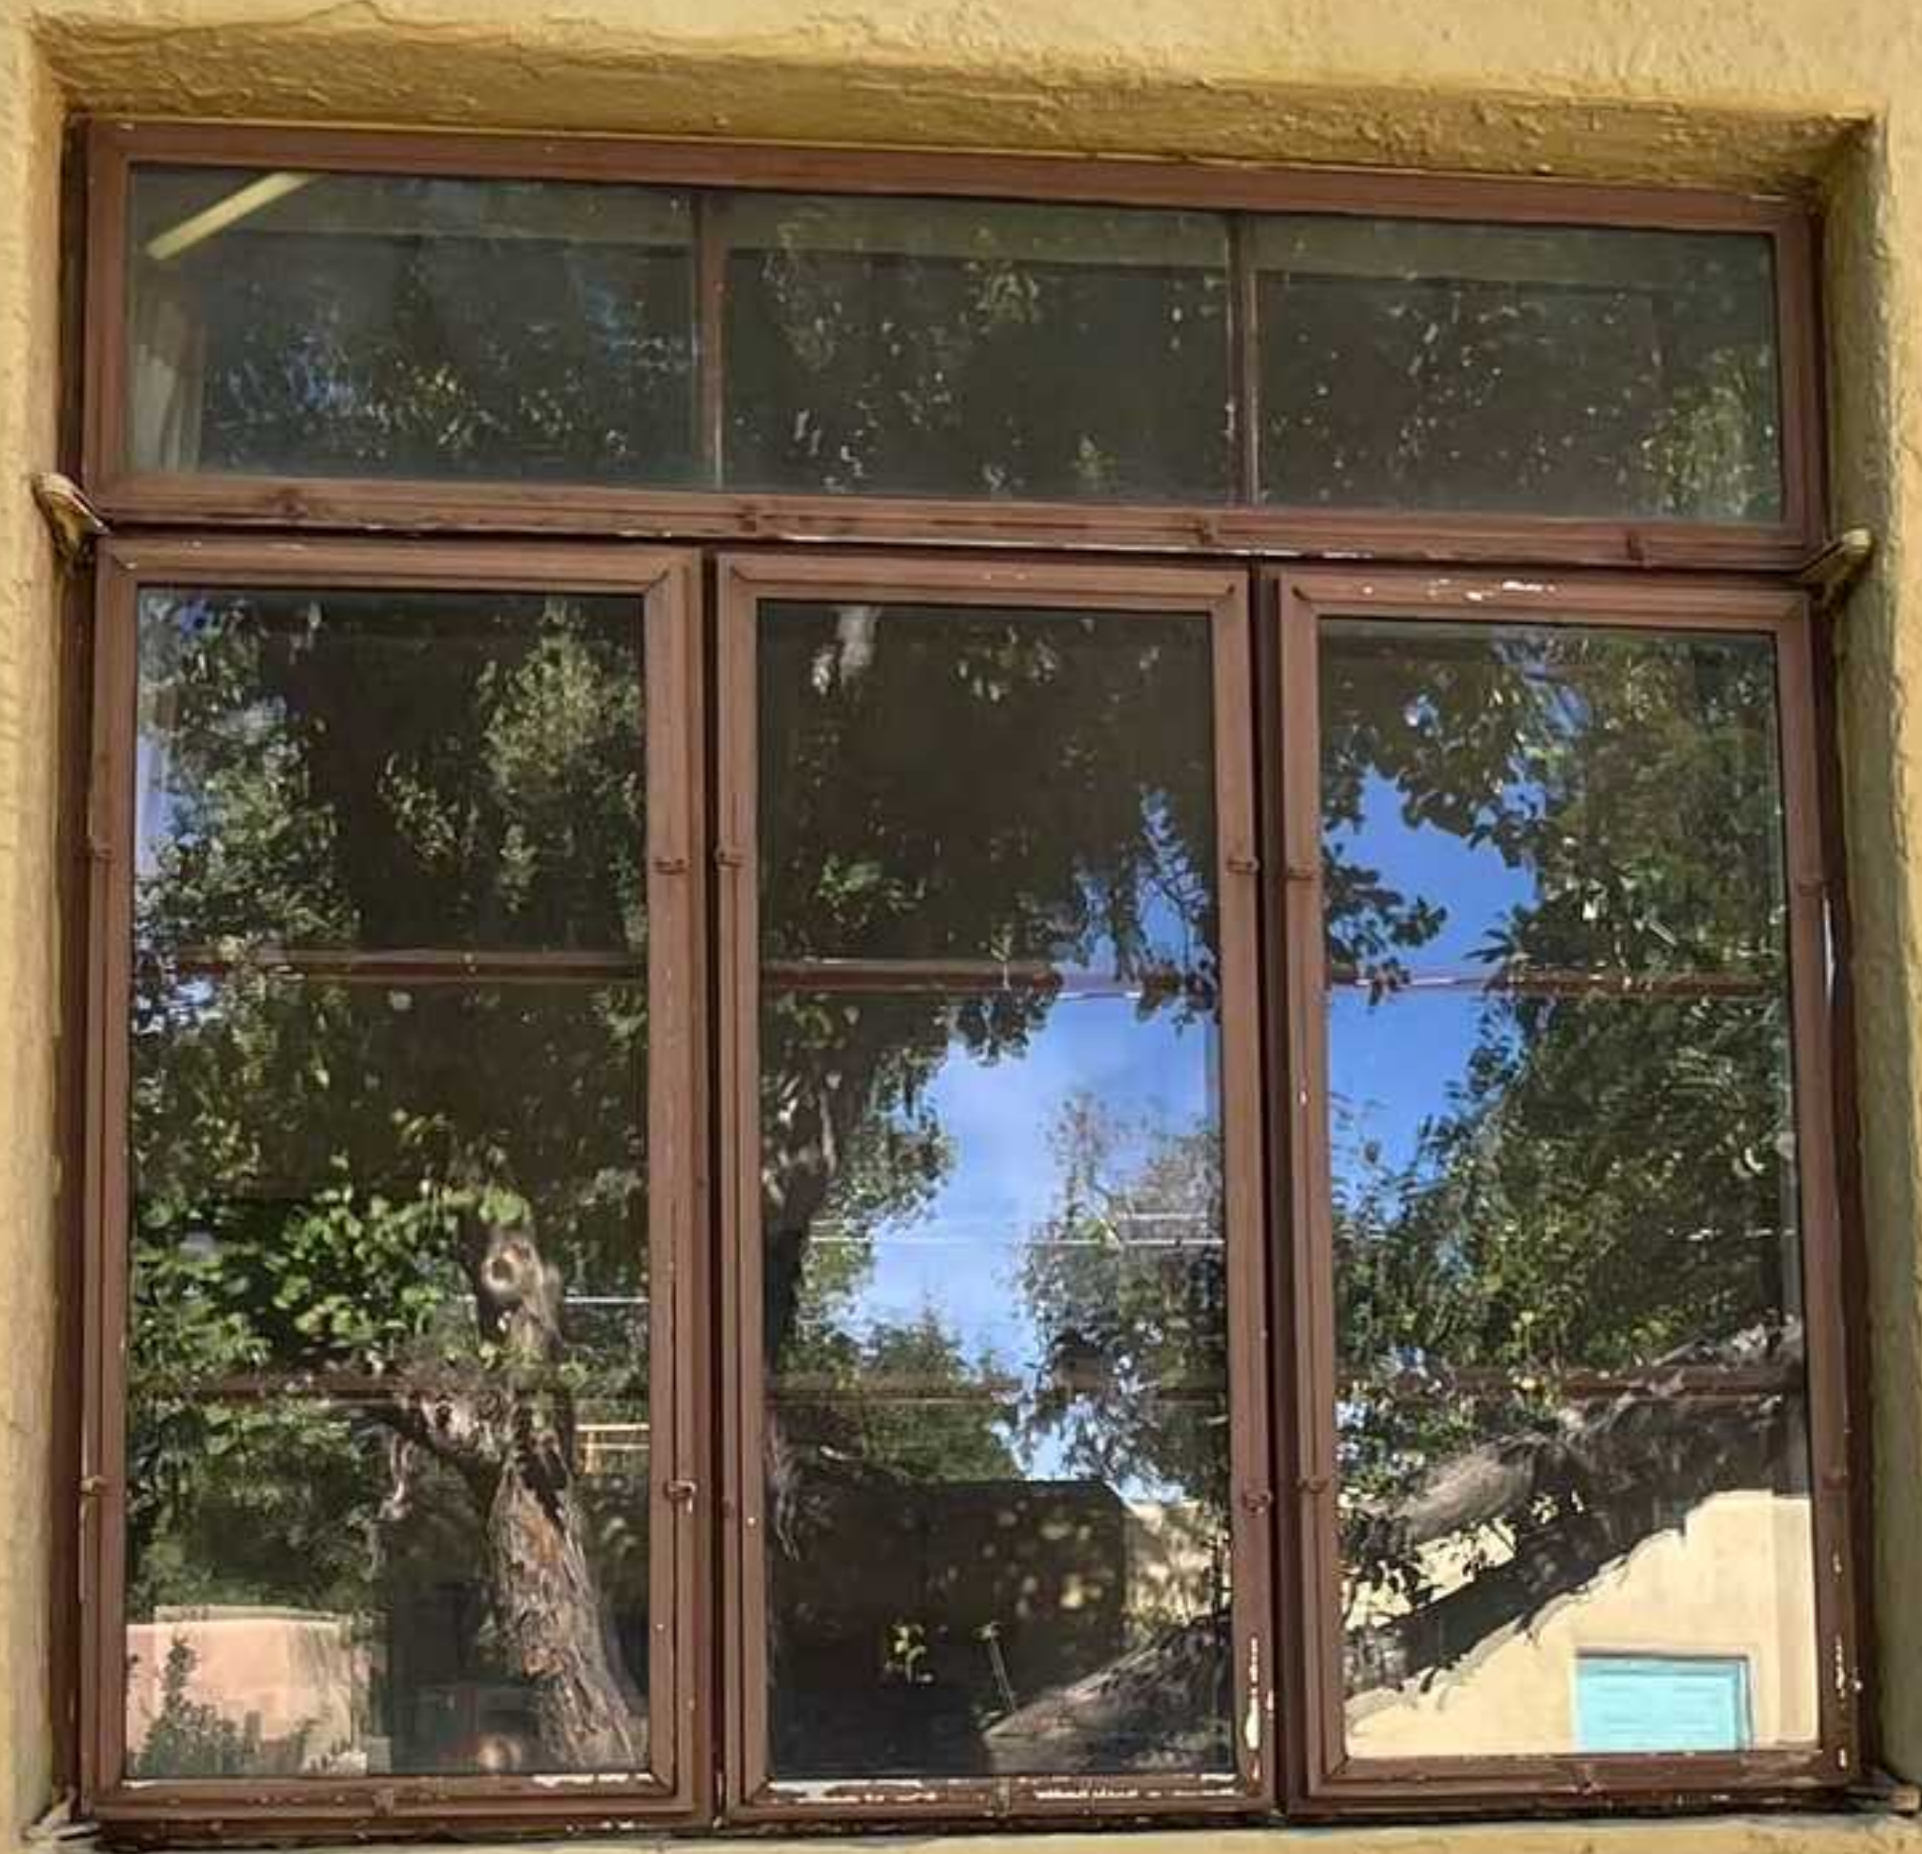
West
Elevation
Window
L

LABEL	WINDOW & DOOR DESCRIPTION	CONDITION & INTEGRITY CODE	HISTORIC/NON-HISTORIC – AGE
L	54" x 50" LSR STEEL CASEMENT (54" x 38"/12 TRANSOM) ^{3W1H/1W3H/1W3H/1W3H}	F	HISTORIC – METAL HAS RUSTED EXCESSIVE CONDENSATION TO THE STEEL CAUSING PLASTER DAMAGE. THERE IS EVIDENCE OF LEAKING IN THE WALL STRUCTURE.
	GREENHOUSE DETACHED	F	NON-HISTORIC – (1995)
GARAGE			
G-DR #5	32" x 80" LH INSWING 6-PANEL METAL DOOR WITH FINGER JOINTED JAMB	S	NON-HISTORIC – (2008)
G-DR #6	32" x 80" RH INSWING 6-PANEL METAL DOOR WITH FINGER JOINTED JAMB	S	NON-HISTORIC – (2008)
G-M	35" x 34" SINGLE HUNG BRONZE ALUMINUM SKOTTY	S	NON-HISTORIC – (1988)
G-N	84" x 48" PICTURE HUNG SLIDER MILL FINISH ALL ALUMINUM	S	NON-HISTORIC – (1977)
G-DR #7	36" x 80" RH FLUSH BIRCH SOLID CORE VENEER DOOR WITH WOOD JAMB	U	NON-HISTORIC – DOOR DELAMINATION
G-O	8" x 64" 1W8H GLASS BLOCK	S	NON-HISTORIC – (2010)

It would be my opinion to allow the owners of this residence to replace with clad/wood and divided lite to match the configuration of the existing steel casements of that era.
