# Historic Cultural Properties Inventory (HCPI) Base Form (FORM 1)

For HPD Office use only: HCPI No. _____ District No. _____ NRHP ___ SRCP ___ Criteria ___A___B___C___D		
1. Name of property: 619 West Alameda	2. Location: 619 West Alameda, Santa Fe, NM	3. Local Reference Number: Santa Fe ID #:

14. Setting: ___Suburban ___Rural ___Village ___X___Urban If Urban: ___Commercial ___Industrial ___X___Residential ___Public		
15. Relationship to Surroundings: ___X___Similar ___Dissimilar Comments: N/A

**PROJECT** 2025-010664-HDRB, 619 W Alameda St., Westside-Guadalupe Historic District,  
**DESC:** non-contributing, Dura Build Construction, agent for Max Scott, owner, requests a historic status review with primary facade(s) designation, if applicable, for a residential structure.

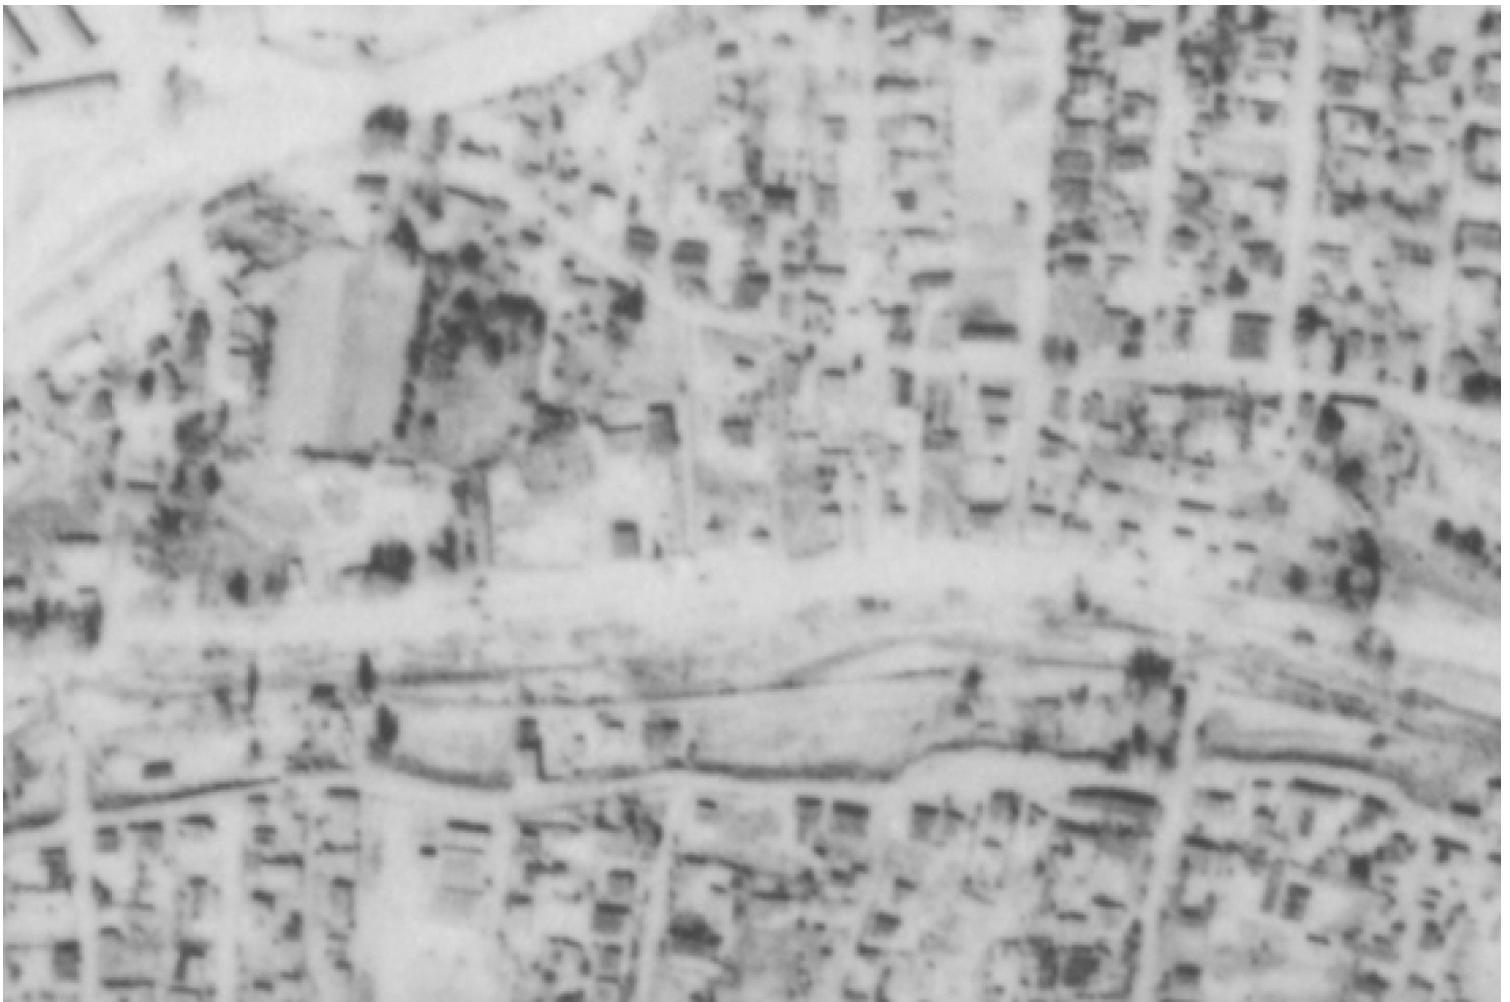
Aerial photography, documenting the property, was obtained from the City of Santa Fe, the UNM Earth Data Analysis Center, and Google Maps. The earliest image, dated 1935, is too low resolution to be useful. A 1948 image is also low resolution, but appears to show a building on the property. However, its shape cannot be discerned. An image from 1951 clearly shows a building, which appears to be a square, suggesting the pen tile addition had been constructed by this time. The building footprint does not change in several photos from the 1960’s. The wood framed addition first shows up in a 1975 photo, and remains there in photos up to and including a dated May of 2023.

Aerial view – 1948 – appears to show a building on the property
