RPA & Associates LLC

JOB	DATE
1121 Paseo de Peralta, Santa Fe, NM 87501	01/22/2026

RPA & ASSOCIATES, LLC | WINDOW & DOOR CONDITION AND INTEGRITY CODES

JOB	DATE
1123 Paseo de Peralta, Santa Fe, NM 87501	01/22/2026

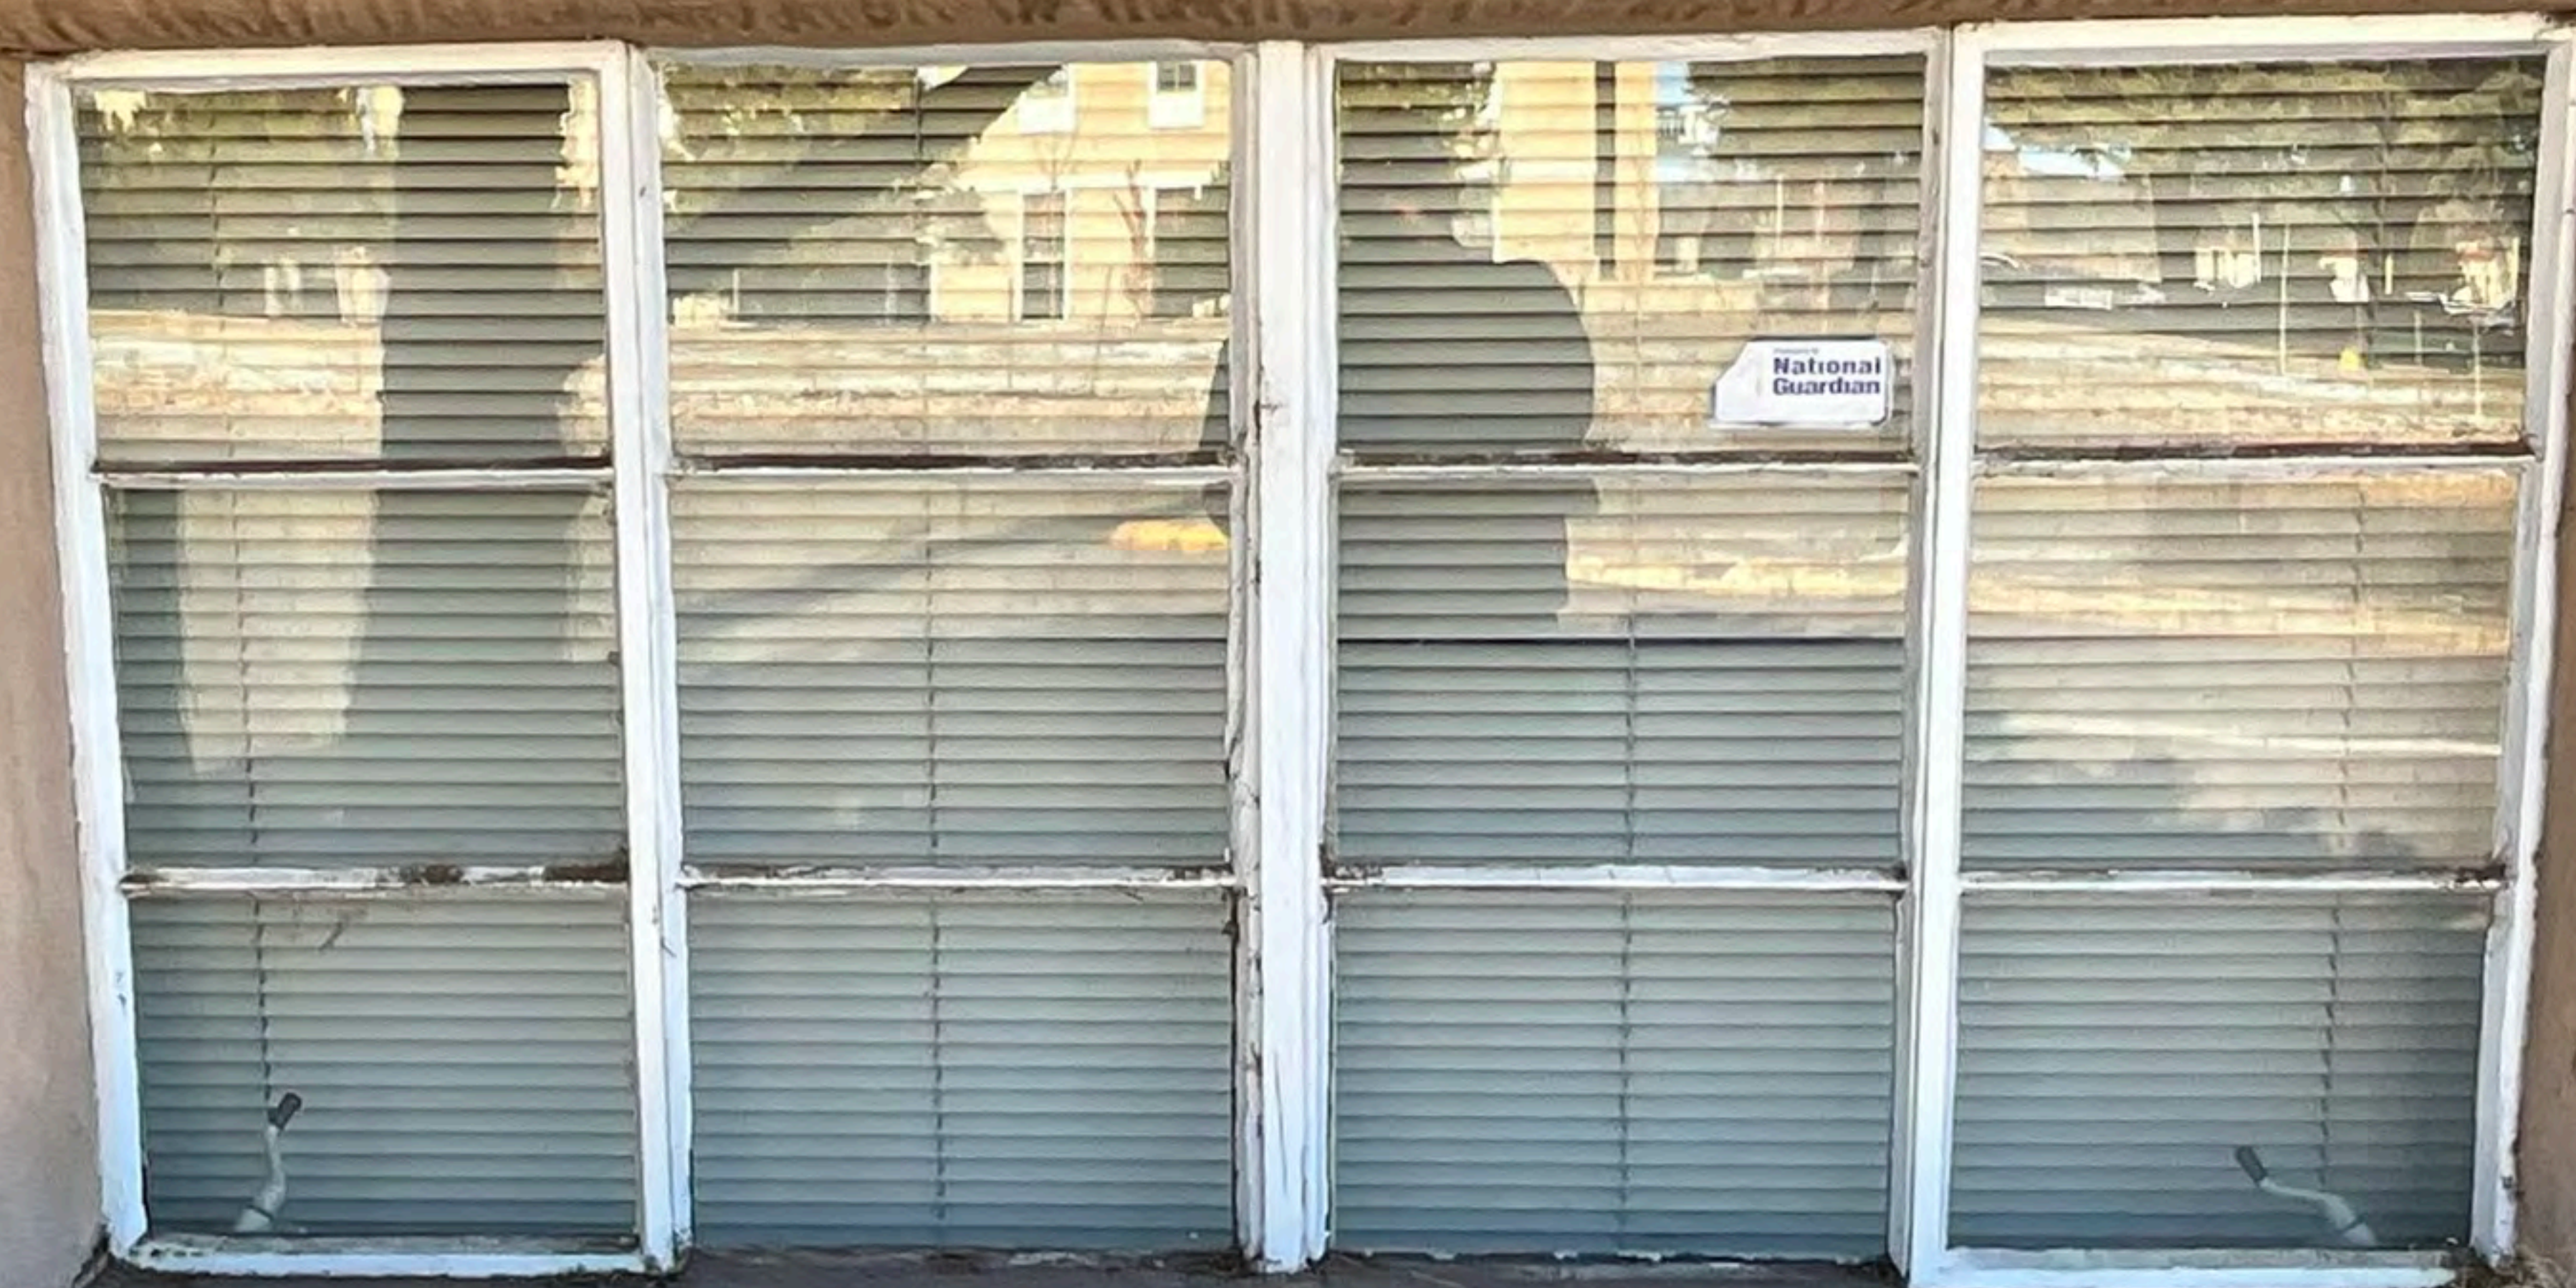
North
Elevation
Window
A

Windows A & B are historic.

LABEL	WINDOW & DOOR DESCRIPTION	CONDITION & INTEGRITY CODE	HISTORIC/NON-HISTORIC - AGE
<u>NORTH</u>			
A	72" x 36" LSSR STEEL CASEMENT 1W3H	F	HISTORIC – NOT THE ORIGINAL WINDOW OF THE BUILDING ERA, SEVERE SILL DAMAGE FROM CONDENSATION, ESPECIALLY ON THE NORTH SIDE BEING THAT IT IS STEEL
<u>WEST</u>			
B	68" x 49" FIXED/LSSR 68" x 37" LSSR 1W3H/68" x 12" TRANSOM 4W1H STEEL CASEMENT	F	HISTORIC – NOT ORIGINAL WINDOW OF THE BUILDING ERA, SILL DAMAGE FROM CONDENSATION OF THE STEEL SILL FRAME BURIED IN THE STUCCO
DR #1	32" x 79" LH INSWING DOOR ALL WOOD 1 ¾" 32-PANEL	F	NON-HISTORIC – "SIMPSON" FIR MANUFACTURED DOOR (1996)
<u>NORTH</u>			
C	29" x 66" DOUBLE HUNG ALL WOOD 5W2H/1-LT	U	HISTORIC – WINDOW SILL IS ROTTED & STUCCOED OVER, SIGNS OF WATER PENETRATION BY EVIDENCE OF STAINING BELOW THE WINDOW, THIS UNIT WILL NEED TO BE REMOVED & REPAIRED
D	29" x 66" DOUBLE HUNG ALL WOOD 5W2H/1-LT	U	HISTORIC – WINDOW SILL IS ROTTED & STUCCOED OVER, SIGNS OF WATER PENETRATION BY EVIDENCE OF STAINING BELOW THE WINDOW, THIS UNIT WILL NEED TO BE REMOVED & REPAIRED

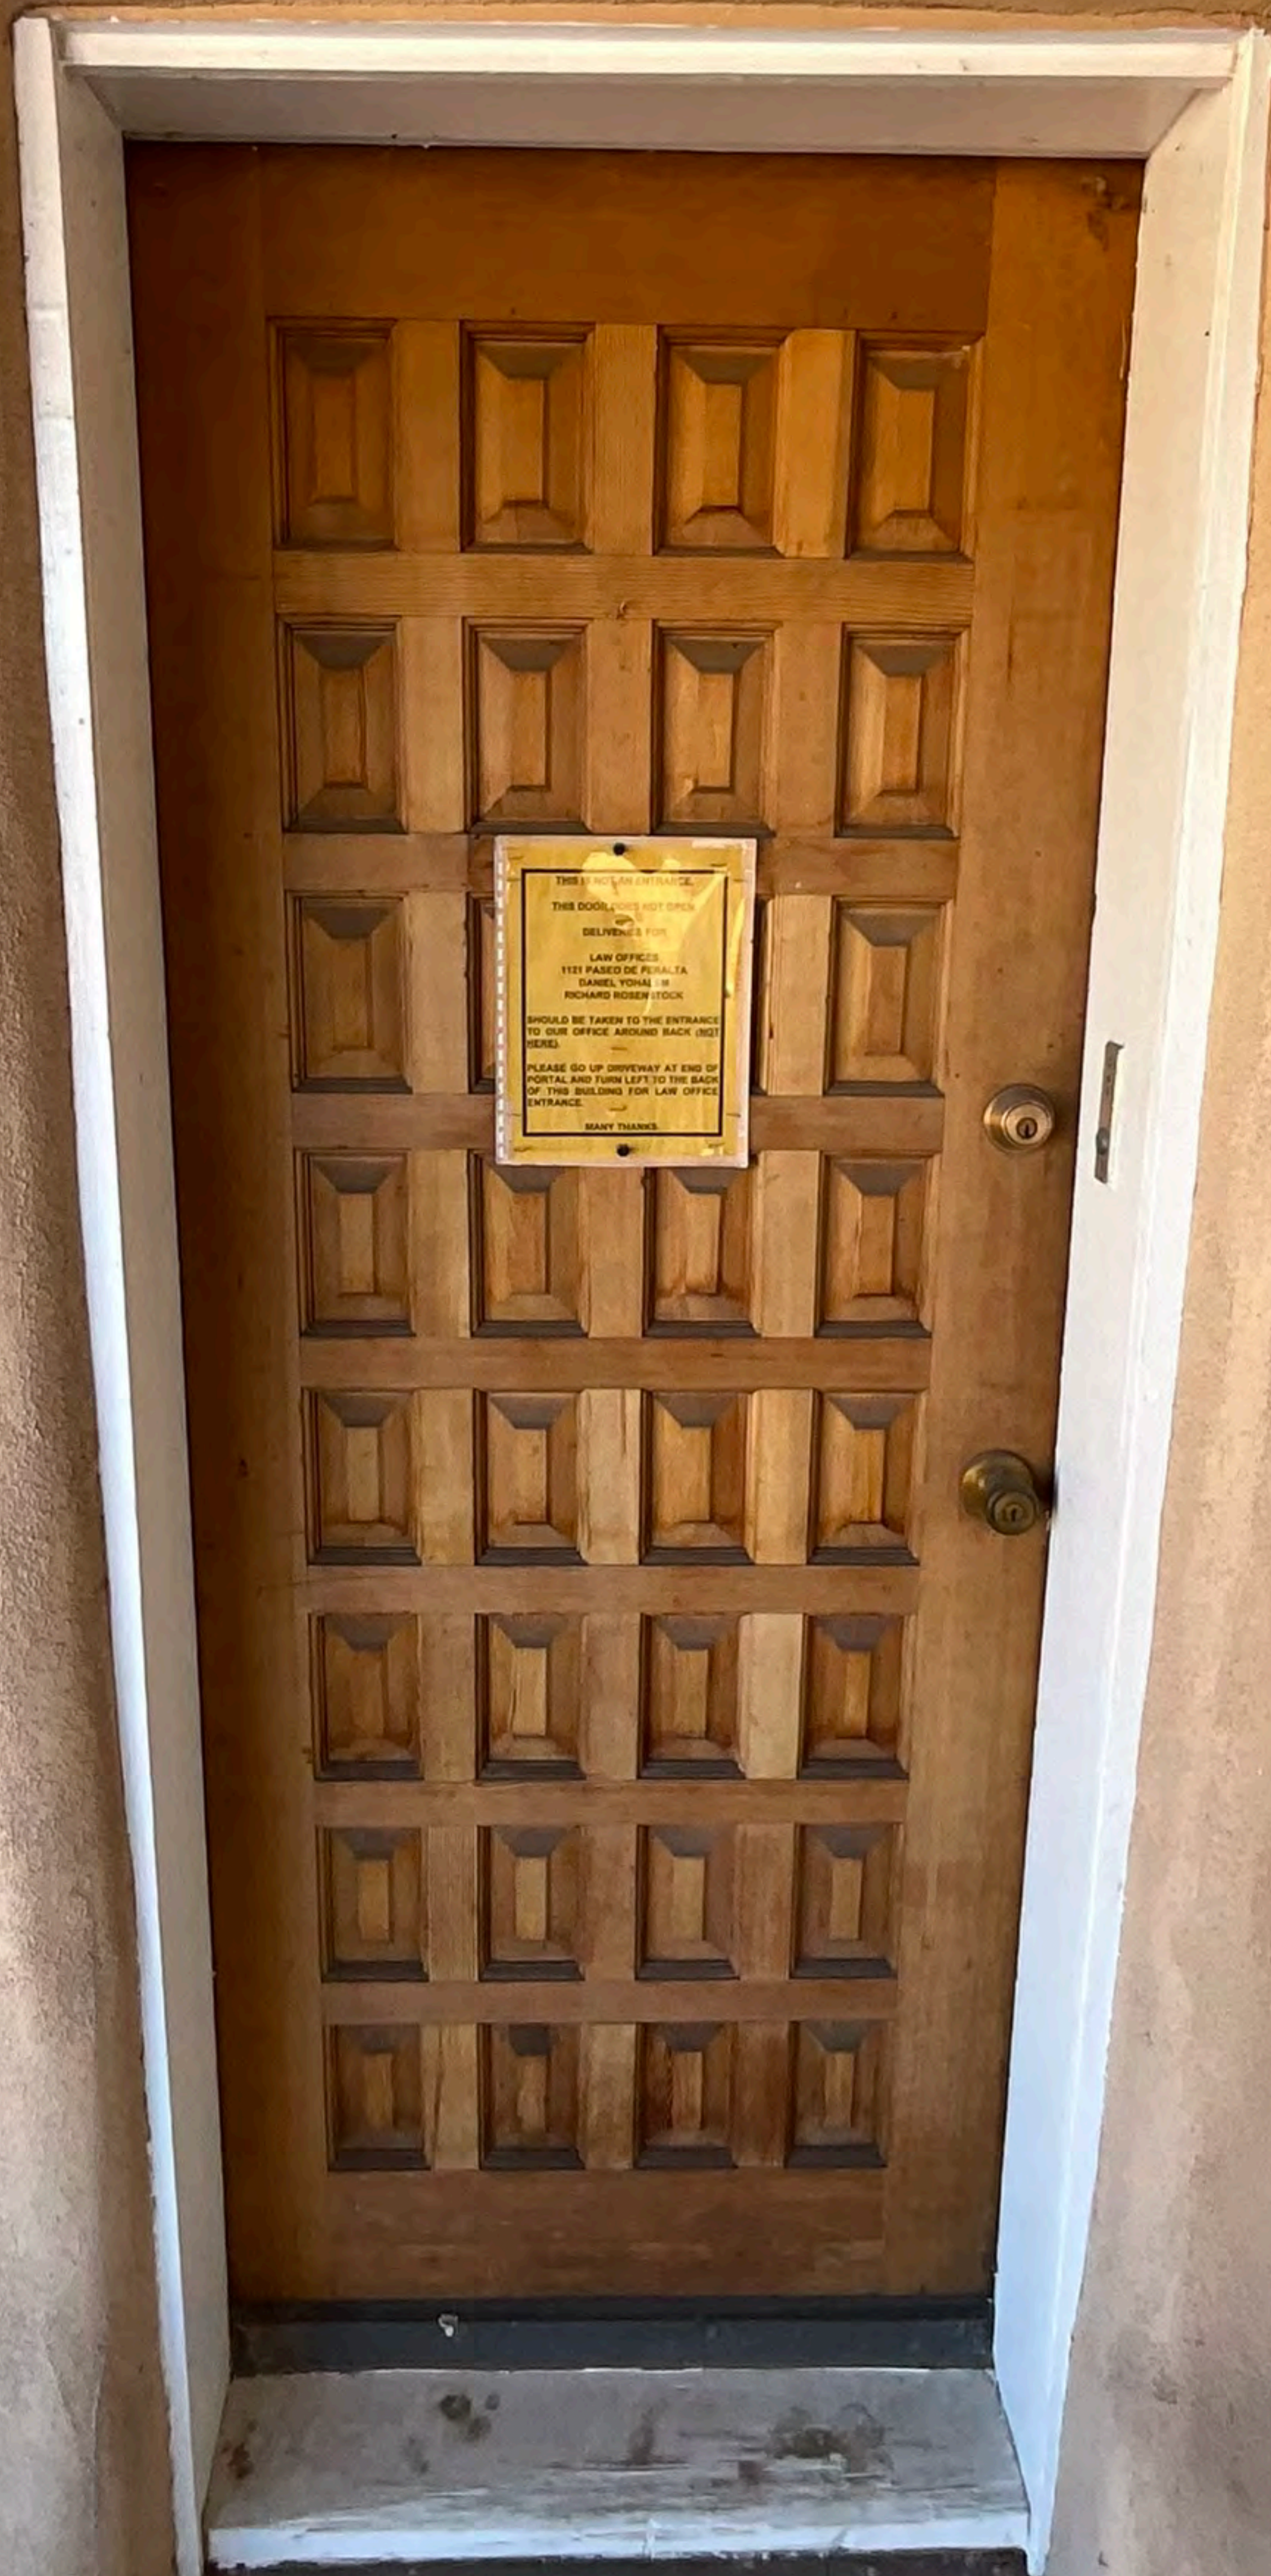
West
Elevation
Door
#1

Doors #1, #2, #3, #4, #6, #7, #8, and #9 are non-historic.

The windows and doors that are non-historic and unrestorable are to be replaced in “like and kind” to the windows of that era, wood divided lite (simulated or TDL), insulated Low-E glass (such as Kolbe or Weathershield manufactured). K-KRON would be a good alternative because of exterior low maintenance. K-KRON exterior has a 15-year warranty, whereas paint is approximately 3-5 years.

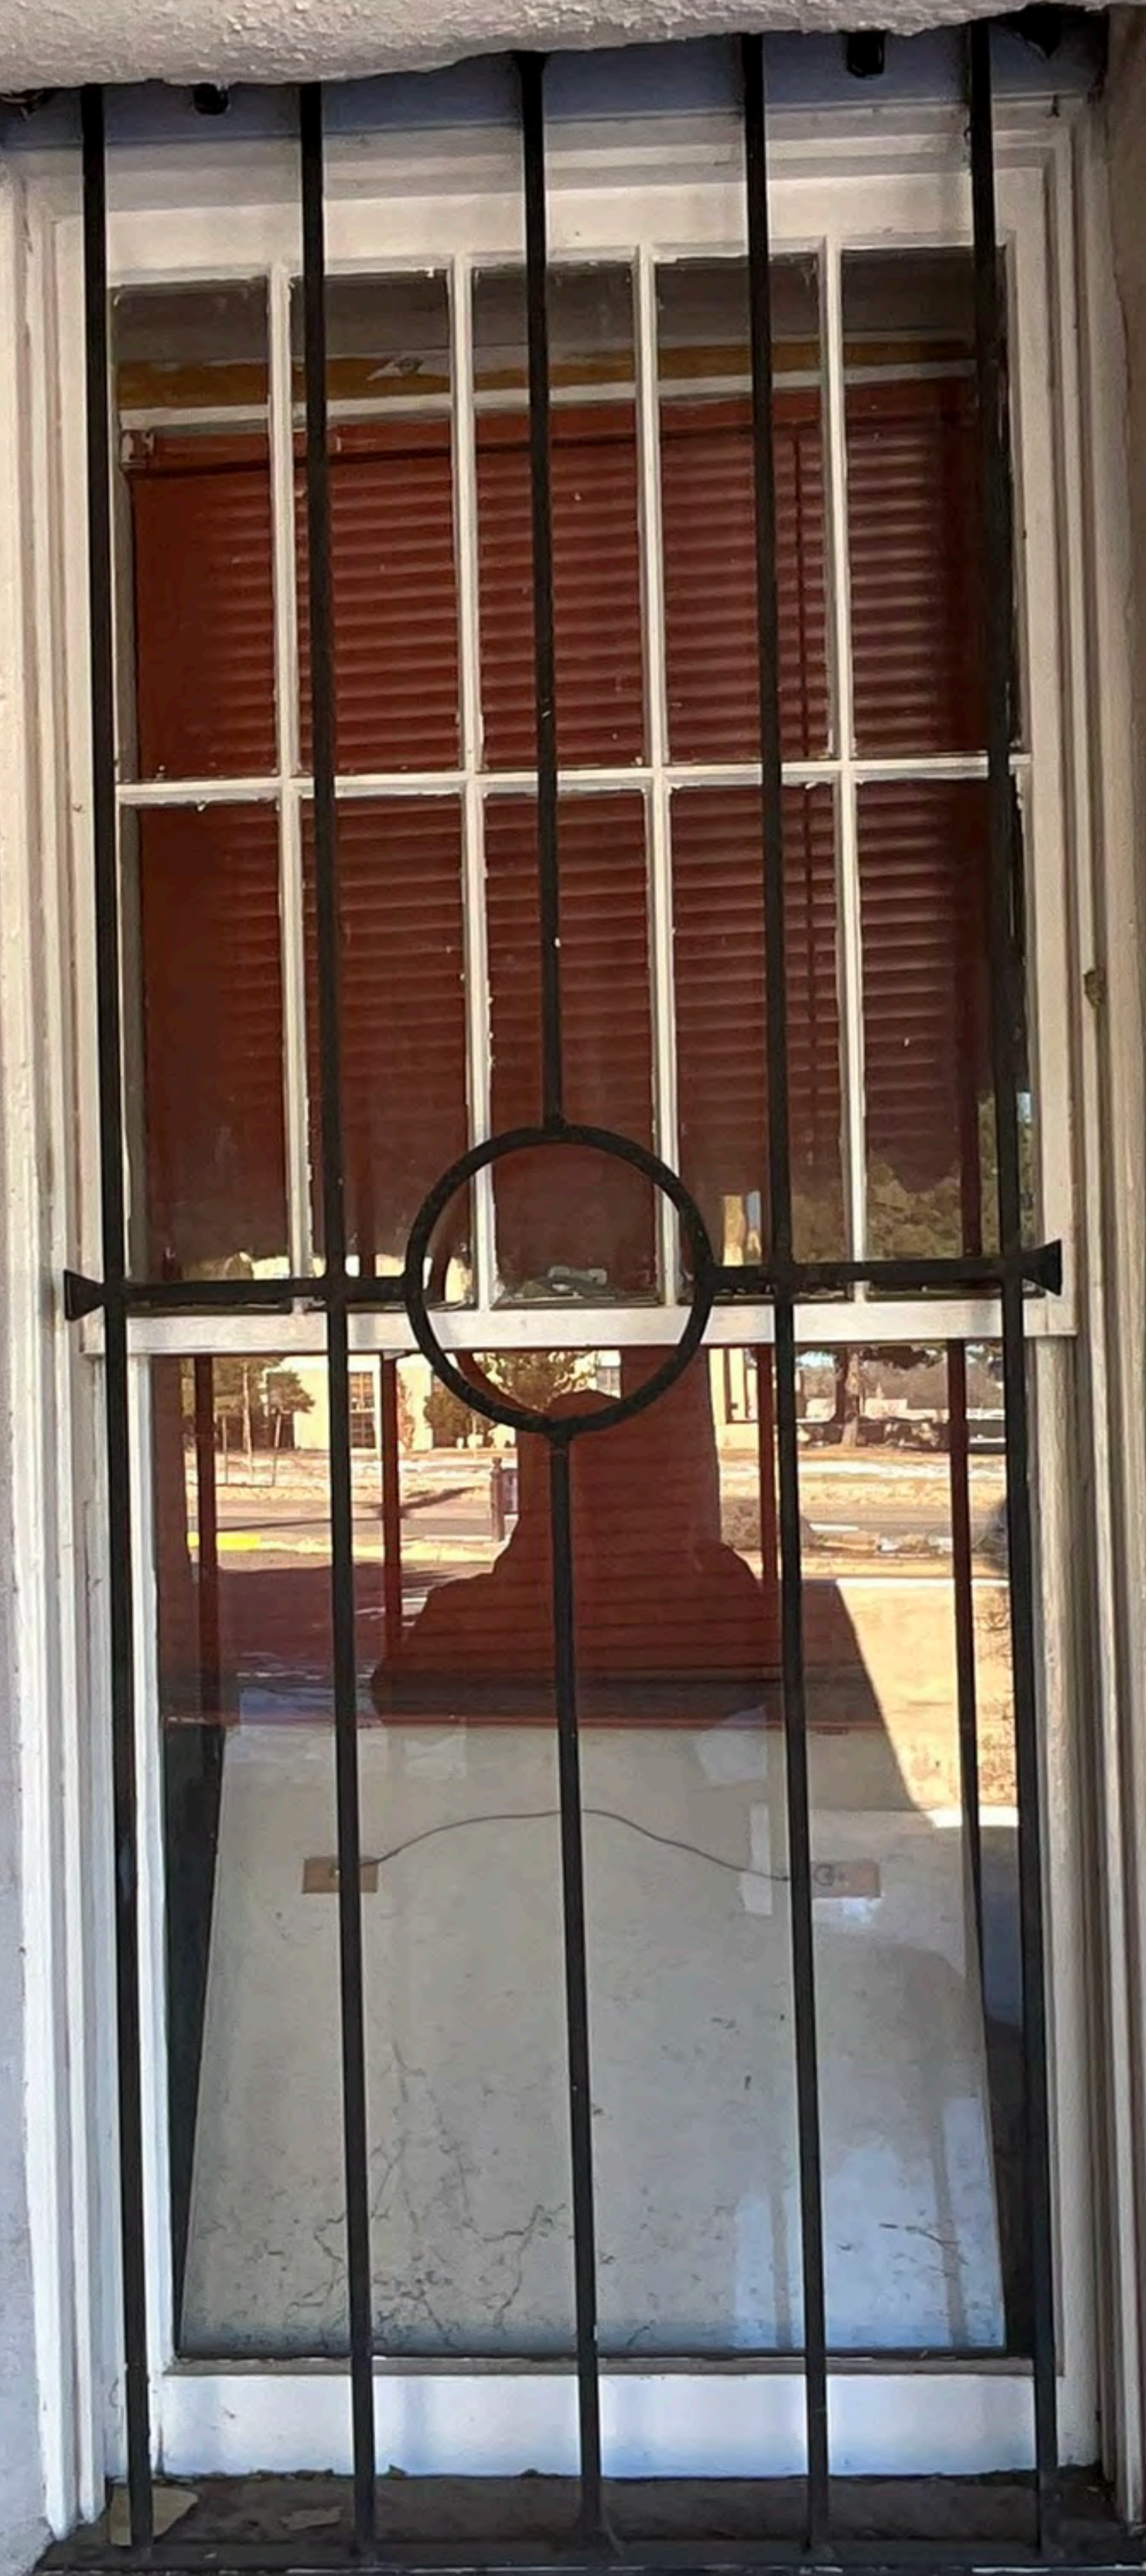
North
Elevation
Window
C

Windows C, D, E, and J are historic, but the units are unrestorable.

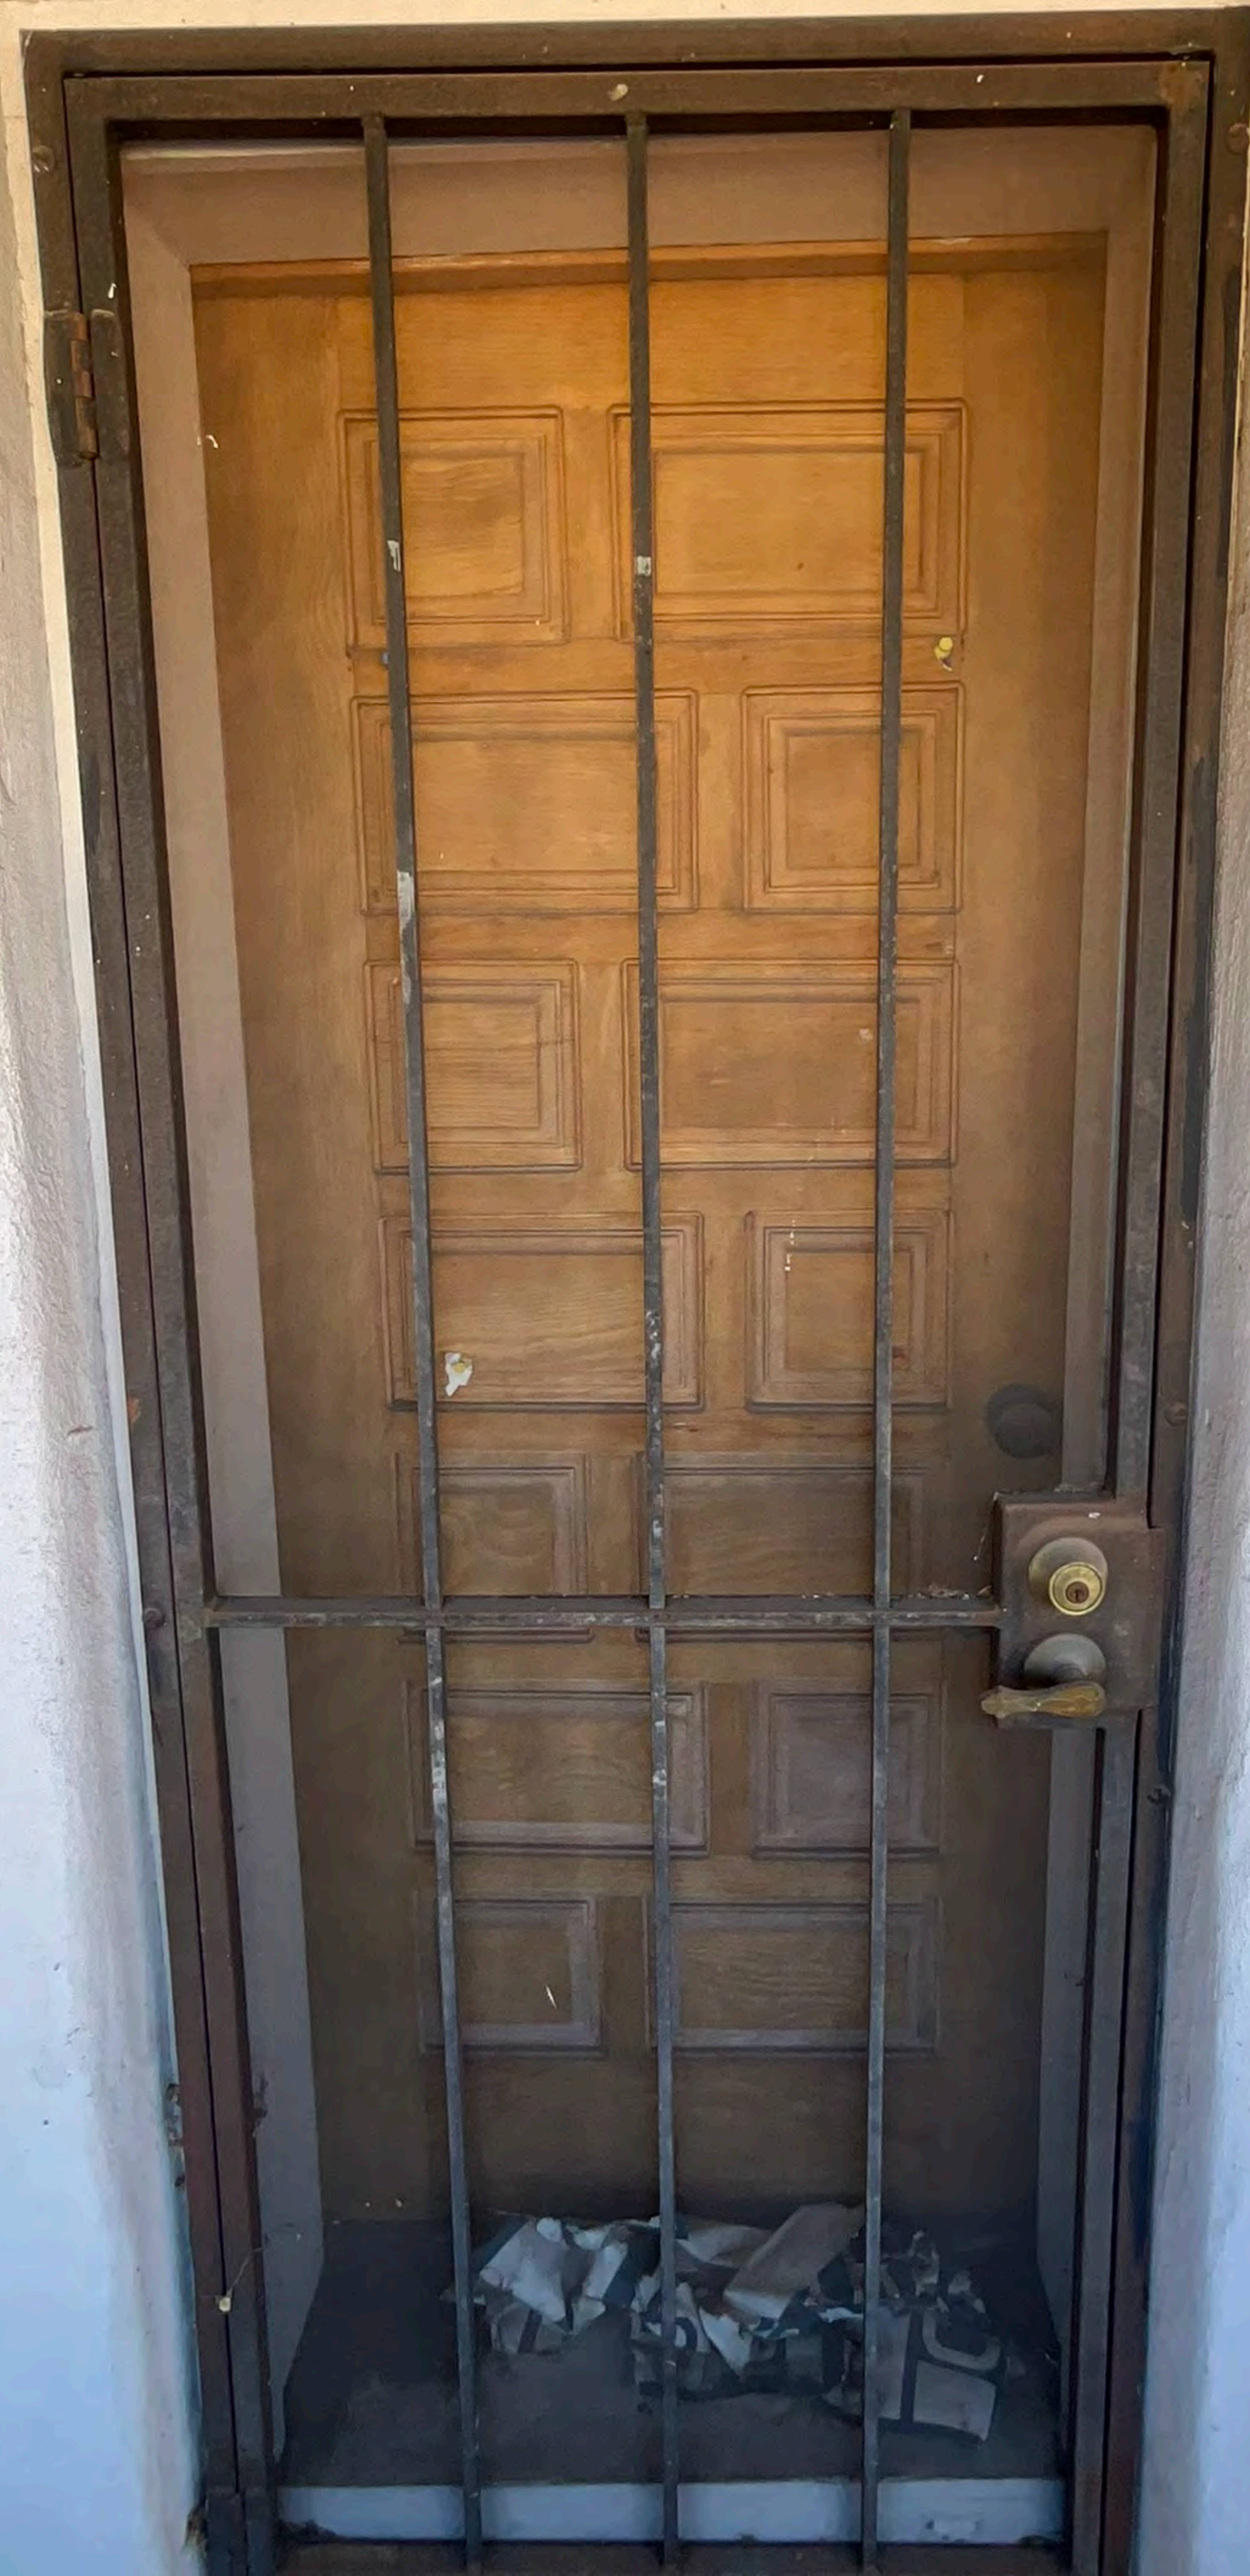
North
Elevation
Door
#2

LABEL	WINDOW & DOOR DESCRIPTION	CONDITION & INTEGRITY CODE	HISTORIC/NON-HISTORIC – AGE
<u>NORTH</u>			
DR #2	32" x 91" LH INSWING DOOR W/TRANSOM OA ALL WOOD 1 3/4" 14-PANEL 32" x 80" DOOR W/32" x 11" TRANSOM ABOVE	F	NON-HISTORIC – "SIMPSON" FIR MANUFACTURED DOOR (1996)
DR #3	32" x 91" LH INSWING DOOR W/TRANSOM OA ALL WOOD 1 3/4" 14-PANEL 32" x 80" DOOR W/32" x 11" TRANSOM ABOVE	F	NON-HISTORIC – "SIMPSON" FIR MANUFACTURED DOOR (1996)
E	29" x 66" DOUBLE HUNG ALL WOOD 5W2H/1-LT	U	HISTORIC – WINDOW SILL IS ROTTED & STUCCOED OVER, SIGNS OF WATER PENETRATION BY EVIDENCE OF STAINING BELOW THE WINDOW, THIS UNIT WILL NEED TO BE REMOVED & REPAIRED
<u>WEST</u>			
F	24" x 77" – 2 <u>FIXED</u> – ALL WOOD 24" x 77" – 2 <u>FIXED</u> – ALL WOOD STOPPED IN GLAZING/MANUFACTURED QUARTER ROUND W/2 1/2" MACHINE ROUTERED CASING ON EXTERIOR	F	NON-HISTORIC – GLASS (1988)

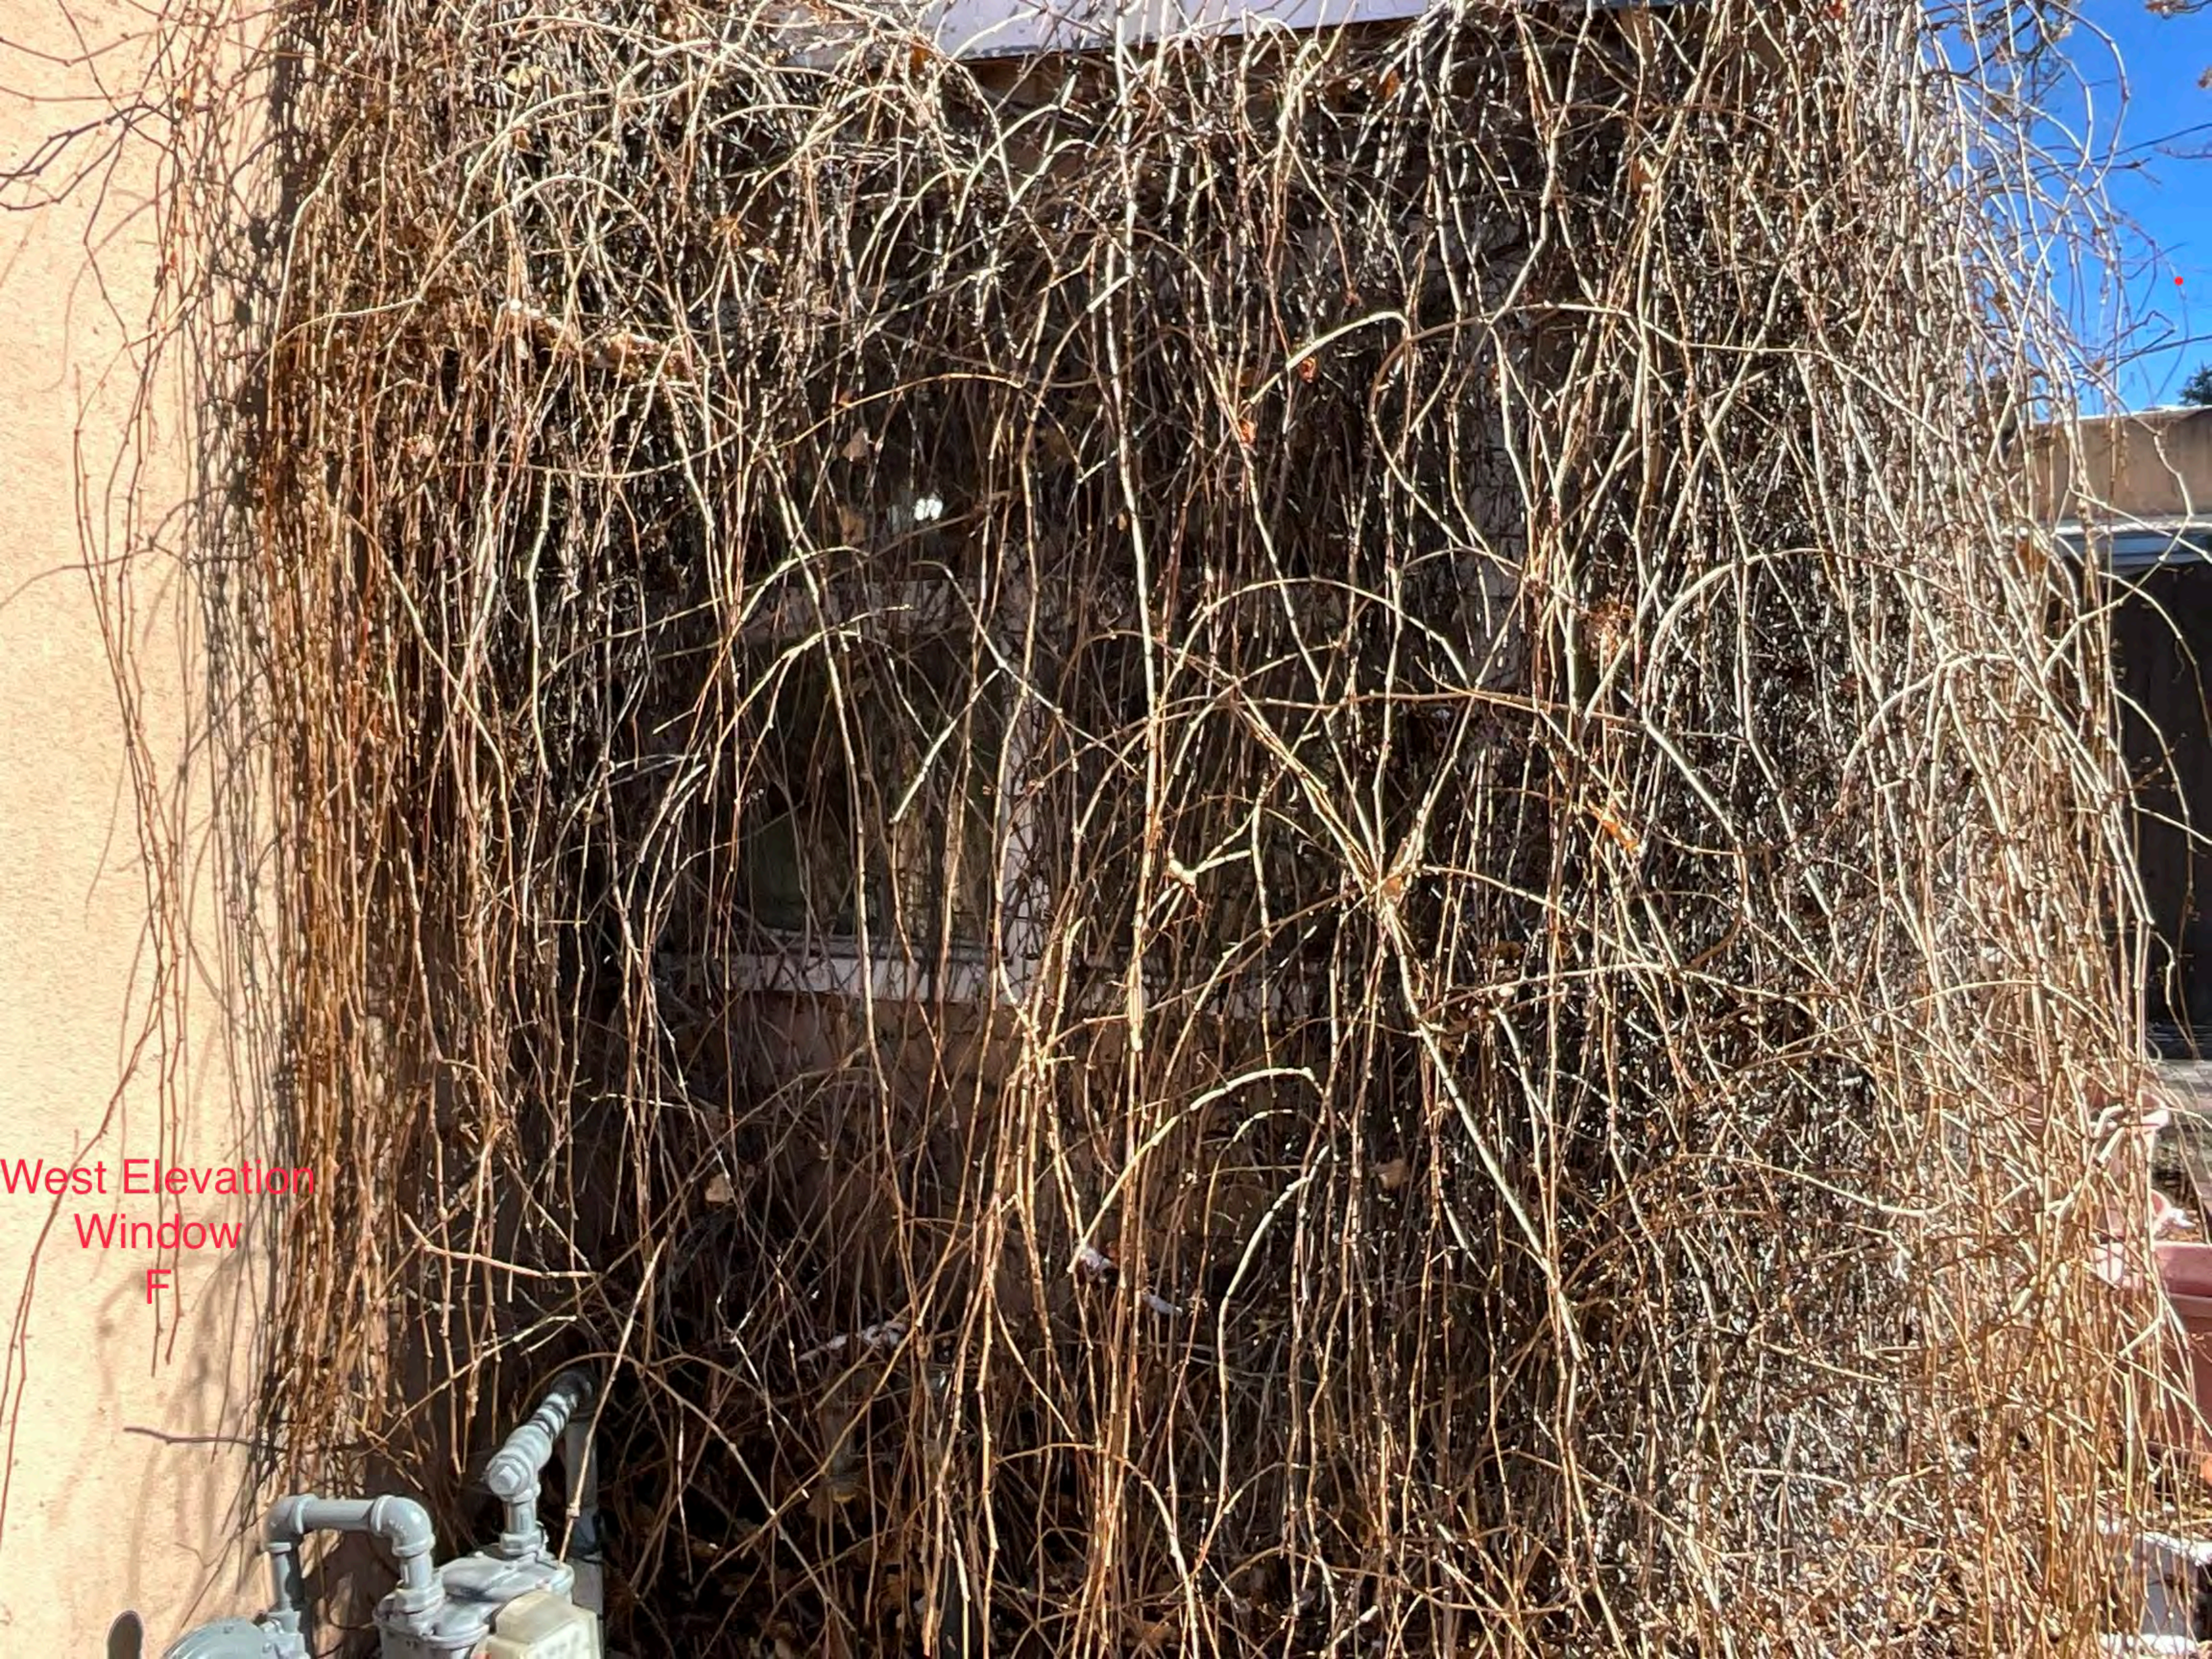
West Elevation
Window
F

Windows F, G, H, I, K, L, M, N, O, and P are non-historic.

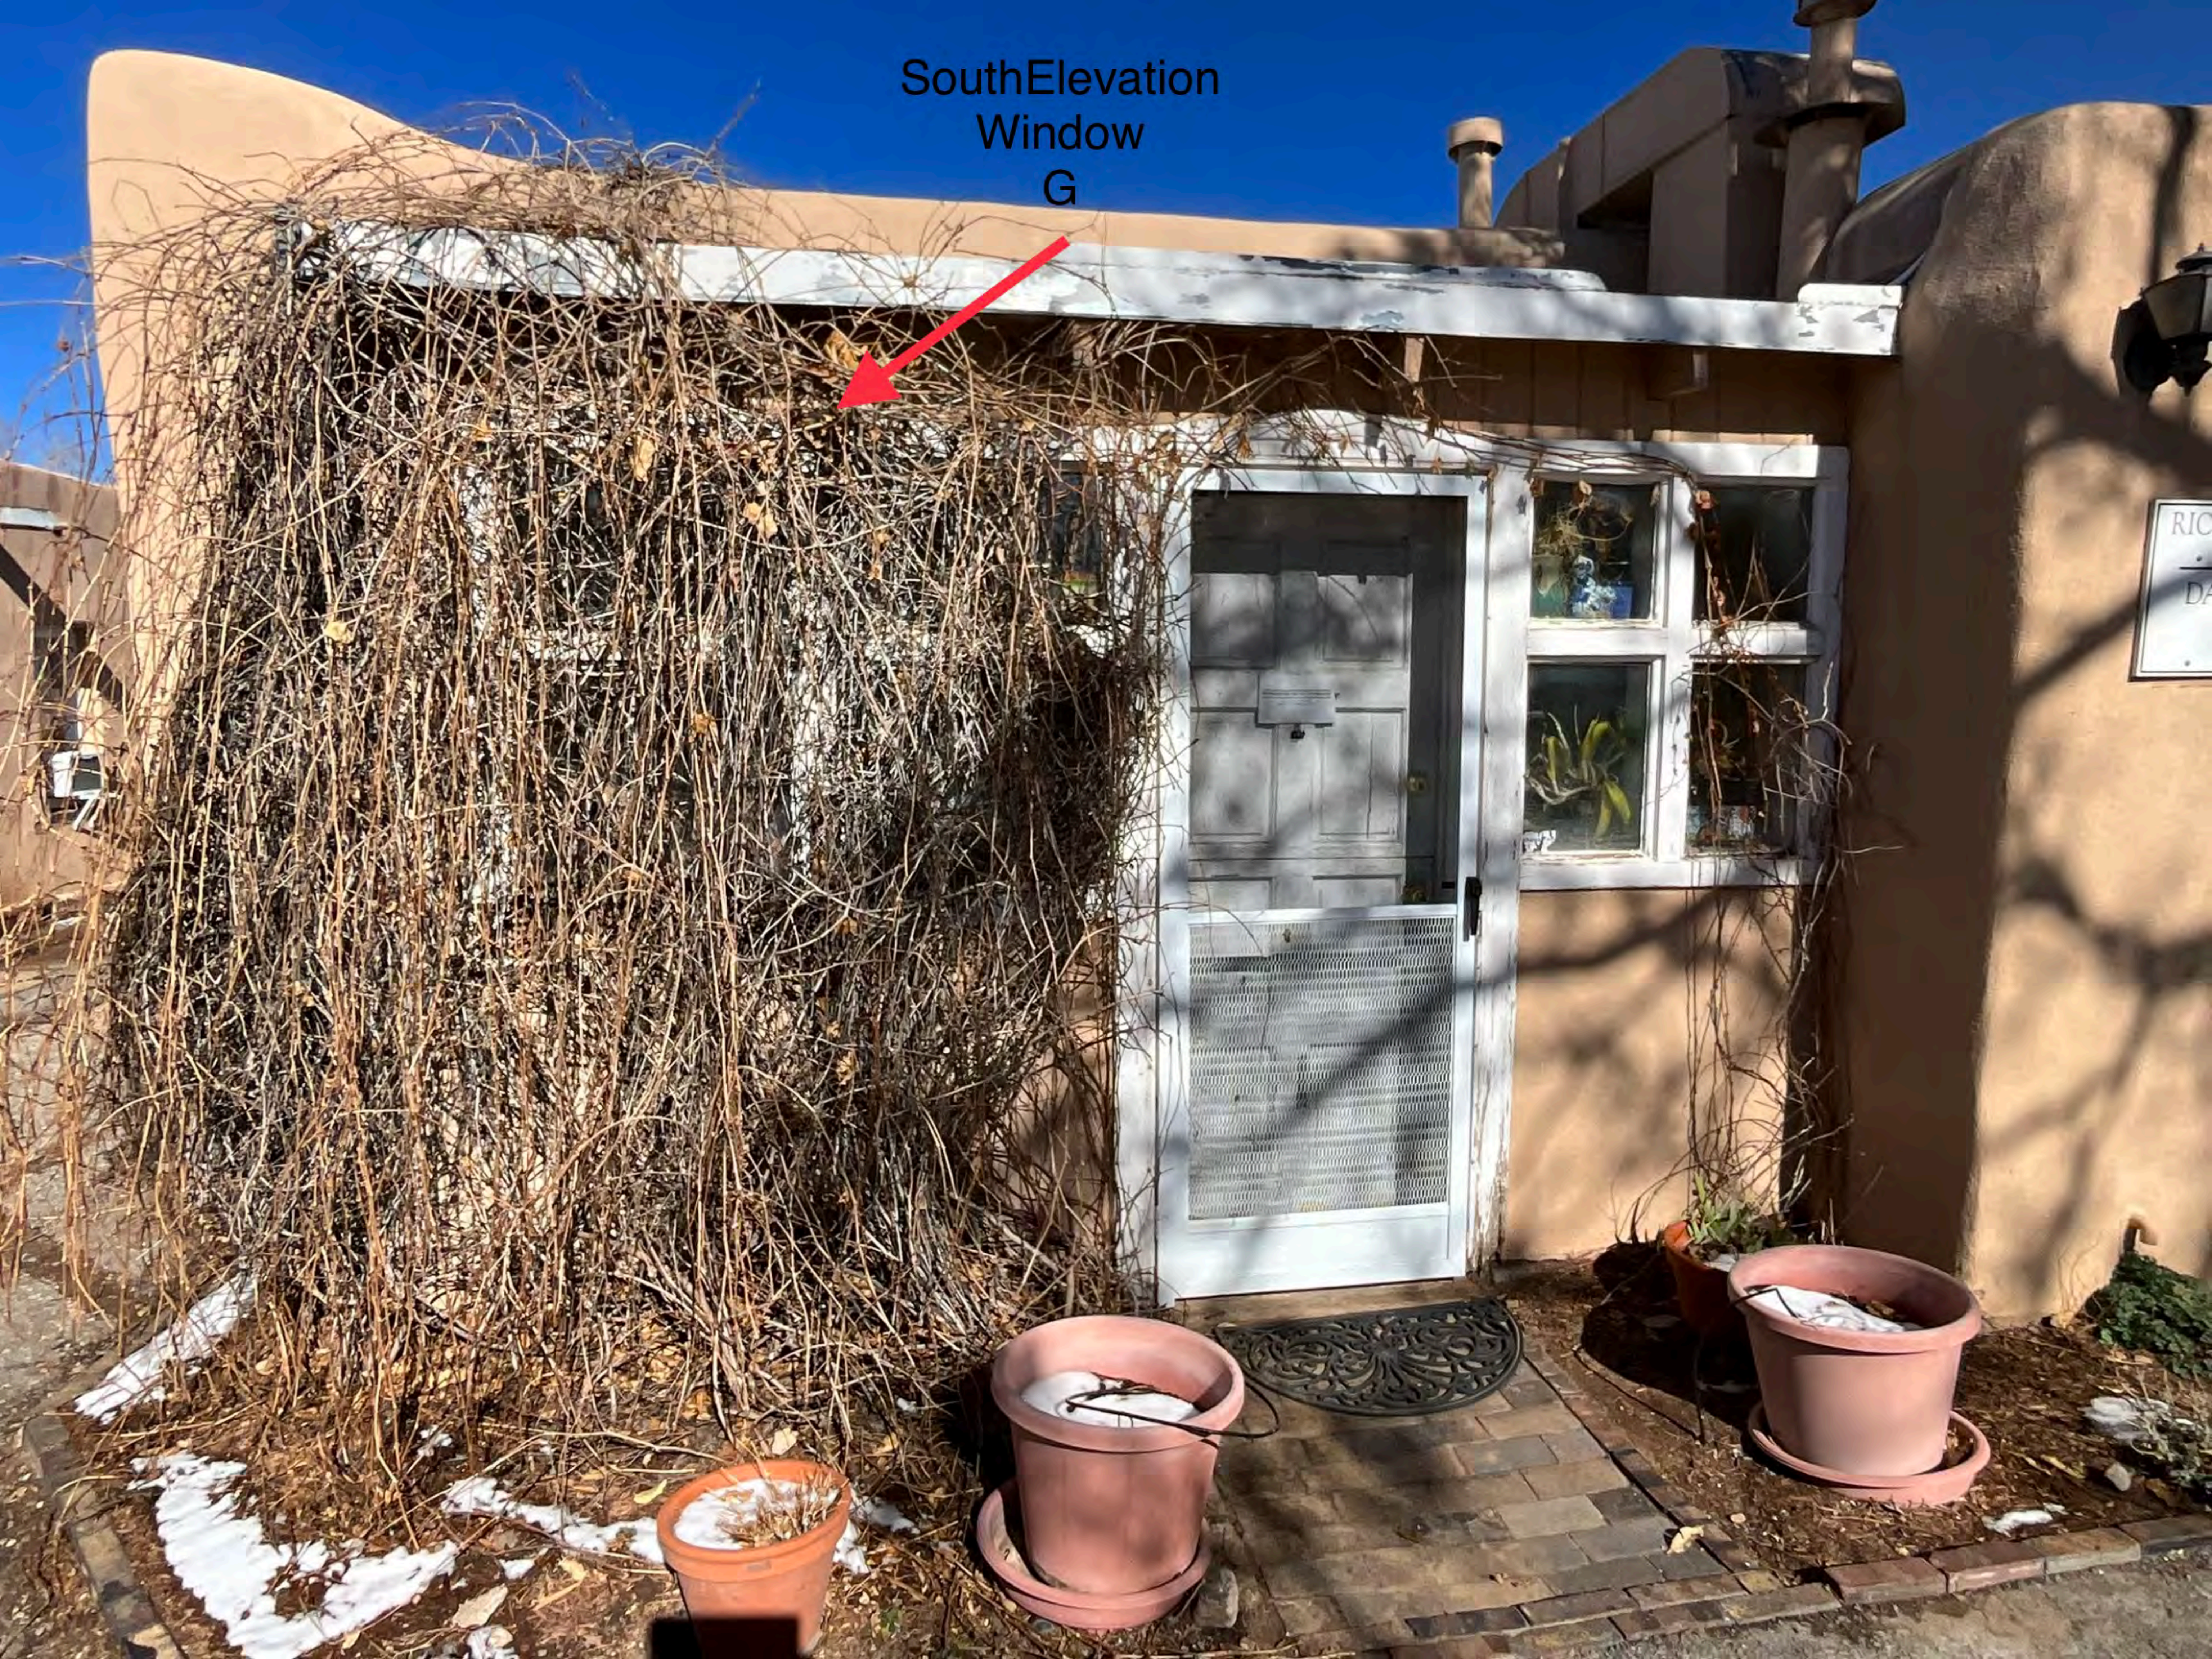
South Elevation
Window
G

LABEL	WINDOW & DOOR DESCRIPTION	CONDITION & INTEGRITY CODE	HISTORIC/NON-HISTORIC – AGE
<u>SOUTH</u>			
G	24" x 77" – 2 <u>FIXED</u> – ALL WOOD 24" x 77" – 2 <u>FIXED</u> – ALL WOOD STOPPED IN GLAZING/MANUFACTURED QUARTER ROUND W/2 ½" MACHINE ROUTERED CASING ON EXTERIOR SILL COMPLETELY ROTTED	U	NON-HISTORIC – GLASS (1988)
DR #4	32" x 80" LH DUTCH DOOR ALL WOOD 8-PANEL	F	NON-HISTORIC – “SIMPSON” MANUFACTURED (1992)
H	18" x 16" – 2 <u>FIXED/FIXED</u> – ALL WOOD 18" x 26" – 2 <u>FIXED/FIXED</u> – ALL WOOD STOPPED IN GLAZING/MANUFACTURED QUARTER ROUND W/2 ½" MACHINE ROUTERED CASING ON EXTERIOR	F	NON-HISTORIC – GLASS (1988)
I	21" x 24" – 1 INSWING CASEMENT <u>FIXED</u> 2W2H 1 1/8" VERTICAL BAR W/5/8" HORIZONTAL BAR	U	NON-HISTORIC – BARN SASH (1987) EMPIRE BUILDERS SUPPLY
L	34" x 28" <u>FIXED</u> 3W2H ALL WOOD 5" FLAT CASING W/2" FLAT CASING APRON MITERED CORNERS BARN SASH	F	NON-HISTORIC – BARN SASH (1994) EMPIRE BUILDERS SUPPLY MITERED 45° CORNERS
