RPA & Associates LLC

JOB	DATE
1121 Paseo de Peralta, Santa Fe, NM 87501	01/22/2026

RPA & ASSOCIATES, LLC | WINDOW & DOOR CONDITION AND INTEGRITY CODES

JOB	DATE
1123 Paseo de Peralta, Santa Fe, NM 87501	01/22/2026

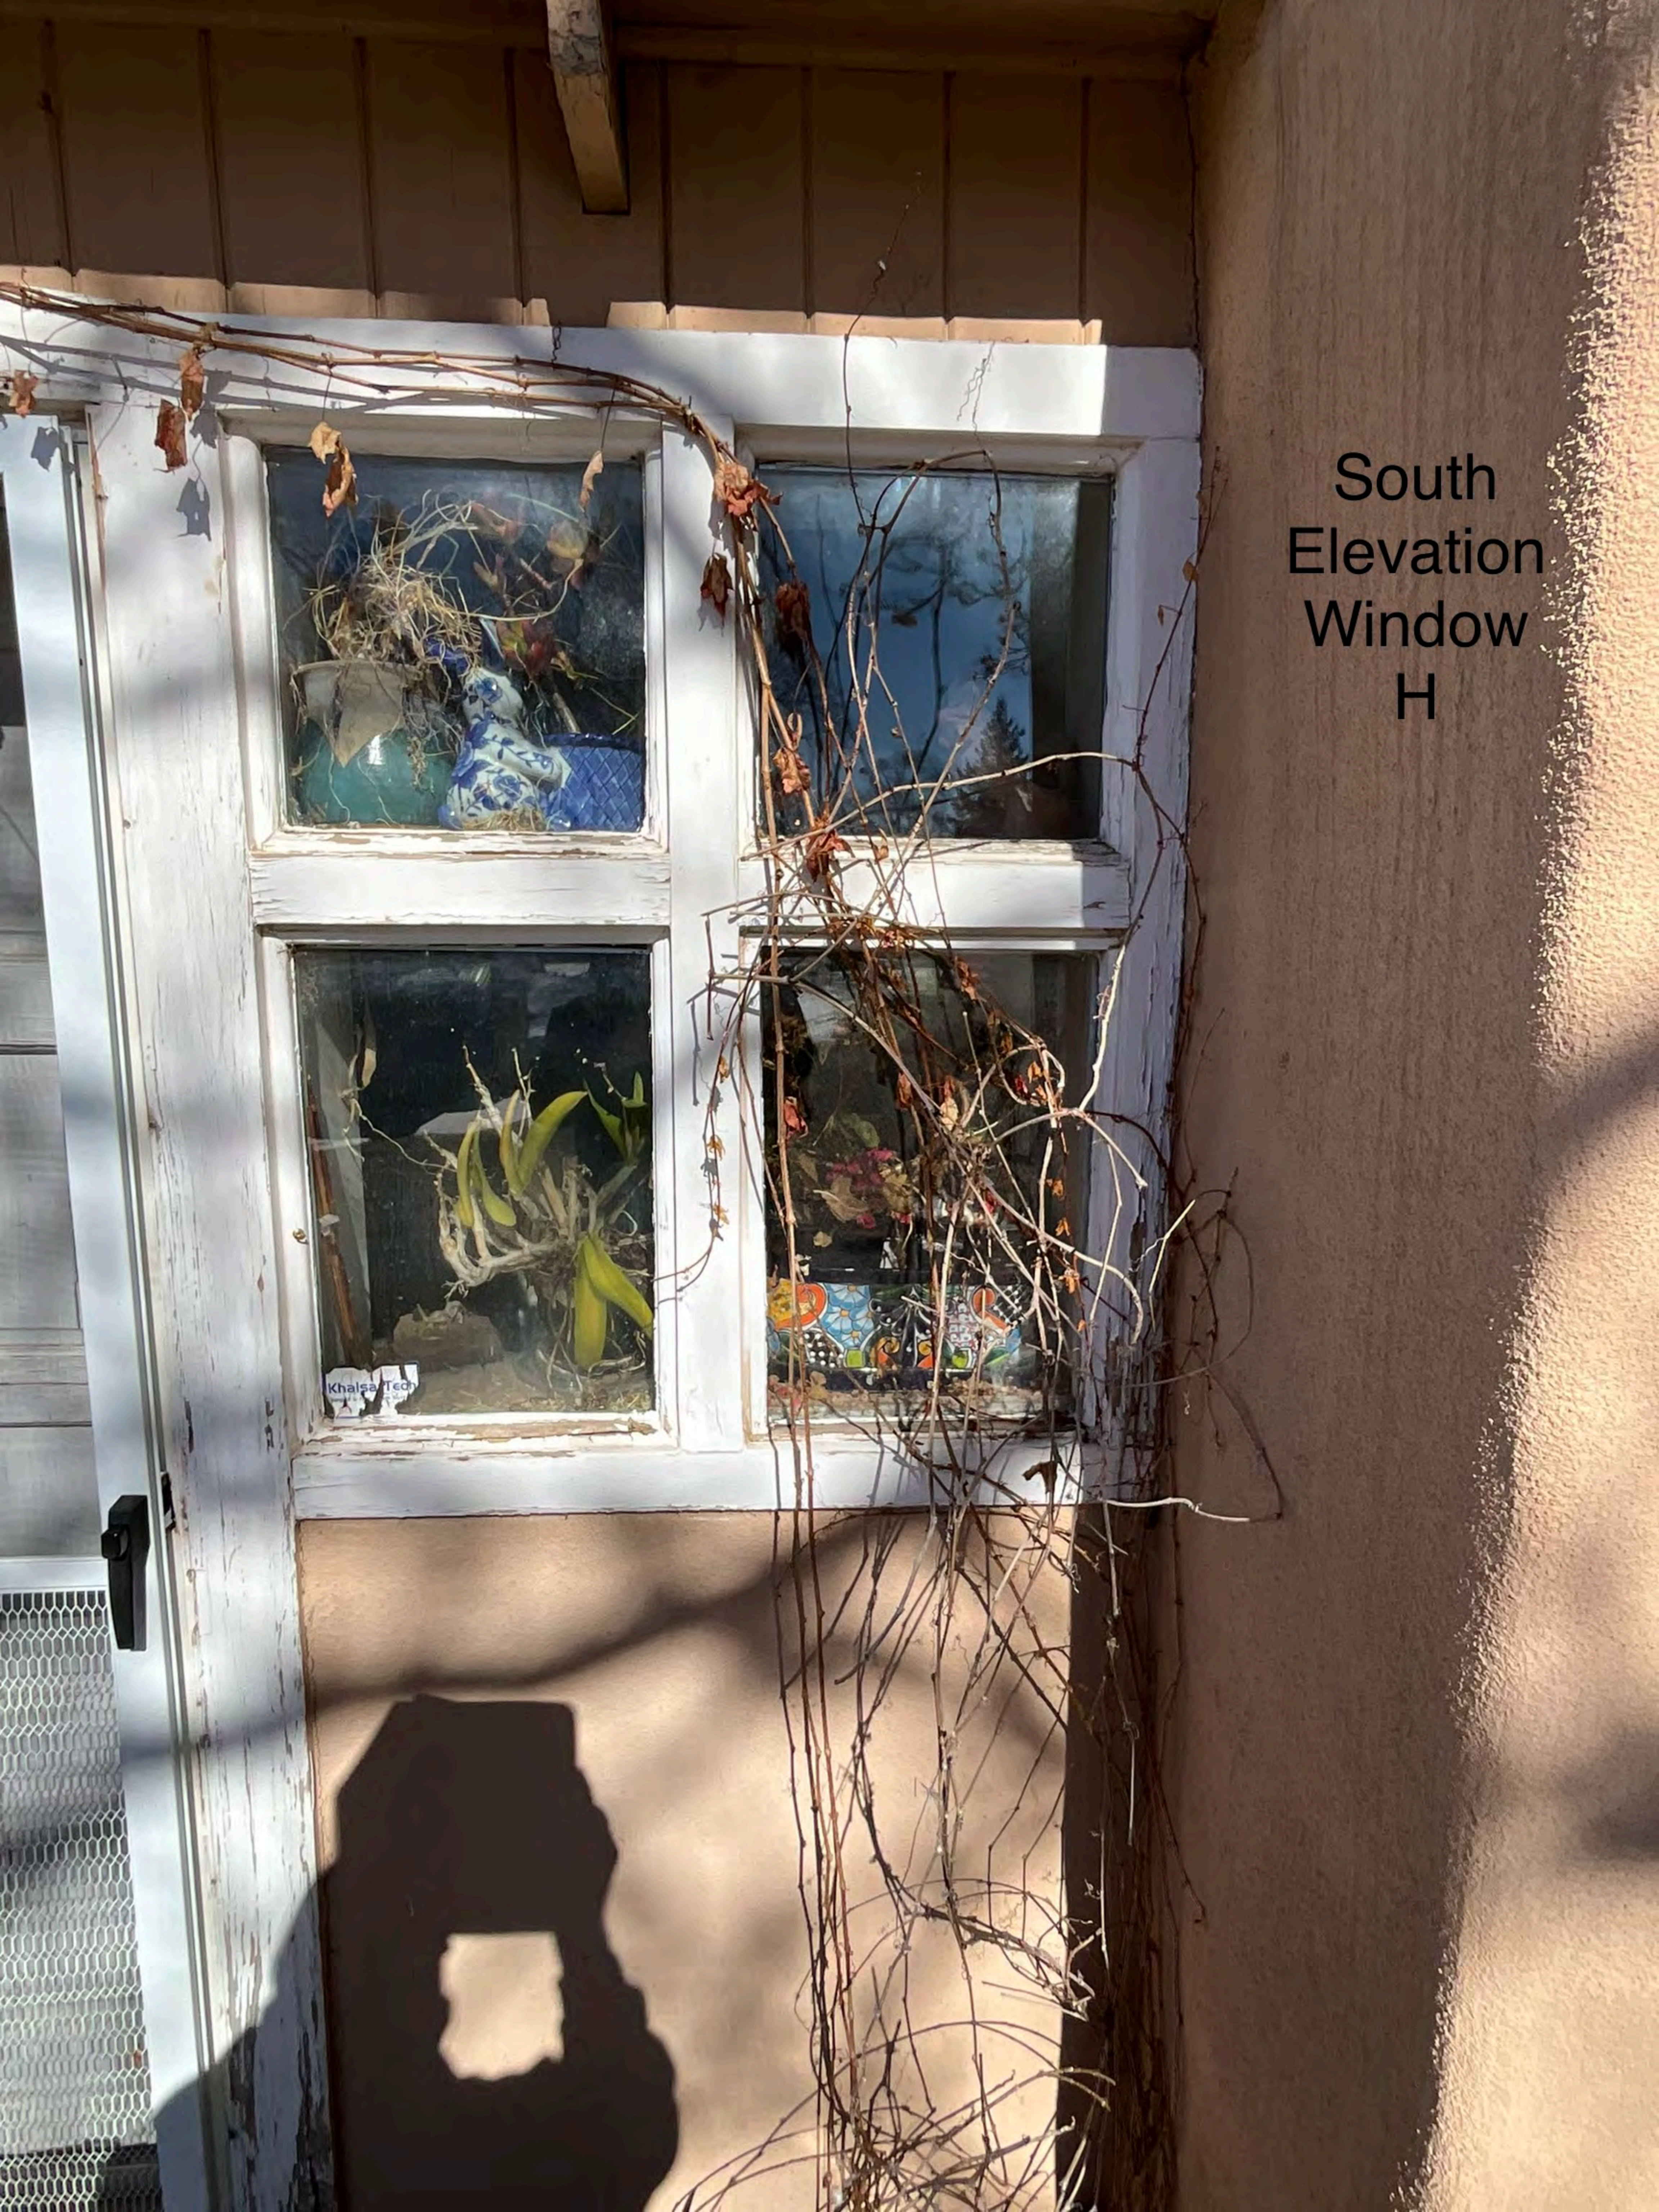
South
Elevation
Door
#4

Doors #1, #2, #3, #4, #6, #7, #8, and #9 are non-historic.

The windows and doors that are non-historic and unrestorable are to be replaced in “like and kind” to the windows of that era, wood divided lite (simulated or TDL), insulated Low-E glass (such as Kolbe or Weathershield manufactured). K-KRON would be a good alternative because of exterior low maintenance. K-KRON exterior has a 15-year warranty, whereas paint is approximately 3-5 years.

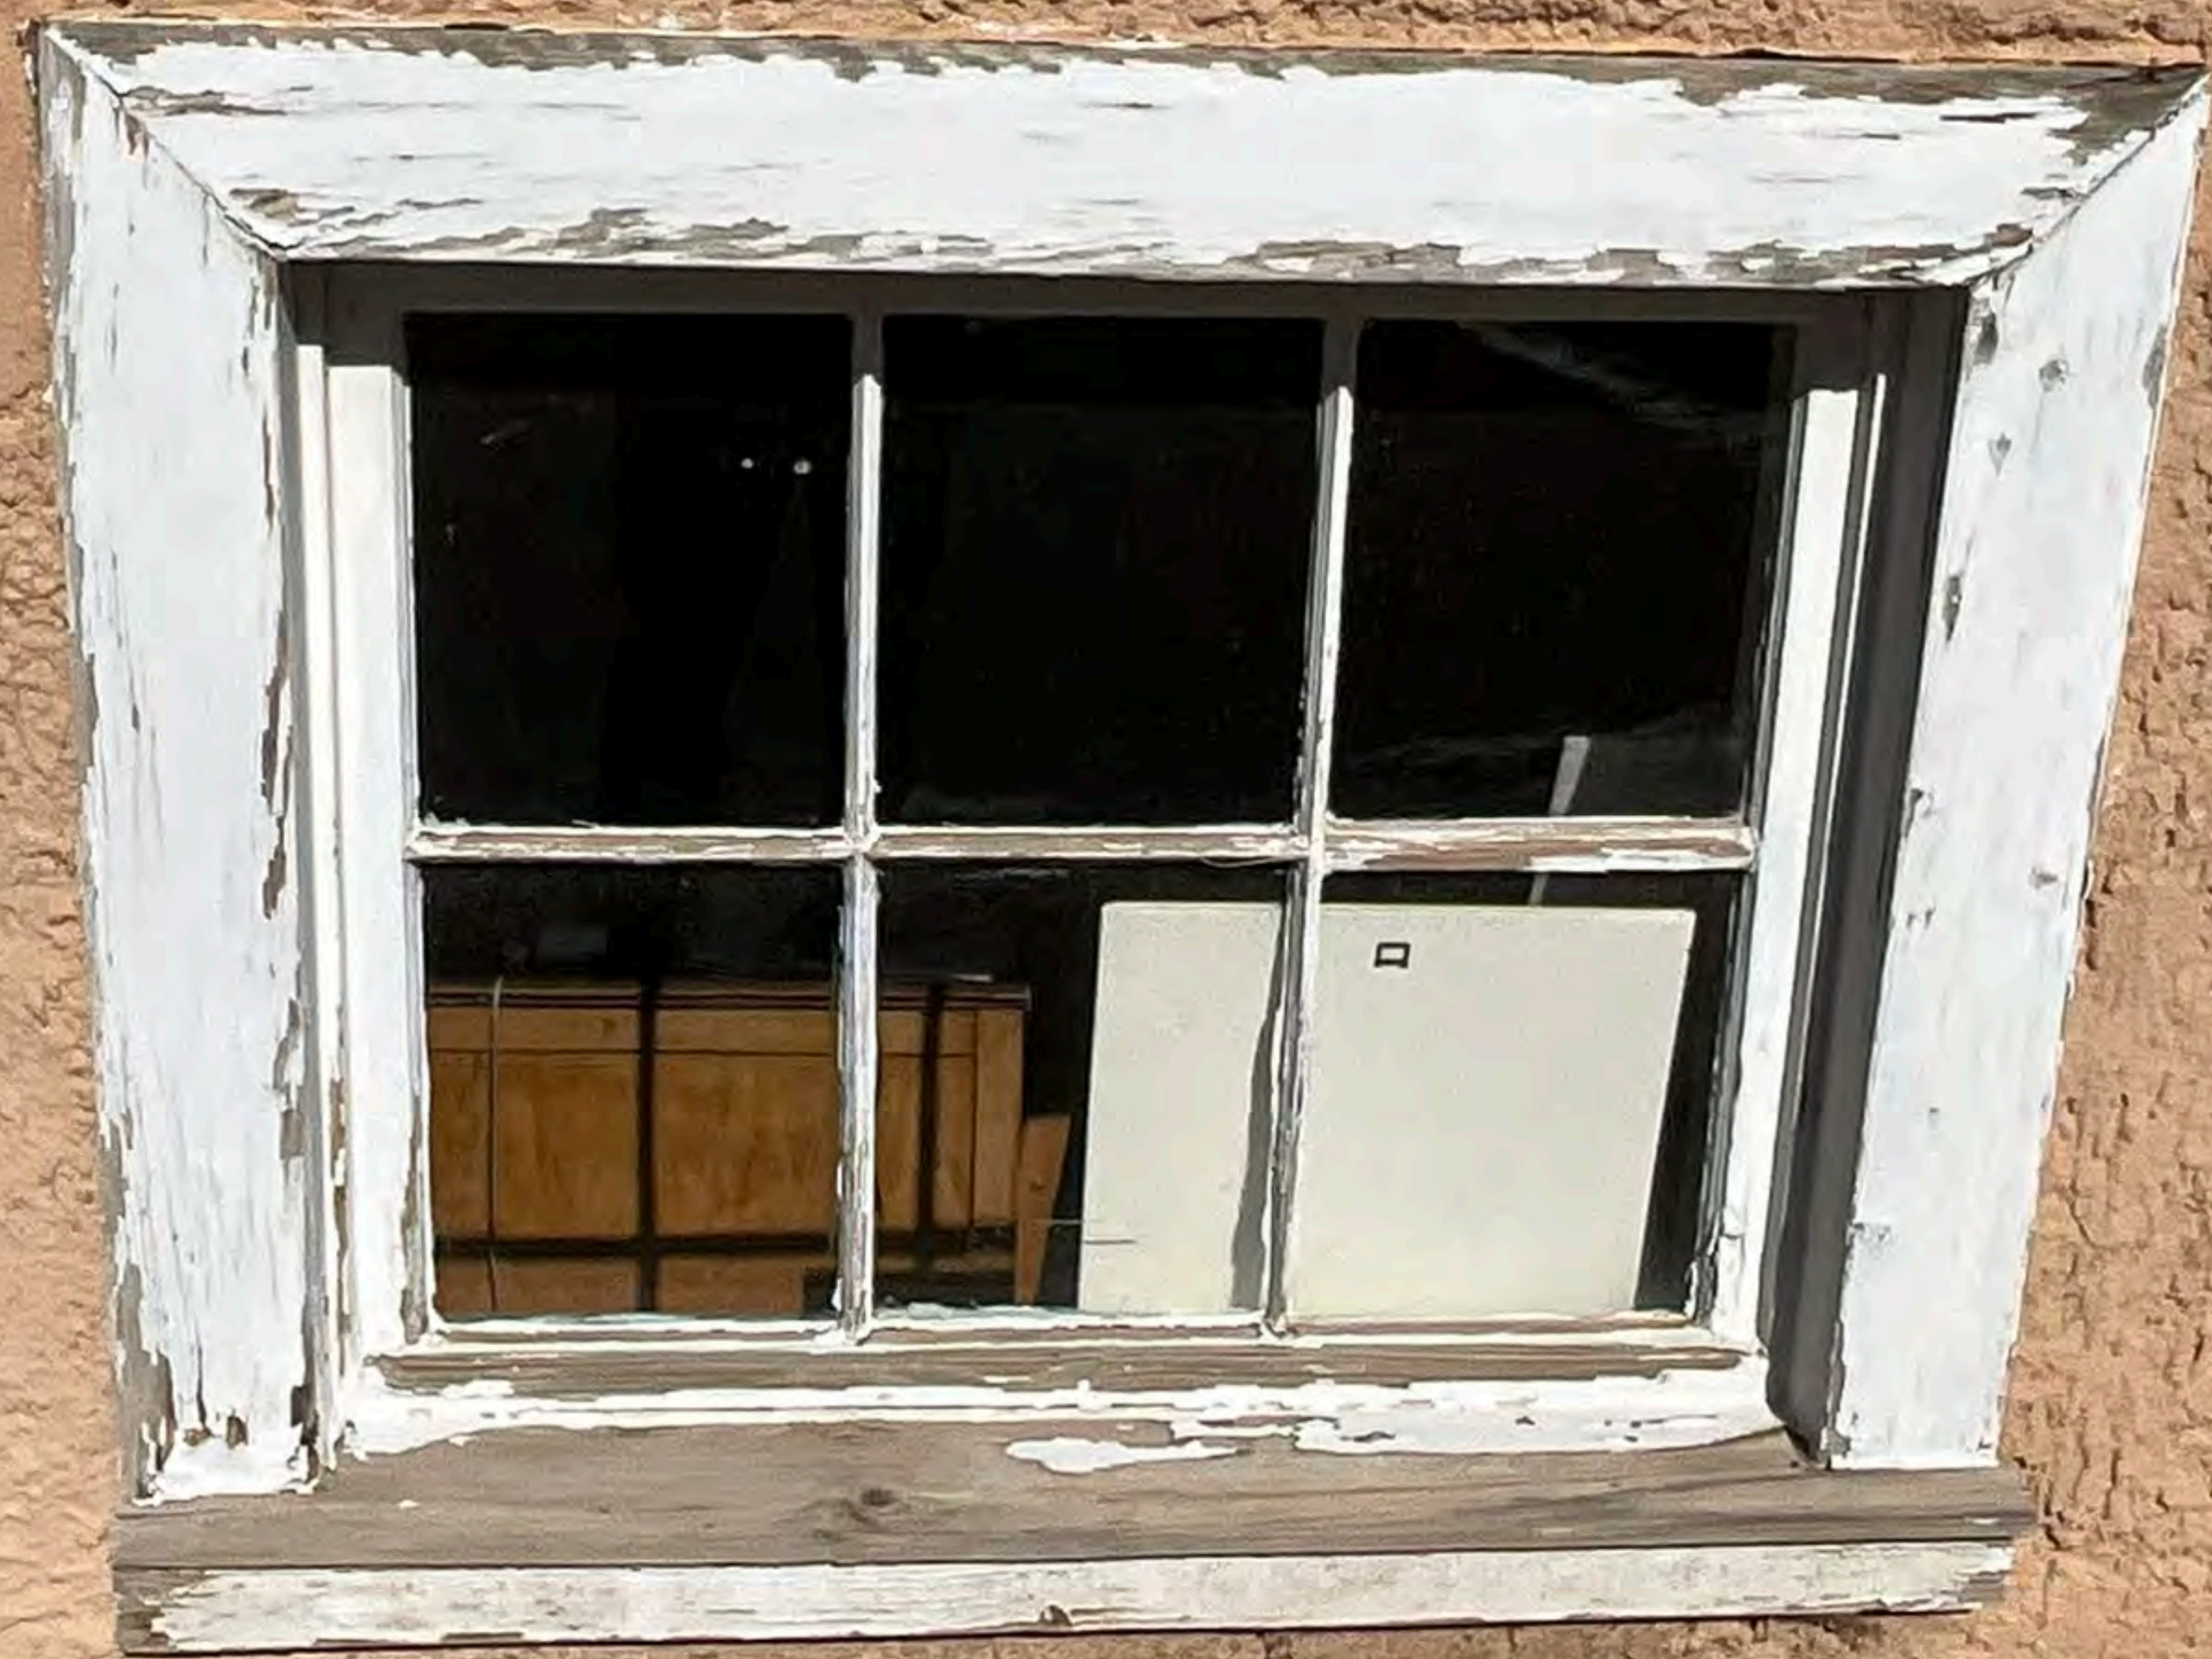
South Elevation
Window
L

Windows F, G, H, I, K, L, M, N, O, and P are non-historic.

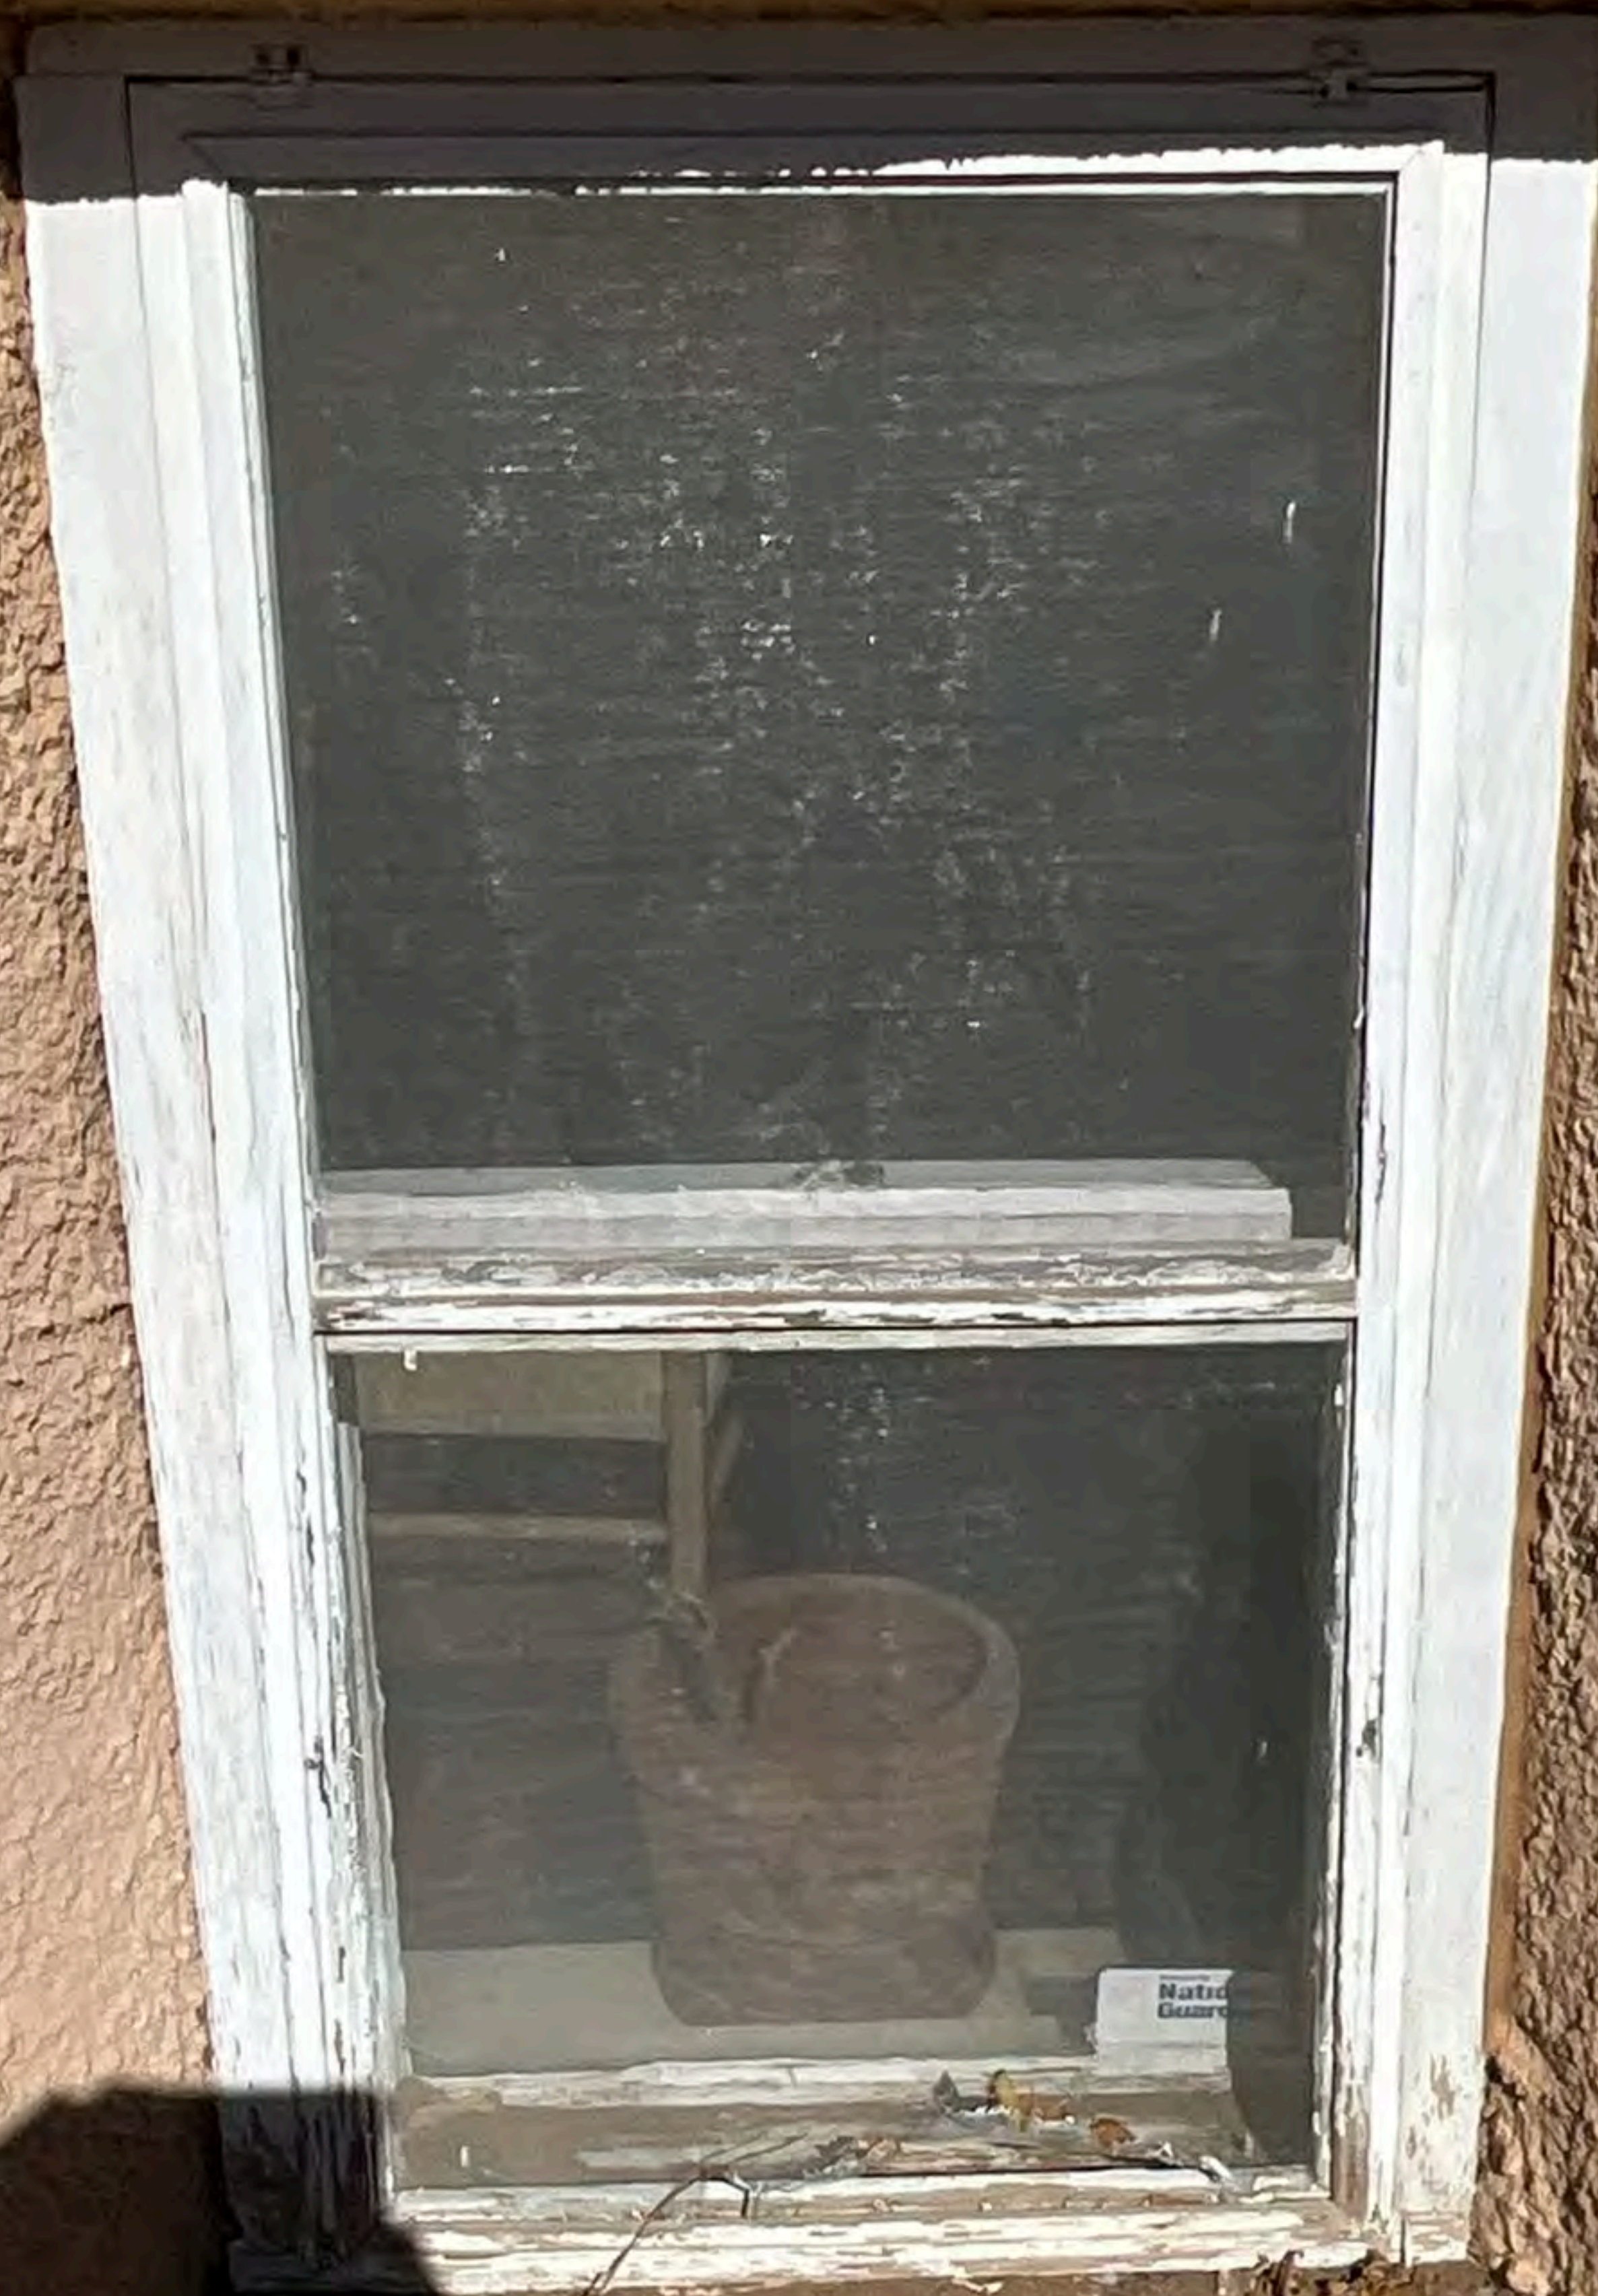
South Elevation
Window
M

LABEL	WINDOW & DOOR DESCRIPTION	CONDITION & INTEGRITY CODE	HISTORIC/NON-HISTORIC – AGE
<u>SOUTH</u>			
M	26" x 50" DOUBLE HUNG 1/1 ALL WOOD 2" FLAT CASING	U	NON-HISTORIC – 1-LITE SASHES (1988) NON-DIVIDED LITE BURIED IN THE SILL AT GROUND LEVEL
<u>EAST</u>			
N	76" x 30" – 3 TRIPLE ALL WOOD ALL FIXED (33" – 3) NO SILL 2W2H 1 1/8" VERTICAL DIVIDED LITE BAR/5/8" HORIZONTAL DIVIDED LITE BAR	U	NON-HISTORIC – BARN SASHES (1988) NO SILL, SIGNS OF WATER PENETRATION ON THE WALL
O	88" x 26" – 3 TRIPLE ALL WOOD LSR 3W2H CENTER MISSING SASH – PLYWOOD ONLY NO SILL (29" – 3)	U	NON-HISTORIC – BARN SASHES (1988) ON TWO (2) OUTSIDE SASHES, MIDDLE SASH IS MISSING, NO SILL, SIGNS OF WATER PENETRATION ON THE WALL
P	18" x 30" HINGED RIGHT INSWING CASEMENT 3W1H/1-LT 1 1/2" HORIZONTAL DIVIDED LITE BAR 5/8" VERTICAL DIVIDED LITE BAR ALL WOOD	U	NON-HISTORIC – SASH (1994) JAMB COMPLETELY ROTTED OVER 40%

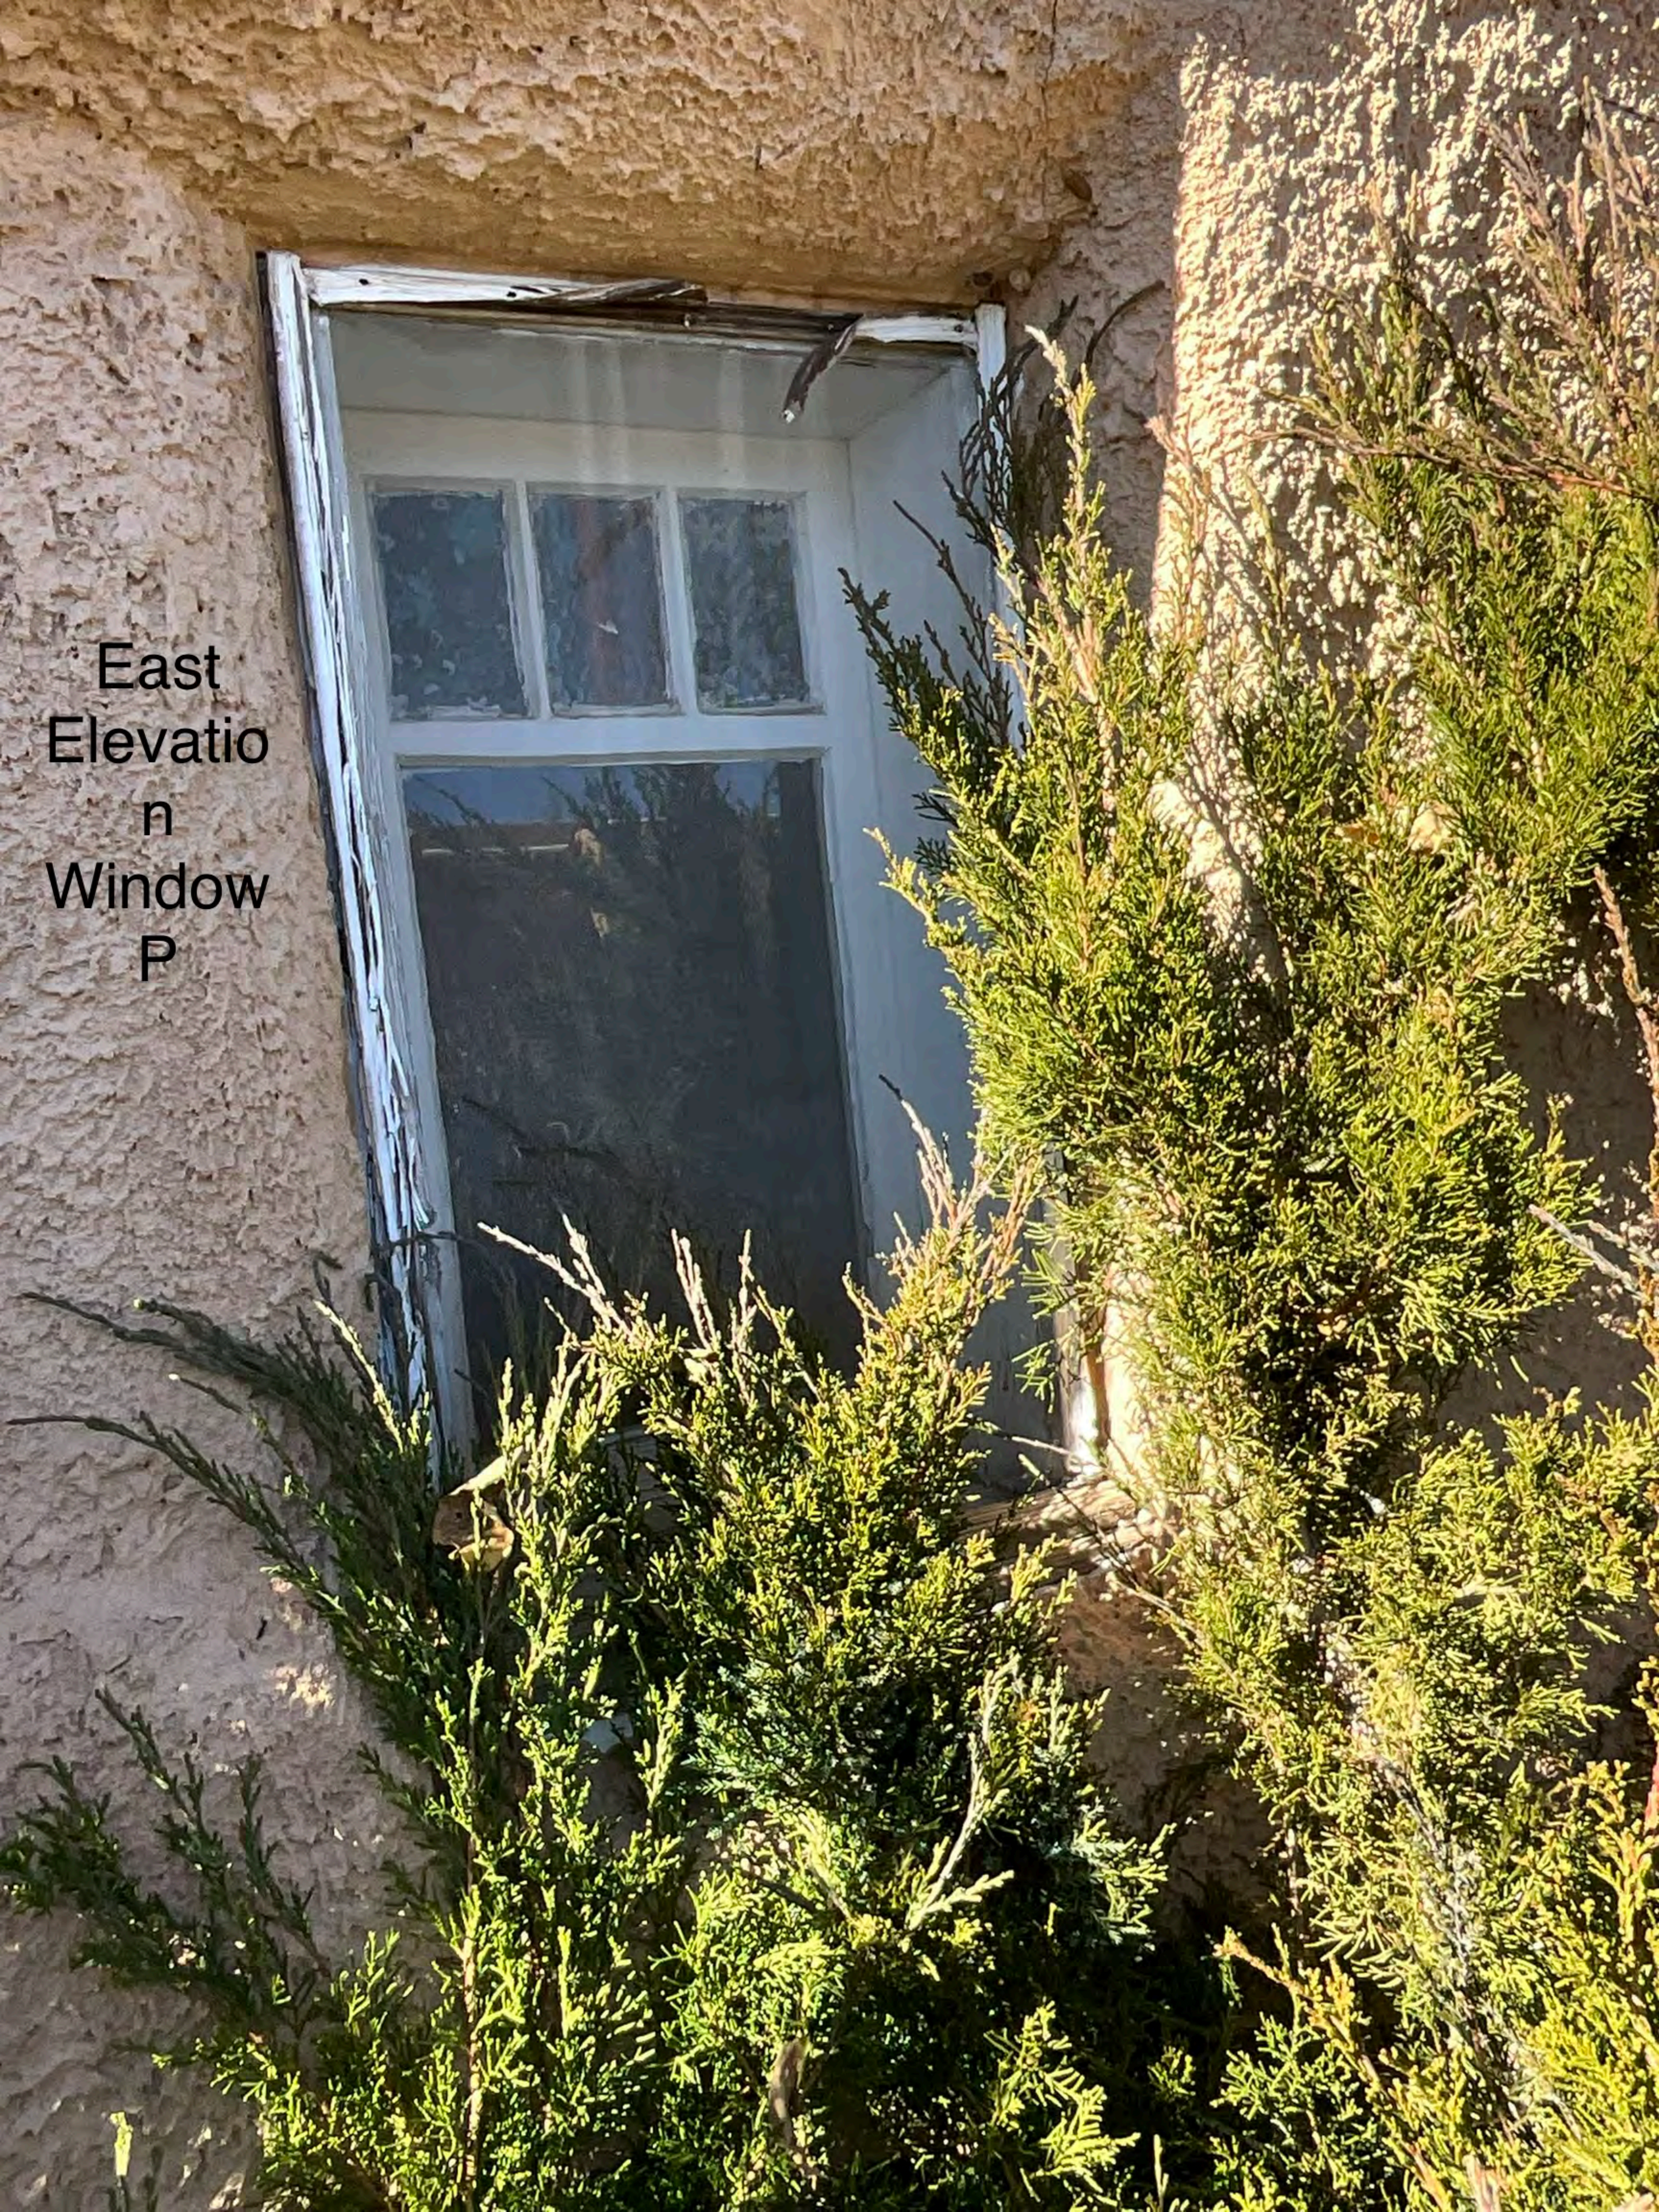
Courtyard
South Elevation
Window
J

Windows C, D, E, and J are historic, but the units are unrestorable.

LABEL	WINDOW & DOOR DESCRIPTION	CONDITION & INTEGRITY CODE	HISTORIC/NON-HISTORIC – AGE
<u>COURT YARD - SOUTH</u>			
J	36" x 63" DOUBLE HUNG 3W2H/1-LT ALL WOOD	U	HISTORIC – UPPER SASH NON-HISTORIC – LOWER SASH JAMBS & SILL MORE THAN 40% ROTTED
DR #5	30" x 80" RH INSWING DOOR 1-HORIZONTAL PANEL/1-LT/3-HORIZONTAL PANEL ALL WOOD	F	HISTORIC
<u>COURT YARD - WEST</u>			
DR #6	28" x 67" RH OUTSWING DOOR 5-HORIZONTAL PANELS CUT DOWN 3 ½" FLAT CASING ALL WOOD	F	NON-HISTORIC – “SIMPSON” FIR DOOR (1991) CUT DOWN TO FIT OPENING
DR #7	32" x 78" RH INSWING DOOR 3W5H SINGLE GLAZED GLASS CUT DOWN 2" FLAT CASING	F	NON-HISTORIC – “SIMPSON” FIR DOOR (1991) CUT DOWN TO FIT OPENING

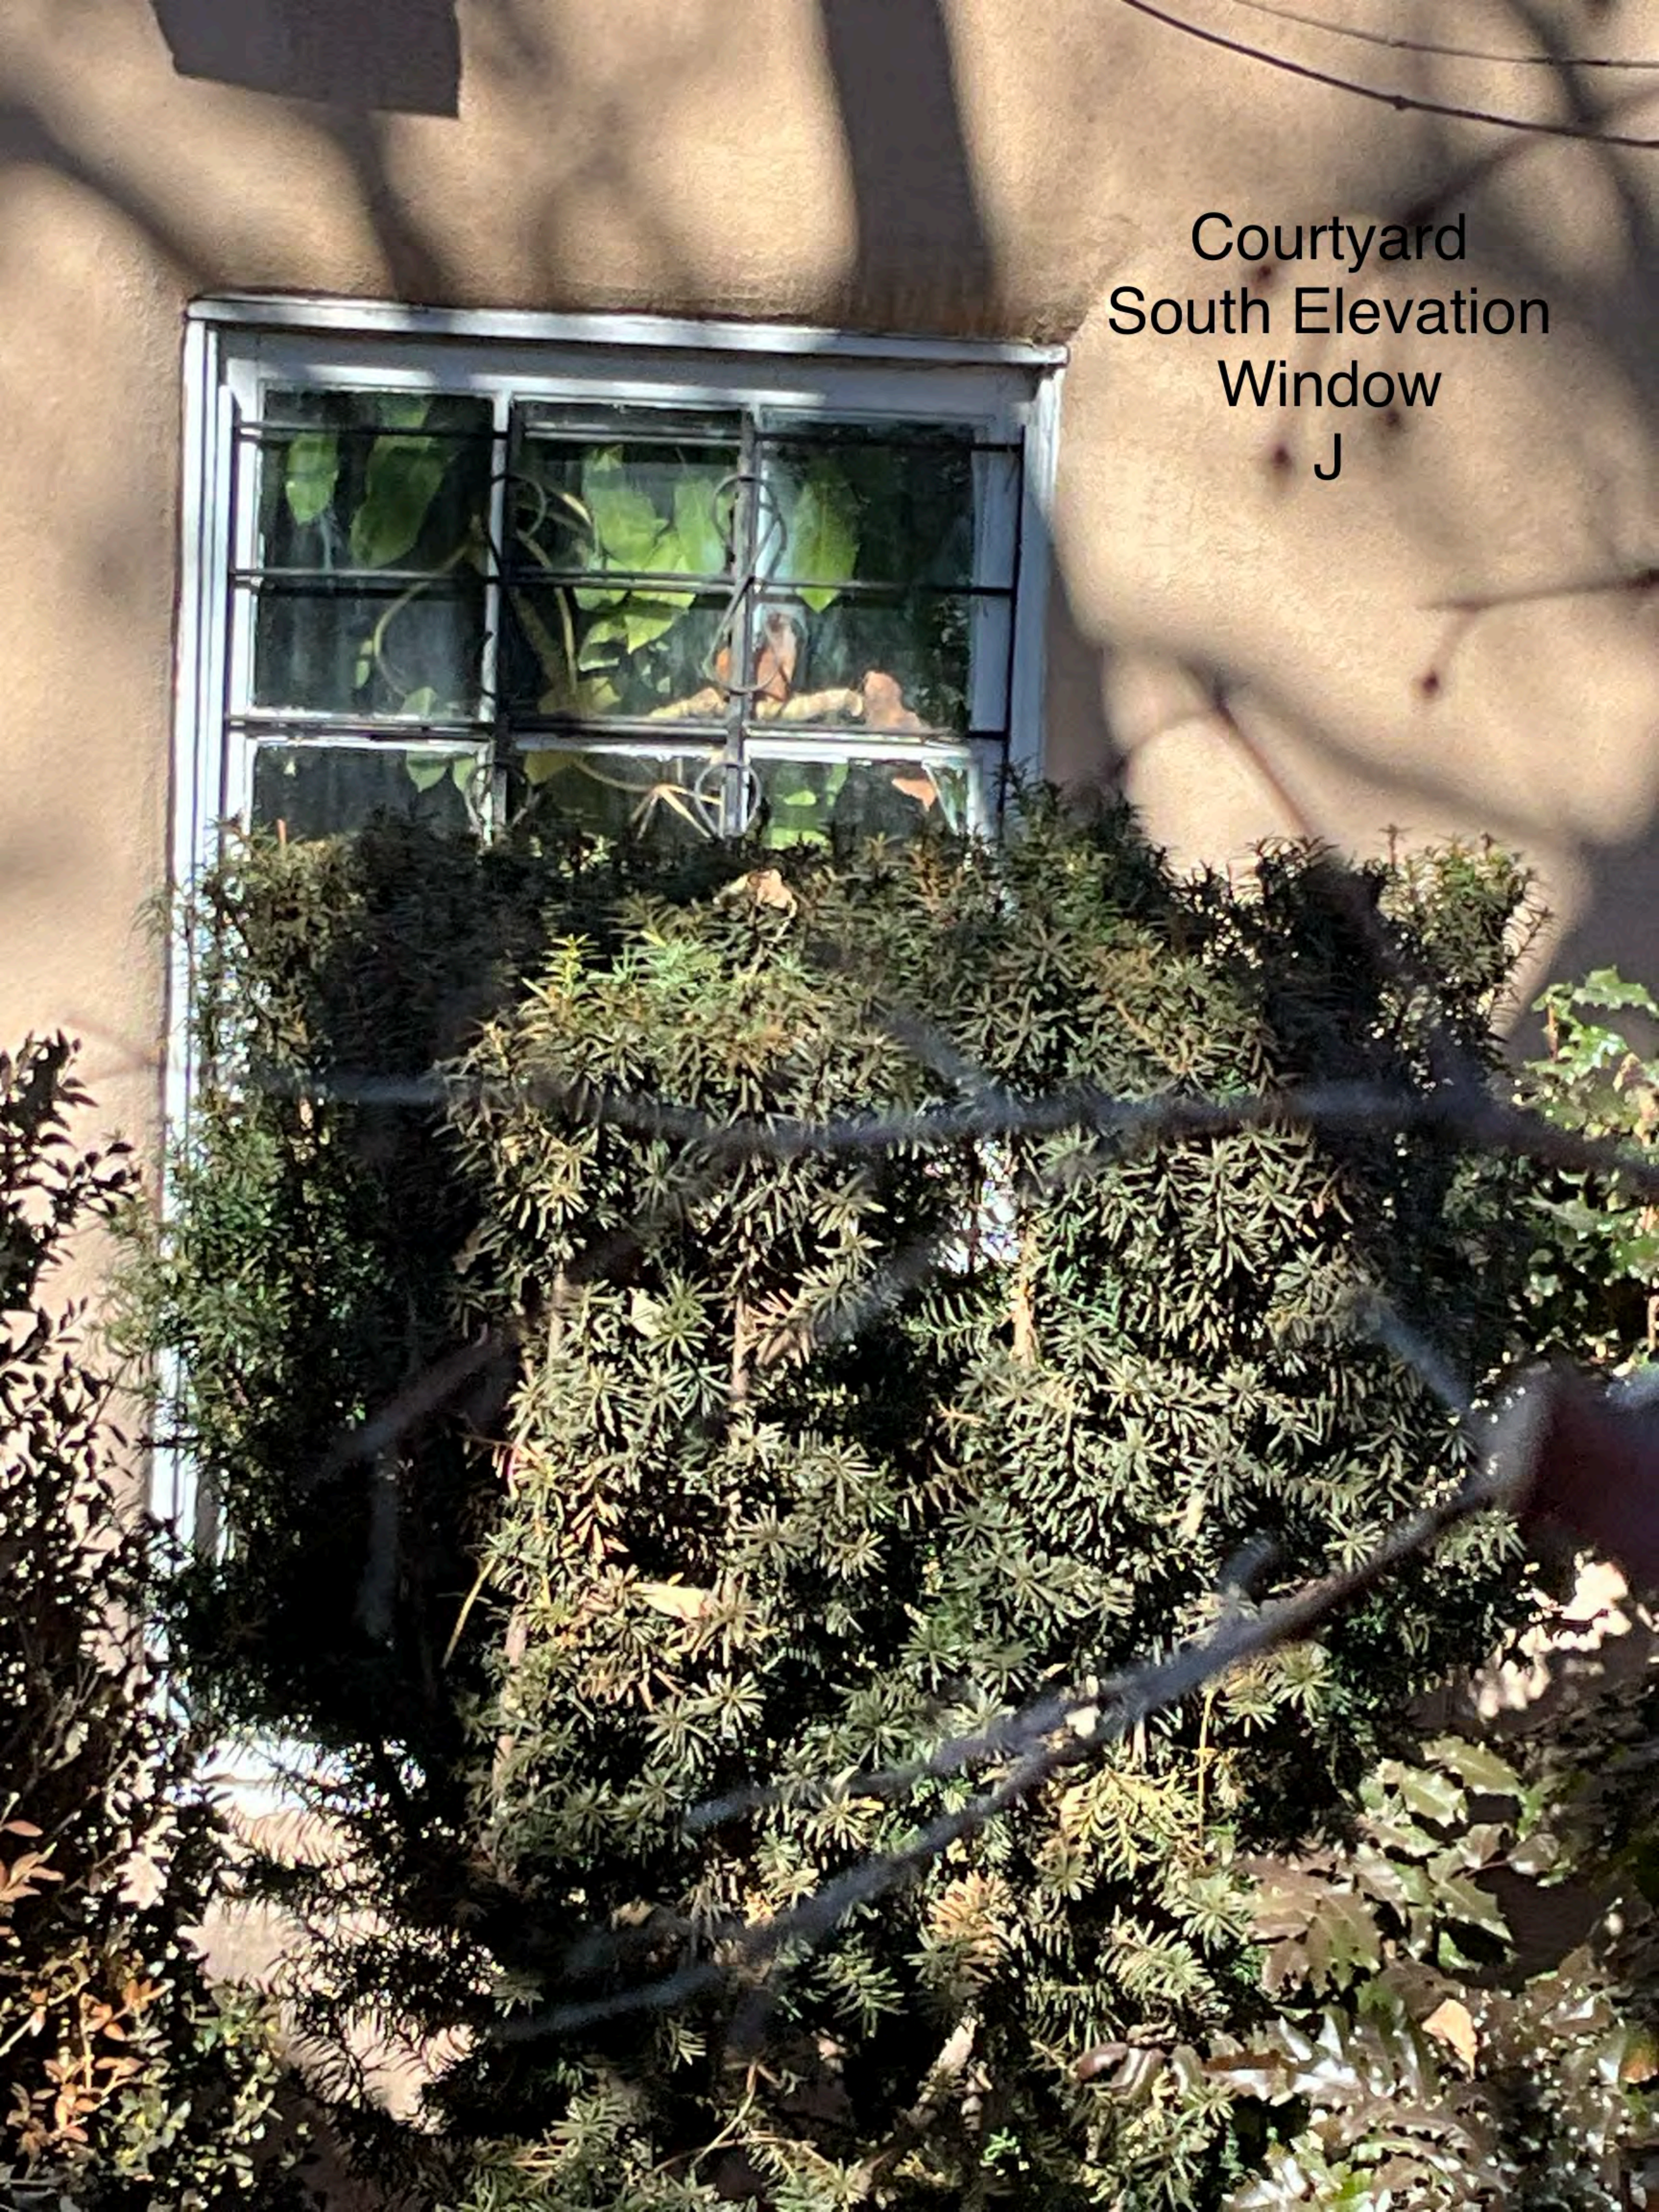
Courtyard
South
Elevation
Door
#5

Door #5 is historic.
