RPA & Associates LLC

JOB	DATE
1121 Paseo de Peralta, Santa Fe, NM 87501	01/22/2026

RPA & ASSOCIATES, LLC | WINDOW & DOOR CONDITION AND INTEGRITY CODES

JOB	DATE
1123 Paseo de Peralta, Santa Fe, NM 87501	01/22/2026

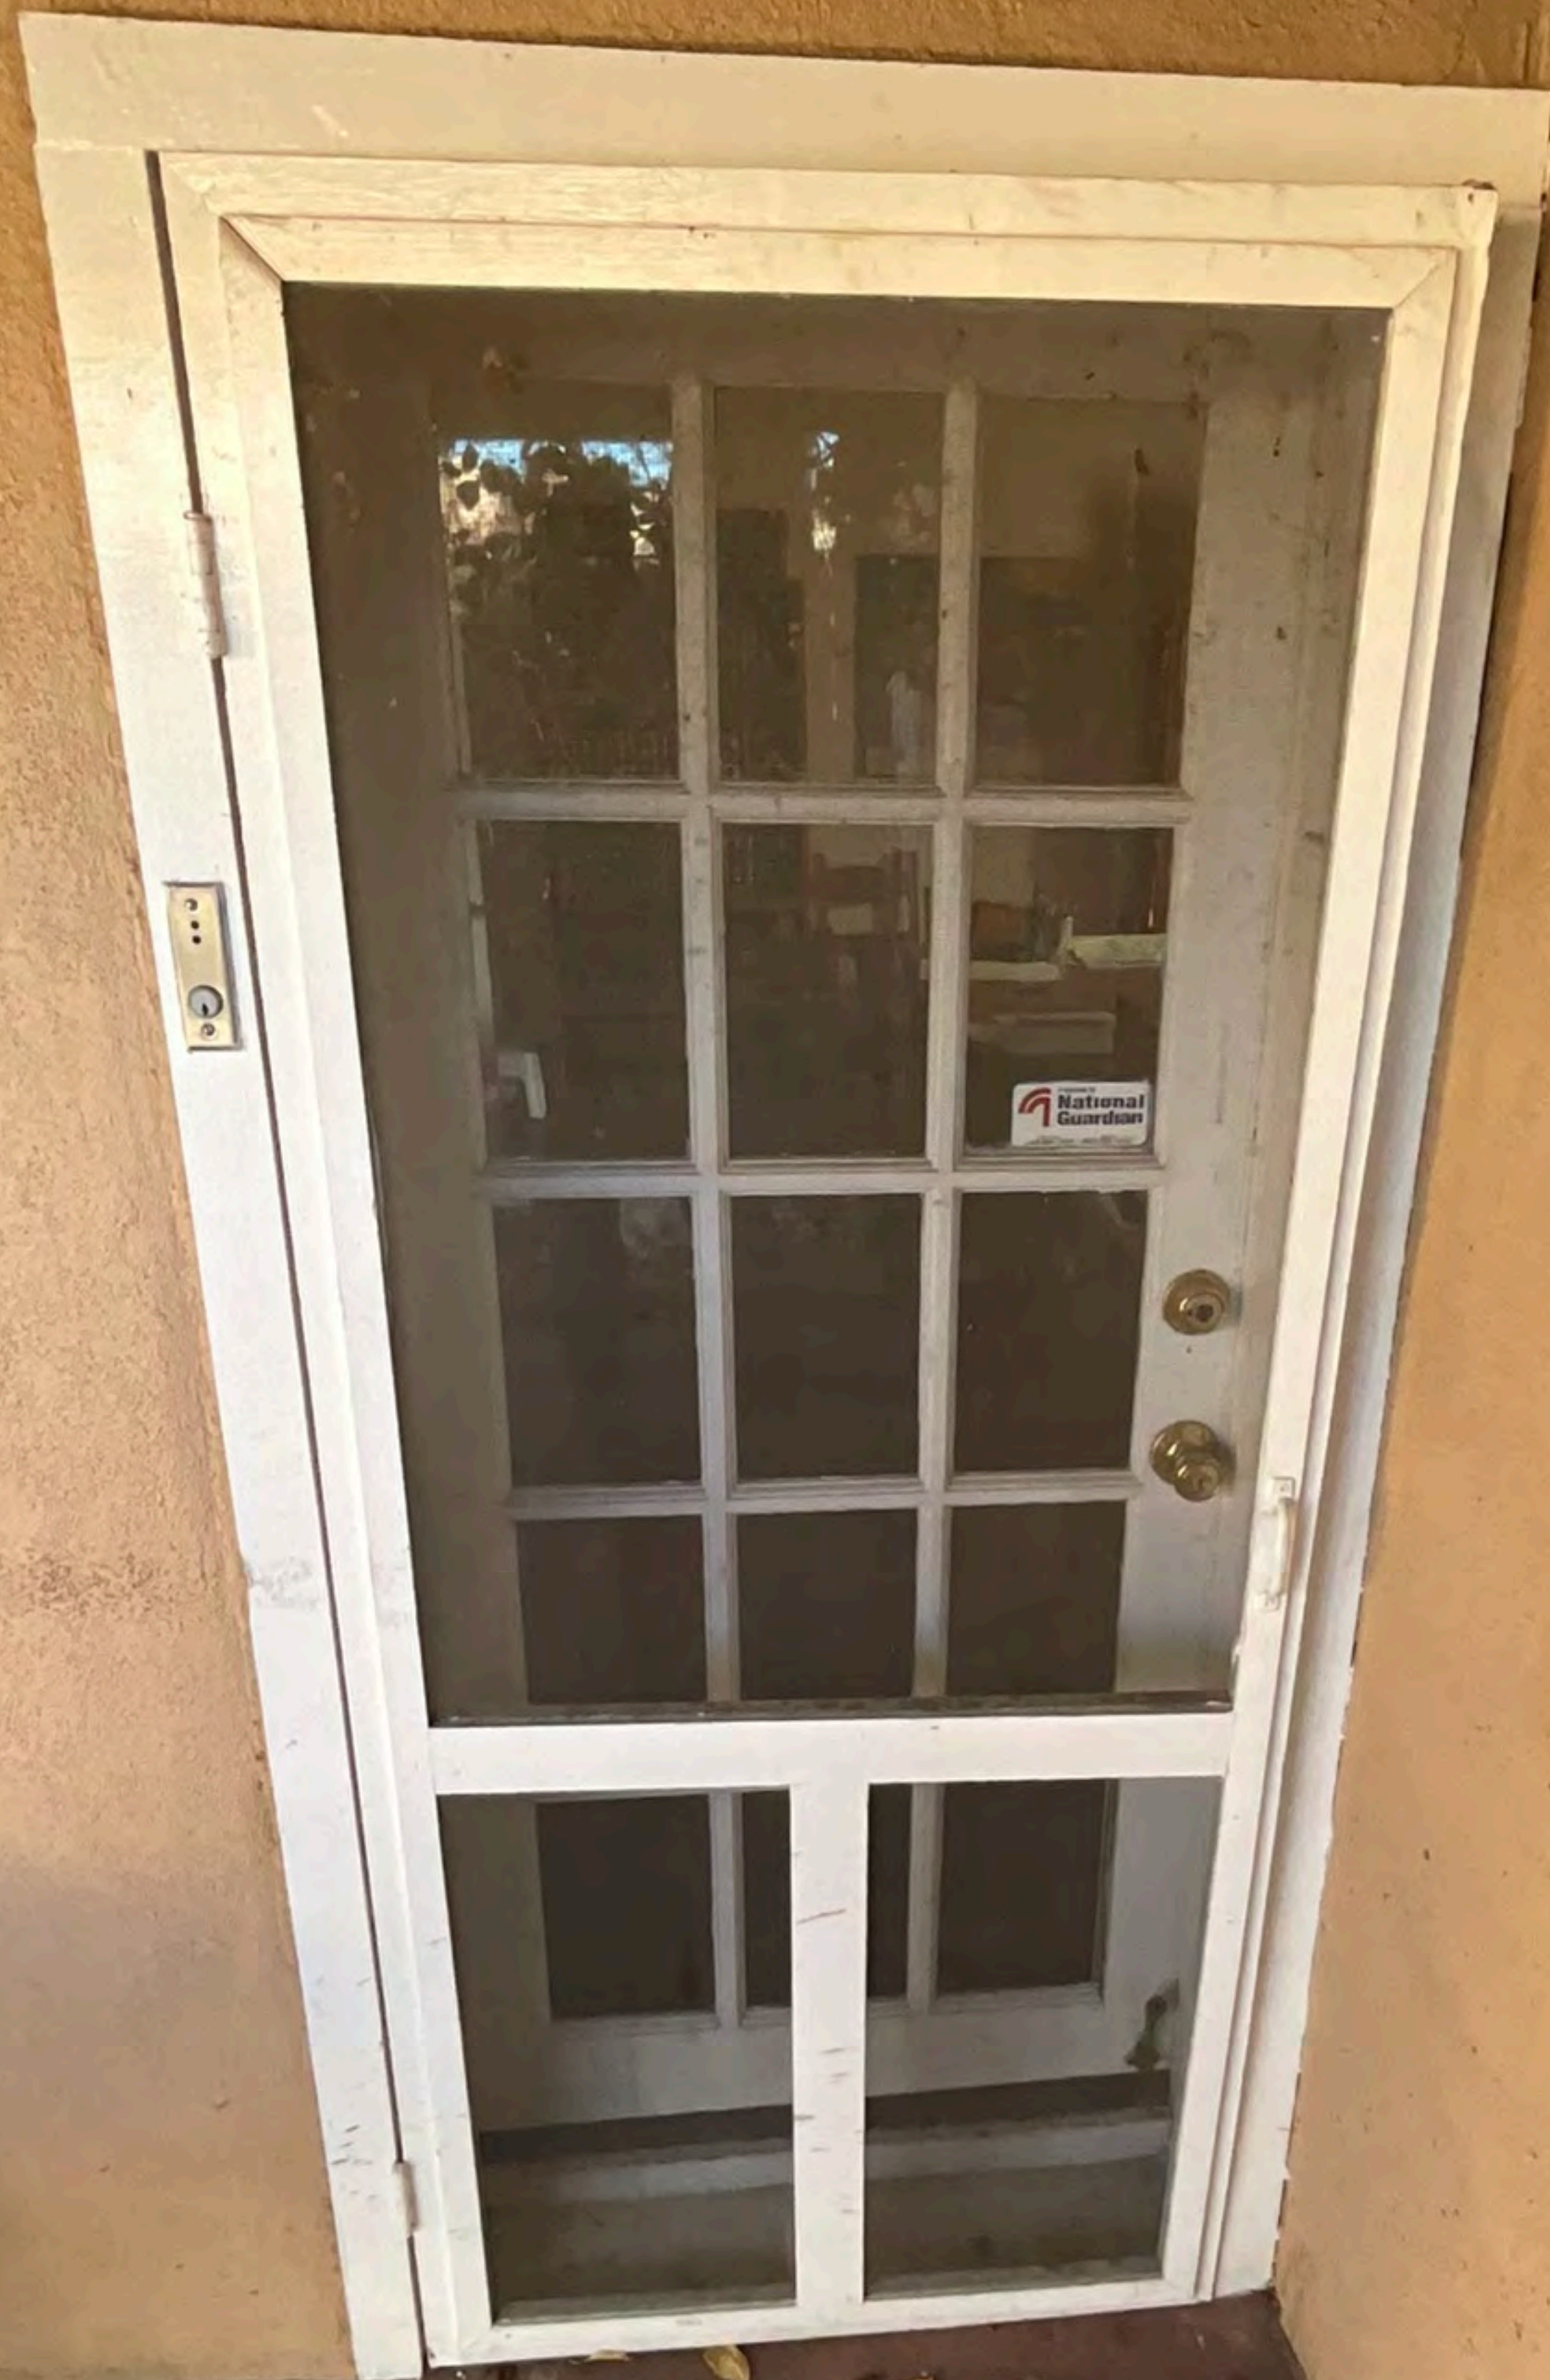
Courtyard
West
Elevation
Door
#8

Doors #1, #2, #3, #4, #6, #7, #8, and #9 are non-historic.

LABEL	WINDOW & DOOR DESCRIPTION	CONDITION & INTEGRITY CODE	HISTORIC/NON-HISTORIC – AGE
<u>COURT YARD - WEST</u>			
DR #8	32" x 72" LH INSWING DOOR 3W5H SINGLE GLAZED GLASS CUT DOWN 3" FLAT CASING	F	NON-HISTORIC – “SIMPSON” FIR DOOR (1991) CUT DOWN TO FIT OPENING
<u>COURT YARD - NORTH</u>			
DR #9	30" x 78" LH INSWING DOOR 3W5H SINGLE GLAZED GLASS CUT DOWN 3" FLAT CASING	F	NON-HISTORIC – “SIMPSON” FIR DOOR (1991) CUT DOWN TO FIT OPENING
K	33" x 38" ARCH TOP OUTSWING HINGED LEFT CASEMENT – USED DOUBLE HUNG TOP SASH & JOB SITE HINGED IT 2W1H ALL WOOD 3" FLAT CASING	F	NON-HISTORIC – (1996)

The windows and doors that are non-historic and unrestorable are to be replaced in “like and kind” to the windows of that era, wood divided lite (simulated or TDL), insulated Low-E glass (such as Kolbe or Weathershield manufactured). K-KRON would be a good alternative because of exterior low maintenance. K-KRON exterior has a 15-year warranty, whereas paint is approximately 3-5 years.

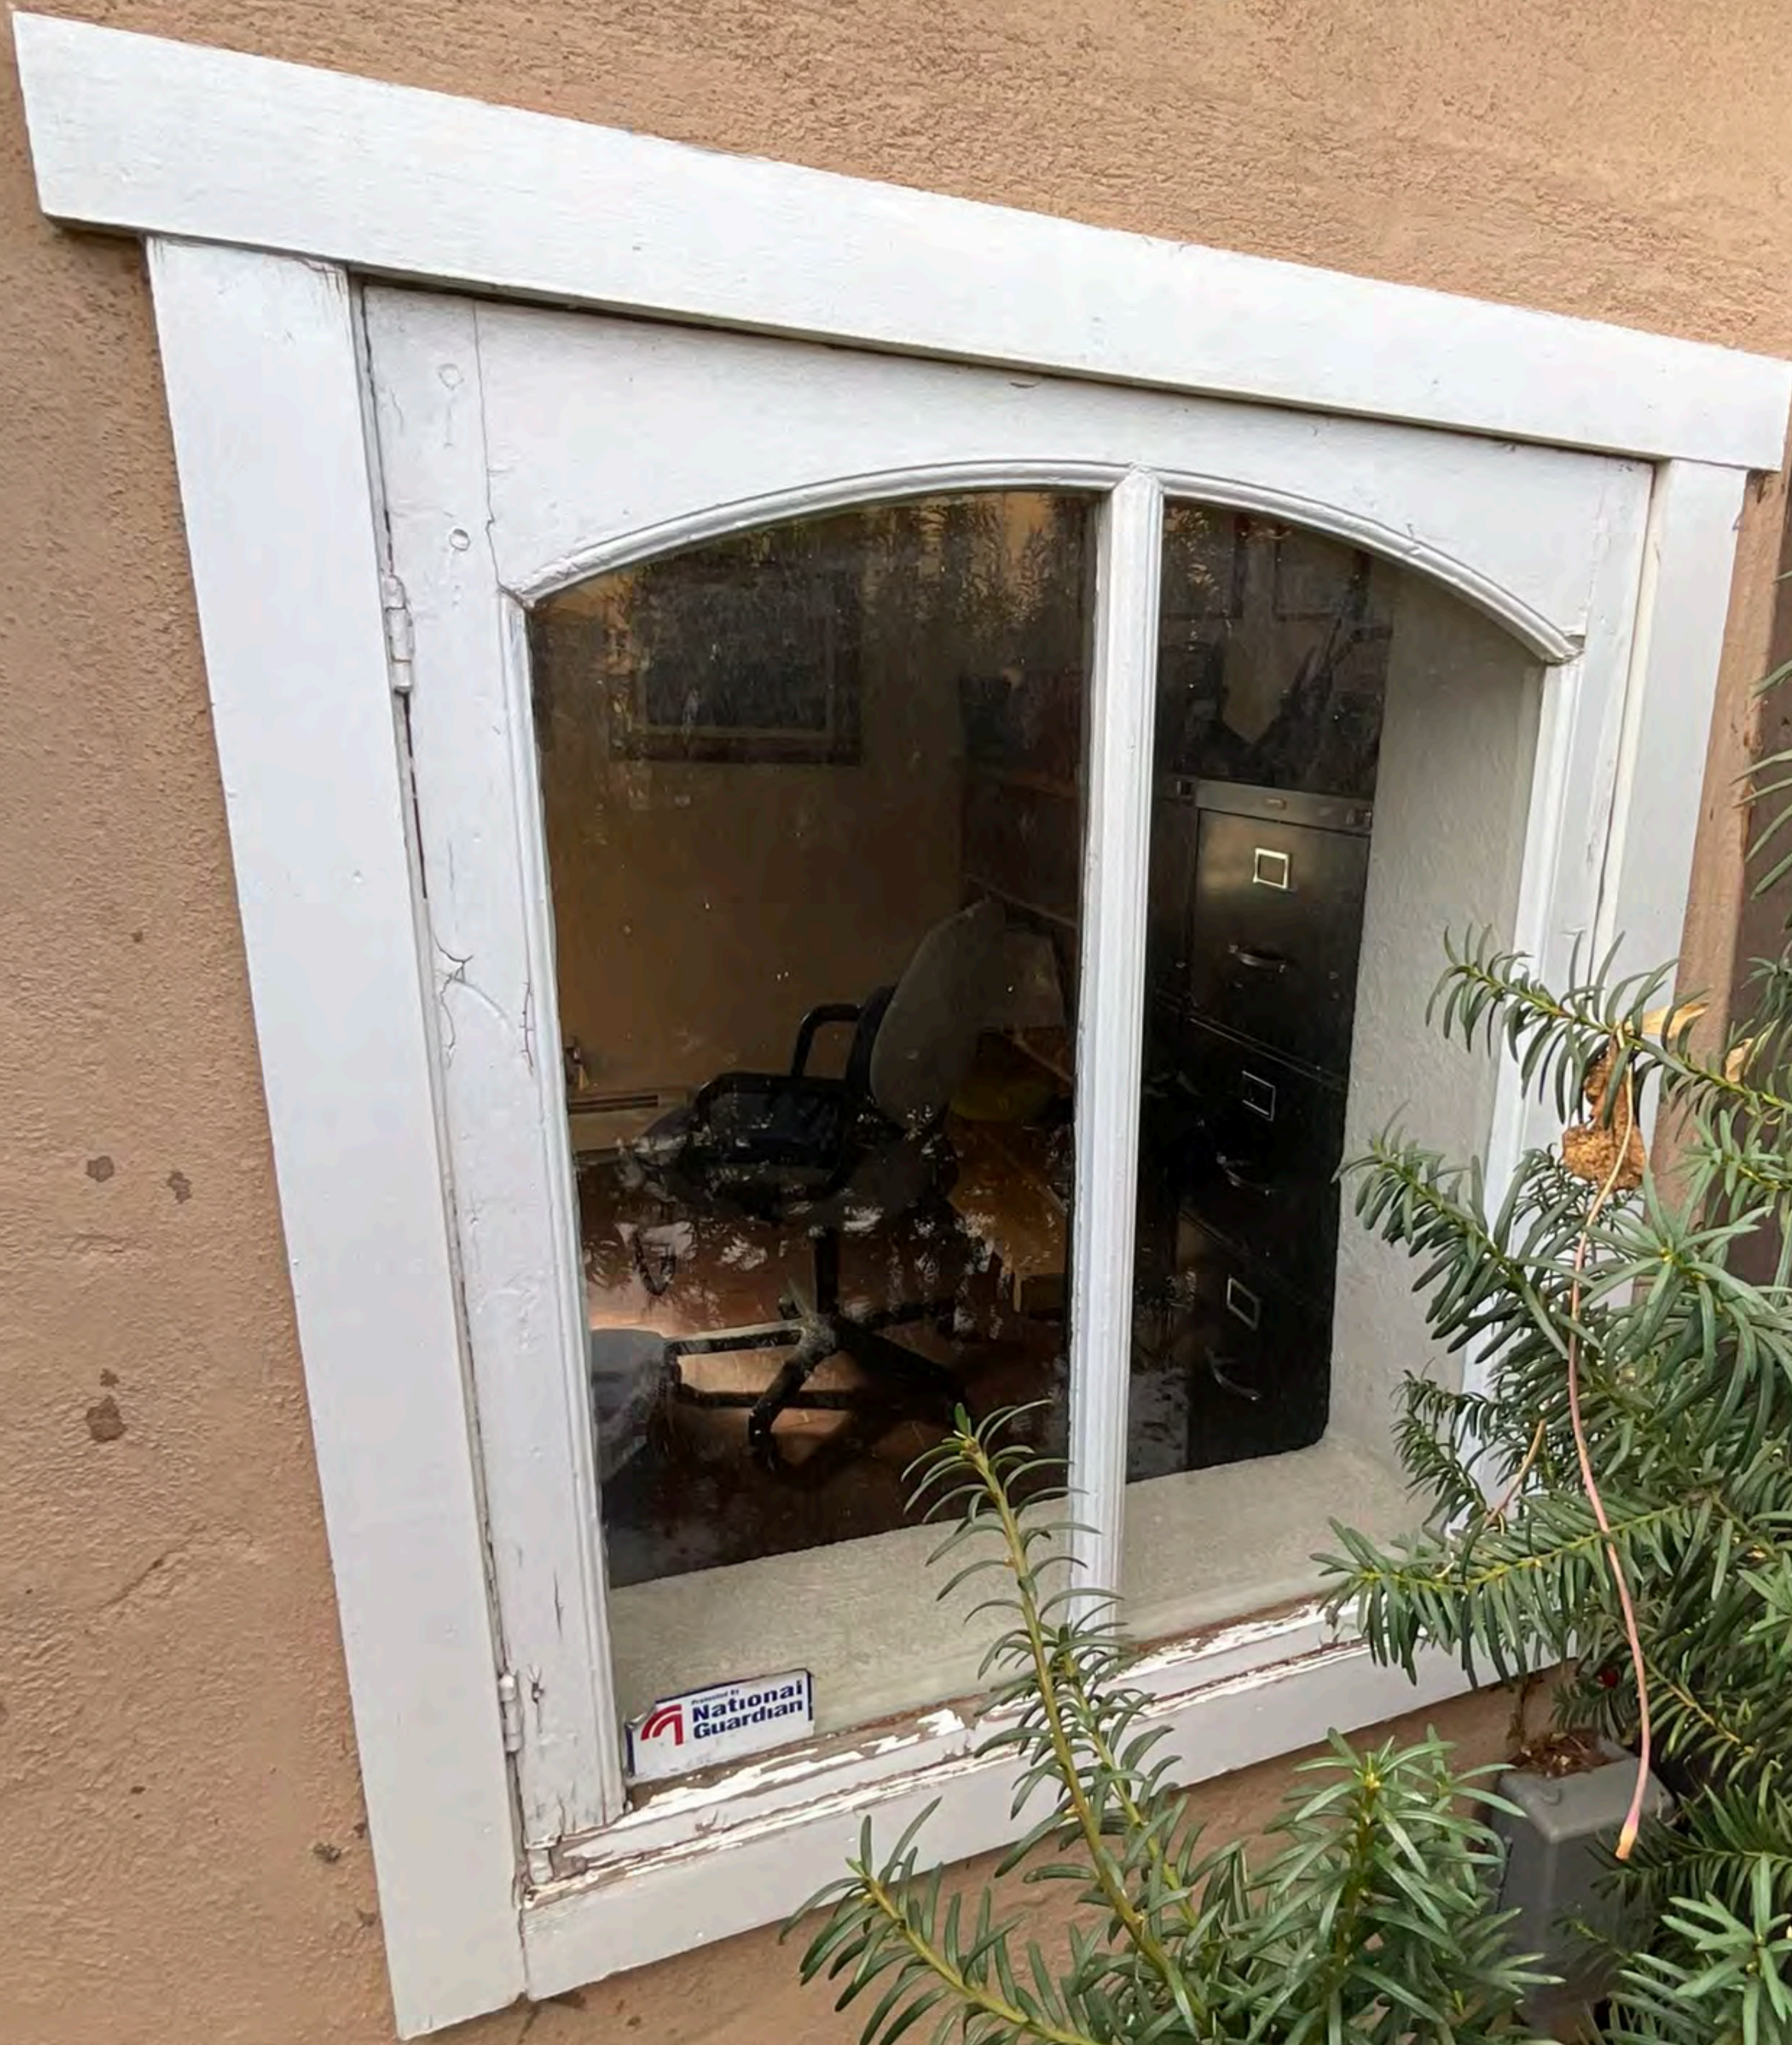
Courtyard
North Elevation
Window
K

Windows F, G, H, I, K, L, M, N, O, and P are non-historic.

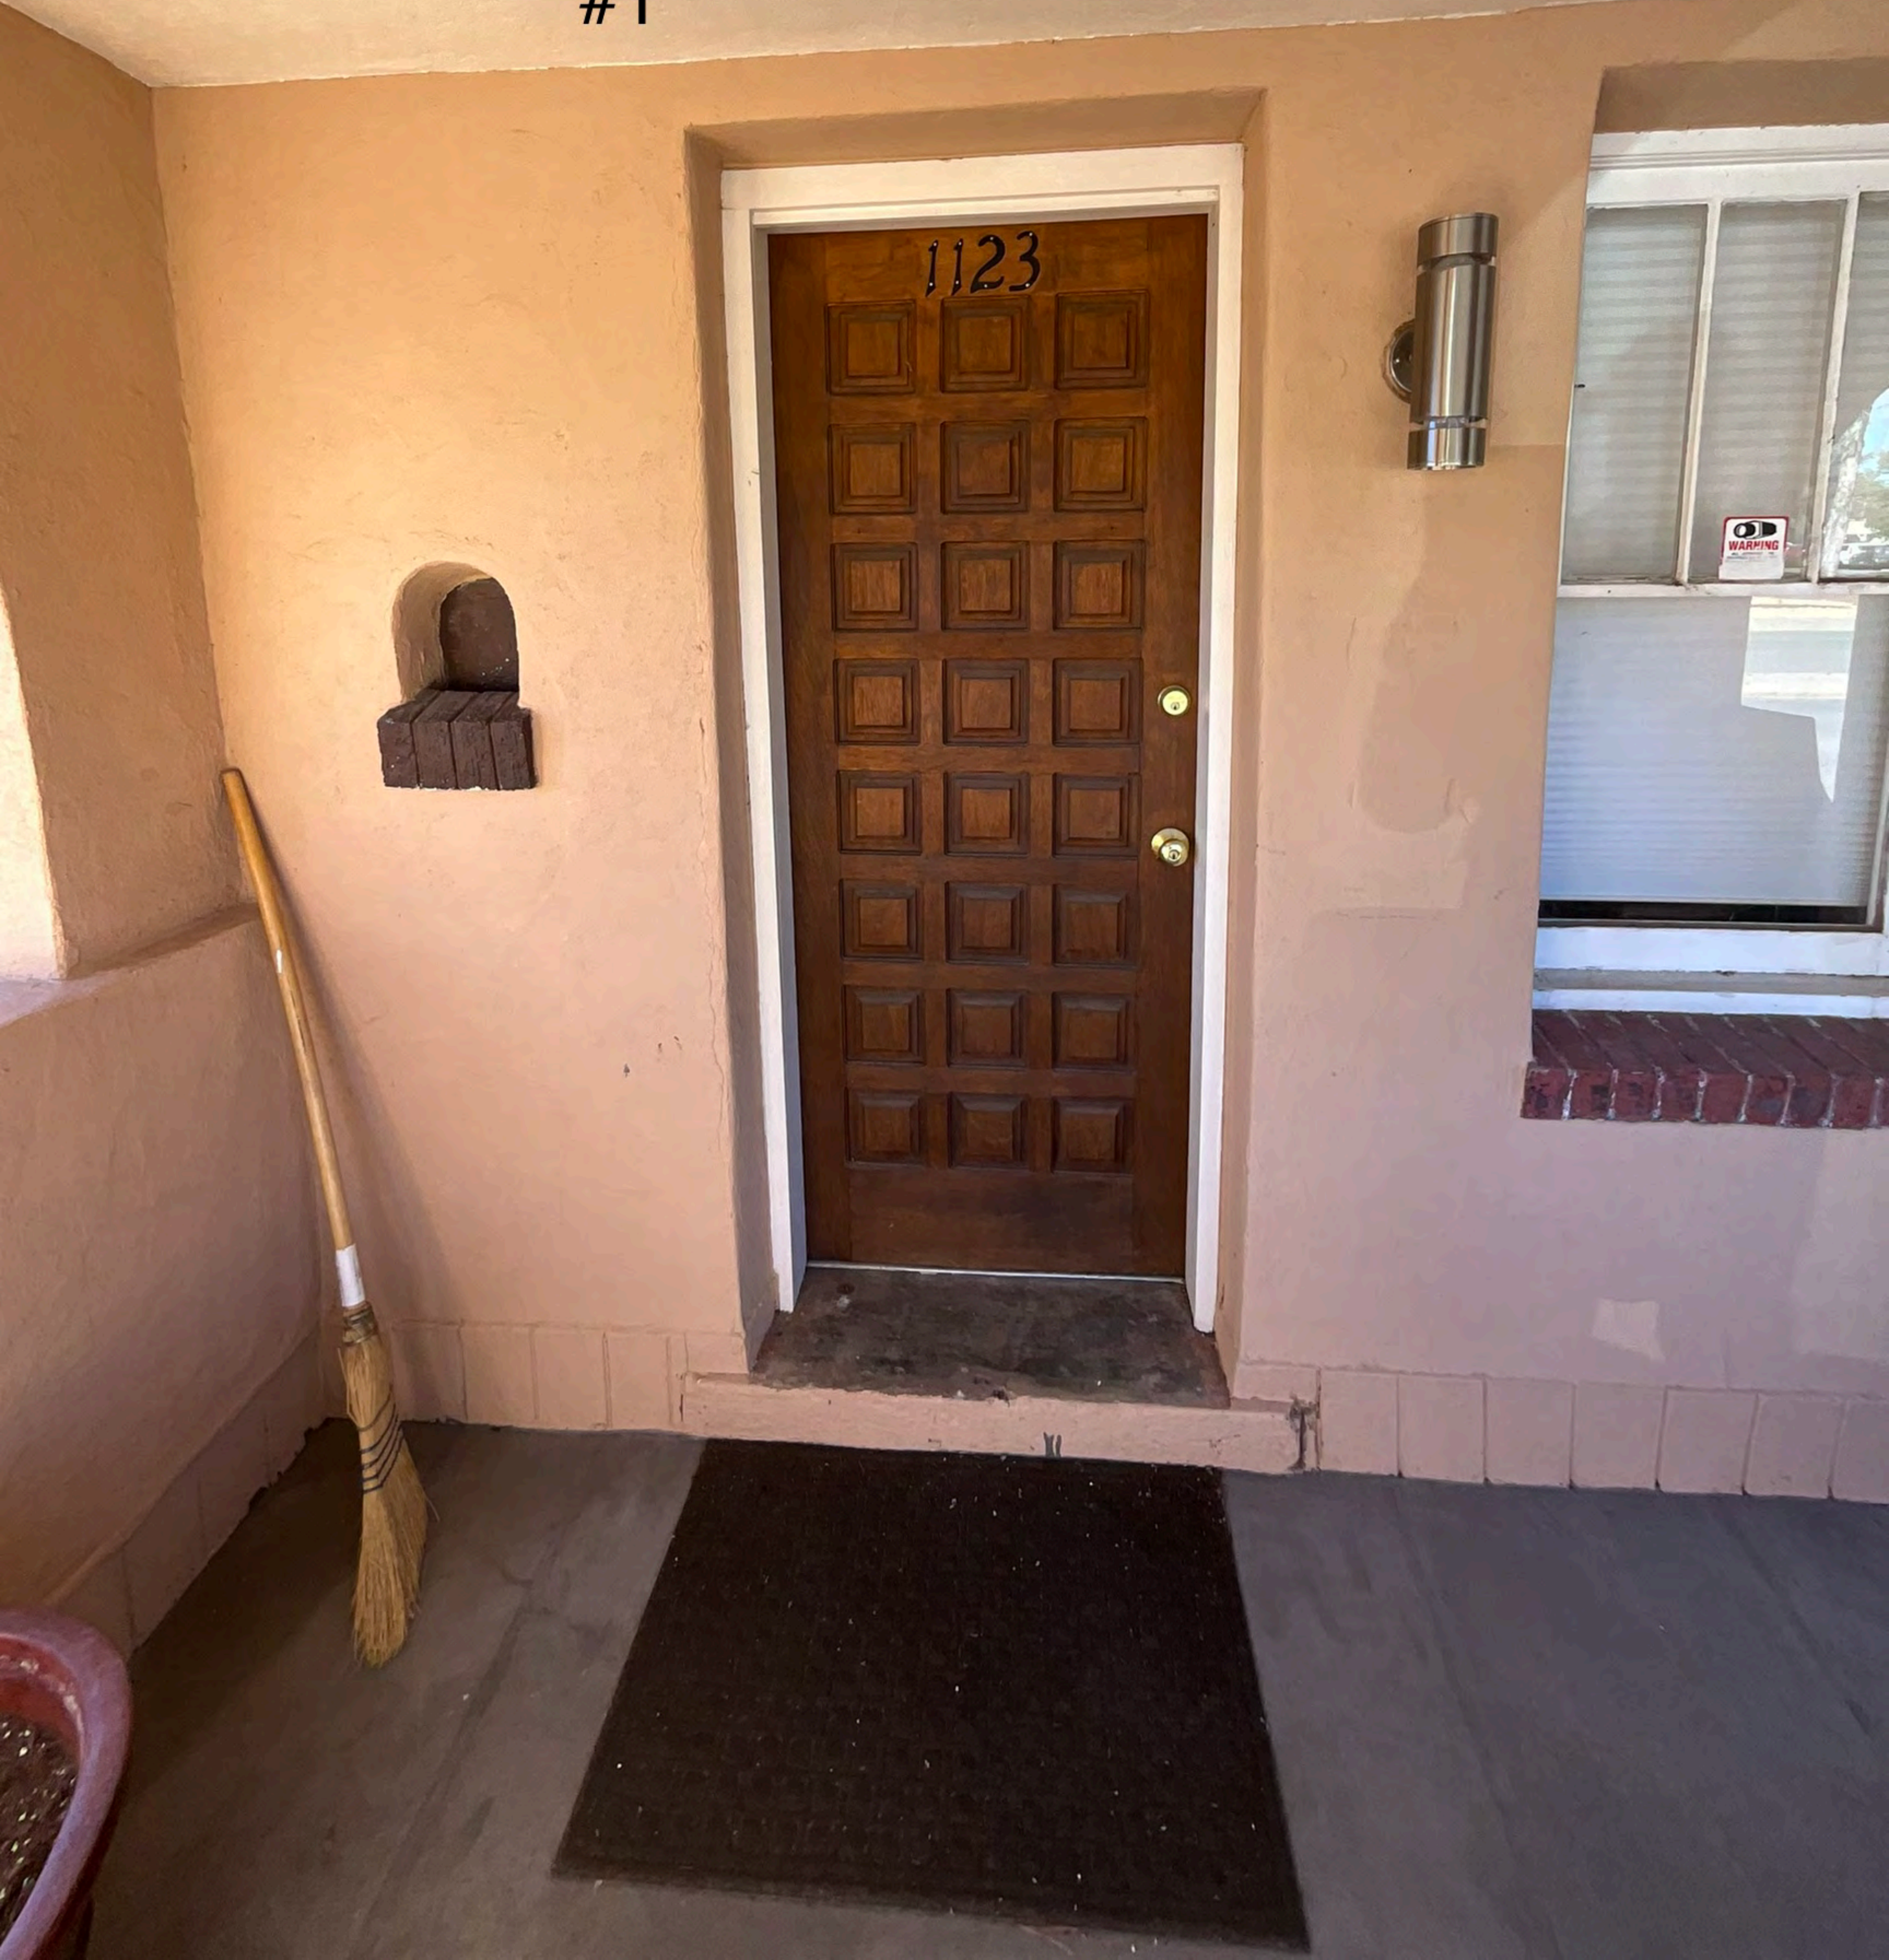
North Elevation
Door
#1

Doors #1, # 2, #3, and #4 are non-historic.

LABEL	WINDOW & DOOR DESCRIPTION	CONDITION & INTEGRITY CODE	HISTORIC/NON-HISTORIC - AGE
<u>NORTH</u>			
DR #1	32" x 80" LH INSWING DOOR 24-PANEL	S	NON-HISTORIC – "SIMPSON" FIR MANUFACTURED DOOR
A	28" x 54" DOUBLE HUNG 3W1H/1-LT ALL WOOD	F	HISTORIC
<u>WEST</u>			
B	37" x 38" LR STEEL CASEMENT 1W3H	F	NON-HISTORIC – PUT IN THE OPENING TO REPLACE A WOOD ORIGINAL WINDOW
C	44" x 29" LR INSWING CASEMENT 2W2H 1 1/8" – 5/8"	F	HISTORIC – SASHES NON-HISTORIC – BARN SASHES EMPIRE BUIDLERS SUPPLY
D	39" x 29" LR INSWING CASEMENT 2W2H 1 1/8" – 5/8"	F	HISTORIC – SASHES NON-HISTORIC – BARN SASHES EMPIRE BUIDLERS SUPPLY
<u>EAST</u>			
DR #2	32" x 80" RH INSWING DOOR 3W5H	F	NON-HISTORIC – FIR "SIMPSON" DOOR 10-LITE (1996)
<u>NORTH</u>			
E	16" x 28" LH INSWING CASEMENT 2W3H	U	HISTORIC – JAMB, EXTERIOR COMPLETELY ROTTED CAUSING WATER PENETRATION IN THE WALL, ROTTED BEYOND 40% UNRESTORABLE

The windows and doors that are non-historic and unrestorable are to be replaced in “like and kind” to the windows of that era, wood divided lite (simulated or TDL), insulated Low-E glass (such as Kolbe or Weathershield manufactured). K-KRON would be a good alternative because of exterior low maintenance. K-KRON exterior has a 15-year warranty, whereas paint is approximately 3-5 years.

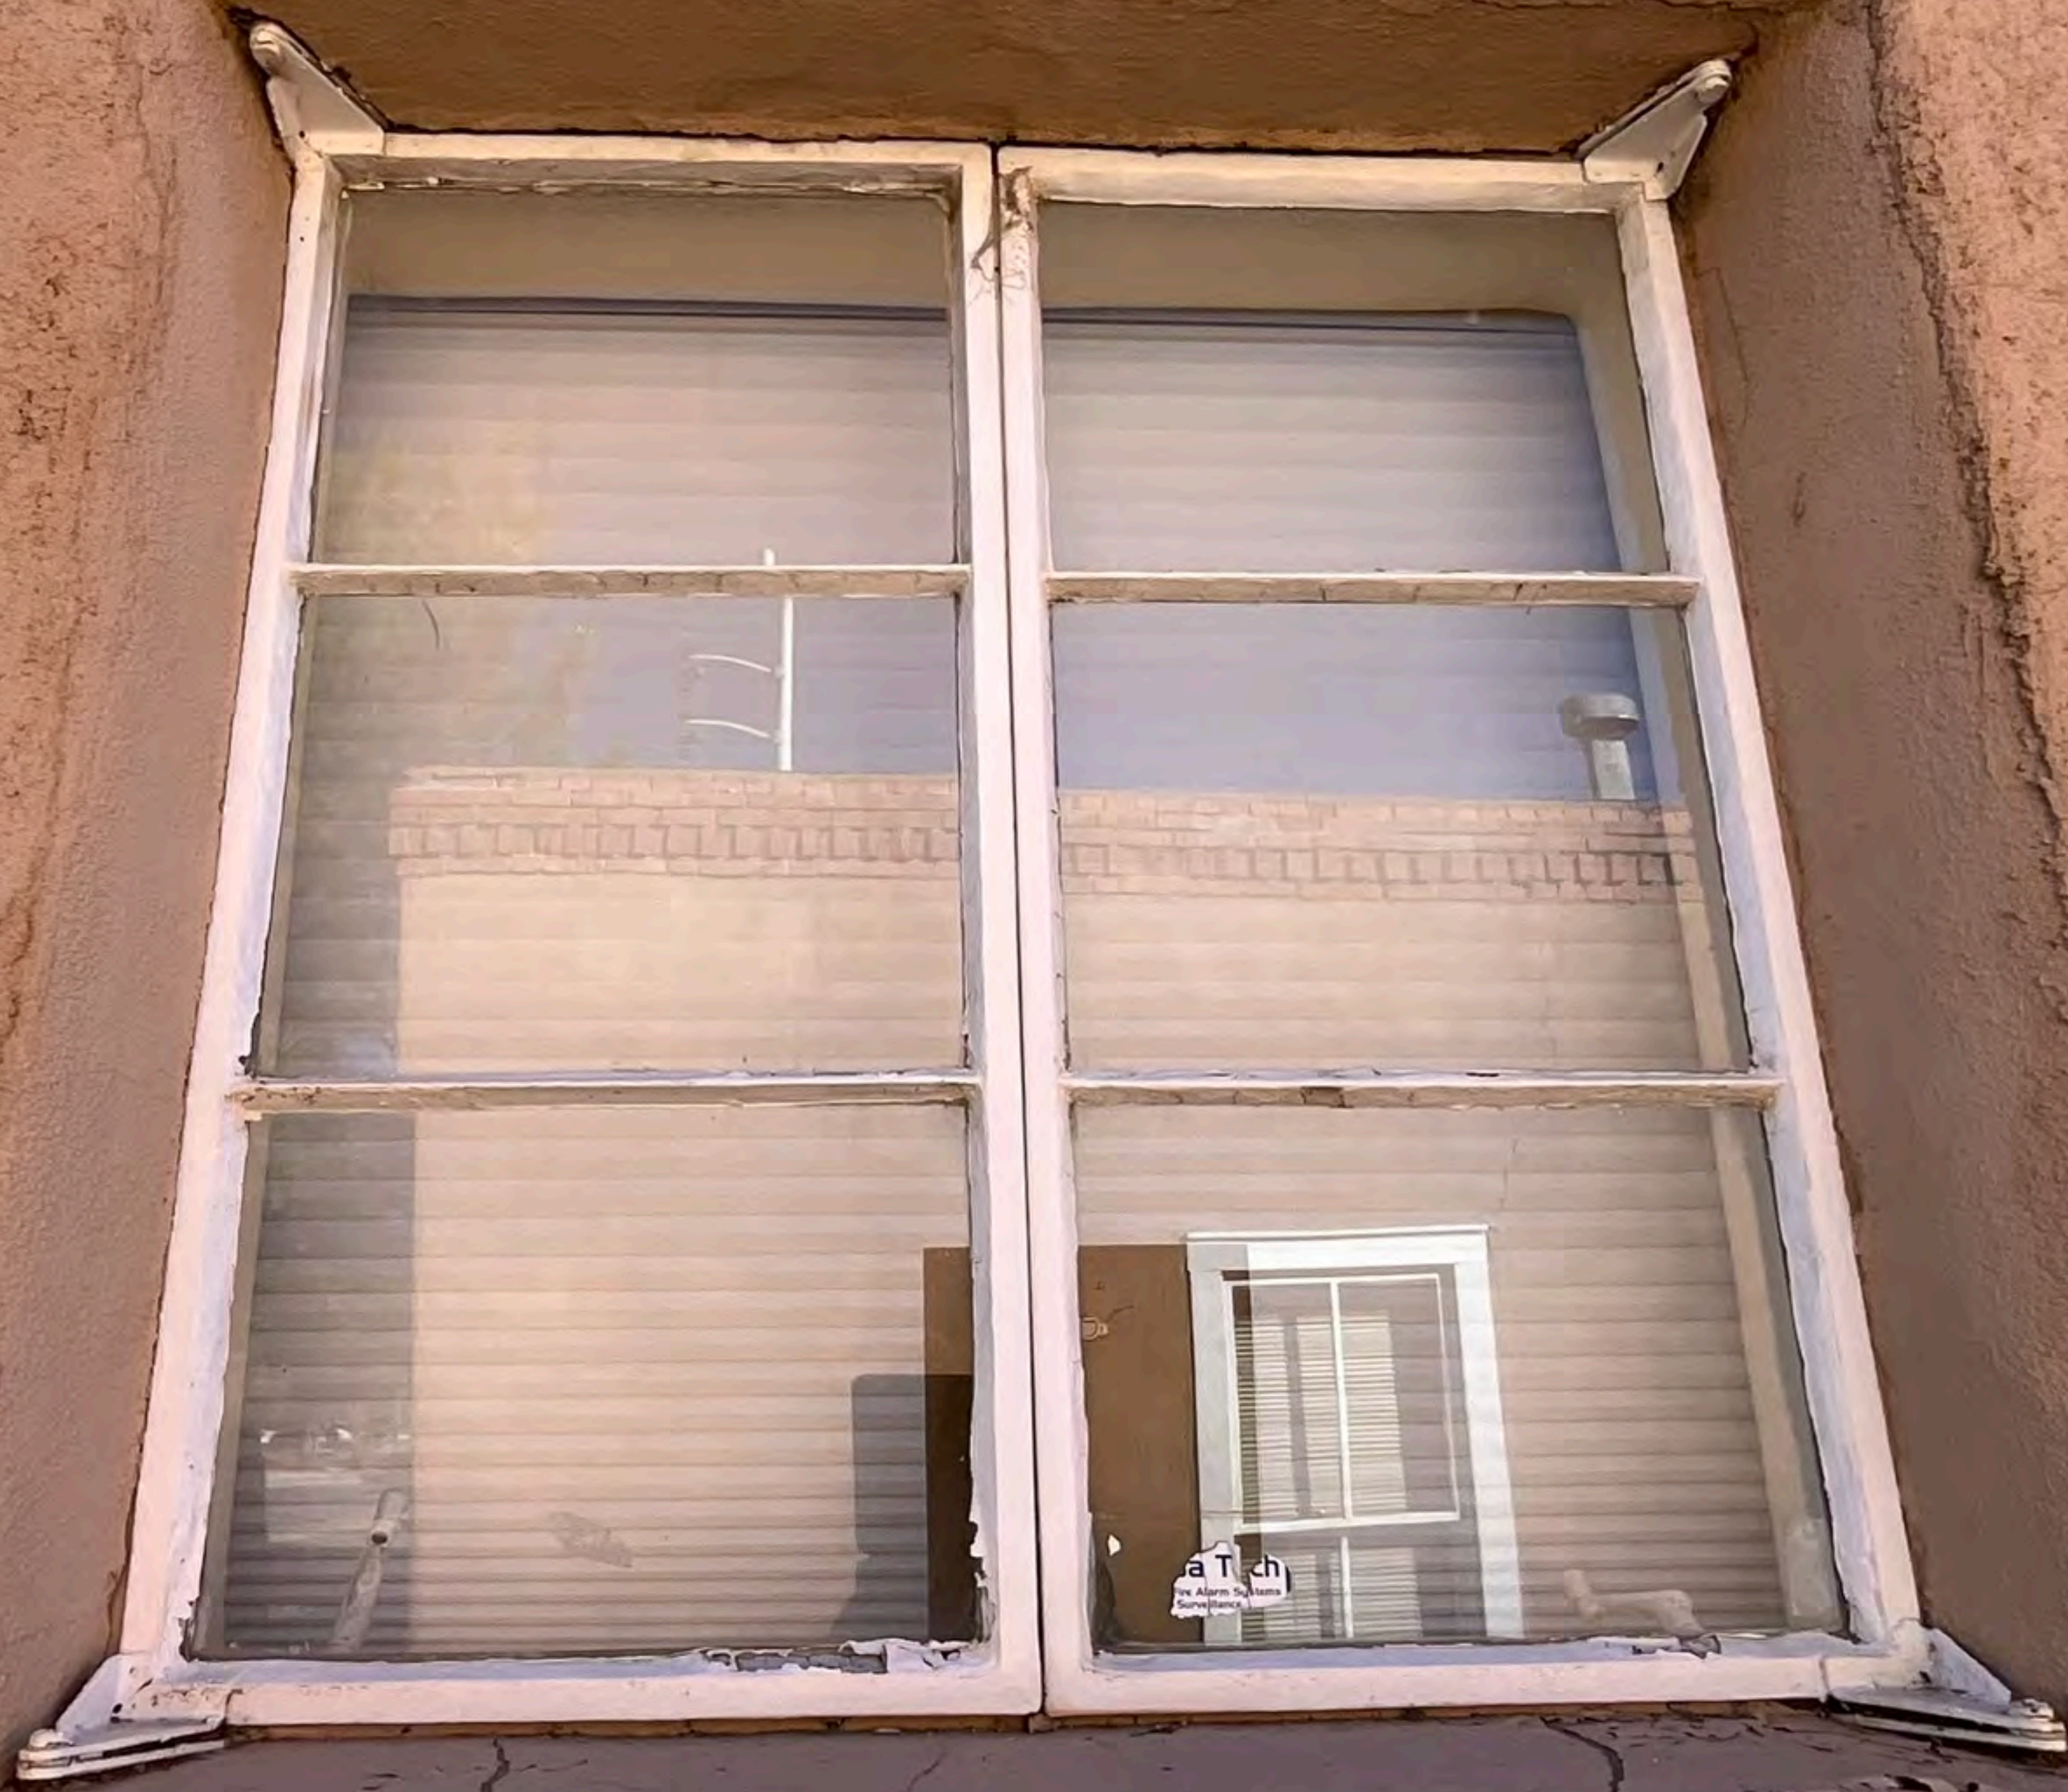
West Elevation
Window
B

Windows B, C, D, and F are non-historic.

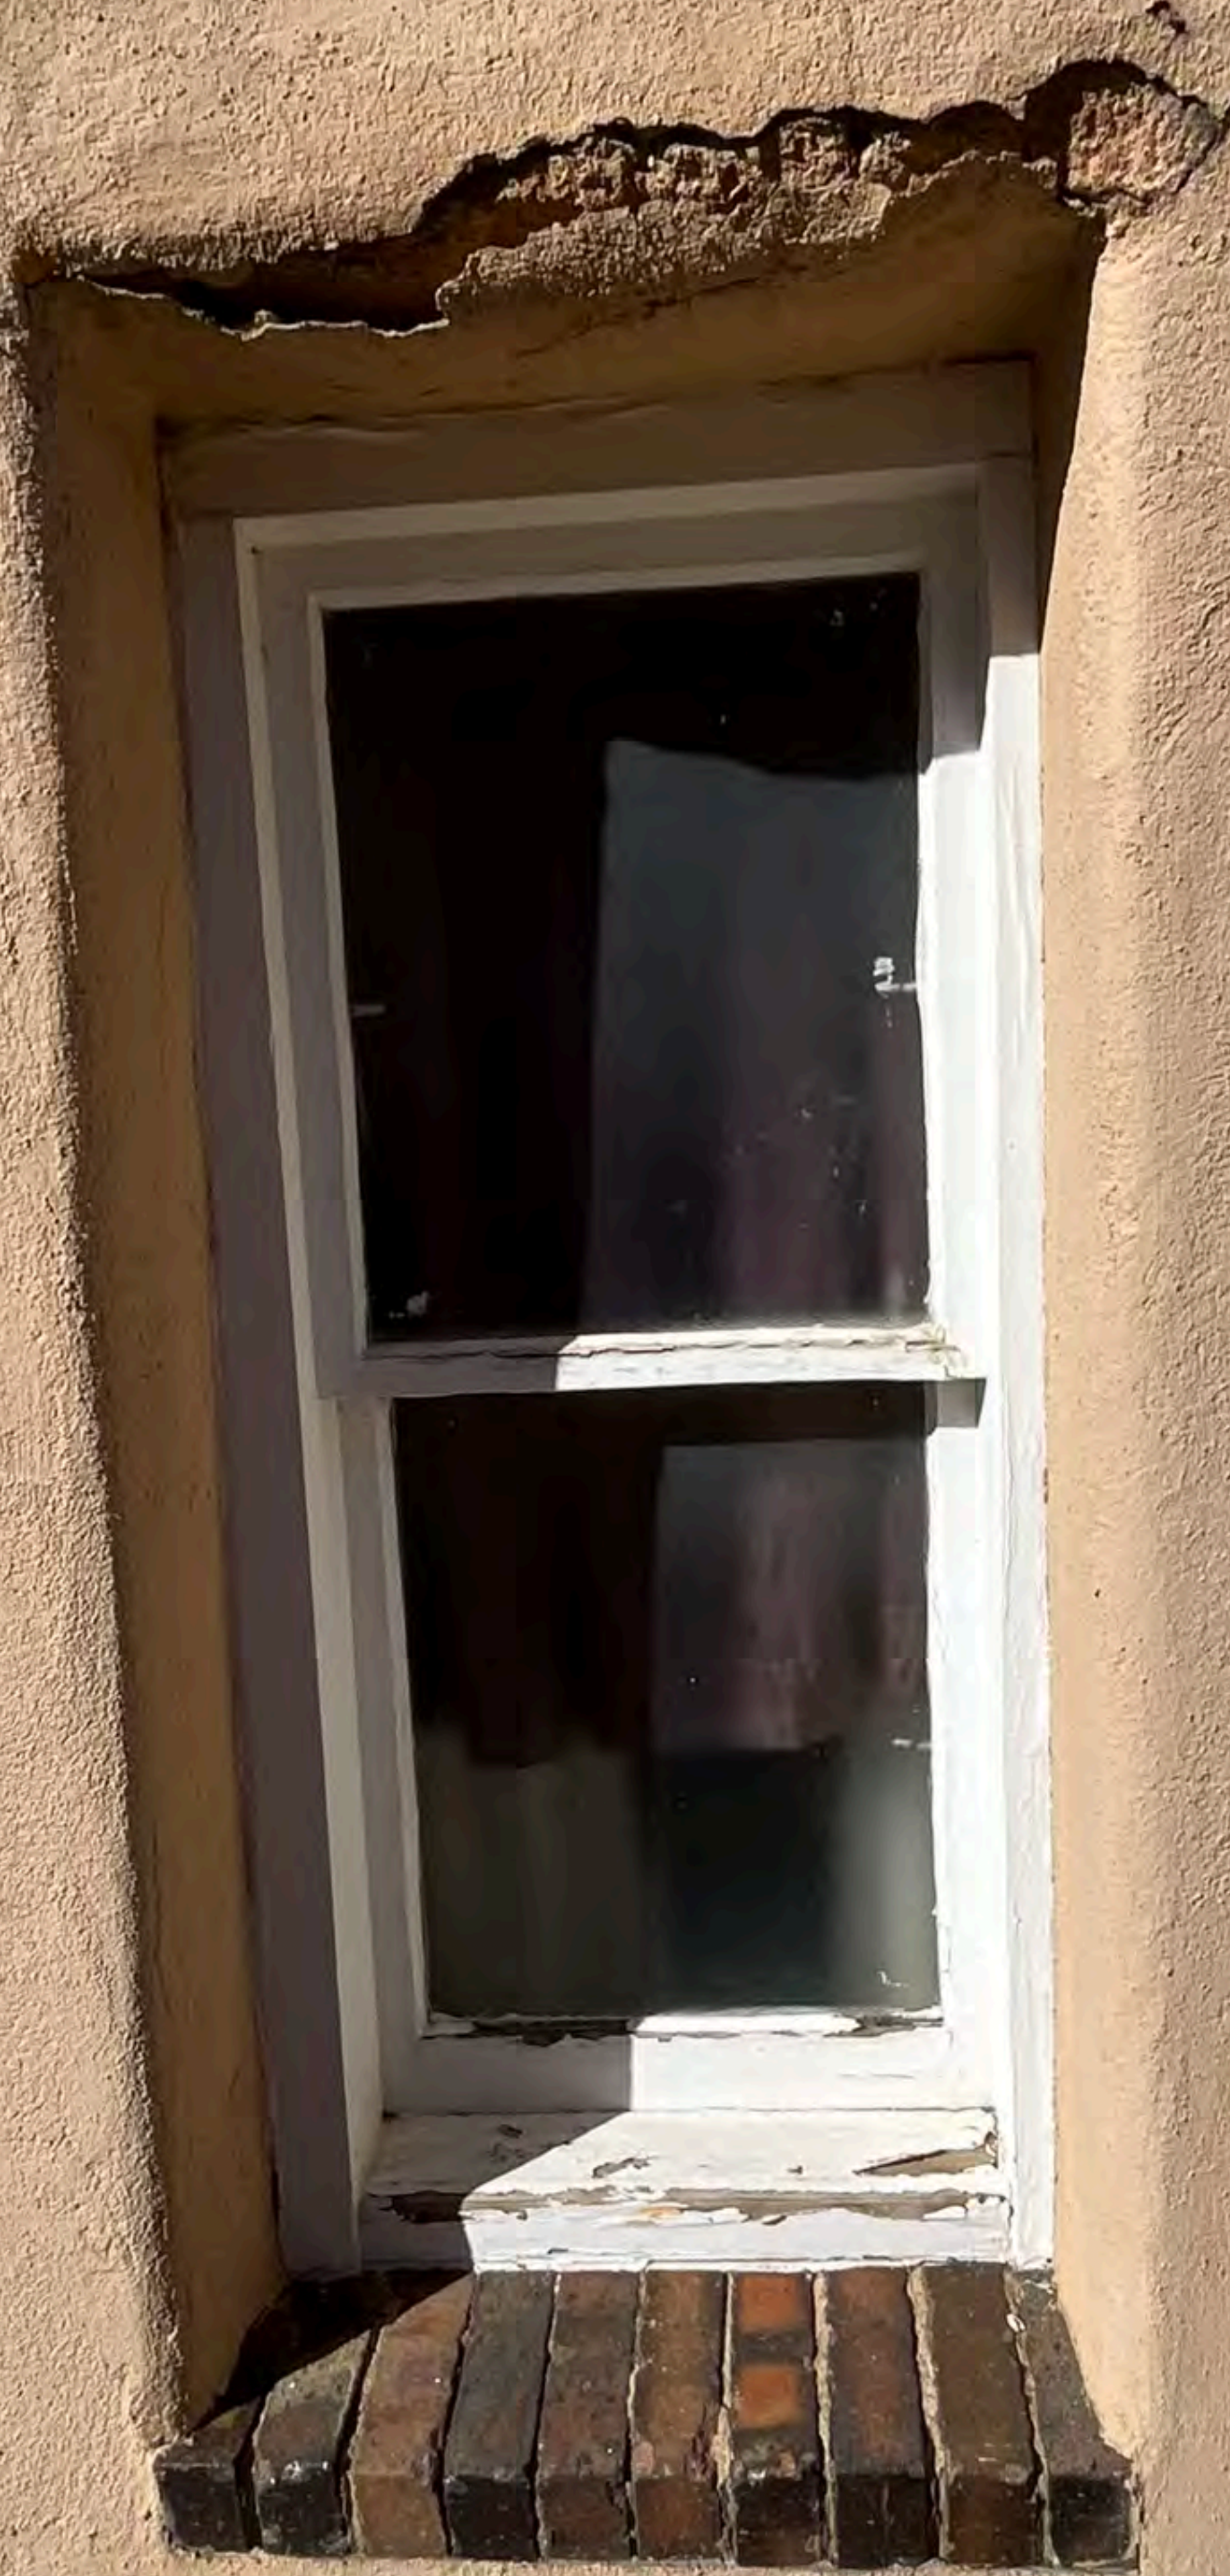
East Elevation
Window
F

LABEL	WINDOW & DOOR DESCRIPTION	CONDITION & INTEGRITY CODE	HISTORIC/NON-HISTORIC – AGE
<u>EAST</u>			
DR #3	32" x 80" LH INSWING DOOR 3W5H	F	NON-HISTORIC – FIR “SIMPSON” DOOR (1996)
F	20" x 50" DOUBLE HUNG 1/1 OBSCURE	F	NON-HISTORIC – SASHES REPLACED EARLY 1980’s PER GLASS, NON-DIVIDED LITES
G	28" x 56" DOUBLE HUNG 3W1H/1-LT	F	HISTORIC
DR #4	32" x 80" RH INSWING DOOR 6-PANEL	F	NON-HISTORIC – FIR “SIMPSON” DOOR (1996)
H	28" x 56" DOUBLE HUNG 3W1H/1-LT	F	HISTORIC
I	28" x 56" DOUBLE HUNG 3W1H/1-LT	U	HISTORIC – AC UNIT HAS LEAKED/CONDENSATED CAUSING WATER DAMAGE IN THE WALL BELOW THE WINDOW, ROTTED BEYOND 40% WINDOW JAMB WILL NEED TO BE REMOVED TO REPAIR WALL, THE JAMB IS THE WINDOW BUCK AND WILL BE DESTROYED UPON REMOVAL

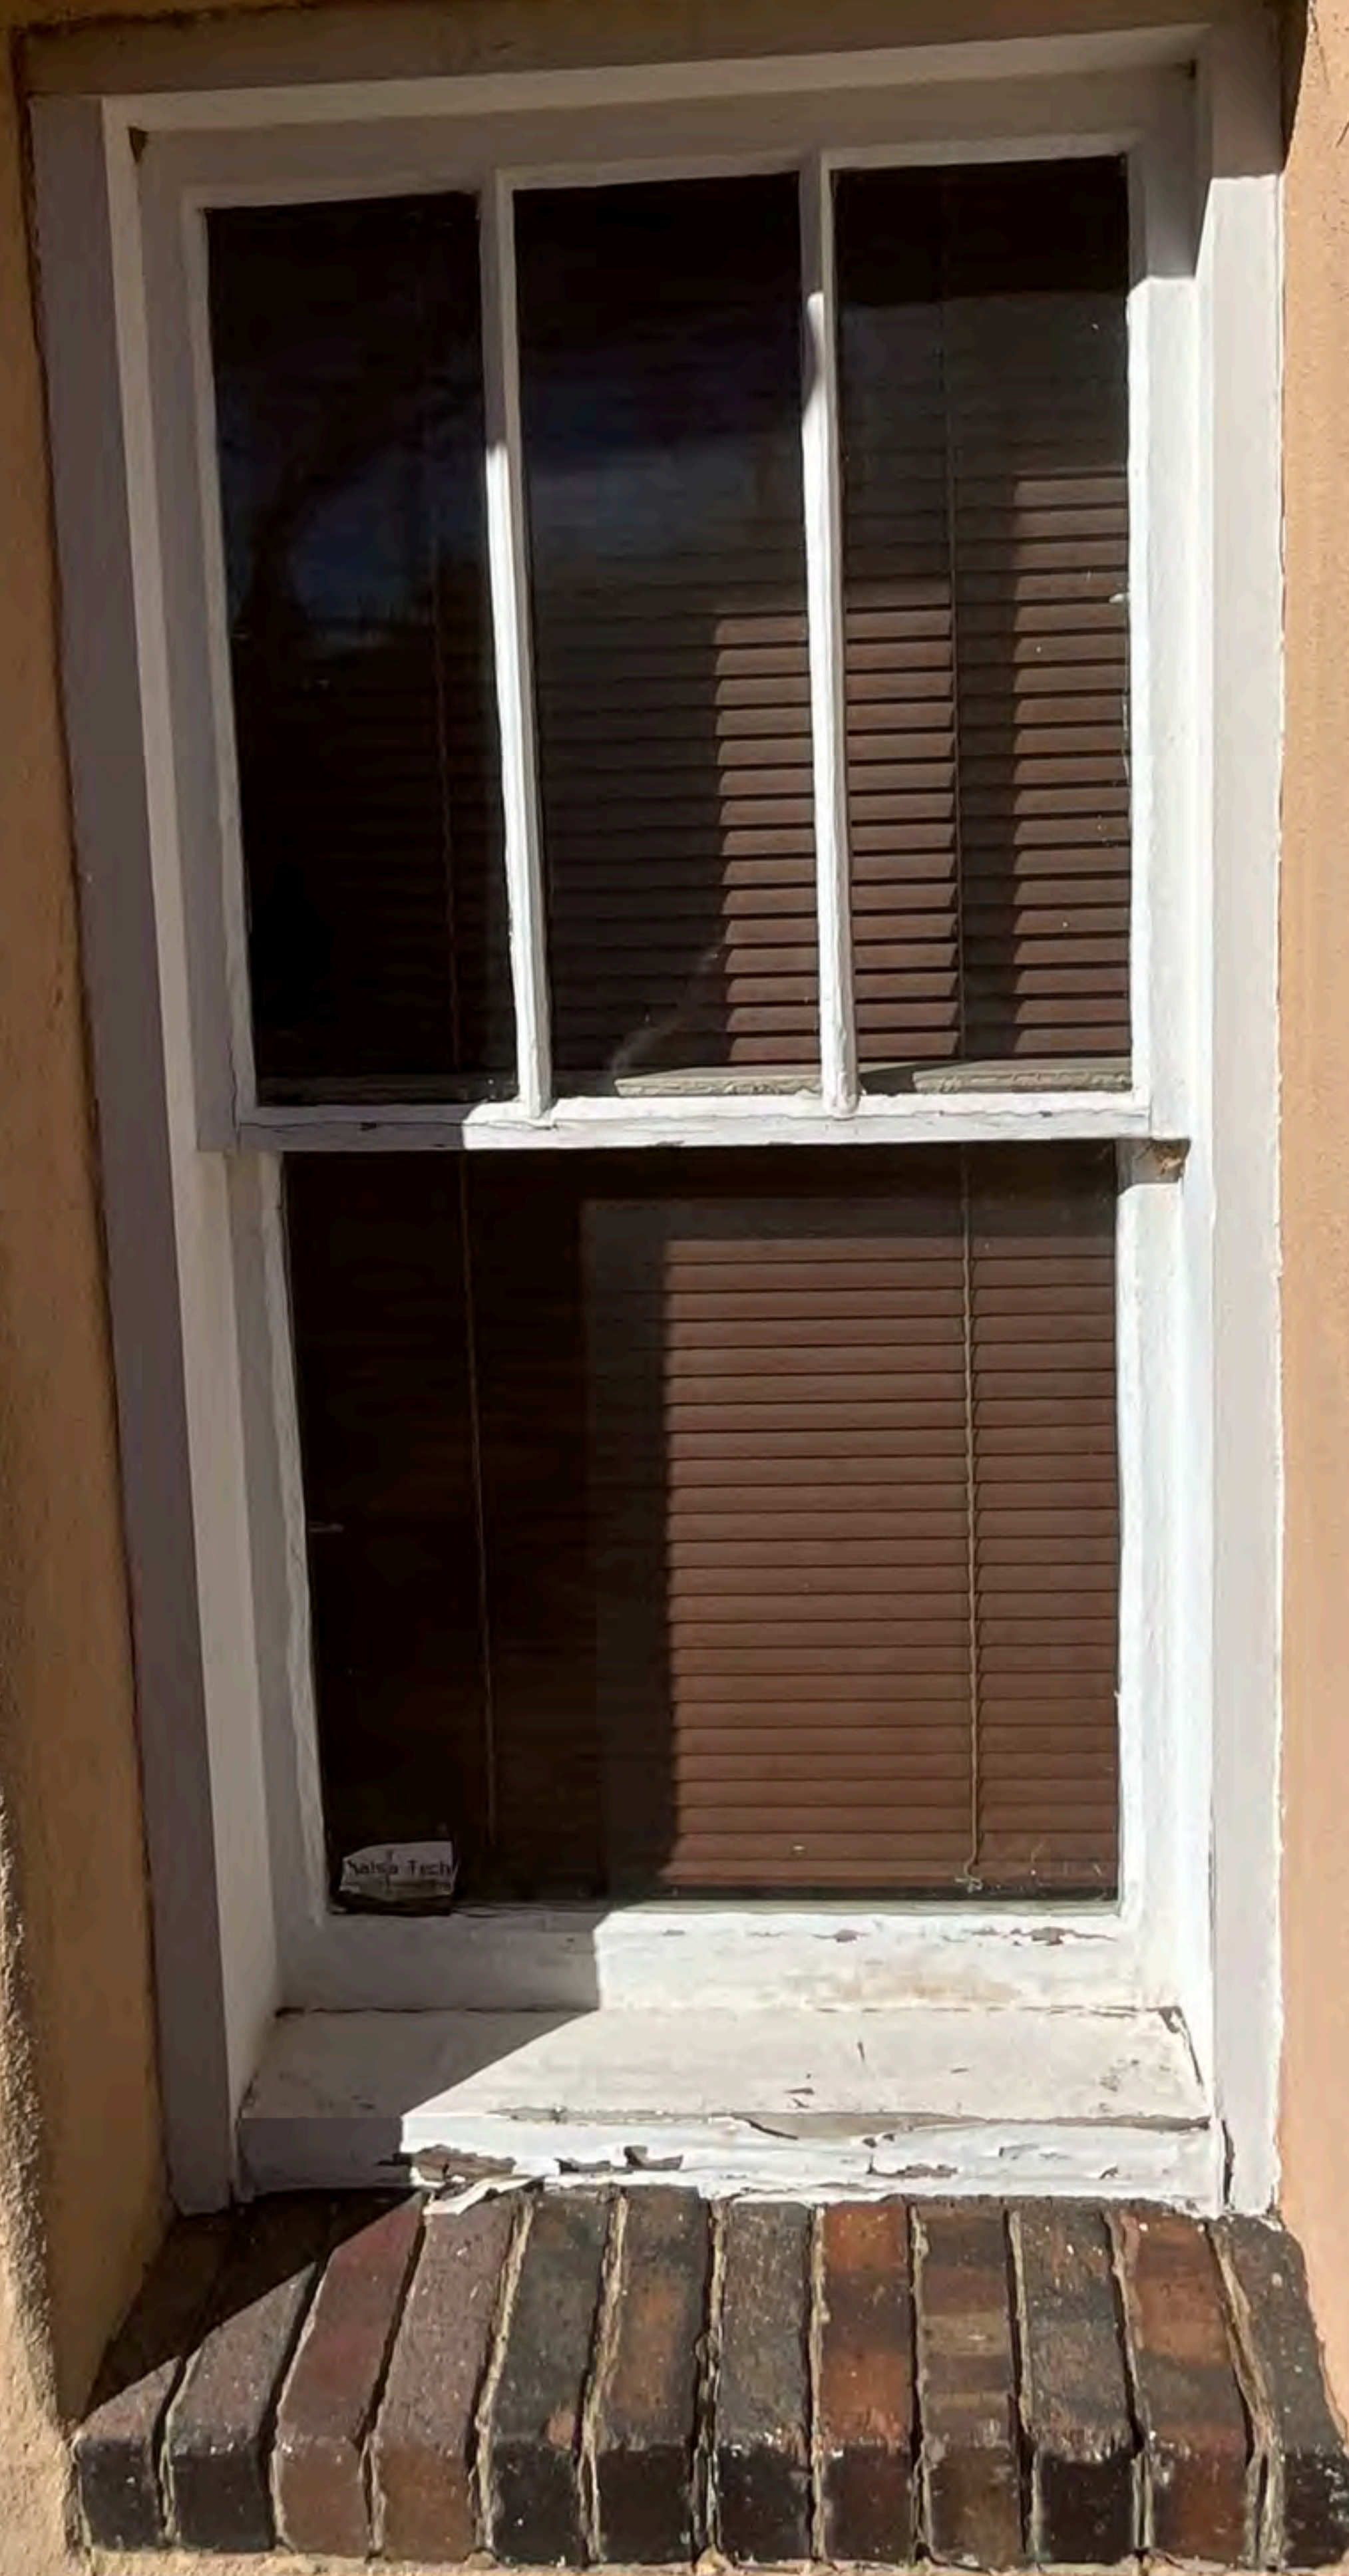
East
Elevation
Window
G

Windows G & H are historic.
