RPA & Associates LLC

JOB	DATE
1121 Paseo de Peralta, Santa Fe, NM 87501	01/22/2026

RPA & ASSOCIATES, LLC | WINDOW & DOOR CONDITION AND INTEGRITY CODES

JOB	DATE
1123 Paseo de Peralta, Santa Fe, NM 87501	01/22/2026

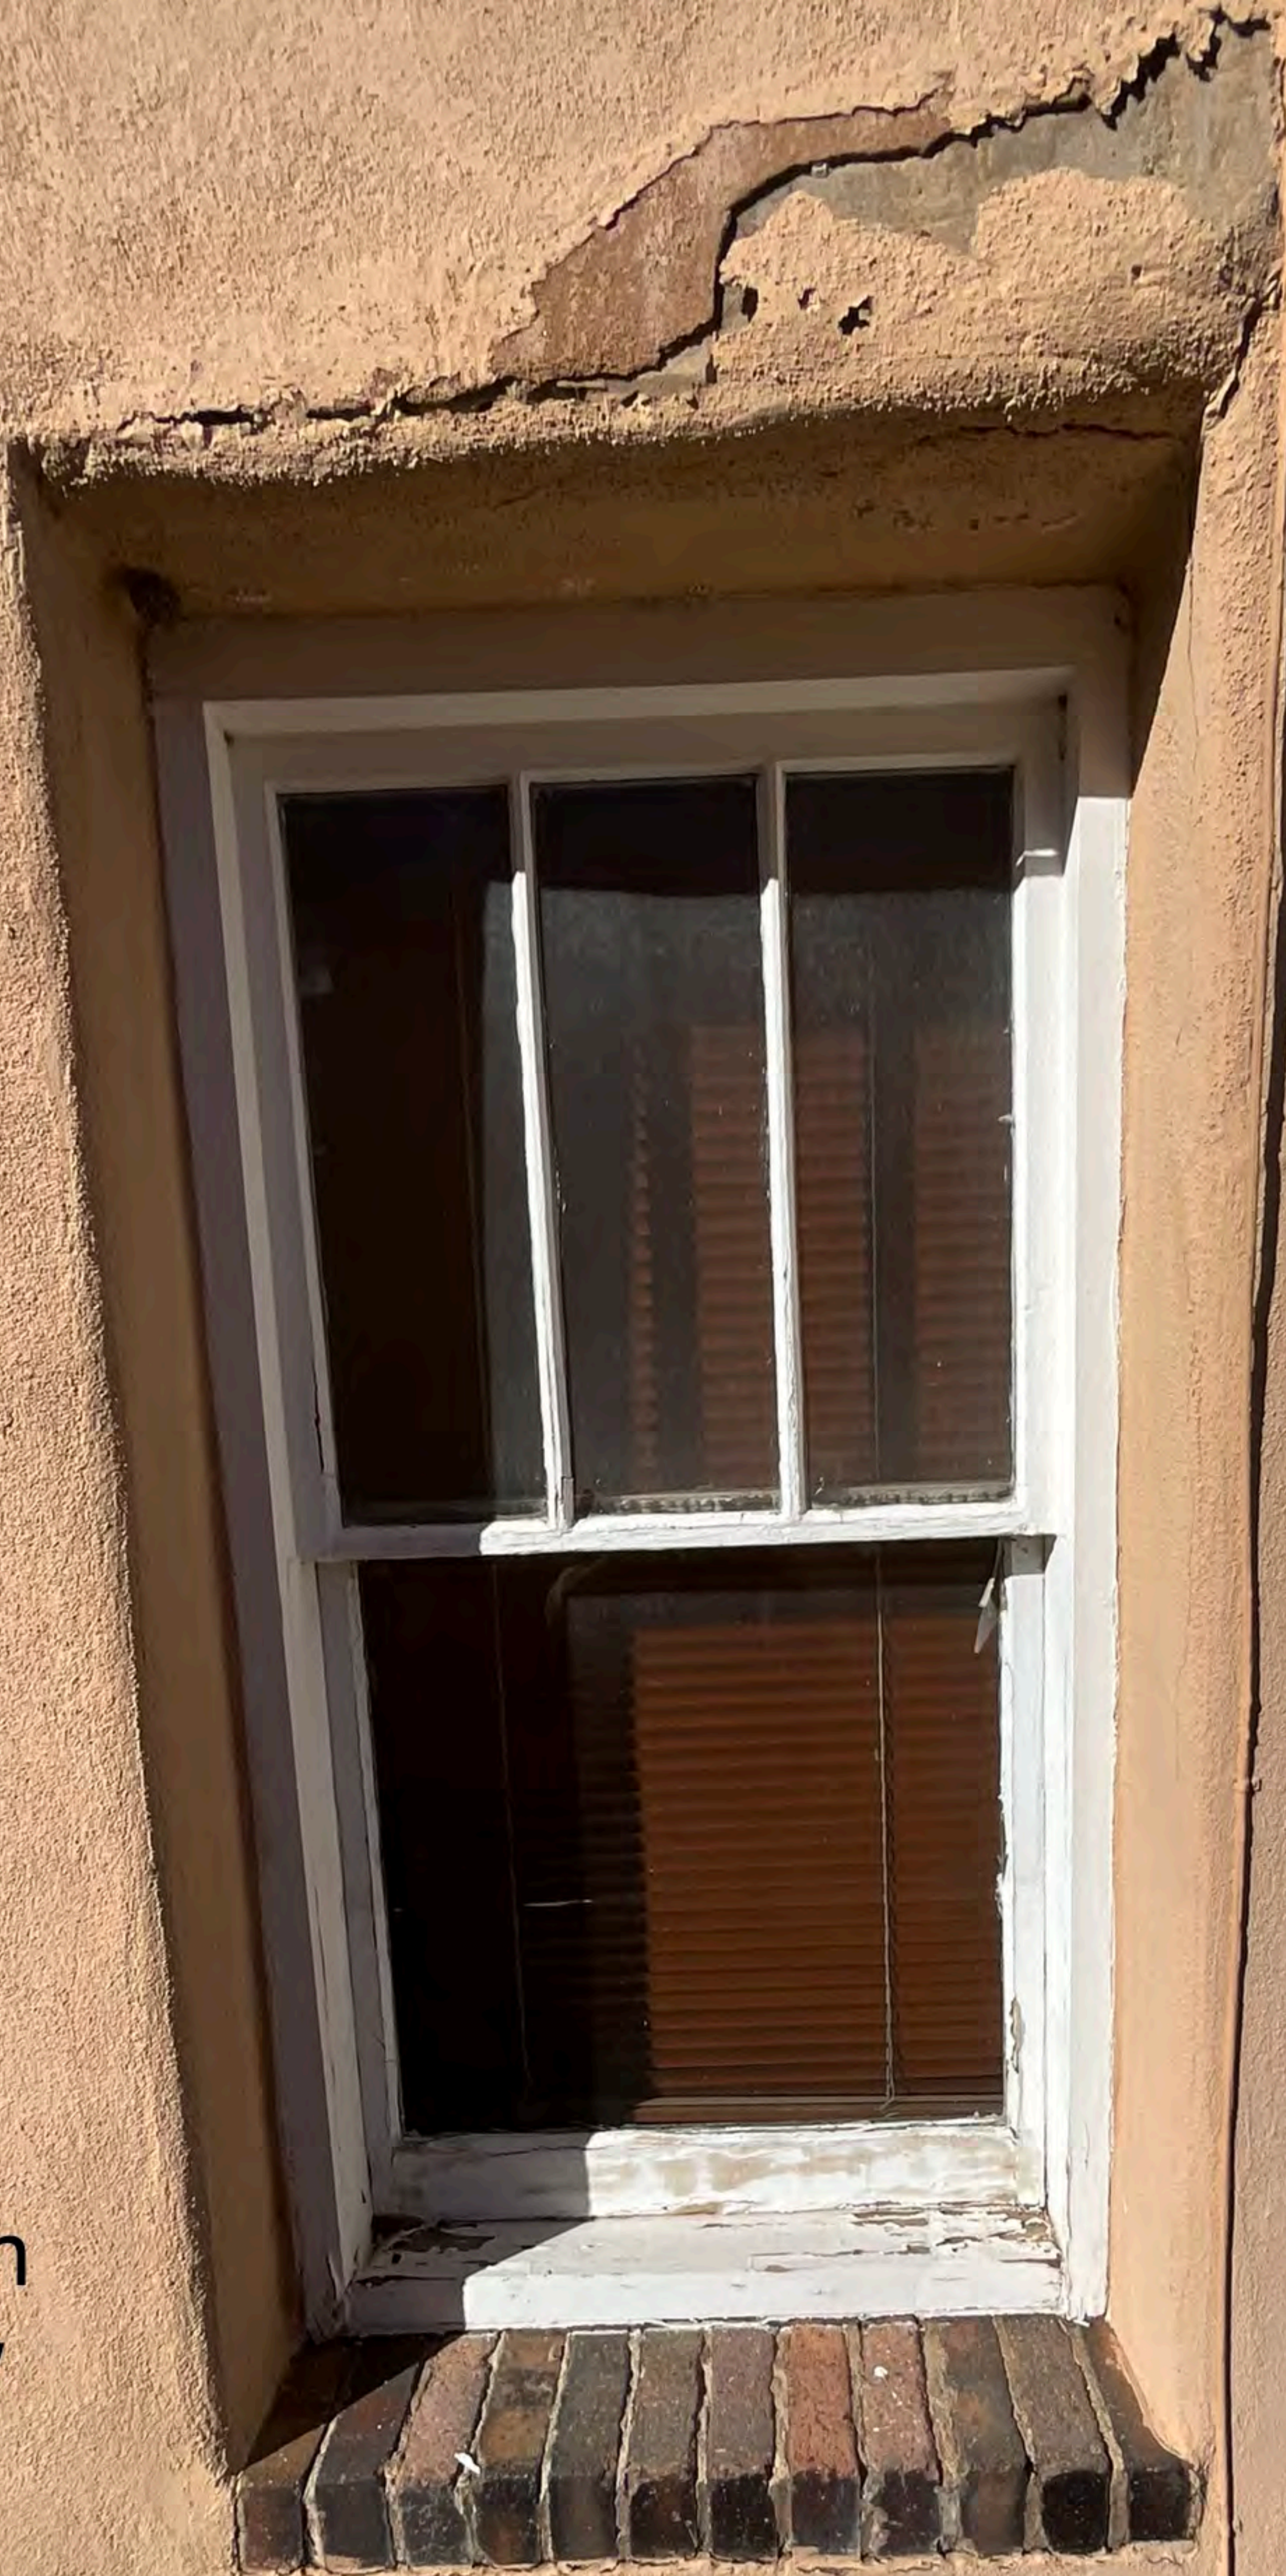
East
Elevation
Window
H

Windows G & H are historic.
