216 Maynard Street

Historic Cultural Properties Inventory (HCPI) Base Form (FORM 1)

1. Name of property: Ramon Vigil House and Rental Units	2. Location: 216 Maynard Street 216 Maynard Street B Westside-Guadalupe Historic District – Santa Fe	3. Local Reference Number: Santa Fe ID: H-2676 4. County: Santa Fe Parcel # 12950144

8. Name of Project: HDRB Status Evaluation		
9. Lat/Long: 35.68692,-105.9524795		
10. Photo Information: John W. Murphey, photographer. Photo 1: View of east elevation. Camera facing southwest.

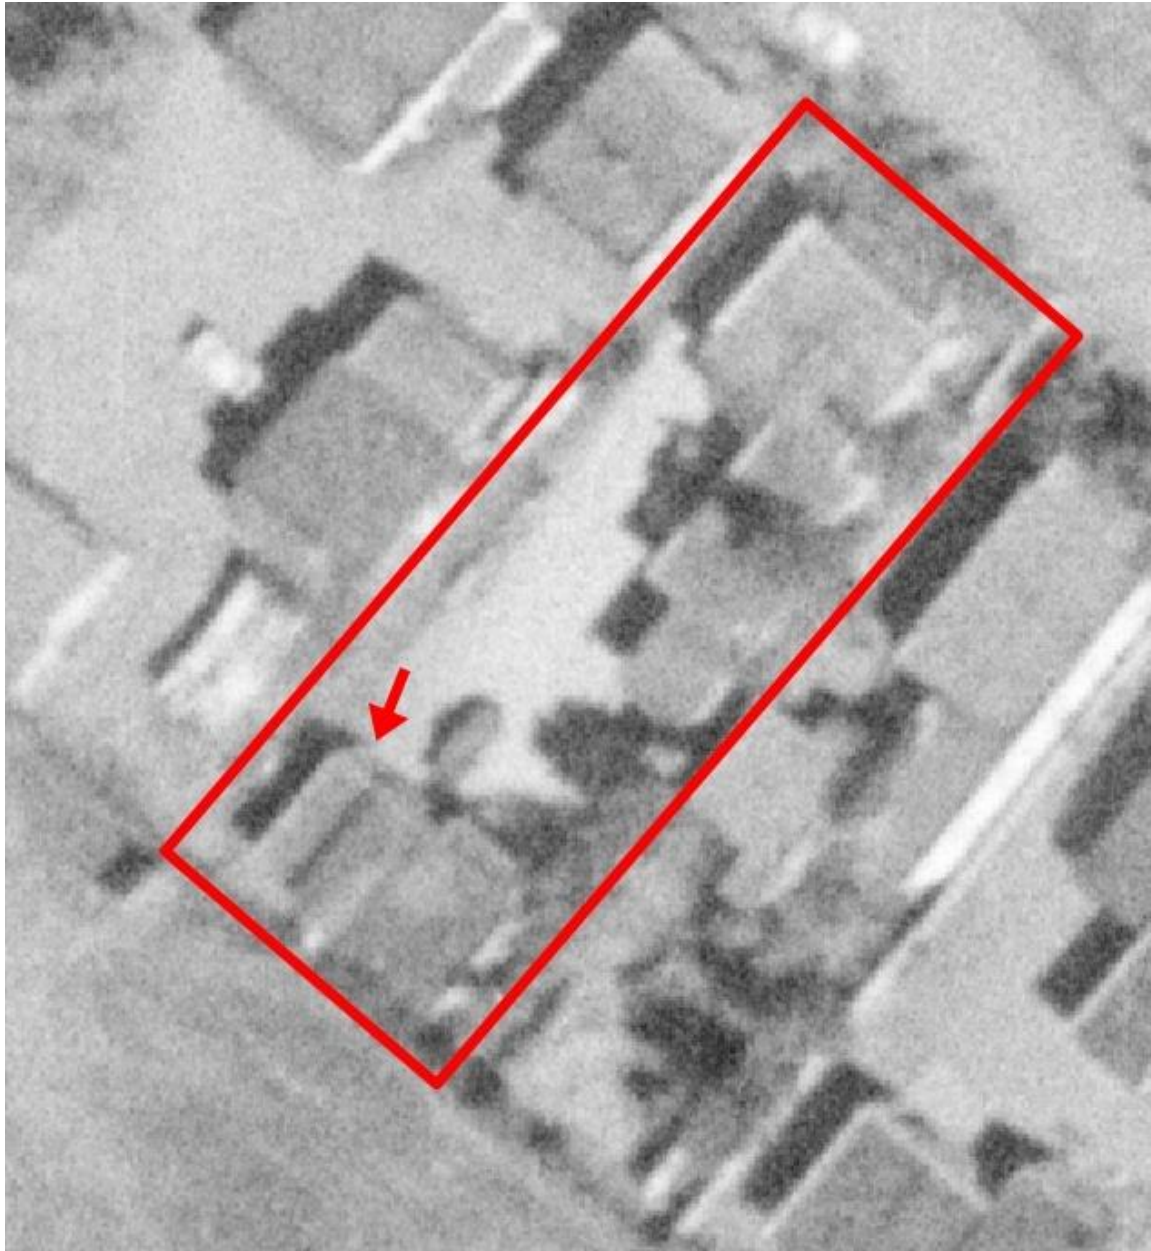
Figure 3: November 10, 1958, aerial photograph. Attached garage observed (arrow).

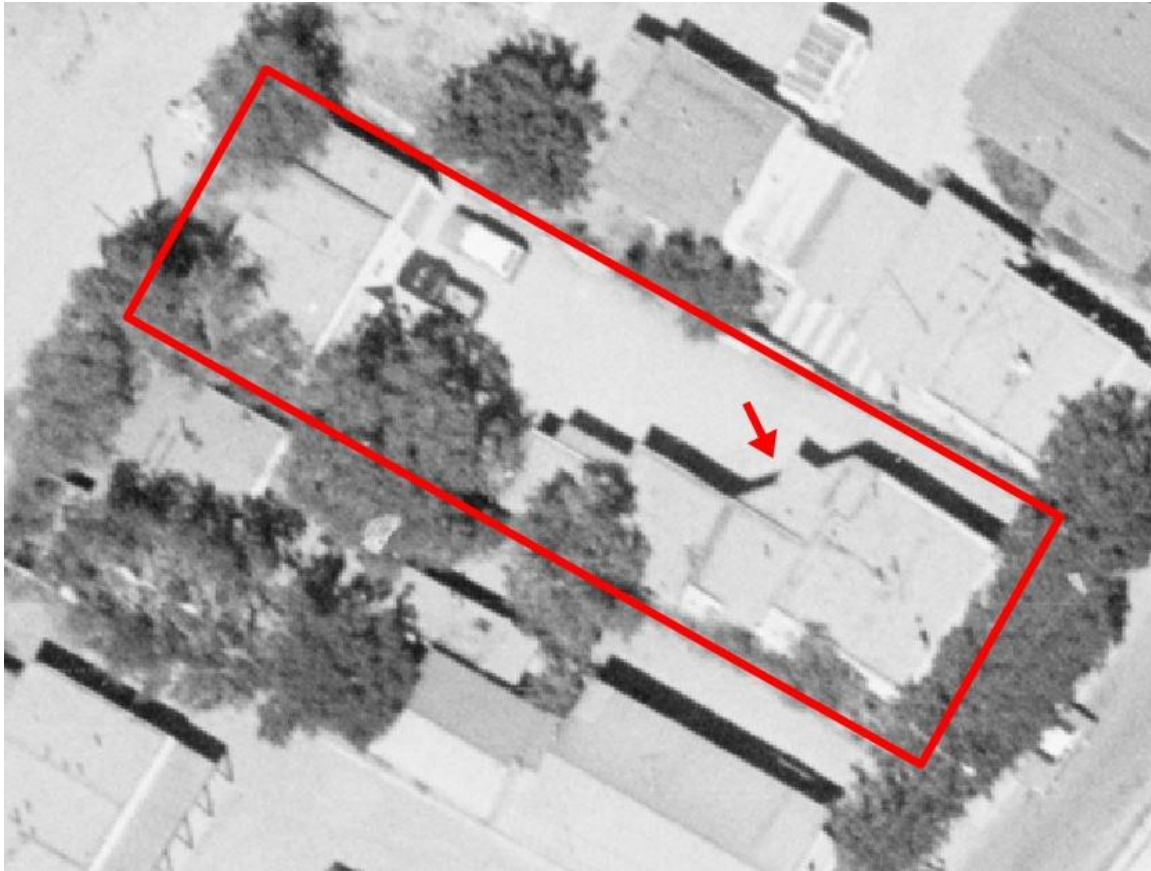
Figure 4: September 11, 1978, aerial photograph. Enclosed porch and porch addition observed (arrow).

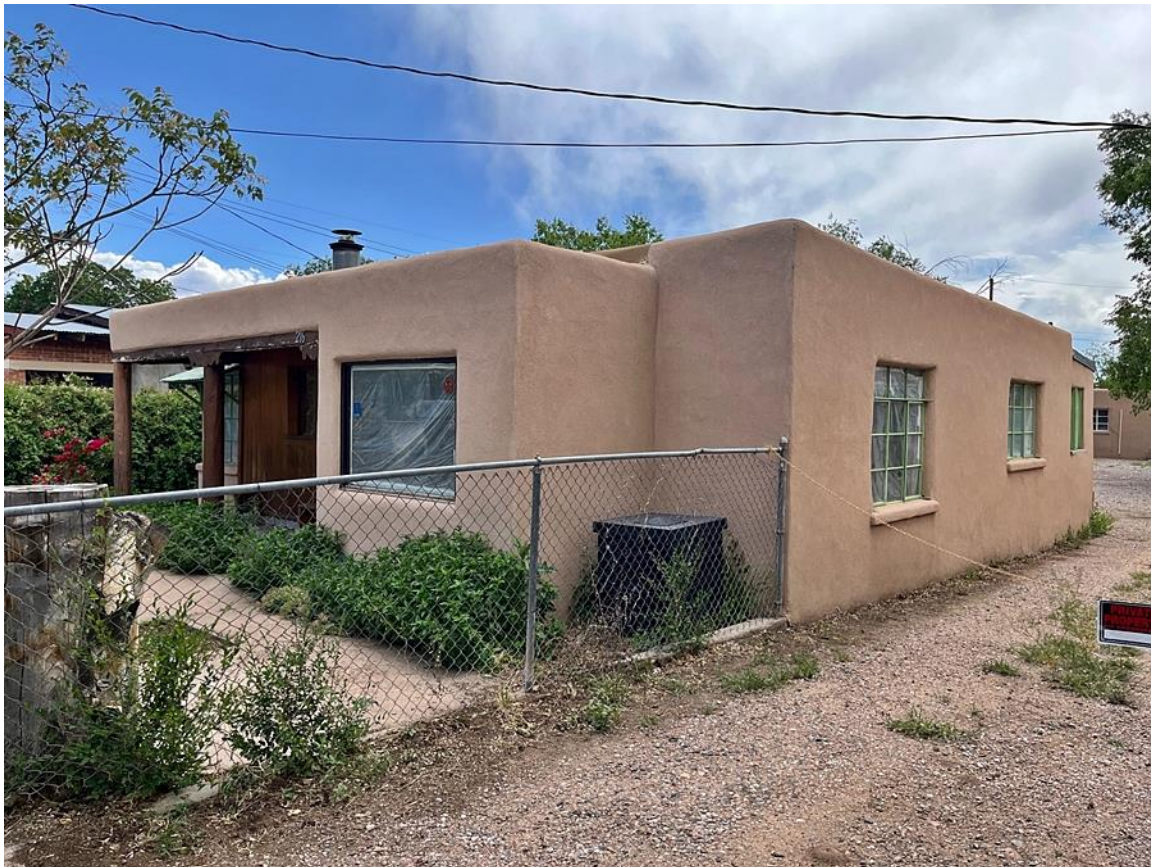
The primary house faces the street with an altered façade (Photo 1). Aerial photographs indicate that the original design consisted of a flat façade. Before 1958, a portal and entry vestibule were added to this elevation (Fig. 3) (Photo 2). In the recent past, the portal was infilled with vertical boards, enclosing the space and obscuring the original windows (Photo 3). This infill now occupies the center of the façade.

Photo 2: East (front) and north elevations of original home. Portal and entry added later. Camera facing southwest.

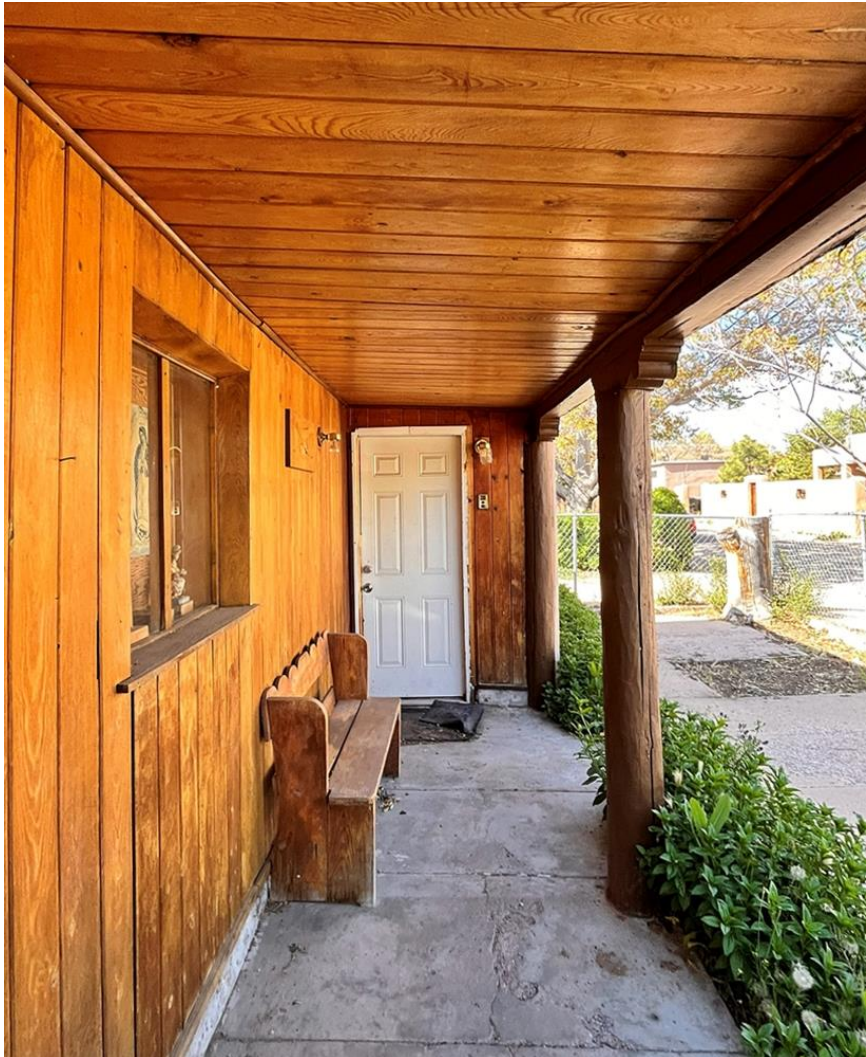
Photo 3: Portal and entry vestibule. Camera facing north.

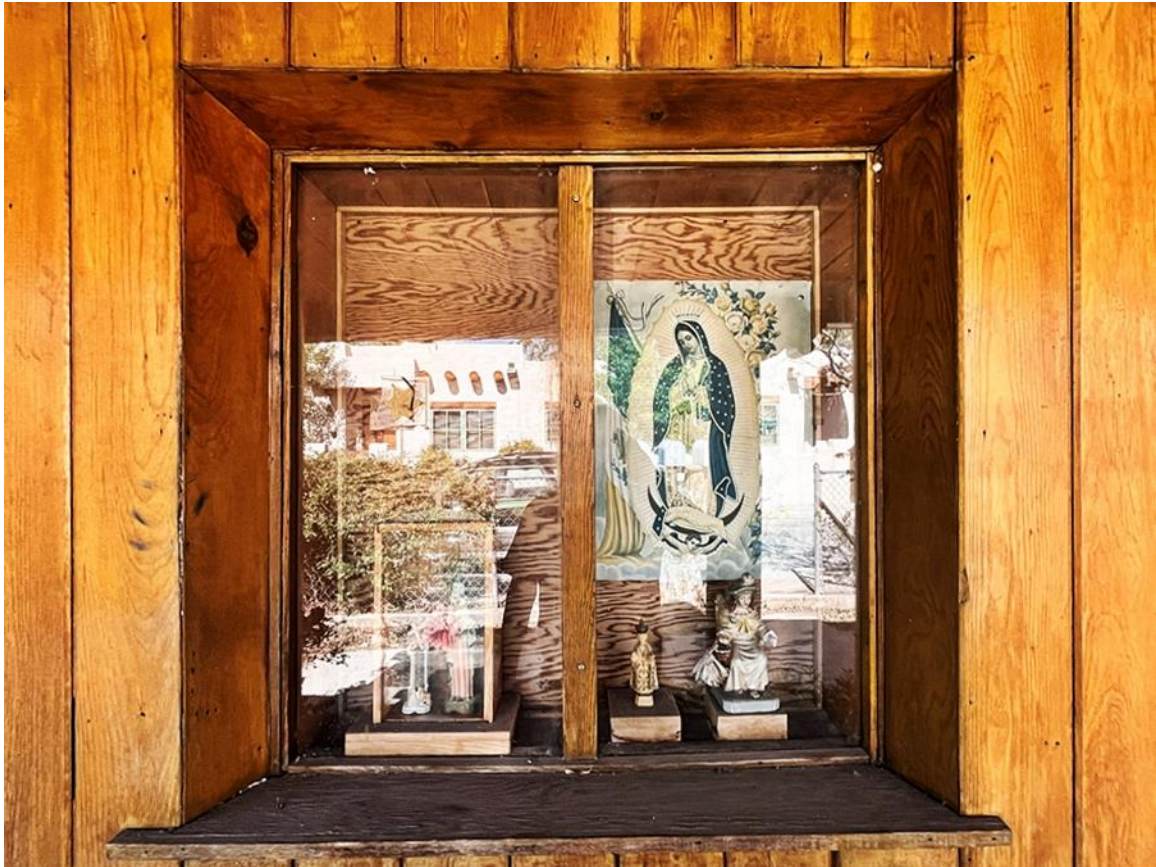
The furred area contains an inset display case holding the Virgin of Guadalupe and representations of Santo Niño and other Catholic saints (Photo 4). The installation appears permanent in character, with fixed glazing and integrated framing rather than a removable shelf or temporary arrangement. At the north end is an entry vestibule with a modern metal door. Beyond it, along the east façade, is a non-historic window lighting the vestibule (Photos 5 & 6). This opening, unlike those in the historic portion of the house, lacks the stuccoed lug sill found elsewhere, further suggesting that this section represents a later addition.

Photo 4: Display of saints. Camera facing west.

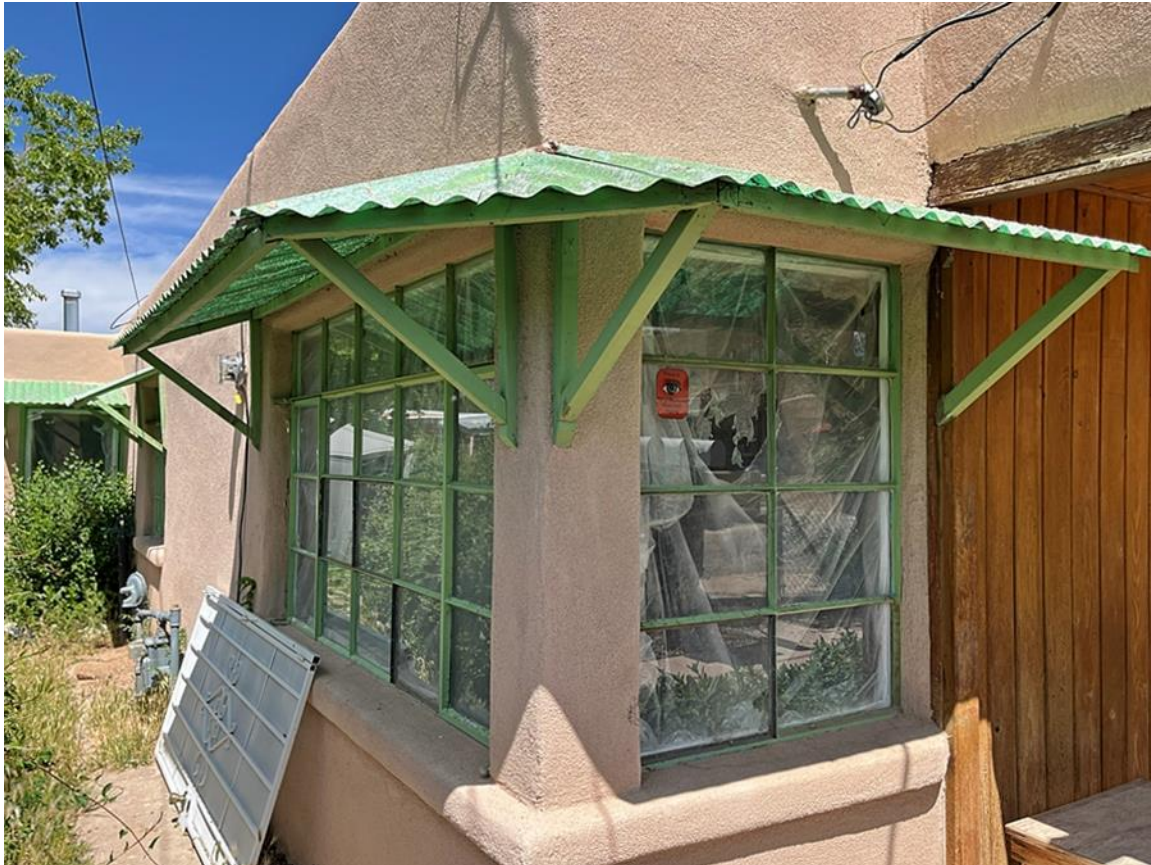
The opposite end of the façade contains a steel combination window (Photo 7). This, and the adjacent windows along the south elevation, are sheltered by shallow green corrugated fiberglass shade canopies supported on triangular wood brackets with diagonal braces and painted to match the window frames. These were likely constructed by the long-term homeowner, Ramon Vigil, who was a carpenter.

Photo 7: Windows at southeast corner. Camera facing northwest.

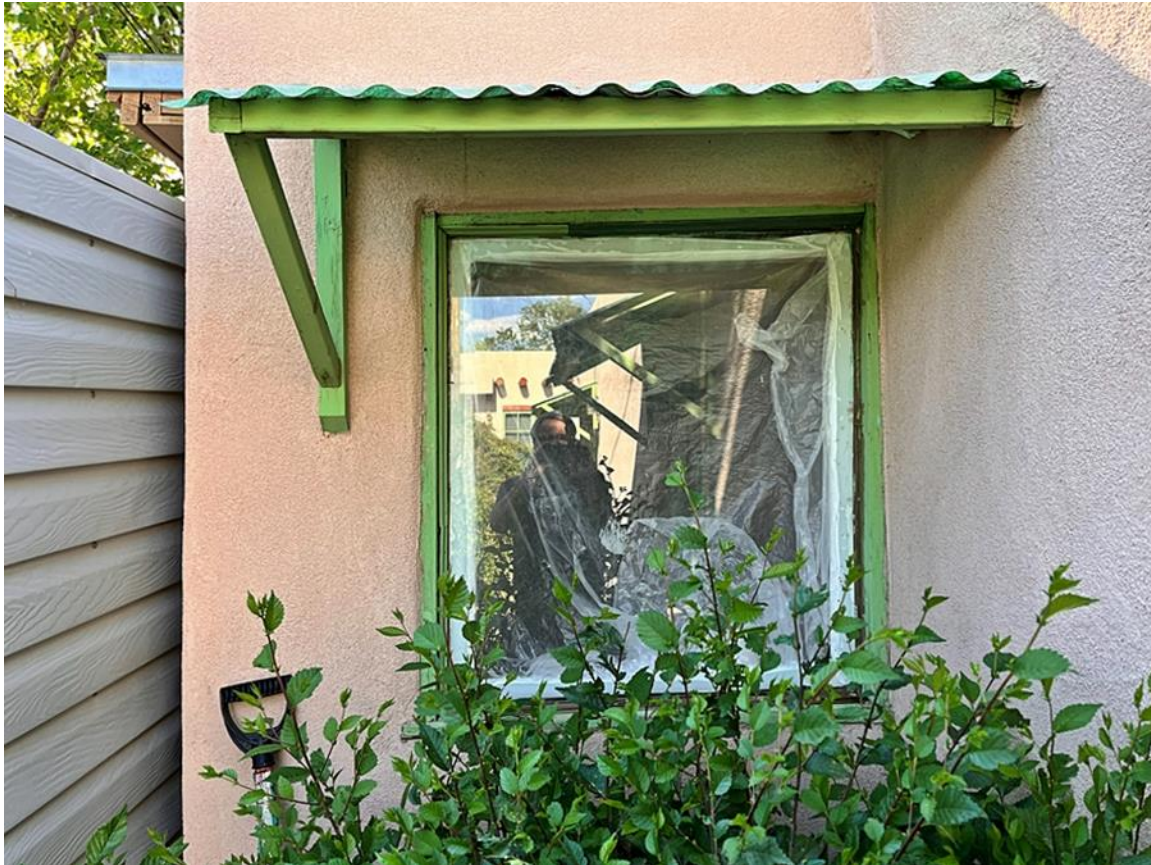
Stepping back 28 feet is the final section of the east elevation, consisting of a portion of a CMU addition (a bonus room) containing a fixed wood window, also sheltered by a shading canopy (Photos 8 and 9).

Photo 8: Window at CMU addition. Camera facing west.

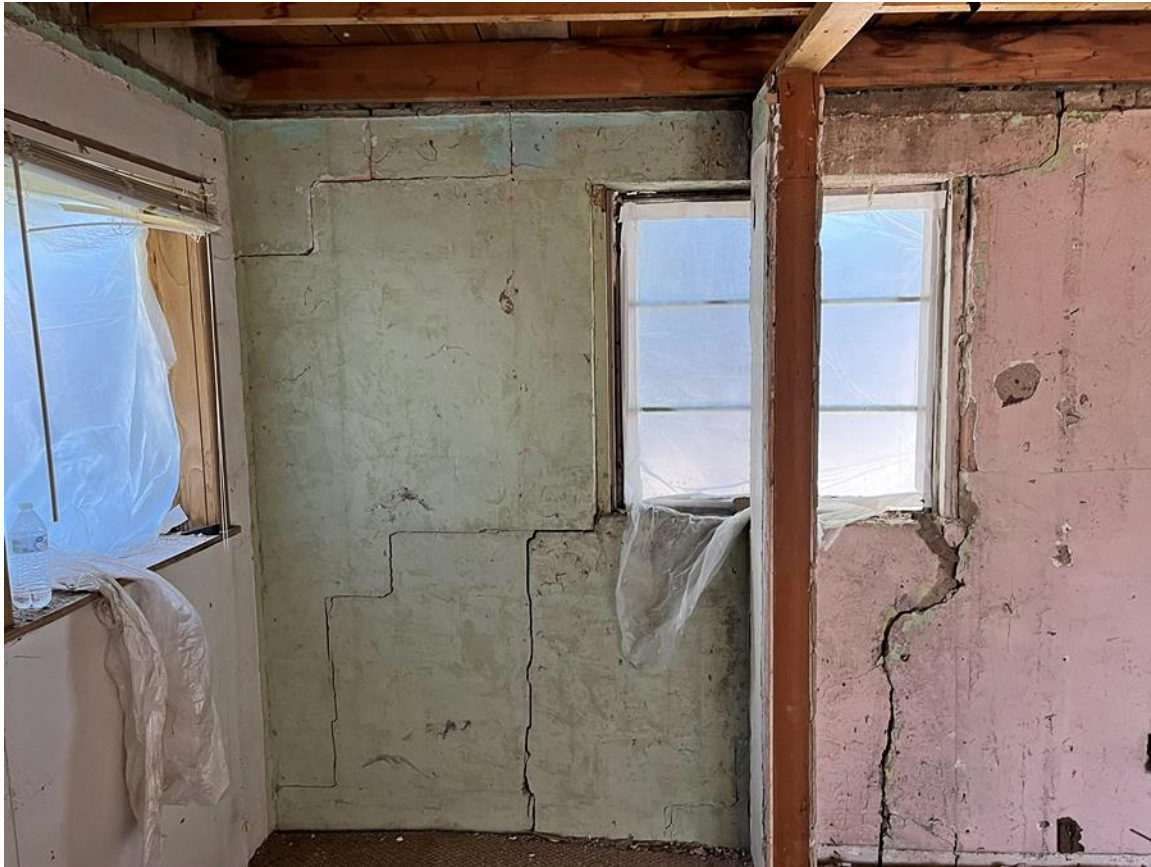
Photo 9: Windows at interior of CMU addition. Camera facing southeast.

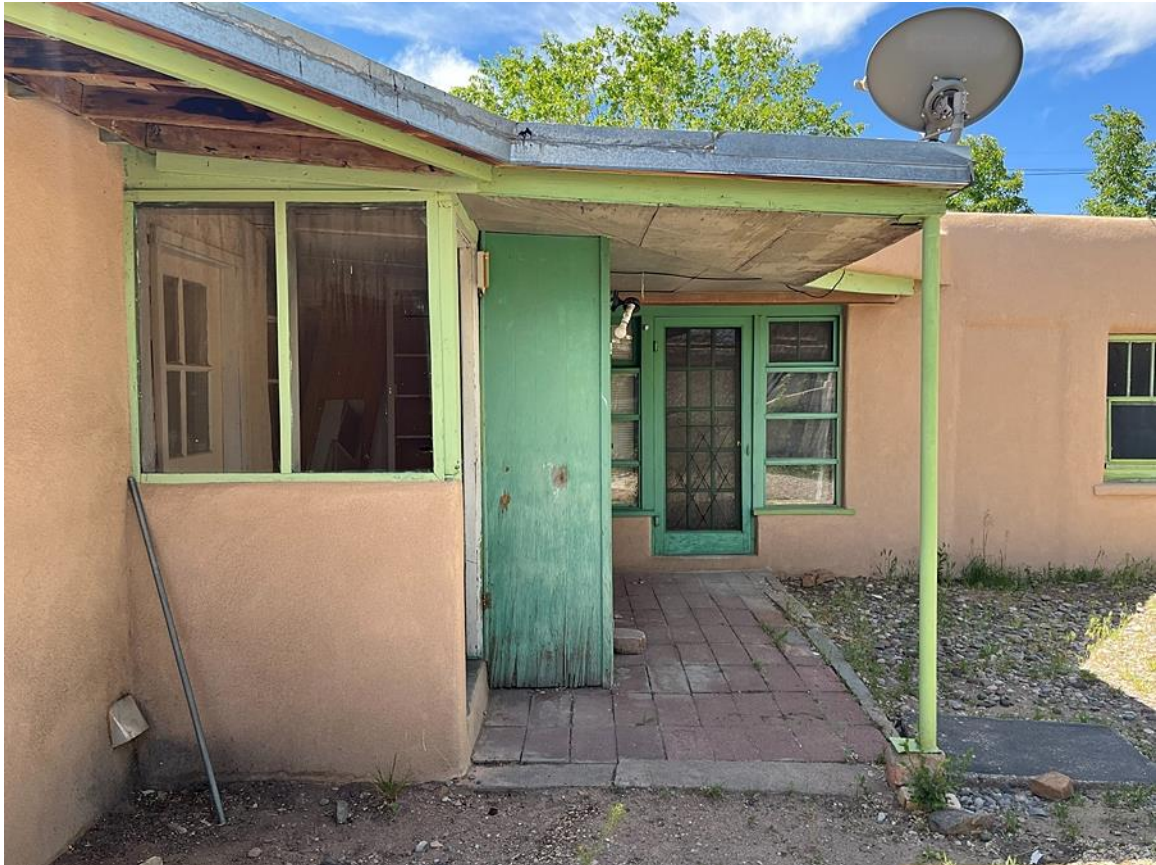
Turning the corner is a porch that was enclosed at some point between 1958 and 1978, based on aerial photographs (Photo 13). The original porch windows and door remain behind plywood sheathing (Photo 14).

Photo 13: Enclosed porch and porch addition. Camera facing south.

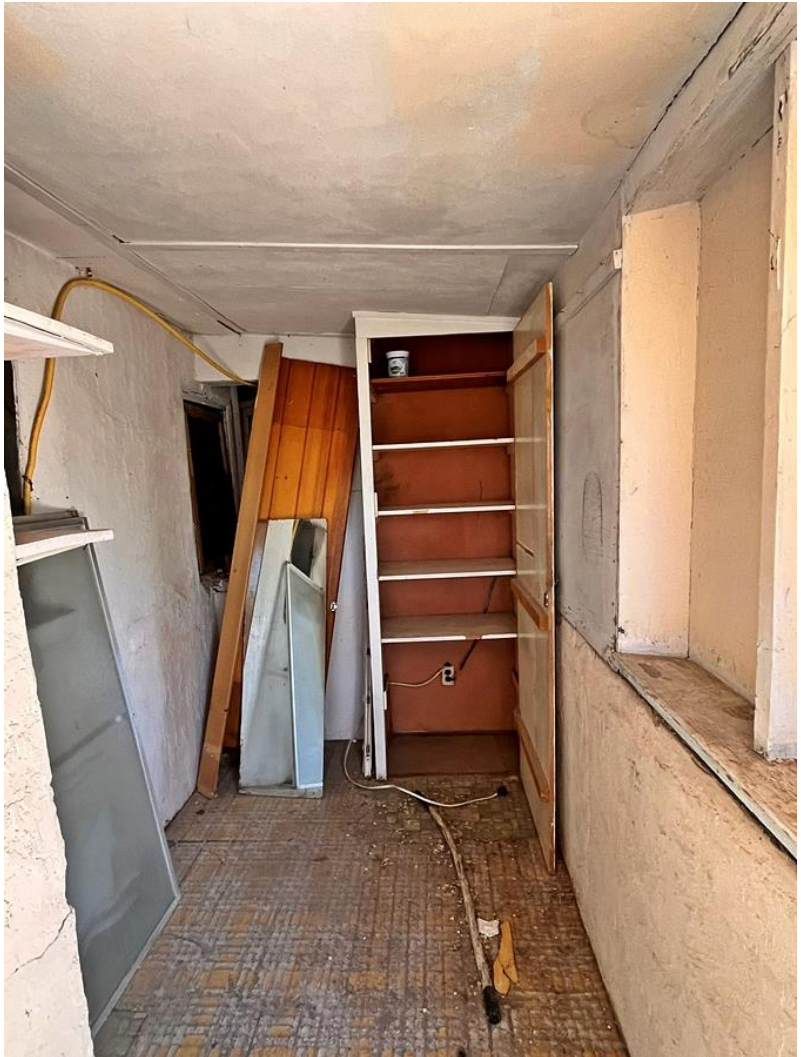
Photo 14: Interior of enclosed porch. Camera facing south.

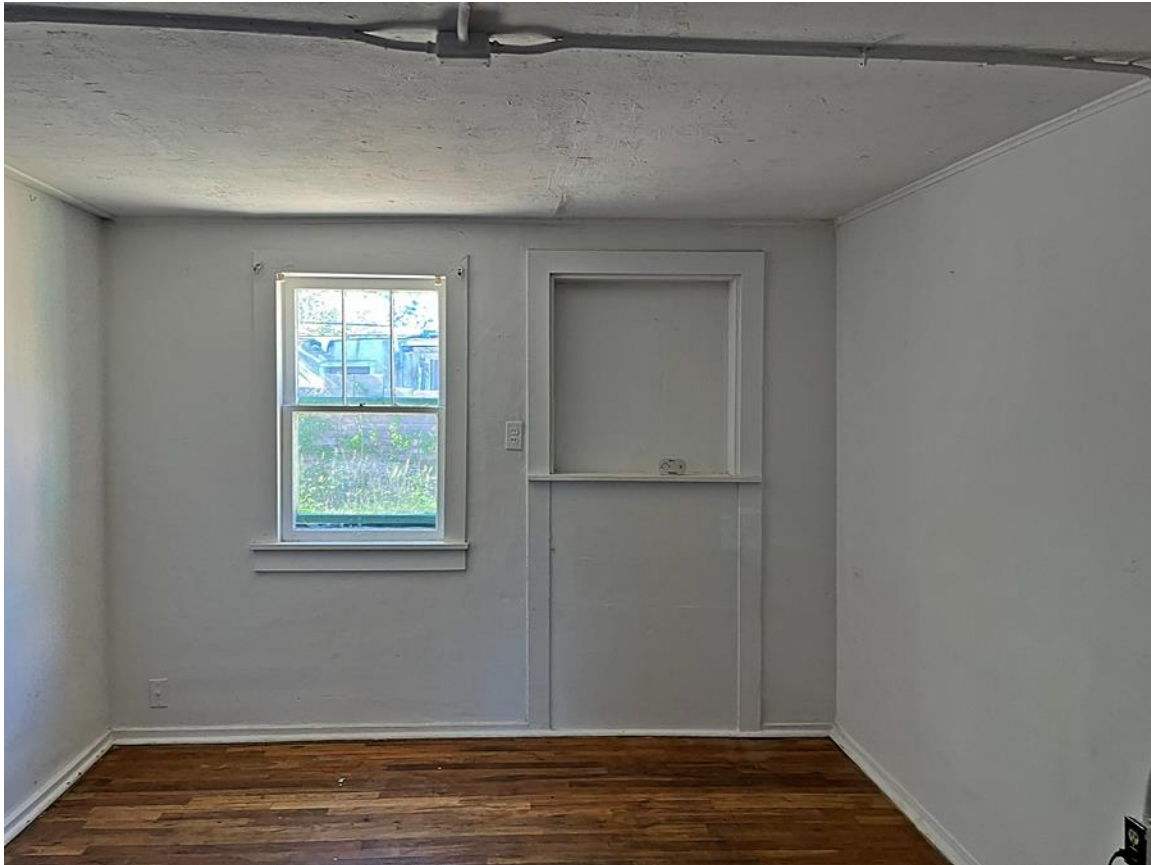
Photo 20: Interior of apartment showing window and deleted door. Camera facing north.

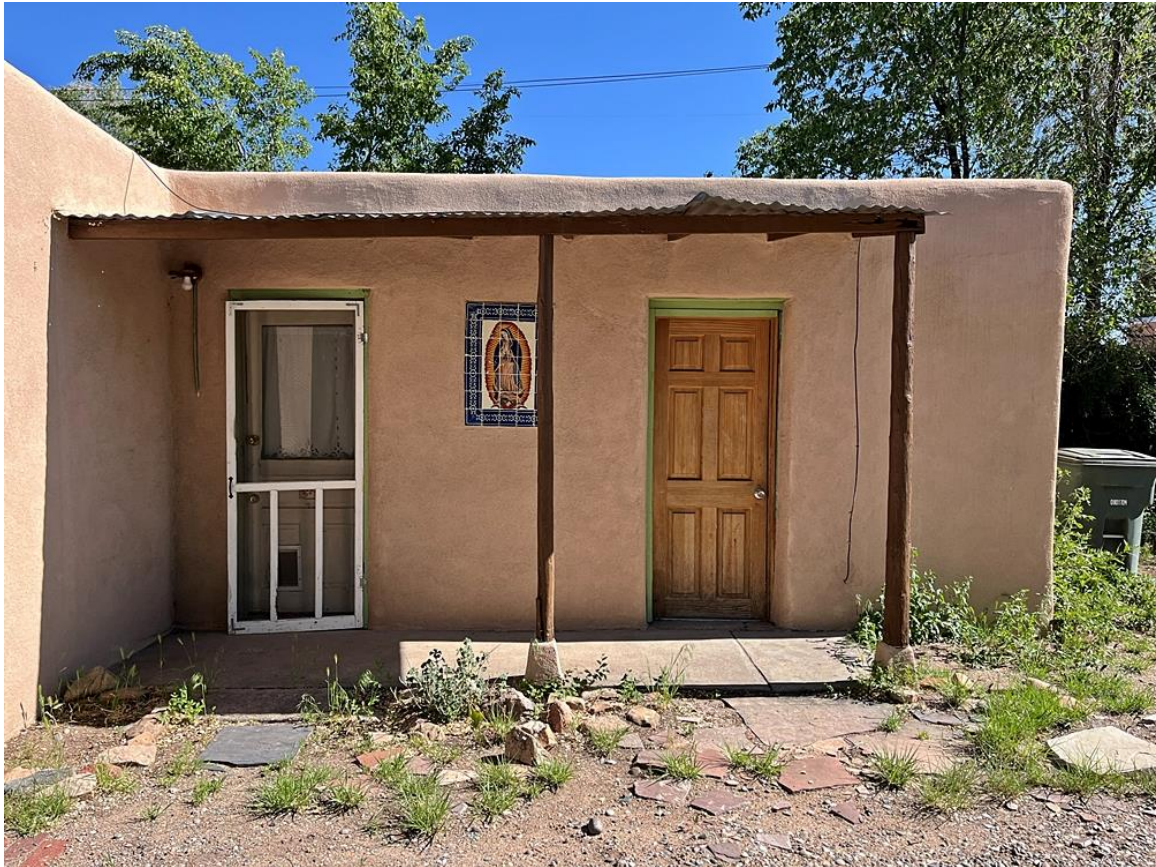
The apartment narrows further to a small entry porch with two doors (Photo 21). One, a half-light-over-wood-panel unit, appears historic; the other is a wood six-panel replacement door.

Photo 21: Entry doors to apartment. Camera facing south.

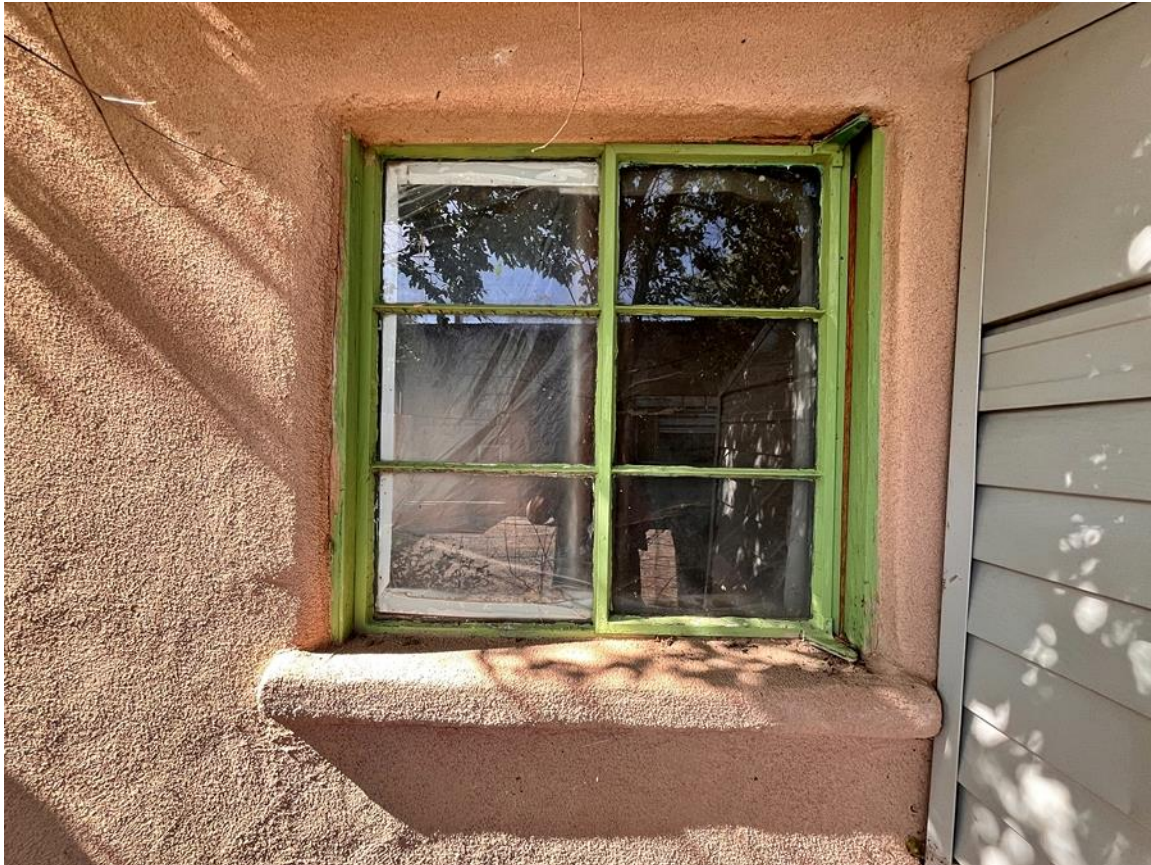
The façade remains low and flat, with a boxed fascia and gutter running along the parapet edge (Photo 25). A pair of small four-light wood casements serve the kitchen (Photos 26 & 27). Nearby is another small window in which a single pane has been replaced with painted plywood.

Photo 25: Window at CMU addition. Camera facing north.

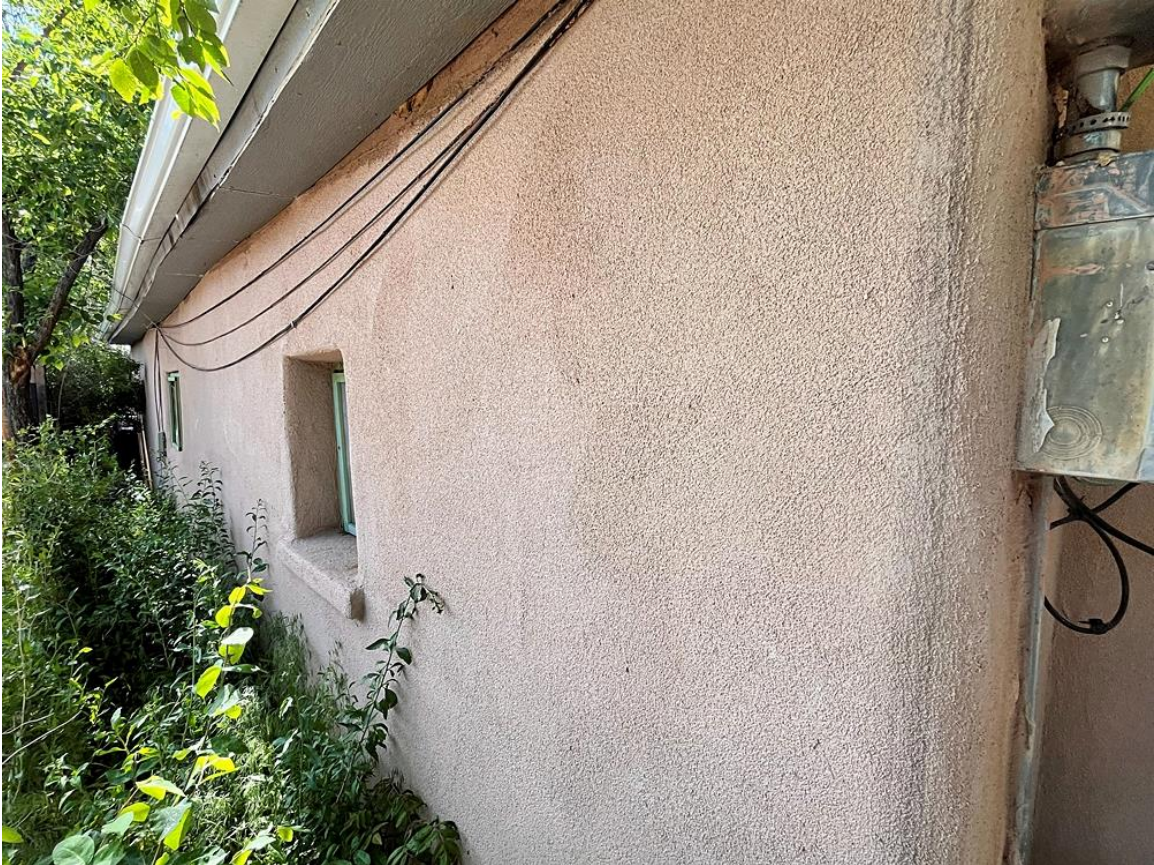
Photo 26: South elevation of apartment addition. Camera facing northwest.

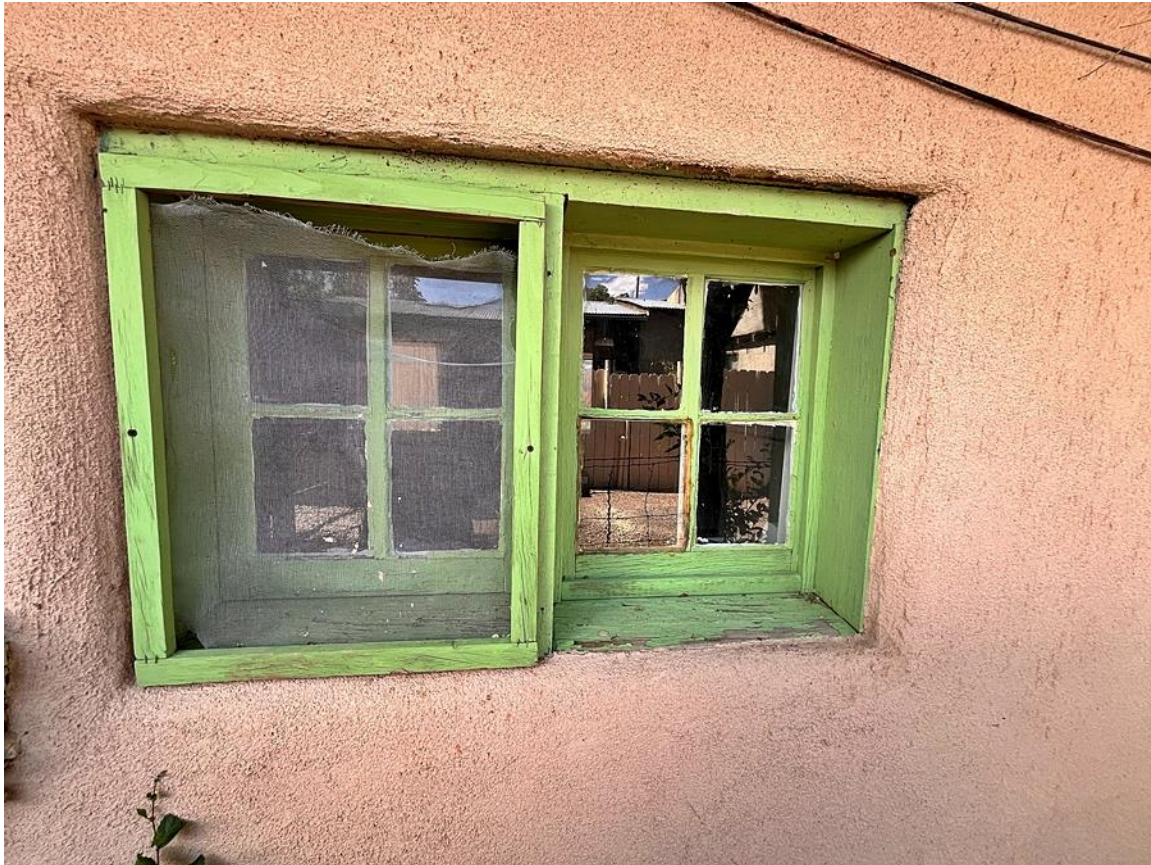
Photo 27: Window at apartment kitchen. Camera facing north.

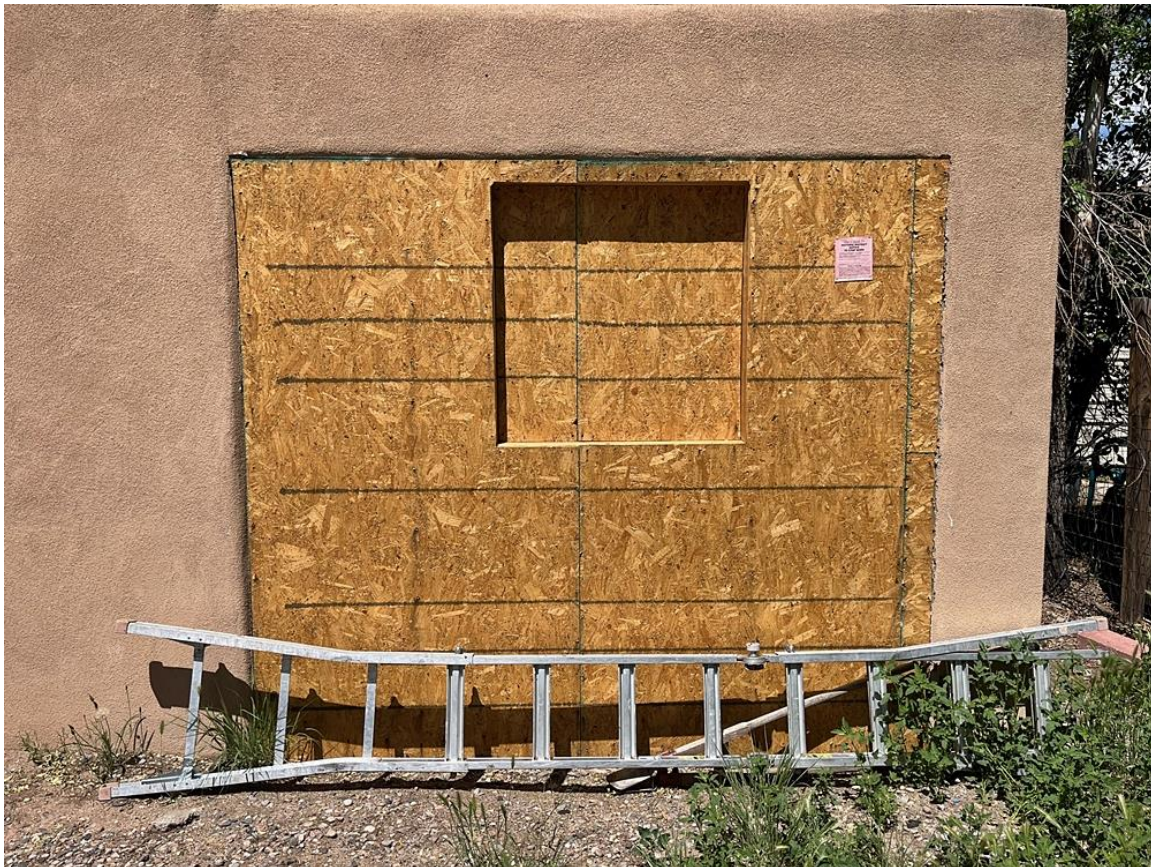
Back House
#1 Date: post-1985; replacement of front porch; 1985 HBI and visual and material evidence.
#2 Date: 2025; closure of garage door opening; red tag and visual and material evidence.

Photo 35: Infilled garage door. Camera facing west.
