MEMORANDUM

RE: 515 Paseo de Peralta

Subject: HDRB Design Review – 515 Paseo de Peralta

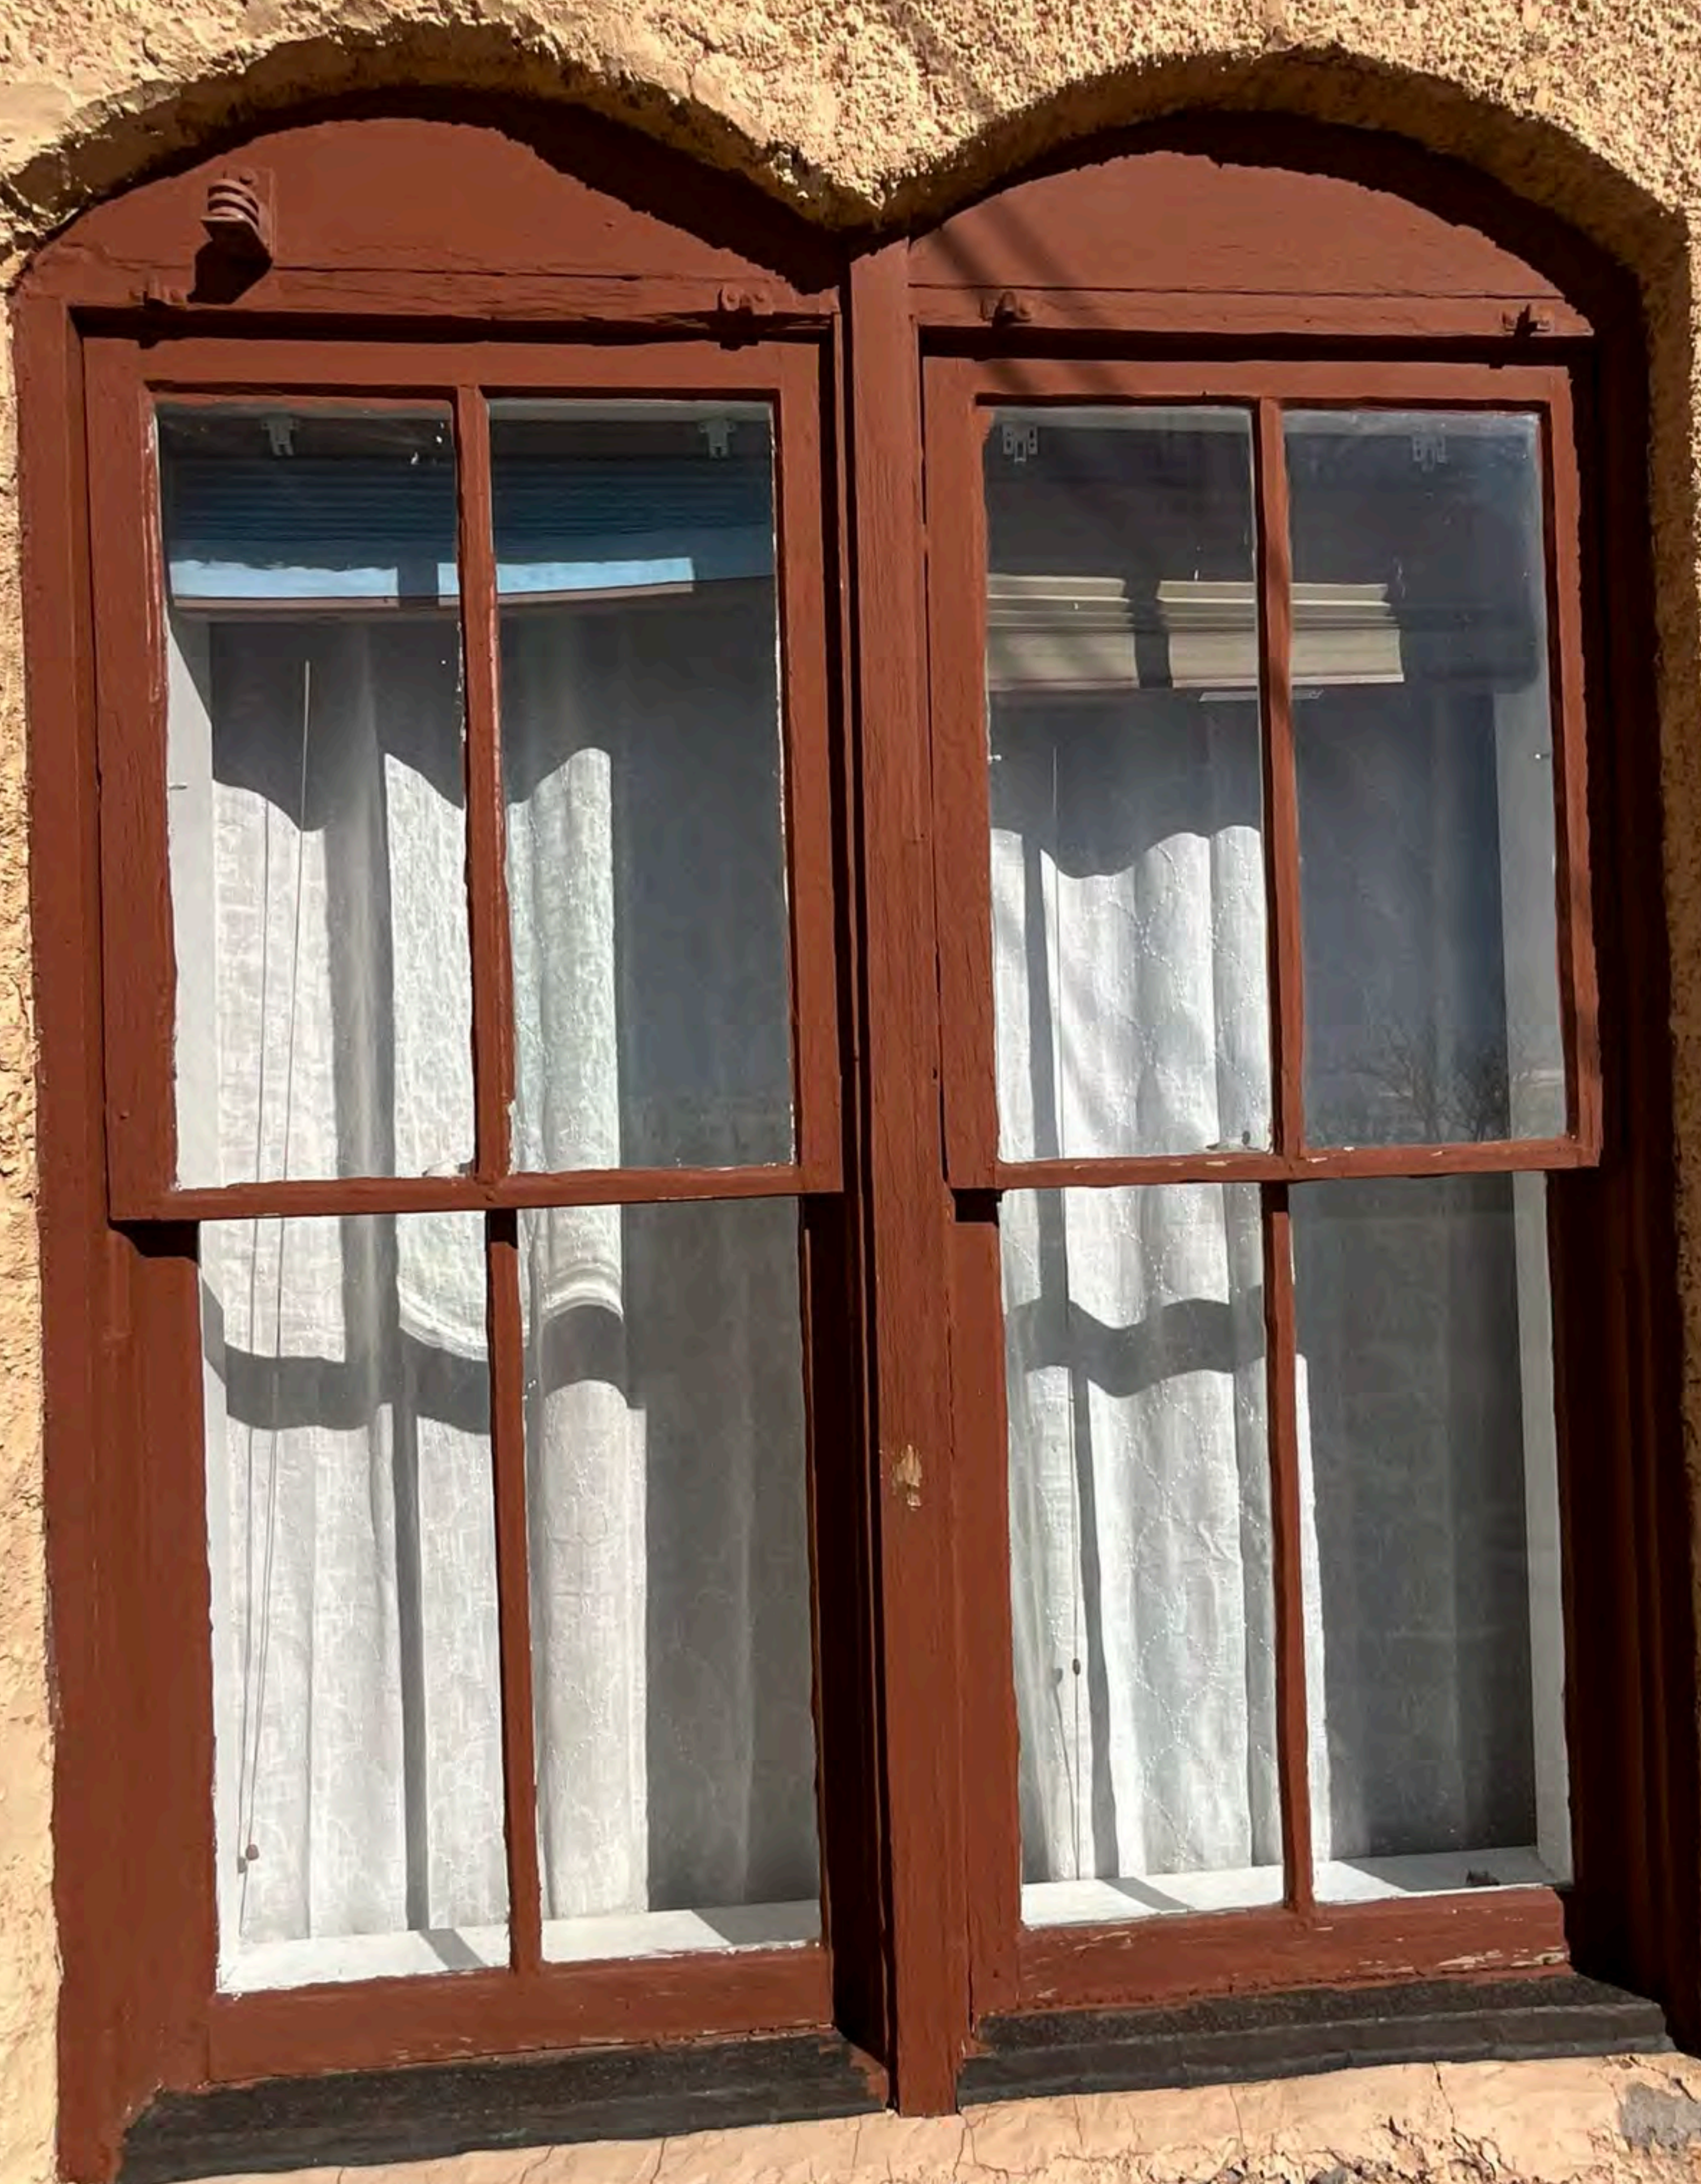
South Elevation
Window
D

Wall
damage
from rotted
sills allowing
water to leak
into the

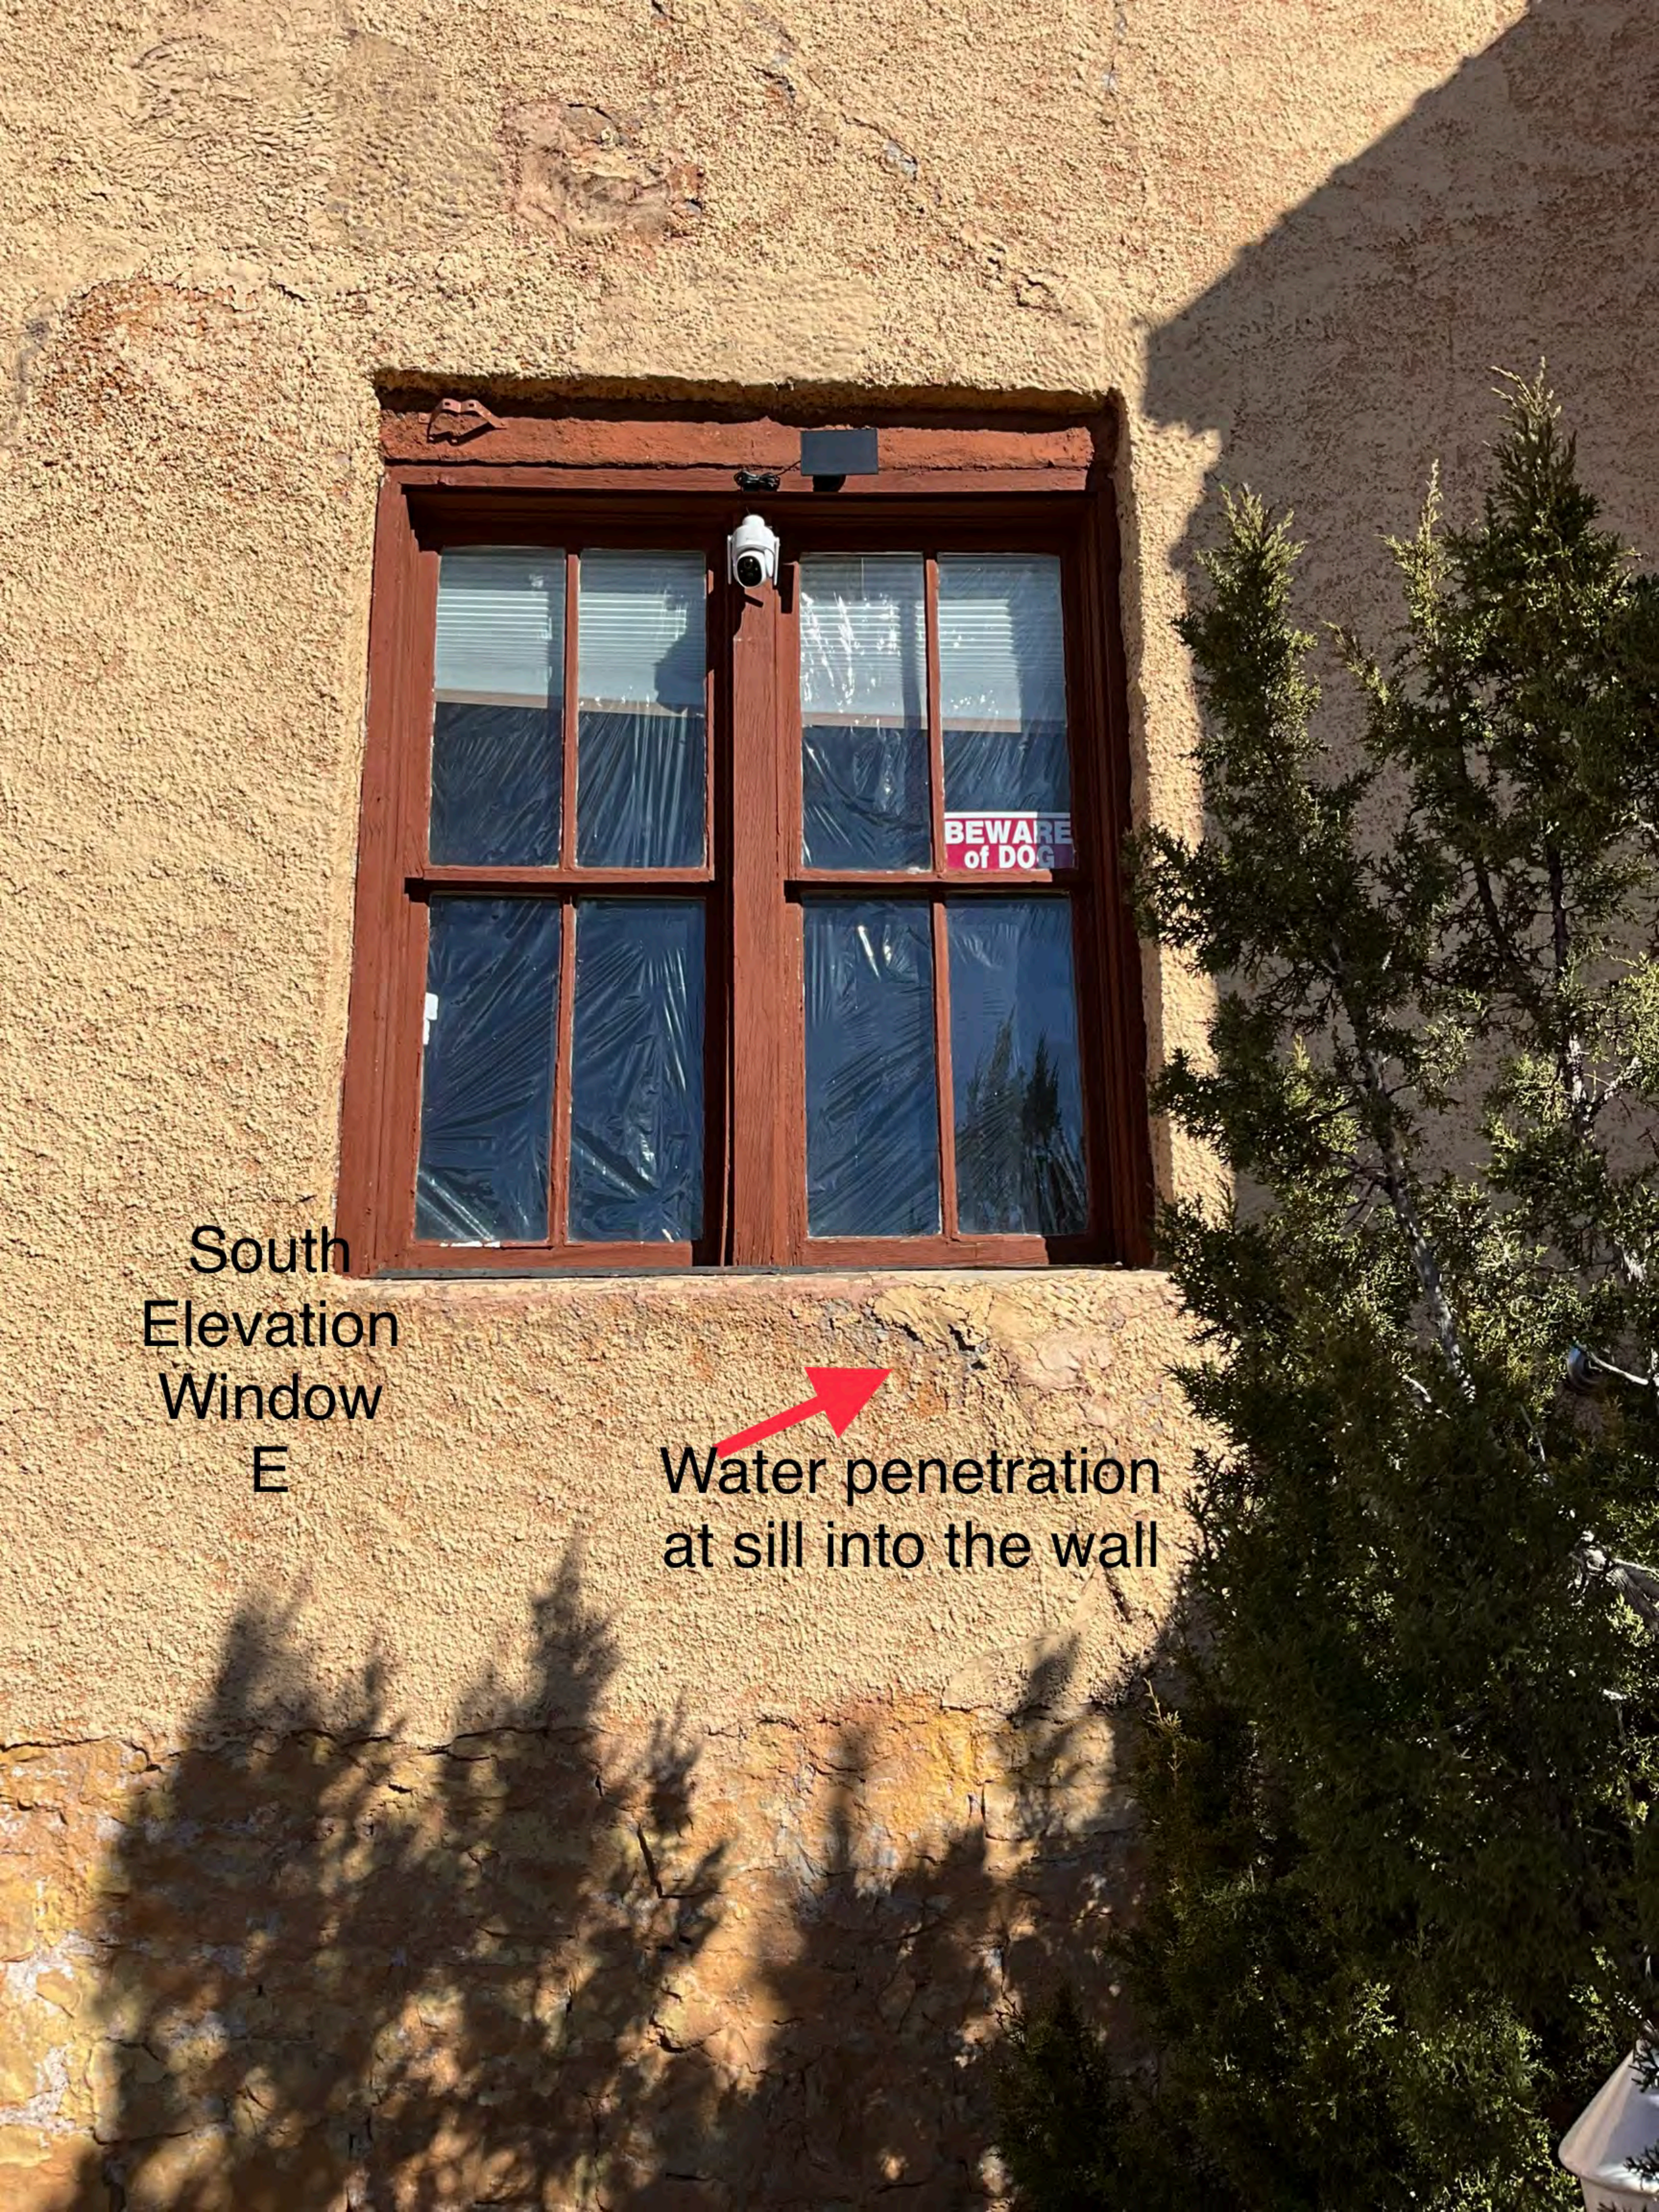
South
Elevation
Window
E

Water penetration
at sill into the wall

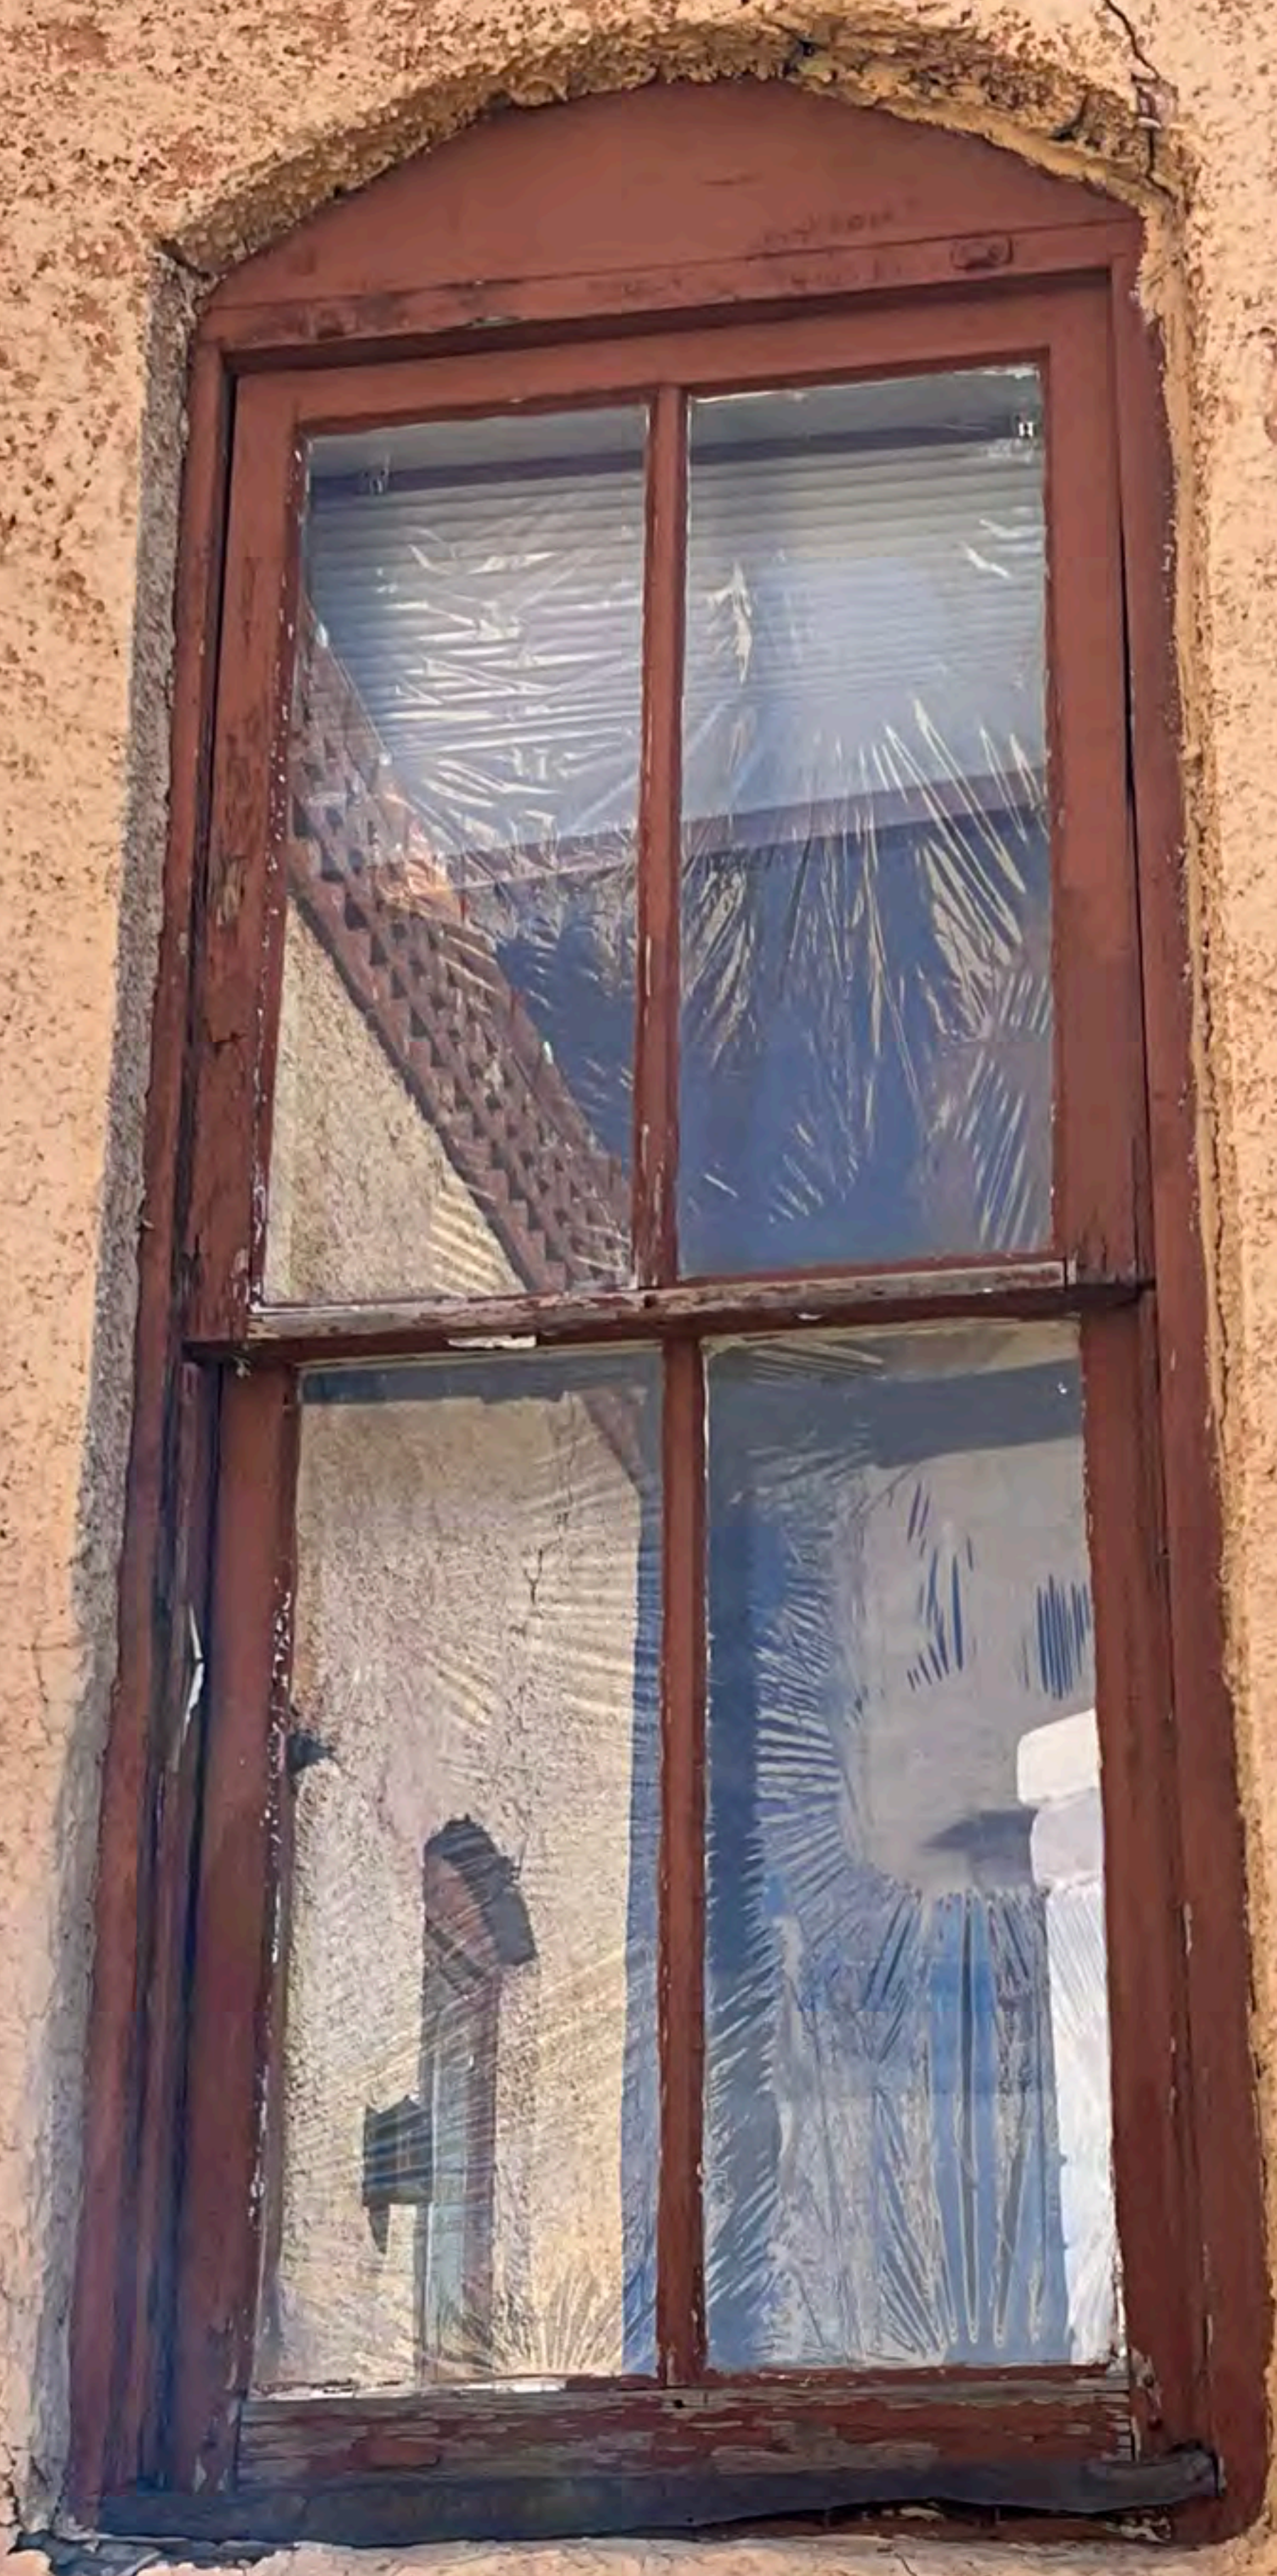
West Elevation
Window
F

Water penetration
at sill into the wall
because of sill rot

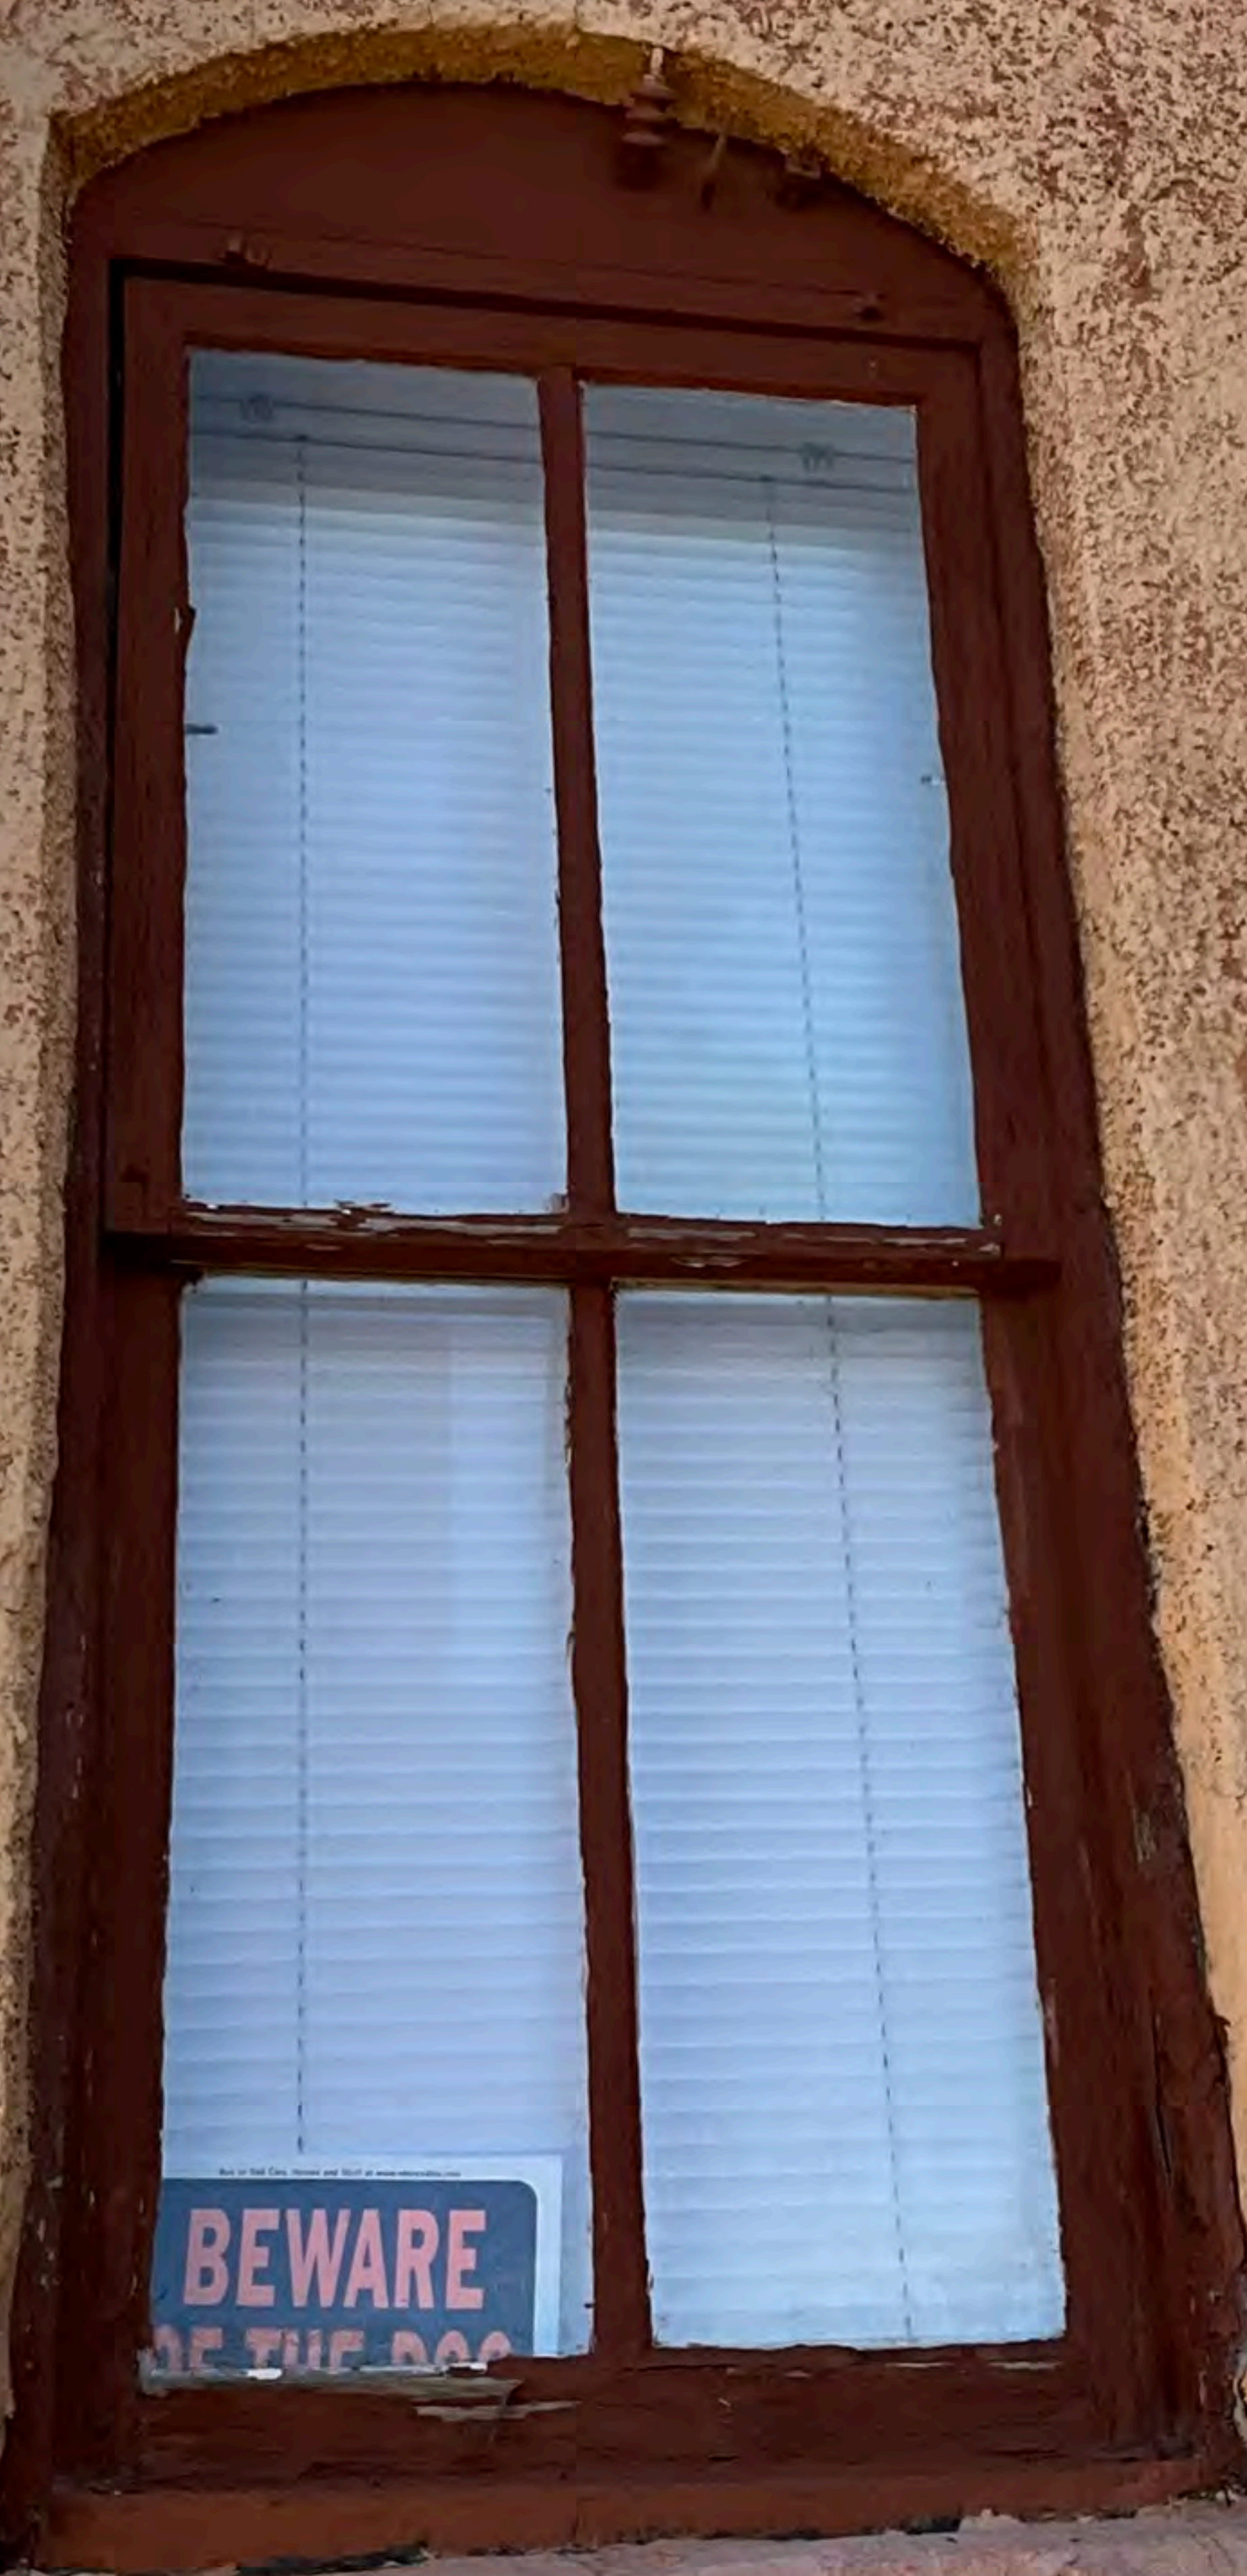
South Elevation
Window
G

Water
penetration at
the sill
causing wall
damage

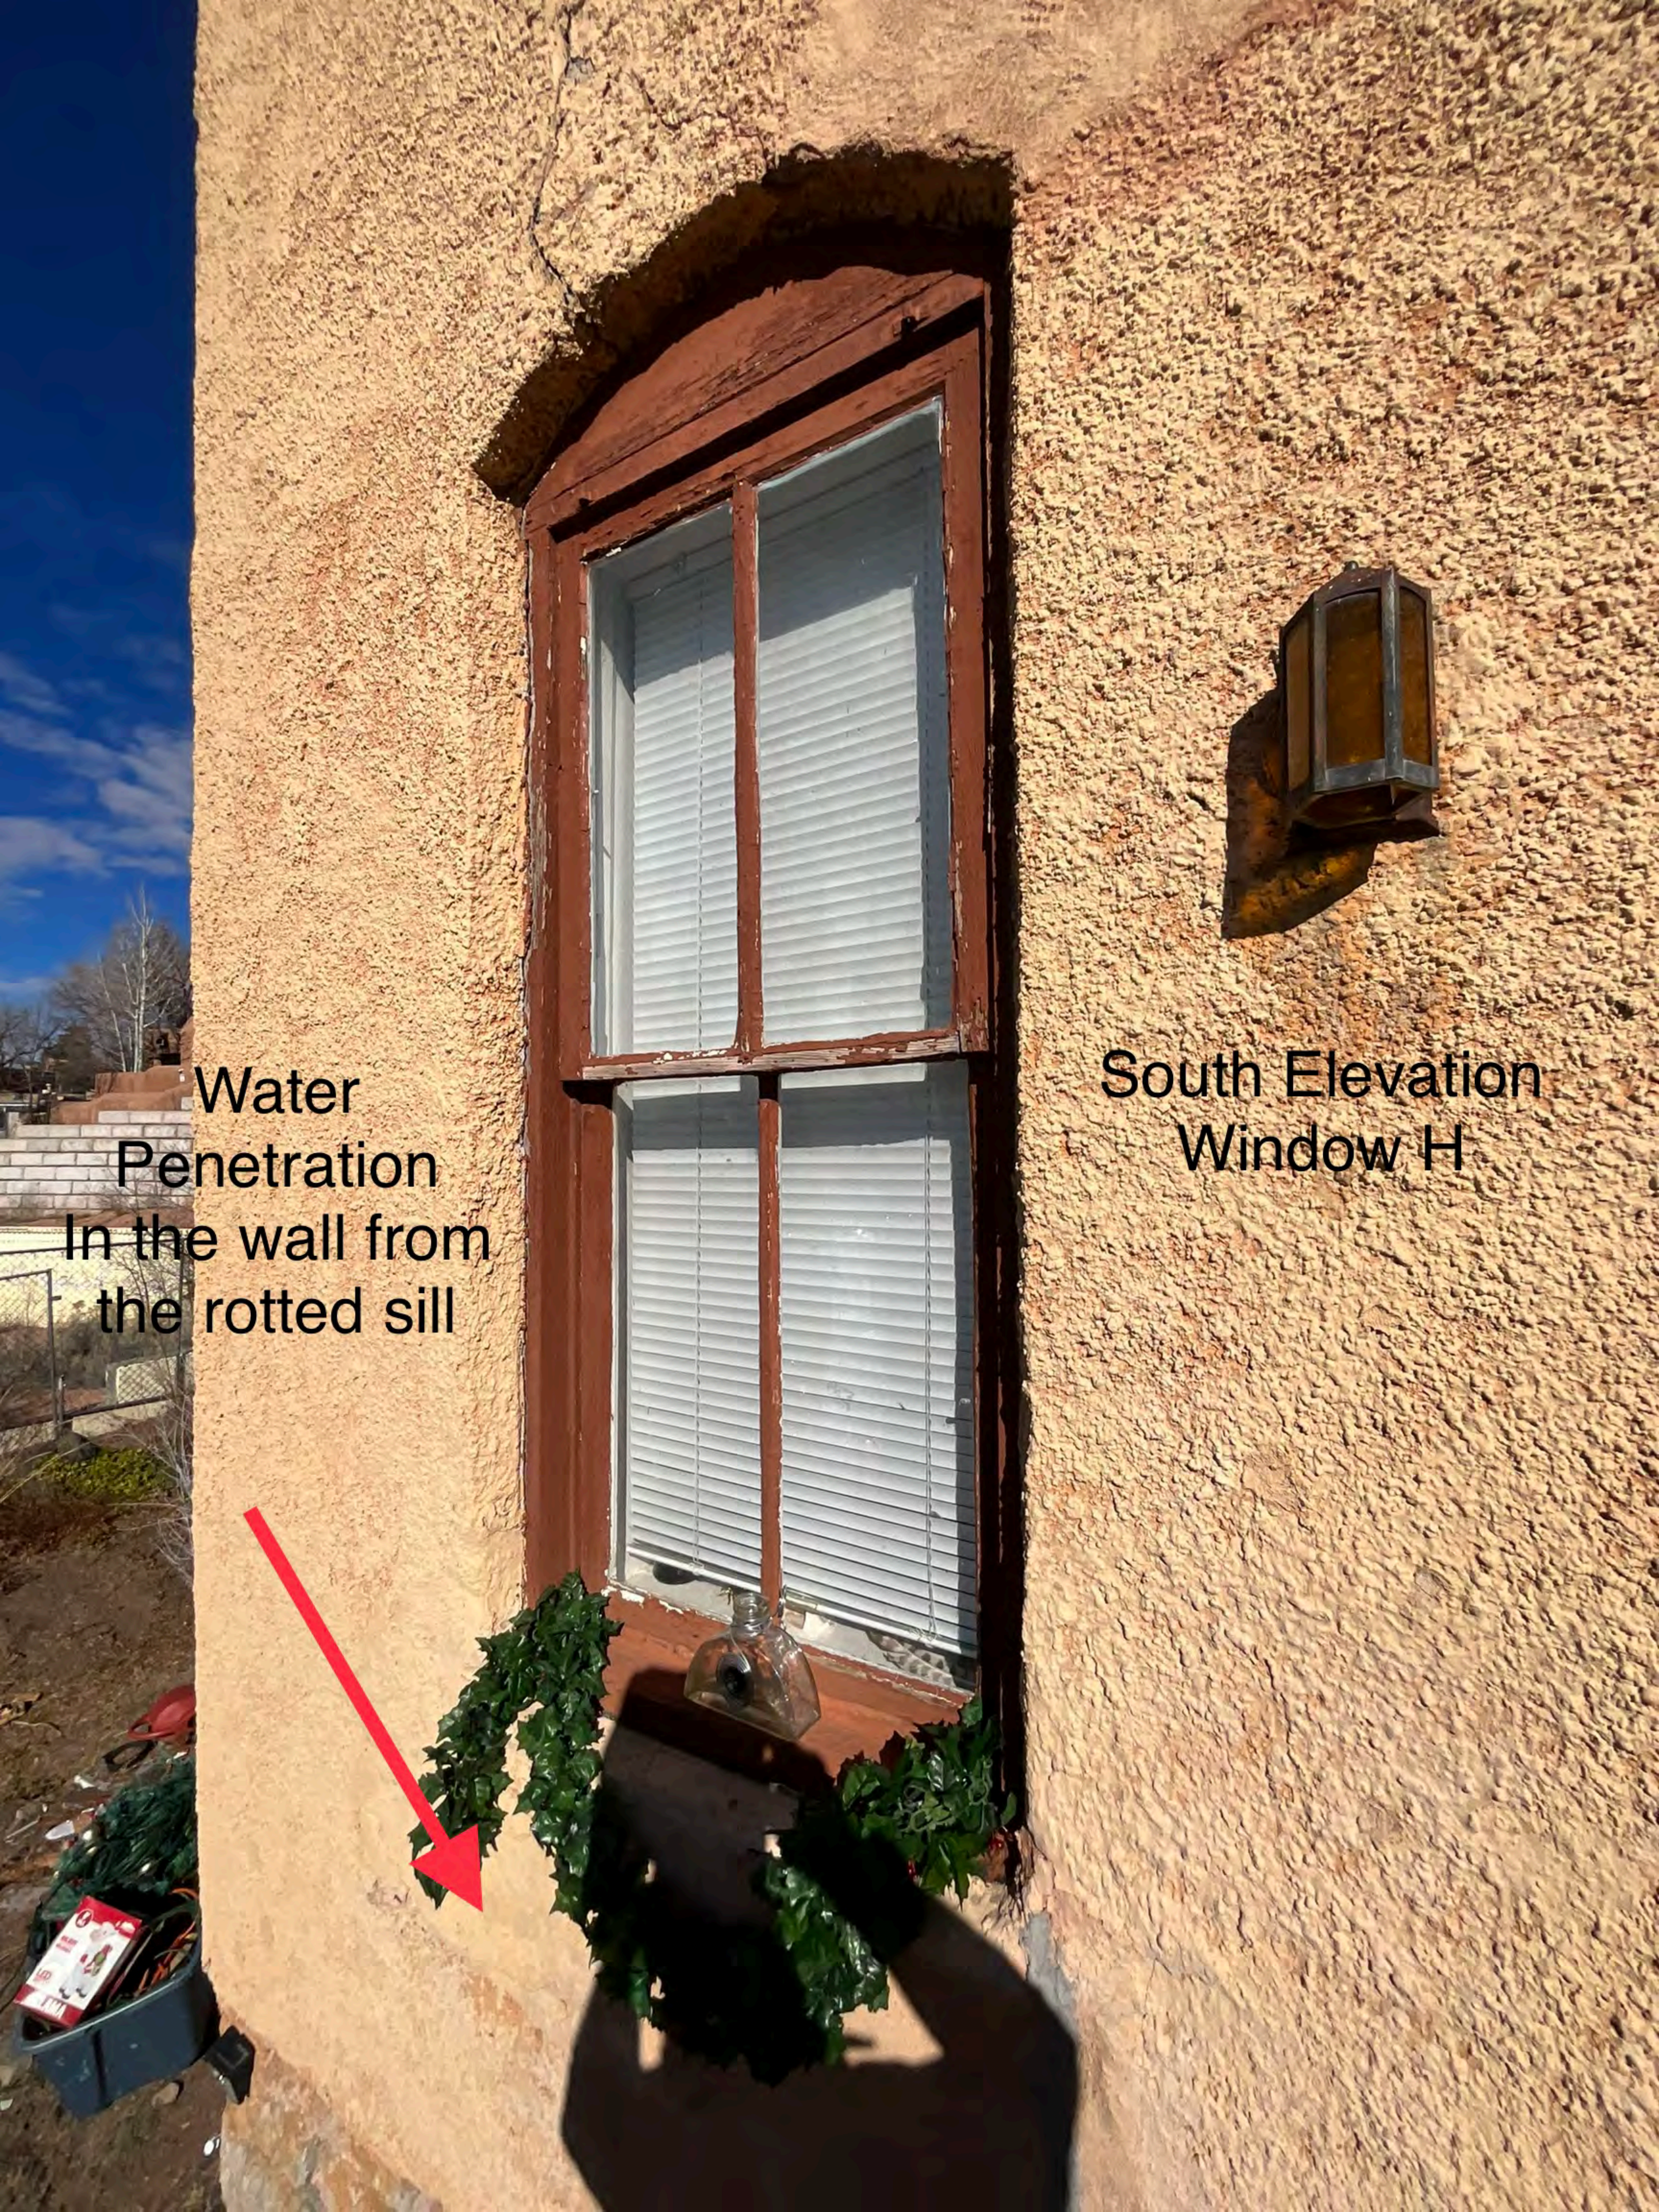
South Elevation
Window H

Water
Penetration
In the wall from
the rotted sill

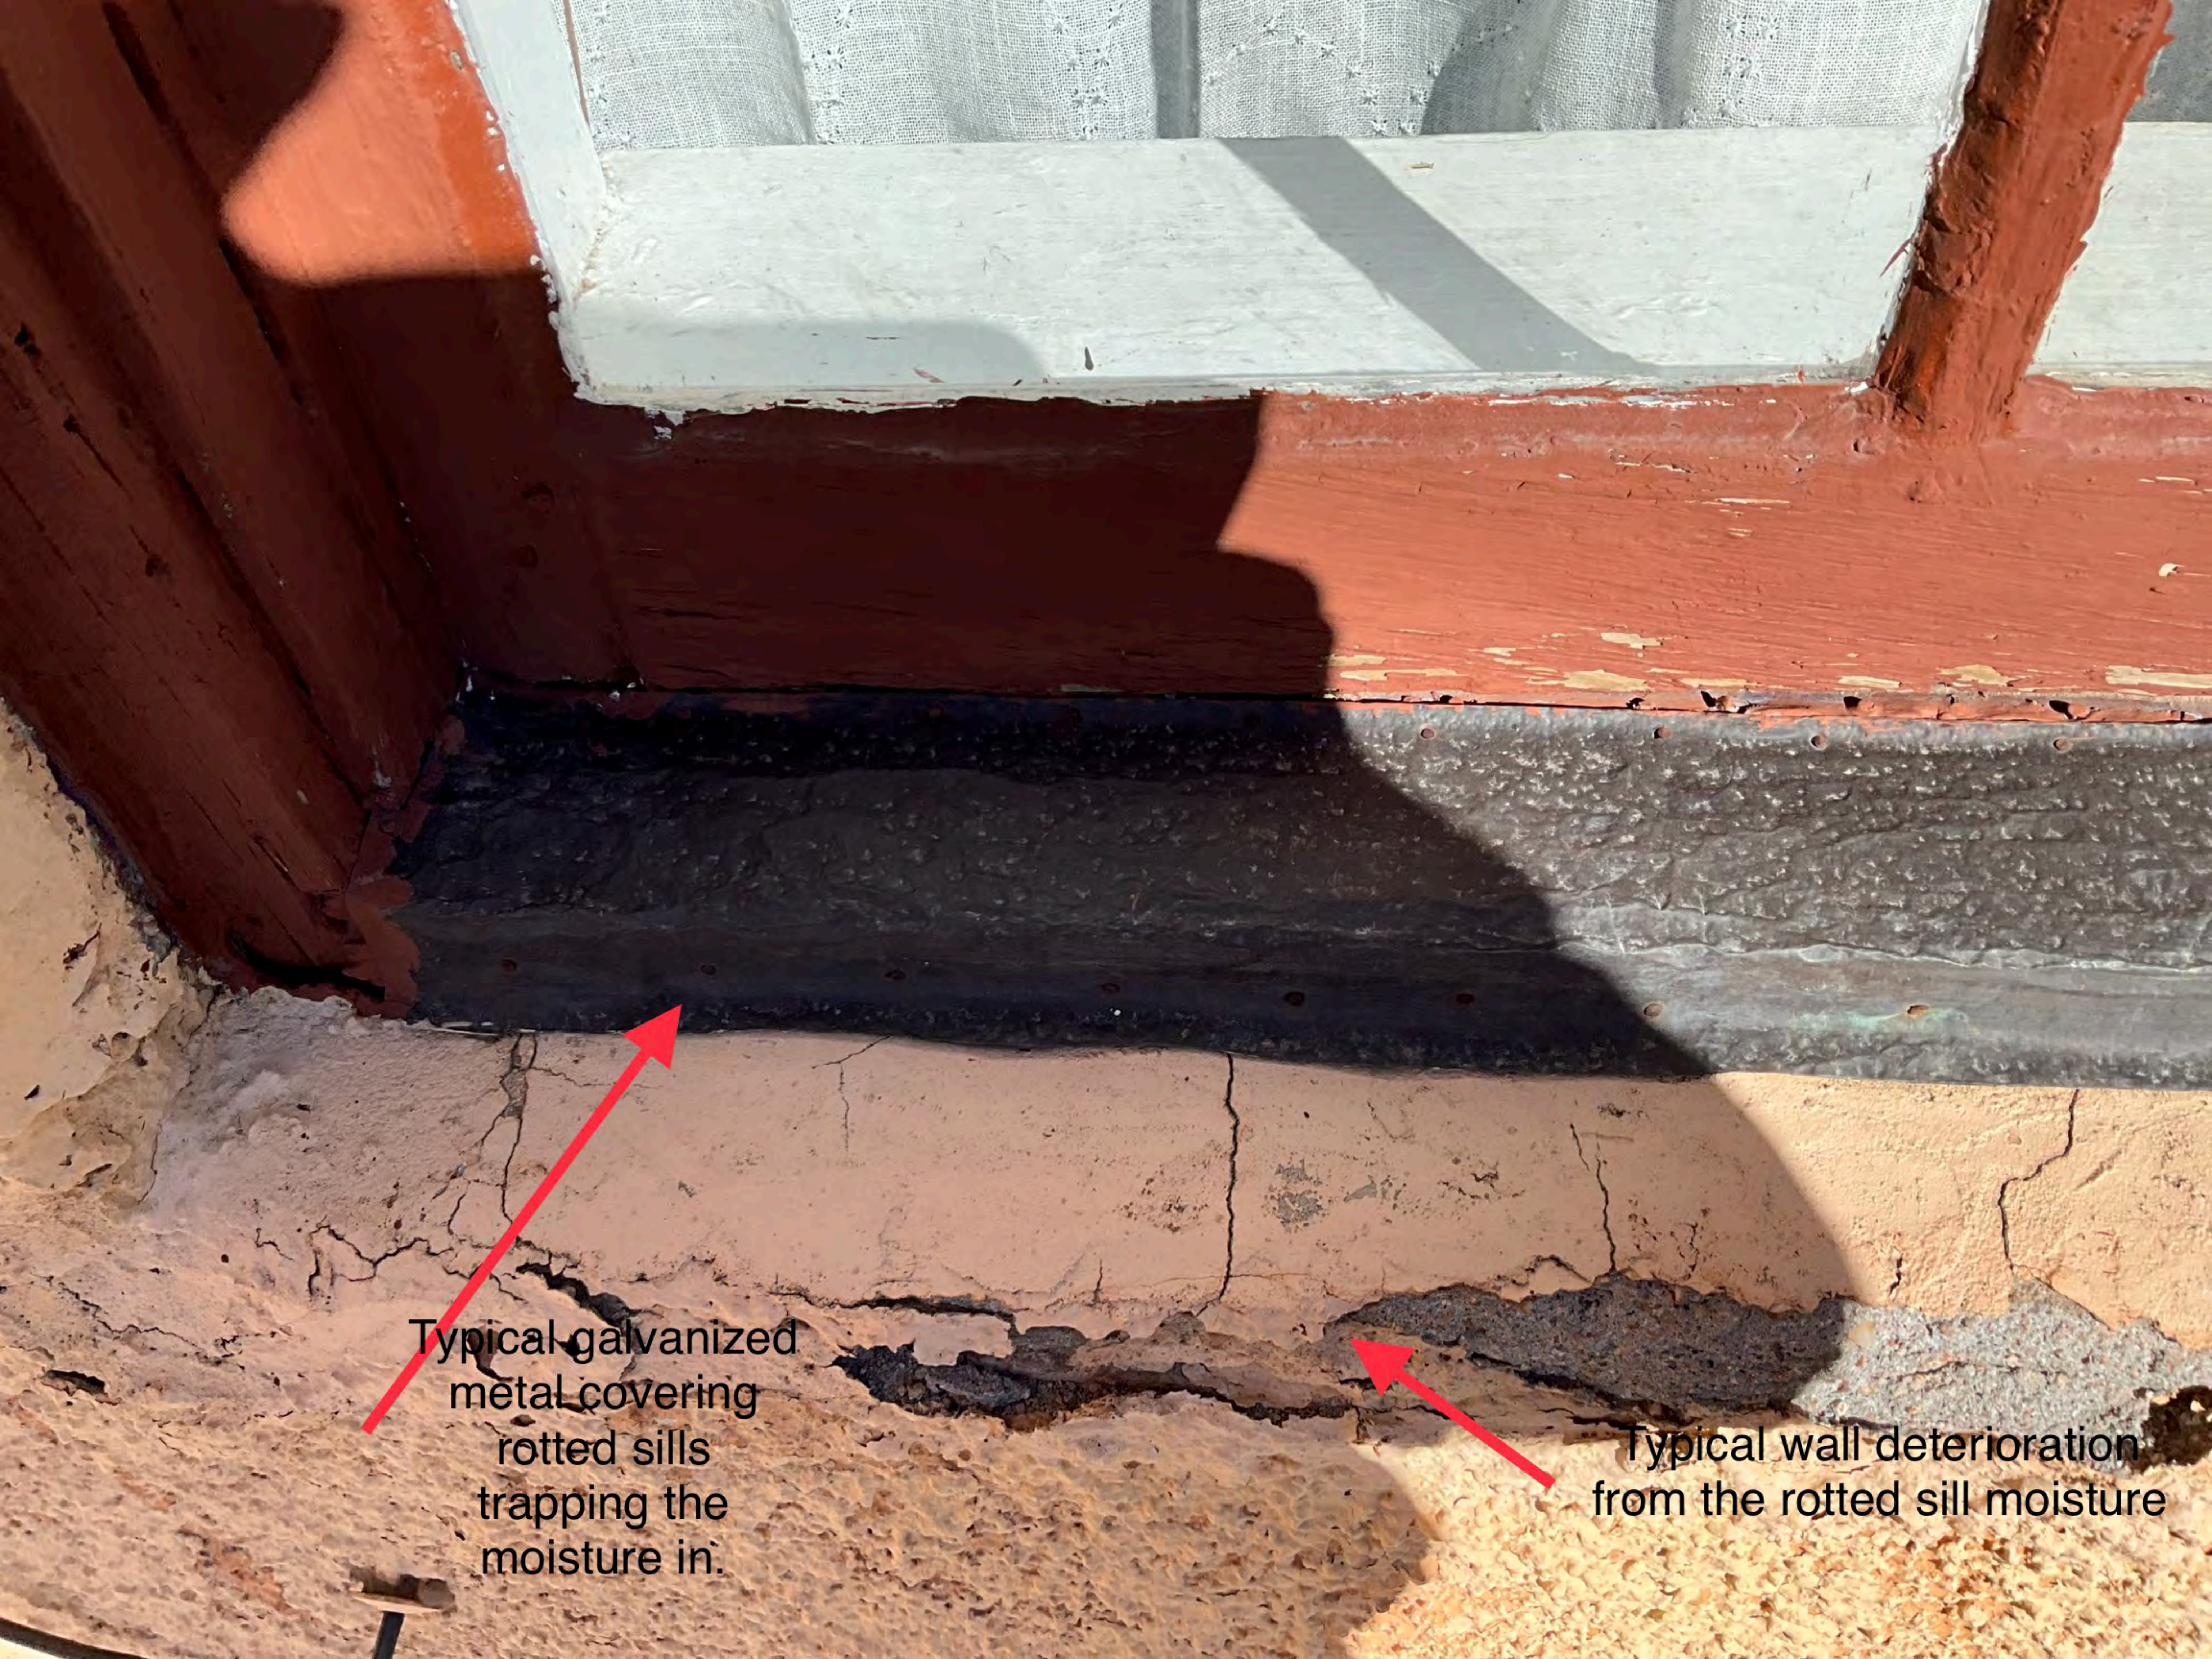
Typical galvanized
metal covering
rotted sills
trapping the
moisture in.

Typical wall deterioration
from the rotted sill moisture

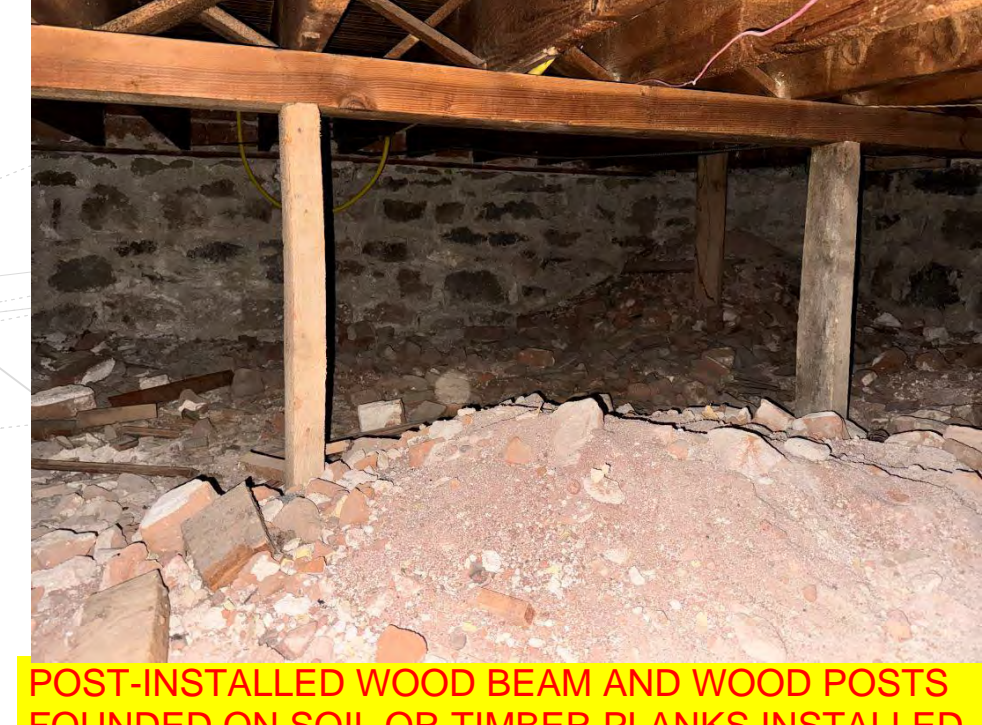
- Wood timber posts were installed in an apparent attempt to control floor joist deflections and correct floor framing alterations. The timber supports are at random locations throughout the residence. This condition will need to be corrected with a new wood post and wood beam system with concrete spot footings at the new posts.

#7 POST-INSTALLED WOOD BEAM AND WOOD POSTS FOUNDED ON SOIL OR TIMBER PLANKS INSTALLED THROUGHOUT FOOTPRINT OF ORIGINAL STRUCTURE

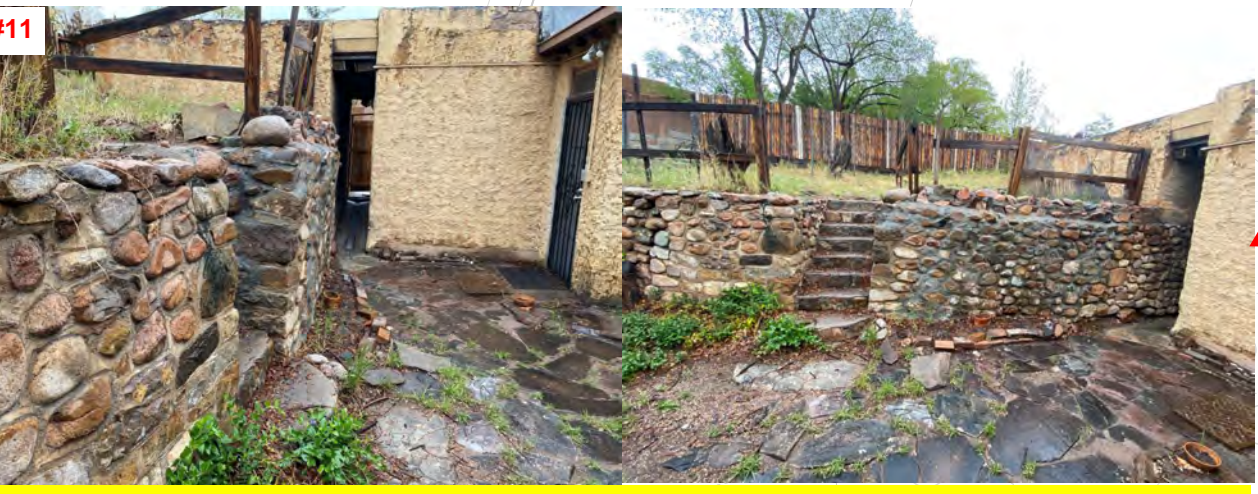
- The southwest corner of the residence exhibited a large crack propagating from the exterior facade to the interior plaster finish. Upon further investigation it was noted that water intrusion had occurred and compromised the masonry and mortar joints in this area. The damaged portion of the wall should be reconstructed with standard masonry techniques to reestablish structural integrity.

#11 CRACK EXTENDS THROUGH ENTIRE WALL SECTION, MASONRY COURSES HAVE DE-BONDED AND THE STRUCTURAL INTEGRITY OF THE WALL HAS BEEN COMPROMISED
