MEMORANDUM

RE: 515 Paseo de Peralta

Subject: HDRB Design Review – 515 Paseo de Peralta

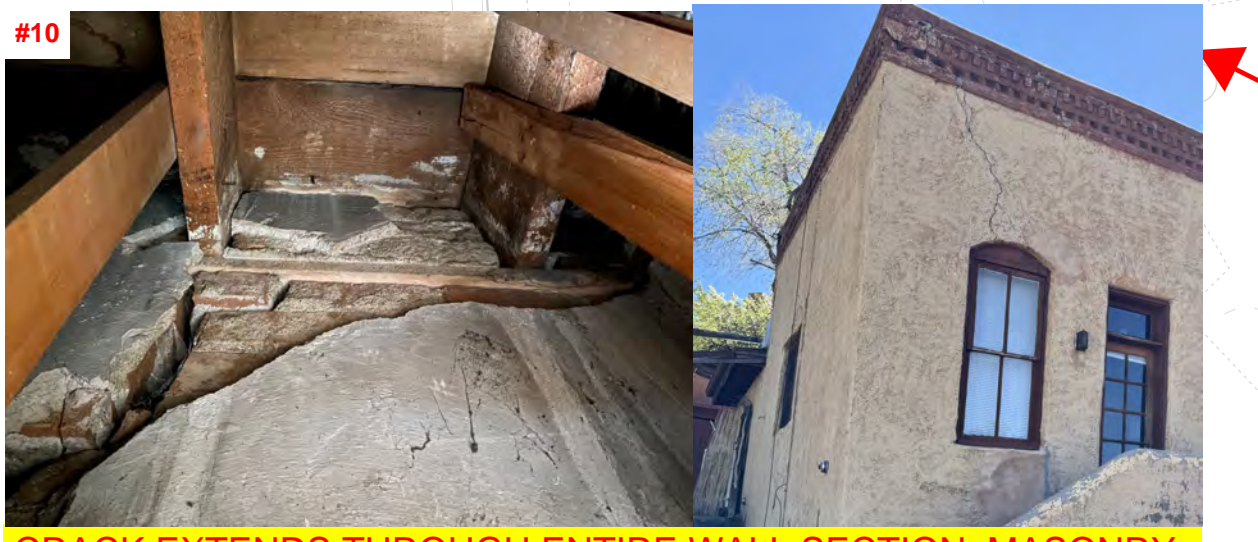
- The southwest corner of the residence exhibited a large crack propagating from the exterior facade to the interior plaster finish. Upon further investigation it was noted that water intrusion had occurred and compromised the masonry and mortar joints in this area. The damaged portion of the wall should be reconstructed with standard masonry techniques to reestablish structural integrity.

#10 CRACK EXTENDS THROUGH ENTIRE WALL SECTION, MASONRY COURSES HAVE DE-BONDED AND THE STRUCTURAL INTEGRITY OF THE WALL HAS BEEN COMPROMISED

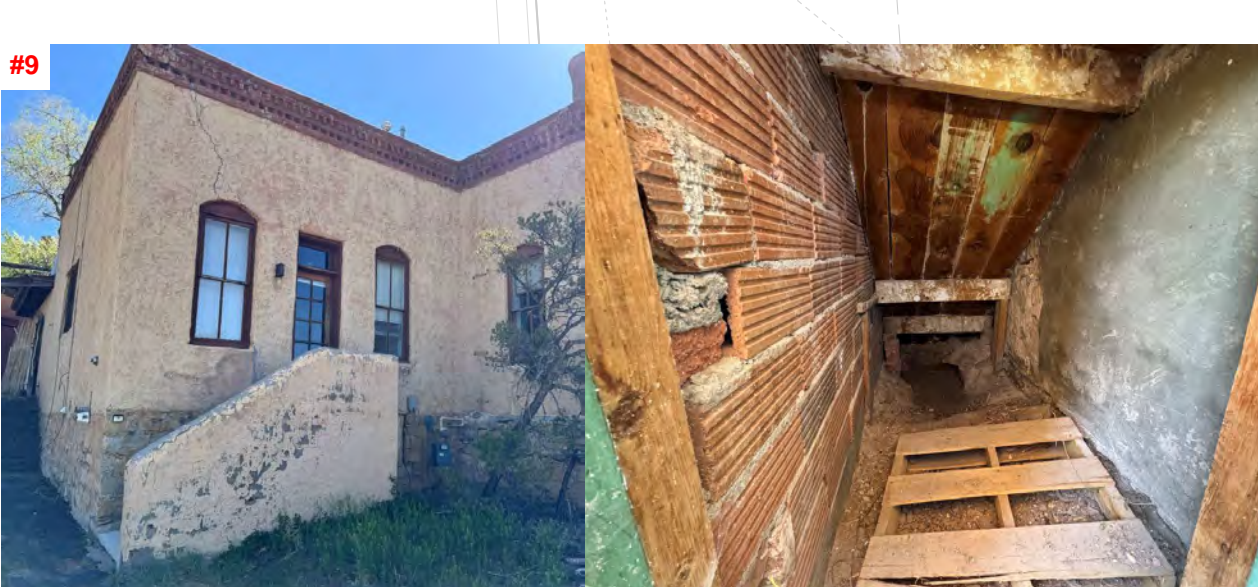
#9 PEN-TILE STAIR WALL AND WATER DAMAGE TO WOOD STAIR FRAMING, FUNGAL DECAY OF WOOD HAS BEGUN AND HAS COMPROMISED THE STRUCTURAL SECTION

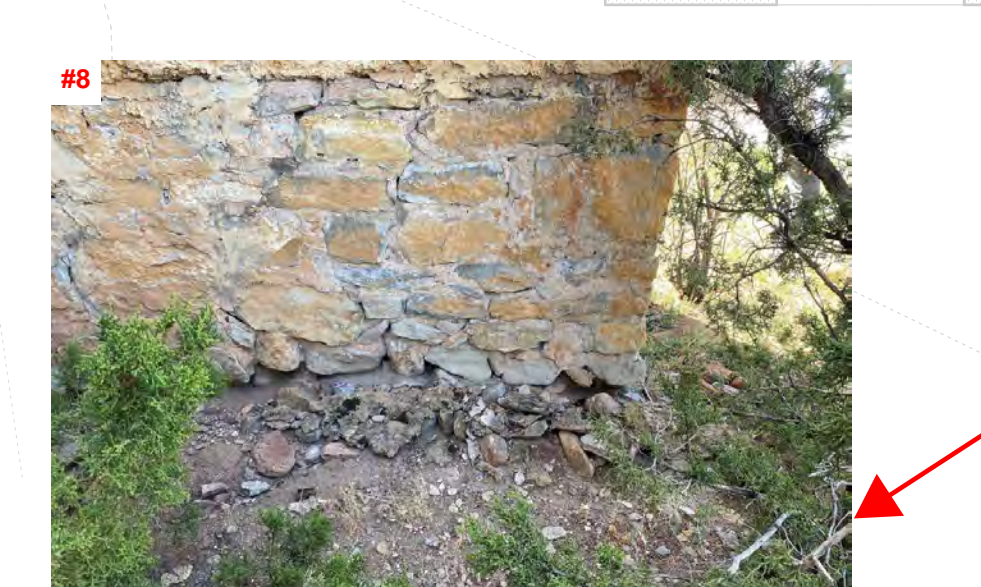
- Tunneling through stone masonry stem walls to accommodate HVAC & plumbing chases were noted to occur in numerous locations throughout the main residence. This alteration will need to be corrected as it has caused localized failures of the wood bearing plates for the floor system.

#8 DAMAGE TO RUBBLE FOUNDATION STEM WALL
