Regarding: 1062 Camino San Acacio Rear Building Demolition

Re: Rear southern structure @ 1062 Camino San Acacio, Santa Fe, NM

Historic Inspection Report

1062 Camino San Acacio

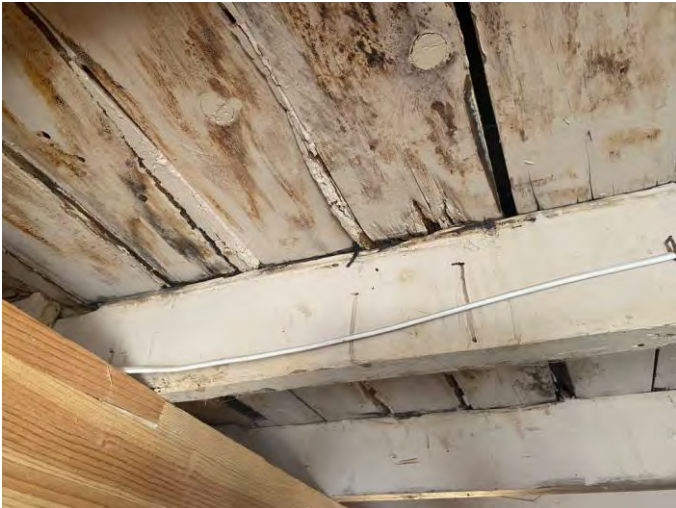
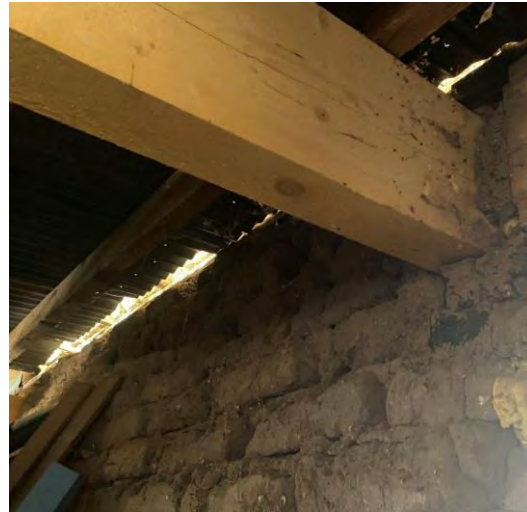
1. Roof Framing

The roof framing was exposed throughout the building and consists of 2x6 rough-sawn lumber at 24" on-center and timber viga framing with varying diameters at 30" on-center, spanning between load bearing adobe walls.

Significant surface staining was observed on the framing members and plank decking, likely due to prolonged moisture intrusion resulting from failure of the roof covering.

Timber viga framing was observed to be in direct contact with adobe walls and exhibited visible decay, resulting in loss of section and reduced structural capacity.

1. Replacement of the roof framing
2. Significant repair or replacement of adobe walls due to moisture intrusion and direct contact with earth in the retaining conditions
3. Installation of continuous bond beams at all adobe walls in
4. Evaluation and potentially the installation of a foundation system

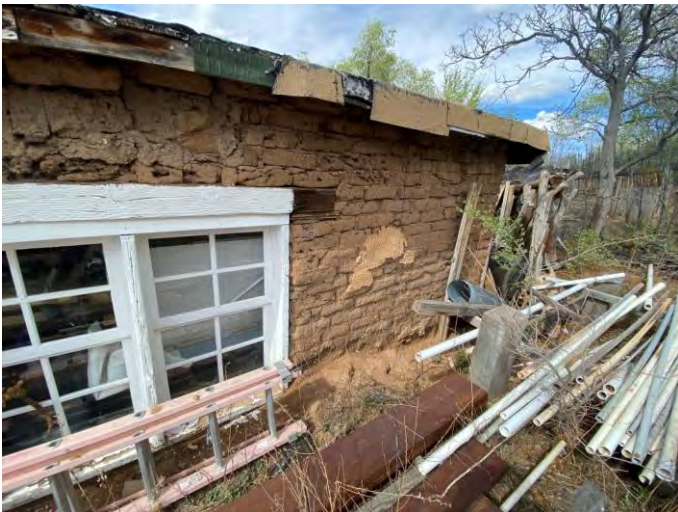
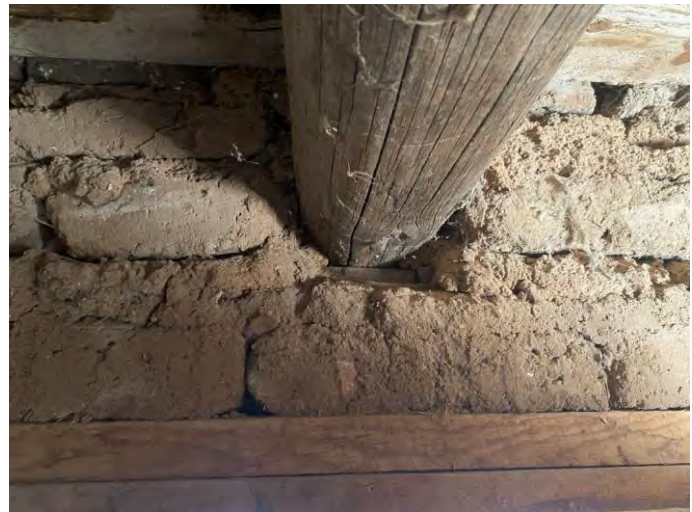
2. Bearing Walls and Lateral Bracing

Structural walls were partially exposed due to deterioration of exterior and interior finishes. Exterior and load-bearing walls consisted of approximately 10" wide adobe block. No wood or concrete bond beam was observed at the top of the adobe walls.

The exterior adobe walls have been exposed to weather due to the absence of protective finishes such as stucco, resulting in erosion and loss of structural section. Several load-bearing adobe walls show evidence of moisture exposure and deterioration due to the failure of the roof covering.

The south exterior load bearing adobe wall partially retains soil. The lower courses of adobe at this location likely have diminished structural integrity due to prolonged moisture exposure and erosion due to the failure of waterproofing finishes and direct contact with retained earth.

The absence of a continuous concrete or wood bond beam makes the buildings' construction fall outside of the prescriptive design methods to resist lateral forces from wind and seismic events.
