Historic Cultural Properties Inventory (HCPI) Base Form (FORM 1)

Date of Form: August 8, 2025 – Revised

1. Name of property: Antonio & Margarita Chavez House/ Karen Parfitt Hughes Second Home	2. Location: 532 Calle Corvo Downtown and Eastside Historic District Santa Fe	3. Local Reference Number: Santa Fe ID: H-638 4. County: Santa Fe Parcel # 10470528

8. Name of Project: HDRB Status Evaluation		
9. Lat/Long: 35.6806349,-105.9331281		
10. Photo Information: Giulia Caporuscio, photographer. Photo 1: View of east elevation, facing northwest.

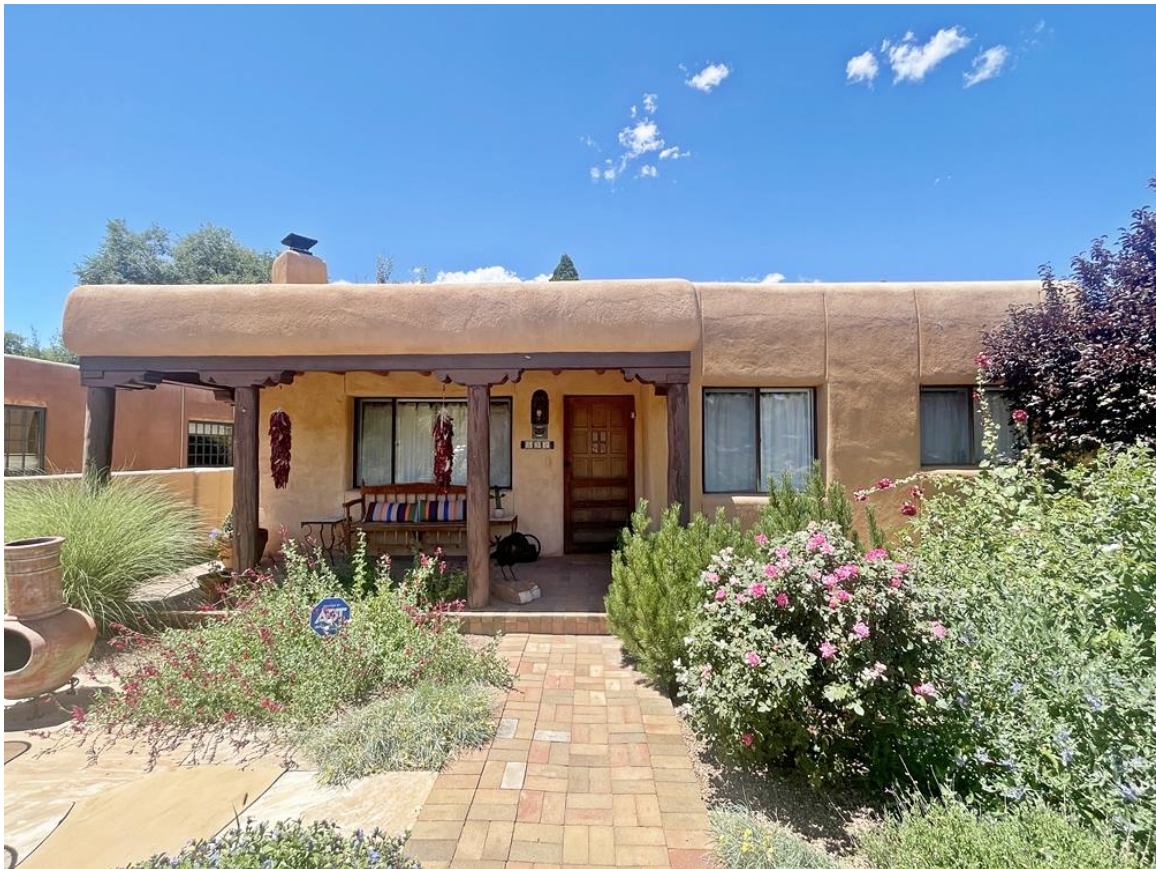
The front façade, which faces Calle Corvo, presents a Spanish Pueblo Revival vocabulary, although several elements were introduced in recent years. At the south end is a generously sized *portal* (Photo 2). This flat-roofed structure with a stuccoed parapet is supported by round wood posts topped with double *zapatas* (corbels).

Photo 2: East (front) façade. Camera facing west.

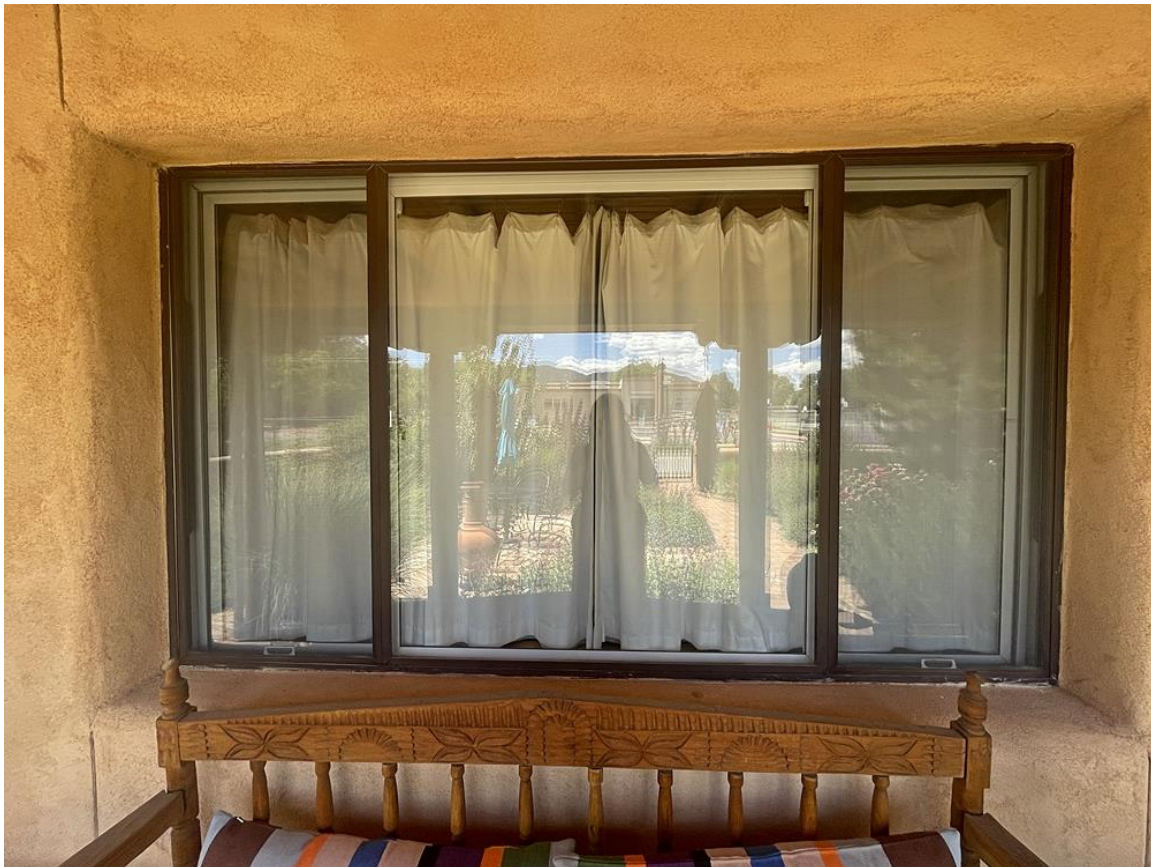
Centered within the portal is an aluminum combination window composed of a fixed central panel flanked by sliding sashes (Photo 3). Like most windows on the house, it is covered by a metal storm unit. The portal floor is now finished in brick and square concrete pavers, replacing the original poured concrete surface. The main entry door is sheltered beneath the portal; it is a wood unit with an 18-panel design and a small glazed vision light (Photo 4).

Photo 3: East (front) façade. Replaced window at portal. Camera facing west.

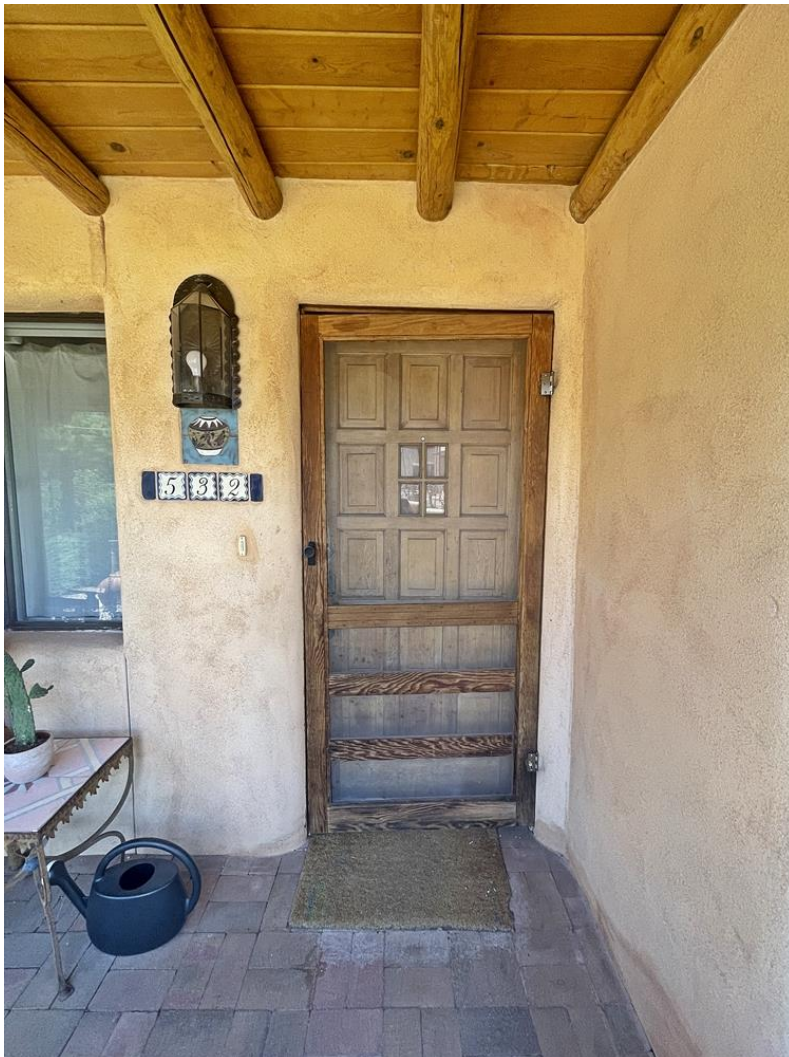
Photo 4: East (front) façade. Front entry door. Camera facing west.

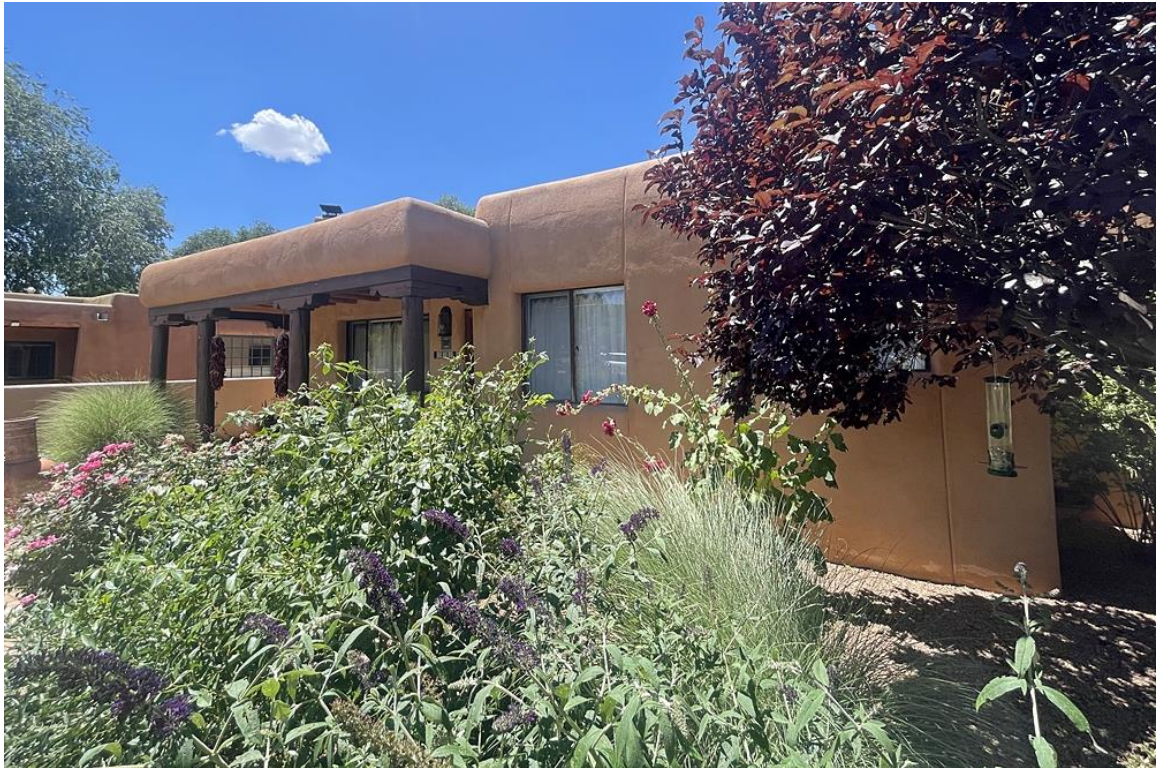
North of the portal, the façade steps forward approximately three feet to accommodate the dining room and kitchen area (Photo 5). This section contains tall sliding aluminum windows, also protected by storm units (Photo 6).

Photo 5: East (front) façade. Camera facing southwest.

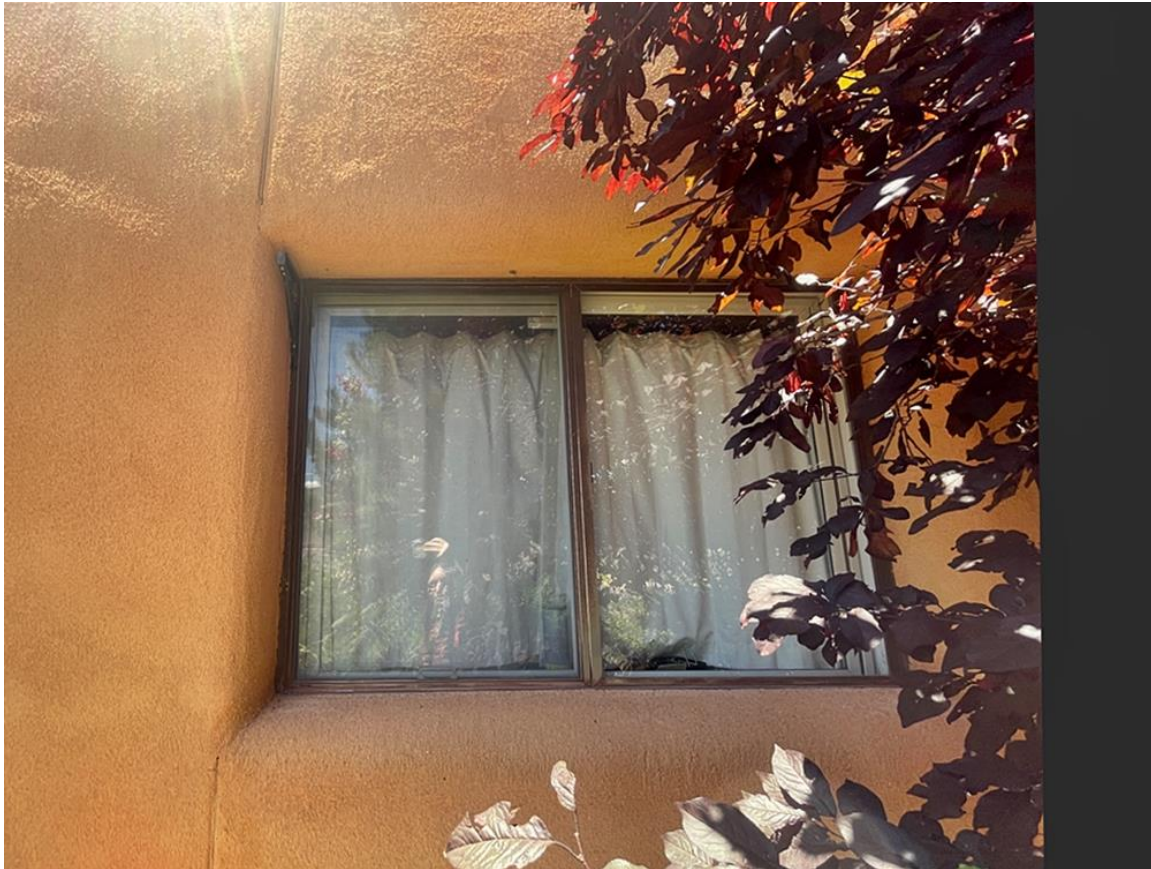
At this point—and continuing around the structure—are pronounced vertical control joints in the stucco, likely introduced to manage cracking or movement in the wall surface. Evidence of prior or ongoing movement is further suggested by an aftermarket metal angle bracket affixed to the top-left corner of the kitchen window surround, apparently installed to stabilize the projecting stucco or conceal visible cracking.

Photo 6: East (front) façade. Window and stucco detail. Camera facing west.

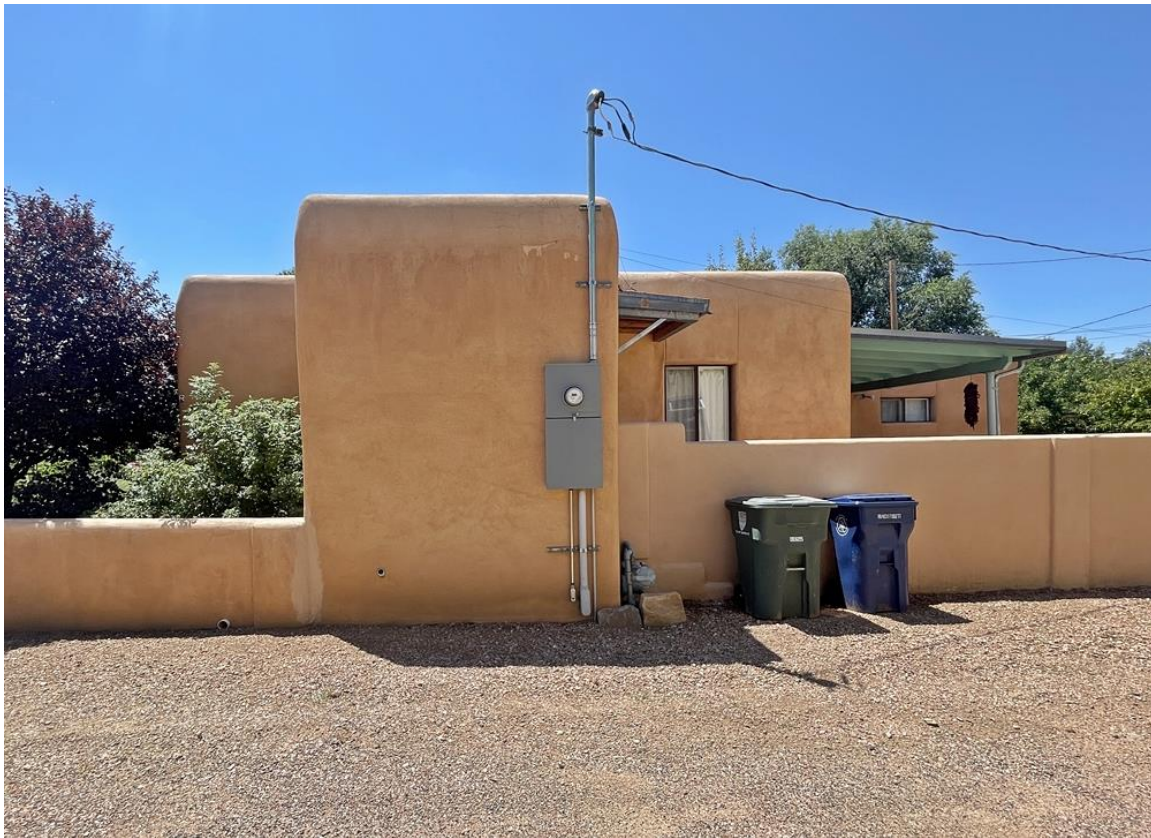
The north elevation, which faces the shared driveway, begins at the east end with the projecting volume of the laundry room (Photo 7). Around the corner, on the west-facing wall of this volume, is a secondary entry providing access to the laundry area (Photo 8). This door is a half-light wood panel unit that appears to be of an earlier vintage.

Continuing west, the north elevation extends approximately 11 feet to enclose a bedroom (Photo 7). Like other walls on the house, this section includes a sliding aluminum window providing light to the interior.

Photo 7: North elevation. Camera facing south.

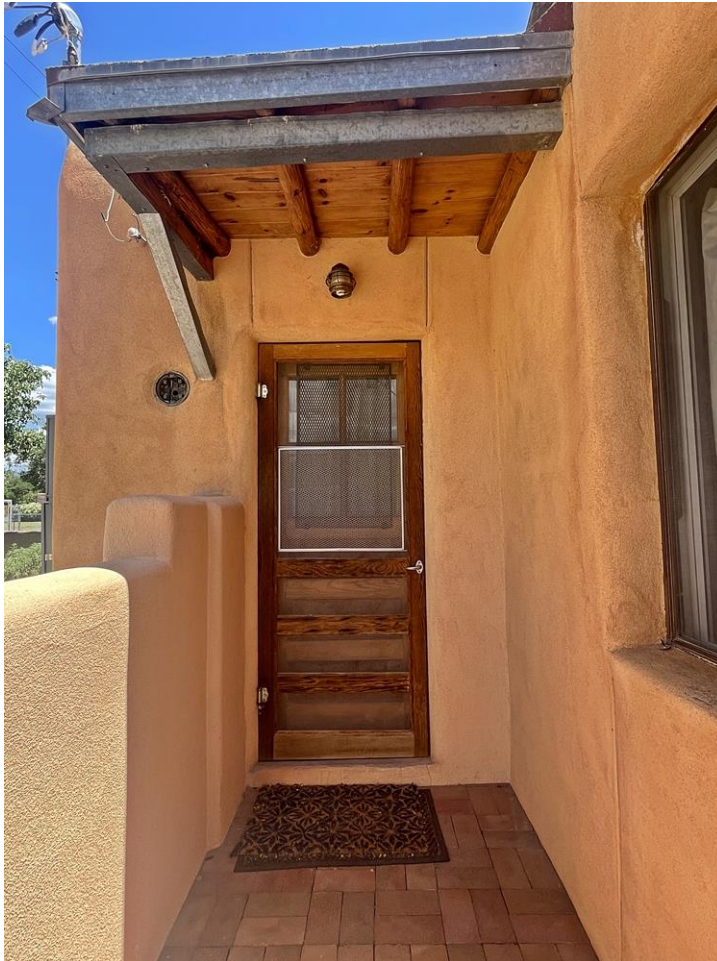
It is sheltered by a shallow shed-roof canopy made of corrugated metal, supported by peeled-log vigas. A galvanized steel brace—likely a later addition—anchors the canopy to the wall, marking it as an aftermarket intervention not original to the building. The canopy does not appear in the 1958 aerial photograph (Fig. 4).

Photo 9: West elevation. Laundry room entry. Camera facing east.

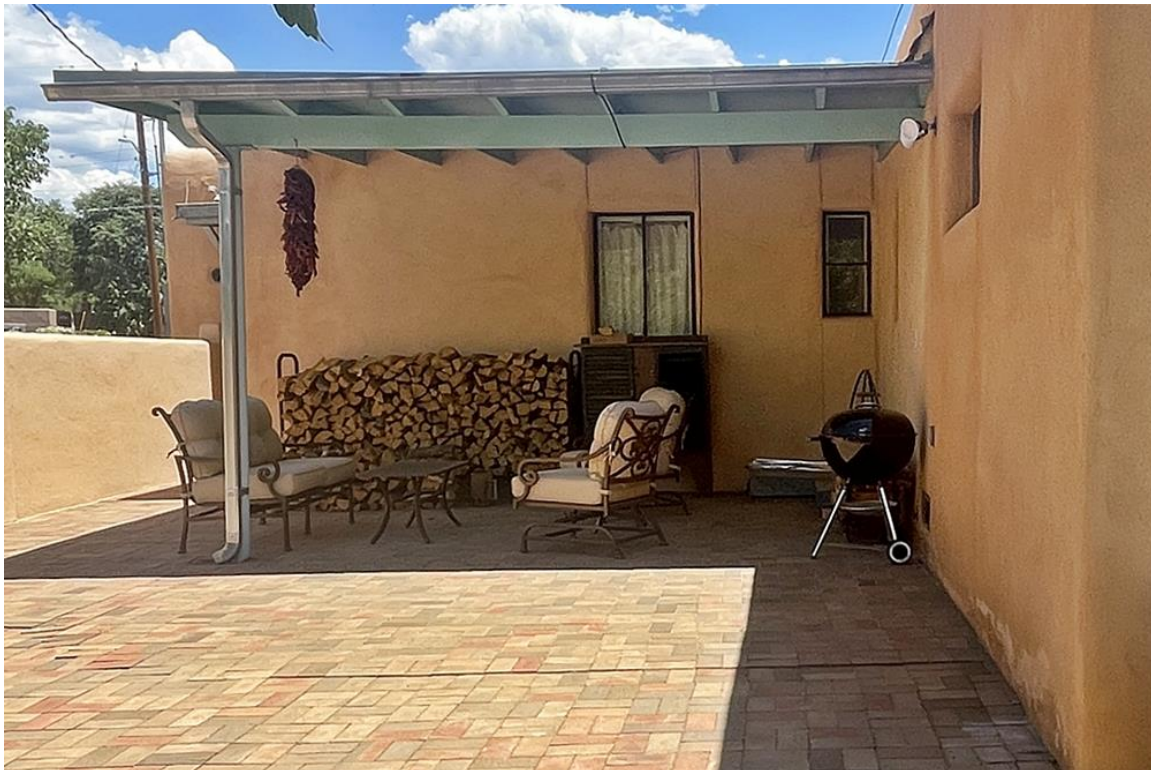
Turning the corner, the west elevation of the original house comes into view. This section includes a sheltered rear porch added after 1958, as well as window openings serving the bedroom and bathroom (Photo 10).

Photo 10: West elevation. Original section. Camera facing east.

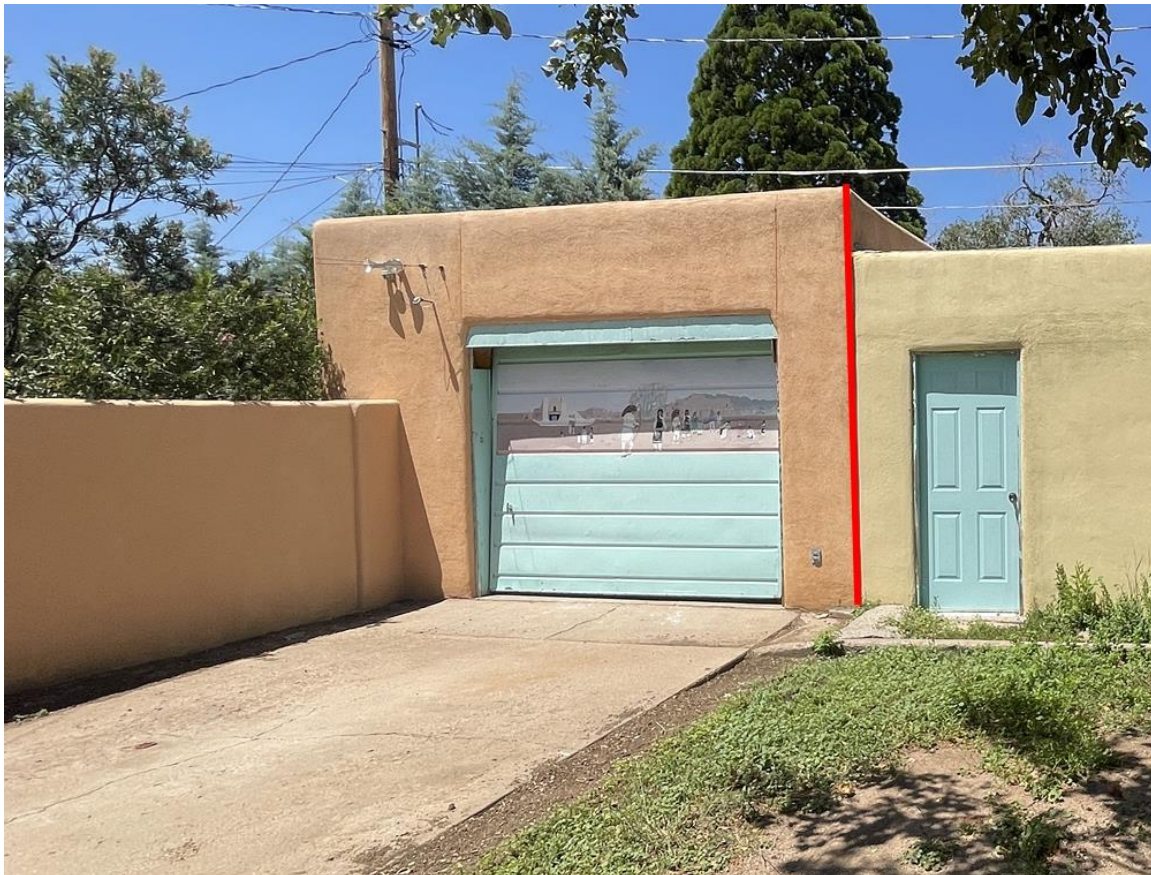
Tucked into the northwest corner of the lot, at the end of the driveway, is a one-bay garage (Photo 15). The roughly 392-square-foot structure is constructed of stuccoed concrete masonry units (CMU) and was likely built contemporaneously with the house. Its north wall shares a zero-lot-line condition with an adjoining garage—now used for storage—on the neighboring property.

Photo 15: Garage (left of red line). Camera facing southwest.
