NEW MEXICO HISTORIC BUILDING INVENTORY - SANTA FE RESURVEY 1991

H16571

CASE NO. 92-687 PROJECT LOCATION 426 Delgado Lane

Historic Design Review Board Proposal Letter

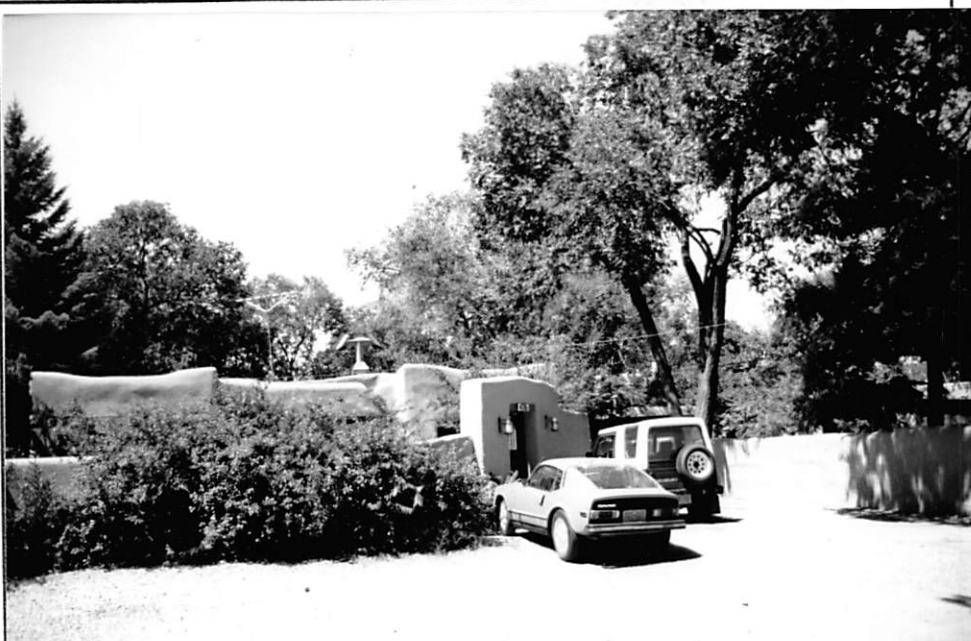
EXPLAIN: NEW WINDOWS OLD PARAPET VISABLE FROM		
	OVERALL CONDITION: <input type="checkbox"/> EXCELLENT <input checked="" type="checkbox"/> GOOD <input type="checkbox"/> FAIR <input type="checkbox"/> DETERIORATED		
	BUILDING THREATENED? <input type="checkbox"/> YES <input checked="" type="checkbox"/> NO		
LISTED ON NATIONAL REGISTER OF HISTORIC PLACES? <input checked="" type="checkbox"/> YES <input type="checkbox"/> NO <input type="checkbox"/> ELIGIBLE <input checked="" type="checkbox"/> CONTRIBUTING <input type="checkbox"/> NON-CONTRIBUTING
