Historic Cultural Properties Inventory (HCPI) Base Form (FORM 1)

1. Name of property: 616 Acequia Madre (previously identified as 614 Acequia Madre or Acequia Madre House) historical: 614 Fenyes-Curtin House, or Curtin-Paloheimo House	2. Location: ~ Santa Fe, New Mexico ~ Downtown & Eastside Historic District – City of Santa Fe ~ Camino Del Monte Sol National Historic District	3. Local Reference Number: 051600019 - House 4. County Santa Fe

8. Name of Project: 616 Acequia Madre House Updated HCPI for HDRB status review		
9. UTM Zone: 13S Easting: 415742 Northing: 3948775		
10. Photo Information Negative Location: DIGITAL FILE Roll #: _____ Frame #: _____

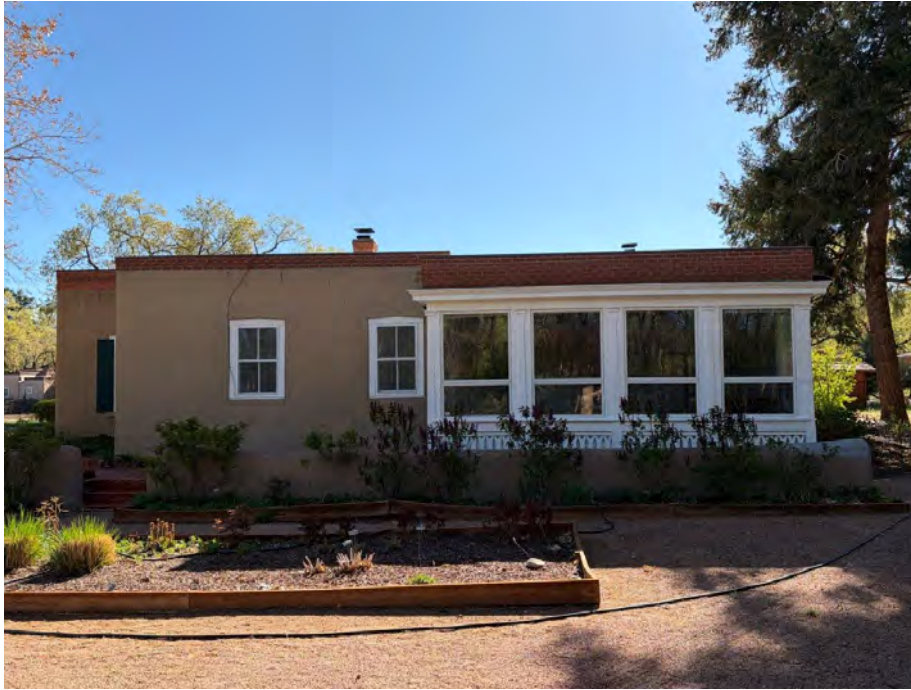
West Façade from within Garden

(1930 infilled sleeping porch visible in center [with two windows] and 1930 added screened sleeping porch shown at right)

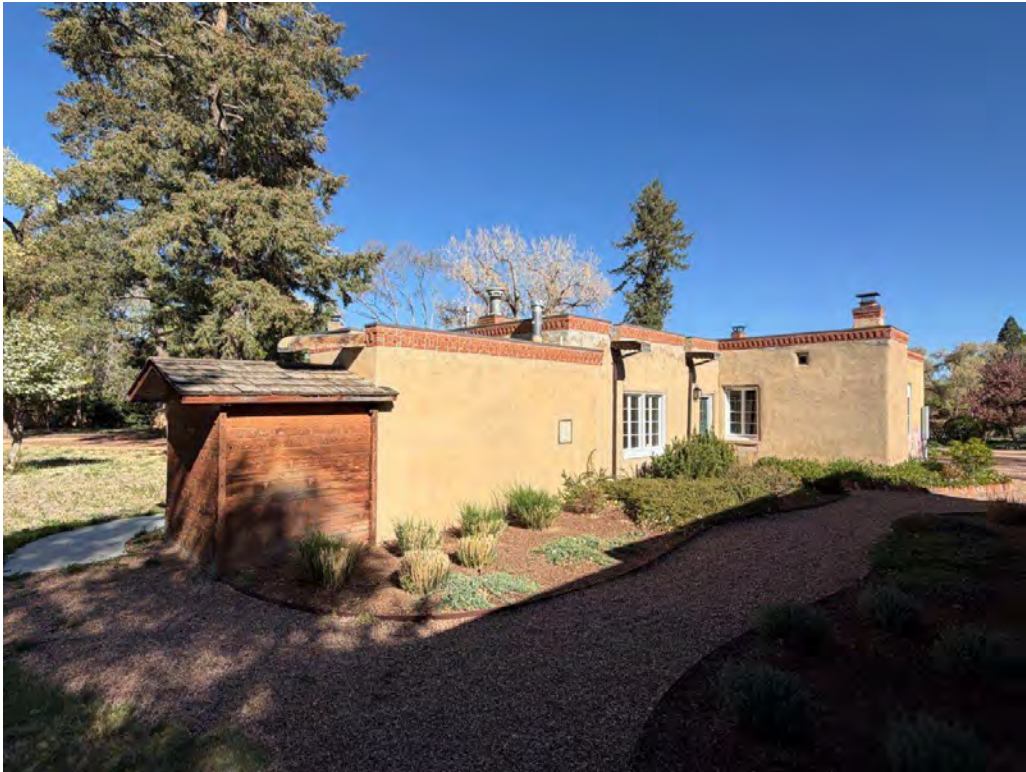
A pool at the rear of the property was added sometime prior to 1991 (since removed). The associated pool changing rooms and sauna are still attached at the southeast corner of the house and add no real value to the property or history.

East Elevation, South Aspect (Sauna and Pool Changing Rooms are at left)

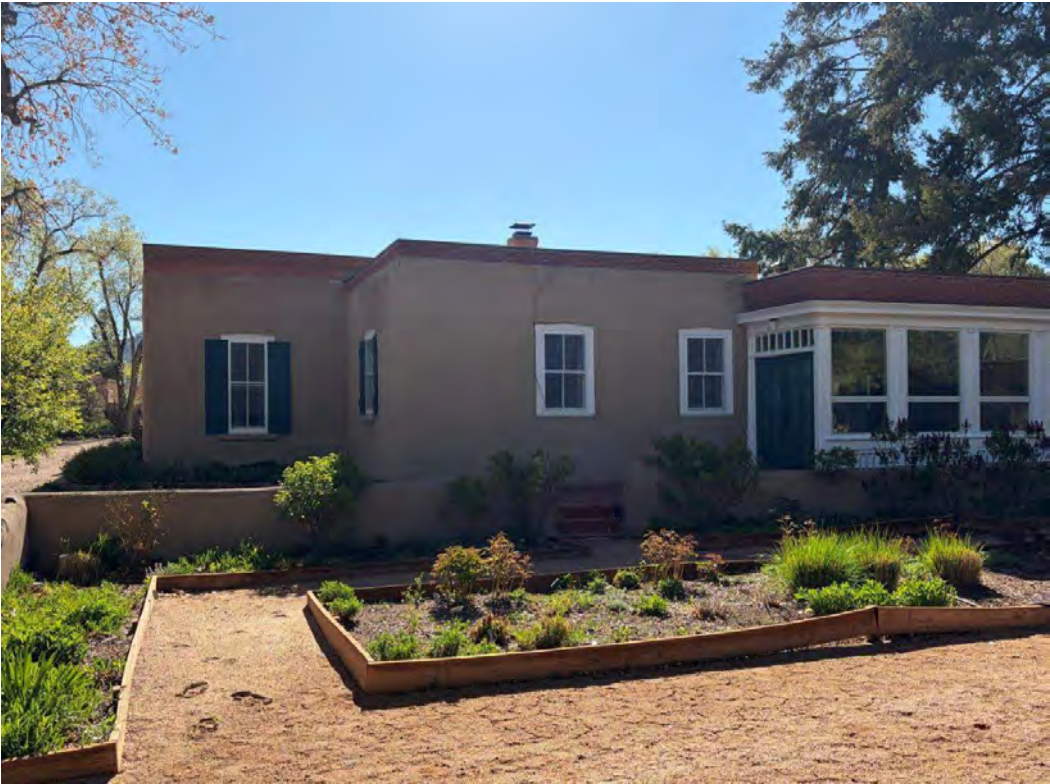
West Façade – at Northwest Corner (Green Door from 1974 Infill)

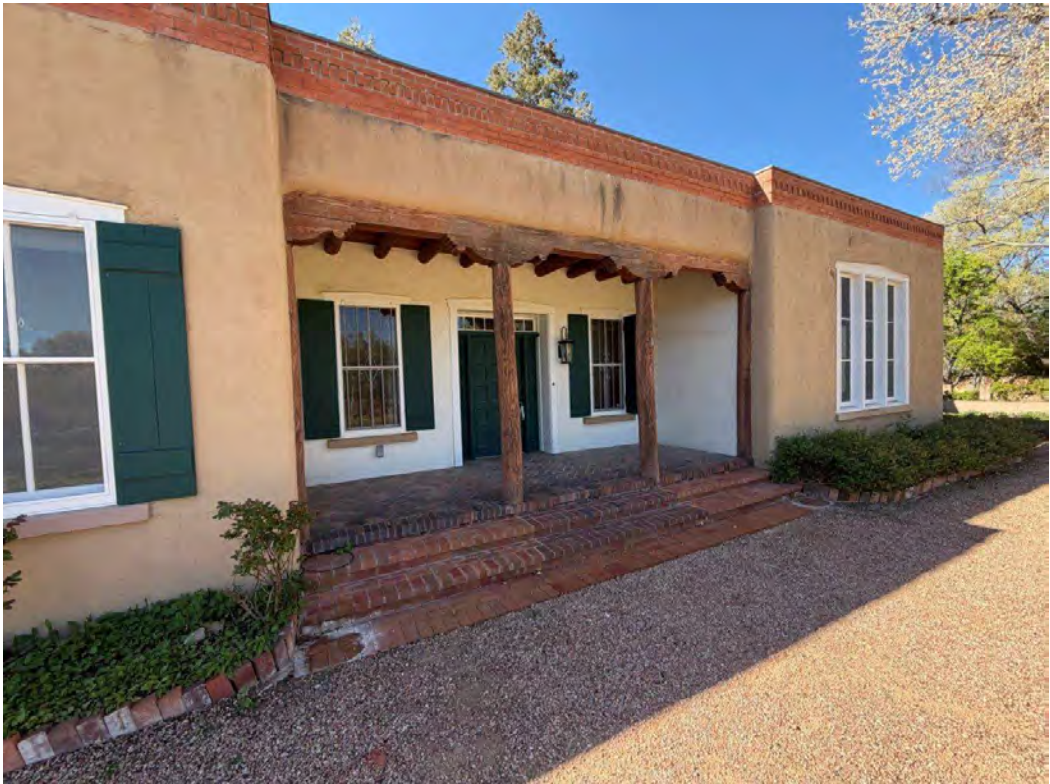
North Façade – Main Entry Portal with Shutters

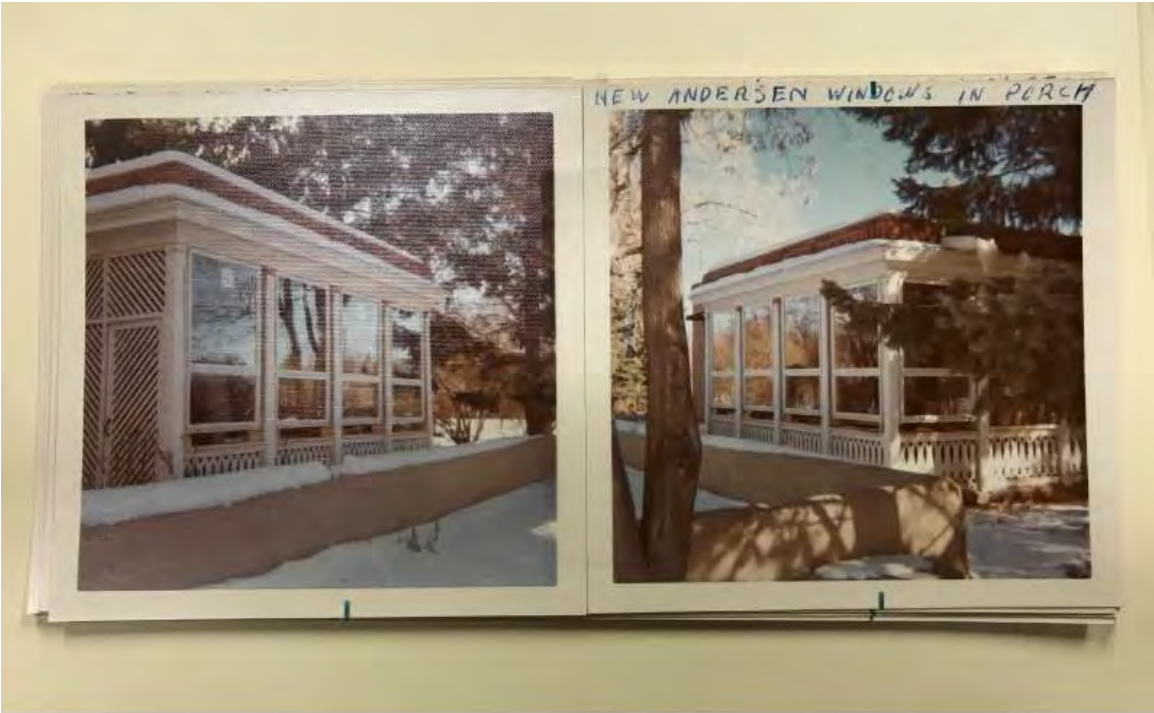
1974 Enclosure of Sleeping Porch
