Historic Cultural Properties Inventory (HCPI) Base Form (FORM 1)

For HPD Office use only: HCPI No. _____ District No. _____ NRHP _____ SRCP _____ Criteria <u> </u> A <u> </u> B <u> </u> C <u> </u> D		
1. Name of property: 616 Acequia Madre Garage (previously identified as 616 Acequia Madre or the Acequia Madre House Garage and Keeper's Quarters)	2. Location: ~ Santa Fe, New Mexico ~ Downtown & Eastside Historic District – City of Santa Fe ~ Camino Del Month Sol National Historic District	3. Local Reference Number: 051600019 - Garage 4. County Santa Fe

8. Name of Project: 616 Acequia Madre Garage Updated HCPI for HDRB status review		
9. UTM Zone: 13S Easting: 415742 Northing: 3948775	10. Photo Information Negative Location: DIGITAL FILES Roll #: _____ Frame #: _____

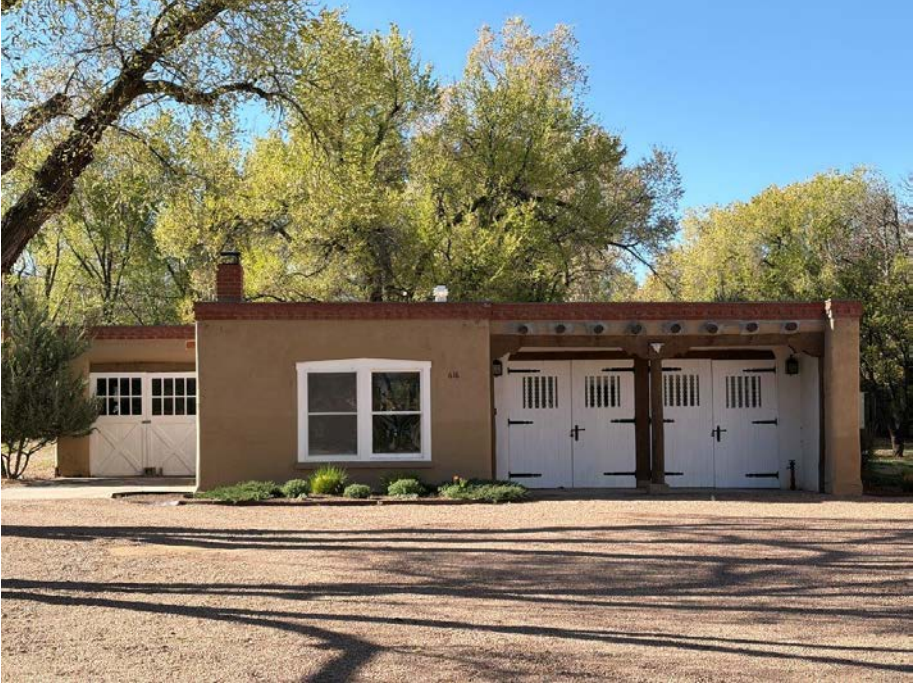
6. Date of Survey: 02/09/2026	<div style="text-align: center;">View of: Front (North) Façade</div>	
7. Previous Survey Date(s): 06/06/1983 HCPI 08/14/1991 HCPI 03/14/1998 National Register District Nom. <u> </u> No previous survey

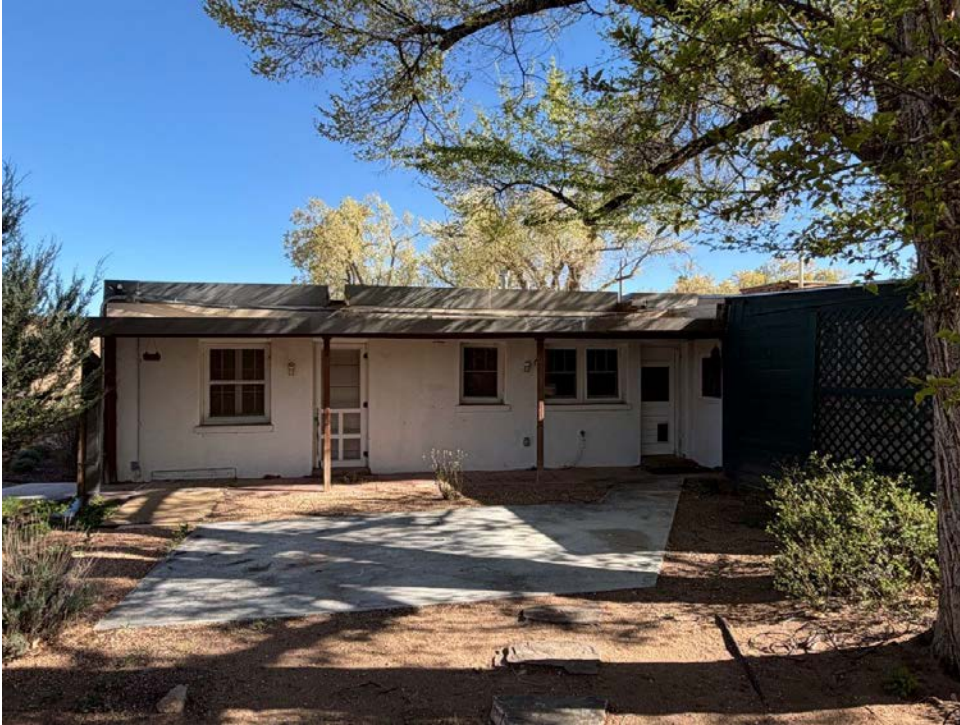
Rear (South) Façade; West Side

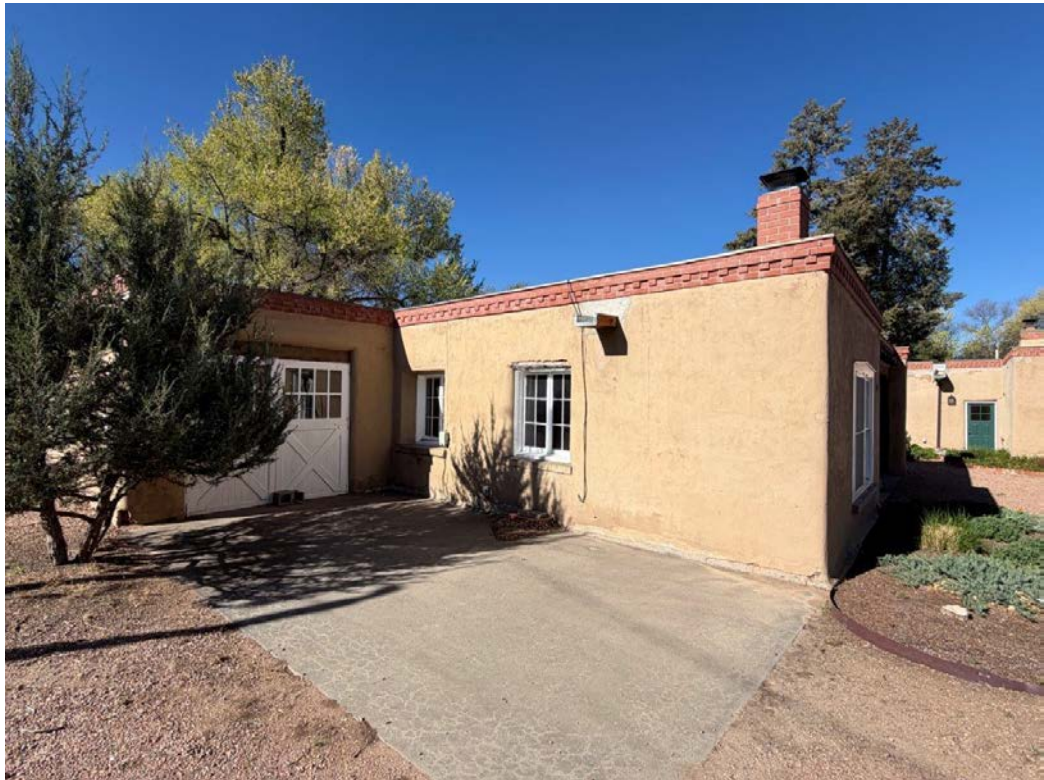
East Elevation perspective at north side (Main House visible beyond)

The main windows on the north are a pair of ganged 1/1 double-hung type. The side garage features similar detailing, with 4/2 top-lites in the double-leaf plank and diagonal-braced doors, this time (in a more Spanish-Pueblo Revival feel) bullnosed opening. Windows on the sidewalls are ganged 2/3 casements in bullnosed openings. One window on the east has severe deterioration of the header.

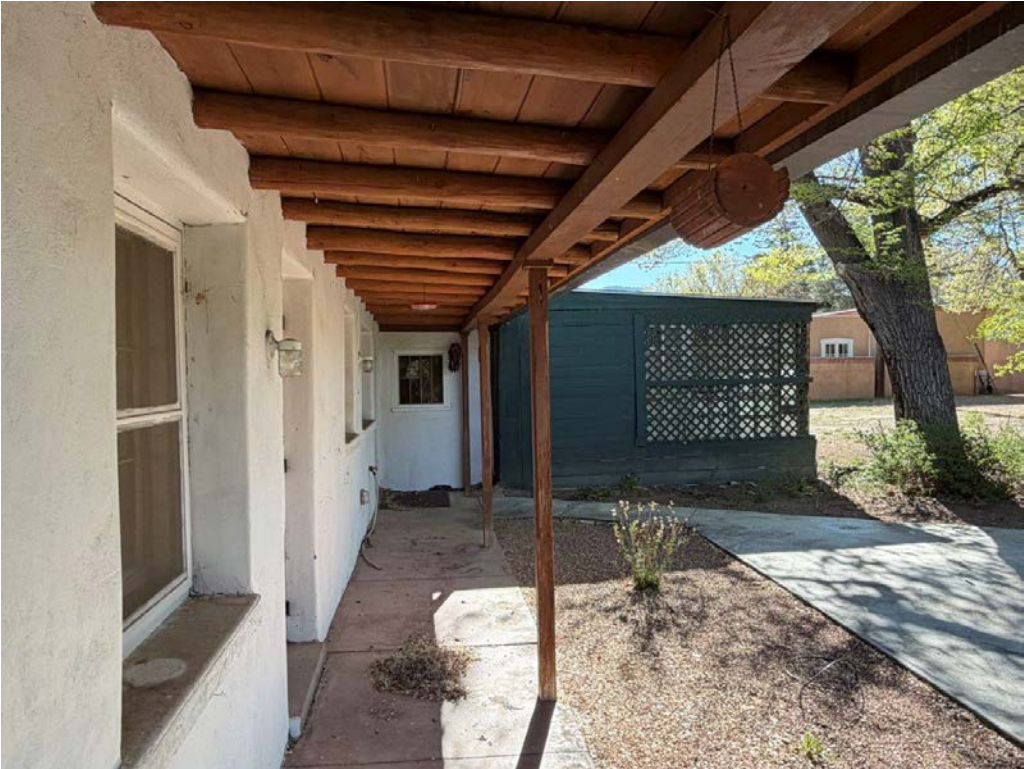
South Elevation – Looking East

The rear addition has no brick coping, suggesting that it was built in a different period than the 1927 additional one car garage, though the finishes are similar and it appears the western elevations' window under the porch of the addition is reused. This window has horizontal metal security bars installed as well. A matching window on the 1927 single car garage, this time with a scrollwork security grille, implies that these windows may date from that time. The back porch has a shed roof resting on 4x4 chamfered wood posts that have a small trimmed "capitol" at the top. Within this space are vertical mullioned 3/3 double-hung windows, a wood panel exterior door with wooden screen door, a wood panel ½ lite door with transparent lites, and a 2/3 casement with metal security grille at the west. The extremely low flat parapet and condition of the canales is less than desirable at this location. A shed-roofed post-and-truss with trellis panels... and other hodge-podge... addition at the south of the structure is non-contributing and could be razed, however its strange diagonal screen doors may be from the 1930 sleeping porch addition converted to an office in 1974, and they might be salvageable. This implies that this addition was added after the 1974 remodel. Canales on this building are simple, and have no decoration, unlike their counterparts on the main house (the canale at the east side has been blocked).
