619 West Alameda

Window Condition Assessment

Prepared by:
Scott Ernst
10/13/2025

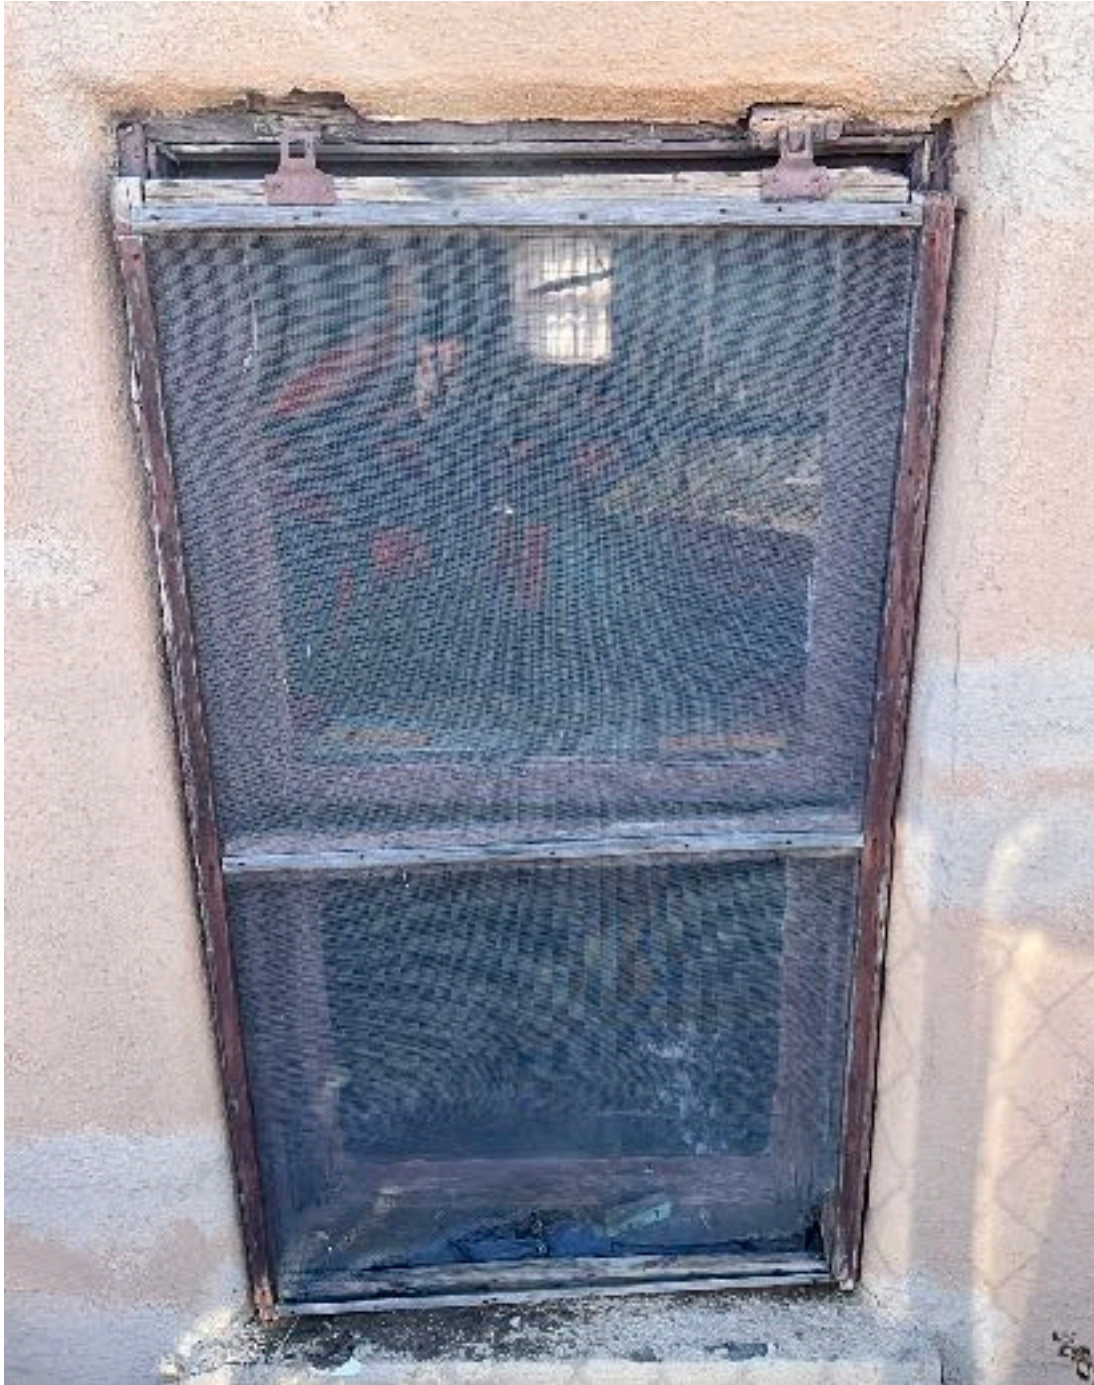
East Window #1
Double Hung Window
24 x 46

This unit is, despite the peeling paint and failing glazing compound, relatively sound. The sill is rotten, but the jamb legs appear to be OK. This probably has been helped by the building being Pen Tile. Adobe usually breaks down and causes dirt to pile against the bottom of the jamb where it collects moisture and rots the jambs. Like the rest of the windows in the house, there were screen sashes made after the fact and jury rigged to fit the openings. The original jambs weren't made deep enough to put screens in in the usual way.

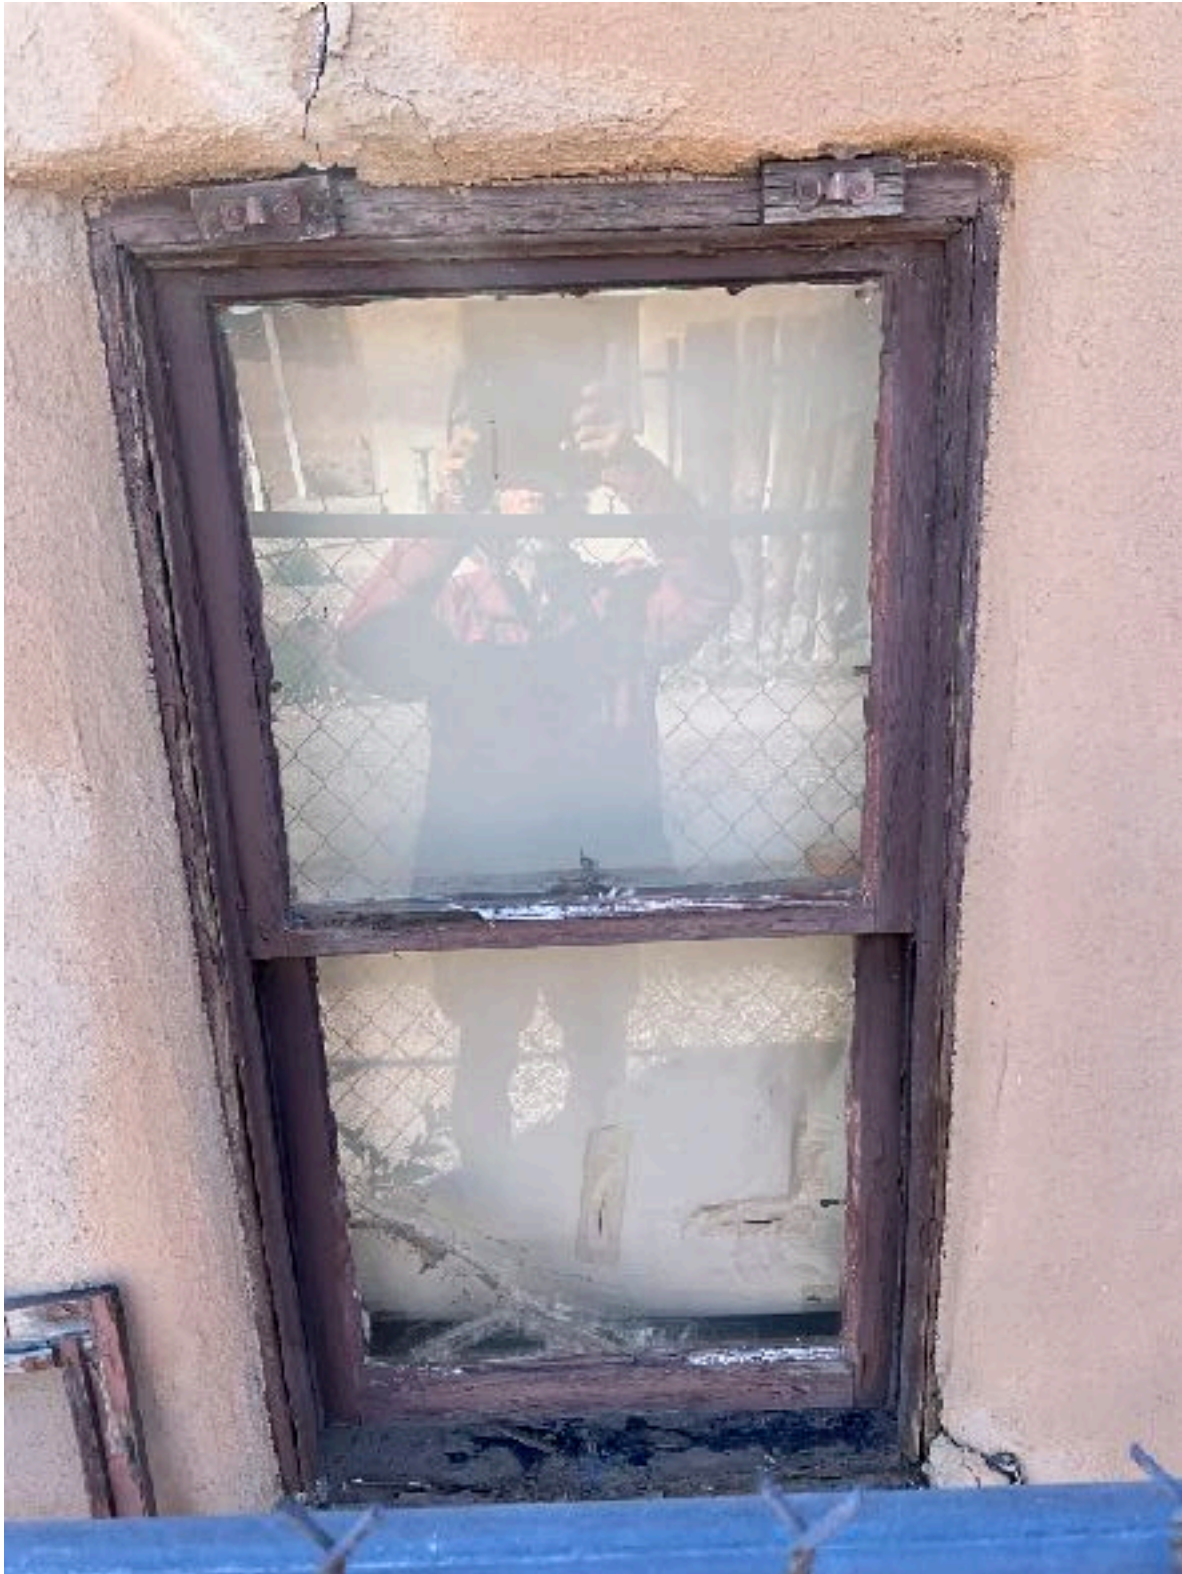
East Window #2
Double Hung
24 x 46

Like all of the windows in the house, the paint and glazing compound have failed on this unit although the sashes remain basically sound. The jamb, however is all rotten. The bottom pane of glass is also broken.

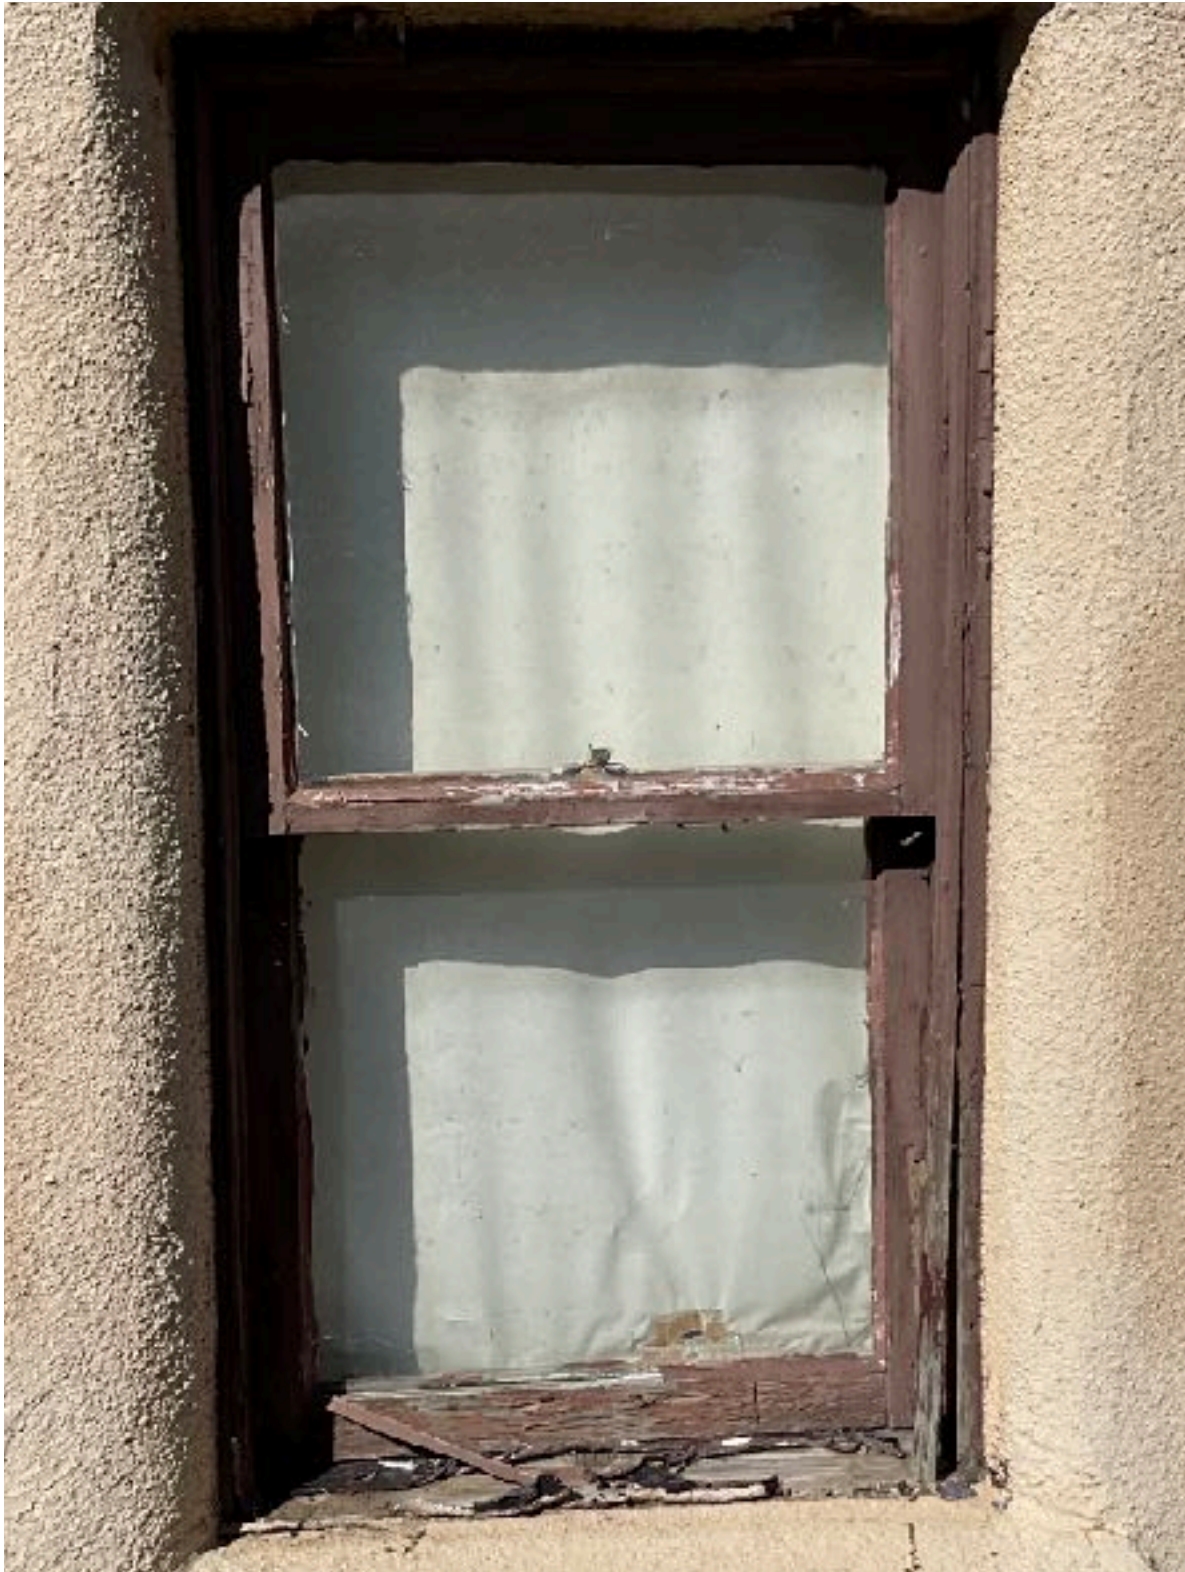
South Window #1
Double Hung
24 x 46

As with many south facing windows in Santa Fe, the sun has taken it's toll, first on the paint, then on the wood. The sashes are still sound, but there are fissures in the wood that will need to be filled with epoxy. The jamb appears to be sound, but, again, you only know for sure once you can get behind it. The bottom rail joints are open a little. Other than that it is in decent shape.

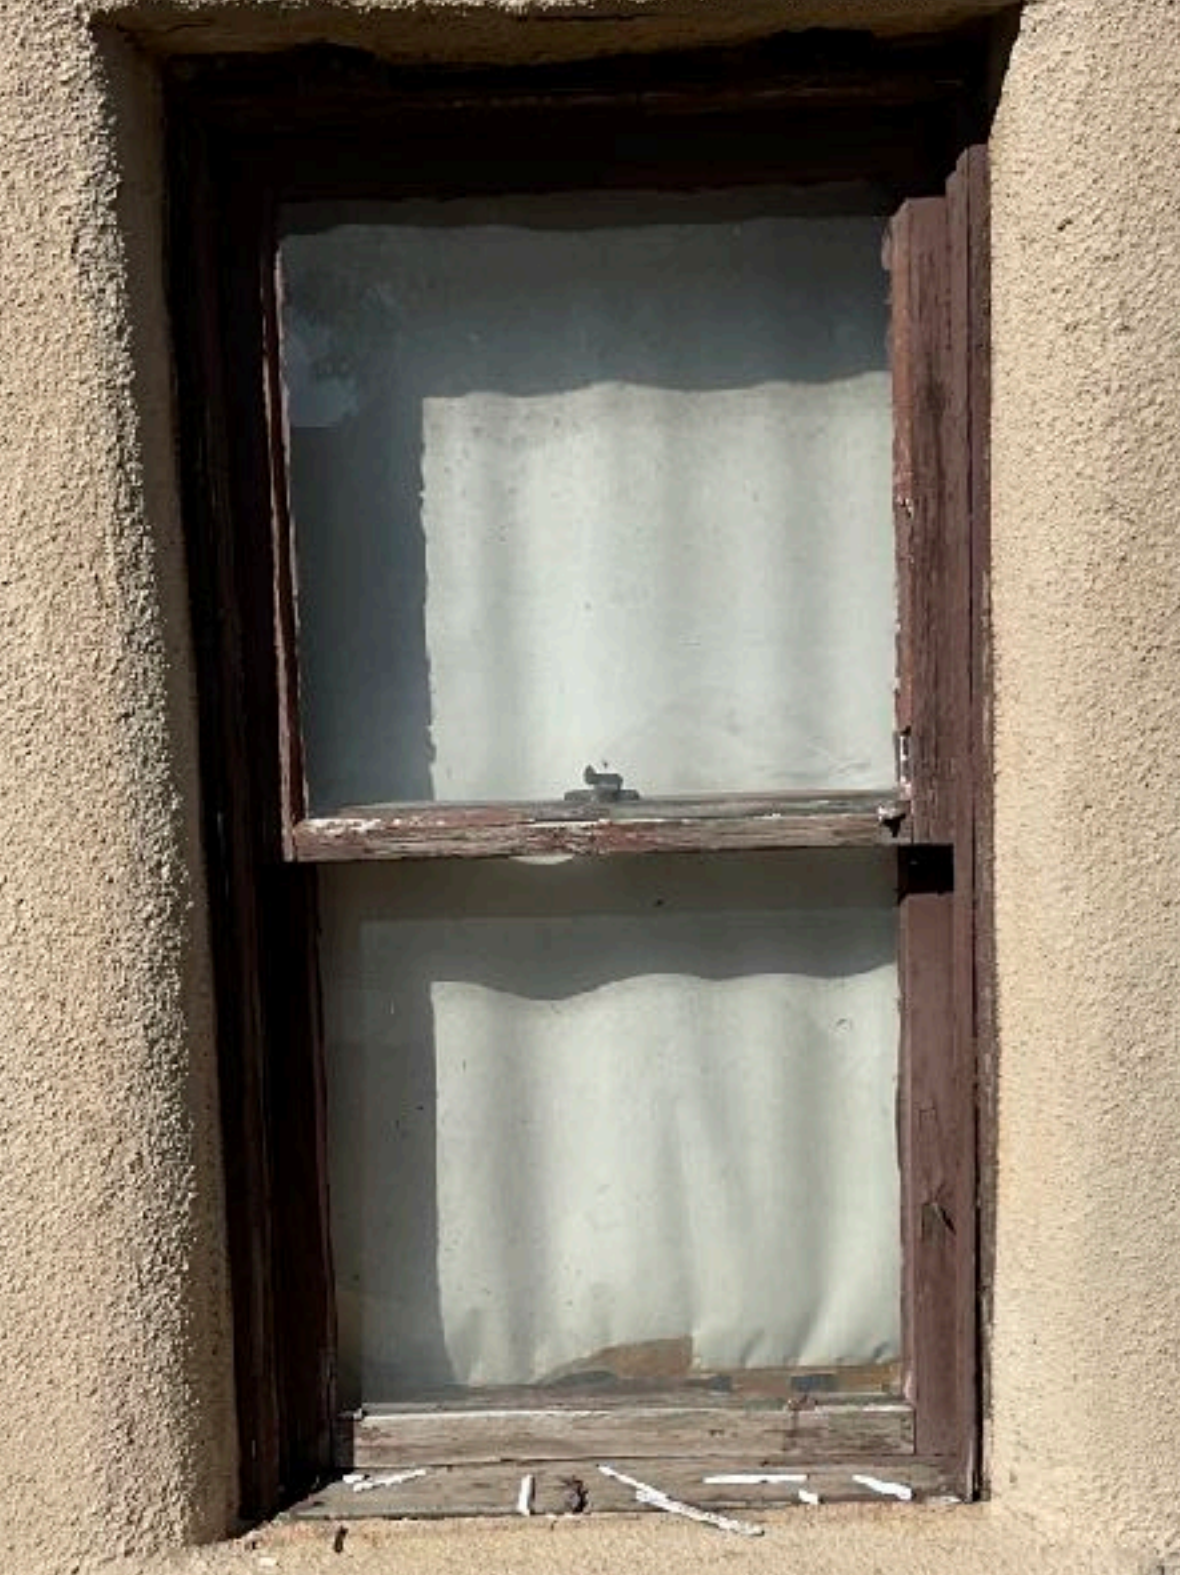
South Windows #2

This unit is in a similar condition to the rest. Failed paint and glazing but still sound. The sill is rotten.

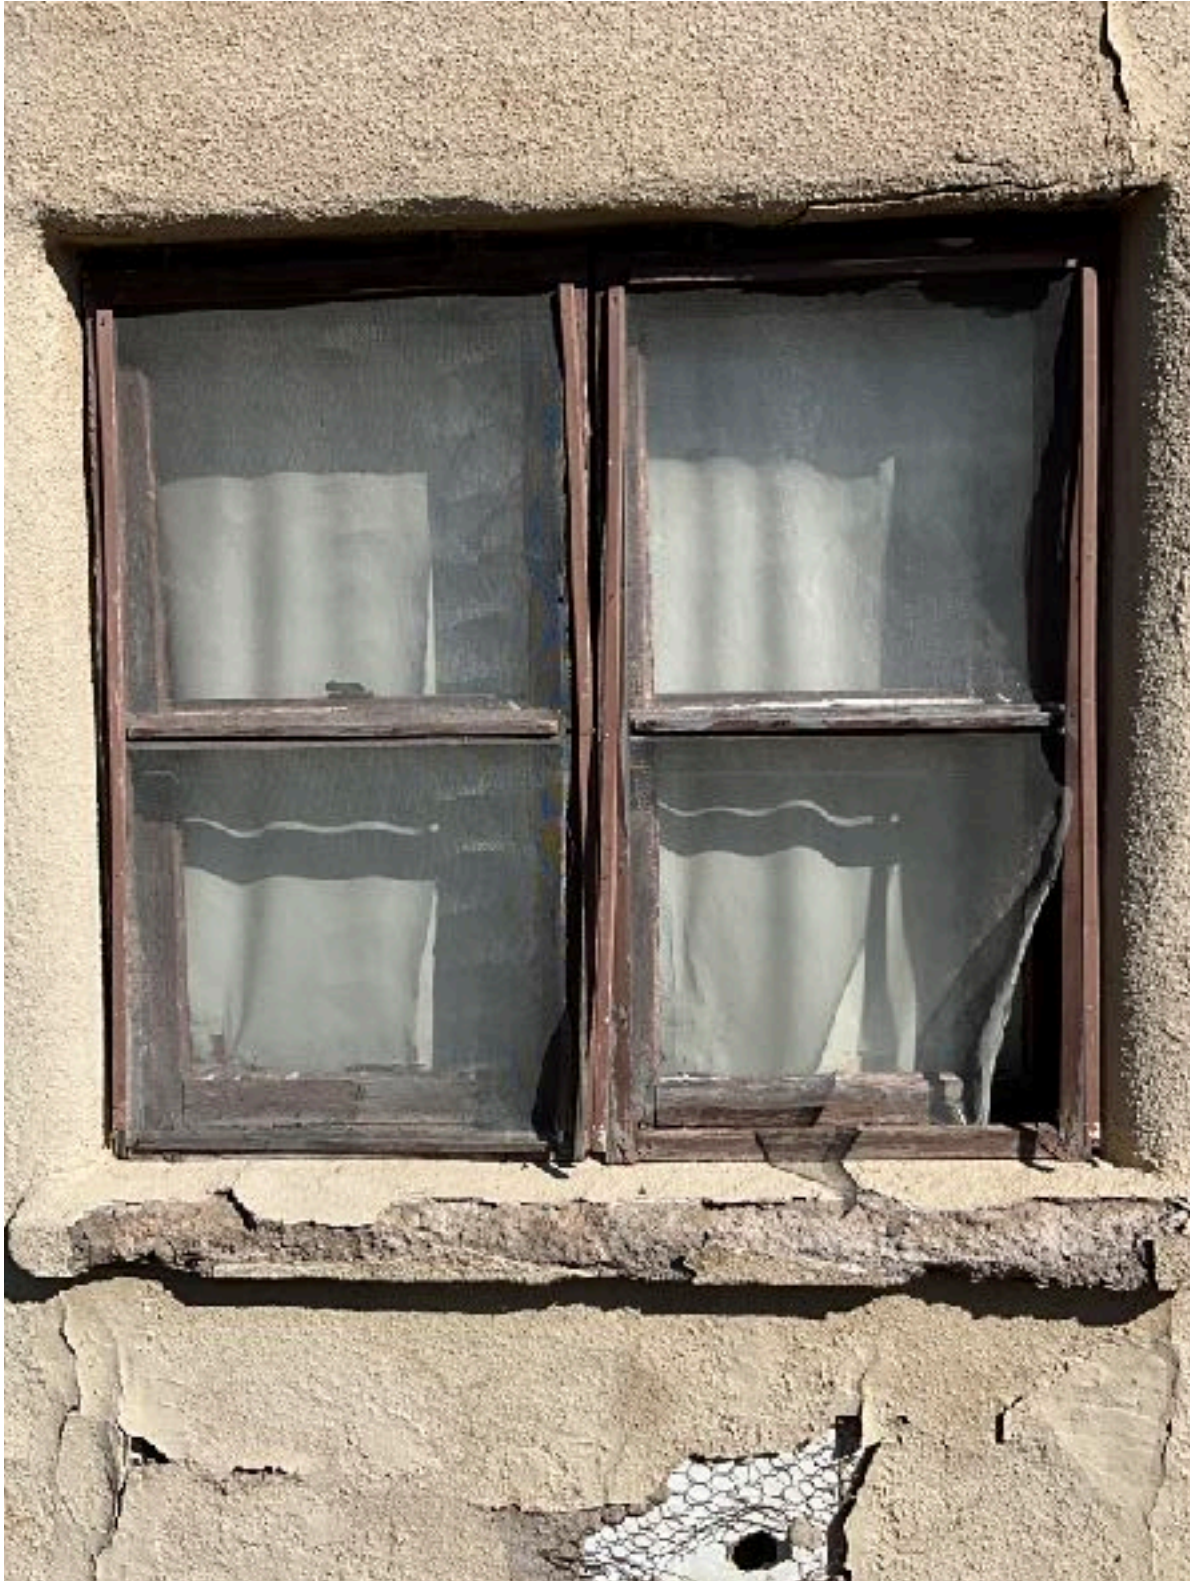
West Window #2 & 3
Double Hung Pair
24 x 48

This mulled pair is in a similar condition to the rest. The wood is sound, but in this case the bottom rail joints have opened up some. This would be repairable in a restoration. Again the sill is rotten.

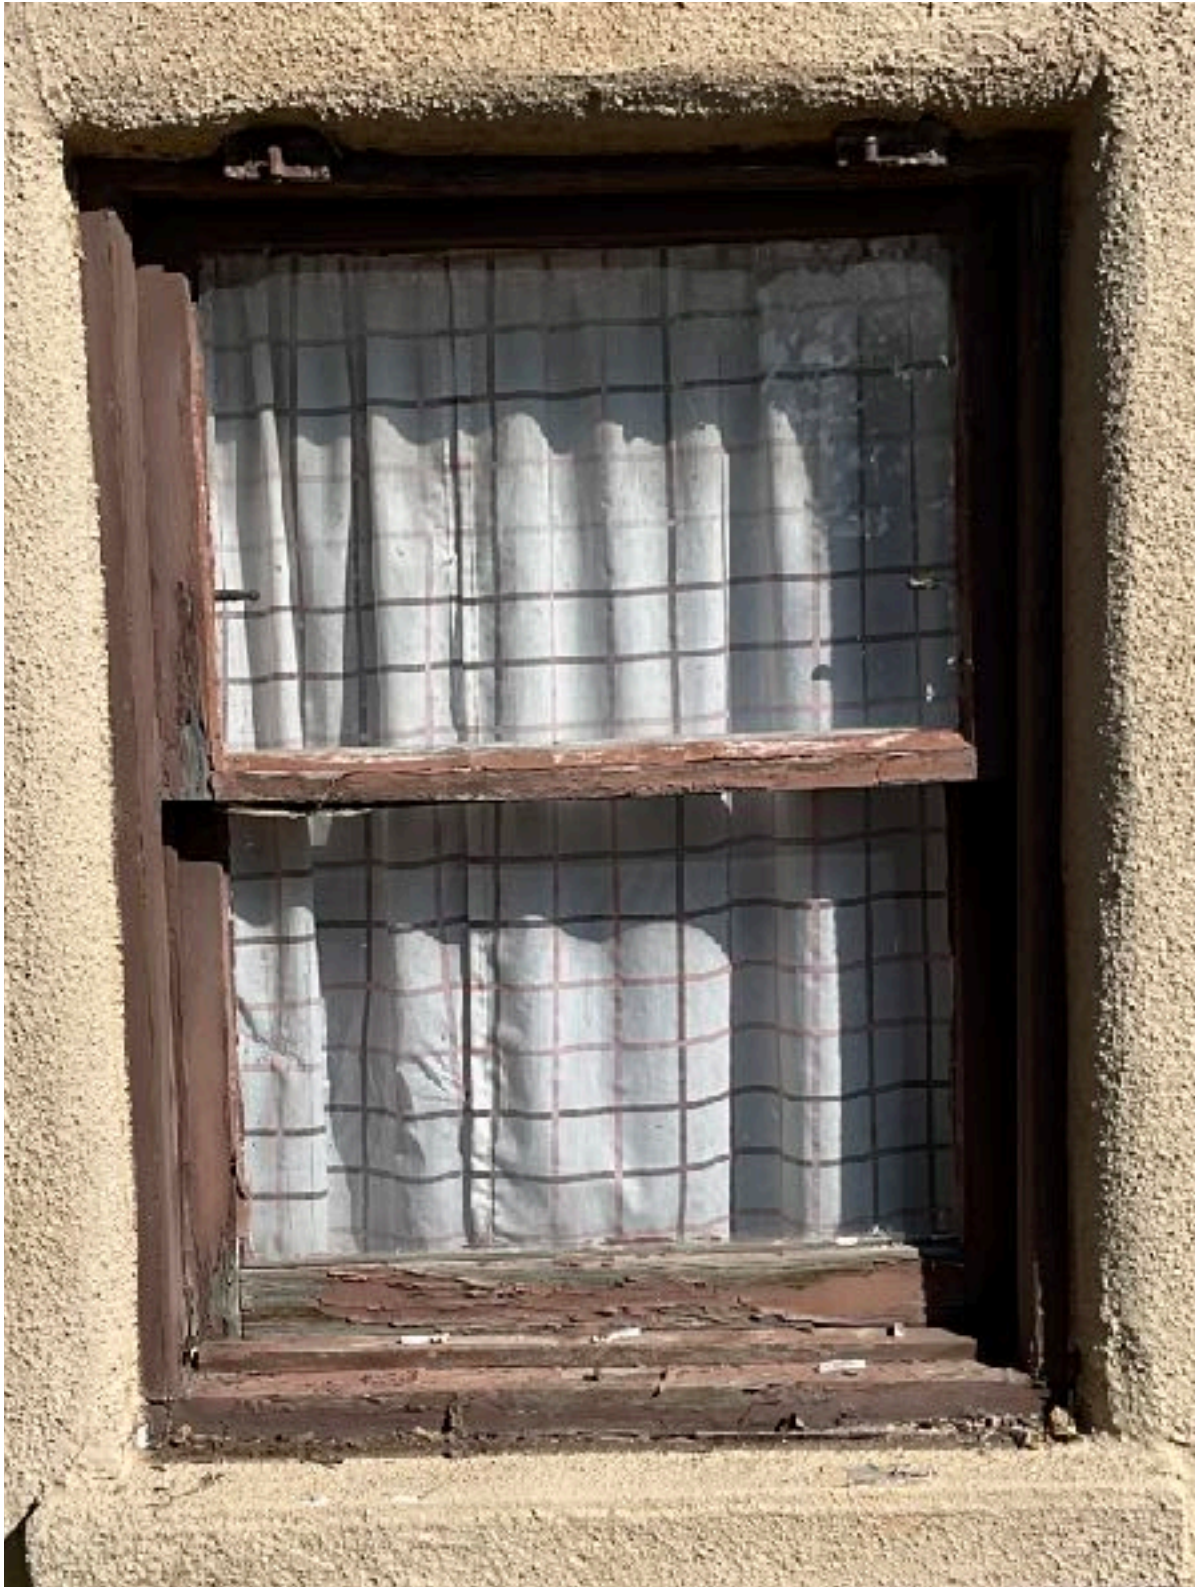
West Window #2
Double Hung
28 x 40

This unit shares the woes of the rest in the house. Shot paint and glazing and rotten sill. On top of that the meeting rail on the top sash has a slight sag. It would be a good idea to replace that rail. Otherwise the sashes are sound.

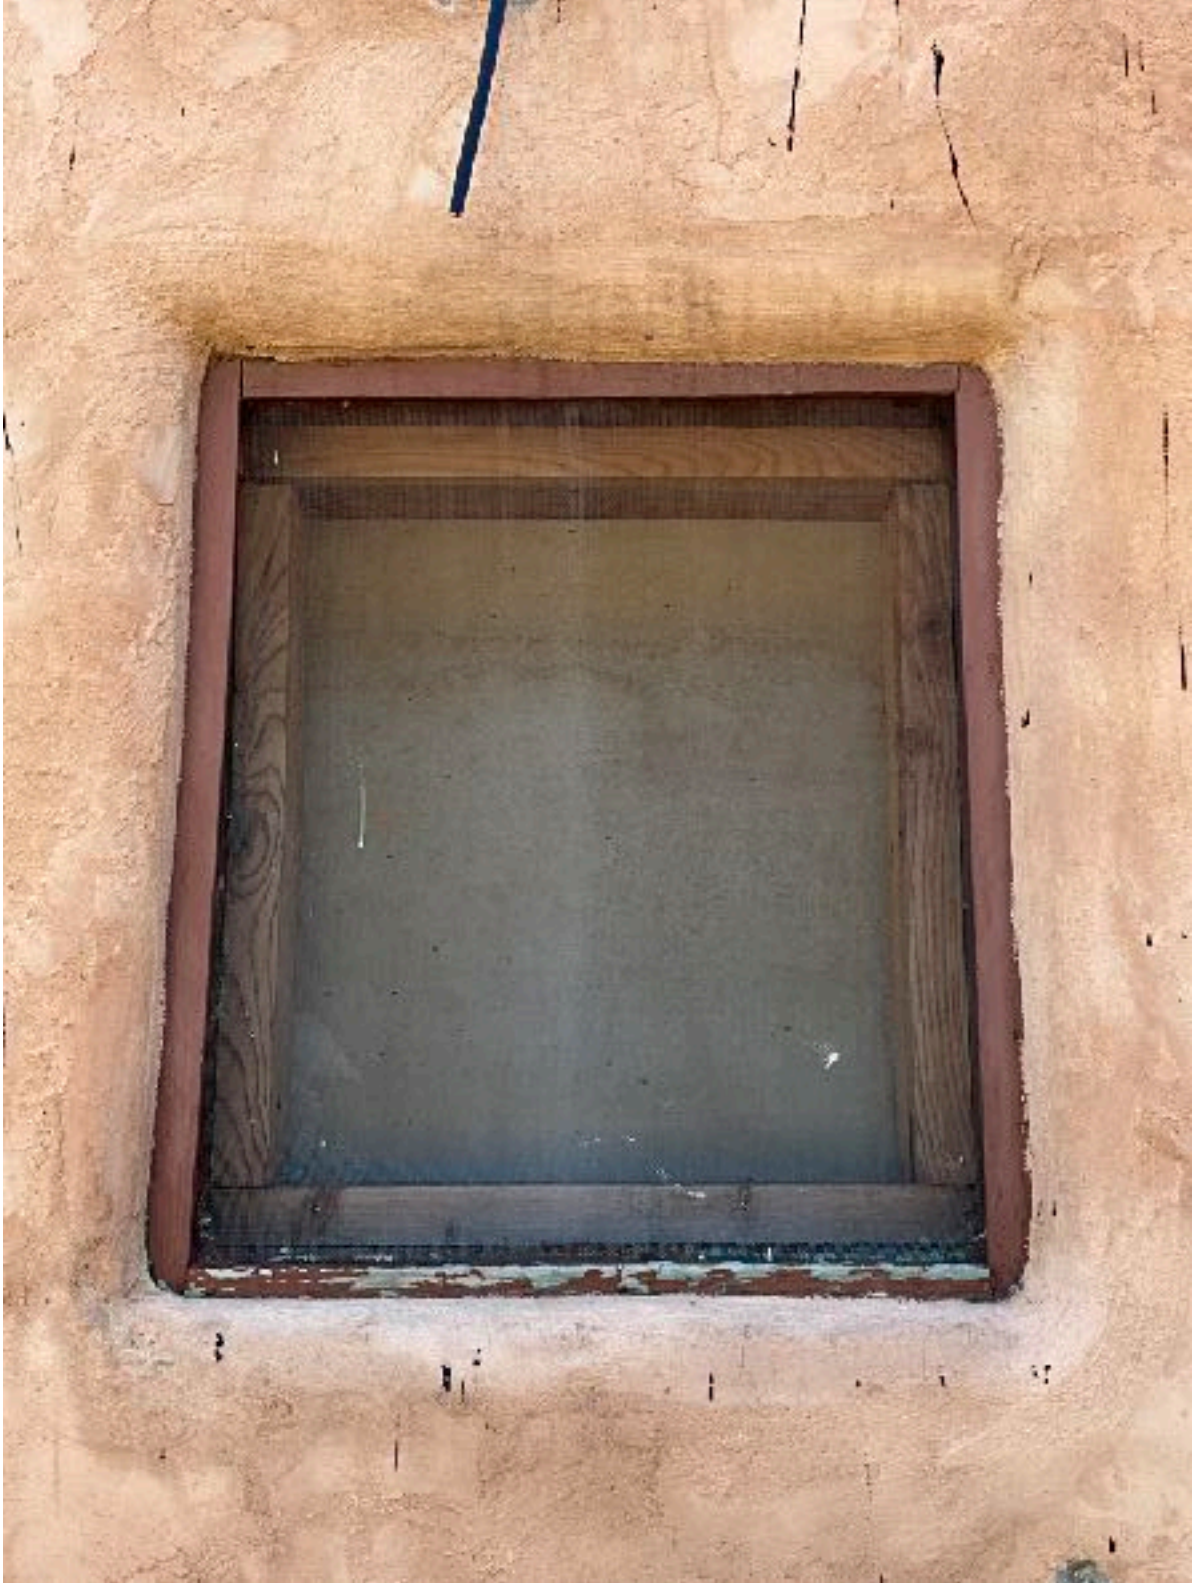
North Window #1

This window has been removed, no doubt when the back addition (that has since been torn down) was built.
