RPA & Associates LLC.

JOB	DATE
1103 Canyon Road, Santa Fe, NM 87501	05/05/2026

RPA & ASSOCIATES LLC | WINDOW & DOOR CONDITION AND INTEGRITY CODES

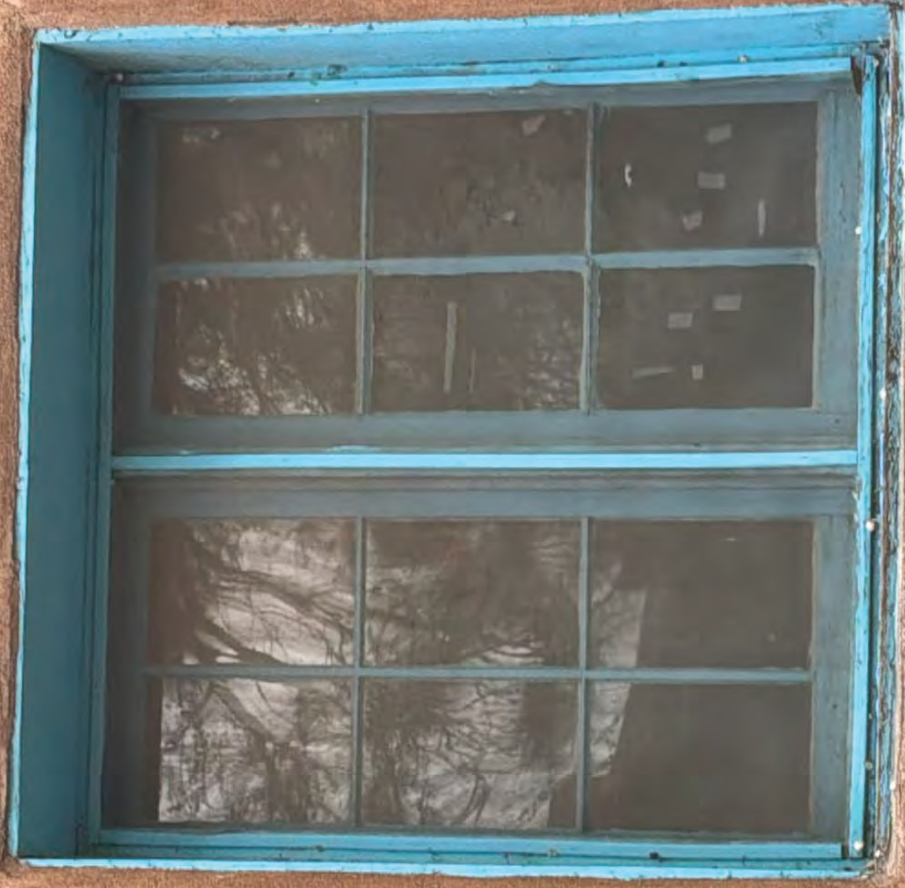
East Elevation
2nd Floor
Window A

LABEL	WINDOW & DOOR DESCRIPTION	CONDITION & INTEGRITY CODE	HISTORIC/NON-HISTORIC - AGE
<u>EAST</u>			
A	42" x 41" TWIN (2-21") LR INSWING CASEMENT ALL WOOD 2W3H/2W3H	U	NON-HISTORIC – ¾ FRAME, SASHES HAVE BEEN REPLACE WITH 1988 BARN SASHES (2001)
<u>SOUTH</u>			
B	48" x 41" TWIN (2-24") LR INSWING CASEMENT ALL WOOD 2W3H/2W3H	U	NON-HISTORIC – ¾ FRAME, SASHES HAVE BEEN REPLACE WITH 1988 BARN SASHES (2001)
<u>EAST</u>			
DR #1	32" x 73" LH INSWING DOOR ALL WOOD 1-LT OVER 1-PANEL W/T&G DIAGONAL W/3-VERTICAL SCALLOPED BARS	F	NON-HISTORIC – SHOP MADE DOOR, AIR GUN NAILS & SHAPER MADE PIECES (2001)
<u>NORTH</u>			
C	48" x 12" HOPPER ALL WOOD 5W1H STACKED ABOVE 48" x 36" FIXED 1-LT (OA 48" x 48")	F	NON-HISTORIC – ¾ FRAME, SASHES HAVE BEEN REPLACE WITH 1988 BARN SASHES (2001)
D	28" x 26" AWNING PUSH-OUT ALL WOOD 1-LT MARVIN	S	NON-HISTORIC – MARVIN MANUFACTURED (2001)
E	20" x 24" L INSWING CASEMENT ALL WOOD 2W2H	U	HISTORIC – FRAME NON-HISTORIC – SASHES HAVE BEEN REPLACED WITH 1988 BARN SASHES

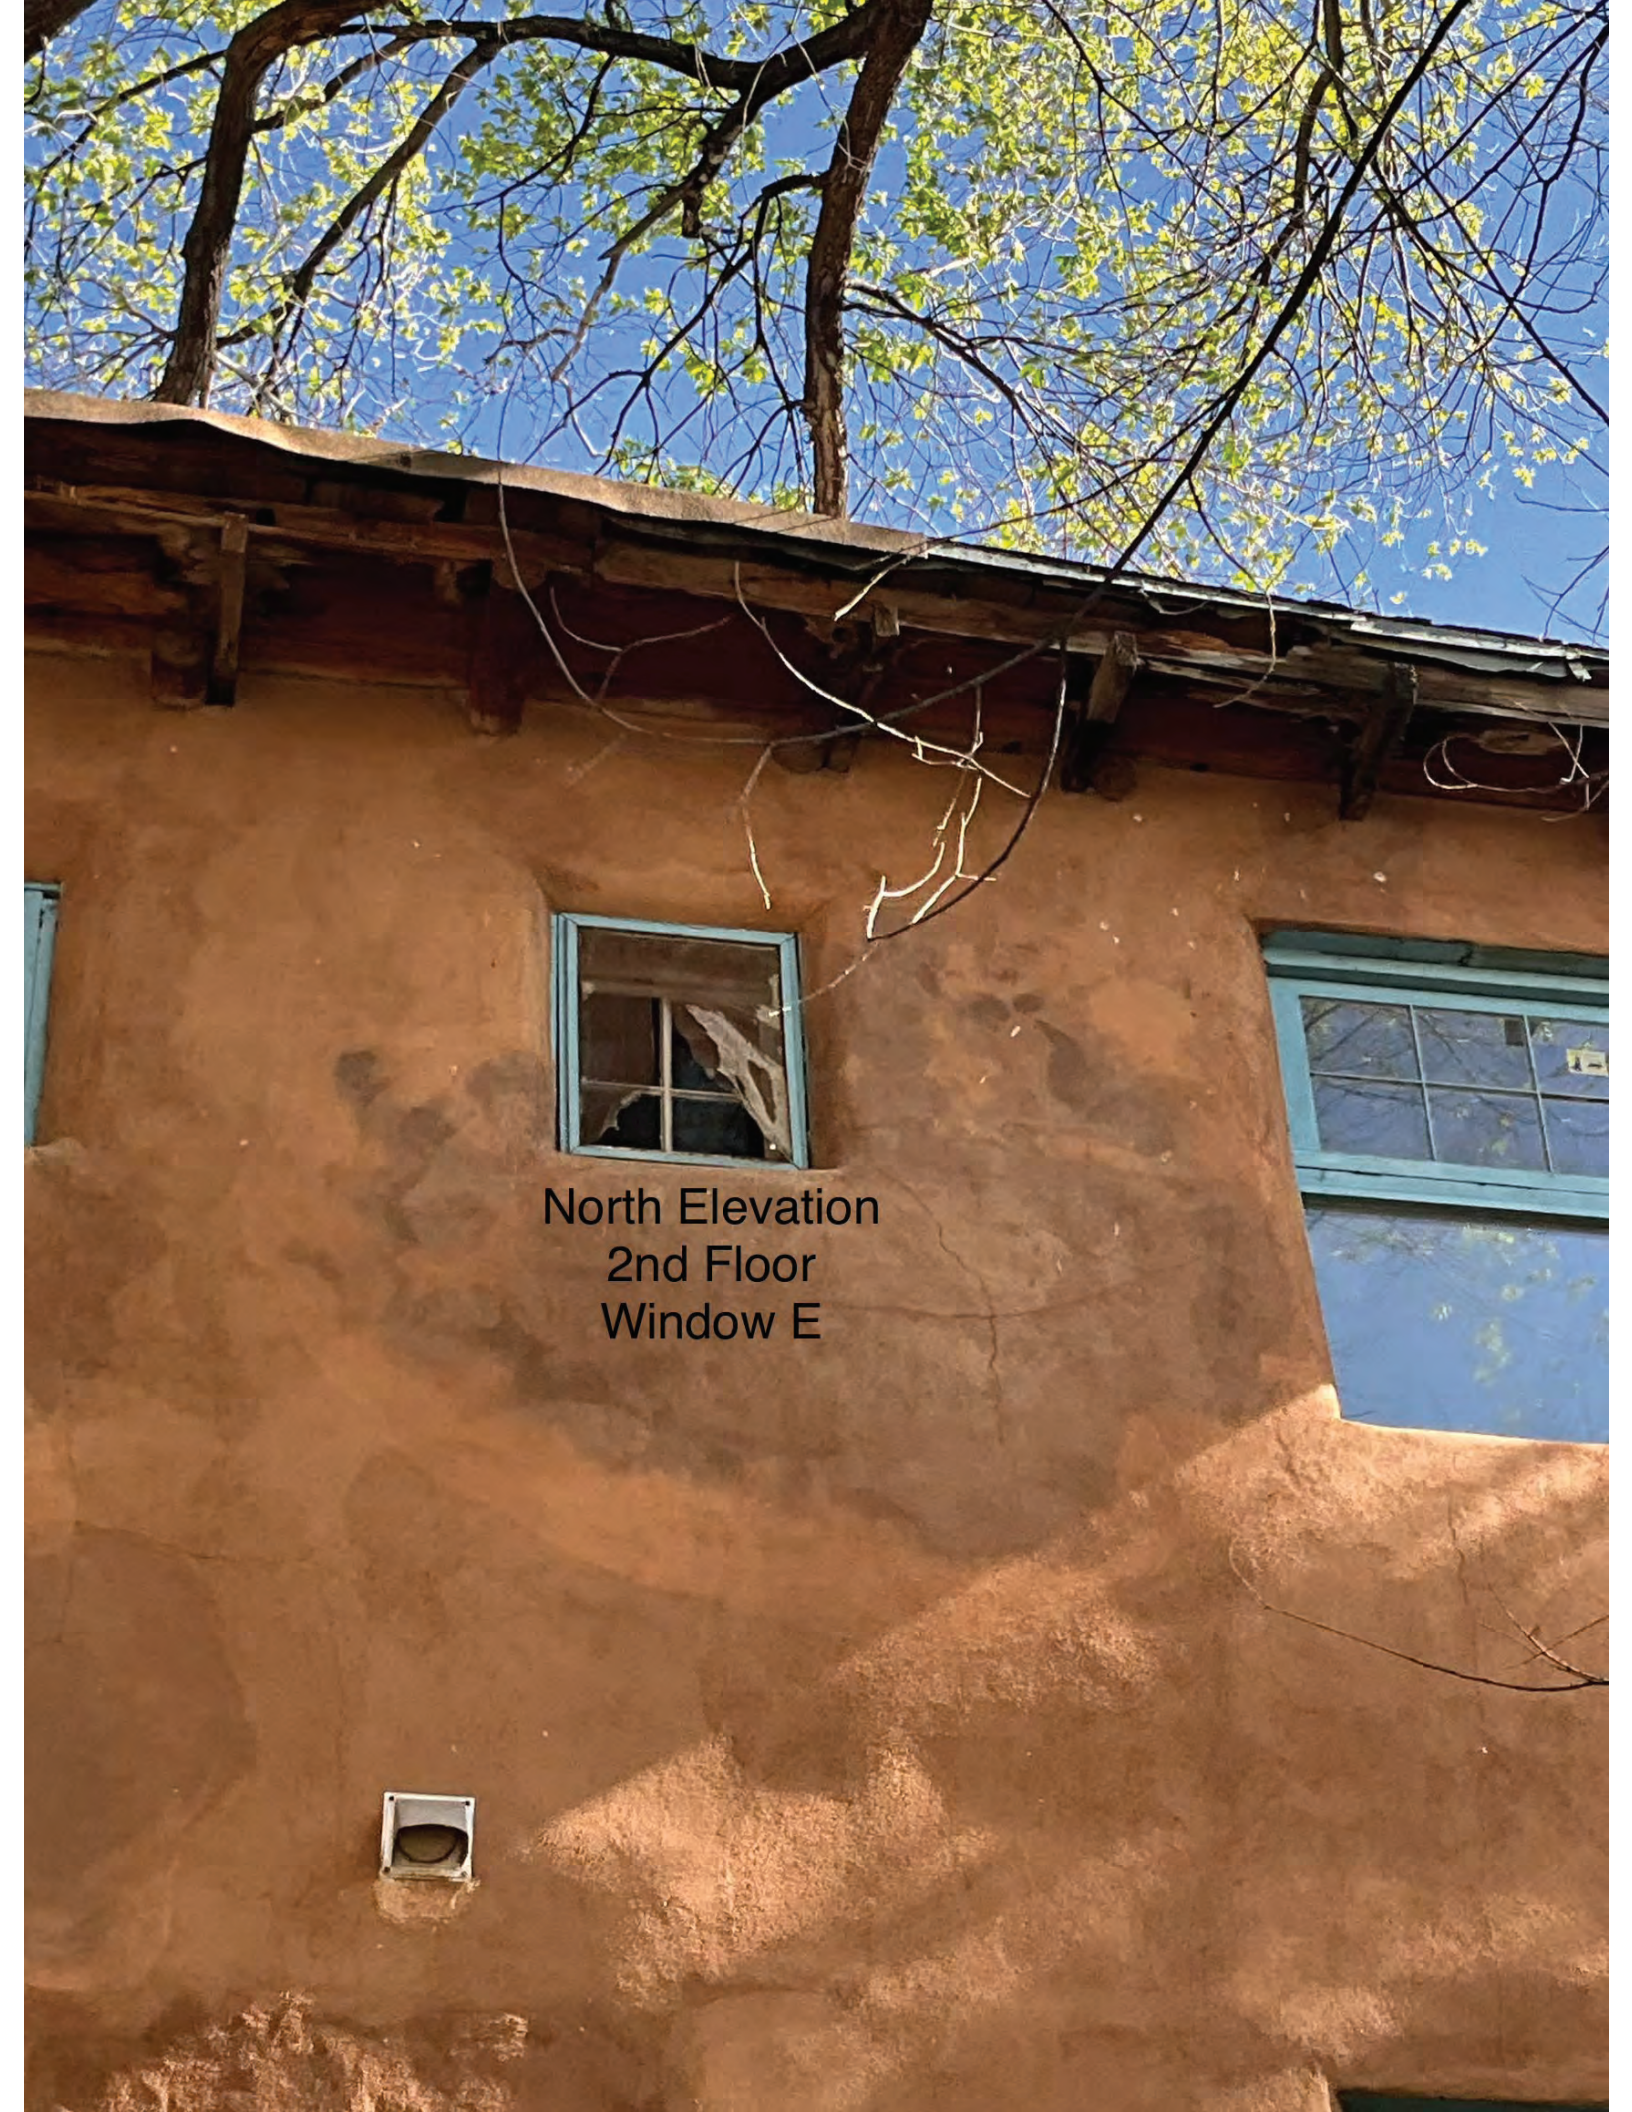
North Elevation
2nd Floor
Window E

Windows E, I, J, and K have historic jambs however the sashes are non-historic. The jambs are rotted beyond 40% and are non-restorable.

The windows and doors should be in “like and kind” to that of that era, casements with divided lites, either wood/wood or clad/wood such as Kolbe, Marvin, or Weathershield.

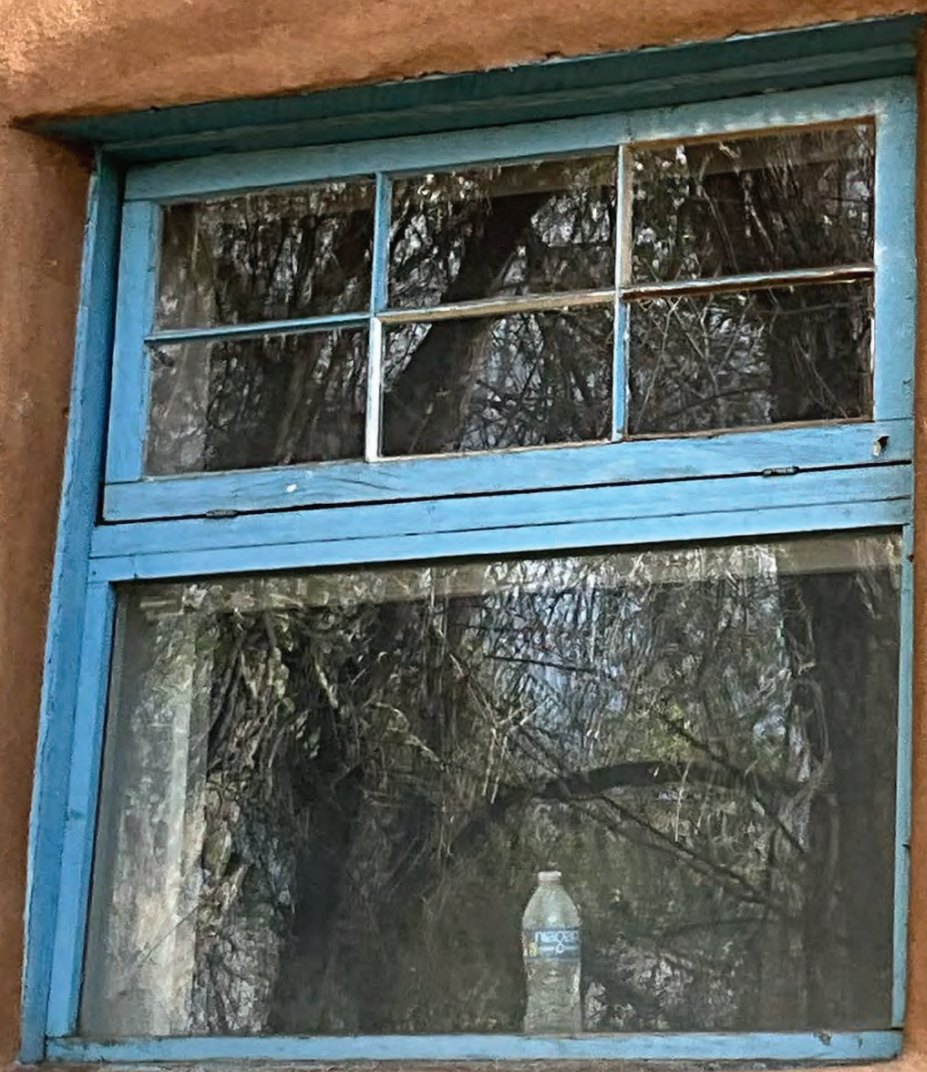
North Elevation
2nd Floor
Window F

LABEL	WINDOW & DOOR DESCRIPTION	CONDITION & INTEGRITY CODE	HISTORIC/NON-HISTORIC – AGE
<u>NORTH</u>			
F	48" x 16" HOPPER ALL WOOD 3W2H STACKED ABOVE 48" x 30" FIXED 1-LT (OA 48" x 46")	F	NON-HISTORIC – ¾ FRAME, SASHES HAVE BEEN REPLACE WITH 1988 BARN SASHES (2001)
G	48" x 16" HOPPER ALL WOOD 3W2H STACKED ABOVE 48" x 30" FIXED 1-LT (OA 48" x 46")	F	NON-HISTORIC – ¾ FRAME, SASHES HAVE BEEN REPLACE WITH 1988 BARN SASHES (2001)
<u>WEST</u>			
DR #2	32" x 77" LH INSWING ALL WOOD DOOR 12-PANEL/1-LT	F	NON-HISTORIC – AIR GUN NAILS SIMPSON DOOR (1988)
<u>SOUTH</u>			
H	47" x 21" HOPPER ALL WOOD 4W2H STACKED ABOVE 47" x 21" FIXED 1-LT (OA 47" x 42")	F	NON-HISTORIC – ¾ FRAME, SASHES HAVE BEEN REPLACE WITH 1988 BARN SASHES (2001)
I	47" x 42" – 2 LR INSWING CASEMENT ALL WOOD 2W3H/2W3H (2-23 ½")	F	HISTORIC – JAMB NON-HISTORIC – SASHES REPLACED WITH 1988 BARN SASHES
J	47" x 47" -2 LR INSWING CASEMENT ALL WOOD 2W2H/2W2H (2-23 ½")	F	HISTORIC – JAMB NON-HISTORIC – SASHES REPLACED WITH 1988 BARN SASHES

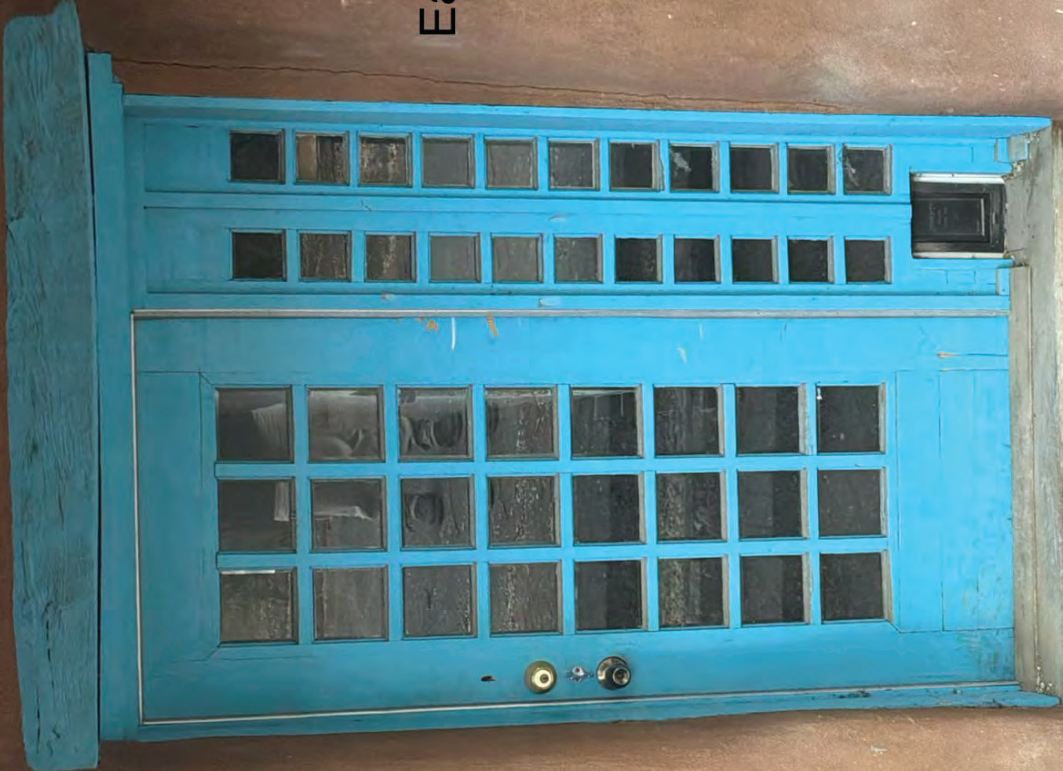
East Elevation
1st Floor
Door #3

WINDOW & DOOR DESCRIPTION		CONDITION & INTEGRITY CODE		HISTORIC/NON-HISTORIC – AGE	
<u>EAST</u>					
DR #3	46" x 73" DOOR & SIDELITE 3W8H/2W1H 32 DOOR/16" SIDELITE	F		NON-HISTORIC – WOOD BEAD DOOR, AIR GUN NAILS (2001)	
<u>SOUTH</u>					
K	84" x 42" LSSR INSWING CASEMENT 2W3H (21" – 4 WIDE)	U		HISTORIC – JAMB NON-HISTORIC – SASHES, REPLACED WITH 1988 BARN SASHES, ROTTED BEYOND 40%	
L	43" x 20" HOPPER ALL WOOD 3W2H STACKED ABOVE 43" x 25" FIXED 1-LT (43" x 45" OA)	U		NON-HISTORIC – ¾ FRAME, SASHES HAVE BEEN REPLACE WITH 1988 BARN SASHES (2001) FRAMES ROTTED BEYOND 40%	
<u>WEST</u>					
M	43" x 20" HOPPER ALL WOOD 4W2H STACKED ABOVE 43" x 25" FIXED 1-LT (OA 43" x 45")	U		NON-HISTORIC – ¾ FRAME, SASHES HAVE BEEN REPLACE WITH 1988 BARN SASHES (2001) FRAMES ROTTED BEYOND 40%	
<u>SOUTH</u>					
N	109" x 61" GLASS BLOCK 12" x 12" 9W5H	S		NON-HISTORIC – BLOCK & PATTERN IS FROM 2002	
DR #4	31" x 78" RH INSWING ALL WOOD HERRING BONE W/DIAMOND LIGHT ON TOP OF DUTCH DOOR	F		NON-HISTORIC – SHOP MADE DOOR (2000) AIR GUN NAILS & KERFED JAMB (1995)

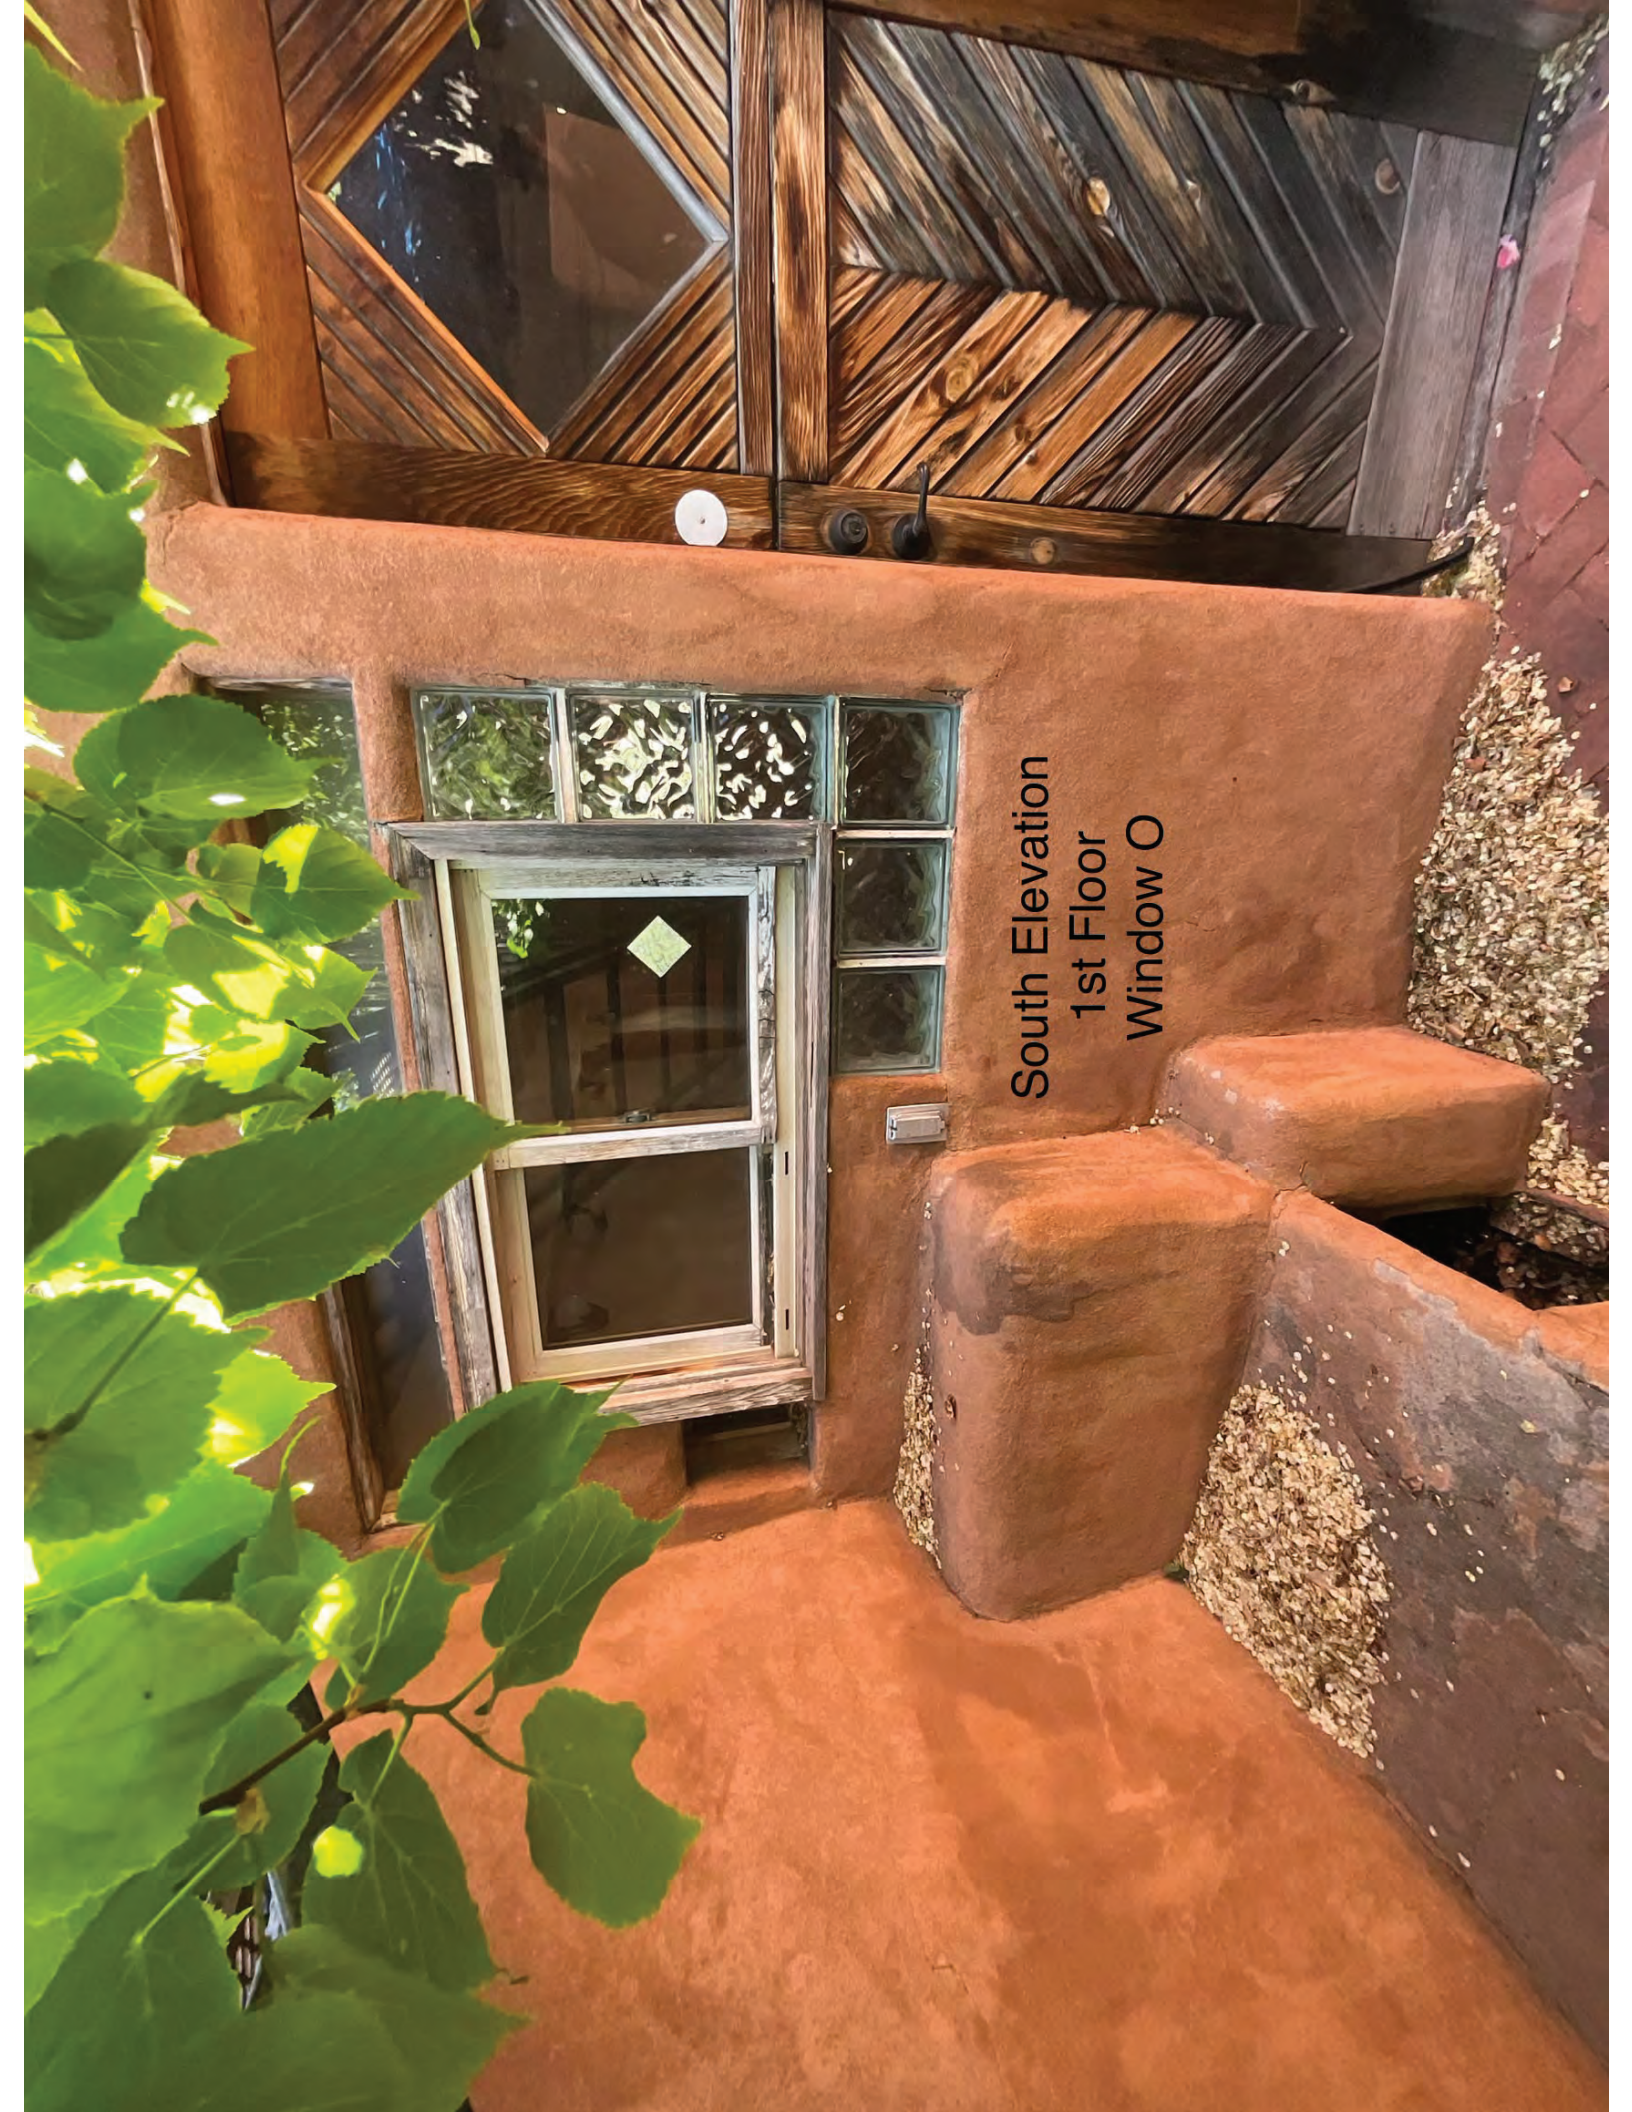
South Elevation
1st Floor
Window O

O	31" x 26" HORIZONTAL SLIDER 1-LT W/54" x 7" TRANSOM W/1-LT STOPPED IN GLASS W/6 PIECE GLASS BLOCK 8" x 8"	U		NON-HISTORIC – MARVIN (1995) WITH VINYL TRACKS ROTTED BEYOND 40%

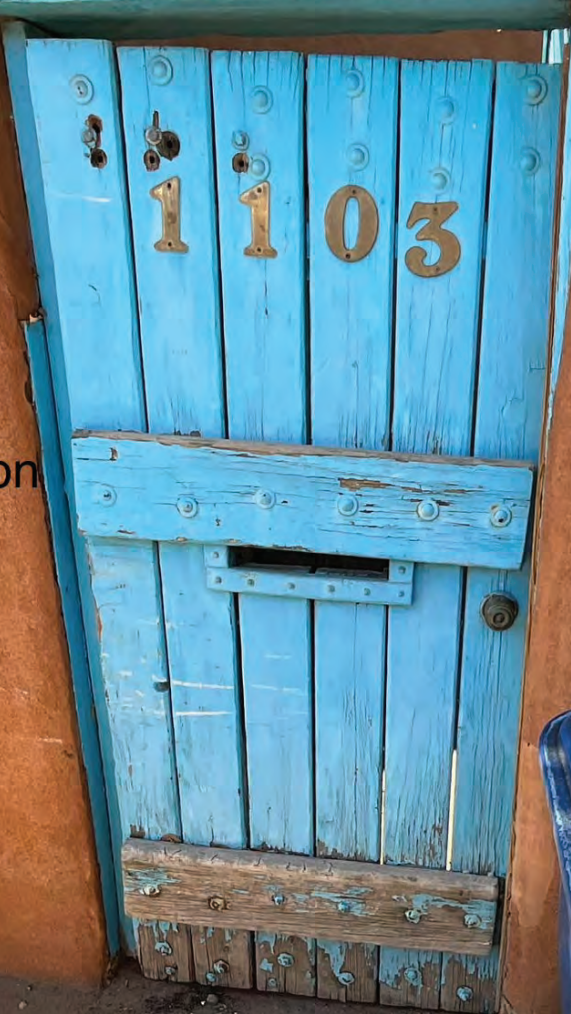
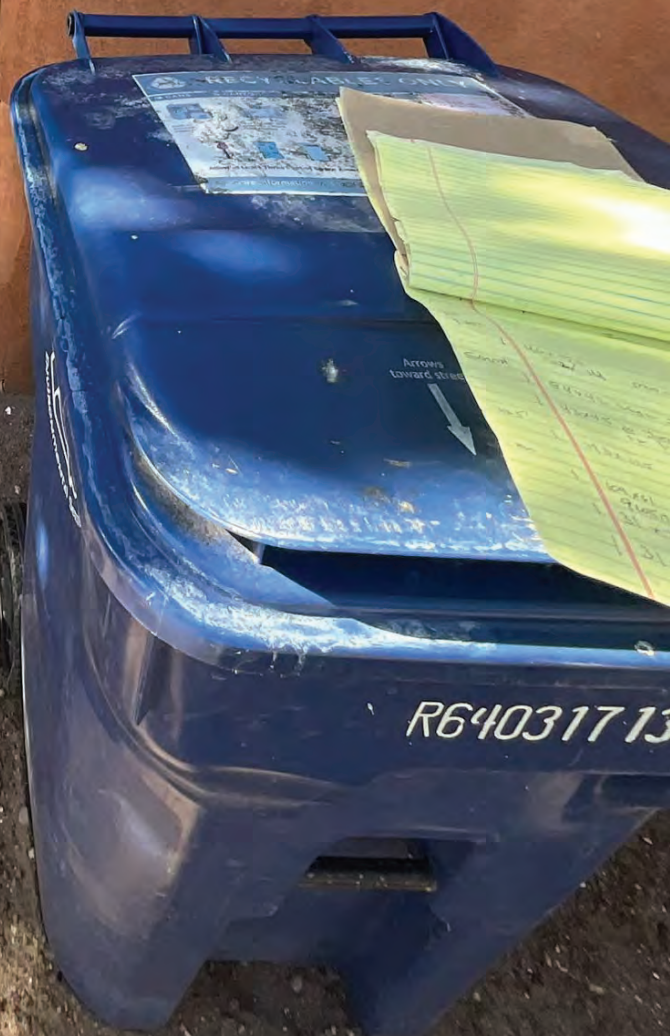
South Elevation
Door #6
Gate

DR #6	28" x 72" LH INSWING GATE ARCH TOP ALL WOOD	F	NON-HISTORIC – DIMENSIONAL LUMBER (1988)
DR #7	9' x 7' ALL METAL EMBOSSED TEXTURED PANELS OVERHEAD ROLL UP DOOR	F	NON-HISTORIC – TAYLOR MANUFACTURED HINGES (1999)
DR #8	32" x 72" LH GATE ALL WOOD 2' x 6' CROSS RAILS & BOLTS	F	NON-HISTORIC – DIMENSIONAL LUMBER (2000) PHILLIPS HEAD SCREWS, AIR GUN NAILS
