# Historic Cultural Properties Inventory (HCPI) Base Form (FORM 1)

For HPD Office use only:		
HCPI No.	District No.	Criteria <u>  </u> A <u>  </u> B <u>  </u> C <u>  </u> D
<b>1. Name of property:</b>  Atanacio and Feliciano Vigil Property Arturo Vigil House	<b>2. Location:</b>  925 Acequia Madre Street Downtown and Eastside Historic District – Santa Fe	<b>3. Local Reference Number:</b> Santa Fe ID: Old # 051611486  <b>4. County:</b> Santa Fe Parcel # 12919936
<b>5. Property Type:</b> <input checked="" type="checkbox"/> Buildings: house <input checked="" type="checkbox"/> Structures: walls <input type="checkbox"/> Site <input type="checkbox"/> Object		
<b>6. Date of Survey:</b> November 25, 2024		
<b>7. Previous Survey Date(s):</b> <input checked="" type="checkbox"/> Yes: November 14, 1984, Michael Belshaw; June 27, 2003, Giovana Buckley <input type="checkbox"/> No:		
<b>8. Name of Project:</b> HDRB Status Evaluation		
<b>9. Lat/Long:</b> 35.6791526,-105.92438

# Historic Cultural Properties Inventory (HCPI) Detail Form (FORM 2)

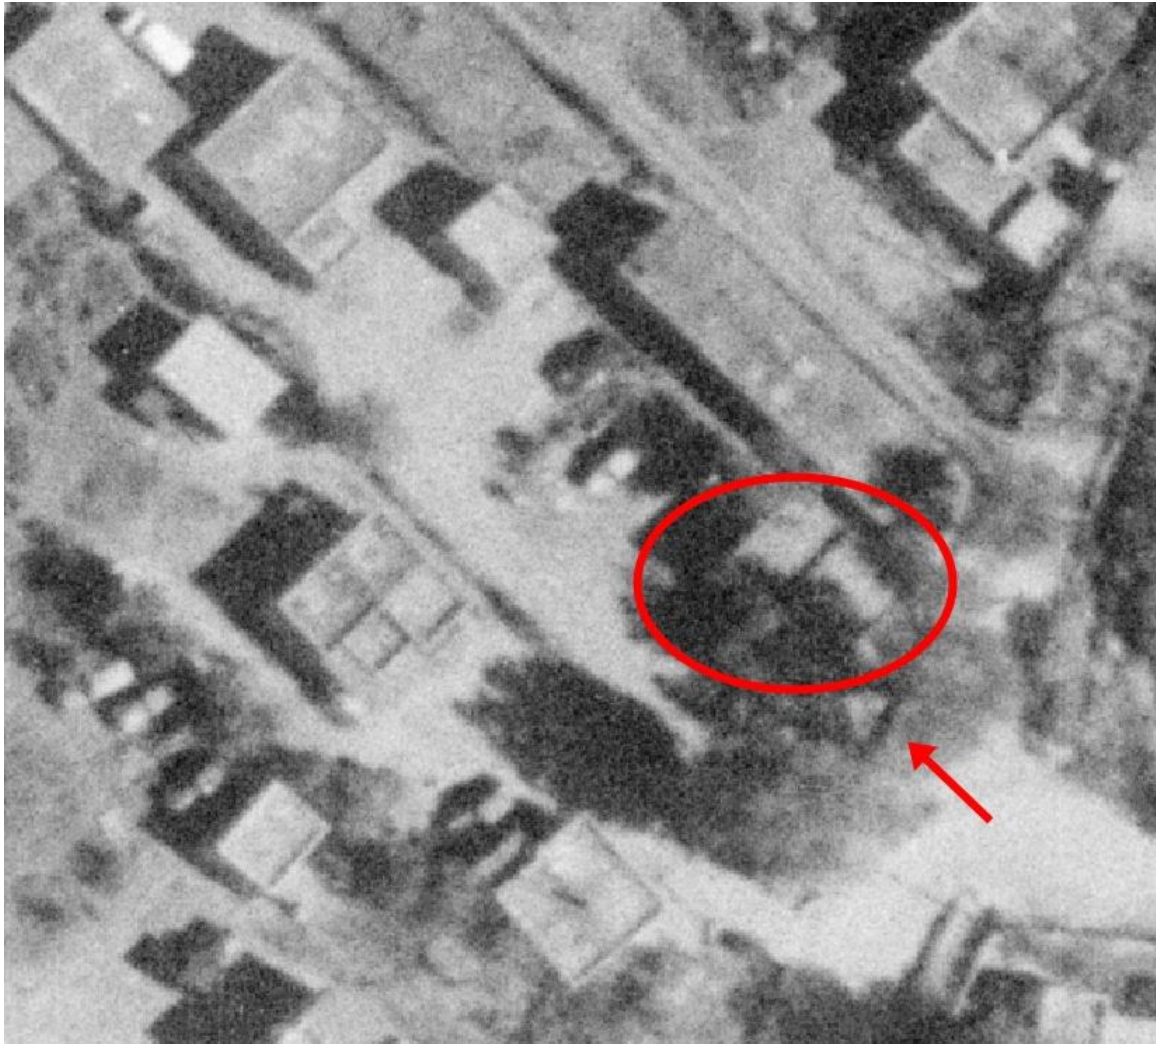
An aerial image from 1958 indicates that the house had achieved its multi-plane roof, indicating it received an addition across its north elevation by this time (Fig. 3). Arturo continued to live at the home throughout the 1970s.

**Figure 3: November 10, 1958, aerial photograph.**  
**Note presence of lower north addition and street wall, indicated by an arrow.**

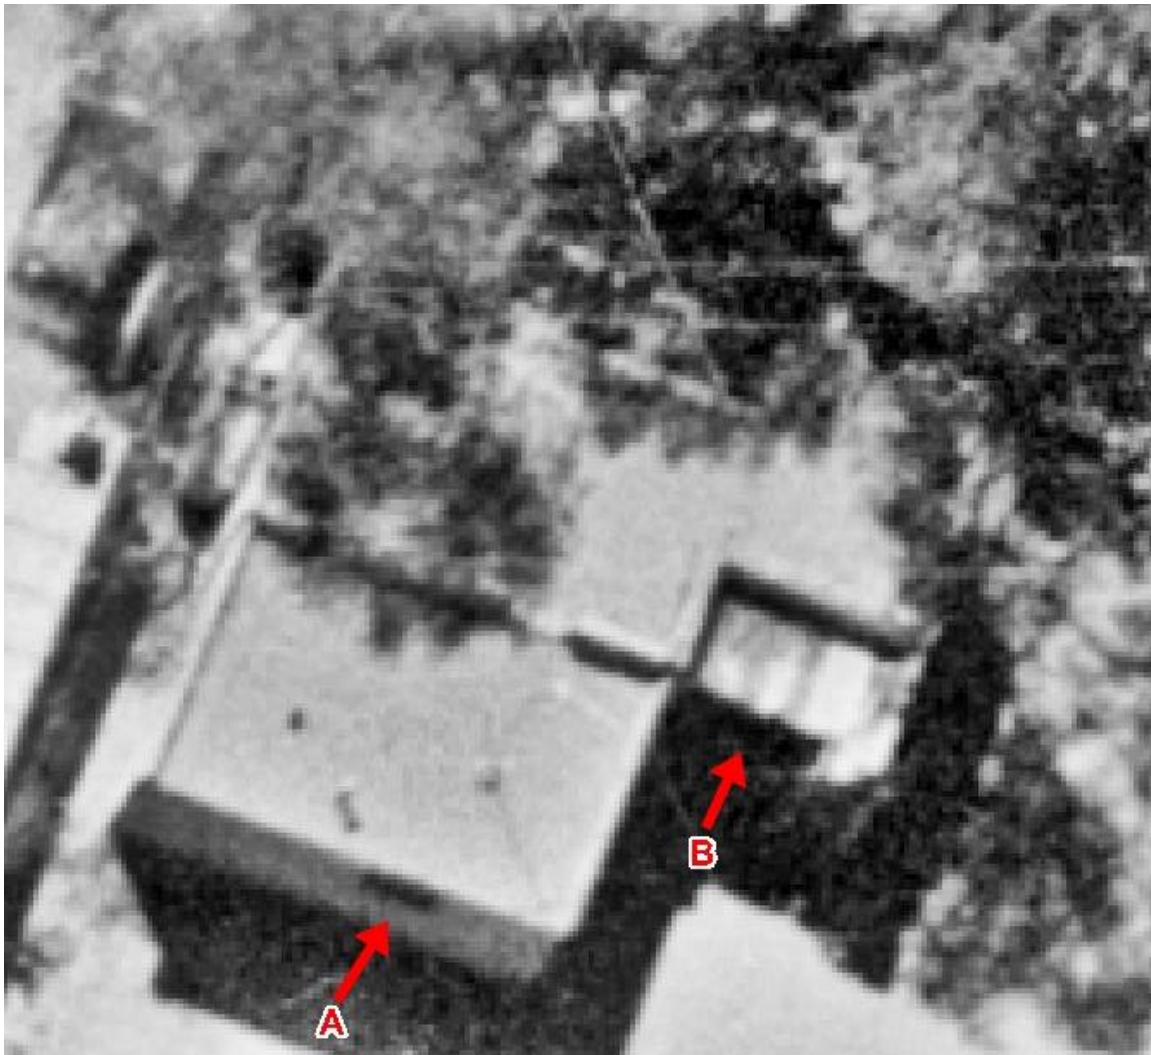
**Figure 5: September 11, 1978, aerial photograph, direction reversed. Note opening closer to west edge of building (A) and what appears to be an open porch (B).**

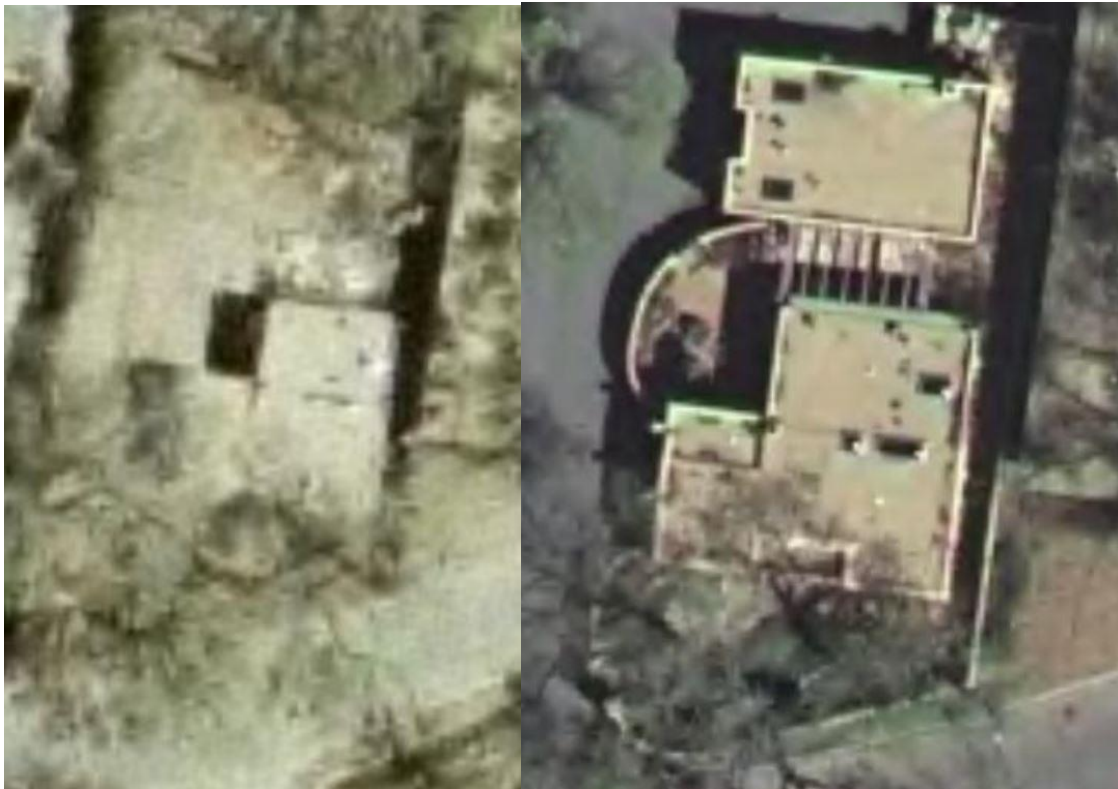
**Figure 7: 2001 (left) and 2005 (right) aerial photographs. Note the introduction of curved privacy walls in the 2005 image.**

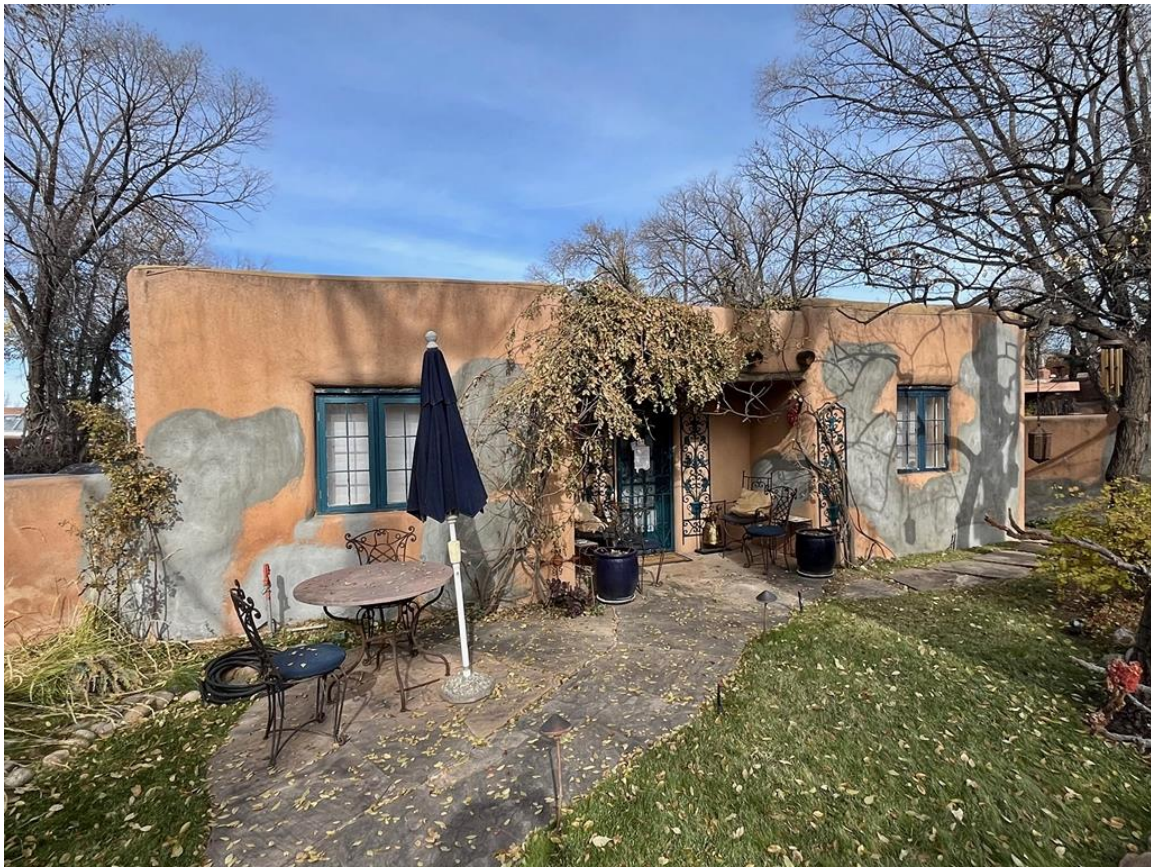
The façade is characterized by strict symmetry, presenting a rough approximation of a centered recessed portal design (Photo 2). This scheme was explored in the 1920s following the New-Old Santa Fe Style competition. Unlike most buildings from that era, this house shows more of the Pueblo Revival style.

**Photo 2: South (front) elevation. Camera facing northeast.**

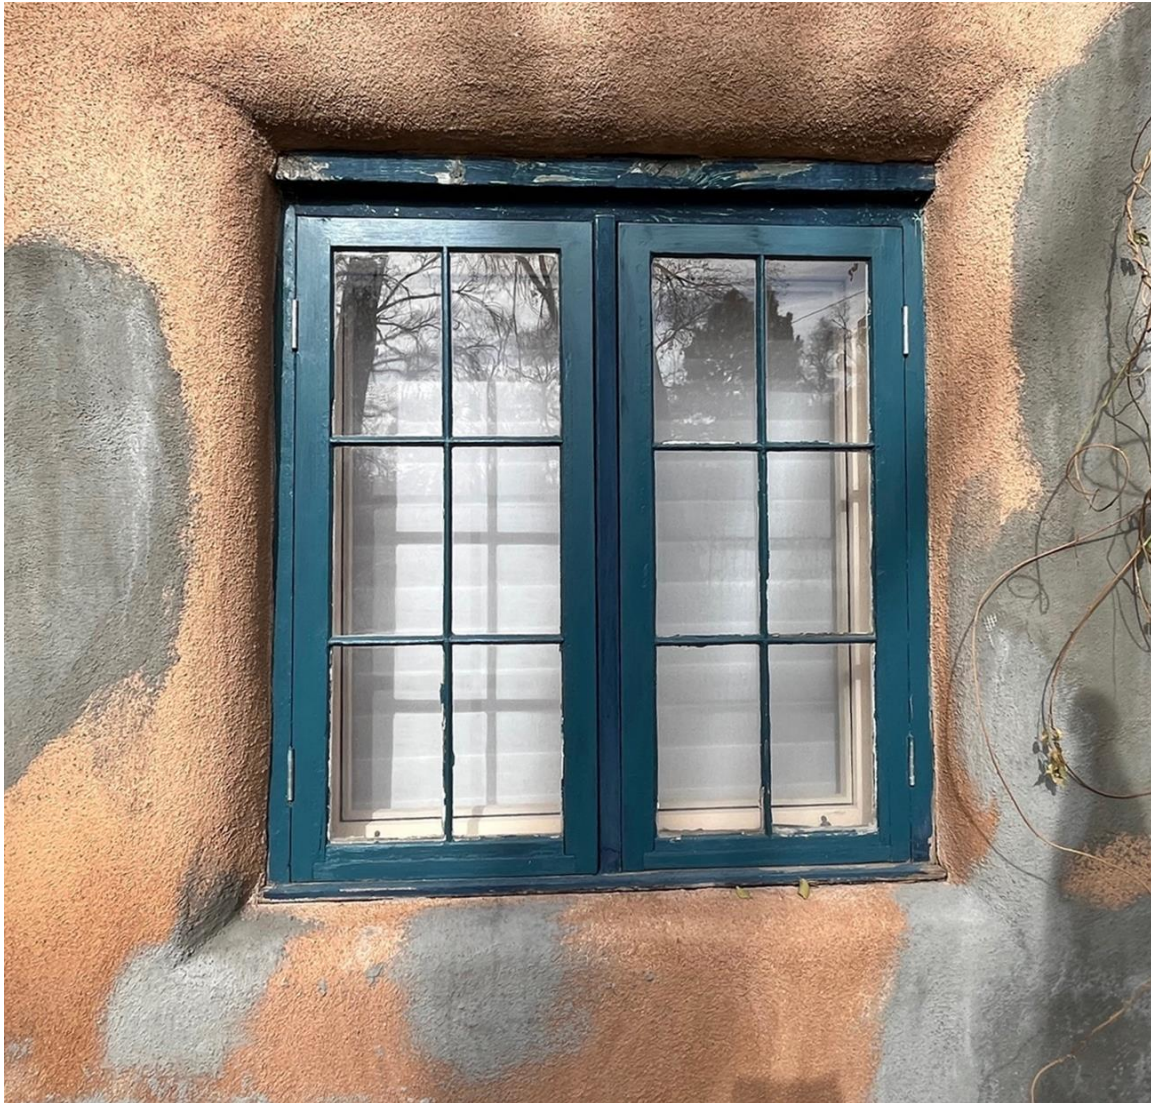
The two openings, each measuring approximately 40”x 45”<sup>1</sup>, contain six light wood casement windows (Photo 3). These windows, with their construction details and geared “crank-out” operation, are replacements. They are situated about 5” back from the wall within bull-nosed openings.

**Photo 3: South (front) elevation. West window. Camera facing north.**

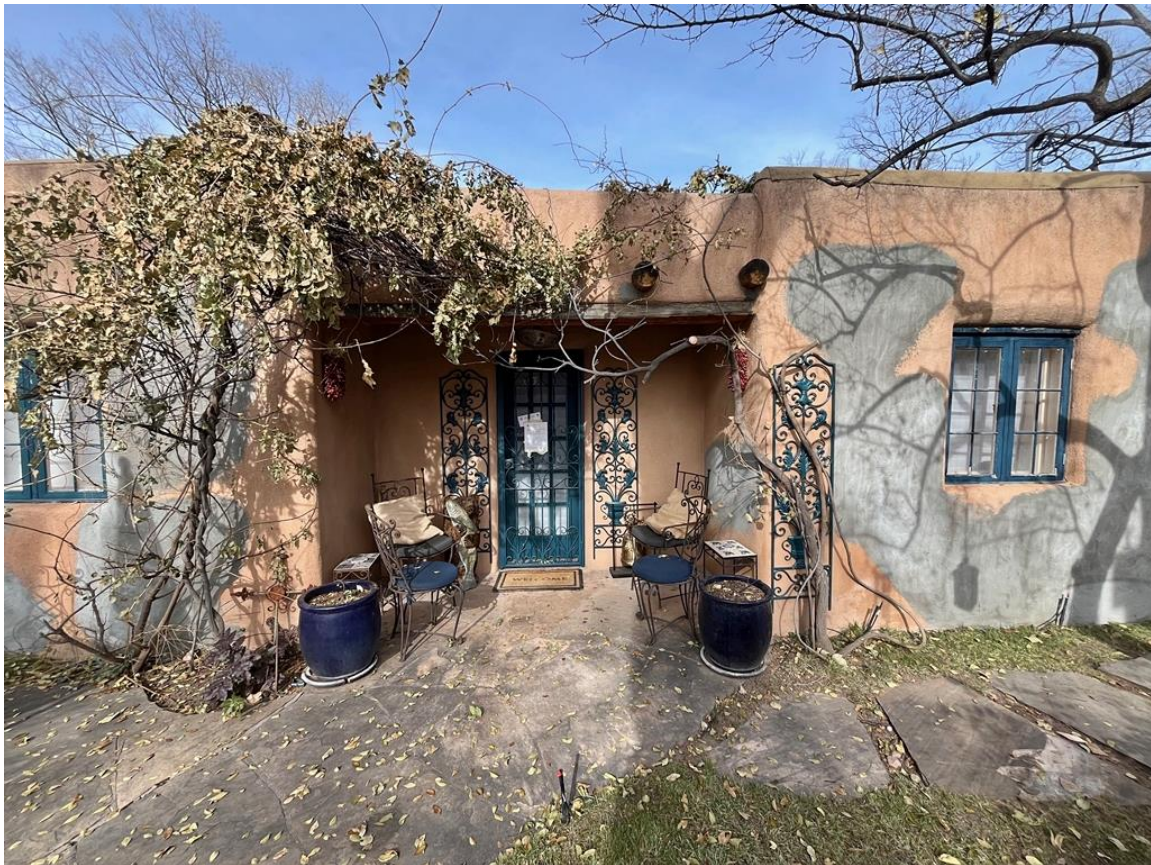
At the center of the façade is the recessed porch, which features a 400-square-foot void and a non-historic entry door (Photo 4). Although the decking has been replaced, the beam appears to be historic (Photo 5).

**Photo 4: South (front) elevation. Recessed portal. Camera facing north.**

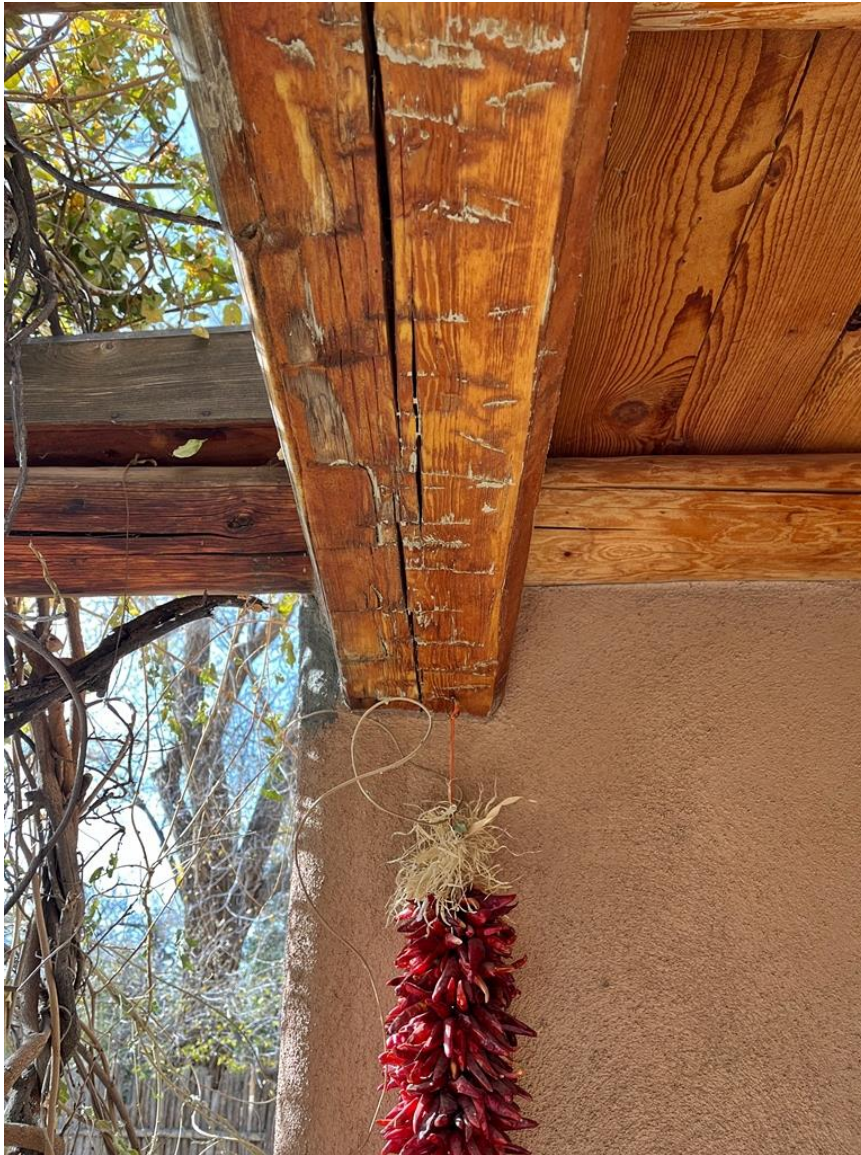
**Photo 5: South (front) elevation. Recessed portal decking and beam. Camera facing up.**

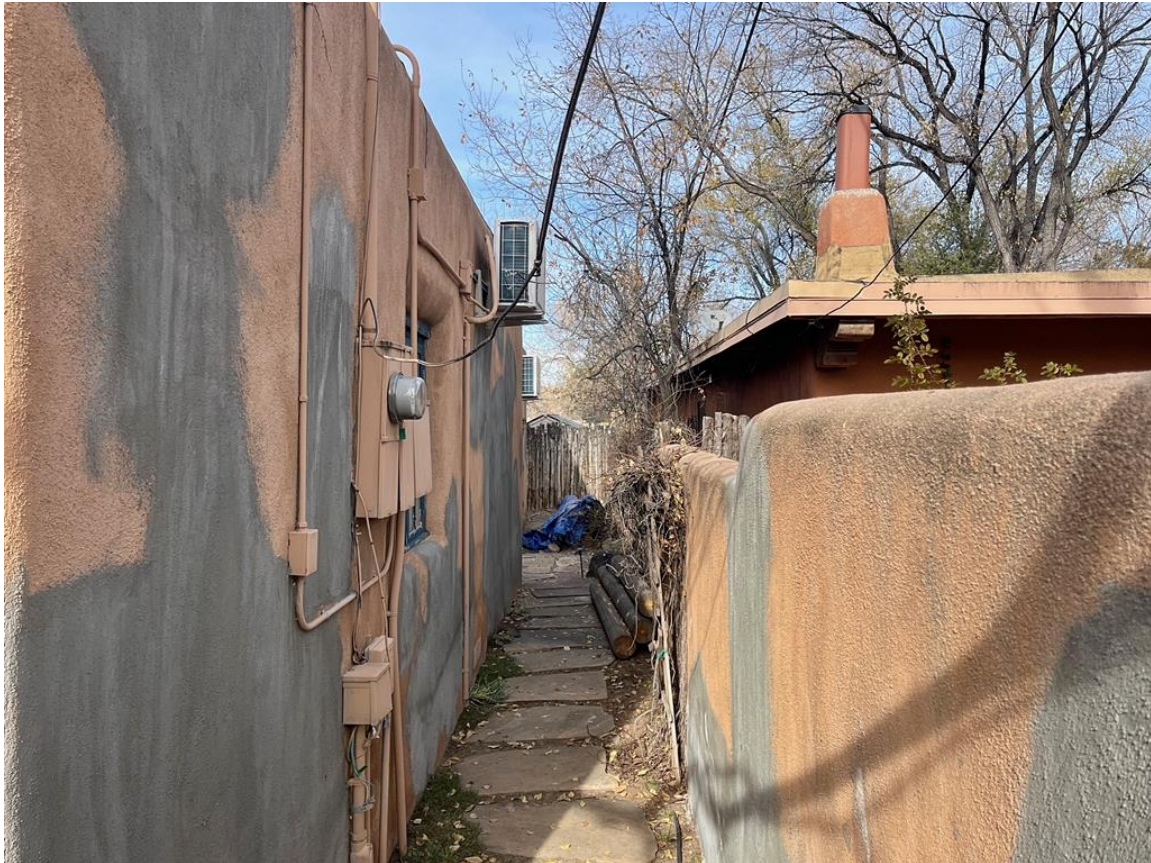
The east elevation sits close to the neighboring property (Photo 6). It is plain, holding the home’s utilities, and has only one opening. Like the front of the house, it is fitted with a pair of six-light casement windows (Photo 7). These, too, are not original. At about 16’ from the facade, the original house ends. North of this point (beginning with a 2” offset), is a lower volume erected before 1958 (Photo 8).

**Photo 6: East elevation oblique. Camera facing north.**

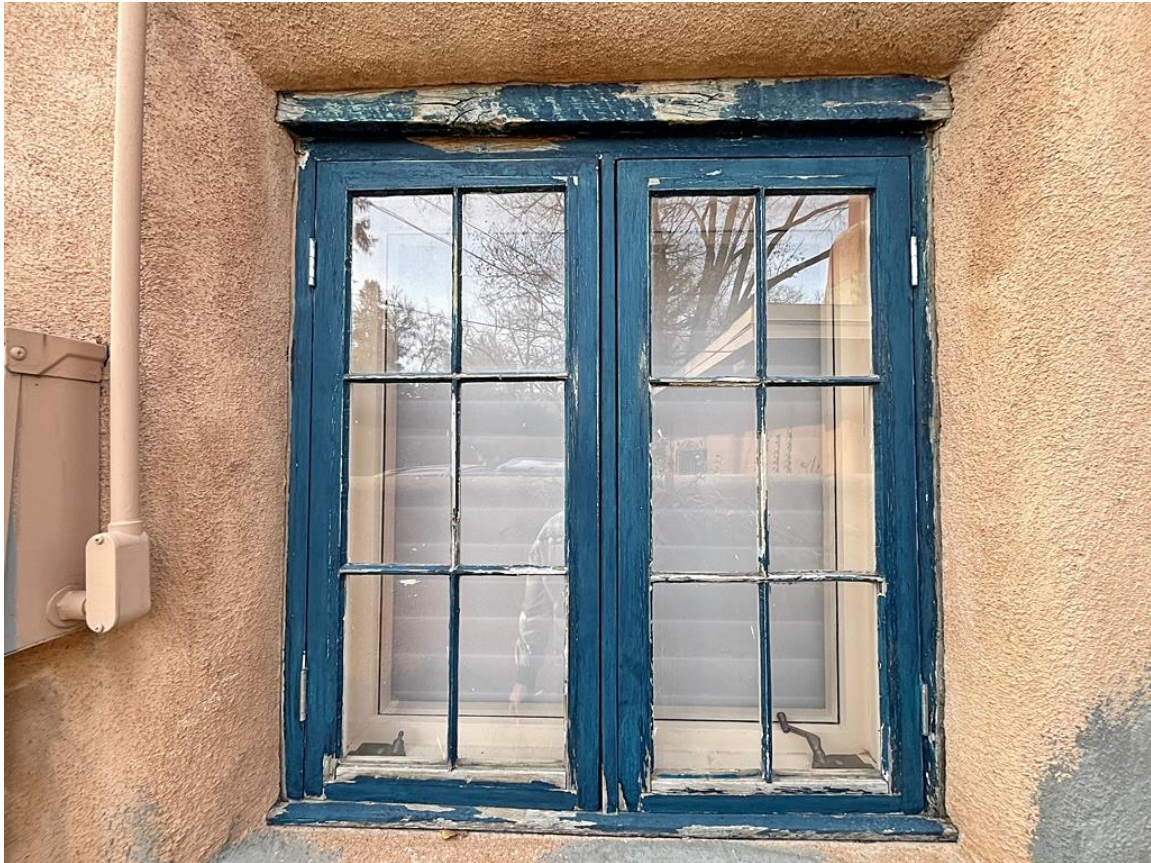
**Photo 7: East elevation. Window. Note geared crank-out hardware. Camera facing west.**

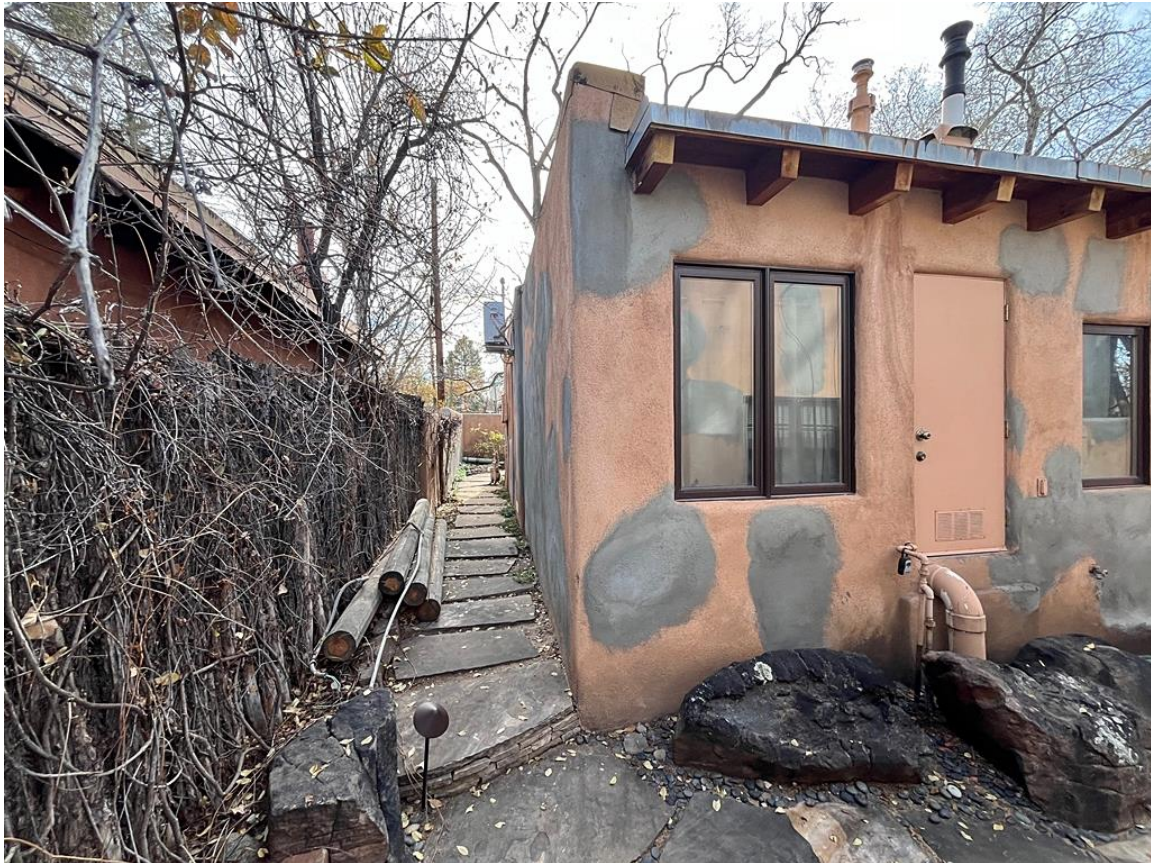
**Photo 8: North elevation. Northeast corner. Camera facing southwest.**

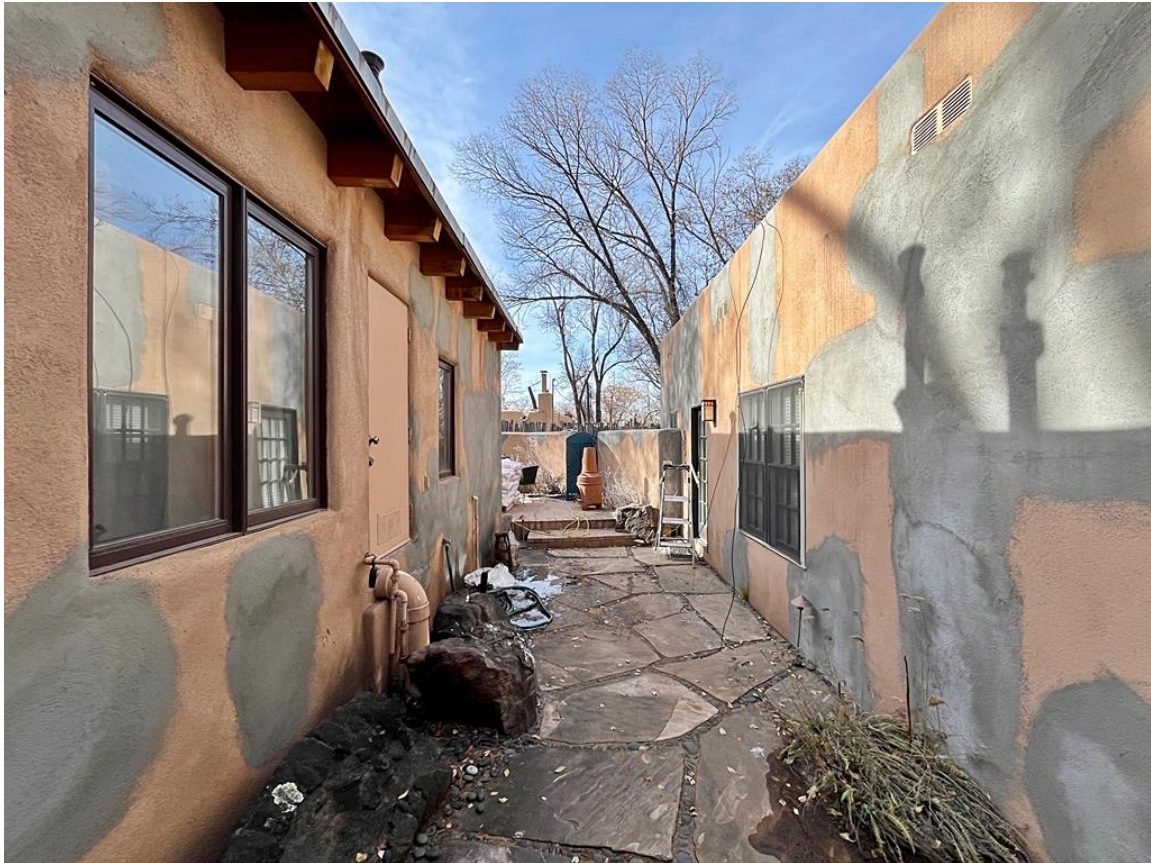
Facing the guesthouse, the north side of the home reveals modifications (Photo 9). These begin with tall single-light clad casement windows bookending a mechanical room door (Photo 10). Cresting the façade is an overhang of recent construction. Up until recently, a roofed structure, creating shelter, connected the house to the guesthouse (Field 16).

**Photo 9: North elevation oblique. 2003 guesthouse at right. Camera facing west.**

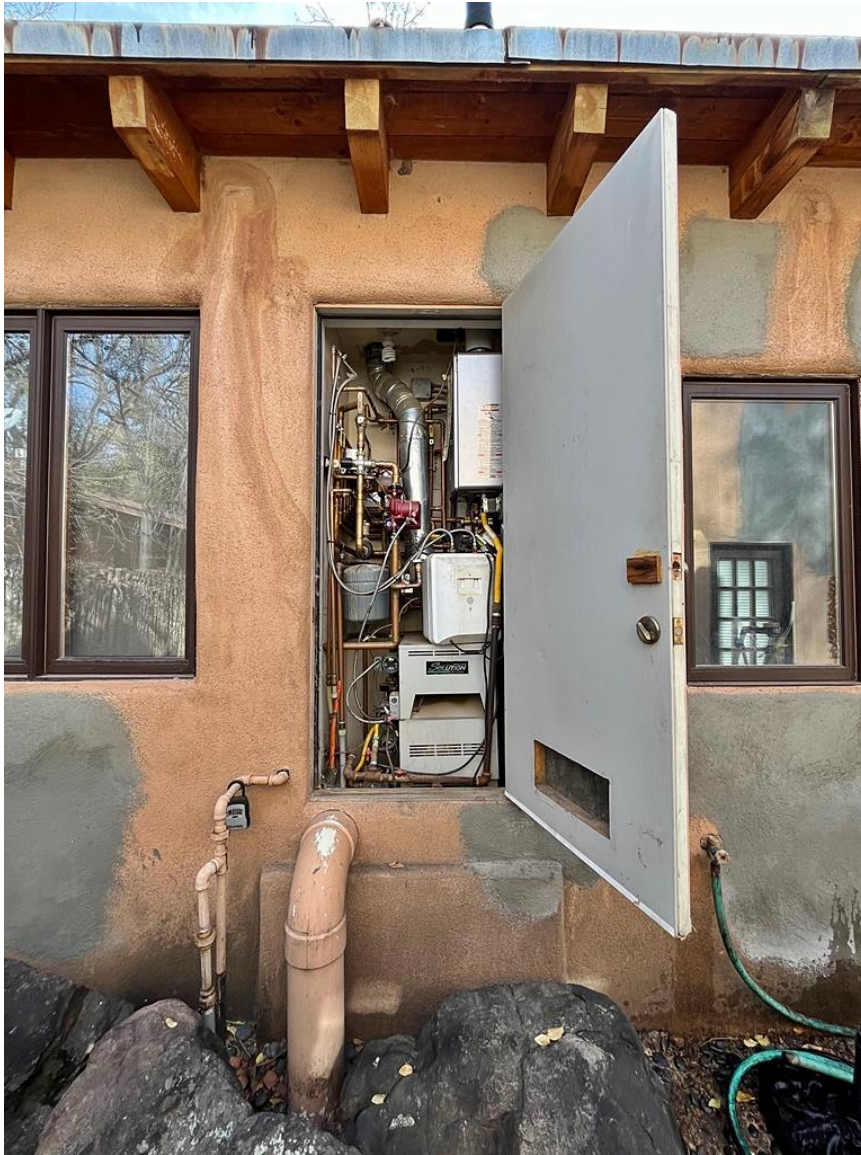
**Photo 10: North elevation. Mechanical room entry. Camera facing south.**

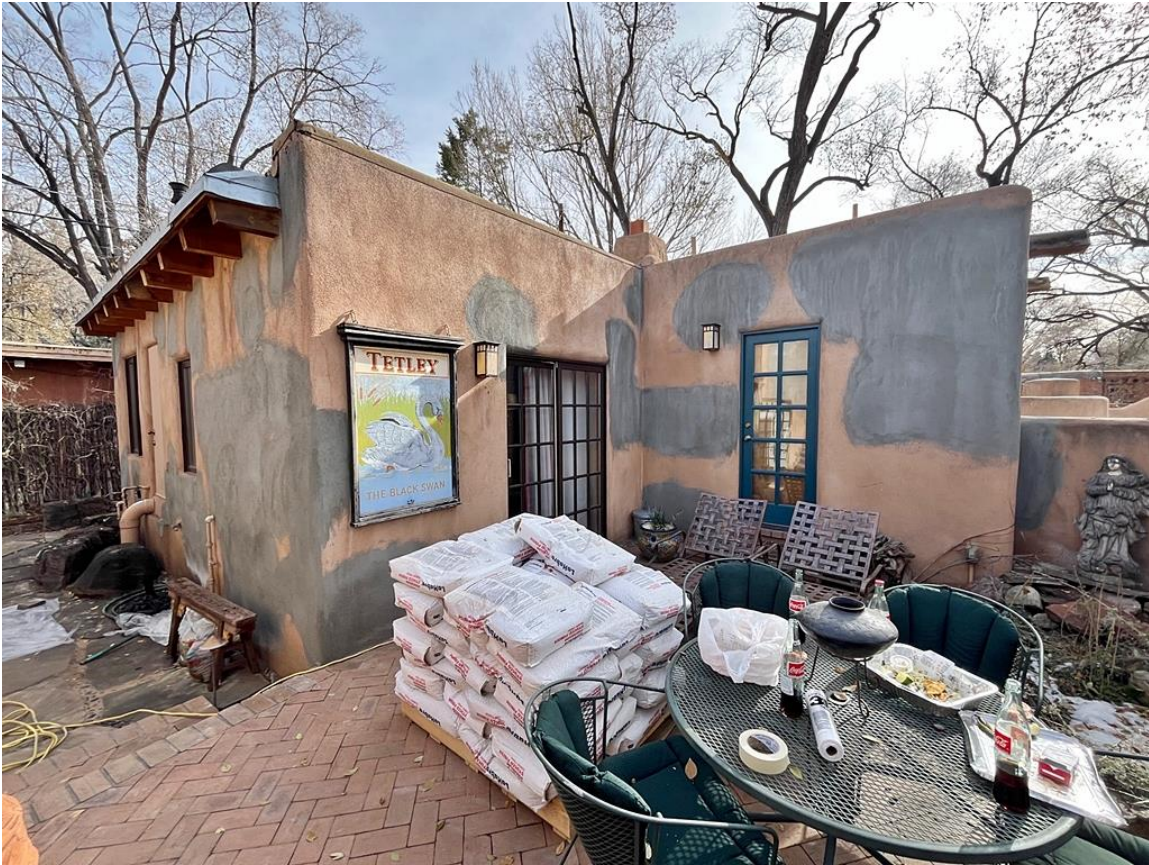
An intimate brick-lined courtyard defines the building’s northwest corner (Photo 11). This feature was likely introduced in the early 2000s (Fig. 7). Double-glazed doors from the kitchen give access to the porch. Judging by their location and design they are probably not original fenestration. The remainder of the west façade, representing the original core of the house, is a solid wall (Photo12).

**Photo 11: Northwest (patio) elevation. Camera facing southeast.**

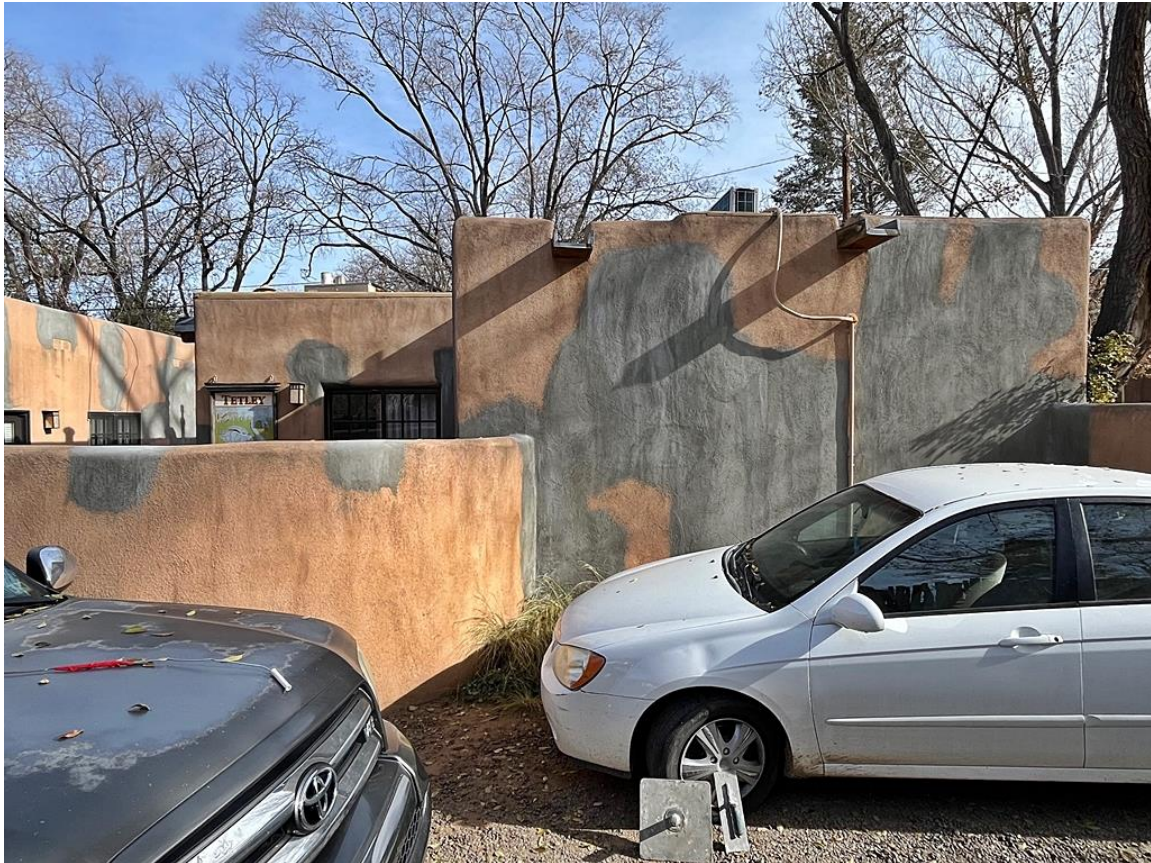
Two sets of curved privacy walls are found on the west side of the house (Photos 12 & 13). The thick walls, which rise 60” and 65½” above the outside grade, were erected around the time of the guesthouse project.

**Photo 12: West elevation. Camera facing east.**  
**Note curved wall was constructed in c.2002.**

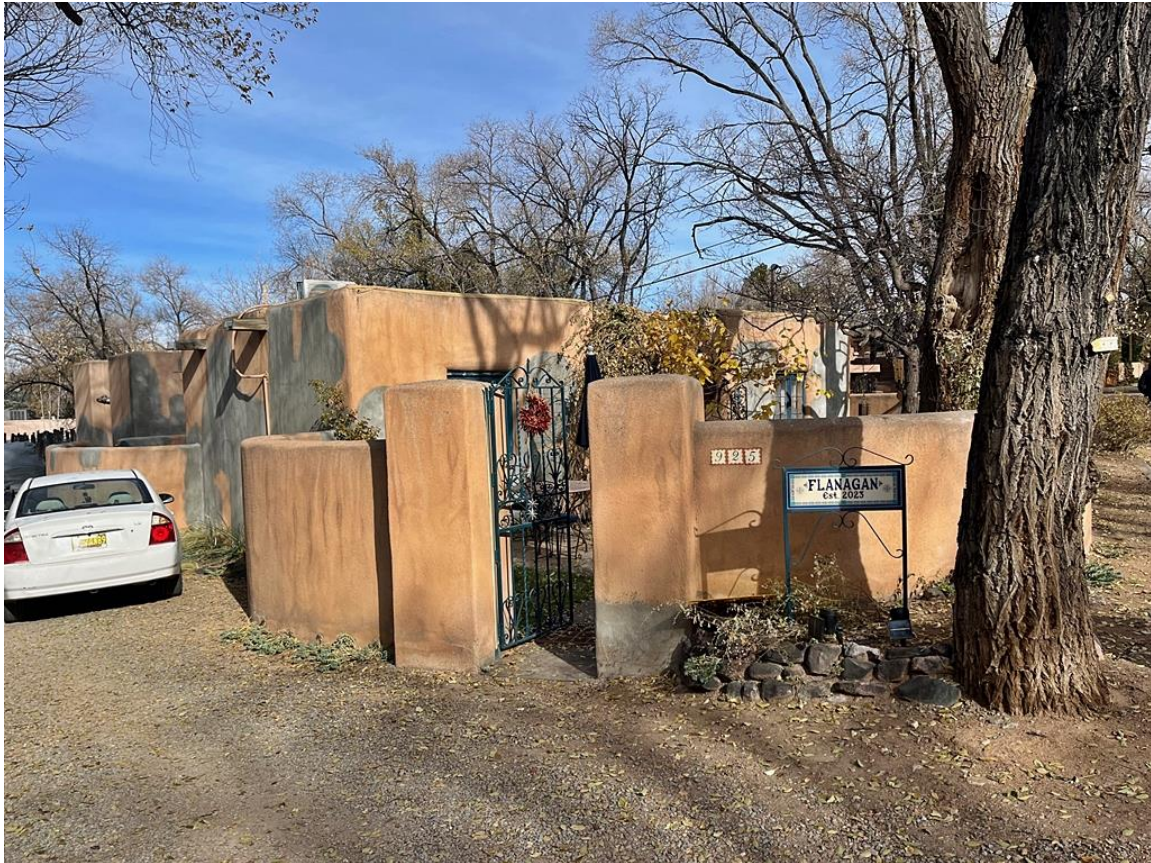
**Photo 13: Entry gate and curved wall. Camera facing northeast. Note gate and wall were erected in c.2002.**
