PROJECT 2024-009369-HDRB, 345 Garcia St., Downtown & Eastside Historic District, Contributing,
DESC: Gayla Bechtol, agent for Robert Holleyman and Bill Keller, owners, requests downgrade of historic status from Contributing to Non-Contributing for a residential structure and an accessory structure and a status review for a street frontage yard wall.

CASE NUMBER: 2024-009369--HDRB

PROJECT TYPE: Historic Status Review

DATE: November 26, 2024
TO: Historic Districts Review Board Members
FROM: Lani McCulley, Senior Planner, Historic Preservation Division

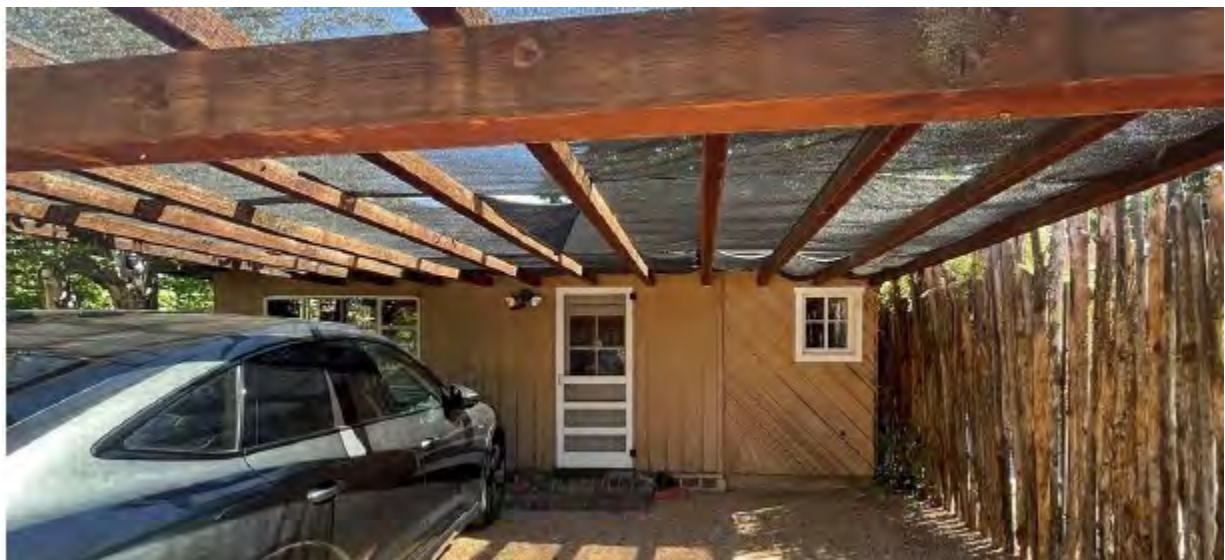
The accessory structure in the southeast corner of the property currently serves as a guesthouse. The front portion appears to have started out as a shed as it has a mixture of board sidings. The remaining portion appears to be an enclosed carport according to the HCPI. A wood structure attaches to the building on the west to create a partial carport. The accessory structure was erected after 1958 and does not match the style of the home. Staff did note when visiting the site that the rear or eastern wall was partially built of particle board. This structure is not mentioned on the 1985 HCPI for the property so the reason for its' contributing status is unclear.

Figure 2: Guesthouse: west elevation under carport

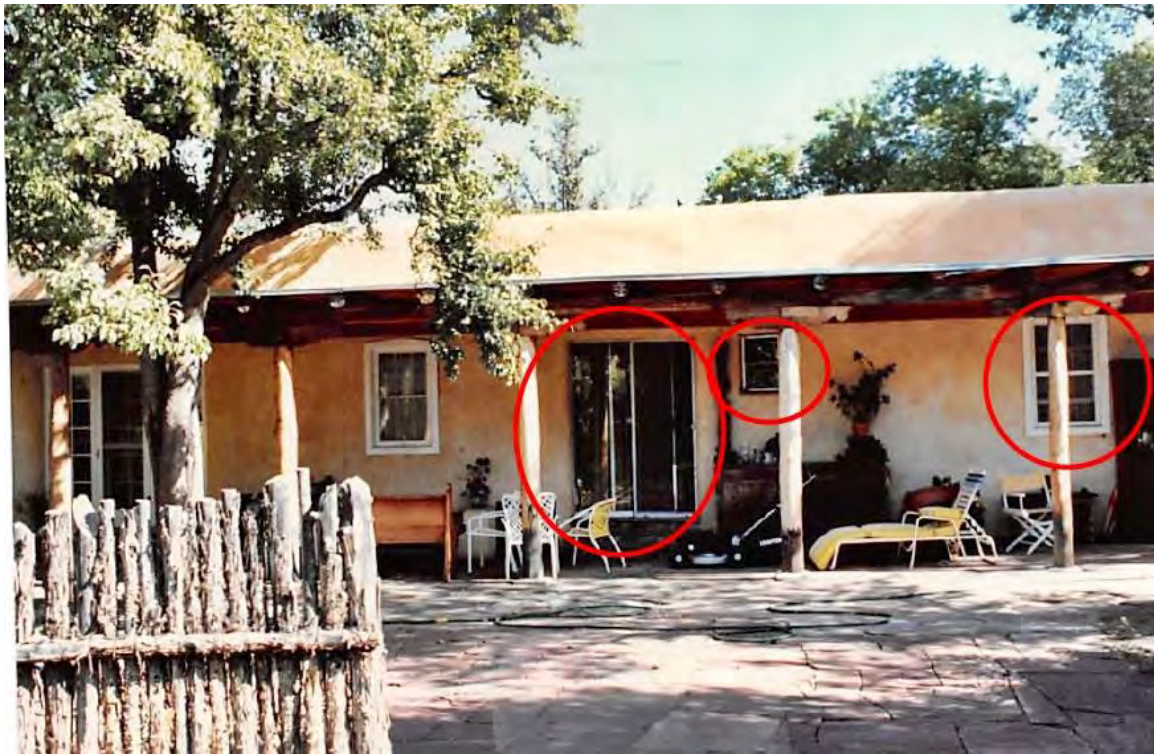
In its shadow is a line of fenestration that has been altered over the years. This is established by comparing current conditions with how the porch appeared in 1987 before being renovated (Fig. 9). Some window openings were removed, while others were newly installed. One enters the house at the west end of the portal through a narrow ten-light wood door flanked by divided side lights. Marching east are various multi-light windows, all with pedimented heads.

Figure 9: 1987 photograph of south elevation. Circles indicate fenestration that was changed by either elimination or enlargement of opening. Compare with Photo 3. Courtesy of City of Santa Fe Historic Preservation Division.

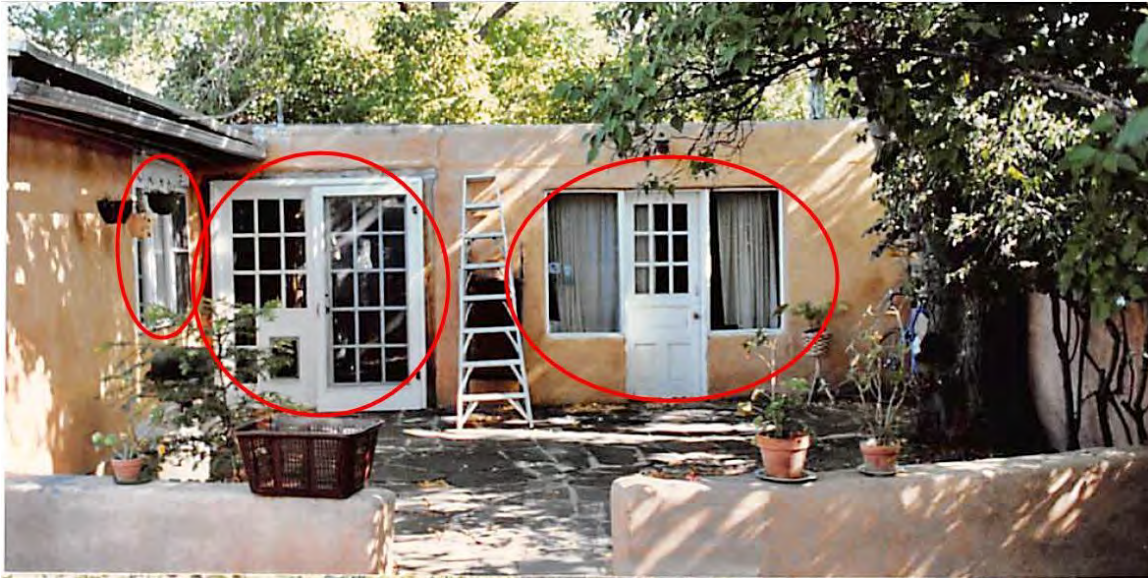
Figure 10: 1987 photograph of south elevation, primary bedroom suite. Circles indicate fenestration that was changed by new openings. Compare with Photos 5 & 6. Courtesy of City of Santa Fe Historic Preservation Division.

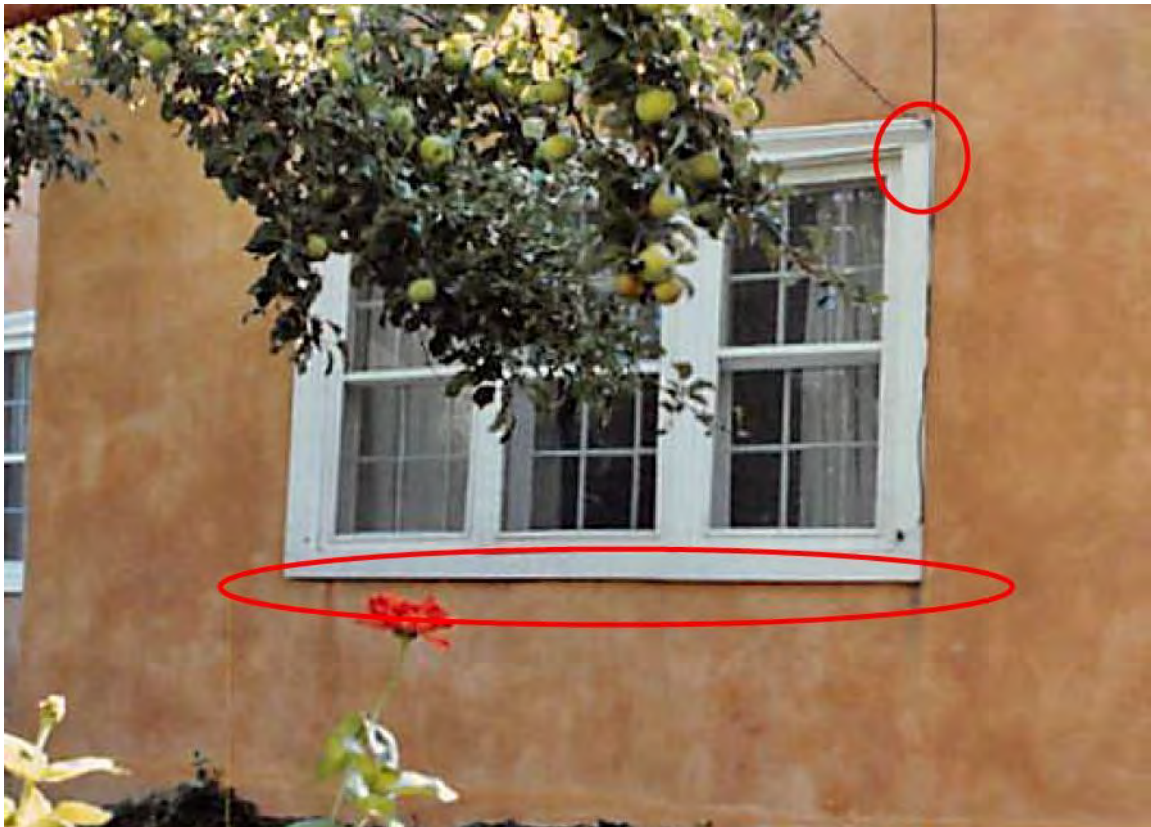
Figure 11: 1987 photograph of west elevation, right window. Circles indicate changes of trim, casing, and sill. Compare with Photo 8. Courtesy of City of Santa Fe Historic Preservation Division.

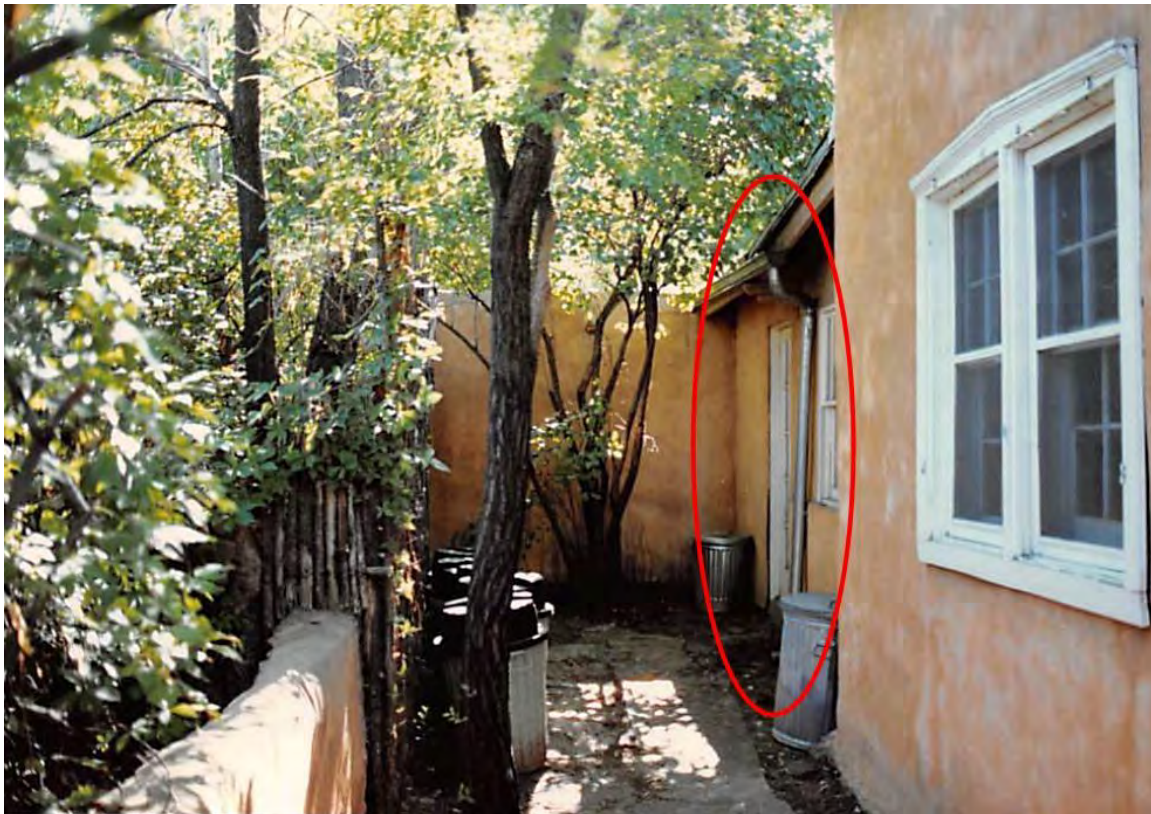
Figure 12: 1987 photograph east end of north elevation. Circle indicates change of wall position and fenestration. Compare with Photo 12. Courtesy of City of Santa Fe Historic Preservation Division.

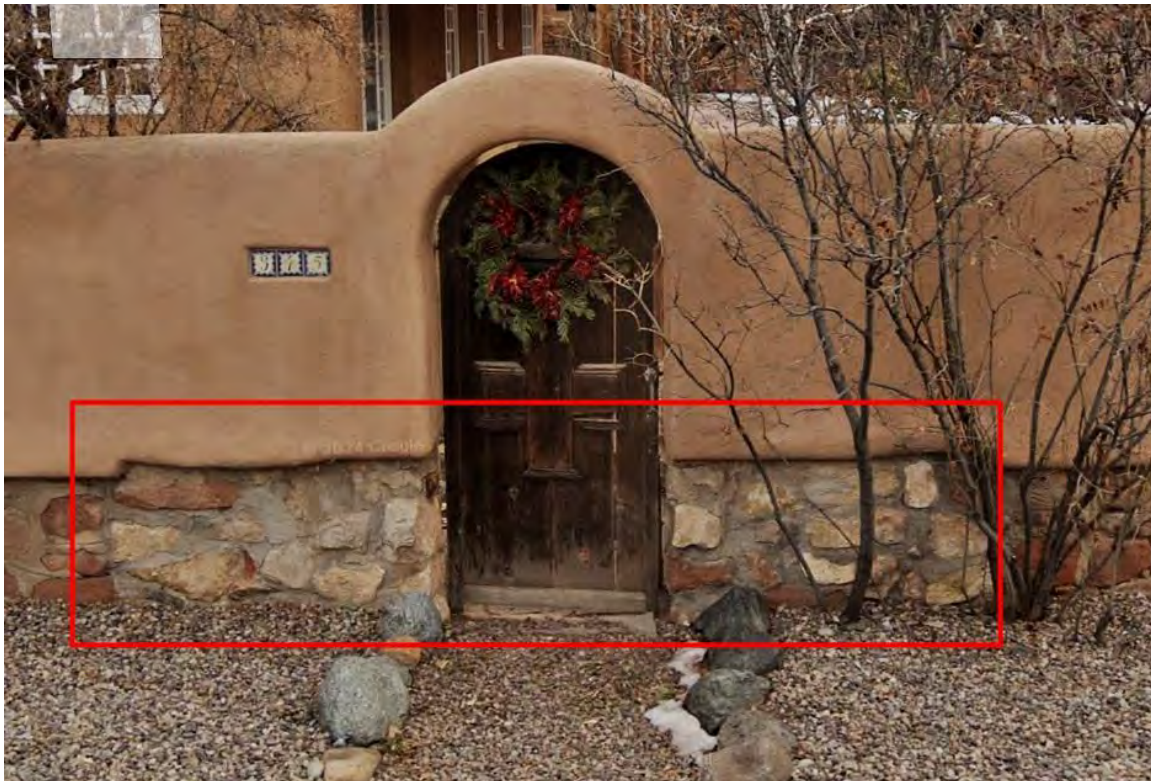
Photo 17: Altered portion of base of wall. Google Street View, December 2023.

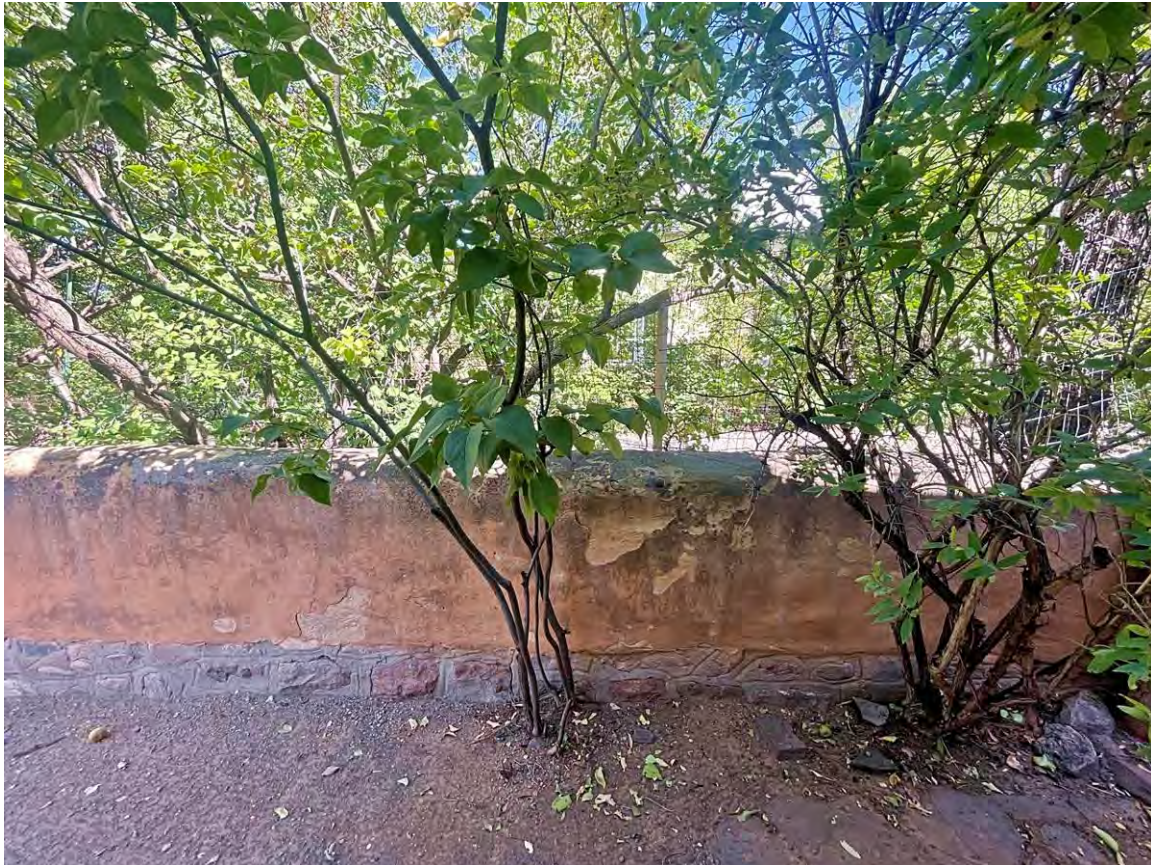
The second piece of wall connects to the front wall at the northwest corner. It extends eastward for approximately 80’ (Photo 18). It measures 39” above grade with a 15” thickness. Areas where the stucco has deteriorated show several layers of traditional plasterwork. It appears to be of the same vintage as the front wall.

Photo 18: North property wall. Camera facing north.

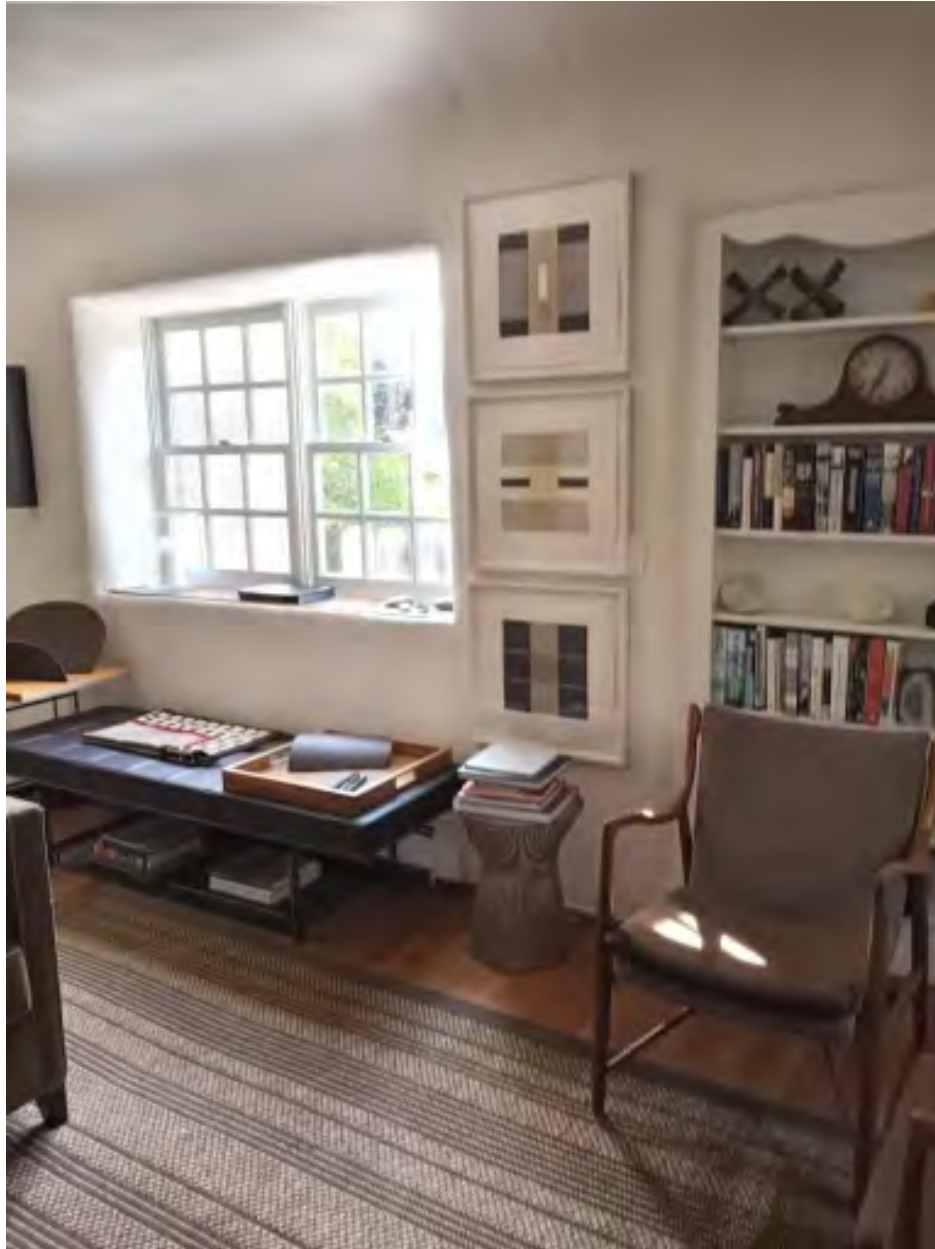
Living Room facing west. Note light switch, now blank, next to the old doorway.

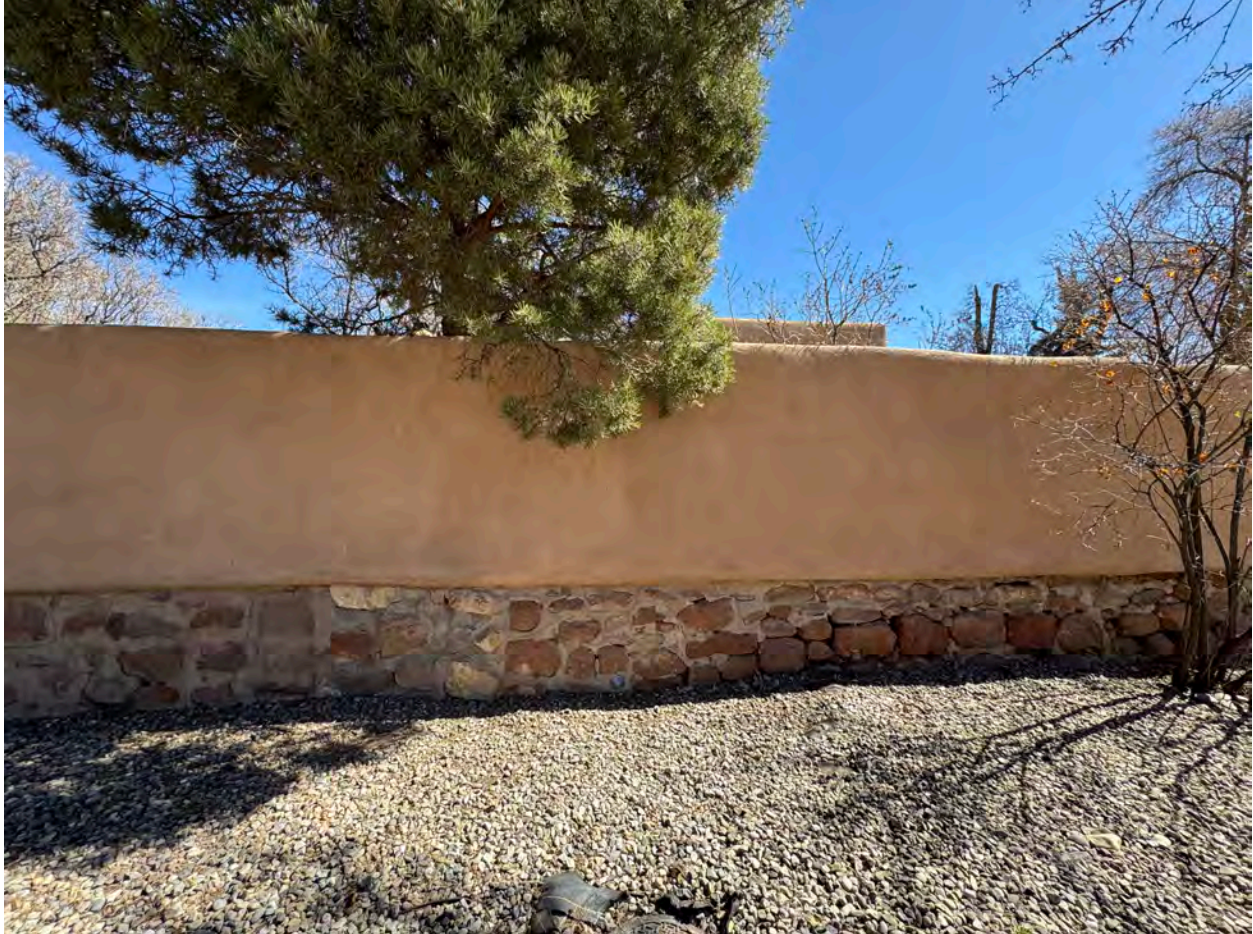
Garcia Street wall. Notice the difference in stone pattern and grout. this entrance would have lined up with the former pedestrian entrance facing west, and Garcia Street.
