**PROJECT** 2024-009369-HDRB, 345 Garcia St., Downtown & Eastside Historic District, Contributing,  
**DESC:** Gayla Bechtol, agent for Robert Holleyman and Bill Keller, owners, requests downgrade of historic status from Contributing to Non-Contributing for a residential structure and an accessory structure and a status review for a street frontage yard wall.

**CASE NUMBER:** 2024-009369--HDRB

**PROJECT TYPE:** Historic Status Review

**DATE:** November 26, 2024  
**TO:** Historic Districts Review Board Members  
**FROM:** Lani McCulley, Senior Planner, Historic Preservation Division

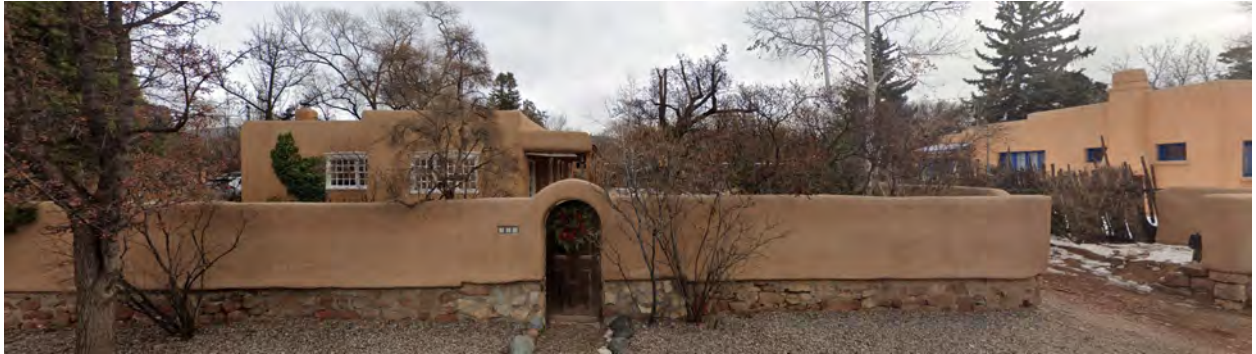
Figure 1: East elevation with front yard wall

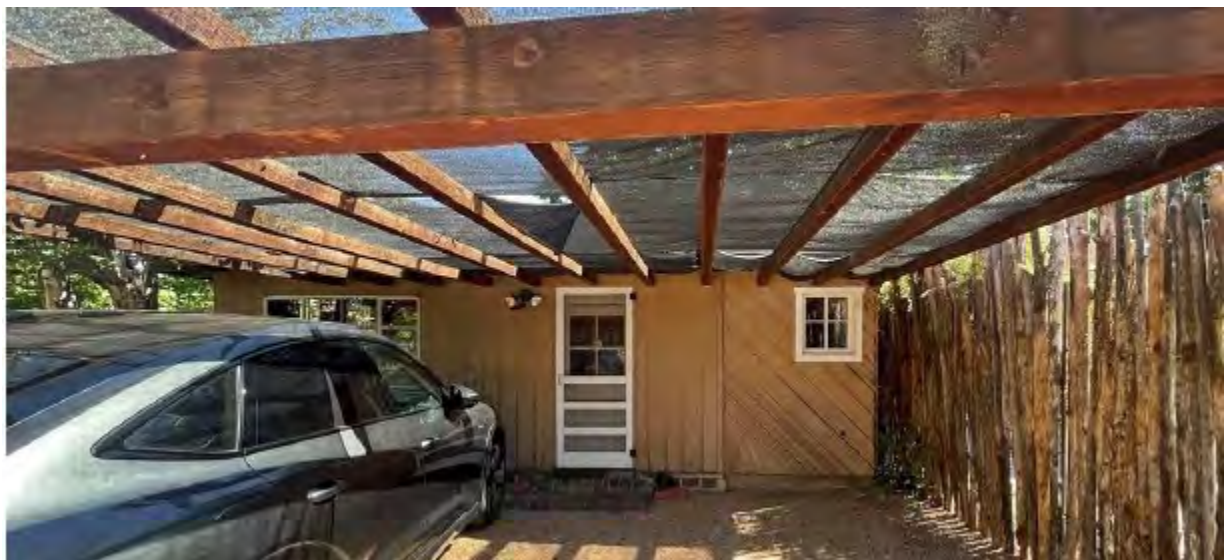
The accessory structure in the southeast corner of the property currently serves as a guesthouse. The front portion appears to have started out as a shed as it has a mixture of board sidings. The remaining portion appears to be an enclosed carport according to the HCPI. A wood structure attaches to the building on the west to create a partial carport. The accessory structure was erected after 1958 and does not match the style of the home. Staff did note when visiting the site that the rear or eastern wall was partially built of particle board. This structure is not mentioned on the 1985 HCPI for the property so the reason for its' contributing status is unclear.

Figure 2: Guesthouse: west elevation under carport

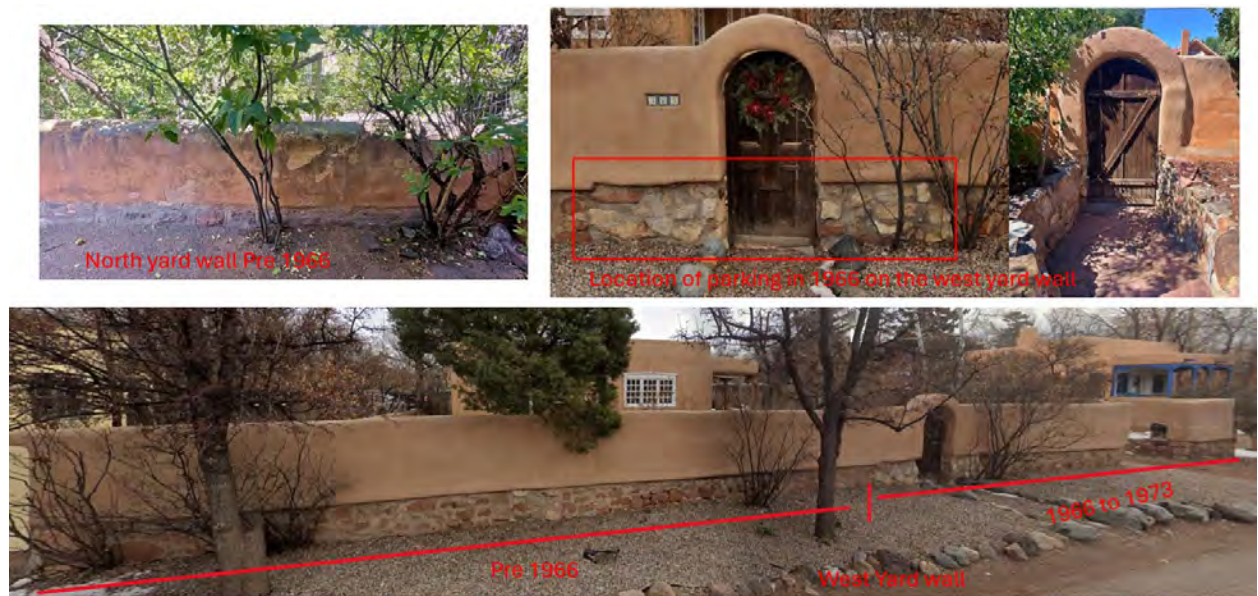
A tall street wall, partially serving as a retaining wall, crosses the front of the property. The base is retaining and is constructed of stone. The remaining portion height of the wall is stuccoed and the full height is about 53". Near the center is an arched opening at the pedestrian gate. The area of the gate was previously a parking space in the 1950s-60s according to aerial photographs. The current driveway and pedestrian entrance were constructed by 1973 and is historic. The second portion of the wall connects to the front wall in the northwest corner and extends east. It is about 39" in height and in areas shows several layers of plasterwork.

Figure 3: Yardwalls with construction dates

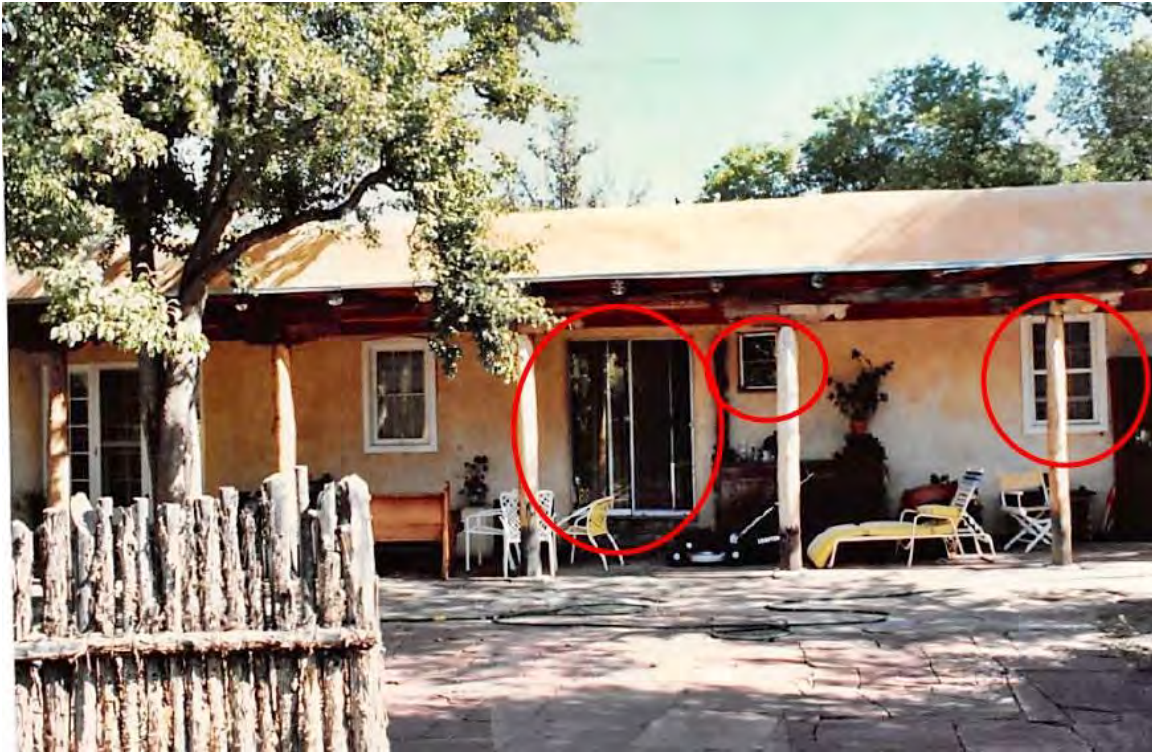
In its shadow is a line of fenestration that has been altered over the years. This is established by comparing current conditions with how the porch appeared in 1987 before being renovated (Fig. 9). Some window openings were removed, while others were newly installed. One enters the house at the west end of the portal through a narrow ten-light wood door flanked by divided side lights. Marching east are various multi-light windows, all with pedimented heads.

**Figure 9: 1987 photograph of south elevation. Circles indicate fenestration that was changed by either elimination or enlargement of opening. Compare with Photo 3. Courtesy of City of Santa Fe Historic Preservation Division.**

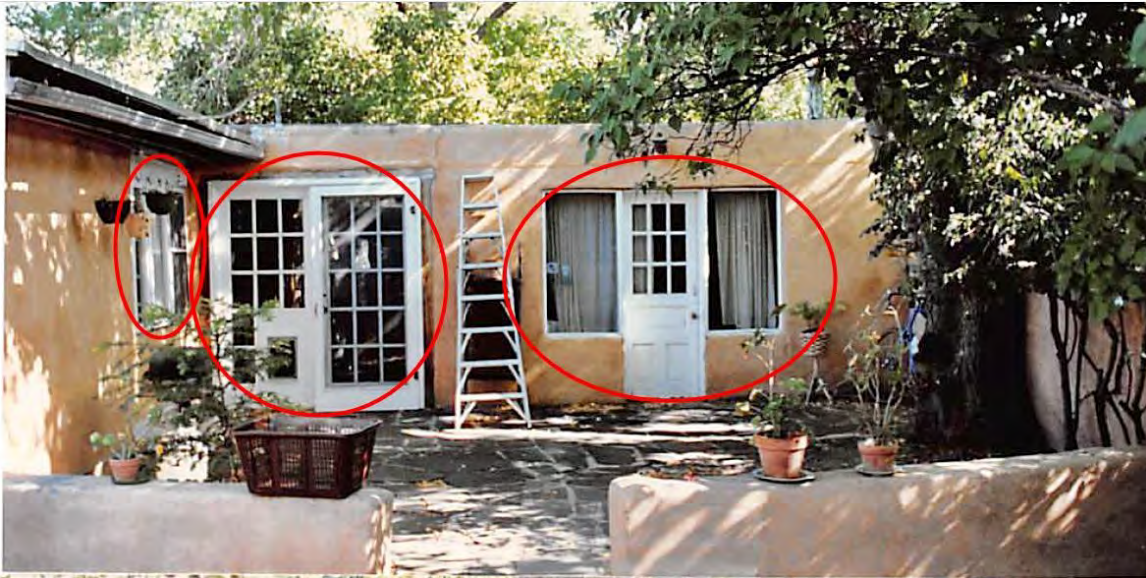
**Figure 10: 1987 photograph of south elevation, primary bedroom suite. Circles indicate fenestration that was changed by new openings. Compare with Photos 5 & 6. Courtesy of City of Santa Fe Historic Preservation Division.**

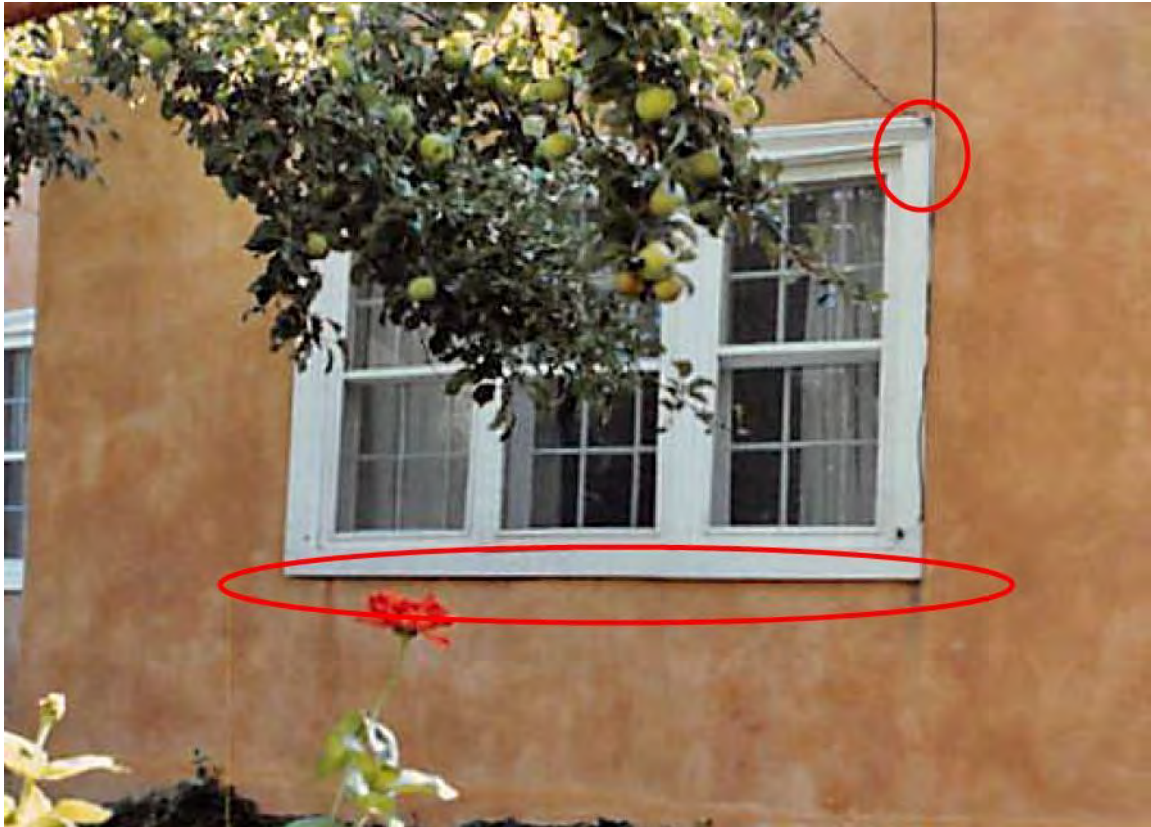
**Figure 11: 1987 photograph of west elevation, right window. Circles indicate changes of trim, casing, and sill. Compare with Photo 8. Courtesy of City of Santa Fe Historic Preservation Division.**

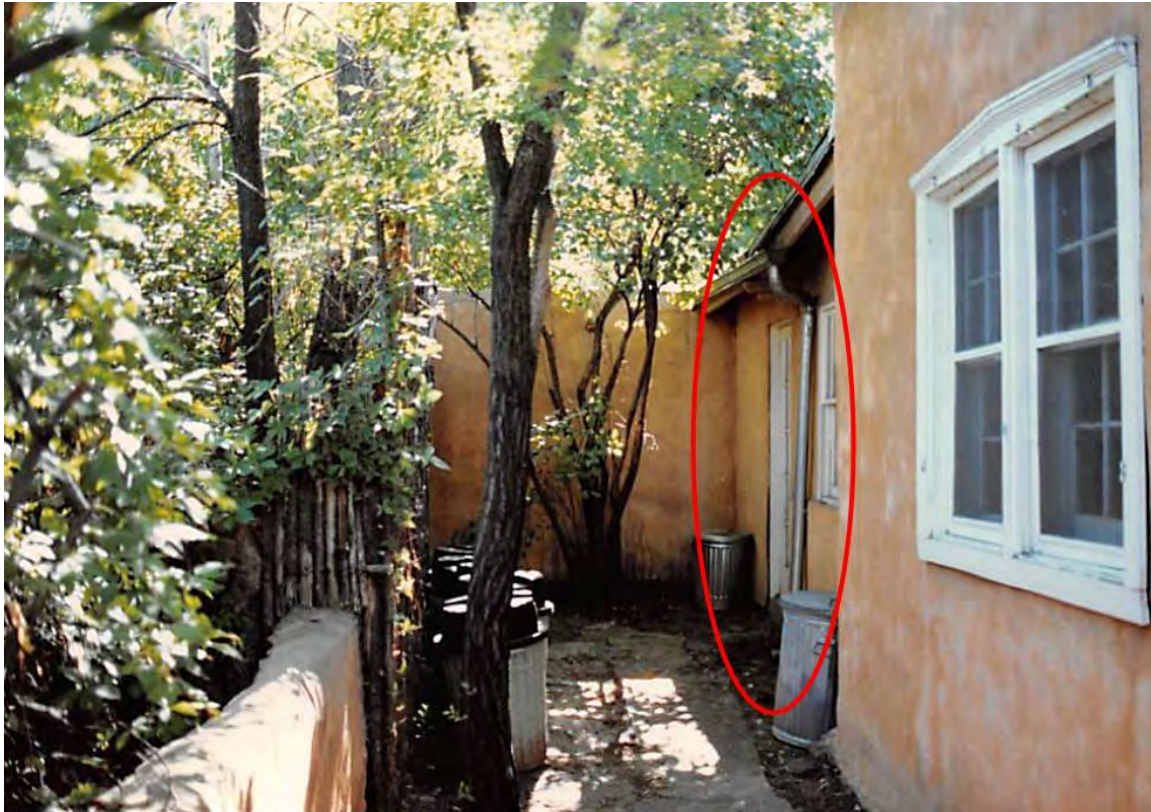
**Figure 12: 1987 photograph east end of north elevation. Circle indicates change of wall position and fenestration. Compare with Photo 12. Courtesy of City of Santa Fe Historic Preservation Division.**

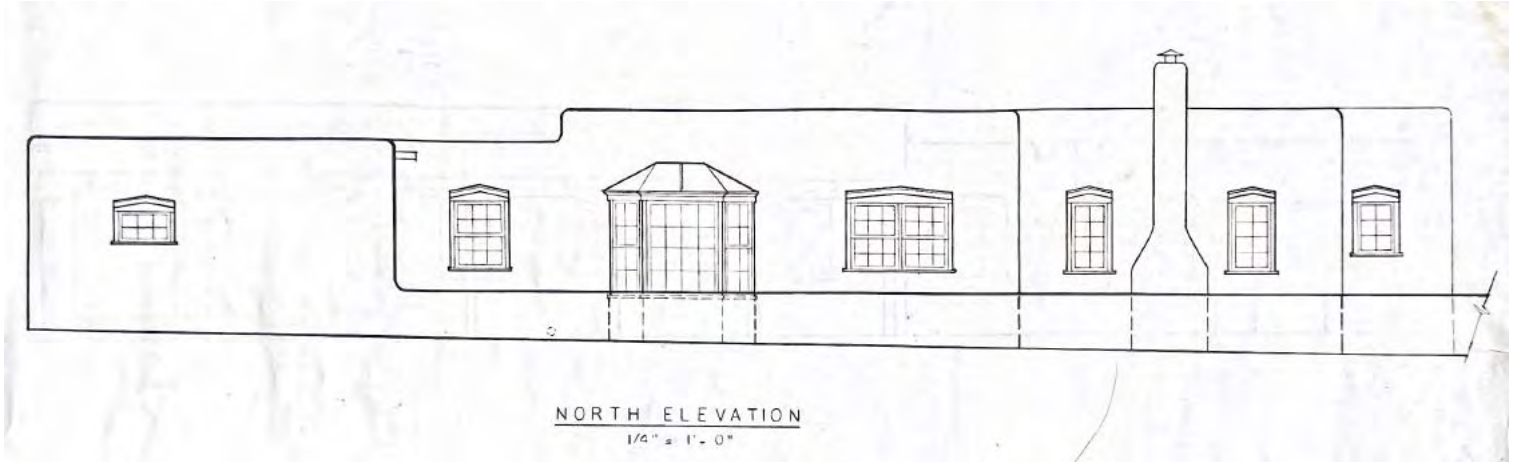
**Figure 13: North elevation, proposed, August 1987. Courtesy of John Dessau. Note introduction of bay window.**

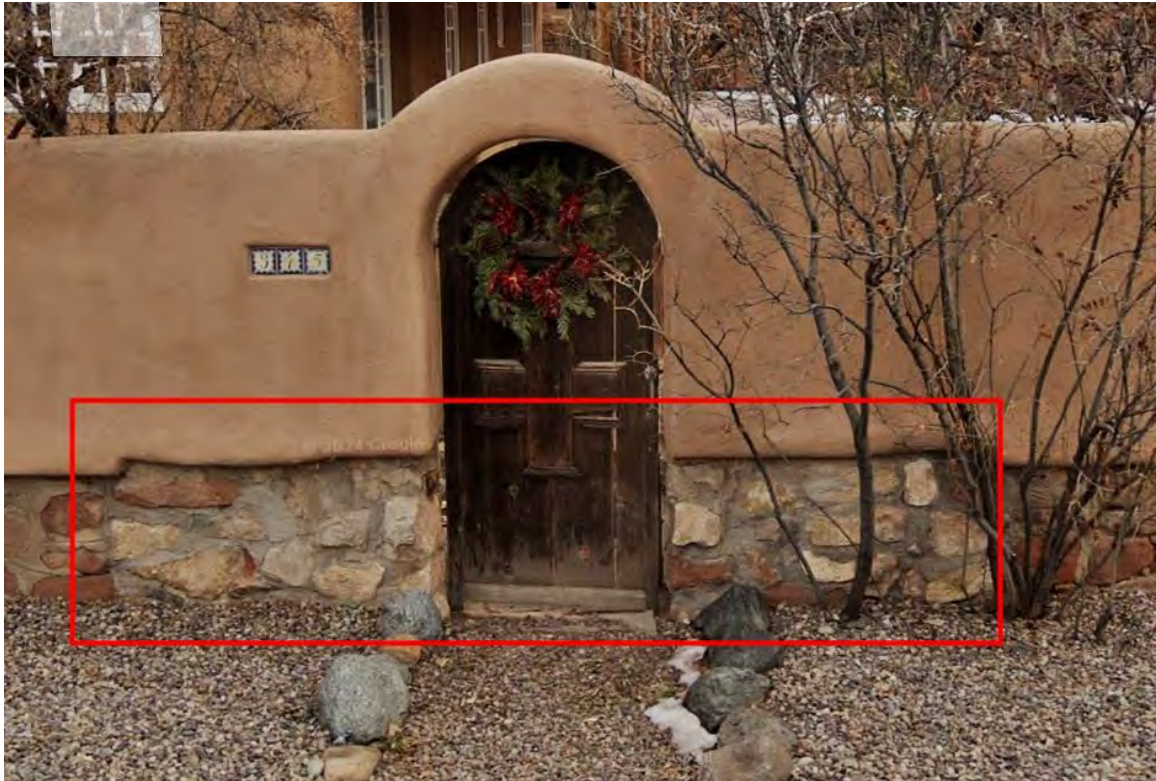
**Photo 17: Altered portion of base of wall. Google Street View, December 2023.**

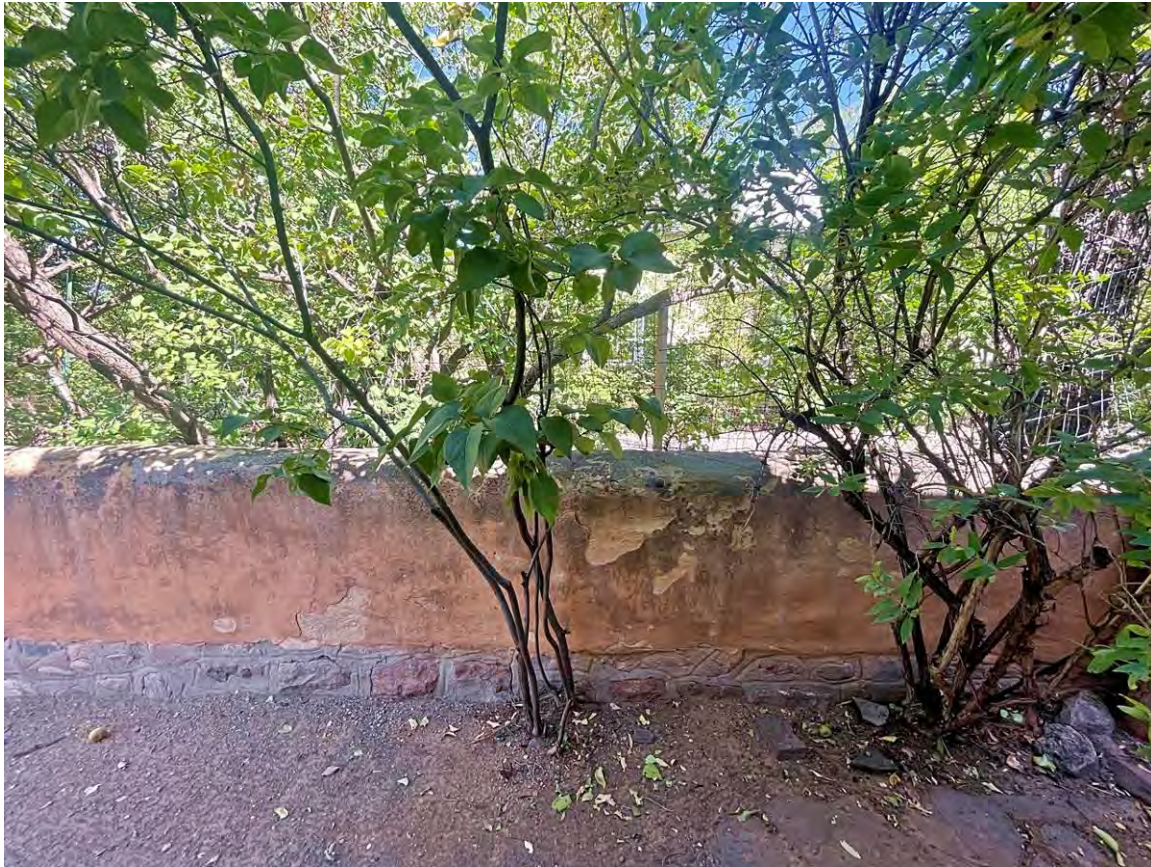
The second piece of wall connects to the front wall at the northwest corner. It extends eastward for approximately 80’ (Photo 18). It measures 39” above grade with a 15” thickness. Areas where the stucco has deteriorated show several layers of traditional plasterwork. It appears to be of the same vintage as the front wall.

**Photo 18: North property wall. Camera facing north.**

Portions of the front wall and the entire span of the north wall appear to be vintage. It is recommended to designate the sections that retain integrity as a Contributing structure.

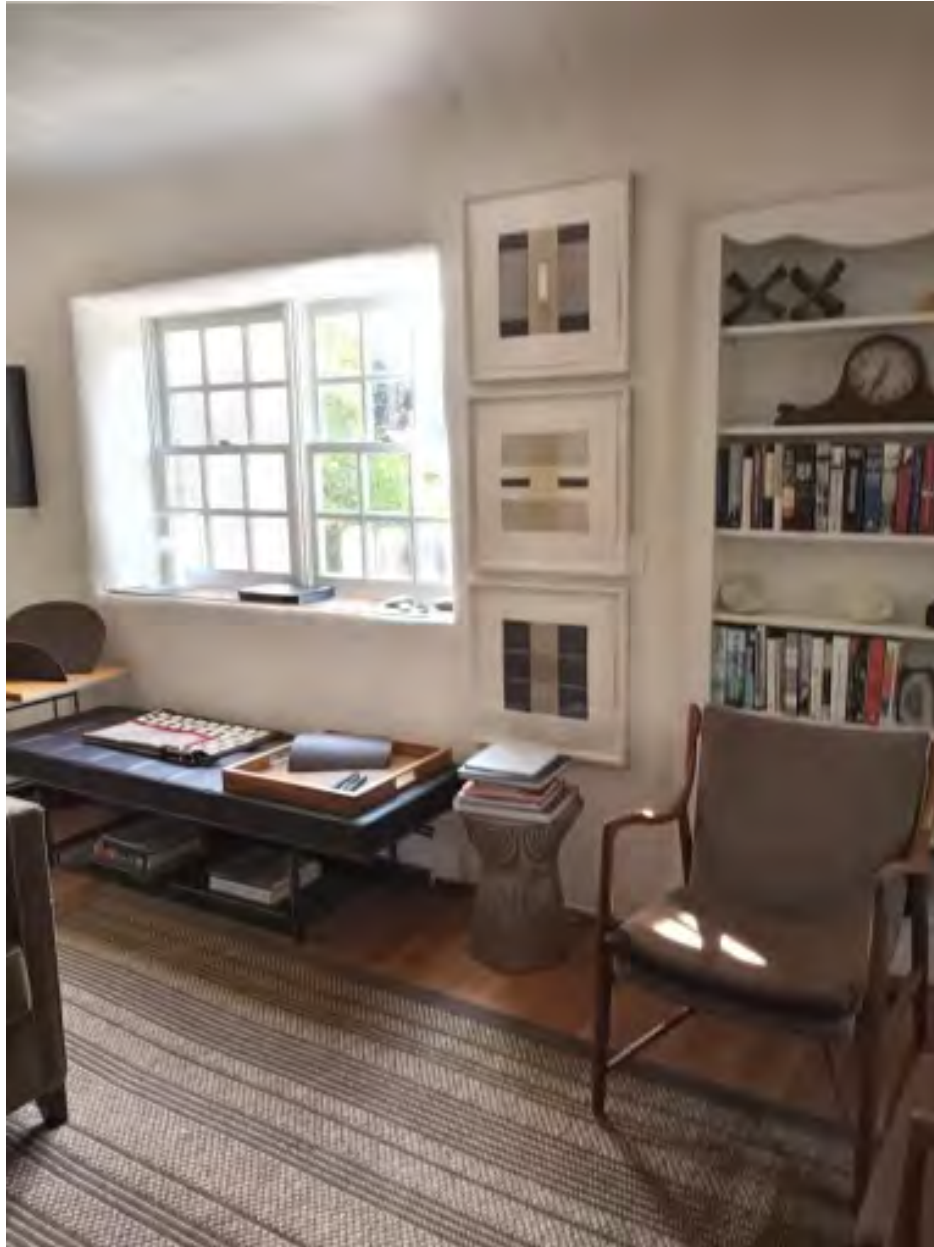
Living Room facing west. Note light switch, now blank, next to the old doorway.

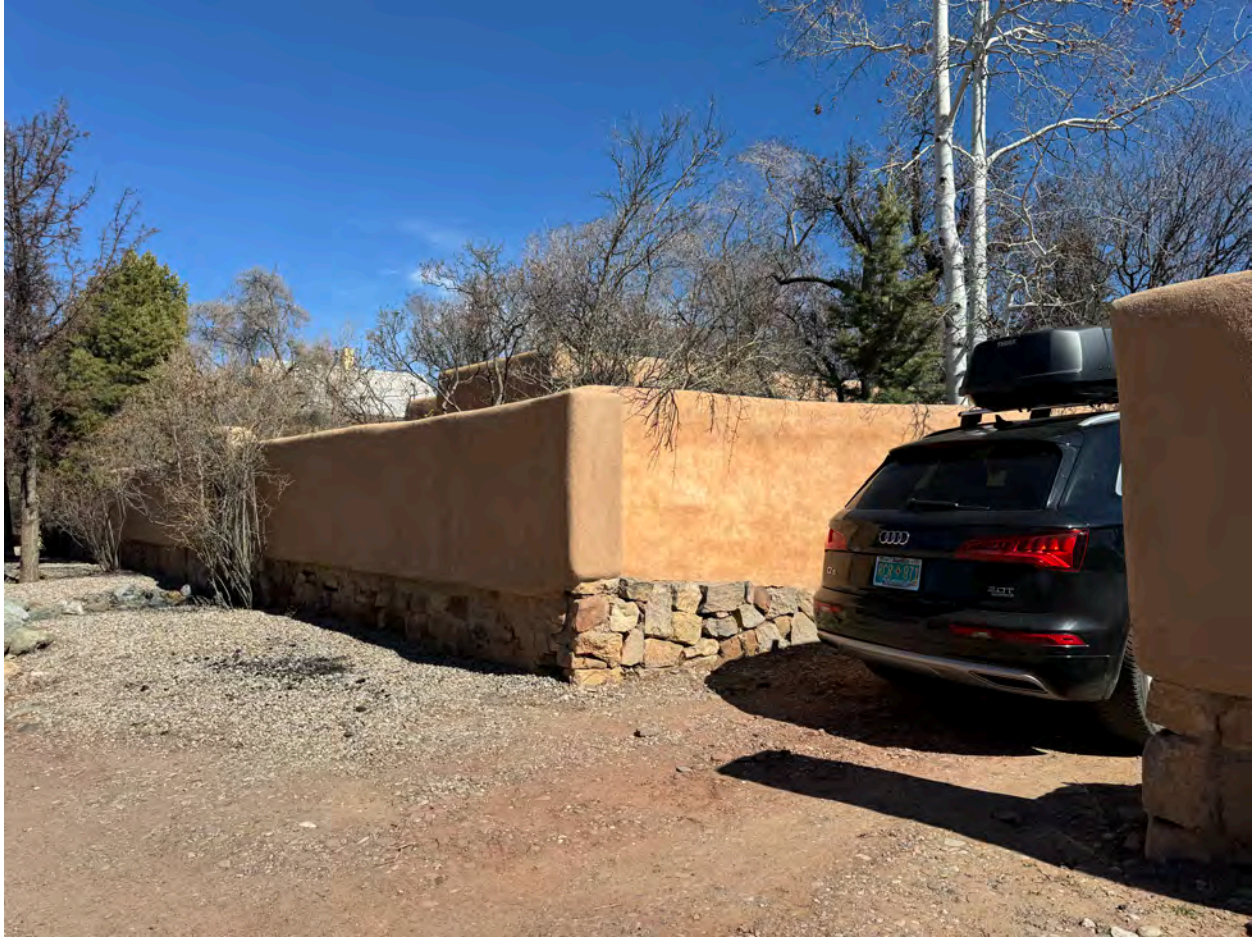
Photo of driveway entrance at wall. Notice different stone and stucco.

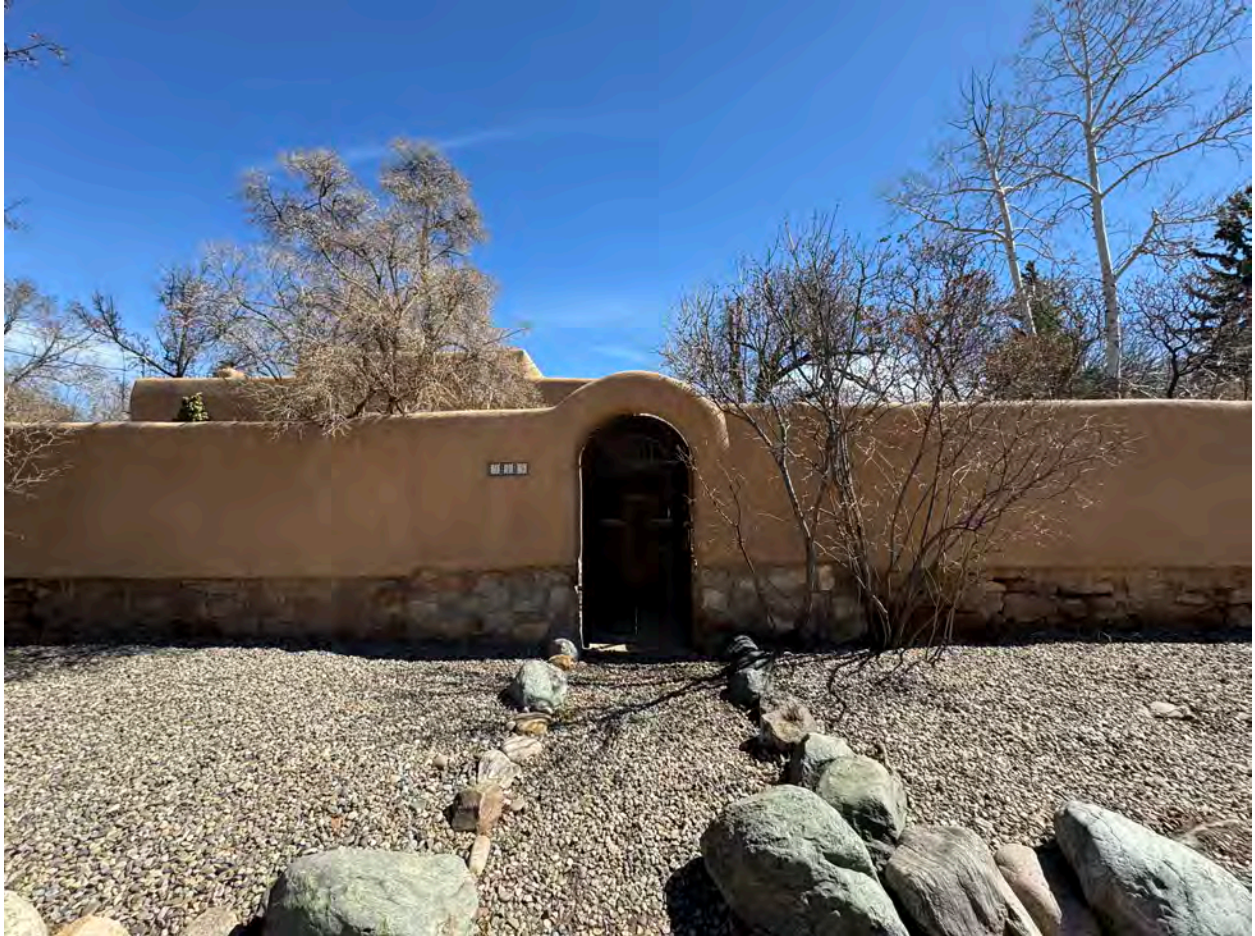
Pedestrian entrance facing west and Garcia Street, formally the car entrance. Notice different stone and grout pattern.

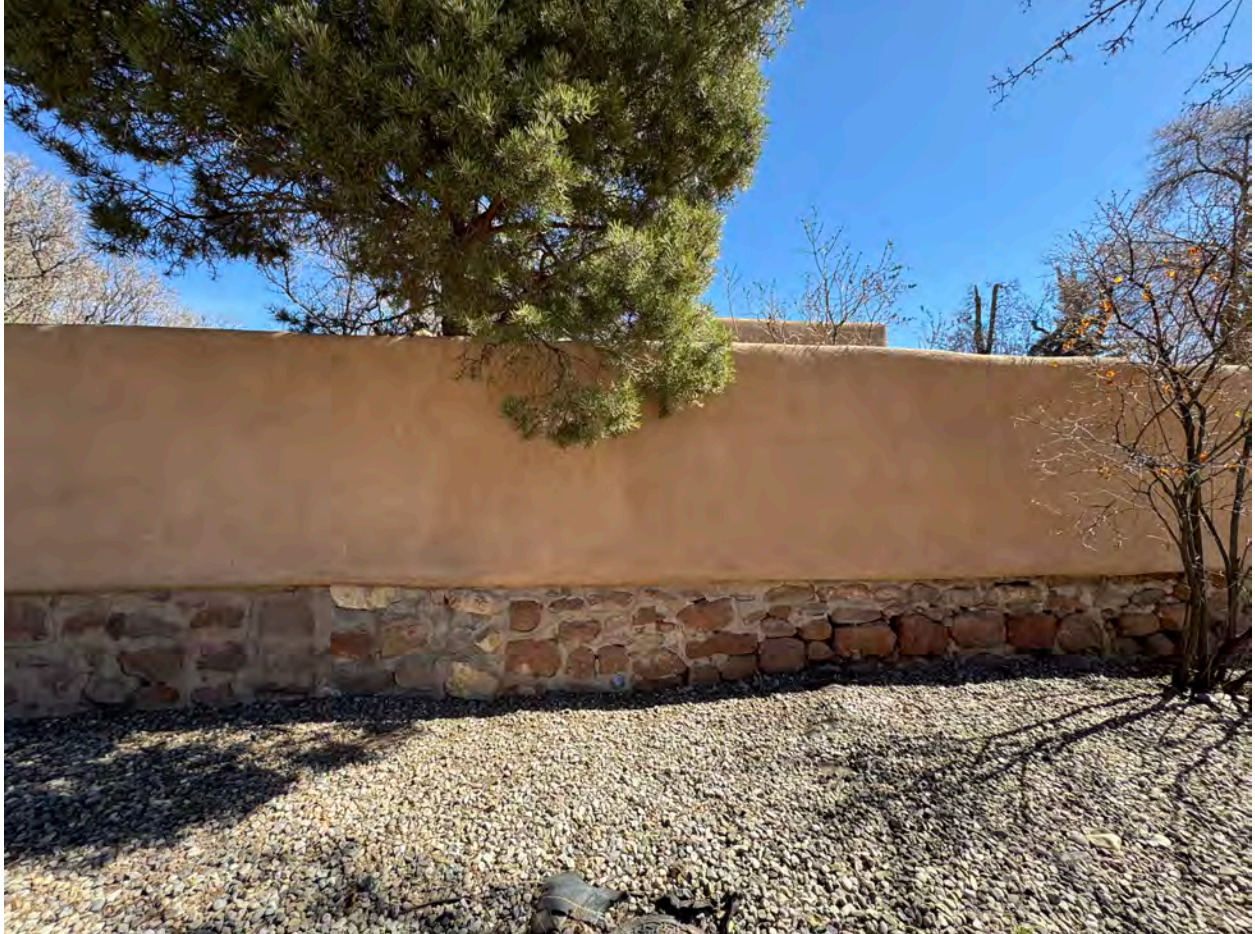
Garcia Street wall. Notice the difference in stone pattern and grout. this entrance would have lined up with the former pedestrian entrance facing west, and Garcia Street.
