City of Santa Fe

Plan Number: 2024-009370--HDRB

memo

2024-009370-HDRB, 1030 ½ W. Houghton St., Don Gaspar Area Historic District, non-contributing and no- historic status (accessory building), Seres Architect LLC, agent for Francesca Banci, owner, requests a historic status review with primary facade(s) designation, if applicable, for a residential and an accessory structure.

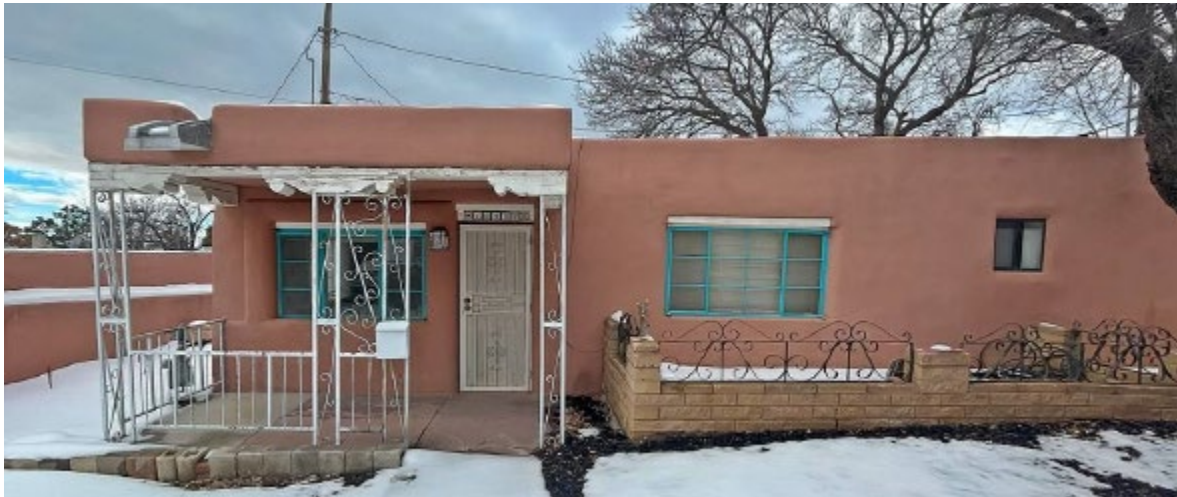
Figure 1: Main Residence

The vernacular style residence is constructed of adobe with cementitious stucco painted pink. The residence was most likely constructed in the late 1940s. On the east side of the residence, panels of wrought-iron balustrade hold the 66-square-foot porch structure. The porch floor is concrete;

the ceiling is finished with stucco. The perma-stone-like treatment of the building wall has been stuccoed over giving a false depth of the inset of the window. The east houses two steel combination windows, one sliding vinyl window and another steel window, and the main entry to the house. The windows are deep set with angled reveals. Each steel window is topped with a wood block lintel.

The north wall has an opening near the center holding a ½-lite wood panel door. This door appears to be original according to the 2024 HCPI. A three-angle piece of galvanized metal shelters the opening.

The west elevation contains one steel combination window, and the roof drains over this side through three galvanized gutters; electrical and gas lines run along the base.

The south elevation holds one steel combination window topped with a wood block lintel.

Though the residence has maintained its overall footprint since 1958 and retains most of its original windows, staff finds that the residence is non-contributing due to the alterations which are misleading on the eastern elevation and that the residence does not particularly contribute to the primary home's setting or the West Houghton streetscape.

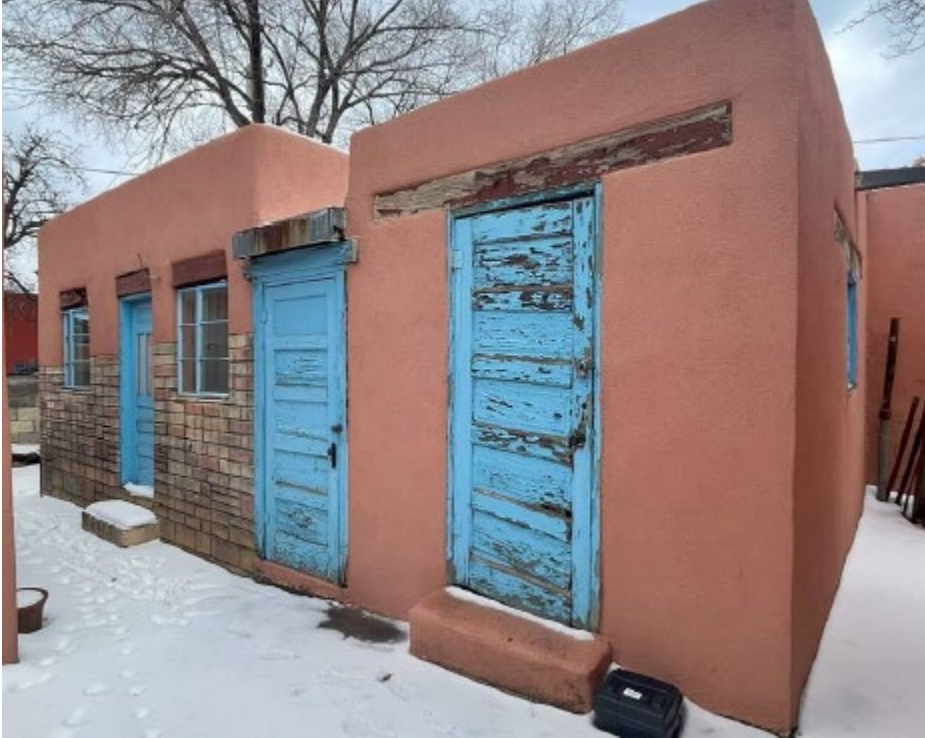
Figure 2: Accessory Structure

The accessory structure is located north of the dwelling and is constructed of concrete blocks. The west half shows on a 1958 aerial in the 2024 HCPI form. The structure appears to be made of three sections and totals about 360 sq. ft. The eastern end of the building encroaches onto the adjacent property and according to aerials, was built after 1969. The western end is the older section and has steel casement windows bracketing a wood door. Going to the east the center area steps down in height and holds a single five-panel wood door perforated with holes. At the eastern end the roof steps up for another rectangular room with a five-panel door. The east has a 6-lite barn sash window. The eastern encroaching section of the accessory structure was approved for demolition under case 2022-005830-HDRB in 2022, which included the renovation of the main residence located at 1030 W Houghton St.

The accessory structure appears to be two buildings of different construction with an addition to merge them into a single building. The conflicting styles and construction types create a rough appearance that is not cohesive to the neighborhood and the streetscape. Therefore, staff finds this to be a non-contributing structure.

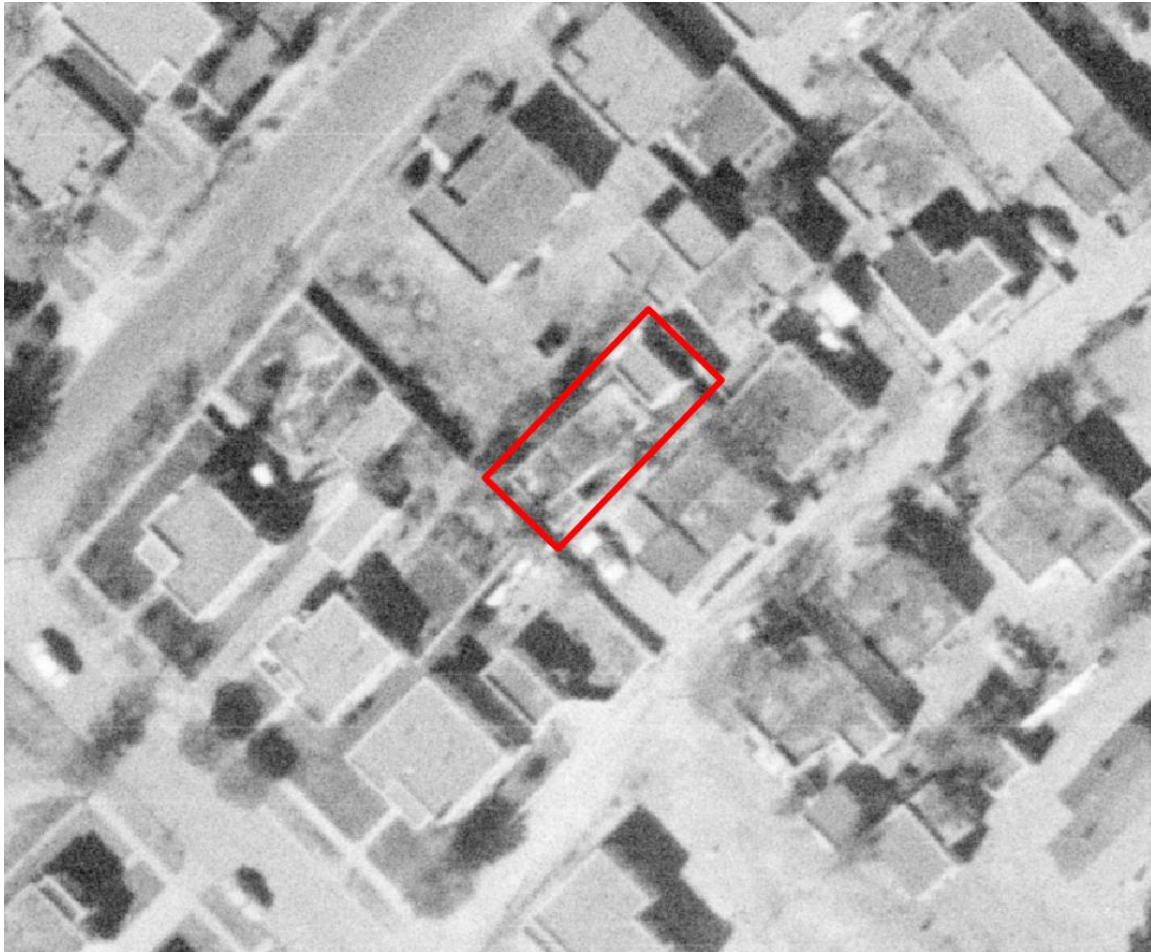
**Figure 5: November 10, 1958, aerial photograph.
 Note shorter length of storage building.**

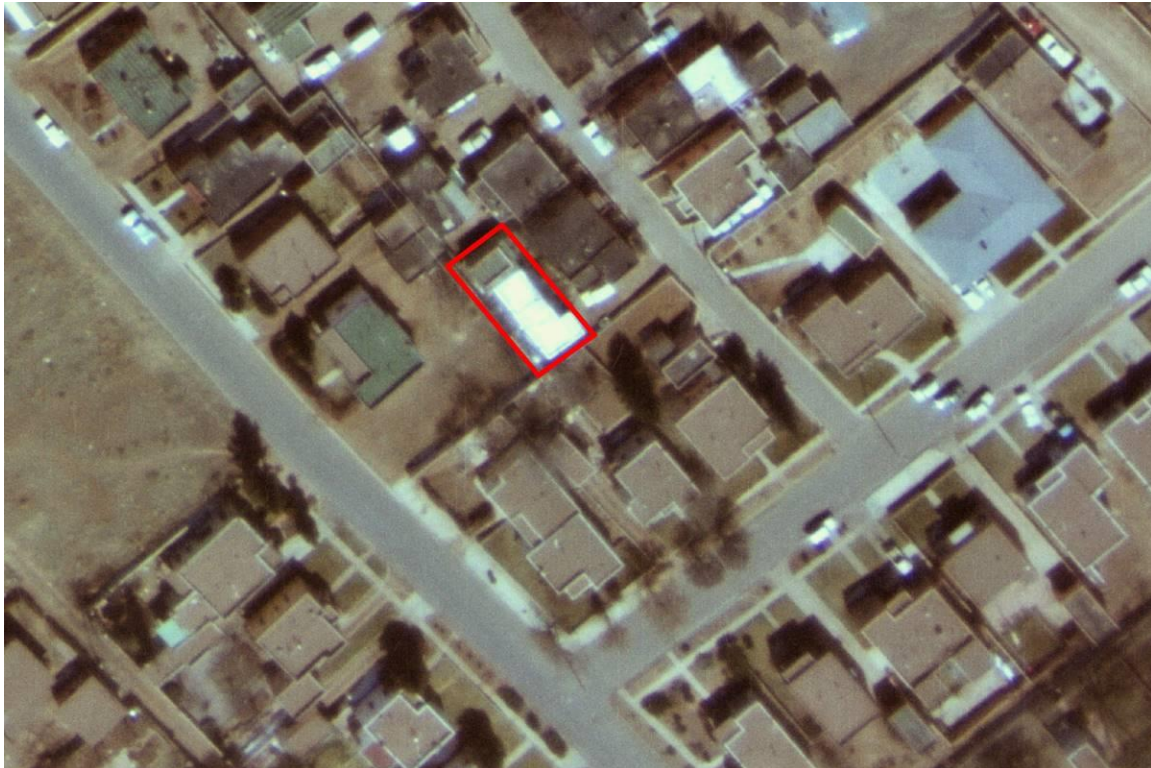
**Figure 6: February 27, 1969, aerial photograph.
 Note shorter length of storage building.**

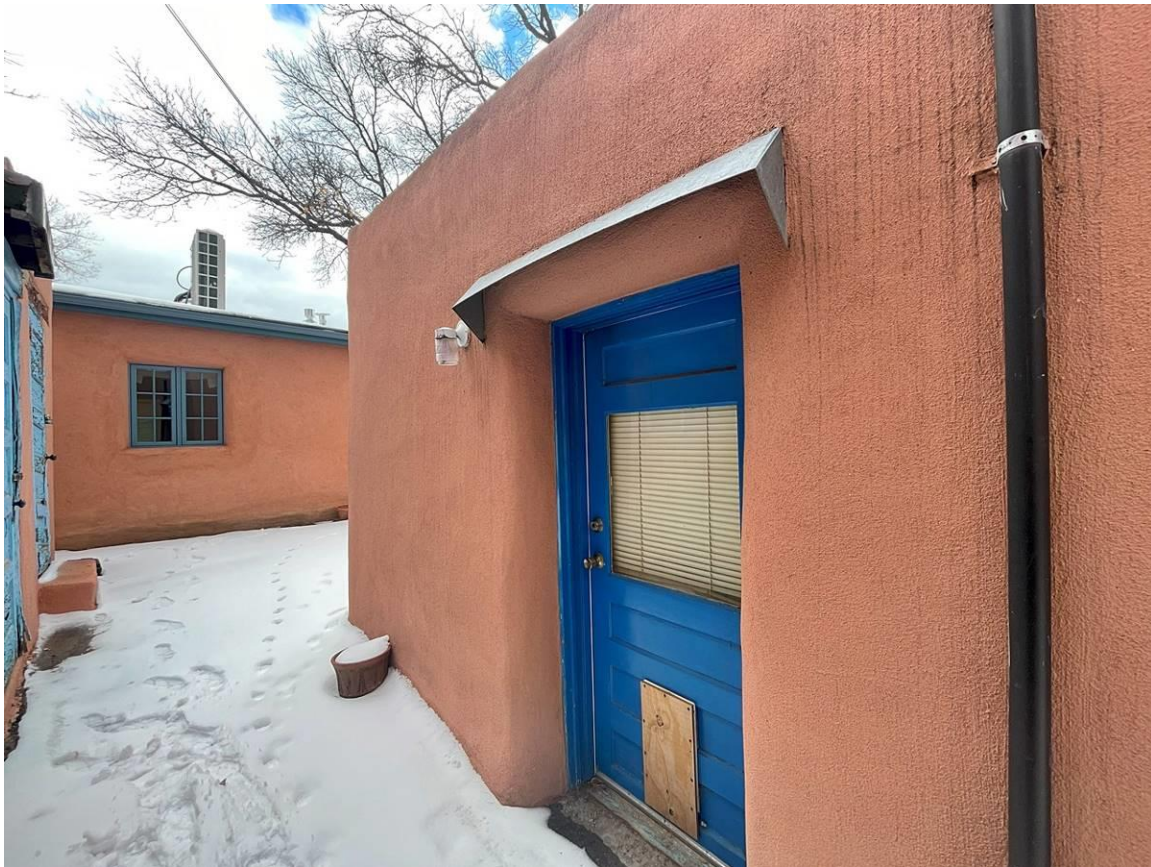
(Photo 8). A three-angle piece of galvanized metal shelters the opening. The rustic canopy postdates the 1995 survey.

Photo 8: North elevation, entry. Camera facing southeast.

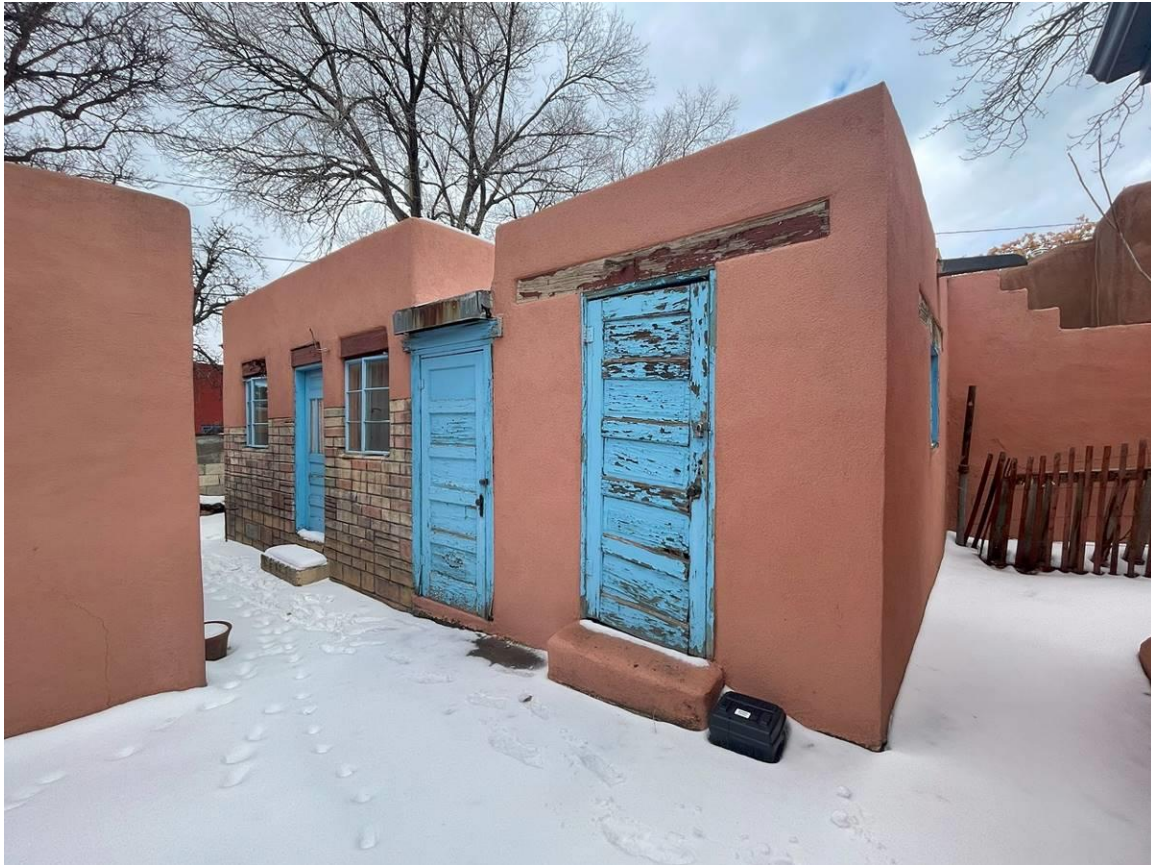
The structure faces south onto the home with a façade of multiple doors. The older west section has two steel casement windows bracketing a wood door. Like across the house, the windows are standard units of steel sash with exterior hinges and are opened by a rotary handle. They are topped with larger blocks than found on the home. The door, a ½-light and panel unit, mirrors the home’s north entry. The lower portion of the wall has a Perma-Stone-like finish. Contrasting with the material across the porch, it was made to look like multi-colored bricks.

The Storage Building is of rougher construction, with only its west portion predating 1958. Part of its east section has already been approved for demolition by the HDRB.²¹ Therefore, the recommendation is to designate the portion in the subject parcel as Noncontributing.

Photo 12: Storage Building. South elevation facing northwest. Right portion of building located in adjacent parcel.

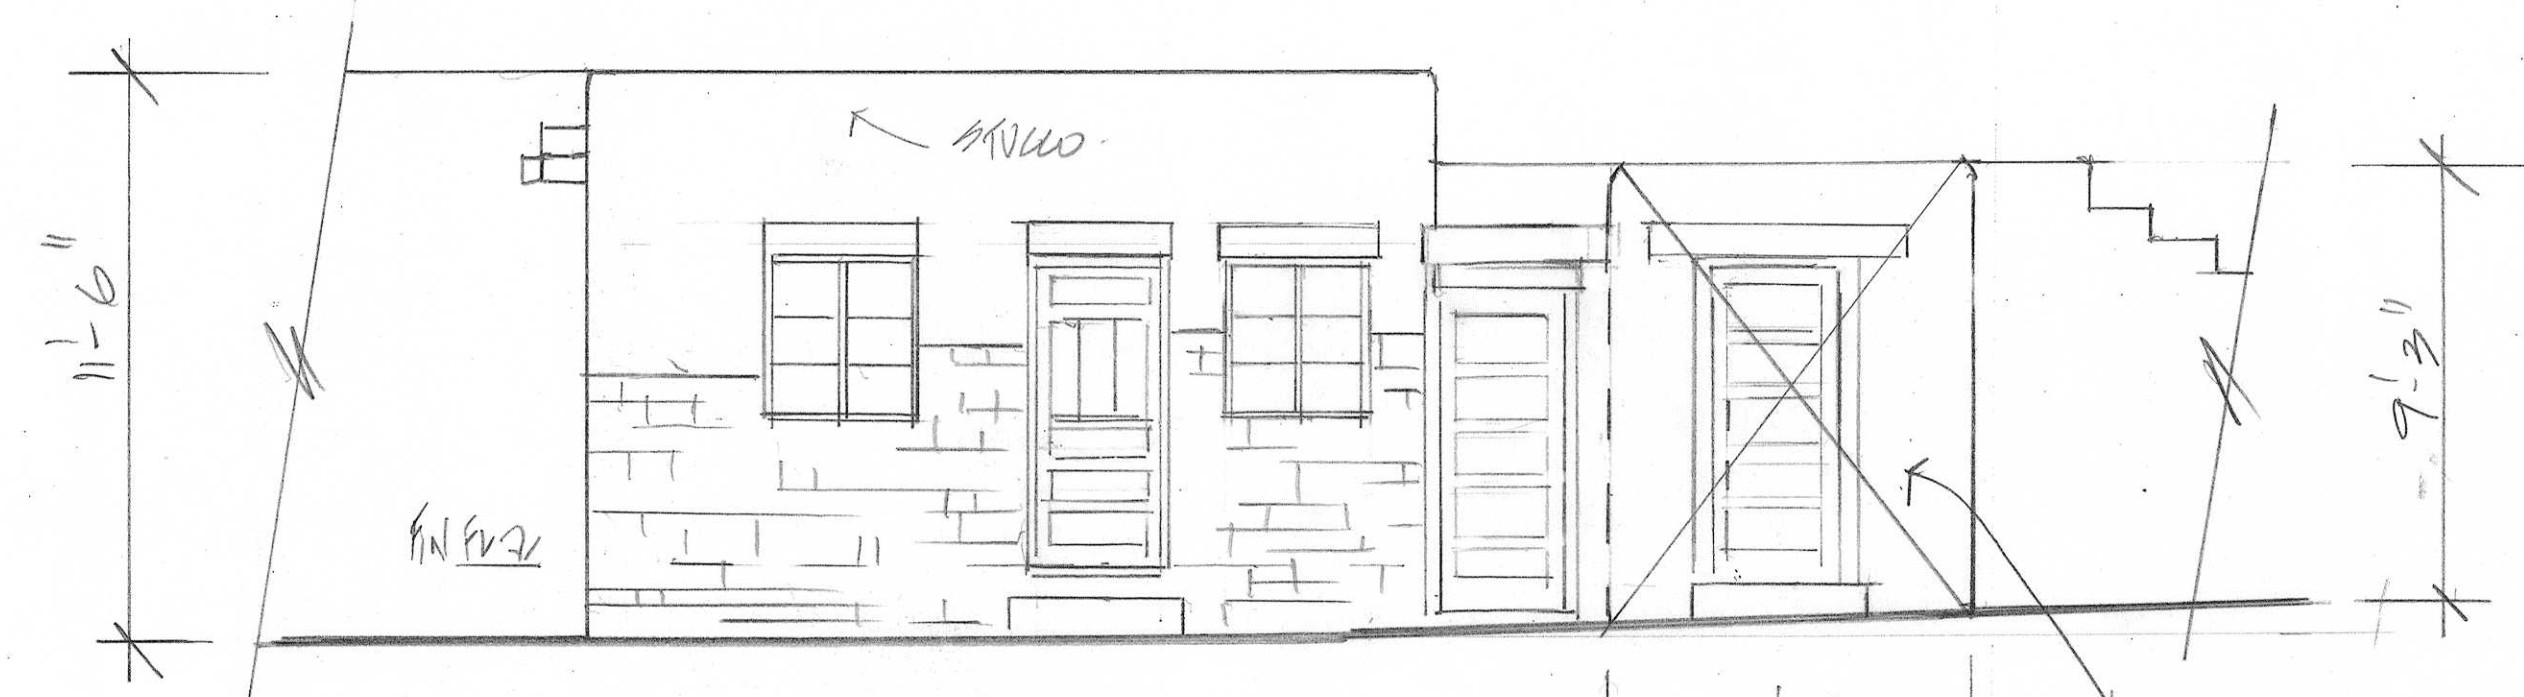
SOUTH ELEVATION - EXISTING
SC: 1/4" = 1'-0"

HRRB CASE 2022-005830
DEMOLITION APPROVED
PORTION OF STORAGE
BLDG.

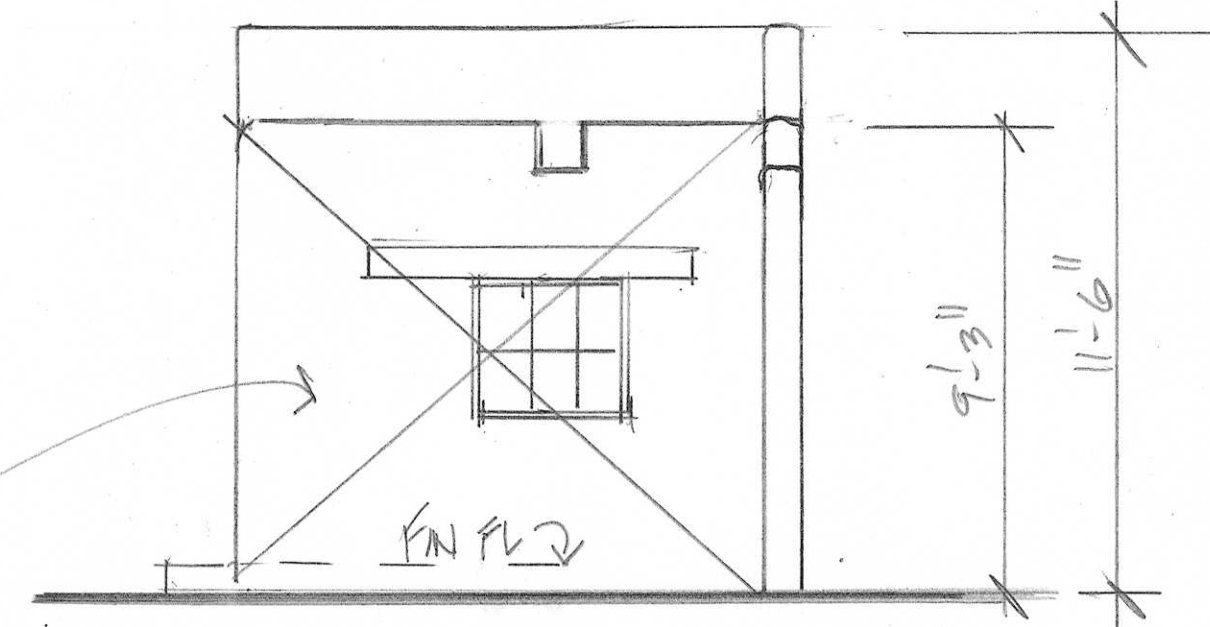
EAST ELEVATION - EXISTING
SC: 1/4" = 1'-0"

HRRB CASE 2022-005830
APPROVED DEMOLITION
PORTION OF
STORAGE BLDG.
