City of Santa Fe, New Mexico

DATE: November 26, 2024
TO: Historic Districts Review Board
FROM: Paul A. Duran, Senior Planner, Historic Preservation Division

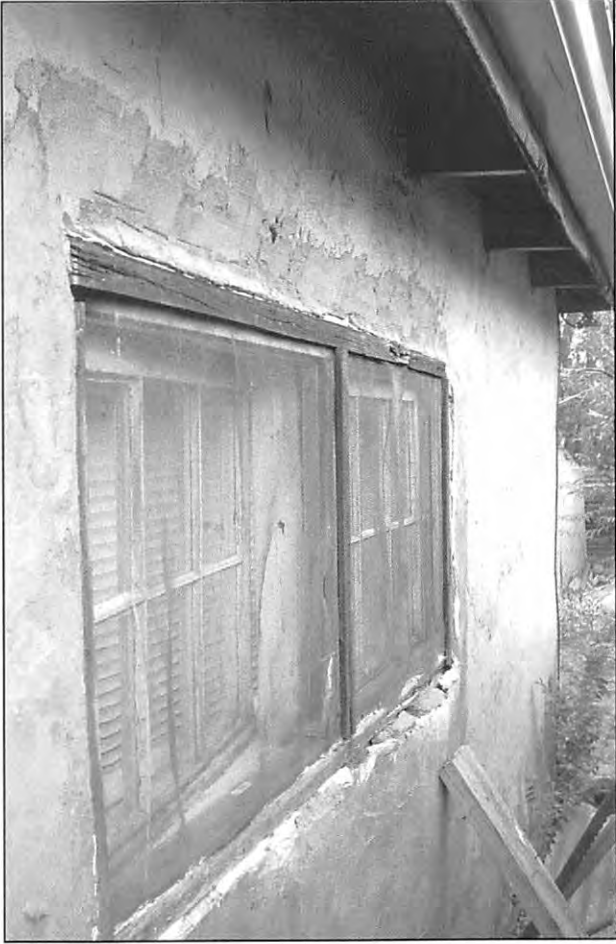
6. View north of portion of east elevation. Windows appear unaltered. Plastered adobe is in poor condition (ArcCom 07-20-06).

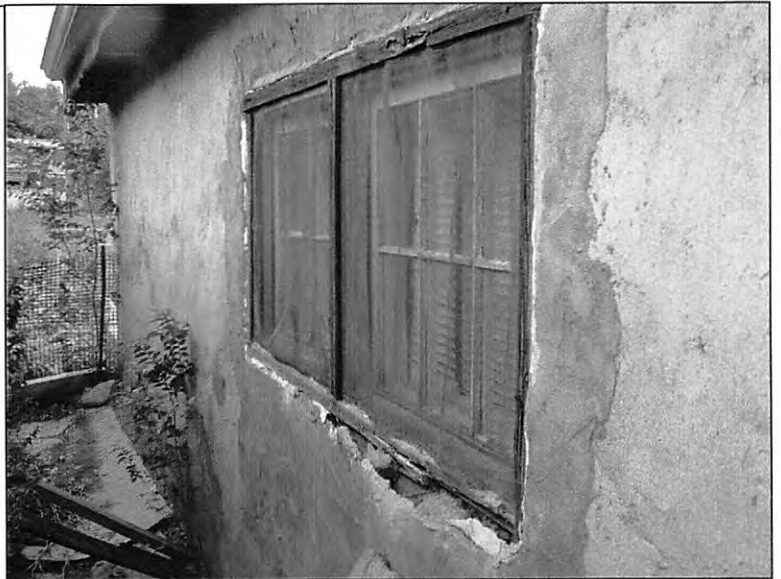
8. View northwest of rolled composition roof (ArcCom 07-20-06).
