CASE NUMBER: 2019-000994--HDRB

PROJECT TYPE: Historic Status Review

LOCATION: 215 WASHINGTON AVE
Santa Fe, NM 87501

Historic Cultural Properties Inventory (HCPI) Base Form (FORM 1)

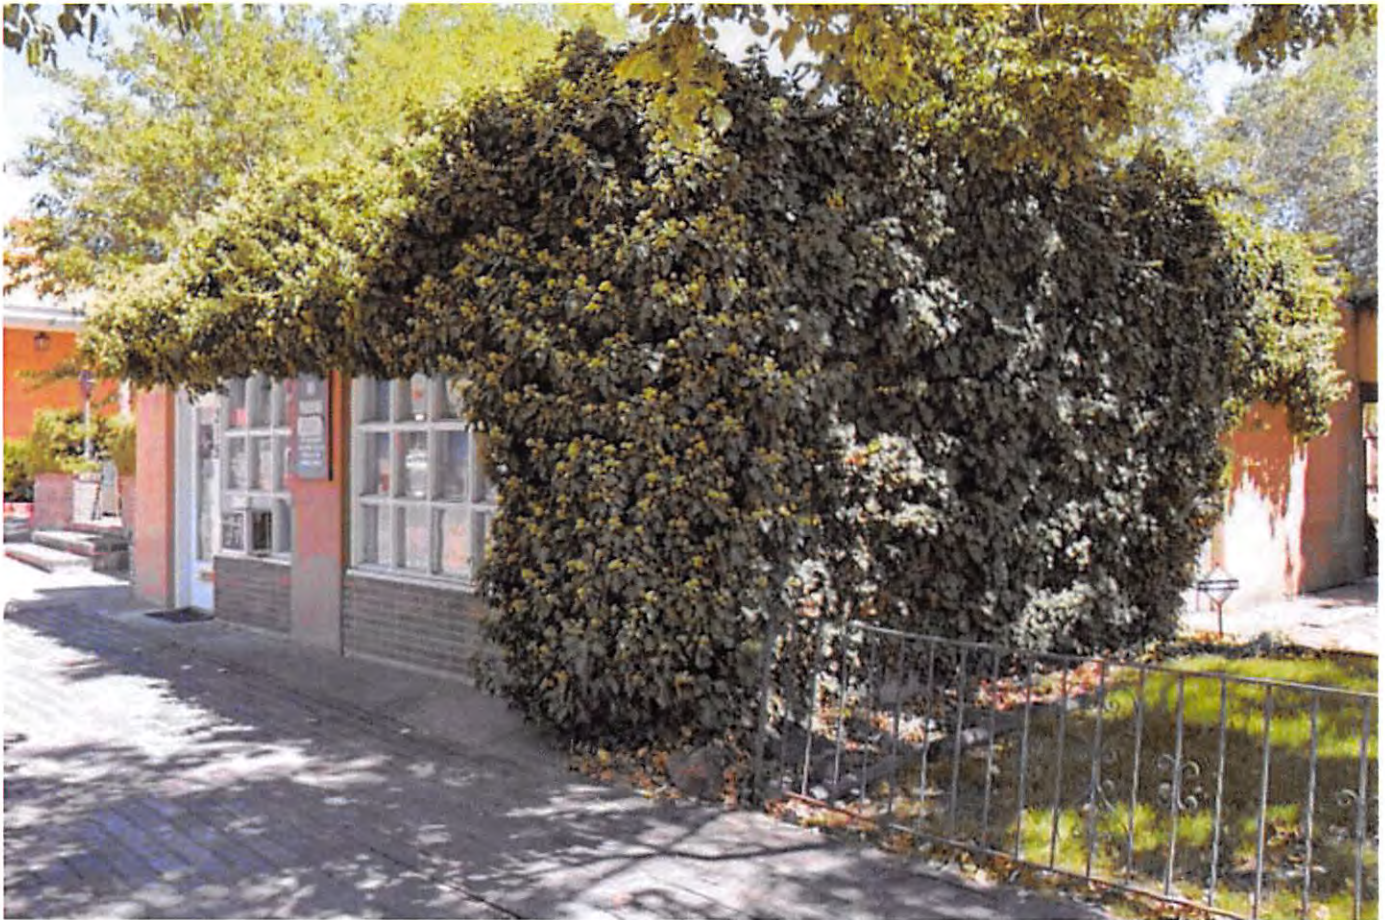
**Photo 1: West (front) elevation.
Camera facing northeast.**

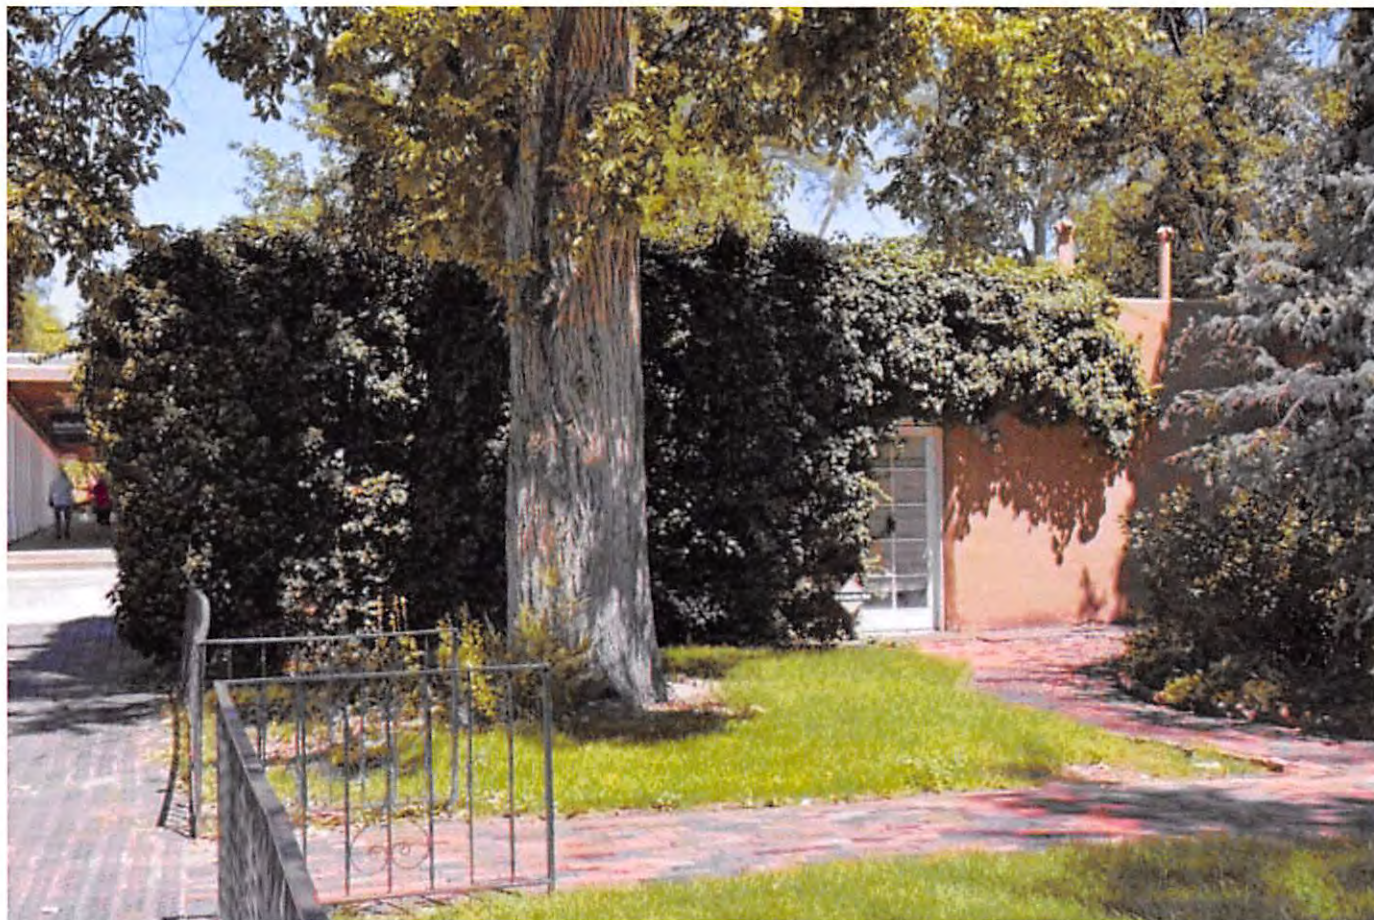
A dense swarm of English ivy covers most of the building’s south exposure and part of its roof. What is visible is a single, 10-light wood door (Photo 2). The north elevation presents a blank wall to the walkway (Photo 3).

Photo 2: Setting and south elevation.
Camera facing northeast.

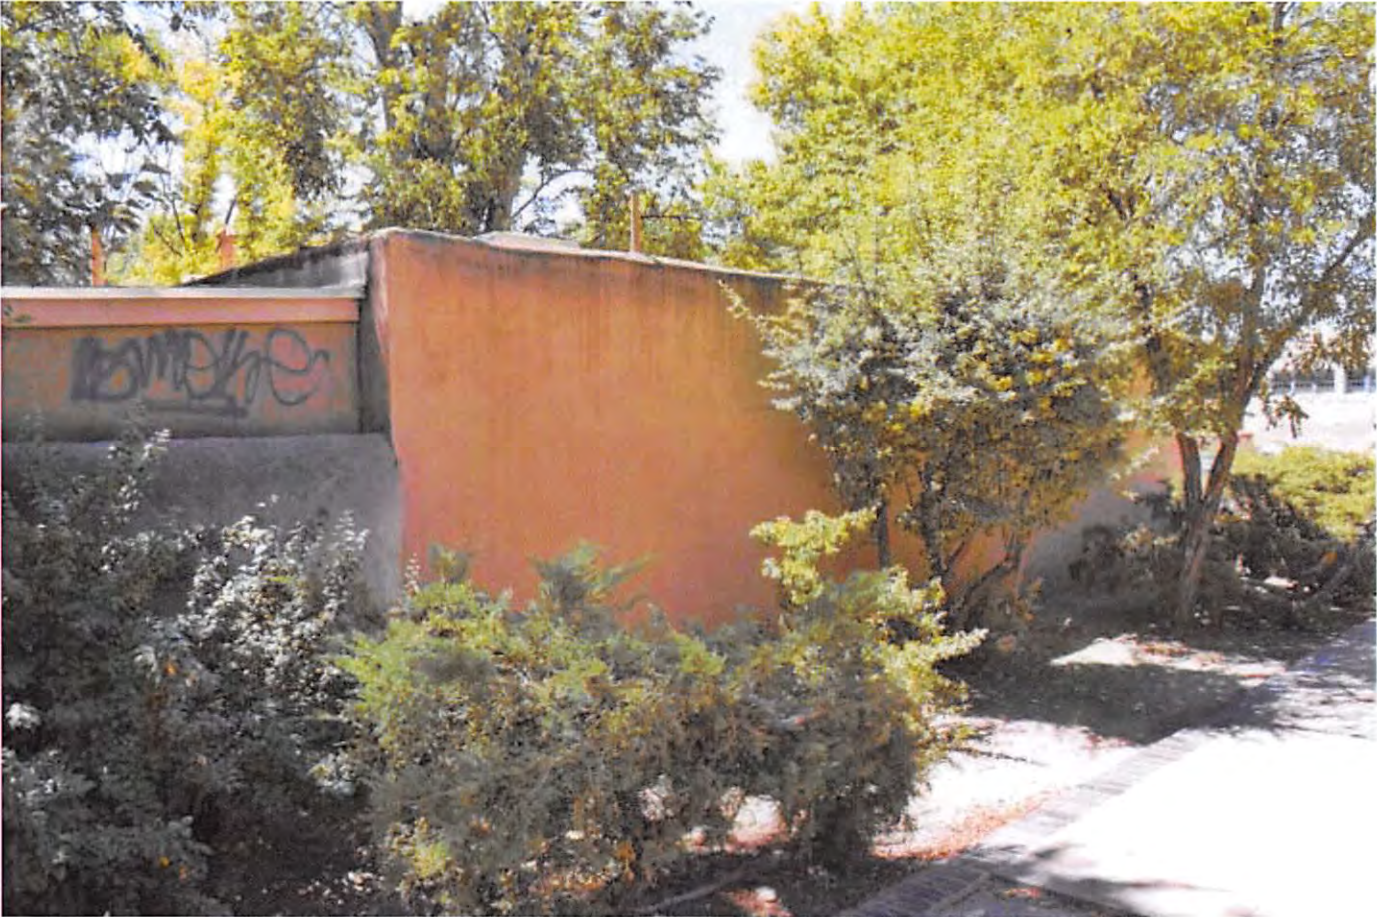
**Photo 3: North elevation, concrete walkway at right corner.
Camera facing southwest.**

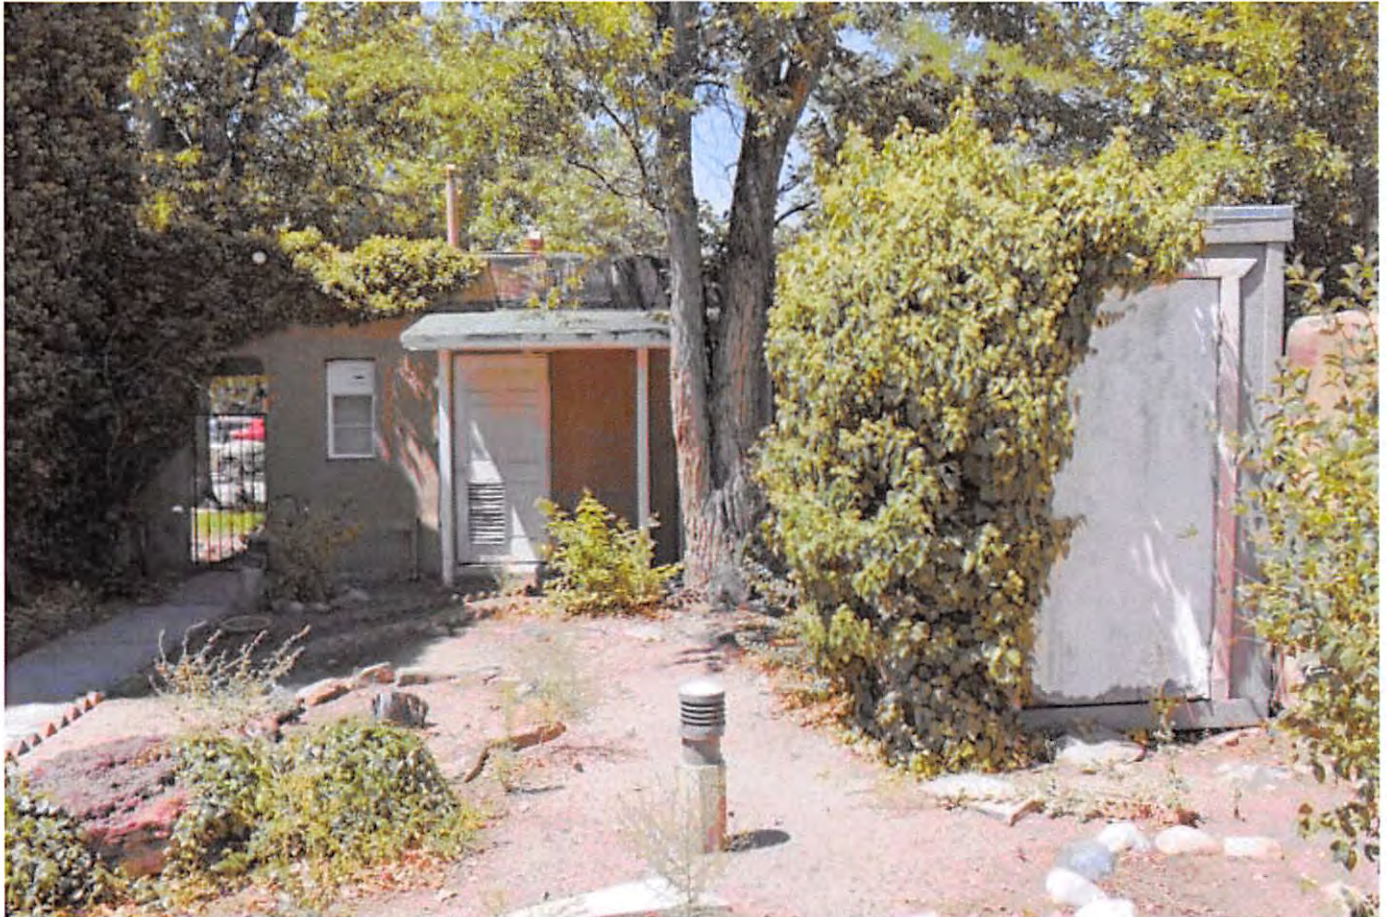
The east elevation is penetrated with a few openings holding an altered steel casement window as well as an older wood-panel door, in which one of the panels has been replaced with a louvered metal vent. A shed-roof porch shelters the entry. Attached this elevation is a 100-square-foot frame utility shed (Photo 4). The primitive addition includes a solid wood door at its east end.

**Photo 4: East elevation, shed addition in foreground.
Camera facing west.**
