HDRB PACKET  
423 A W. SAN FRANCISCO  
Ellen Yarrell

HISTORIC ASSESSMENT  
 NO. 120525-HA

**423 A West San Francisco Street  
 Canale Selection Summary**

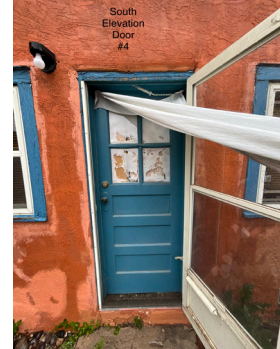
- A. Remove existing non-historic doors, complete partial fill-in, and finish with stucco** The existing opening has been partially filled in from the interior by a prior owner. The primary goal of the proposed exception is to address egress to the east wing. The door has the appearance of a functional exit from the exterior but does not function as a door.

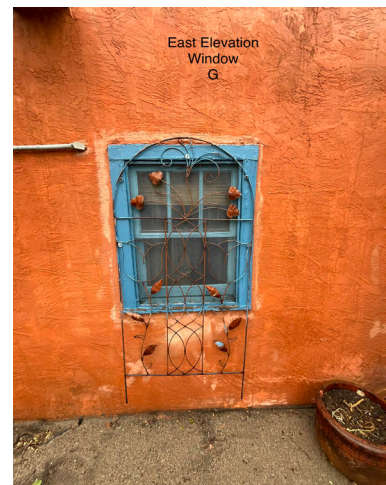
- B. Install double door on the East facade where existing non-historic window.** The proposed door is primarily to improve occupant safety by ensuring that the East Wing bedroom meets current egress requirements. Neither the existing non-historic window on the east wall nor the existing windows on the south wall meet the net clear height minimum size specifications set by the International Residential Code (IRC) for emergency escape and rescue openings. Furthermore, relying on the bathroom windows for egress presents issues

related to privacy and the risk of the bathroom door being locked, which could hinder a quick exit during emergencies. To address these concerns, we propose replacing the non-compliant window on the east wall with a full-height door. This modification will provide a direct and unobstructed exit route from the bedroom to the outside.

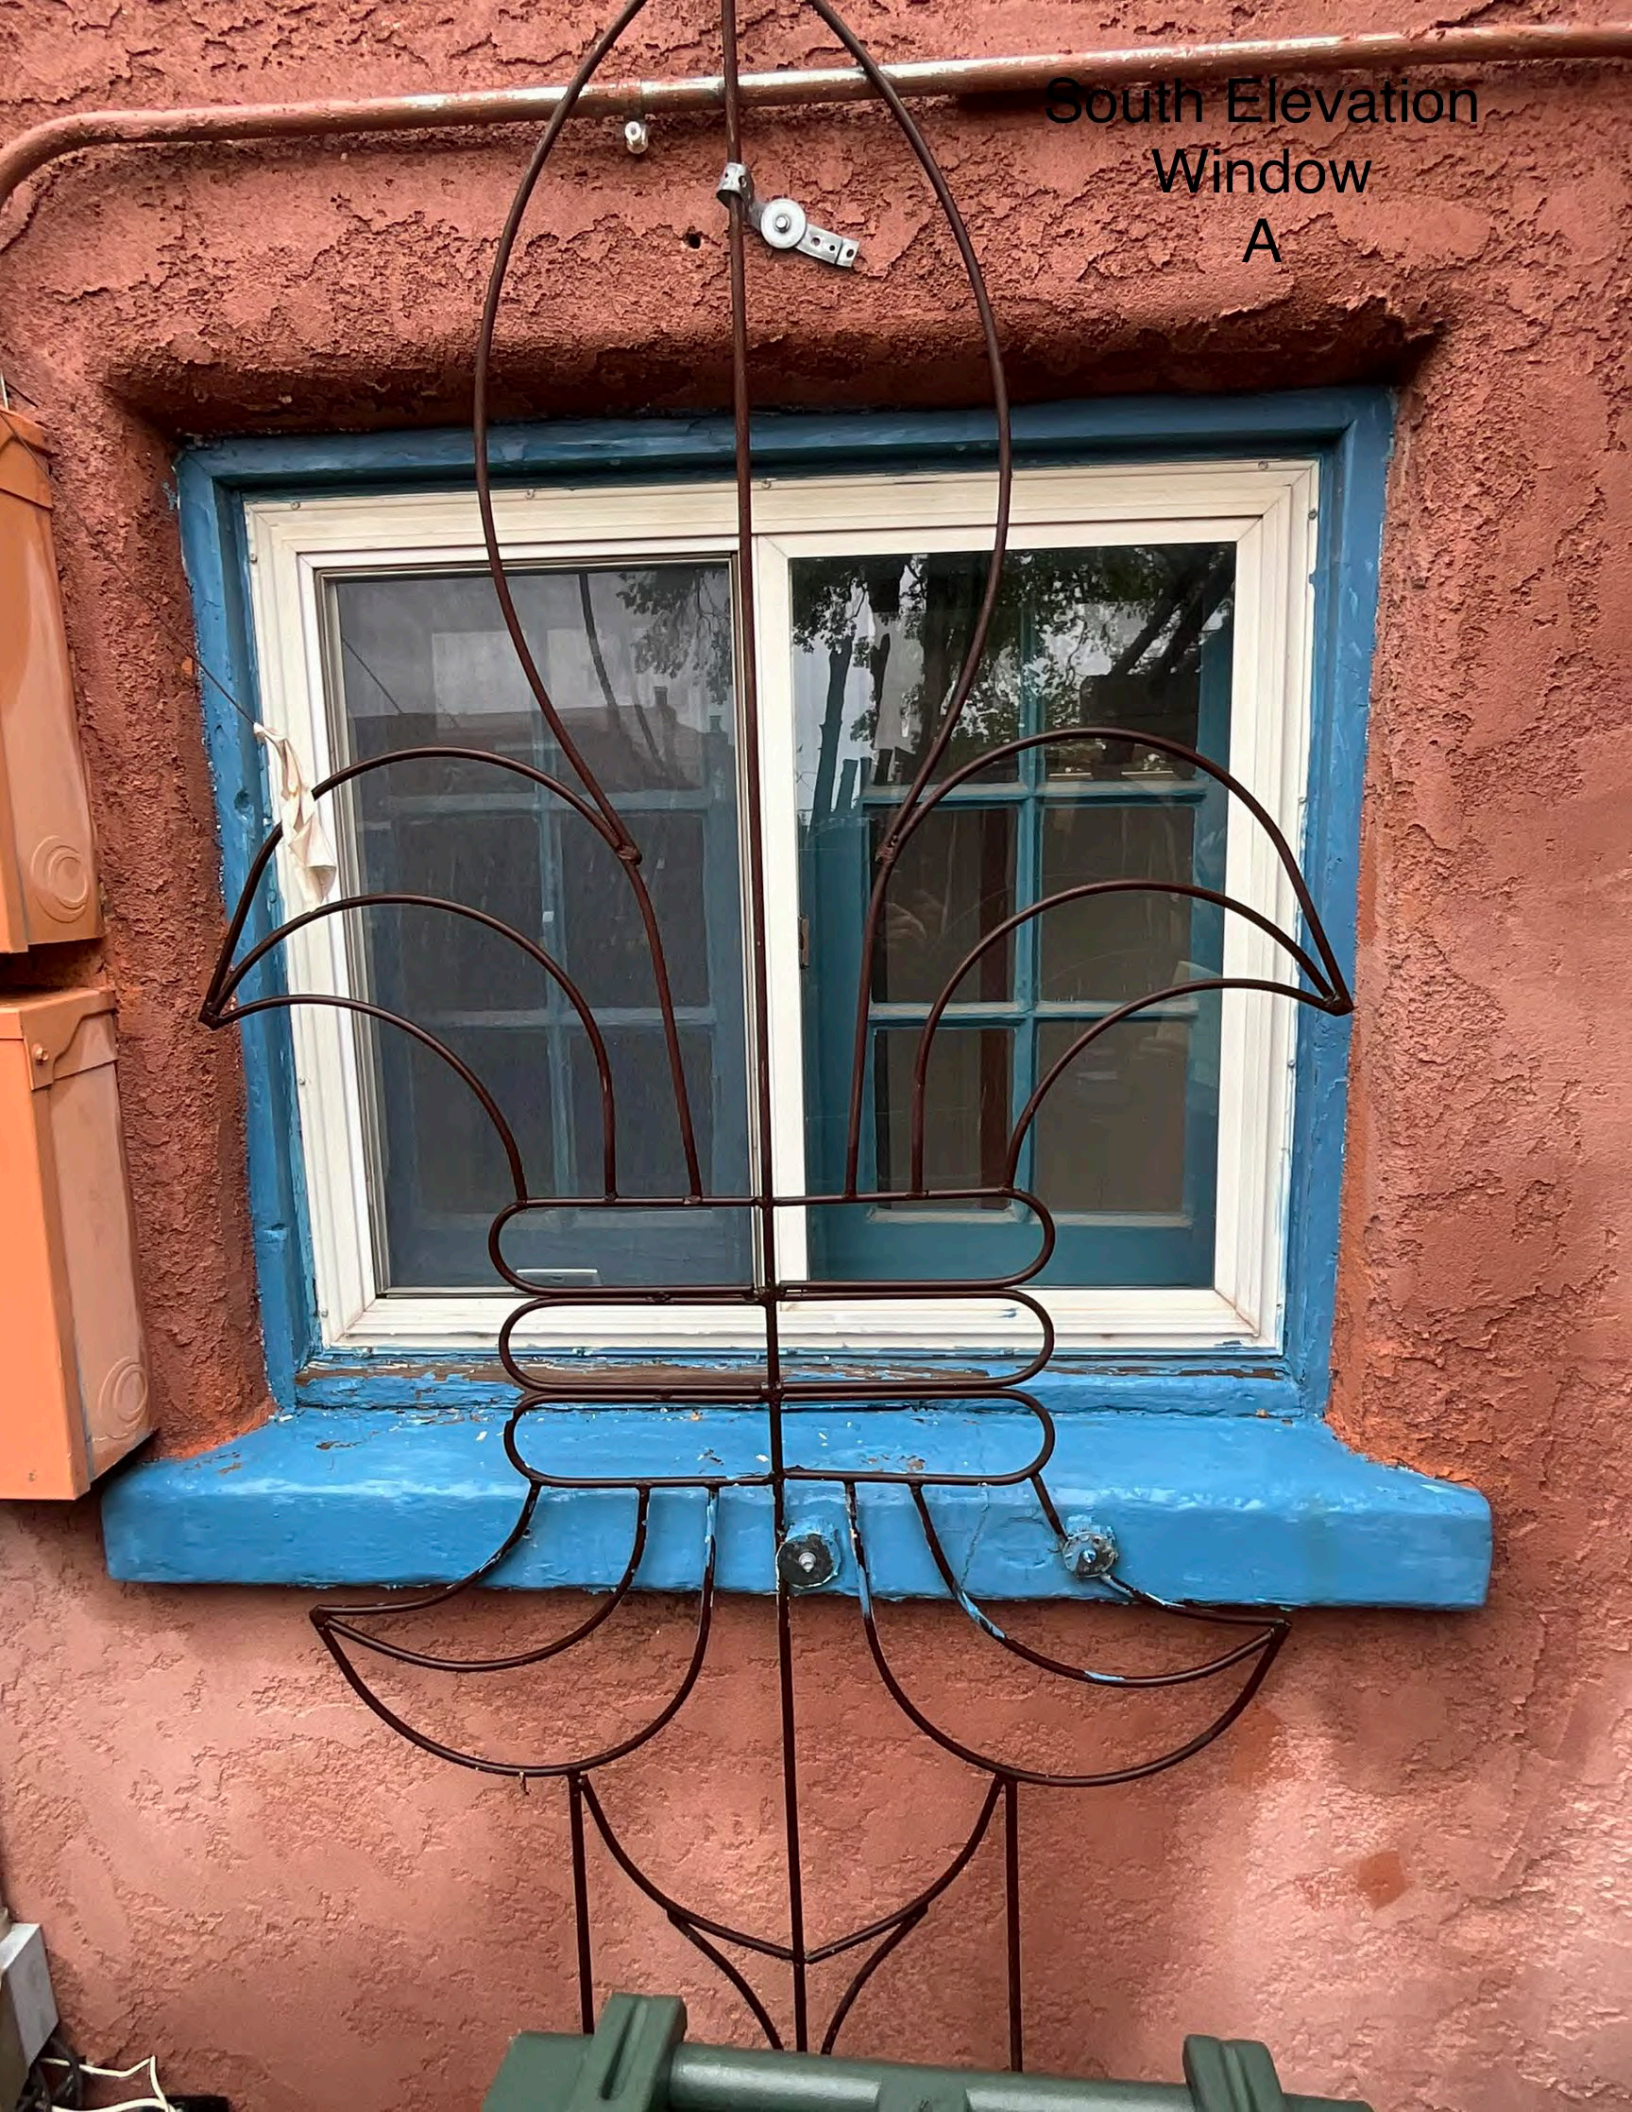
South Elevation  
Window  
A

LABEL	WINDOW & DOOR DESCRIPTION	CONDITION & INTERGRITY CODE	HISTORIC/NON-HISTORIC - AGE
A	18 x 30 – 2 LH INSWING CASEMENT 2W3H STORM ALUMINUM (WHITE)	F	<b>HISTORIC</b> – JAMBS, SASHES, BARN SASHES (1986-1989) <b>NON-HISTORIC</b> – SASHES (1993) <b>NON-HISTORIC</b> – STORM (1993)
DR #1	30 x 75 – LH INSWING DOOR 2W3H/2-HORIZONTAL PANELS ALUMINUM STORM DOOR	S	<b>NON-HISTORIC</b> – DOOR (1993) <b>NON-HISTORIC</b> – STORM DOOR (2000's)
B	16 x 35 – 2 LR INSWING CASEMENT 1-LT W/ALUMINUM STORM (WHITE)	S	<b>HISTORIC</b> – JAMBS, SASHES, SHOPMADE (1986-1989) <b>NON-HISTORIC</b> – SASHES (1993) <b>NON-HISTORIC</b> – STORMS (1993)
C	28 x 54 – DH 1/1 W/ALUMINUM STORMS (WHITE)	S	<b>NON-HISTORIC</b> – 1-LT (NOT DIVIDED LITE LIKE THE ORIGINAL) OPENING CLOSED IN (1986-1989) <b>NON-HISTORIC</b> – ALUMINUM STORMS (2000's)
DR #2	30 x 77 – RH INSWING 3W5H DOOR W/ALUMINUM STORM (WHITE)	S	<b>NON-HISTORIC</b> – SIMPSON DOOR (1993) <b>NON-HISTORIC</b> – STORM (2000's)

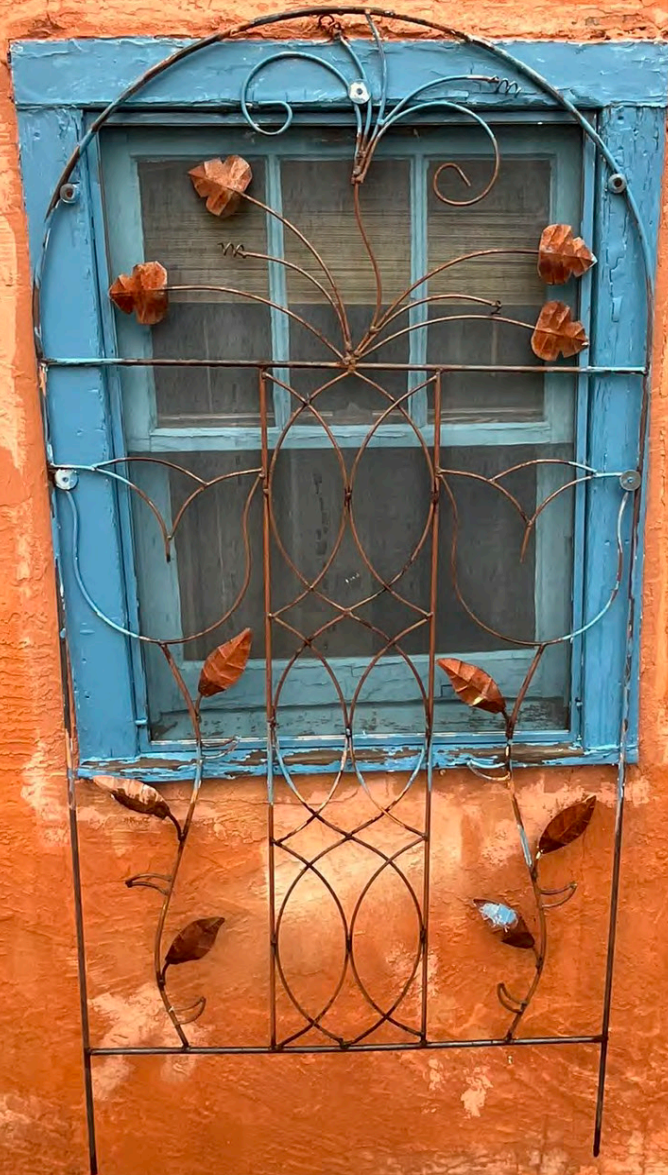
East Elevation  
Window  
G

The only components of the windows and doors that are historic in this building are the jambs in windows A & B. Window G appears to be historic except the stucco and plaster outline appears to be larger than the window.

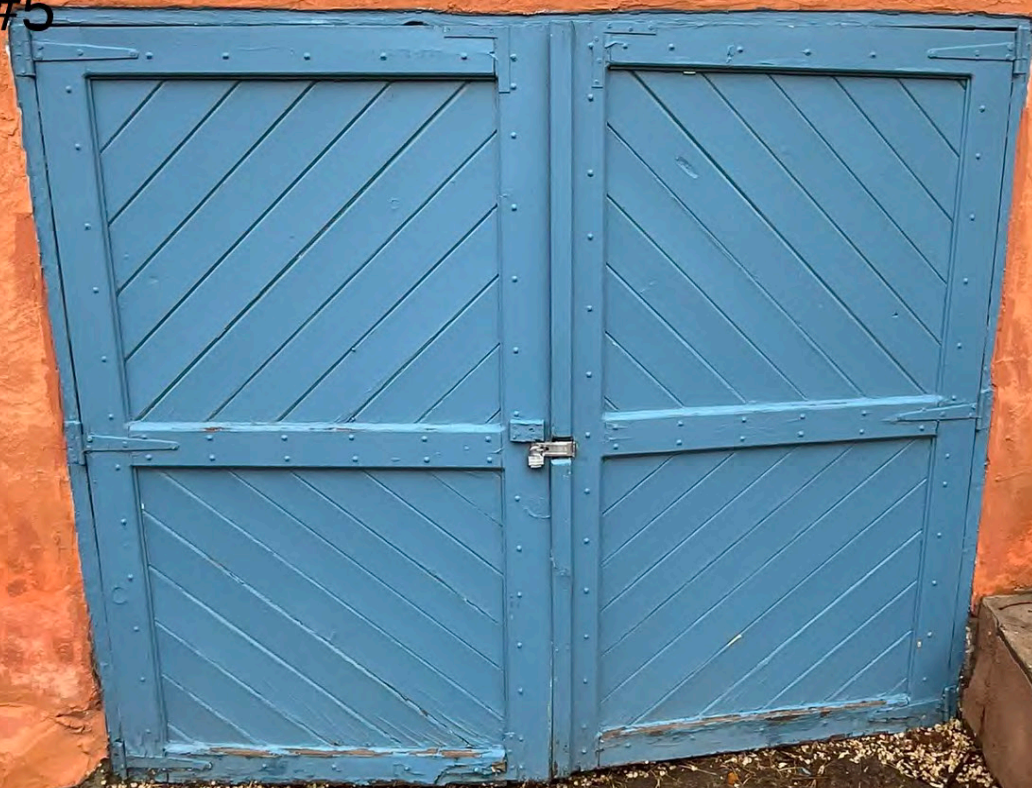
Garage  
West Elevation  
DR #5

Door # 5 on the garage is historic, however most of the wood pieces have been replaced during the 1990's.

This a router end corner on these doors and the router had not been used at this time of early construction Door was redone in the 1990's remodel

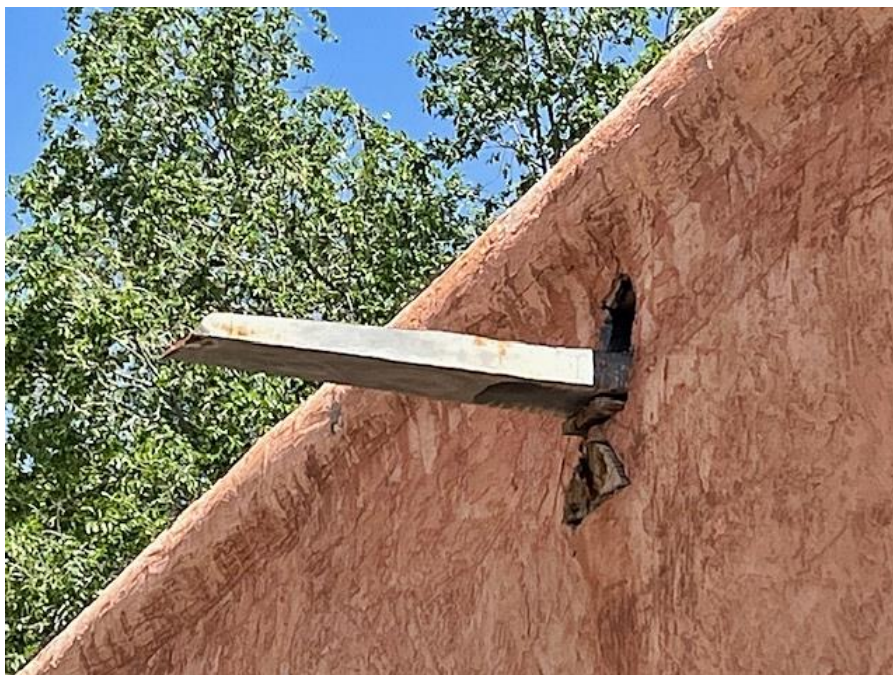
**Figure 1: South façade canale, context view.**

To identify and install suitable replacement canales that match the traditional open-trough style seen on the property—particularly along the south façade of the core block, which exhibits Territorial form and detailing. Both are long and narrow, set into cut-outs in the parapet and supported by vigas. These canales are character-defining features of the building’s era and part of its primary façade designation.

Location	Length from Wall	Parapet Width	Trough Width (at Wall)	Trough Width (at End)	Trough Height
South (two)	2'-3"	1'-3"	6"	4"	3"
East (one)	2'	11"	11"	9 ½"	3 ½"

**Galvanized steel canales**, 18–22 gauge, with welded side flanges and custom U-shape to match historic trough profile. Painted or patinated finish optional.

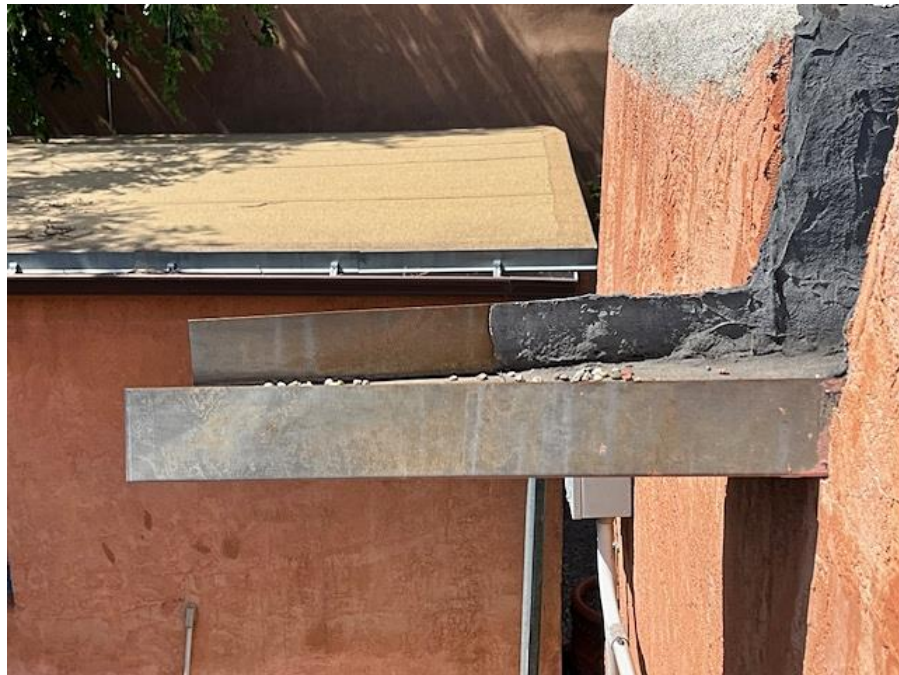
**Figure 4: East elevation canale, side view.**

The east elevation canale is not a character-defining feature and could be replaced with a standard unit approved for use in the Historic Districts
