PROJECT 2025-011537-HDRB, 521 Calle Corvo, Downtown & Eastside Historic District, Contributing,
DESC: Rajah Bose, agent for Louis Pepper & Ruth Williamson, owners, request status review with primary façade(s) designation if applicable.

CASE NUMBER: 2025-011537--HDRB

PROJECT TYPE: Historic Status Review

Historic Cultural Properties Inventory (HCPI) Base Form (FORM 1)

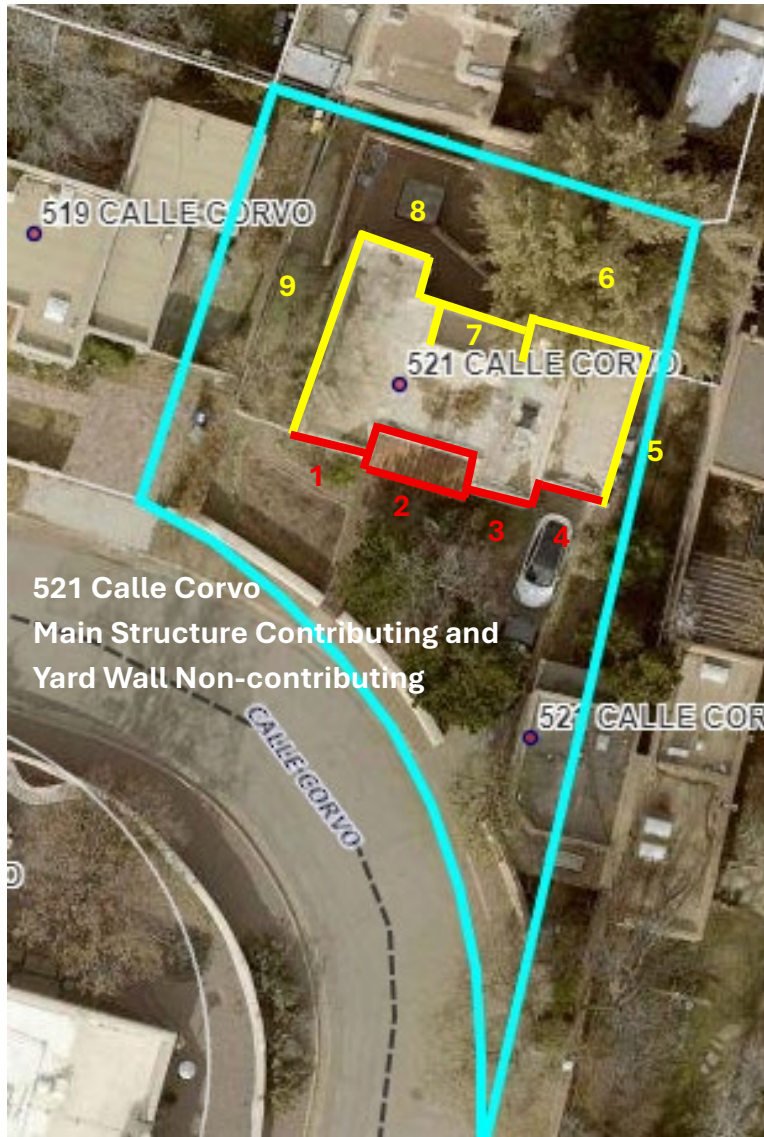
Figure 1: Proposed Façade Diagram for 521 Calle Corvo.

For these reasons, the primary house is recommended to retain Contributing status. The south (front) elevation best expresses the property’s modest Territorial Revival character and architectural details. This elevation, including the attached garage, is recommended as the primary façade. The front yard wall, being of more recent construction, is recommended as Non-contributing.

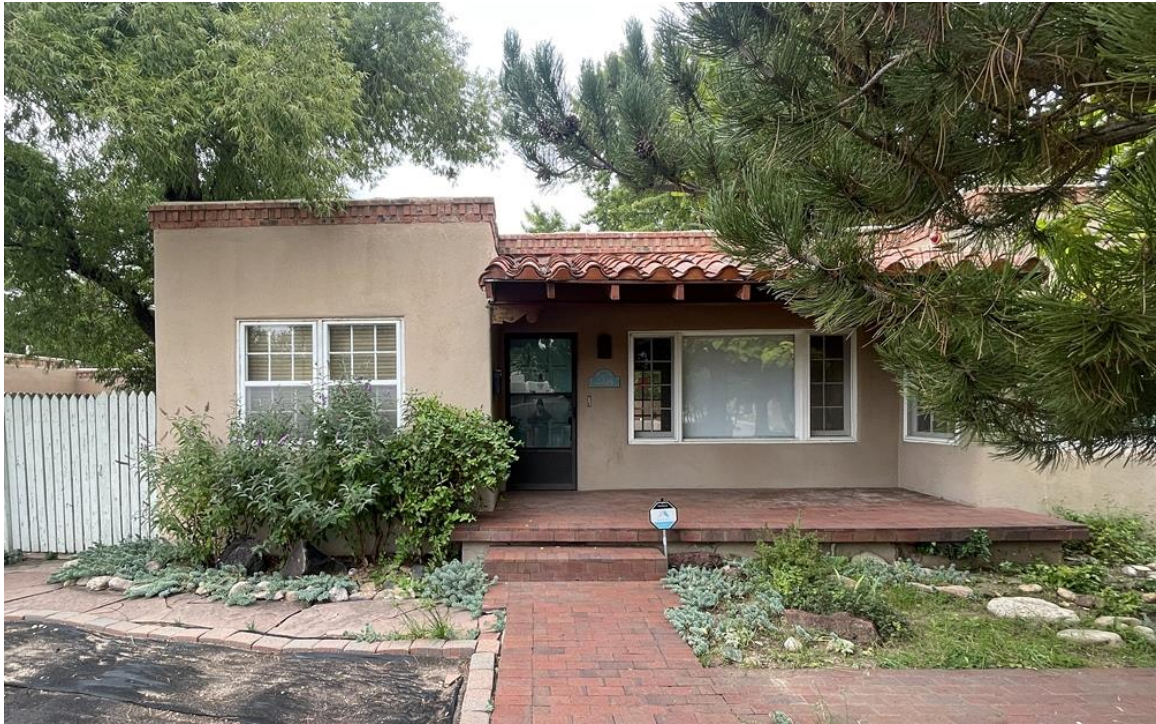
The west projection contains a sitting area with paired six-over-six double-hung sash set closely together without a mullion (Photo 4). Like many of the house’s windows, these are covered by exterior storm units. The east projection contains a modern fixed window that lights a small dining room (Photo 5). Between these two bays lies the *portal*—a four-foot-deep space with a brick floor and a shed roof tiled in clay Spanish units. The use of clay tile over entry roofs is uncommon in the subdivision and contributes to the house’s distinctive appearance.

Photo 4: South (front) façade, west and center sections. Camera facing northeast.

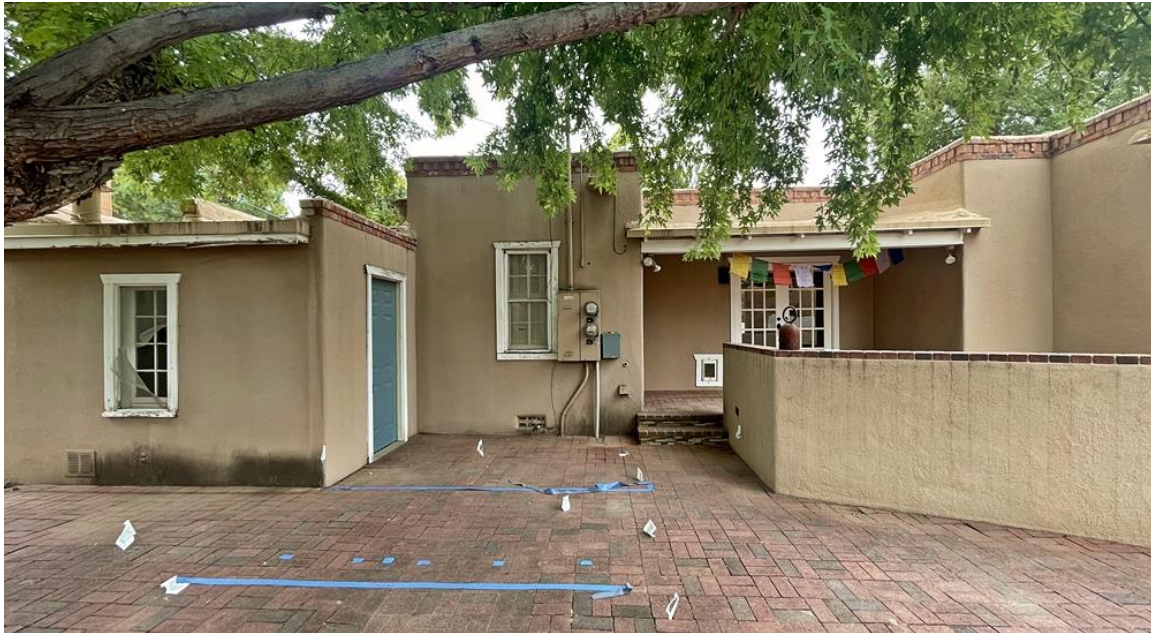
At the east end, the garage extends outward from the house and is fenestrated with an eight-light wood-sash window and a large paneled wood door painted blue (Photo 7). West of the garage is a four-over-four wood double-hung sash lighting the laundry room. The central portion of the elevation includes a small portal that shelters a pair of fifteen-light French doors opening to the living room (Photo 8). The façade terminates in a projecting bay that encloses the primary bedroom, entered from the exterior through a fifteen-light wood door.

Photo 7: North (rear) elevation, east and center sections. Camera facing southwest.
