HISTORIC DISTRICTS REVIEW
BOARD
OCTOBER 08, 2024
5:30 PM
CITY COUNCIL CHAMBERS
CITY HALL
200 LINCOLN AVENUE

PROCEDURES FOR HISTORIC DISTRICTS REVIEW BOARD MEETING:

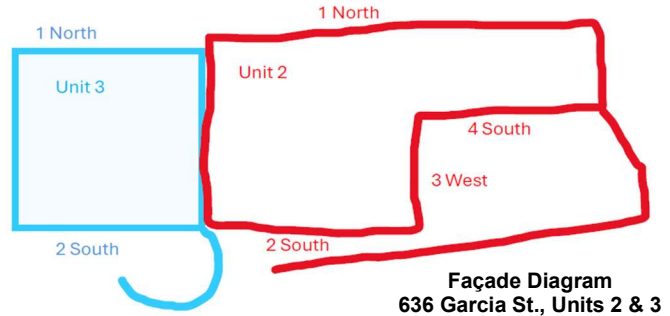
Staff recommends that the historic status of this structure with these two living units be designated as contributing, with the south-facing elevations, façade 2 of Unit 3 and façades 2 and 4 of Unit 2, as the primary façades. The Staff recommends façade 2 of Unit 3 as primary due to the historic width of the door, the layout of the fenestrations and the various rooflines. The Staff recommends façades 2 and 4 of Unit 2 as primary due to the inset of the fenestrations and the variable roofline of the structure.

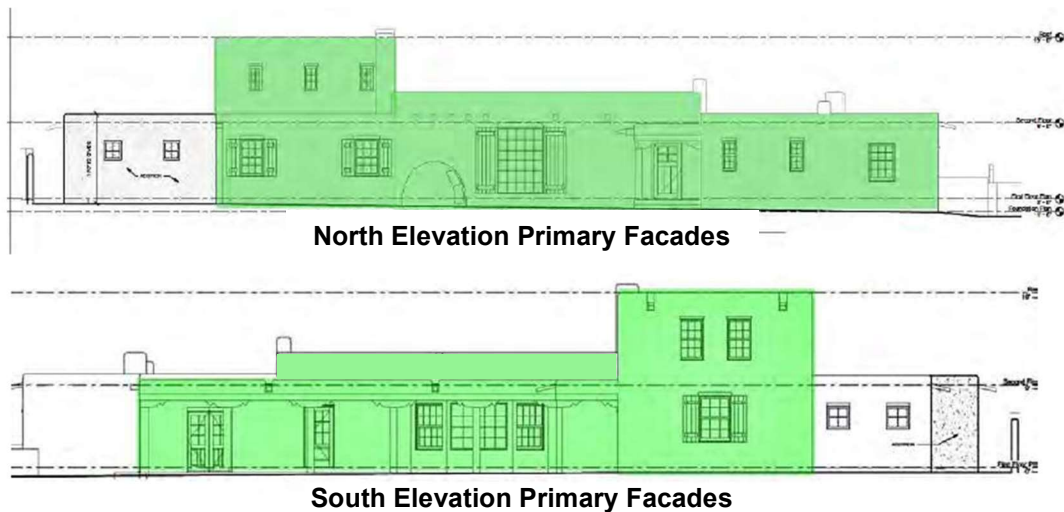
These two facades demonstrate and articulate the original Spanish Pueblo Revival style as seen in the adobe block and wooden viga construction material, flat roof and rounded parapets, and recessed, divided-lite doors and windows.

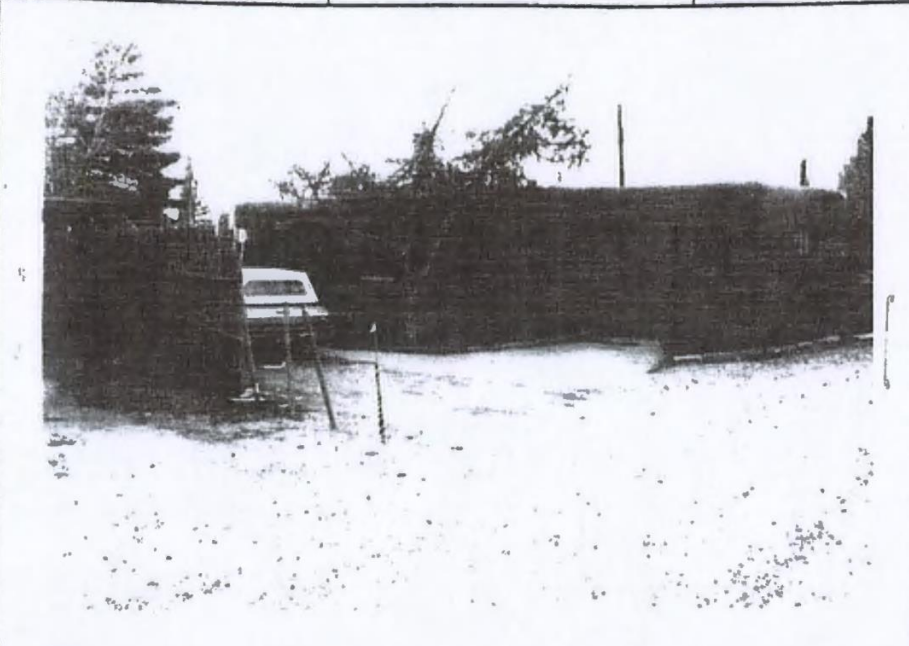
date of construction P estimate actual
source
use present residential other historic residential other
condition excellent good fair deteriorating
degree of remodeling minor moderate major
describe:

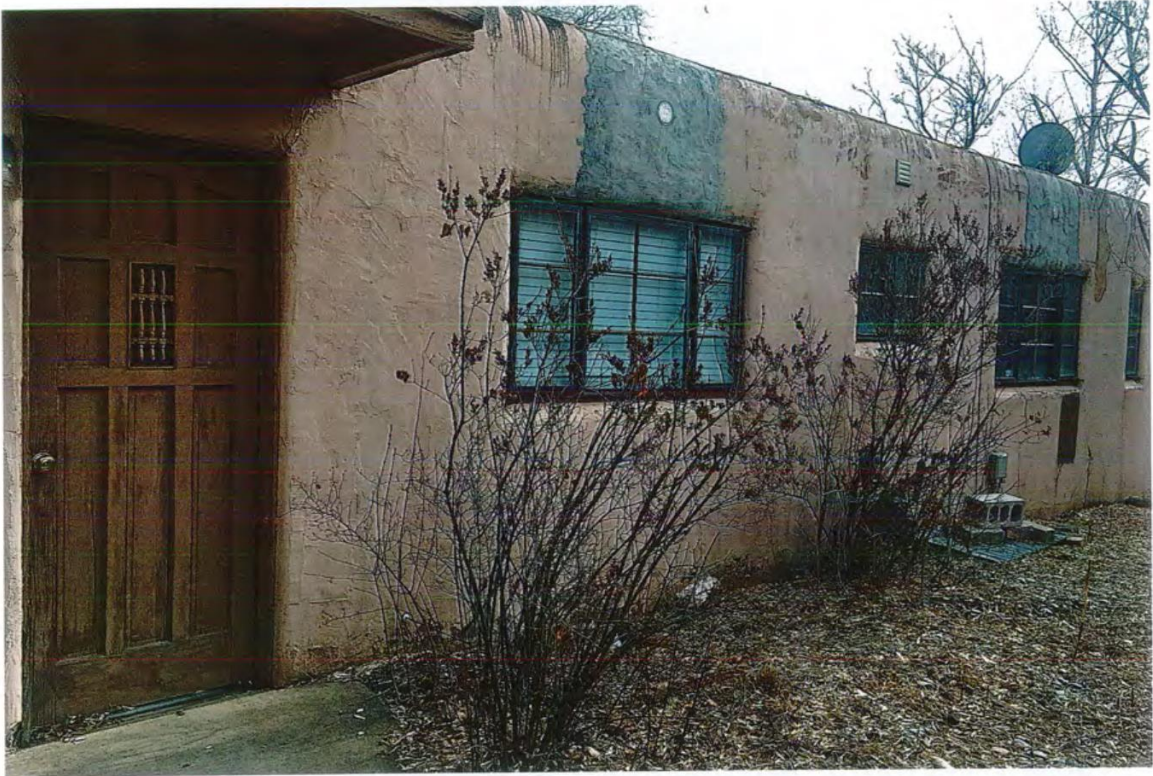
windows J, I, H
(replaced
2019)
WEST

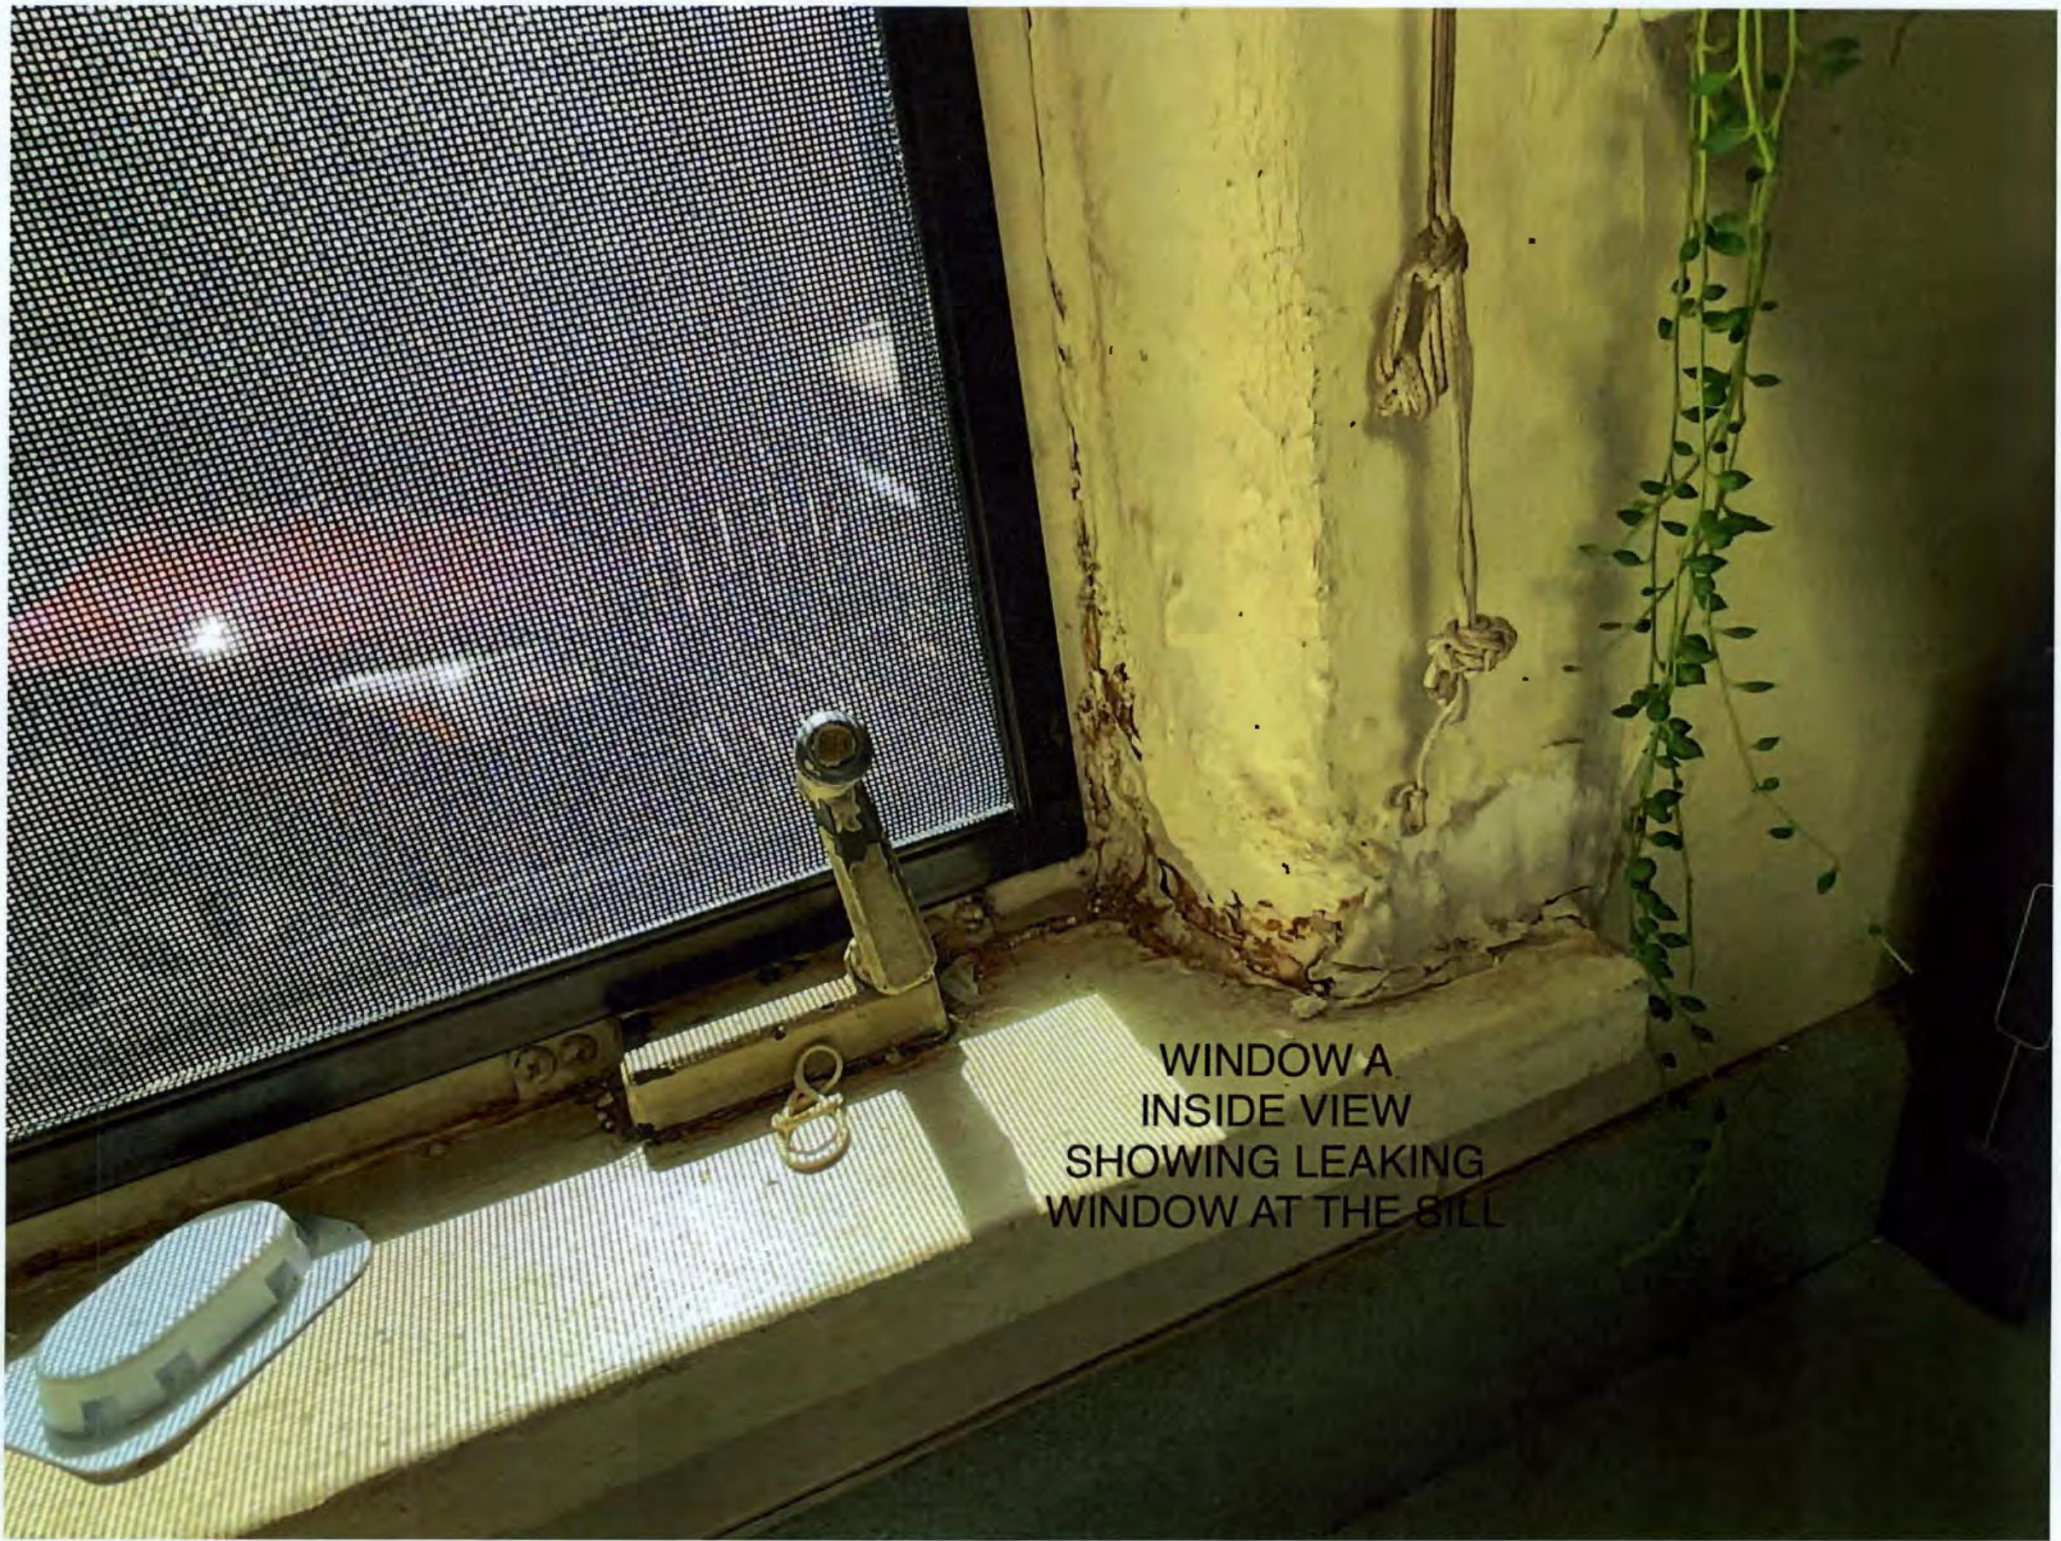
WINDOW A
INSIDE VIEW
SHOWING LEAKING
WINDOW AT THE SILL

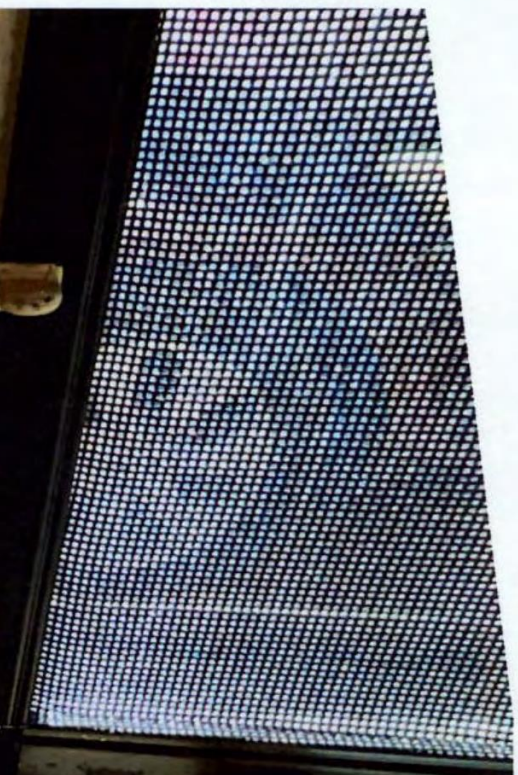
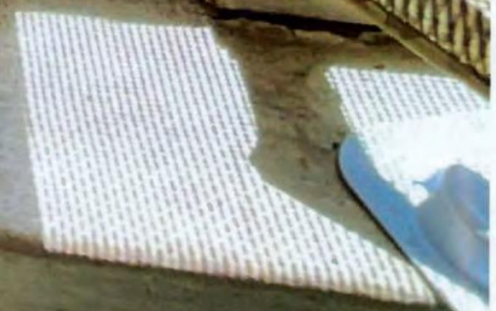
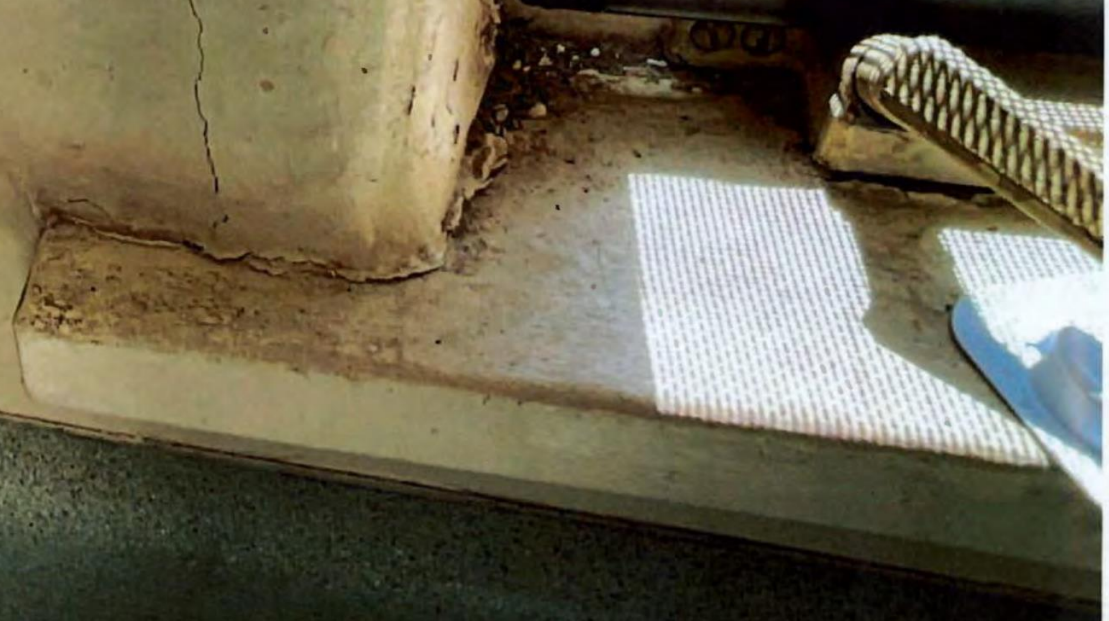
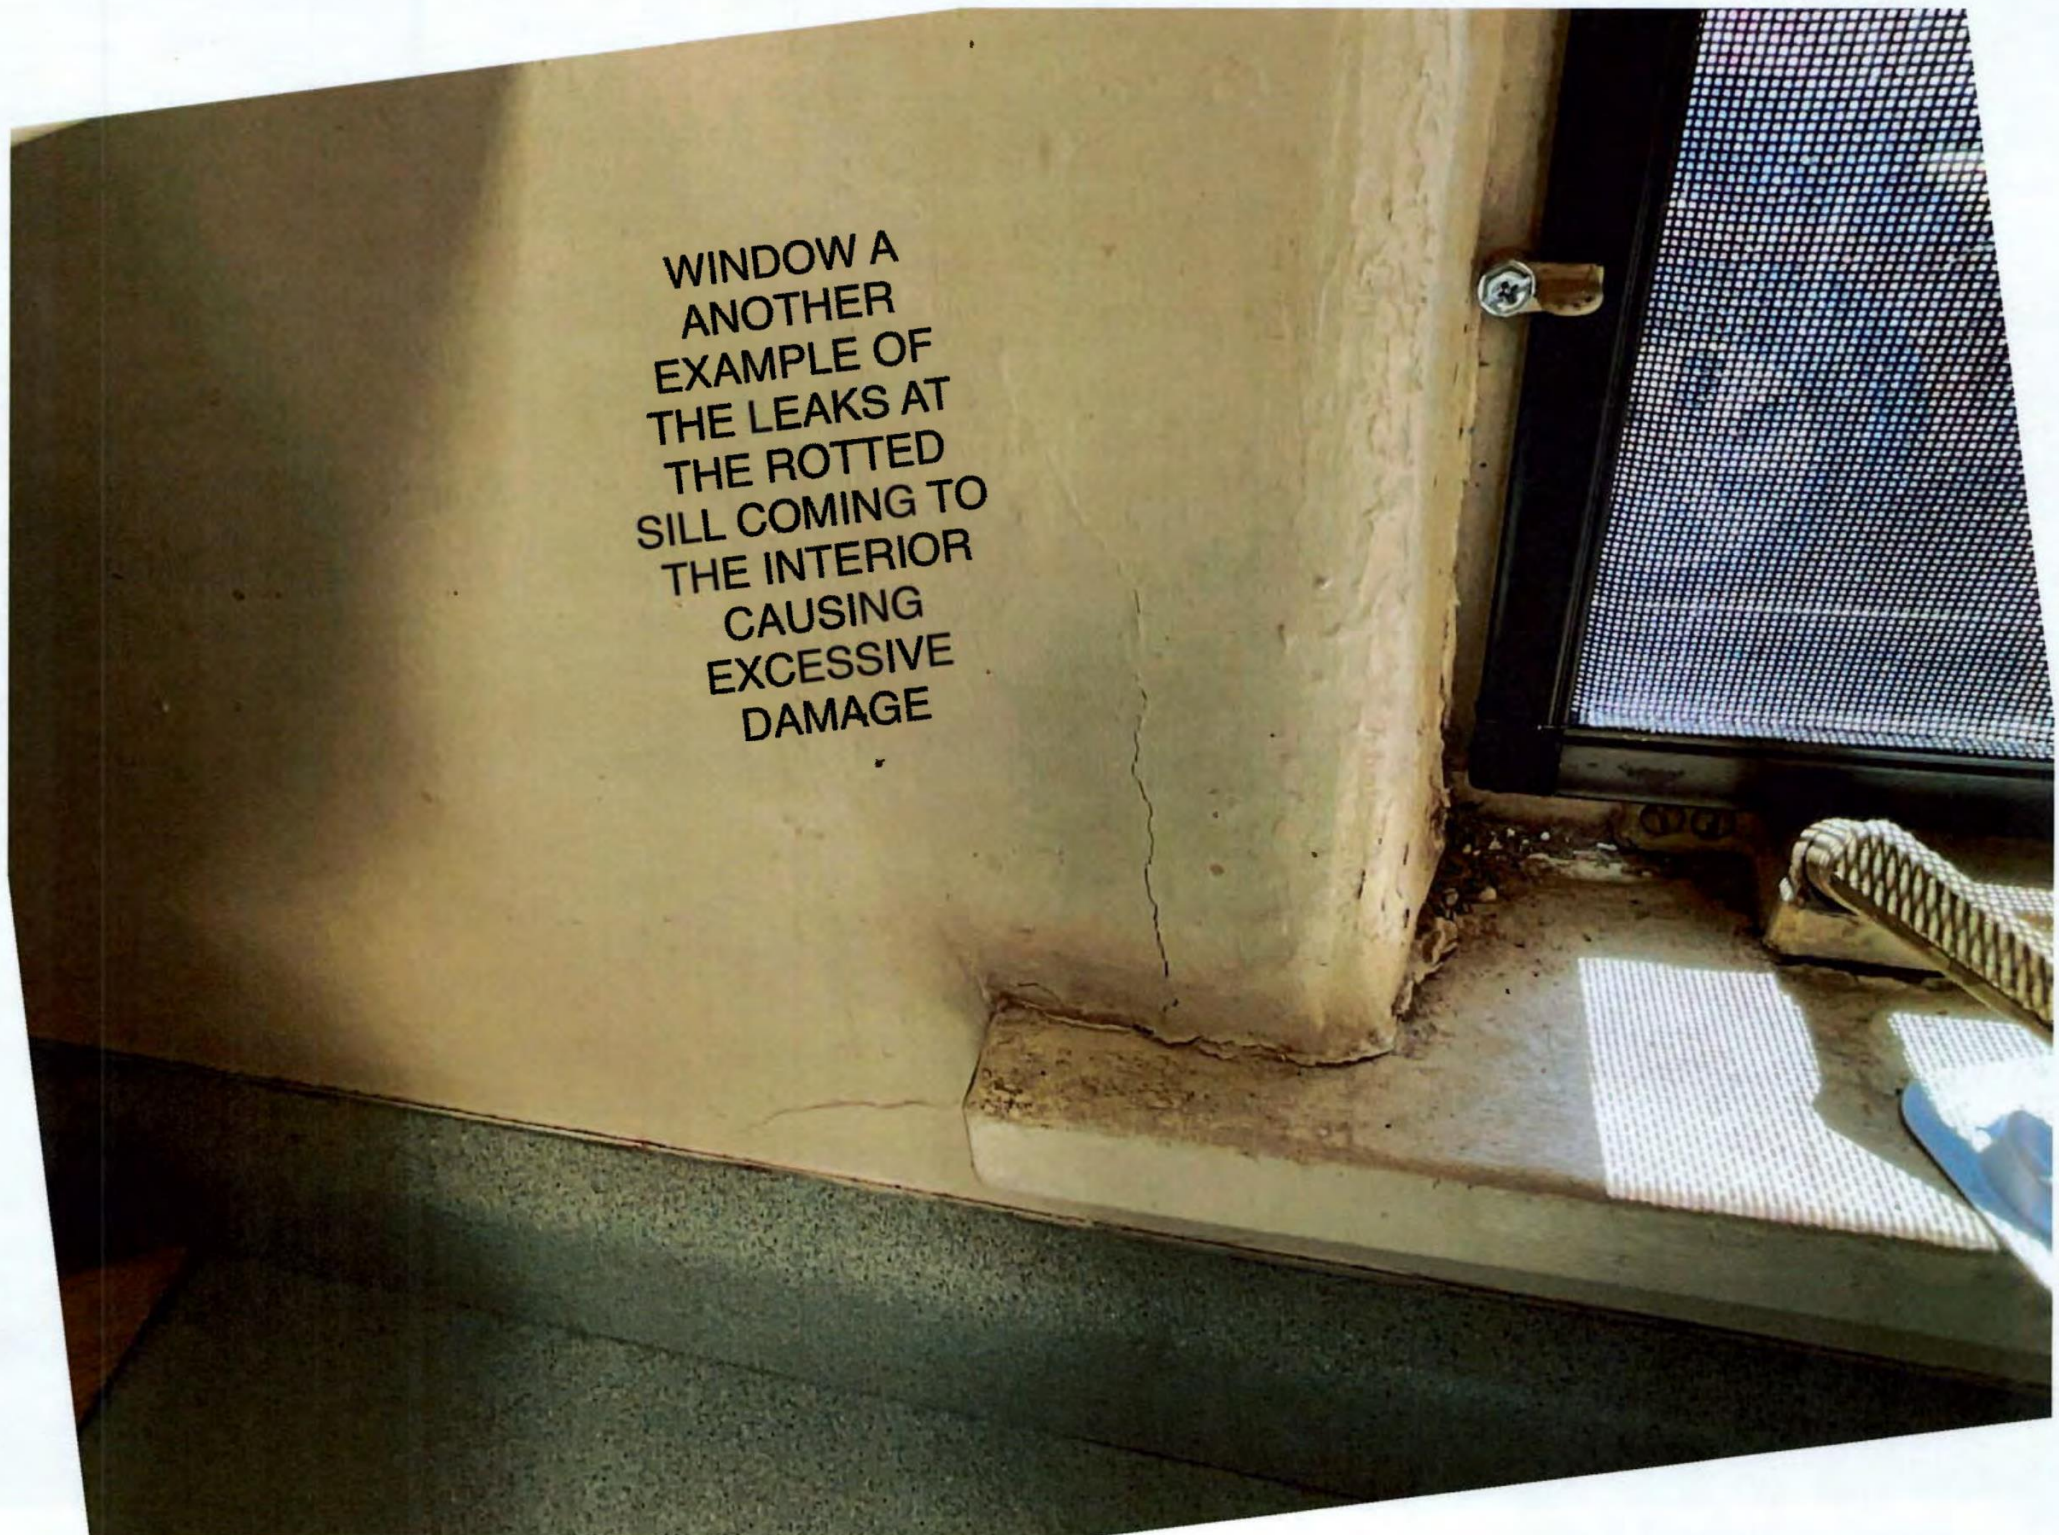
WINDOW A
ANOTHER
EXAMPLE OF
THE LEAKS AT
THE ROTTED
SILL COMING TO
THE INTERIOR
CAUSING
EXCESSIVE
DAMAGE

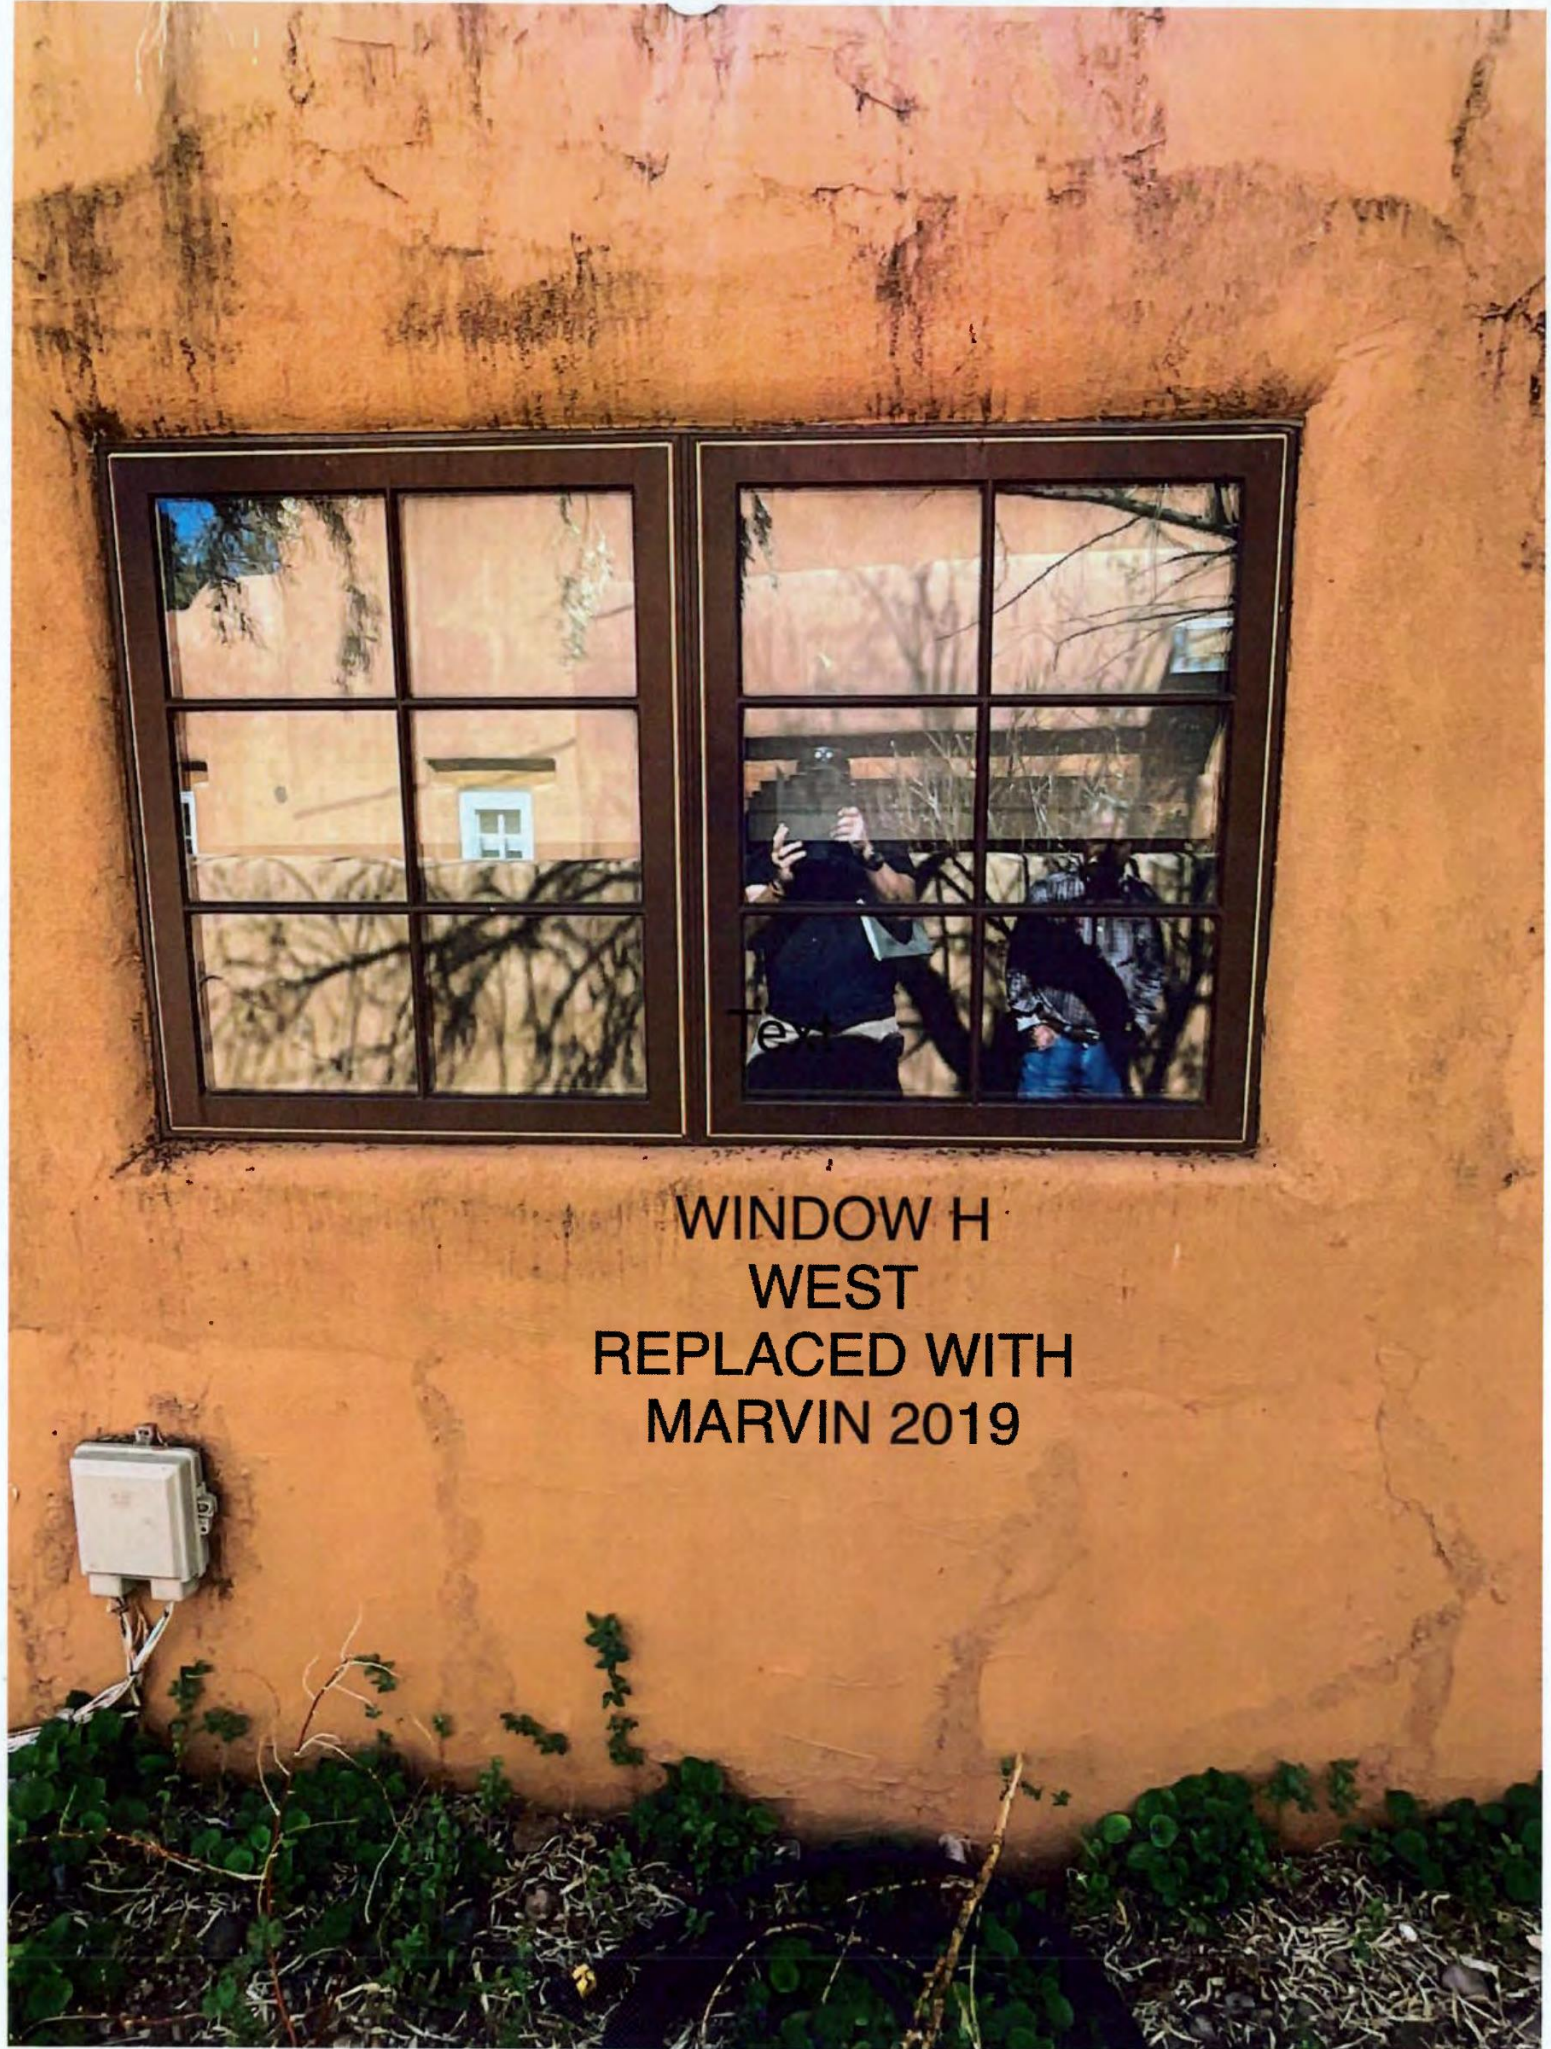
WINDOW H
WEST
REPLACED WITH
MARVIN 2019

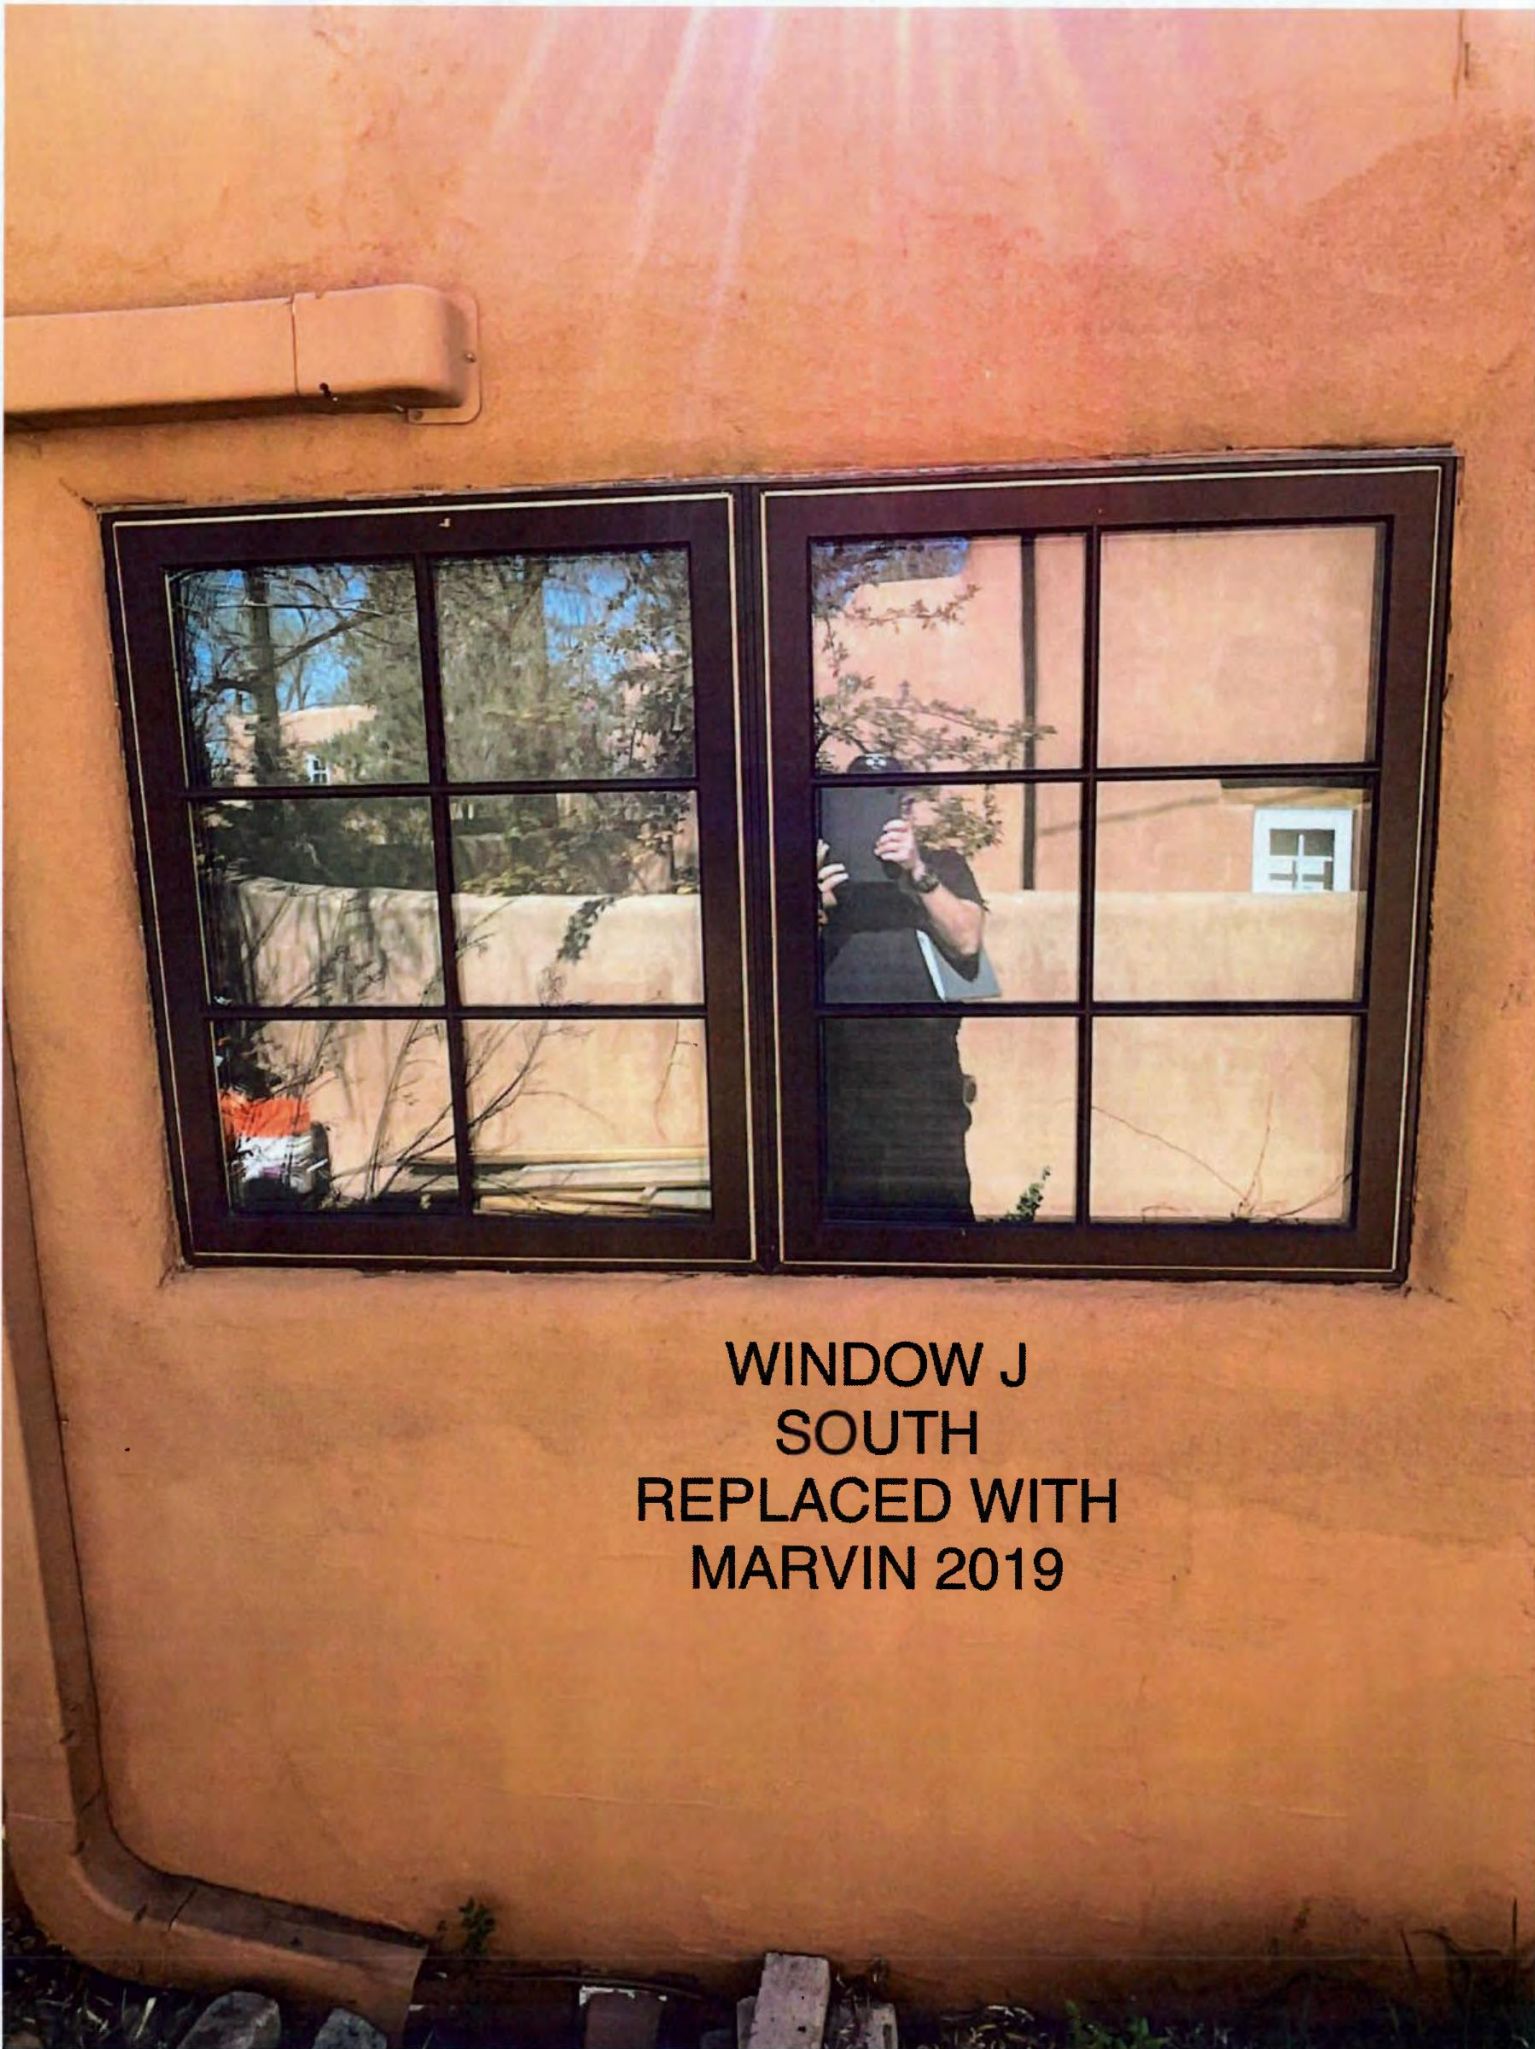
**WINDOW J
SOUTH
REPLACED WITH
MARVIN 2019**

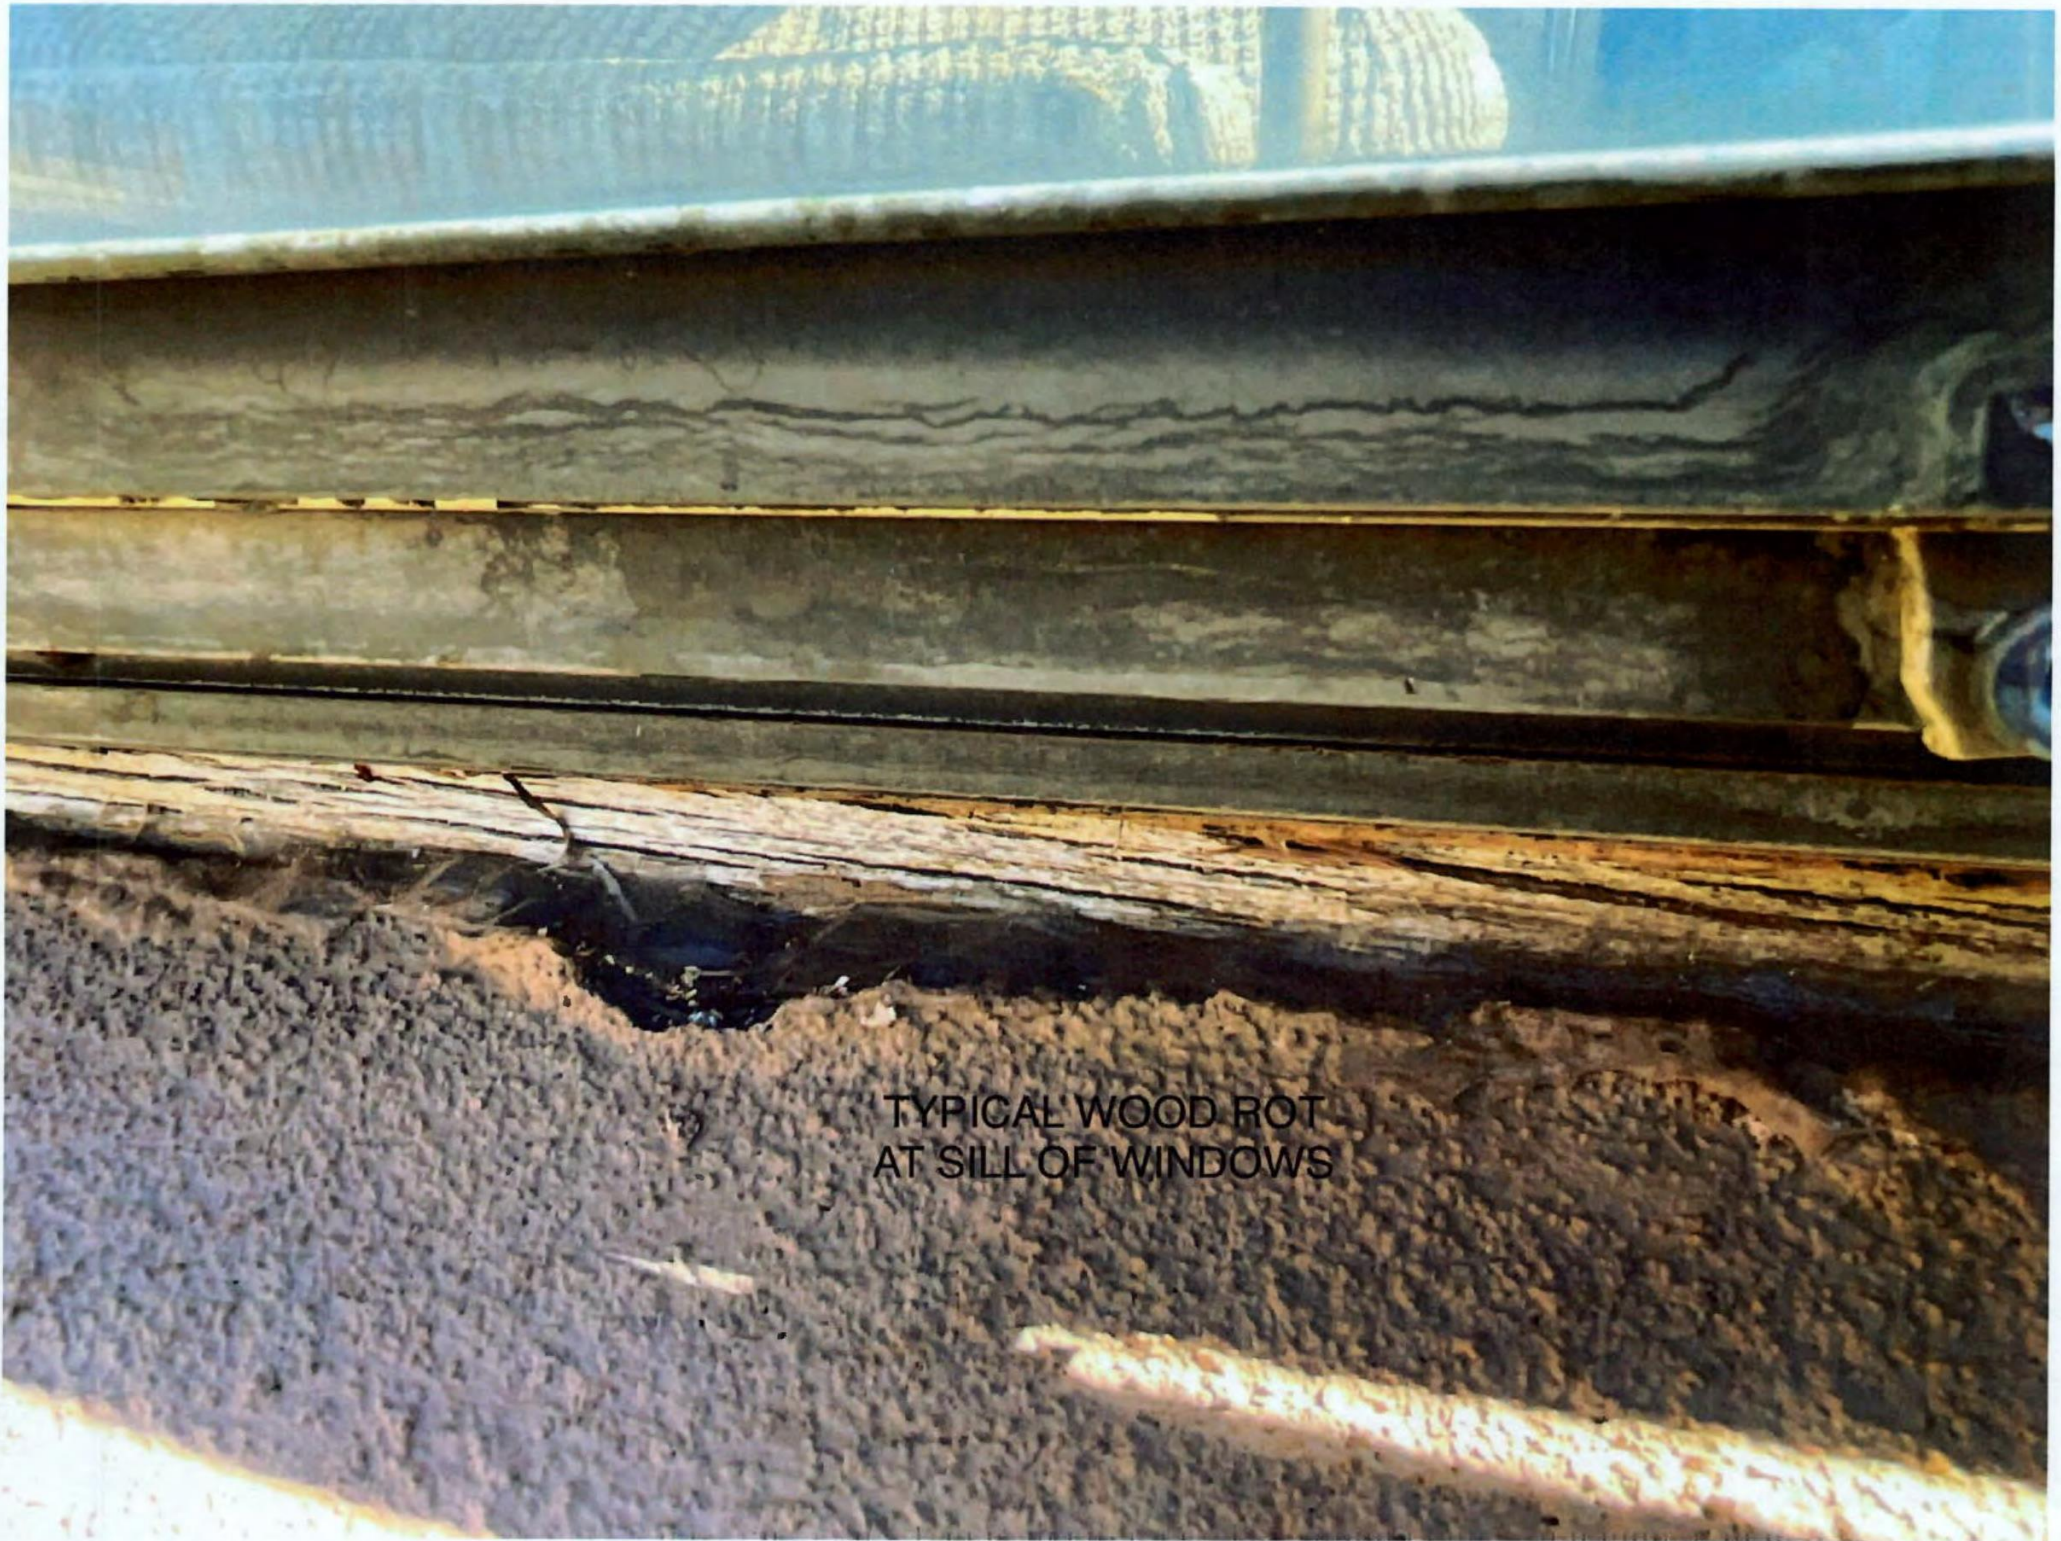
TYPICAL WOOD ROT
AT SILL OF WINDOWS

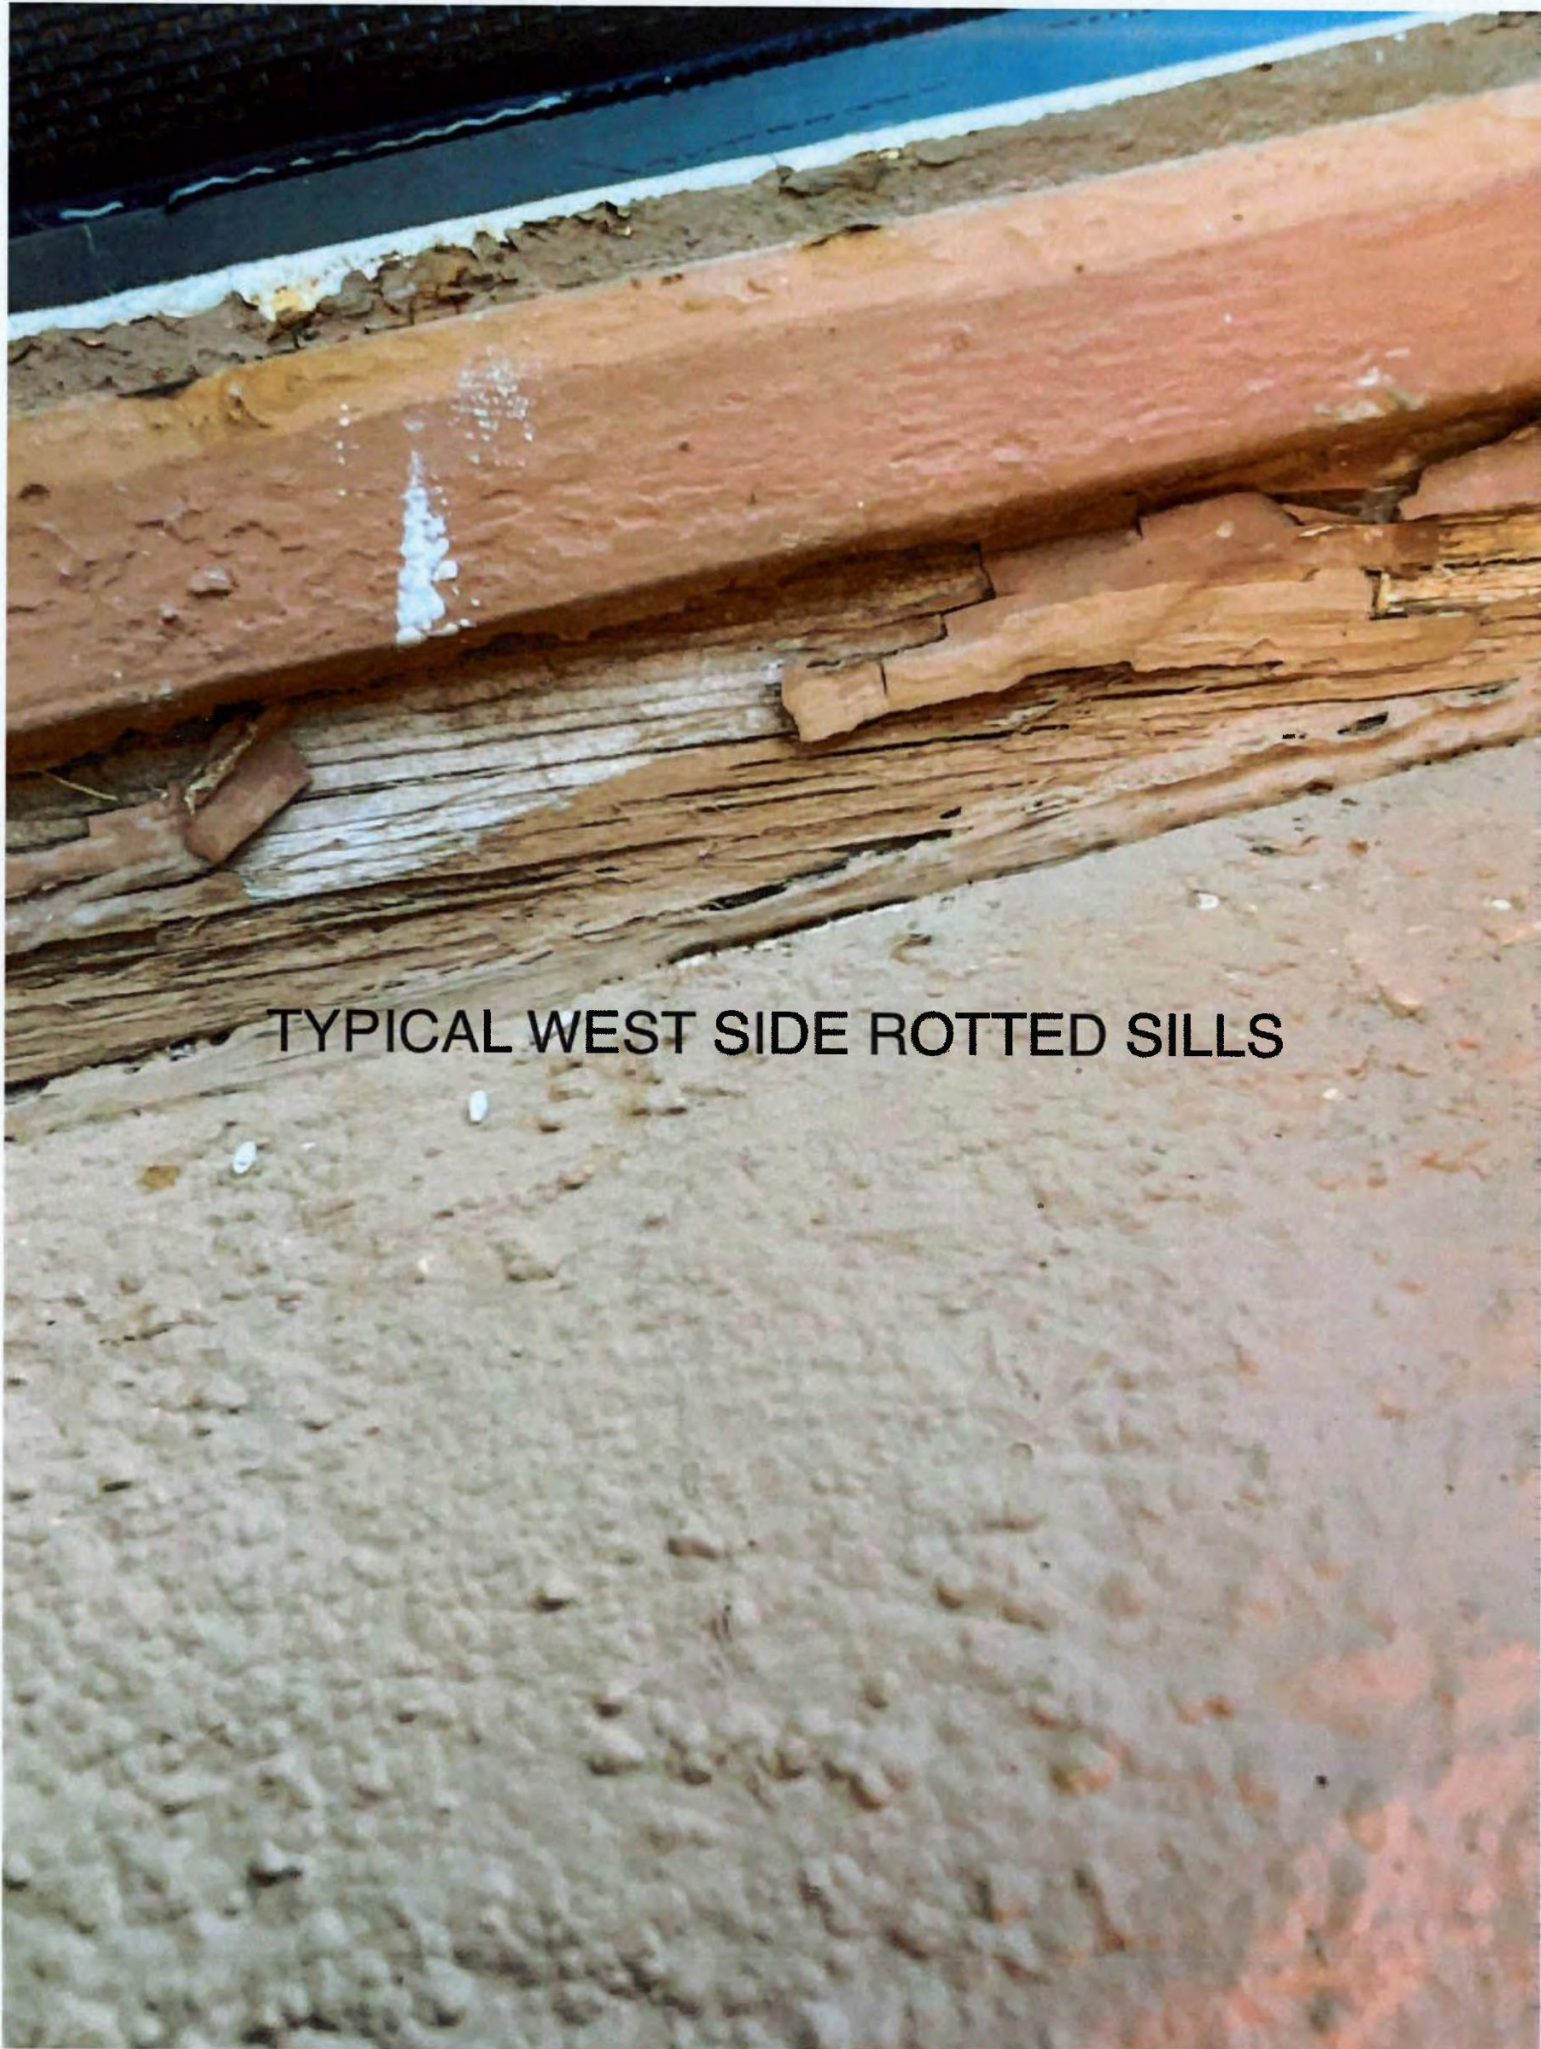
TYPICAL WEST SIDE ROTTED SILLS
