HISTORIC DISTRICTS REVIEW
BOARD
OCTOBER 08, 2024
5:30 PM
CITY COUNCIL CHAMBERS
CITY HALL
200 LINCOLN AVENUE

PROCEDURES FOR HISTORIC DISTRICTS REVIEW BOARD MEETING:

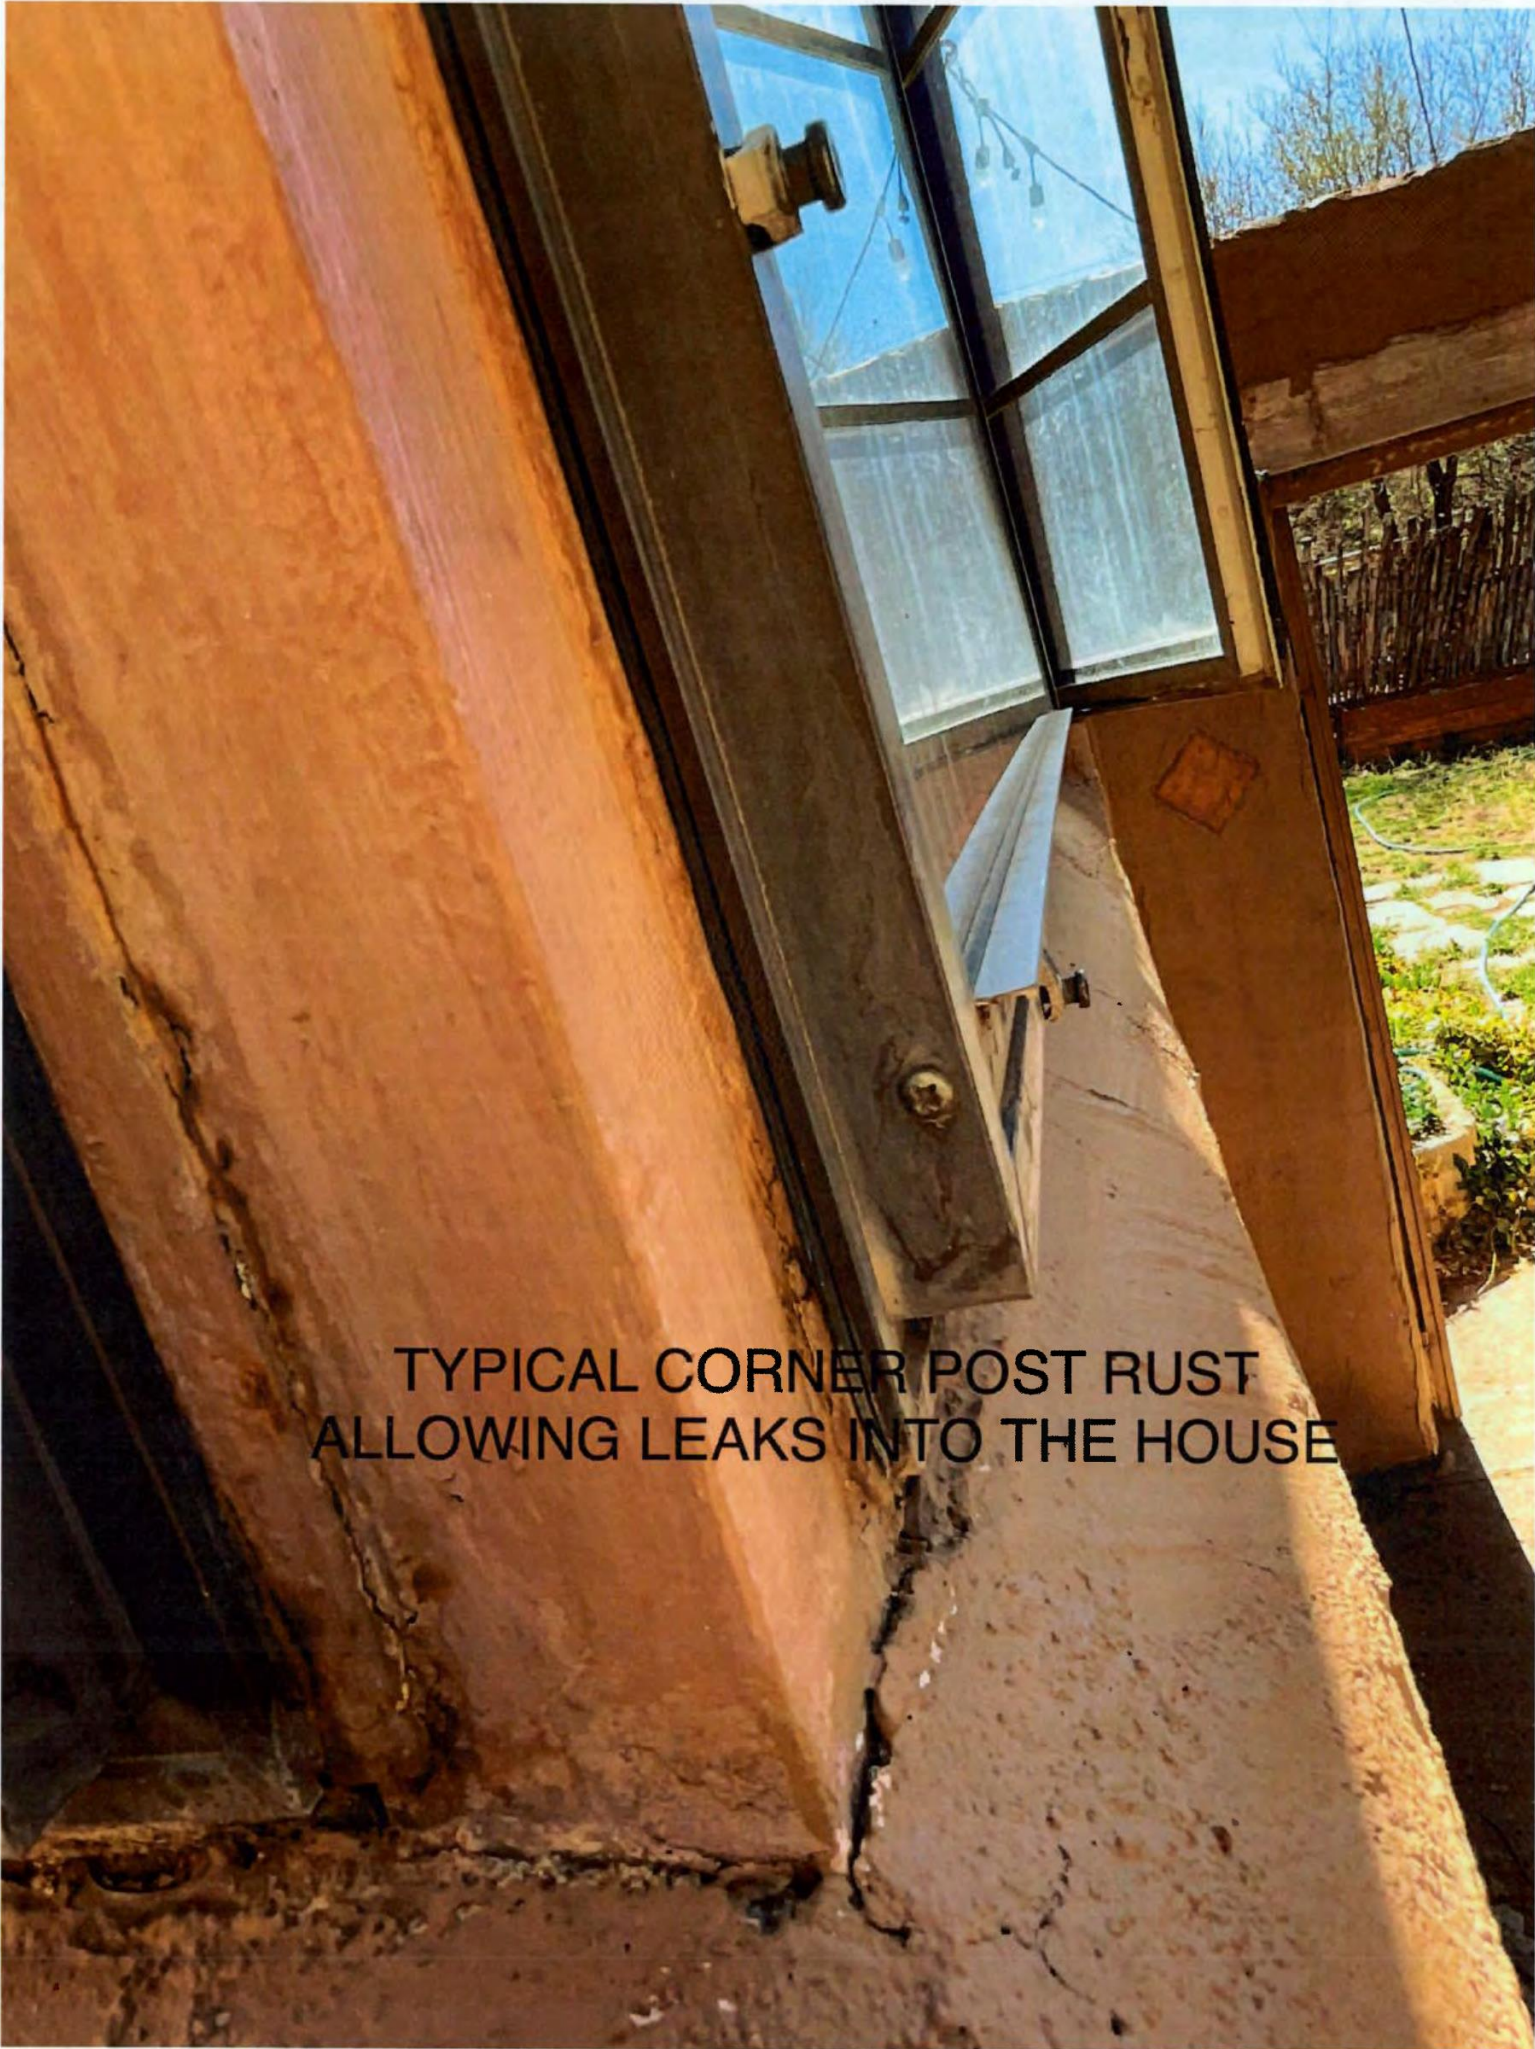
**TYPICAL CORNER POST RUST
ALLOWING LEAKS INTO THE HOUSE**

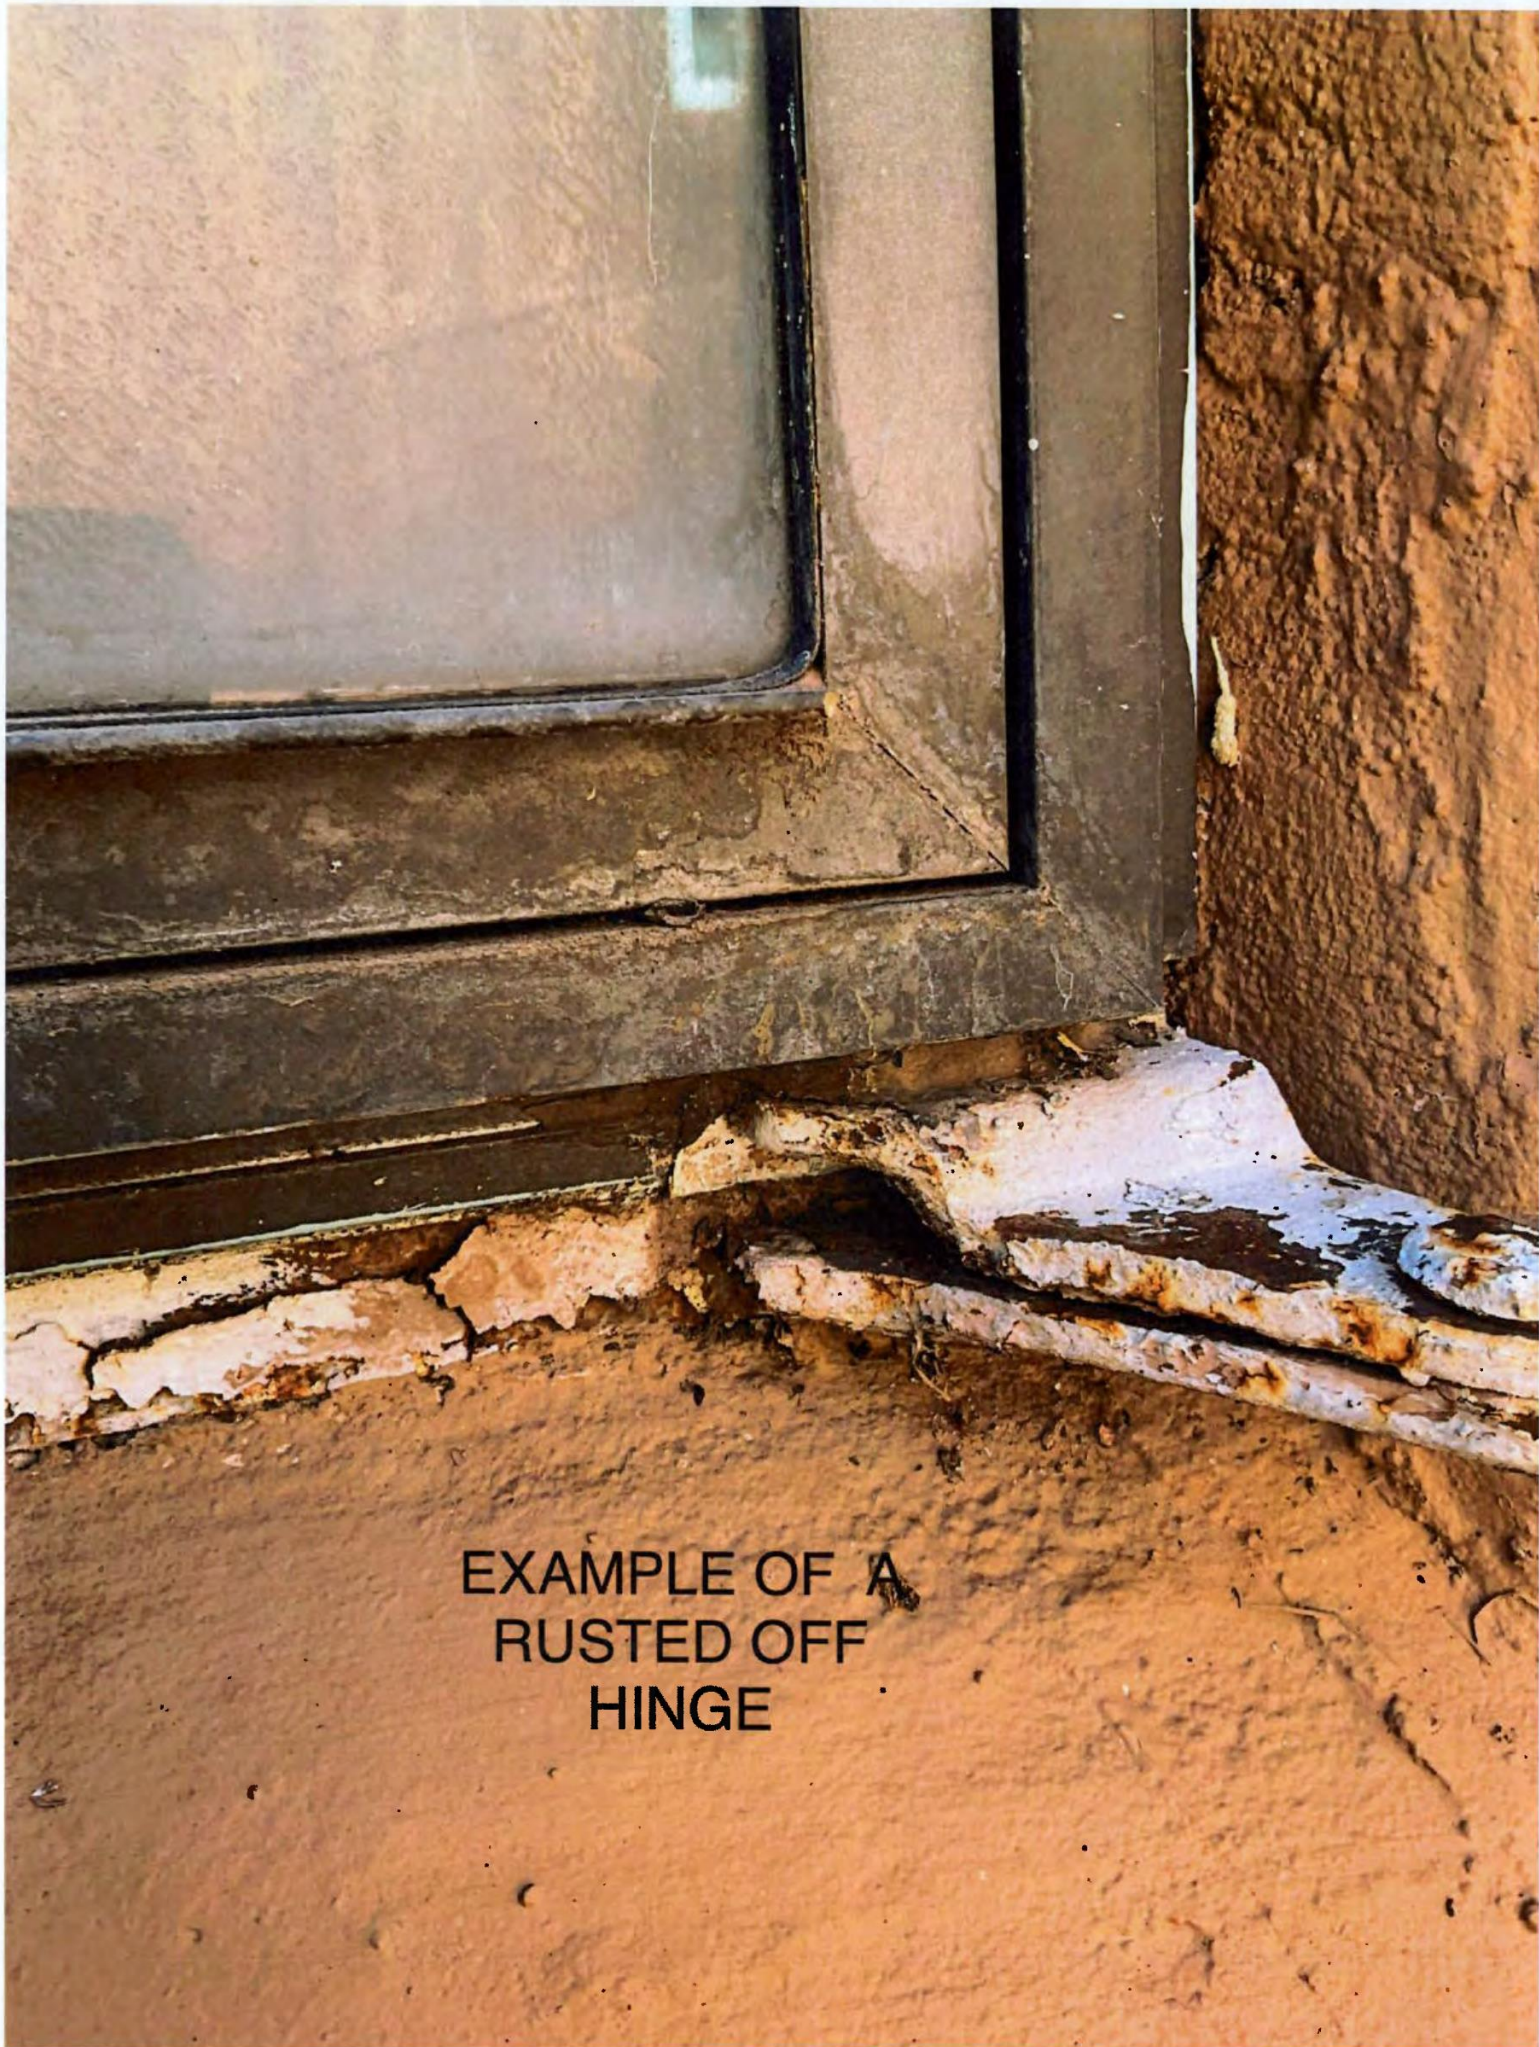
EXAMPLE OF A
RUSTED OFF
HINGE

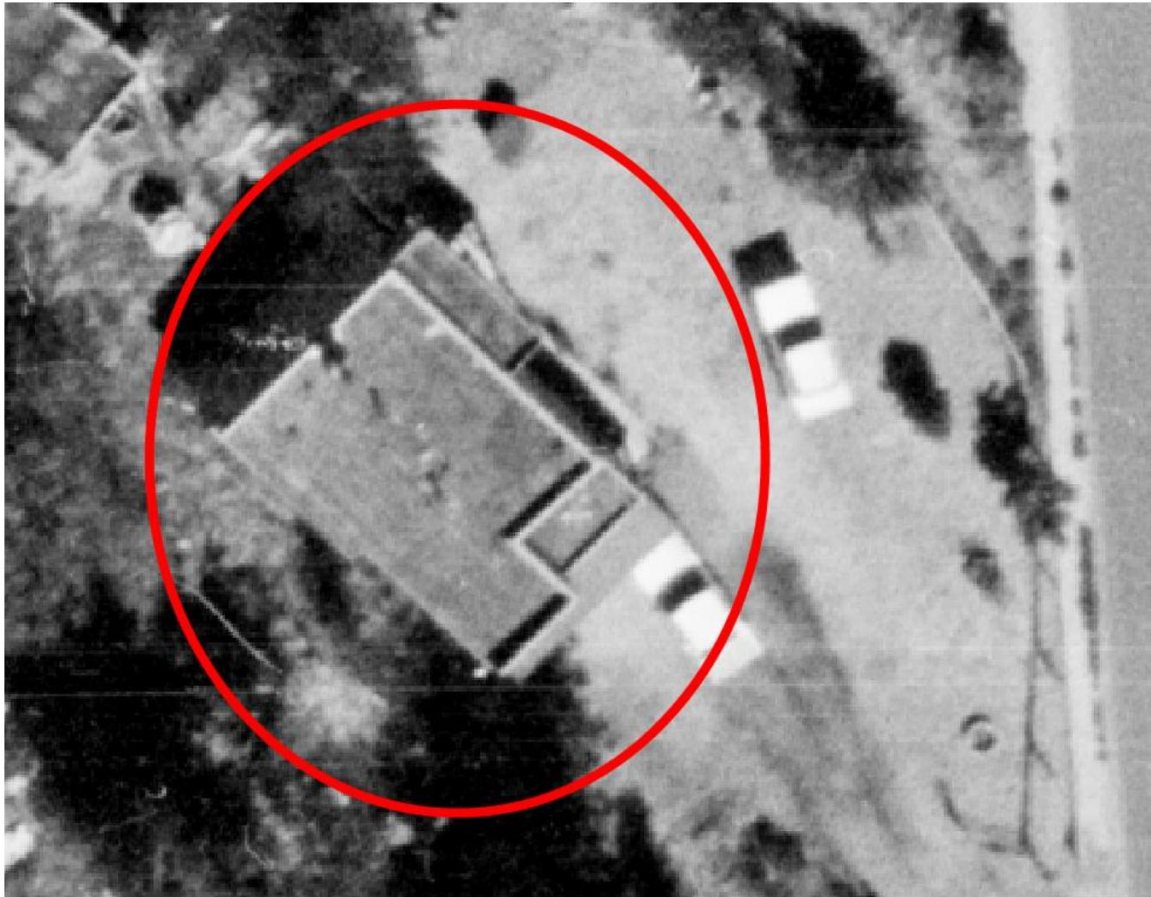
Figure 7: September 11, 1978, aerial photograph.
Building highlighted. Note different portal configuration on east elevation and now the presence of portal on south façade, but of different depth and without the stuccoed parapets founds presently.

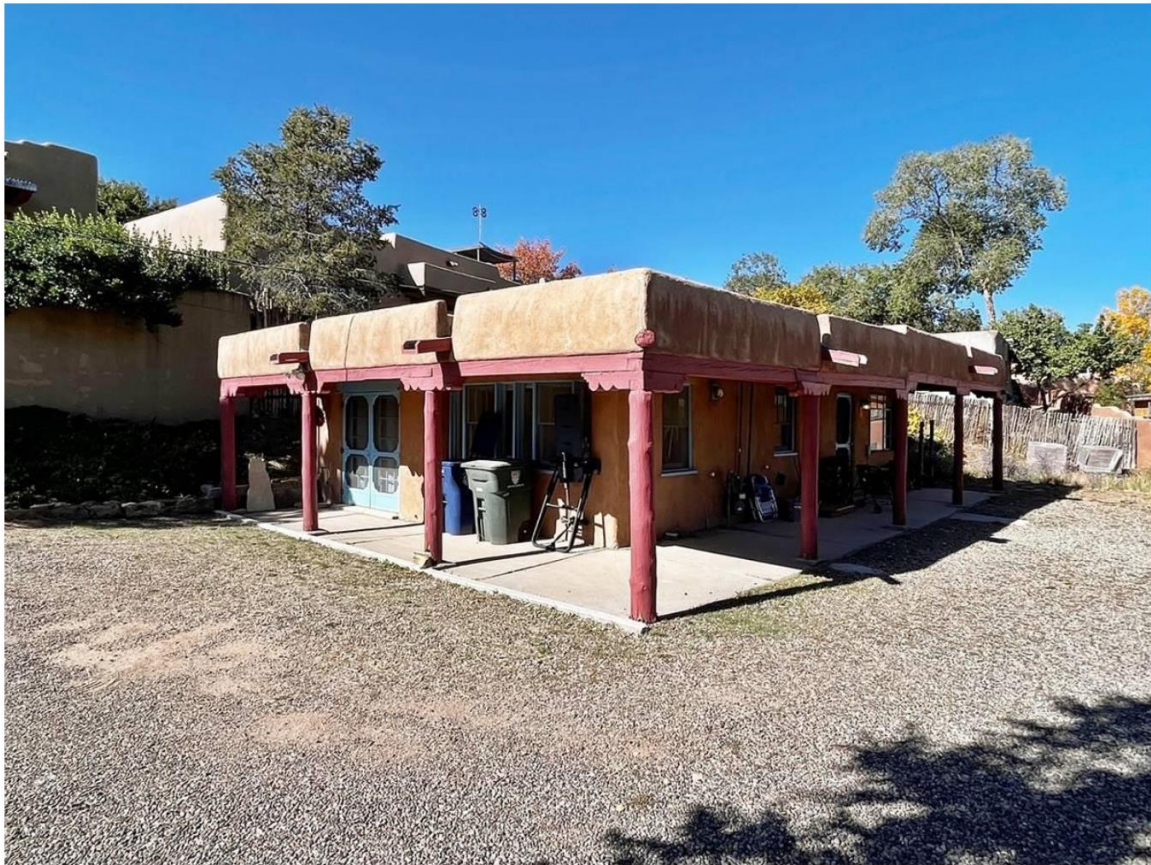
Photo 2: South and east elevations. Camera facing northwest.

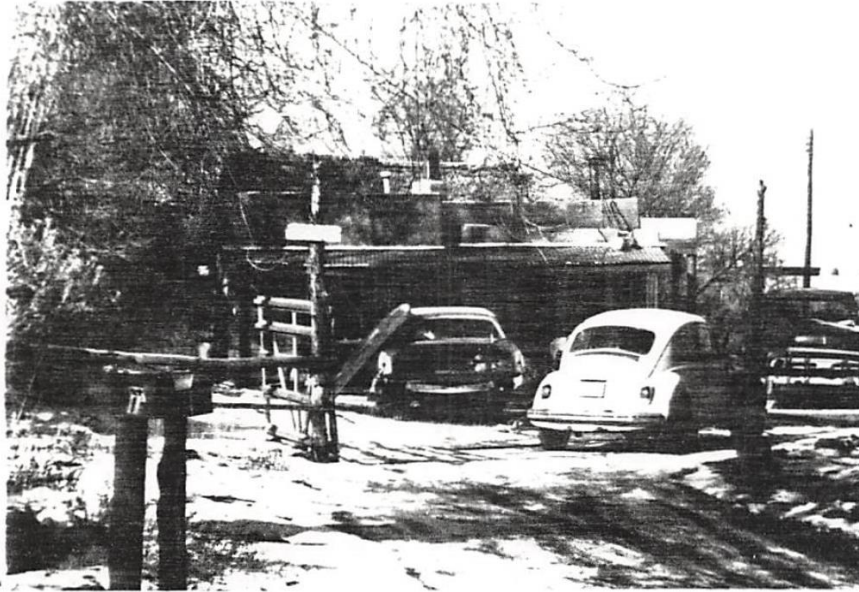
style	foundation material	date of construction ? estimate _____ actual _____
	wall material/surface	source
architectural features		use present _____ residential other _____
		historic _____ residential other _____
		condition _____ excellent _____ good _____ fair _____ deteriorating
		degree of remodeling _____ minor _____ moderate _____ major
		describe:
		surroundings
		relationship to surroundings <input checked="" type="checkbox"/> similar _____ not similar
		historic potential <input checked="" type="checkbox"/> yes _____ no
		significance _____ eligible _____ of <input checked="" type="checkbox"/> none
		if eligible, interest
		why?
		associated buildings? _____ yes
		what type?
		if indented, list ID nos.
		see back? _____ yes

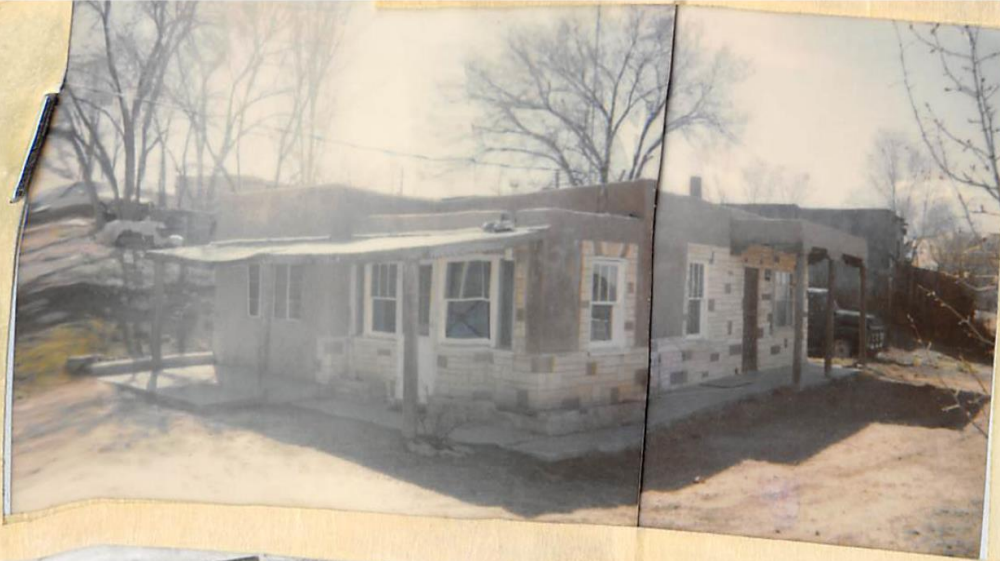
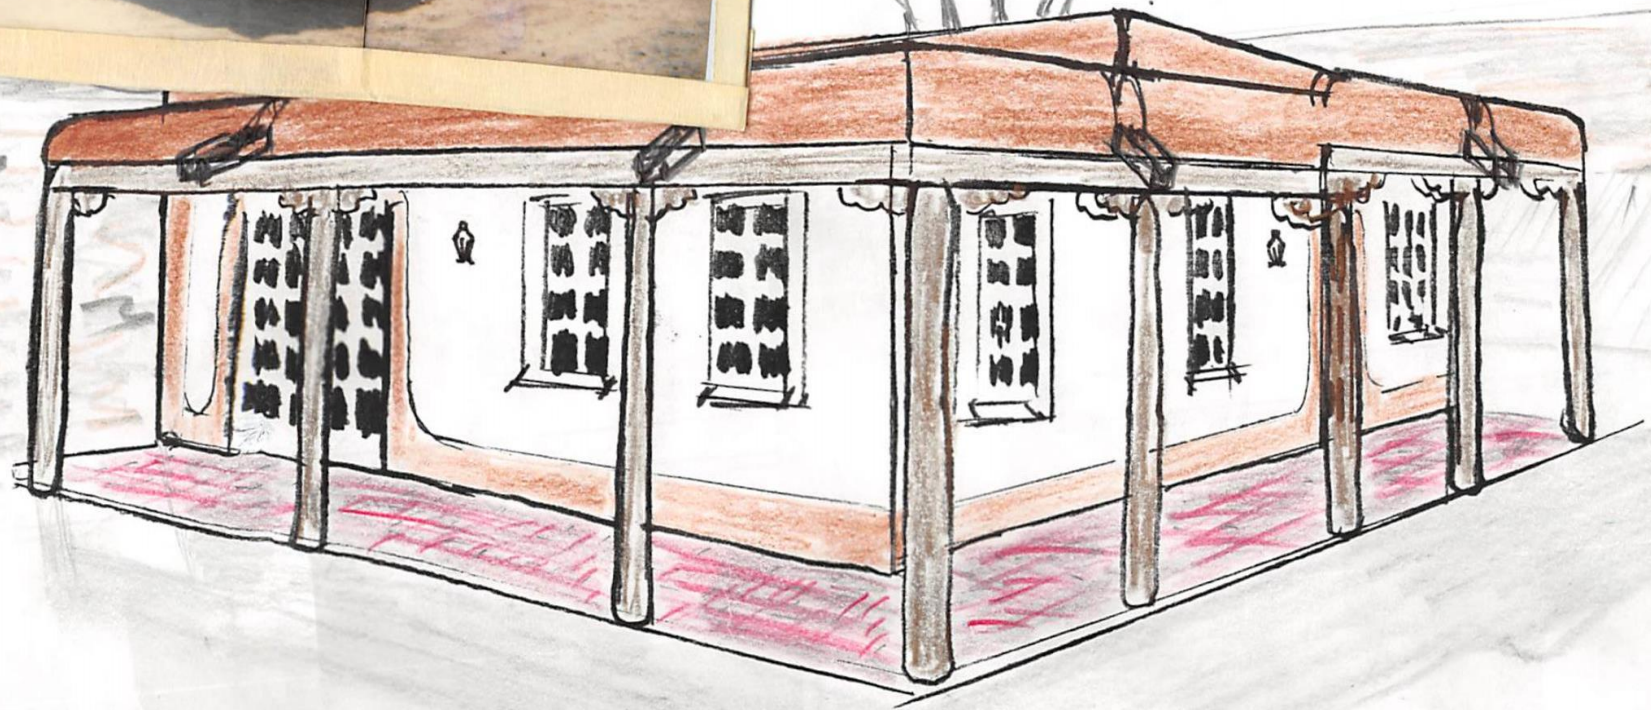
ADDITION TO RESIDENCE FOR VICENTE APODOL
SANTA FE N.M.

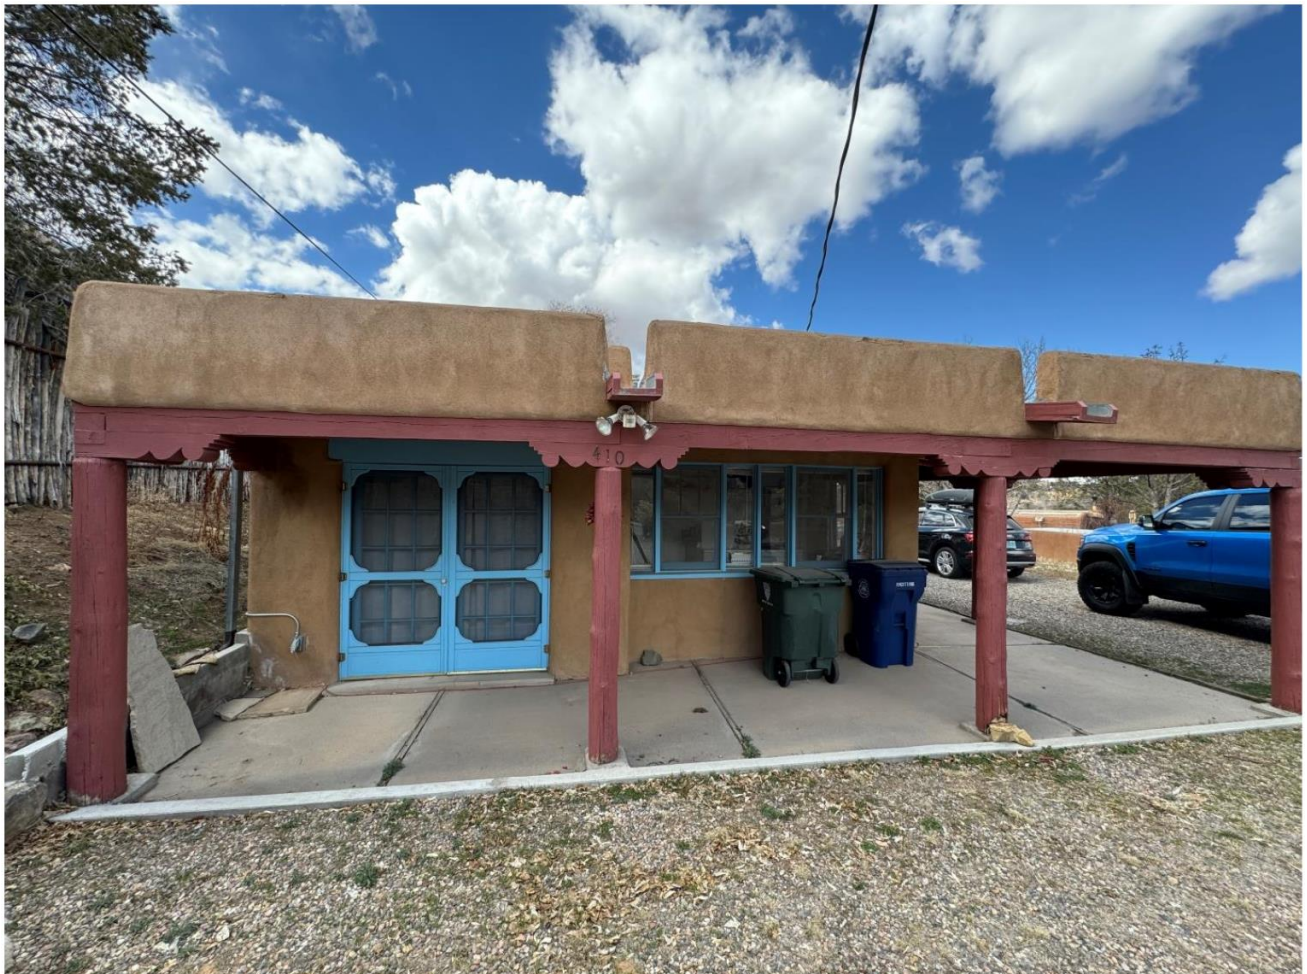
This letter is to acknowledge that I conducted a site visit on March 19, 2024. The purpose of the site visit was to observe the existing condition of the residence and provide an overall opinion regarding its structural integrity. A floor plan has been provided by Gayla Bechtol Architect and was dated December 7, 2023. Roof and floor framing information was collected, while on-site.

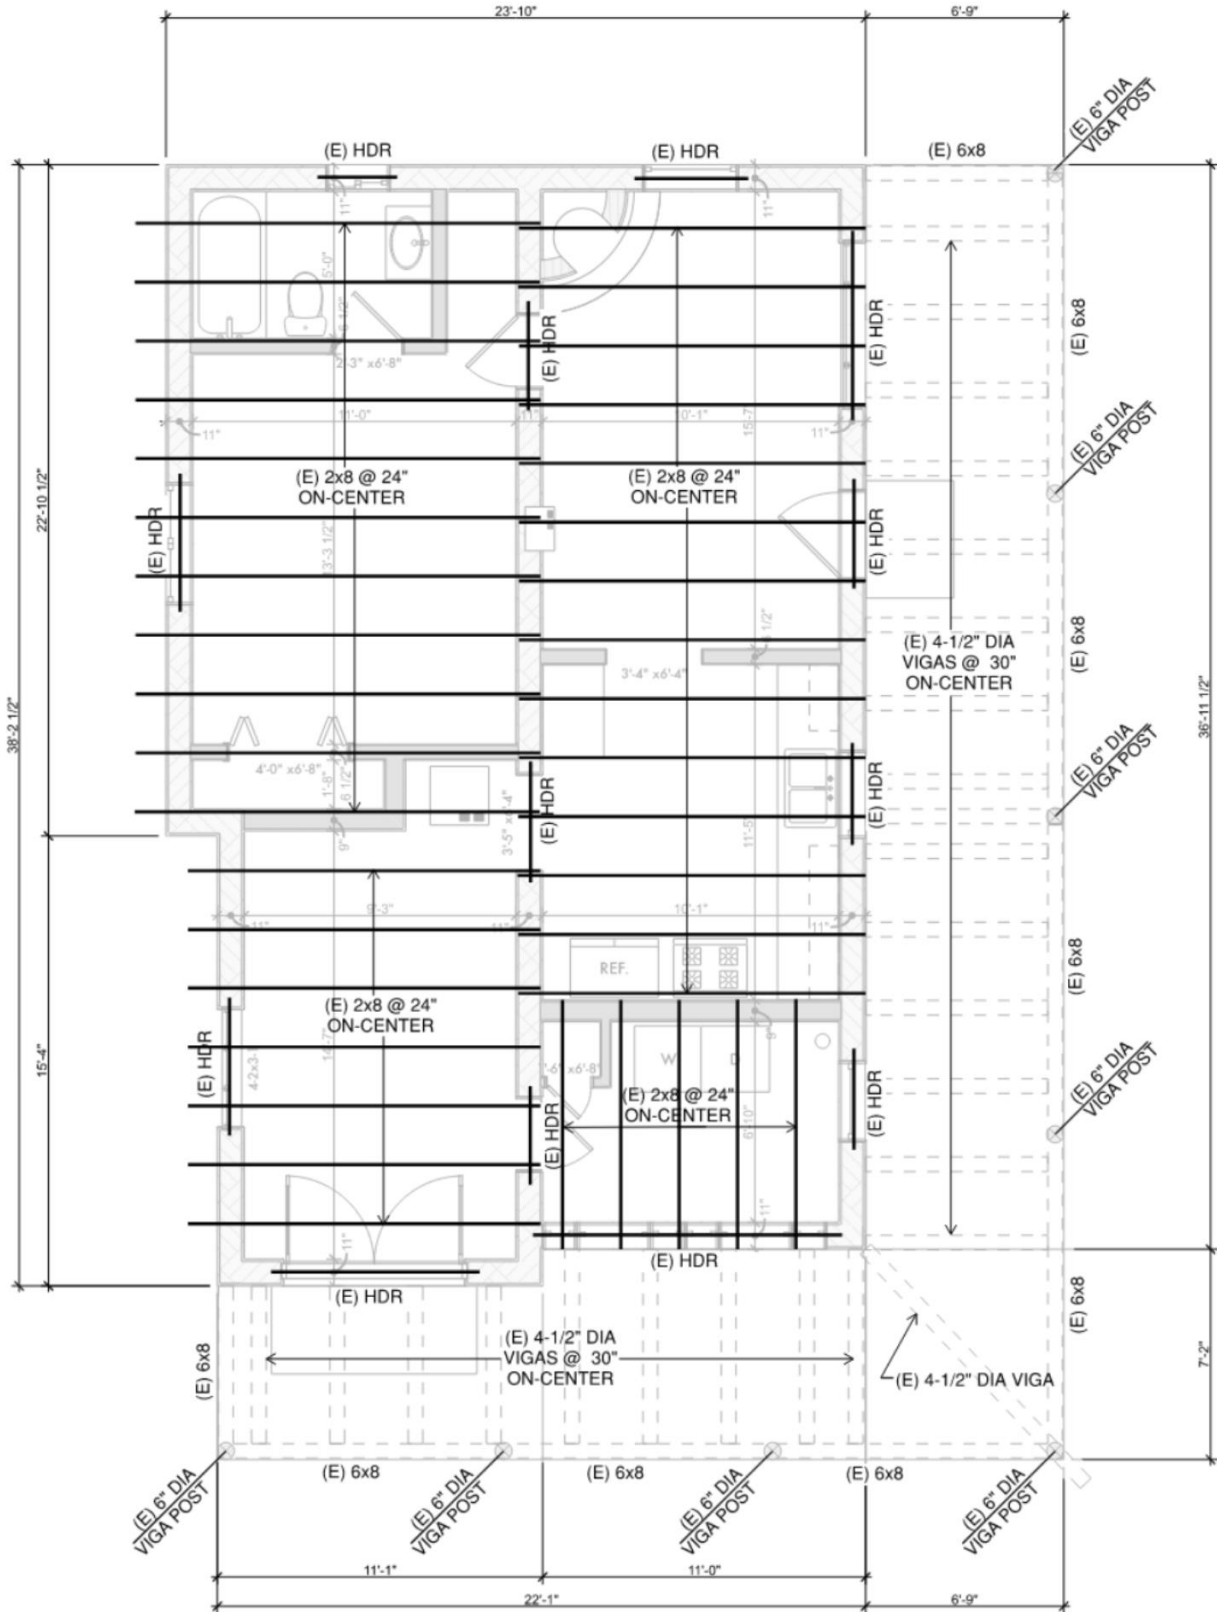
1 EXISTING ROOF FRAMING PLAN
S201

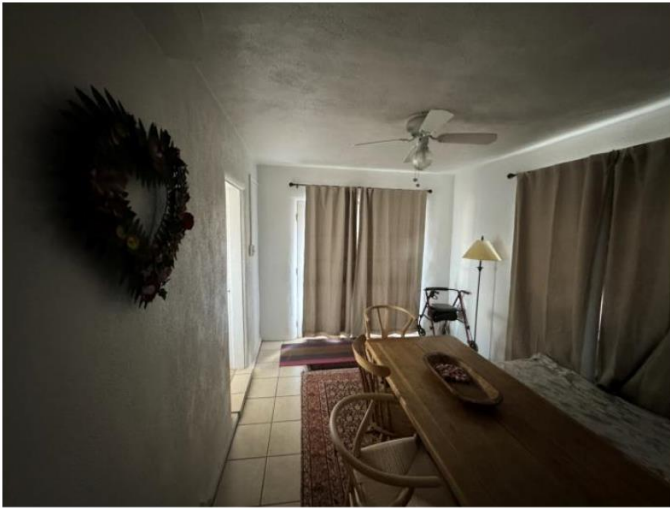
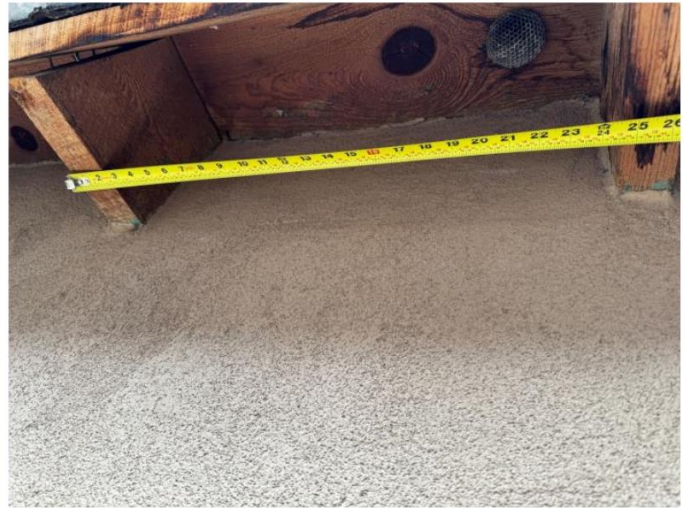
Roof framing was observed to consist of 2x8 rafters spaced at 24-inches on-center. The ends of the roof framing members could be observed where they cantilevered past the rear exterior wall.

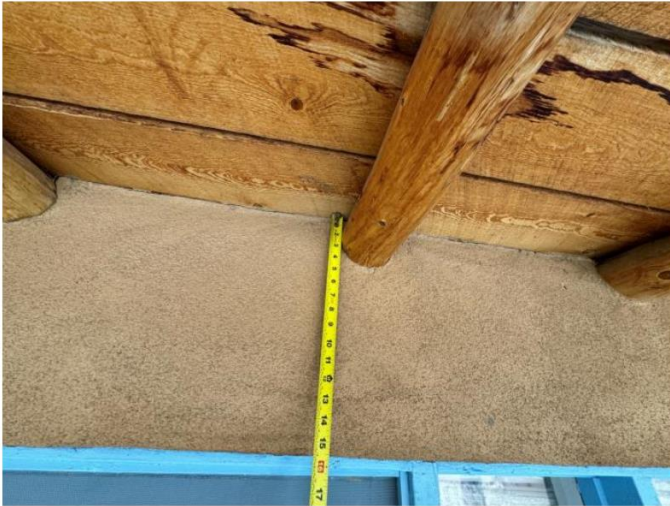
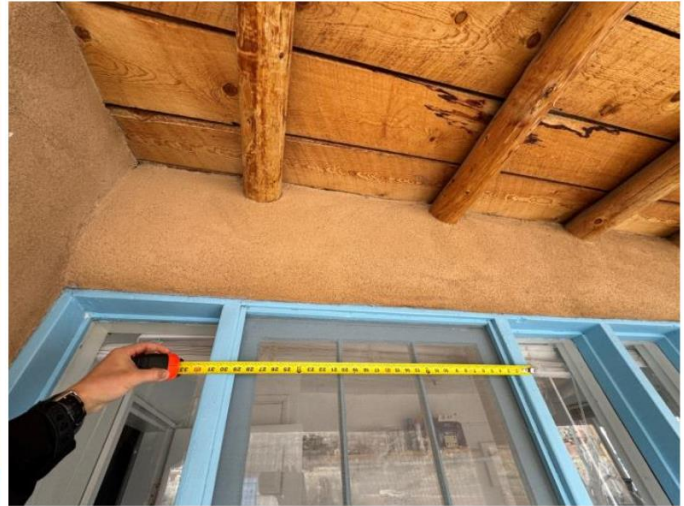
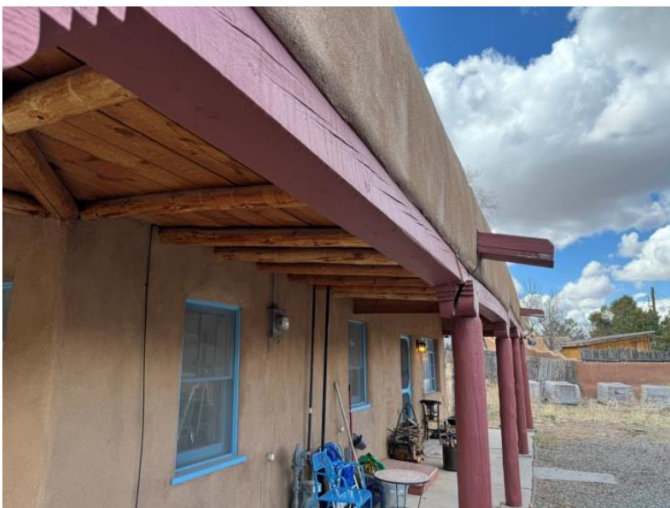
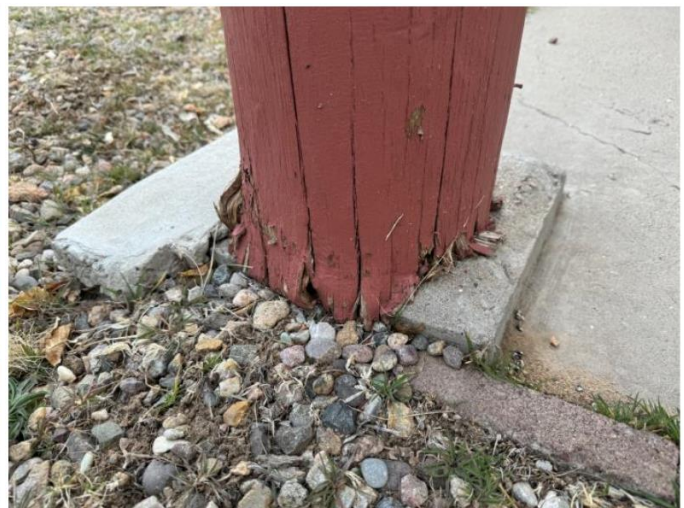
Portal framing consists of 4 ½-inch round viga members that span between the exterior wall of the building and are supported by beams and columns at the outside.

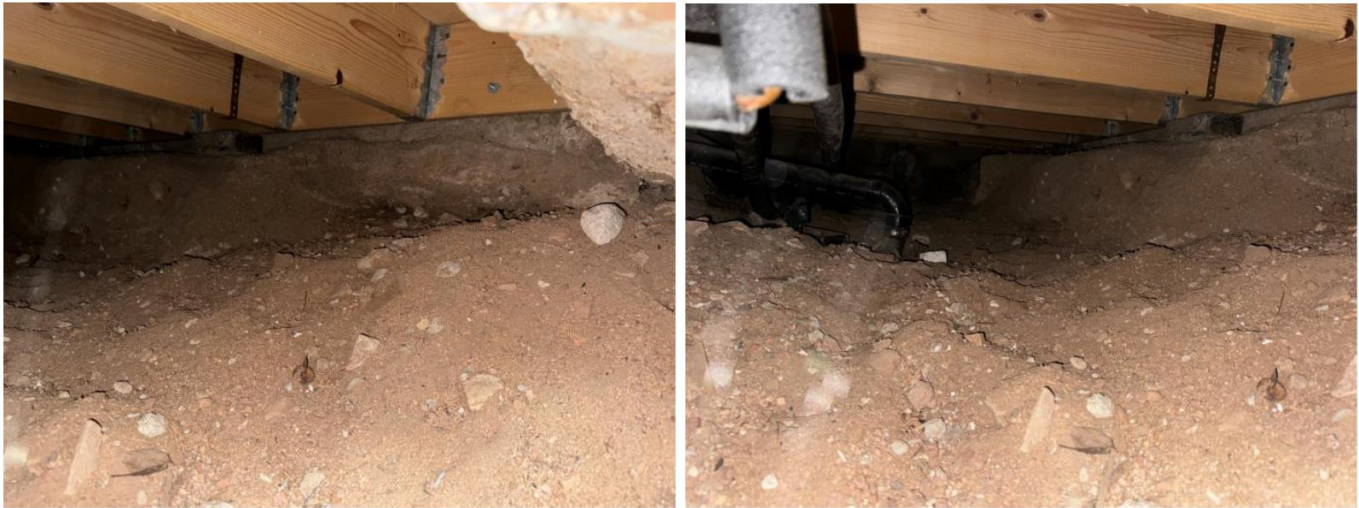
Analysis and Recommendations

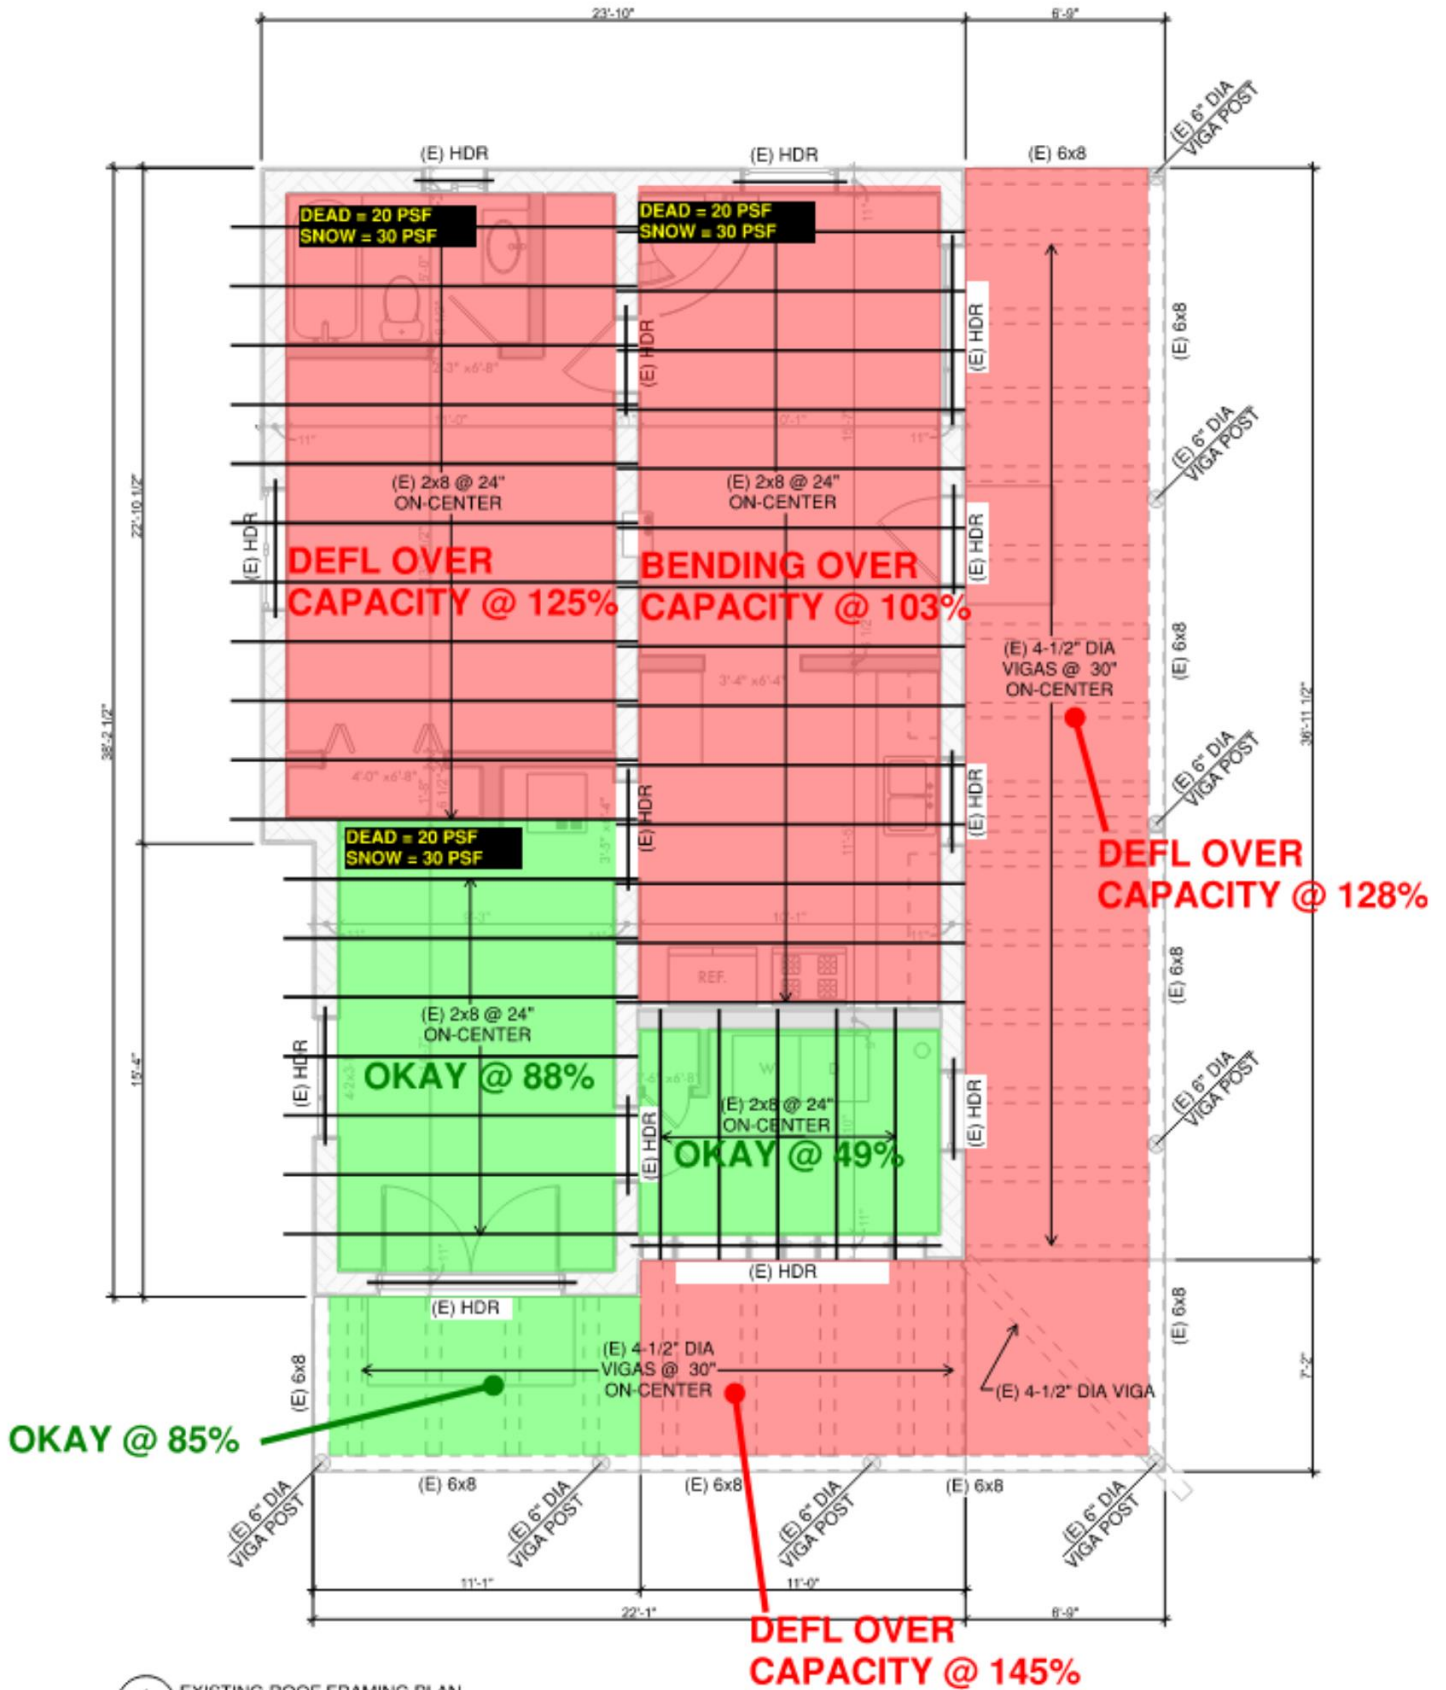
1 S201 EXISTING ROOF FRAMING PLAN

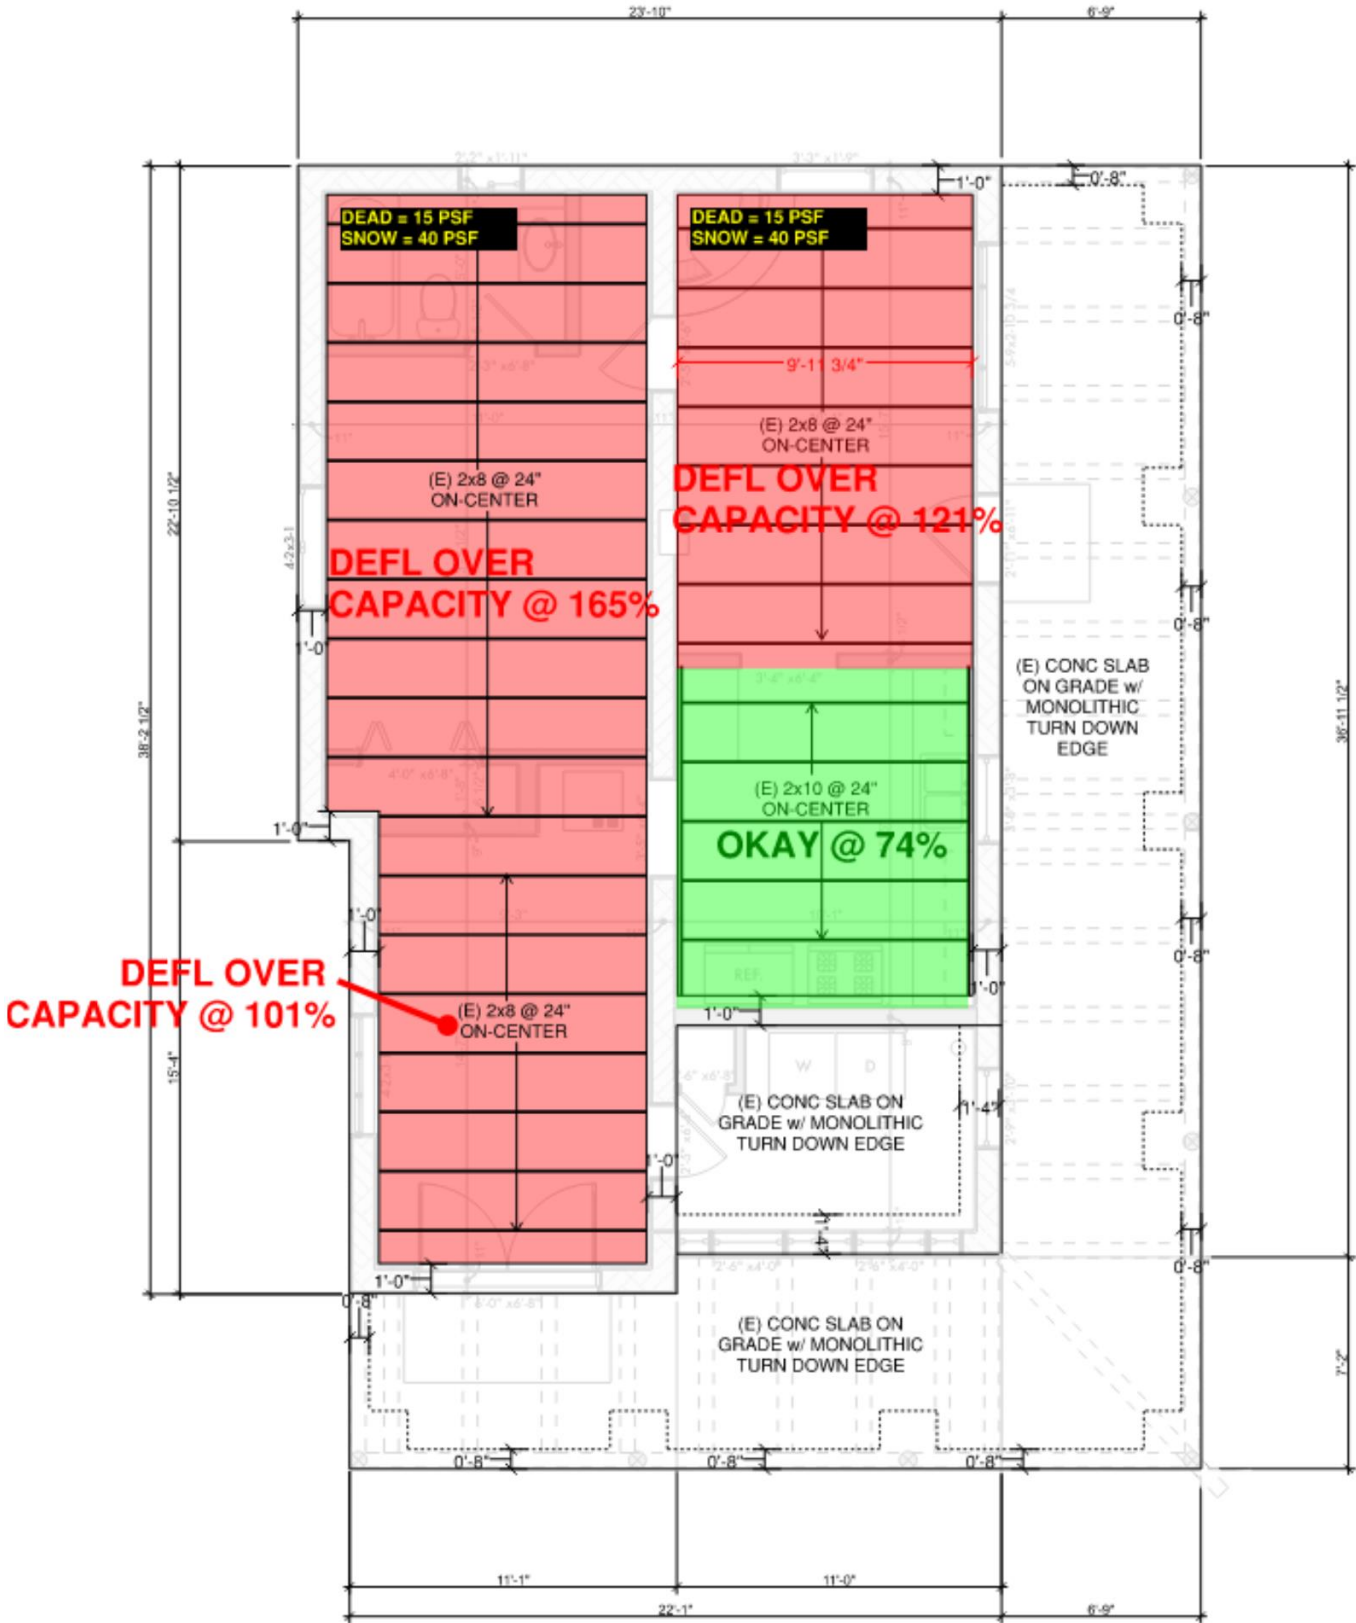
1 EXISTING FLOOR FRAMING & FOUNDATION PLAN
S101

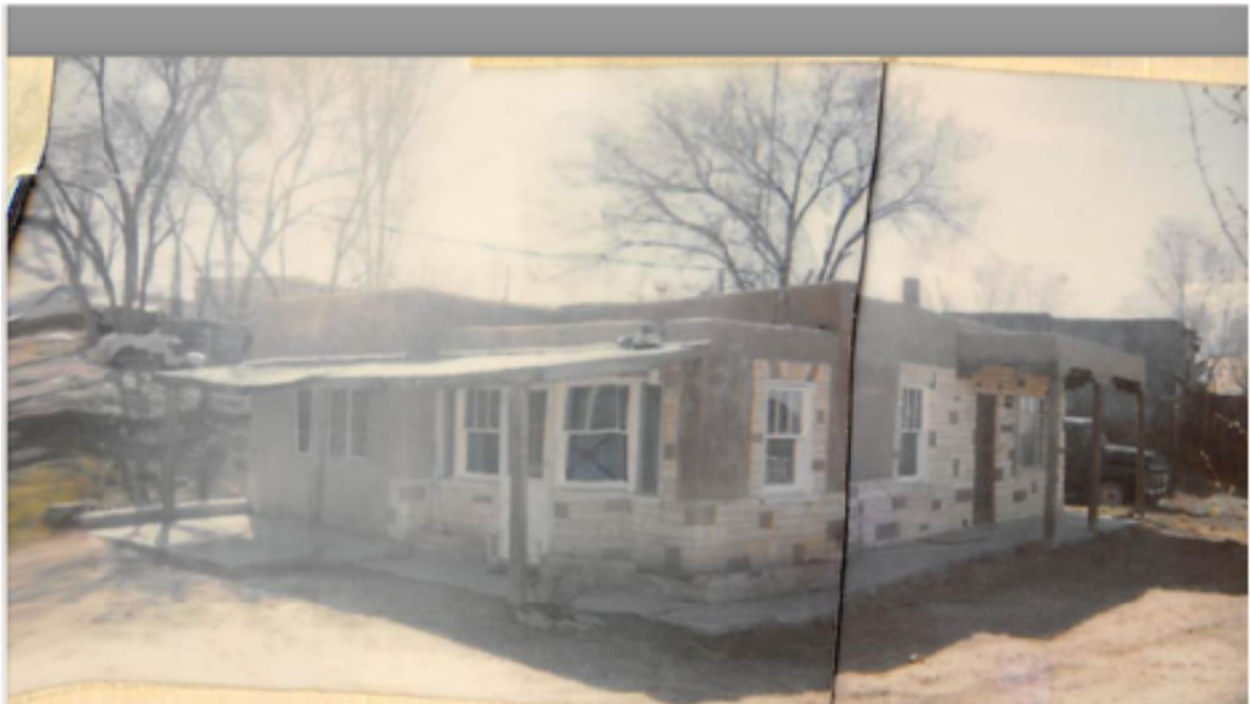
Project Number:
#1011
The drawings and specifications
as instruments of service shall remain
the property of the architect and shall be
used only for the project and for the
purpose intended by agreement in
writing. The architect assumes no
responsibility for construction
conditions not shown or for
dimensions at the site. The architect will not
be responsible for construction means,
methods, techniques, or procedures, or
for any accidents or programs in
connection with the project.

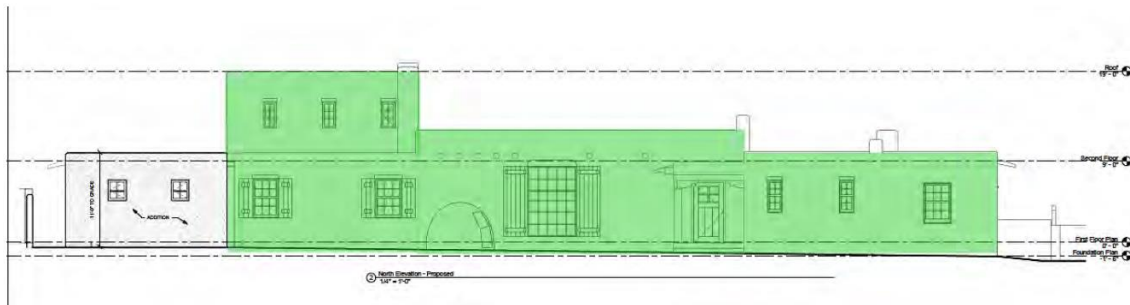
Figure 4: Recommended primary façade, north elevation.
