HISTORIC DISTRICTS REVIEW
BOARD
OCTOBER 08, 2024
5:30 PM
CITY COUNCIL CHAMBERS
CITY HALL
200 LINCOLN AVENUE

PROCEDURES FOR HISTORIC DISTRICTS REVIEW BOARD MEETING:

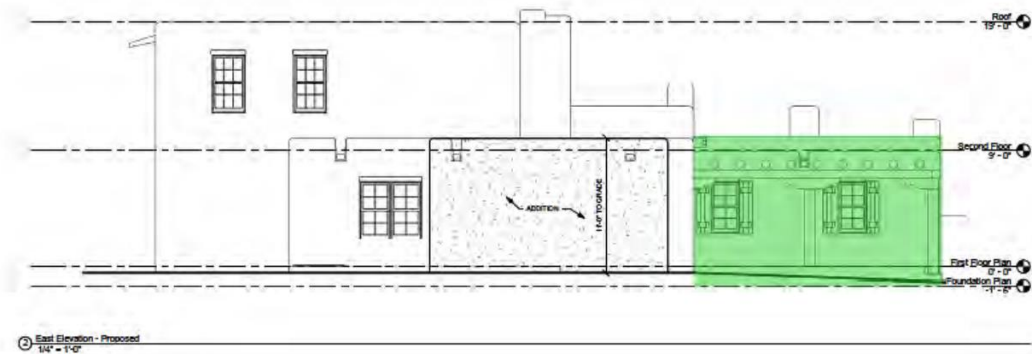
Figure 5: Recommended primary façade, east elevation.

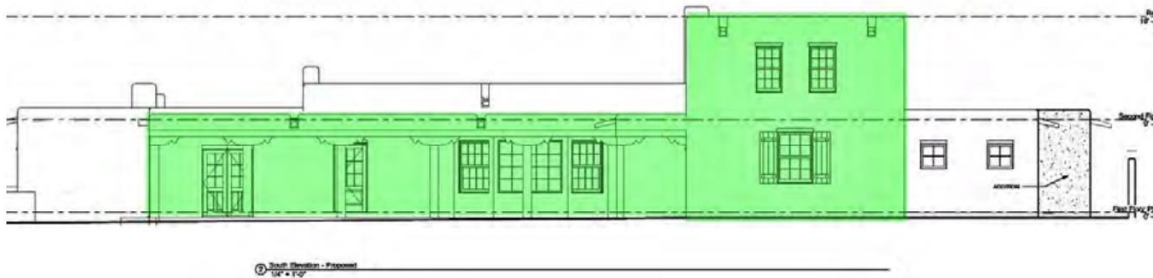
Figure 6: Recommended primary façade, south elevation.

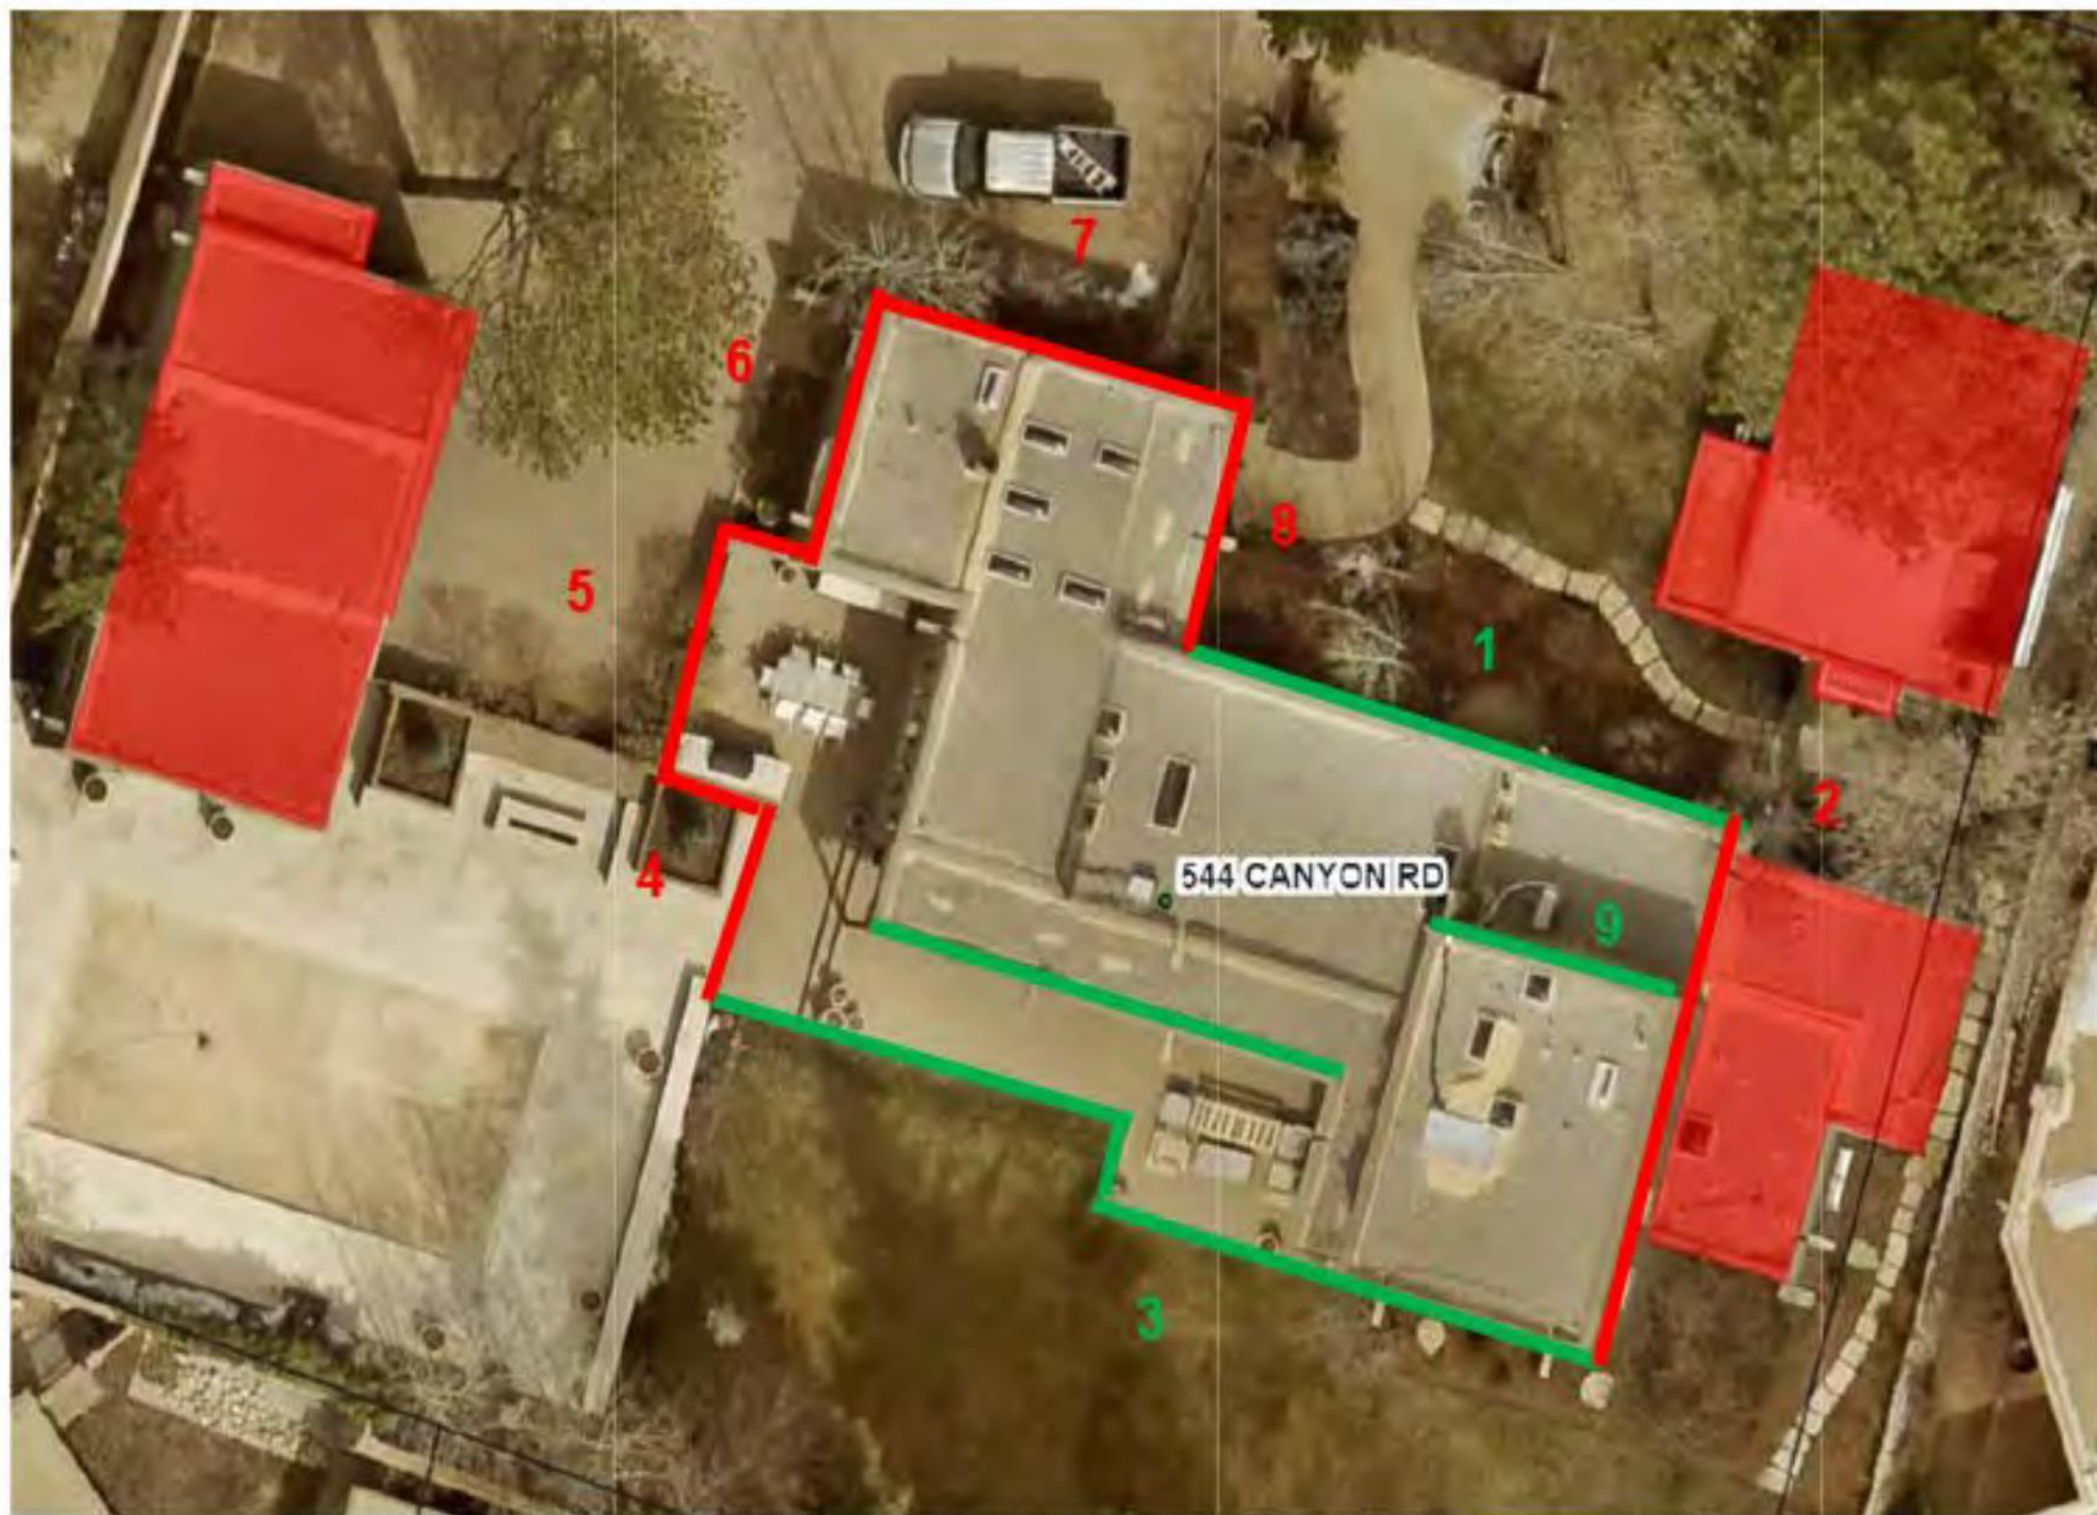
544 Canyon Road: Façade Diagram

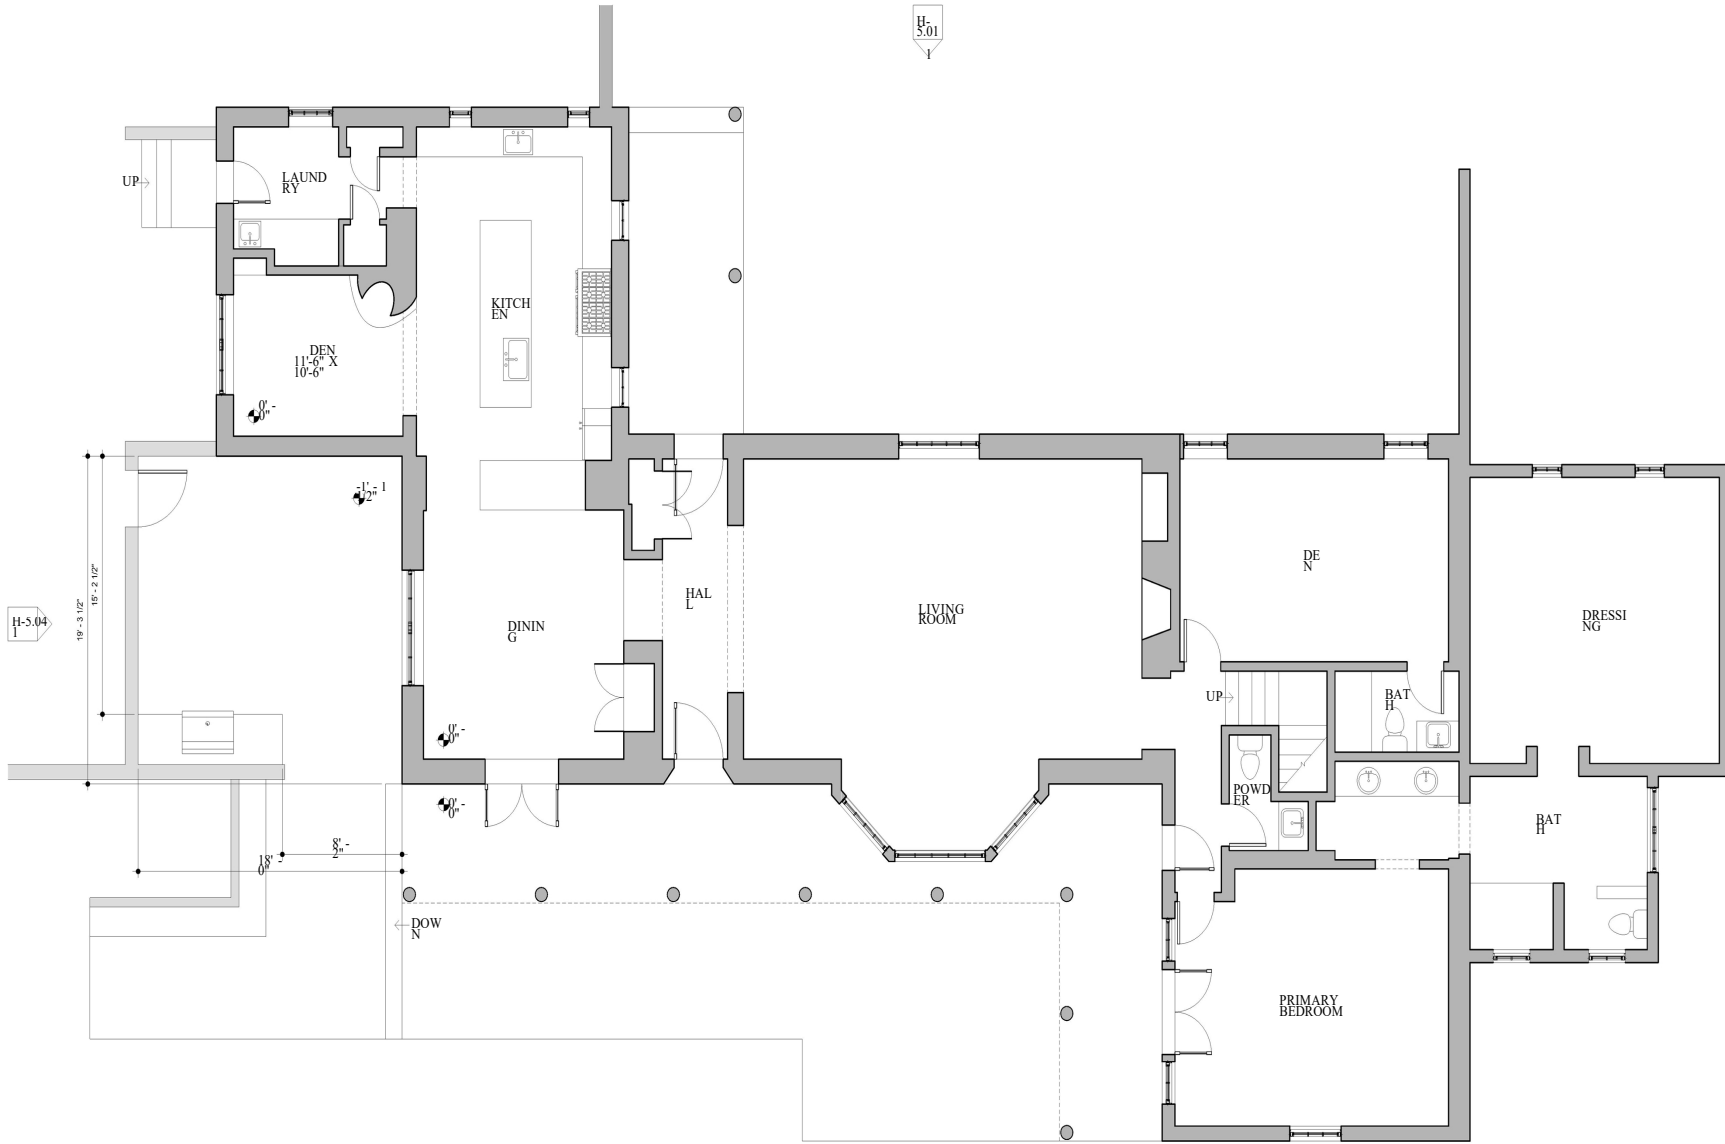
The intent is to use the existing historically contributing building as a design precedent and replicate the overall character and detailing with this addition.
