# Historic Cultural Properties Inventory (HCPI) Base Form (FORM 1)

1. Name of property:  Andrés Sena Property/ <b>Rosina Hernández O’Dell House</b>	2. Location:  312 Pino Road Downtown and Eastside Historic District - Santa Fe	3. Local Reference Number: Santa Fe ID:  4. County: Santa Fe Parcel # 11883648

8. Name of Project: HDRB Status Evaluation		
9. Lat/Long: 35.6804931,-105.9377012		
10. Photo Information: Giulia Caporuscio, photographer. Photo 1: North elevation oblique. Camera facing southwest.

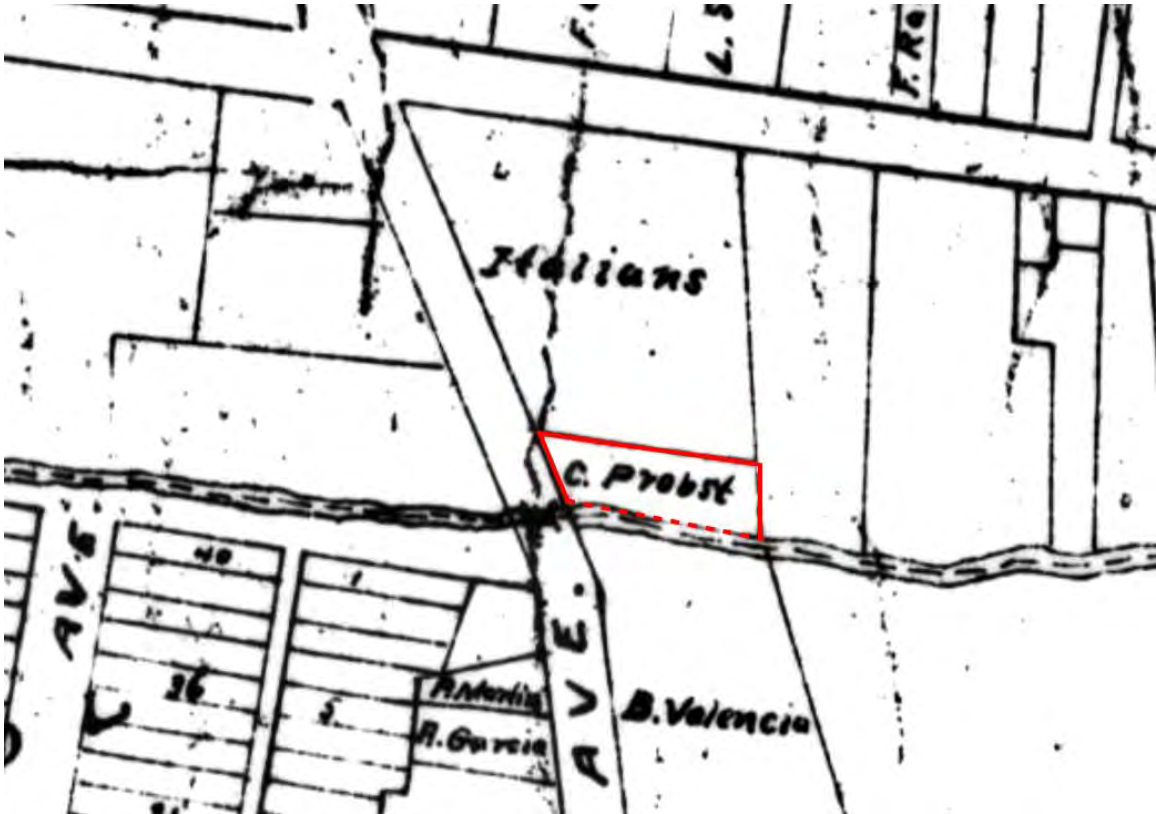
**Figure 2: P. C. Gaynor, "Map of Santa Fe," 1892. The Charles Probst lot is highlighted.**

The 1892 Gaynor map indicates a change to the anvil-shaped property (Fig. 2). The four homes hugging the north side of the arroyo were now in a parcel owned by “C. Probst,” referring to Charles Probst, a German Immigrant drugstore and brewery owner. The larger land to the north was owned by “Italians,” evidently referring to the Berardinelli family.

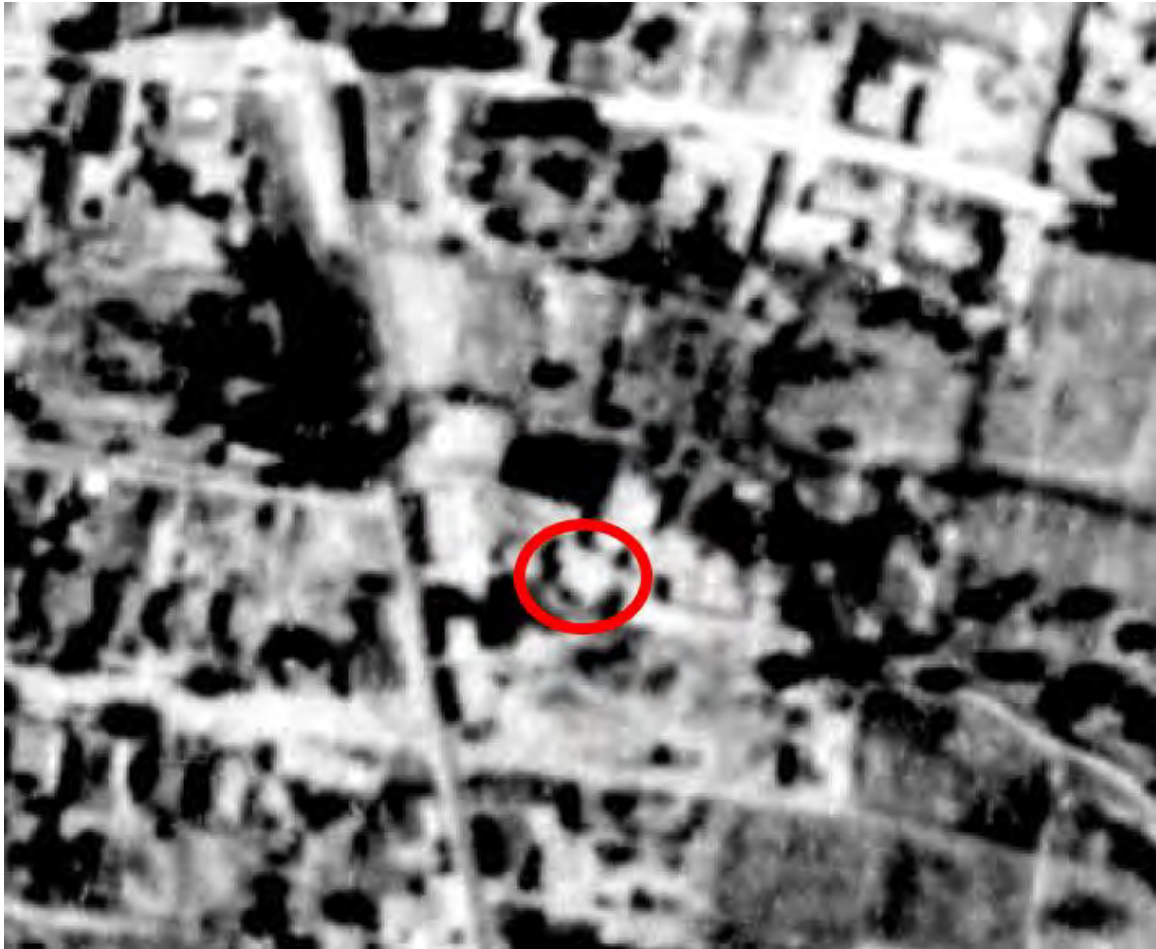
**Figure 5: 1935 aerial photograph. Subject house circled.**

Like many along College Street, the Andrés Sena home would develop a back unit — the subject house. Unlike other homes, it had its own address (312 Pino Road), reflecting its position along the dirt lane. A building in this position appears on a 1935 aerial photograph (Fig. 5). The address first appeared in city directories in 1938.

The 1935 Soil Conservation Service aerial shows a building with the roughly same core walled footprint as the house today (Fig. 5). It consists of a square with a smaller rectangular projection at its northwest corner. There also appears to be a much smaller projection near the southeast corner of the south elevation, which may be a roofed entry.

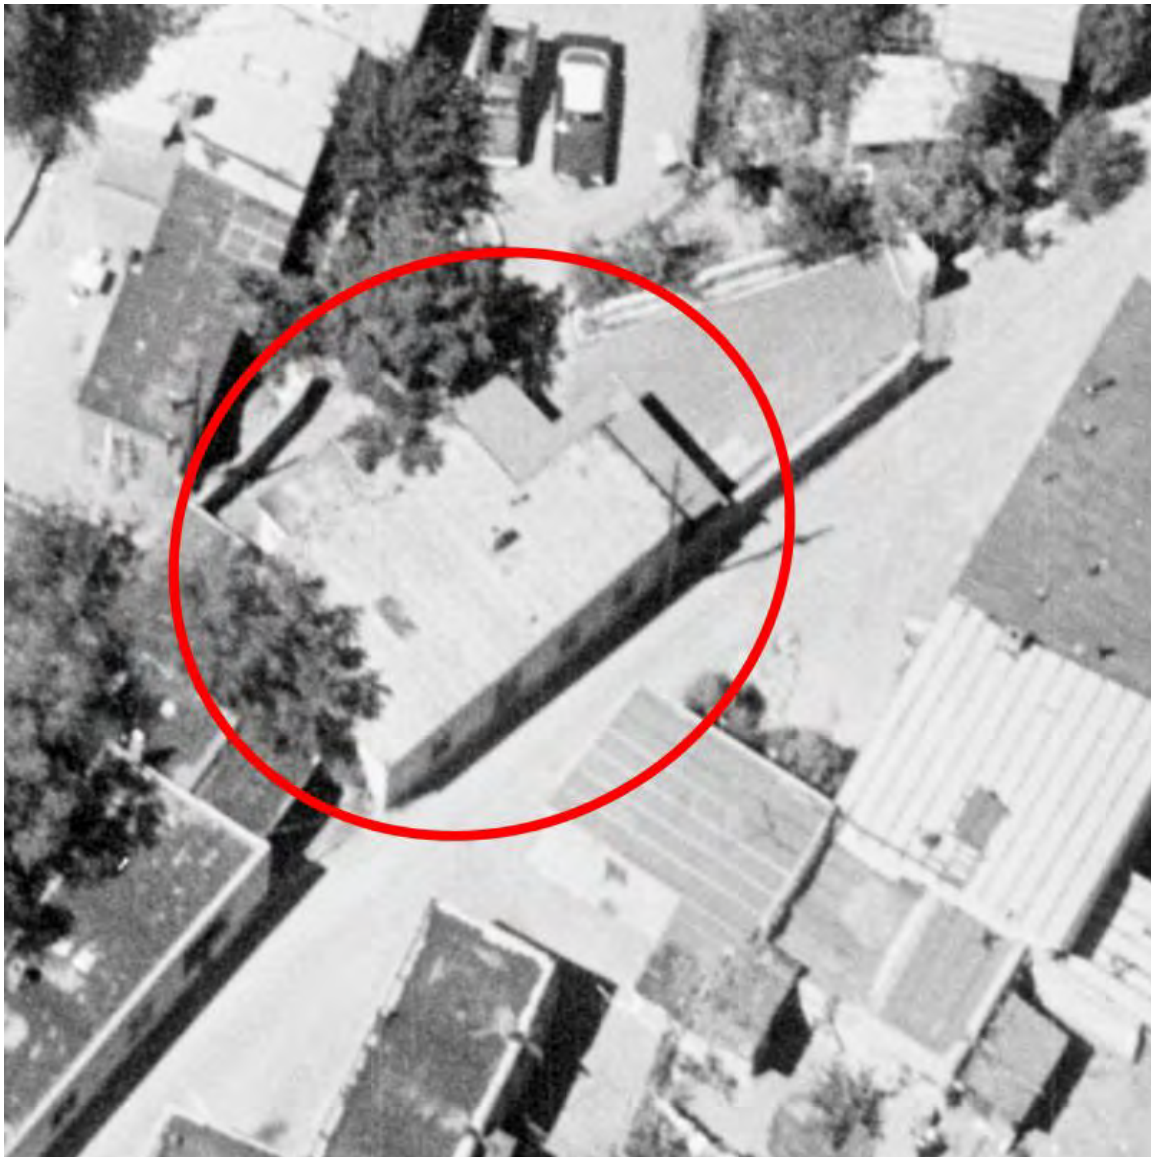
**Figure 10: September 11, 1978, aerial photograph. Orientation reversed. Note consistency of fenestration.**

This altered footprint holds through the 1978 aerial (Fig. 10) and remains consistent with current imagery.

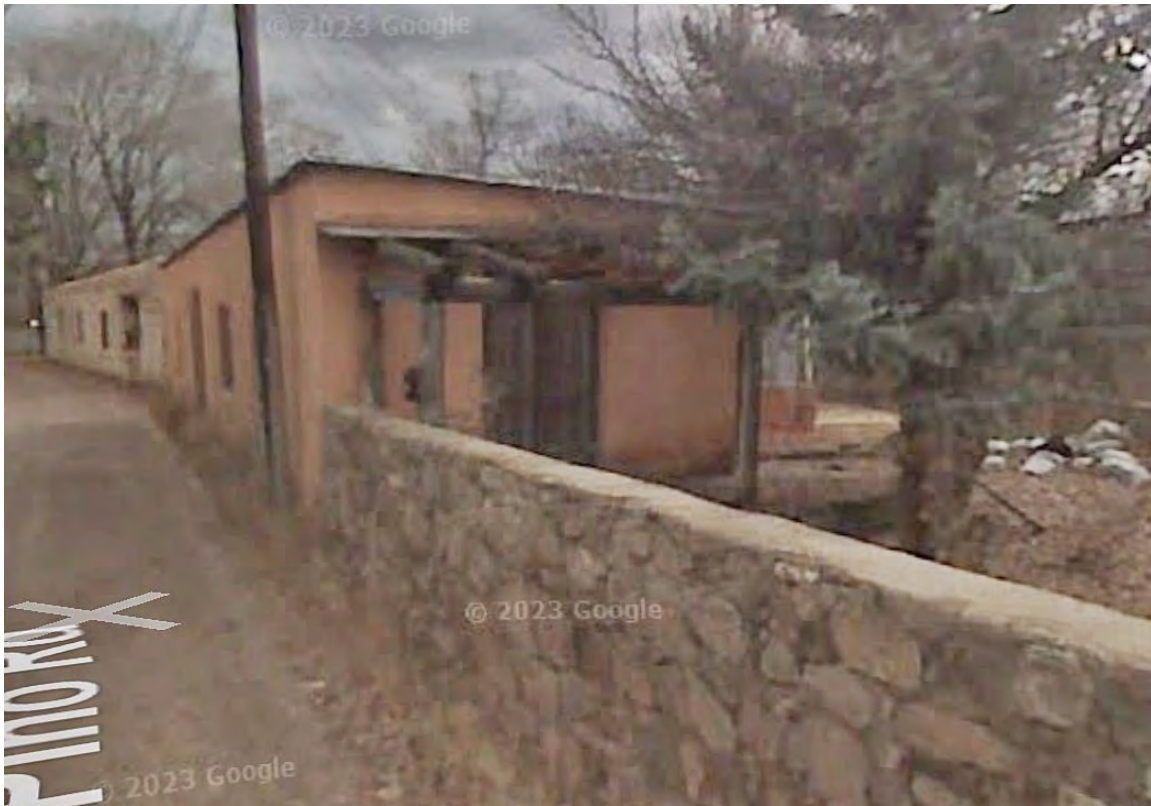
**Figure 12: December 2007 Google Street View image of northwest porch.**

The west porch shows relatively new posts, decking, and roofing material. According to the County Assessor, the original porch was removed and reconstructed in 2016. A 2007 Google Street View shows what may have been the original structure in poor condition (Fig. 12). It changed from a nearly flat shed roof to a more sloping roof with a pronounced ridge and valley.

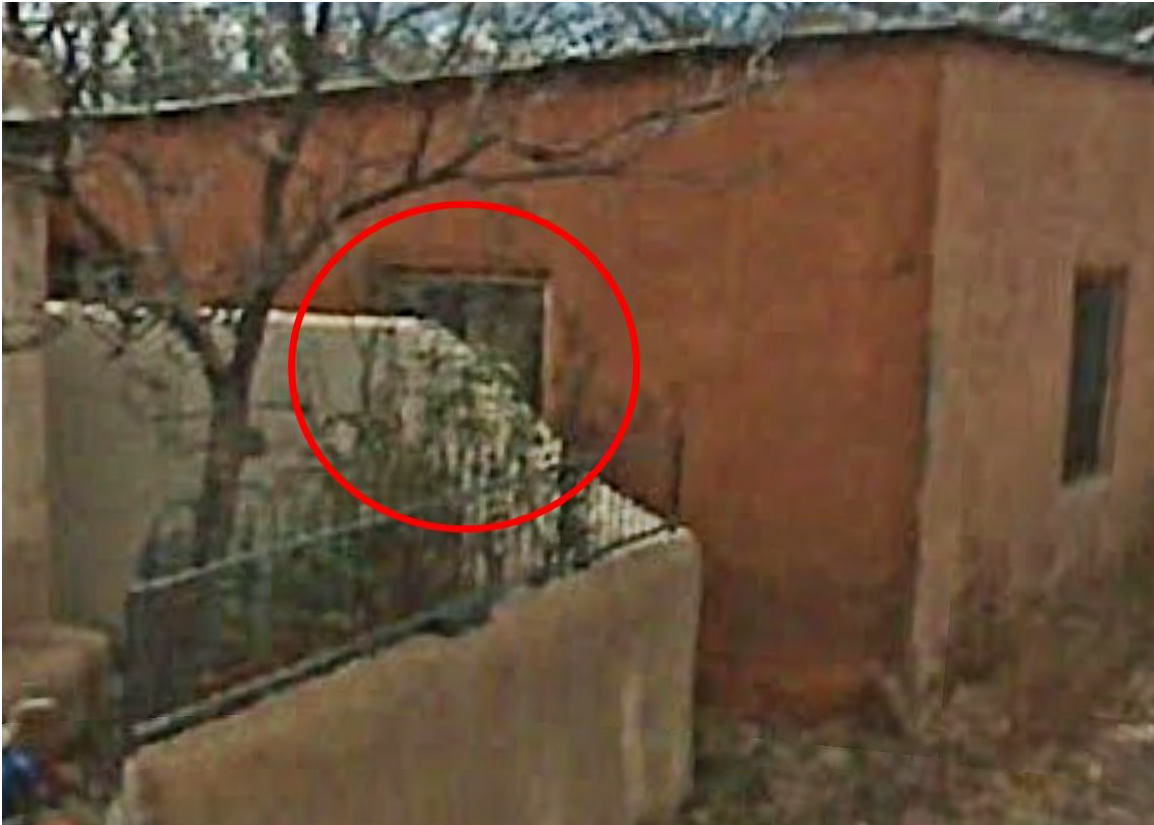
**Figure 13: December 2007 Google Street View image of east elevation showing what appear to be paired casement windows.**

In his historic window assessment, Ra Patterson has demonstrated that nearly all the windows and doors are replacement units. This HCPI survey concludes that Patterson’s inventoried Window A represents a new opening, albeit now more than 50 years old. In addition, several older openings (D, E, F) have changed from paired to single-sash casements, giving these elevations a contemporary appearance (Fig. 13.) (Photos 12 & 13).

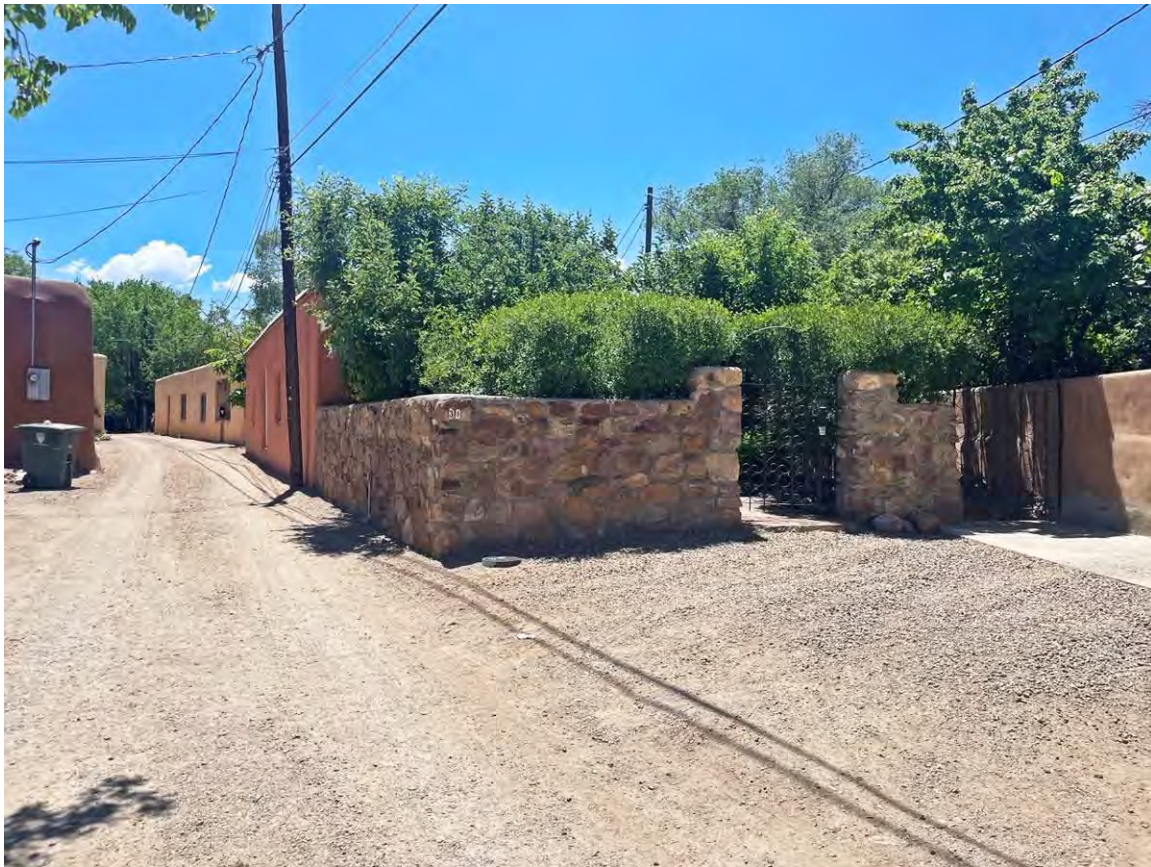
**Photo 2: Streetview. Subject at right foreground. Camera facing southeast. Note shortened stone wall at center.**

Edging the northwest corner of the property is an approximately 53” high, 15” thick native stone wall (Photo 15). In 2015, the Board designated the stone wall Contributing, yet it appears to have permitted the applicant to remove nearly half its length (#H-15-109-A).

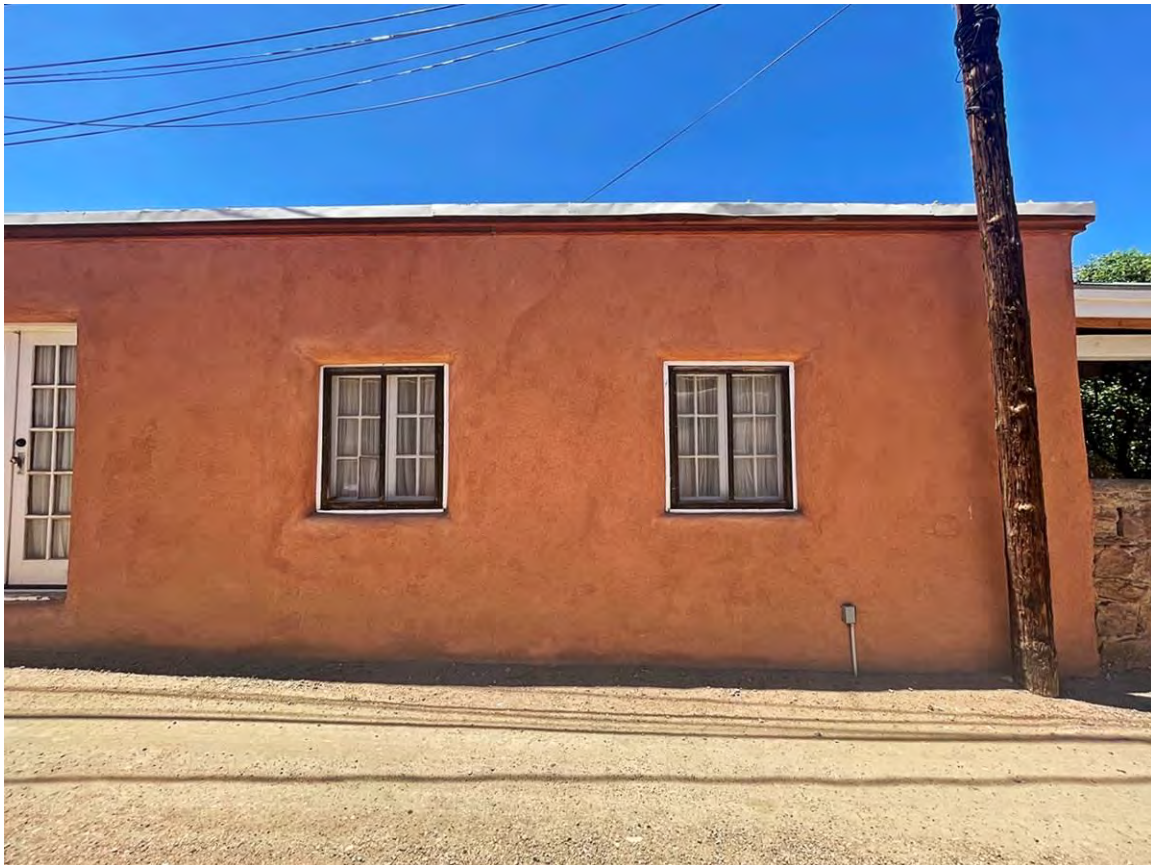
**Photo 3: North elevation, west section. Camera facing south.**

Set on the lane, the north elevation is an uncomplicated façade but retains good integrity (Photos 1, 3 & 4). Four openings cut through its flat adobe wall. These hold three windows and one door. The windows are paired 6-light wood casements that Ra Patterson has dated to 1986 (Photo 5). The door is also recent. Despite their recent vintage, the double casement windows help sustain the home’s historical appearance.

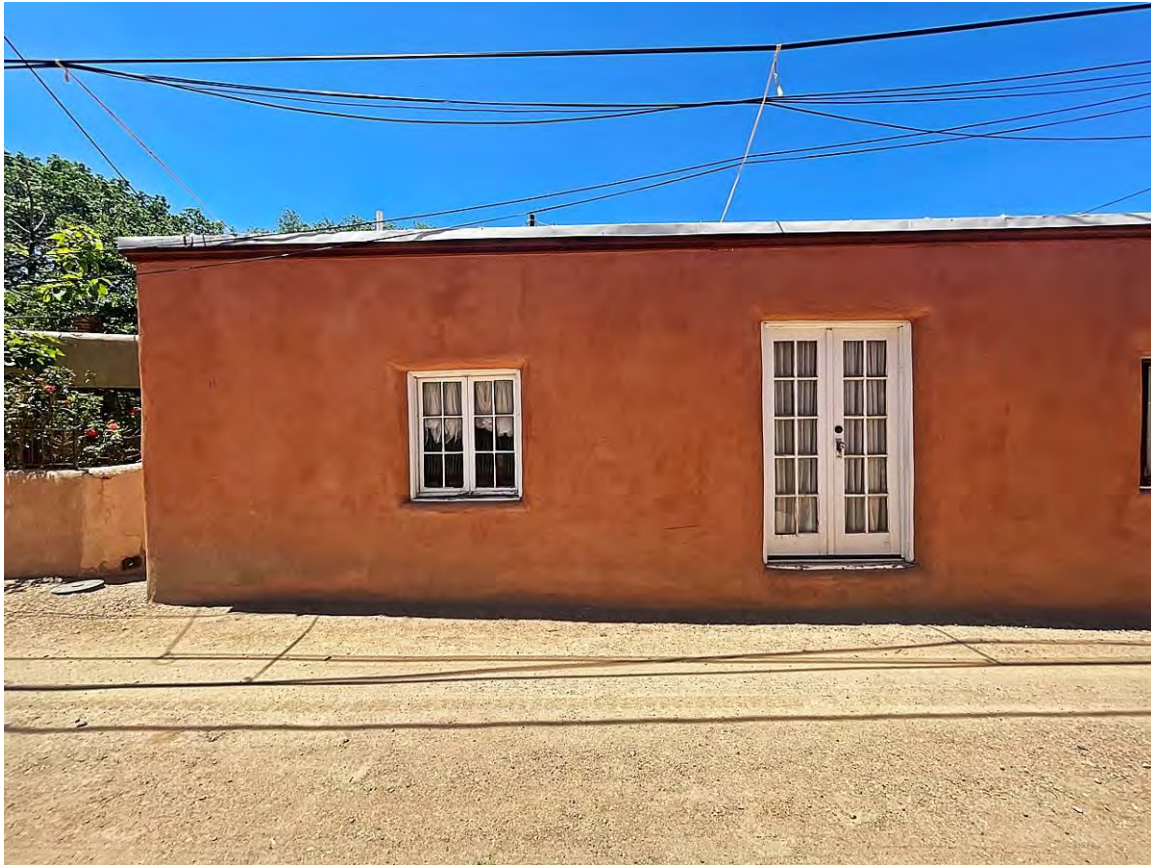
**Photo 4: North elevation, east section. Camera facing south.**

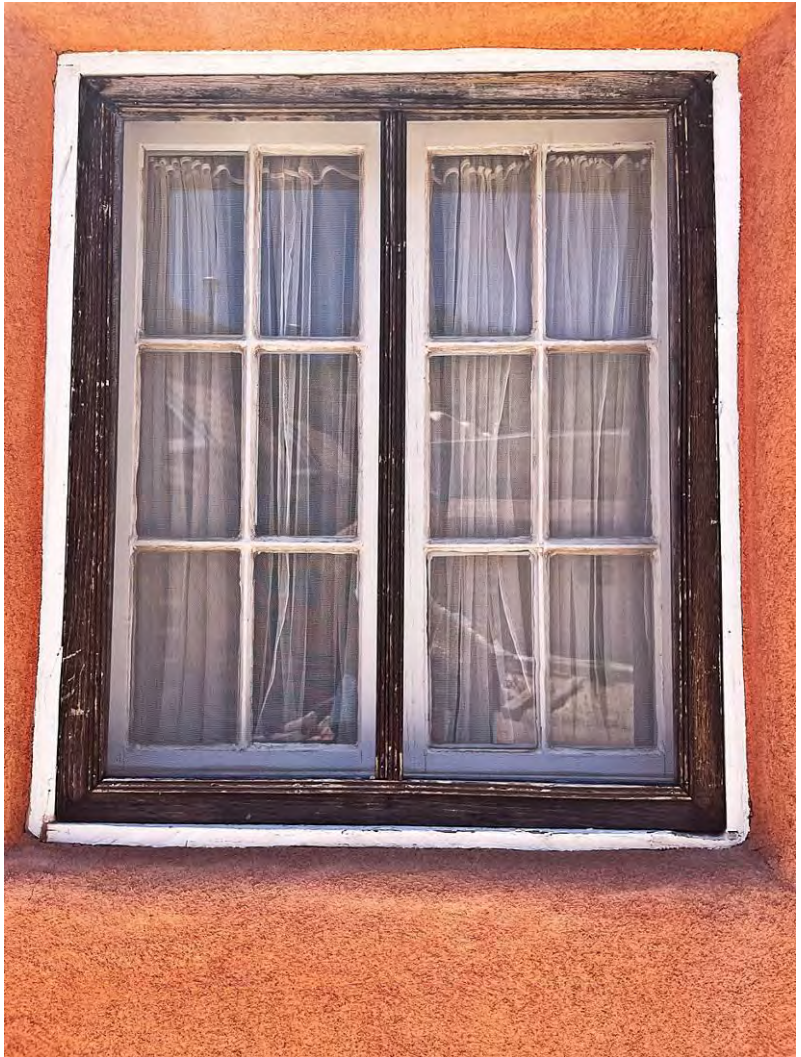
**Photo 5: North elevation, casement windows. Camera facing south.**

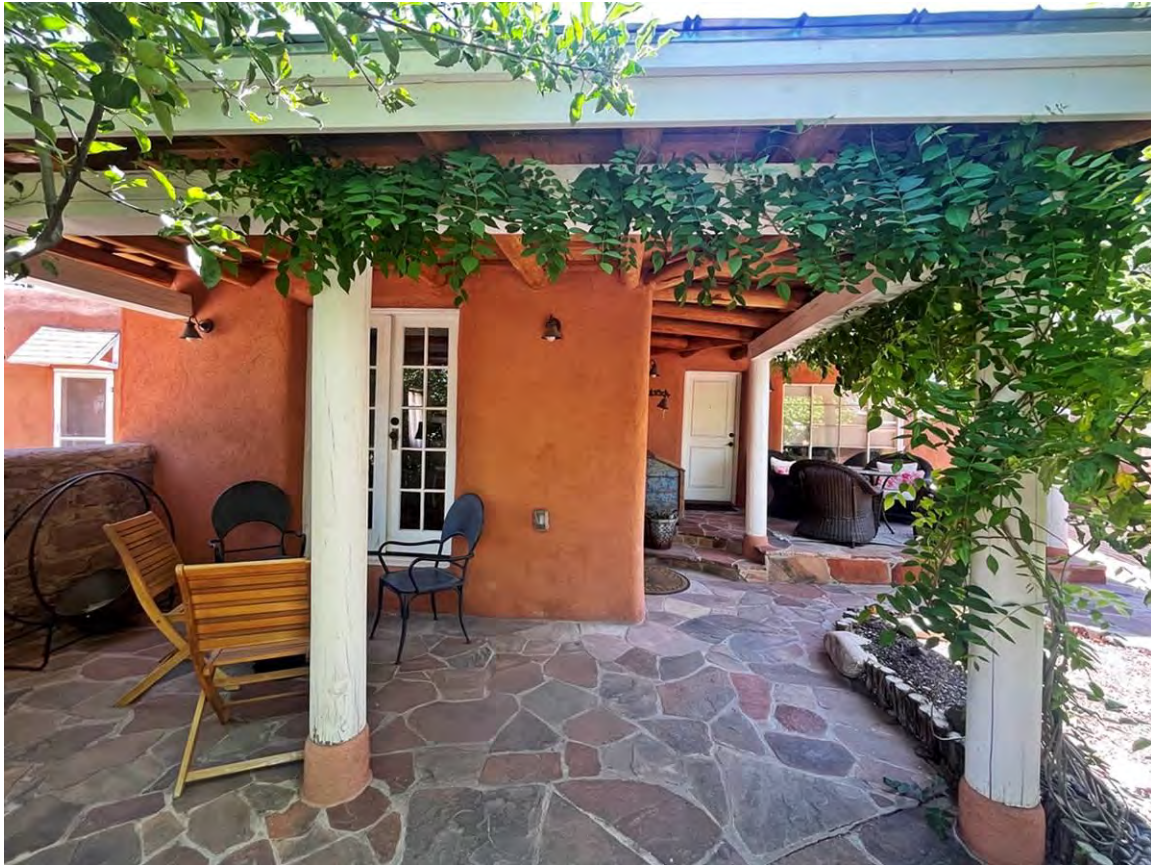
**Photo 6: West elevation, northwest corner. Camera facing east.**

The west elevation reveals change with its shaded outdoor room (Photos 6-8). The change begins with the façade-long porch. While its origin dates to the late 1950s, the current structure is much more recent and has a different design and style. Windows and doors have been replaced; the most authentic unit is a c.1950s steel combination at the southwest corner (Photo 7 & 9).

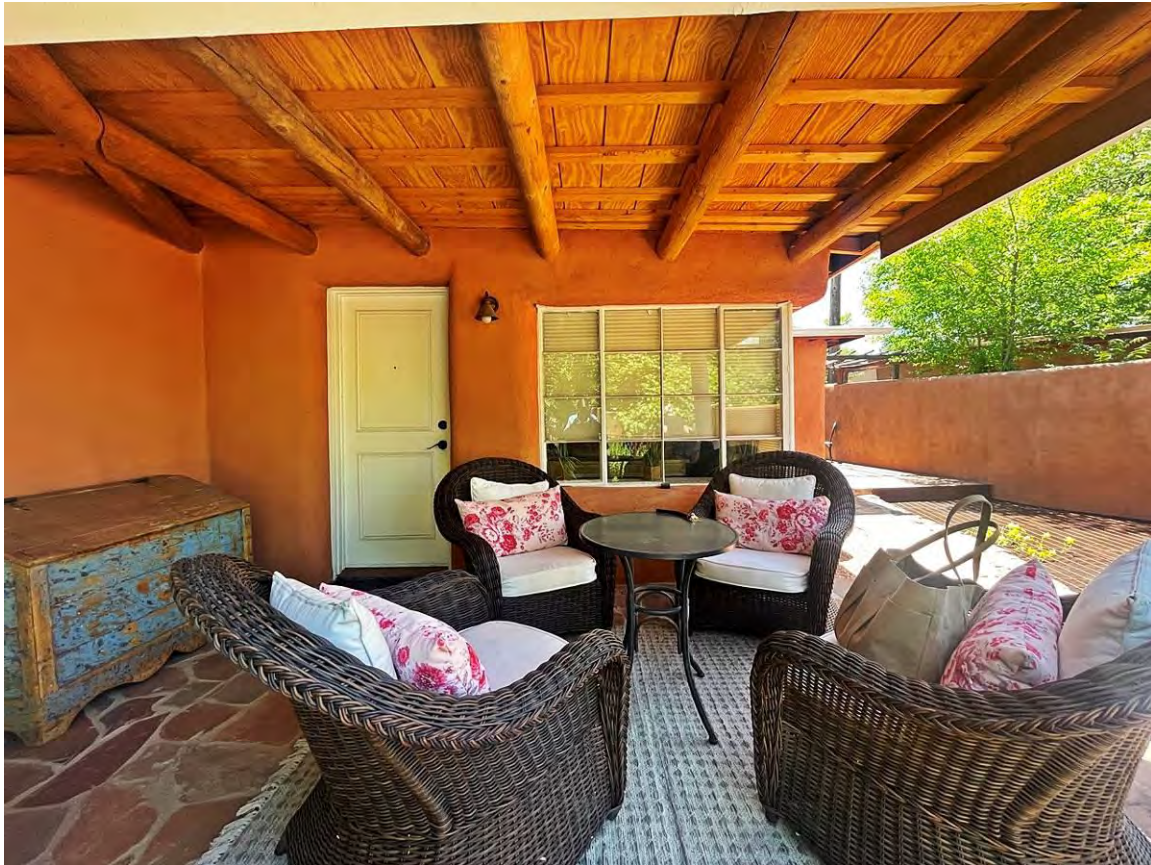
**Photo 7: West elevation, southwest corner. Camera facing east.**

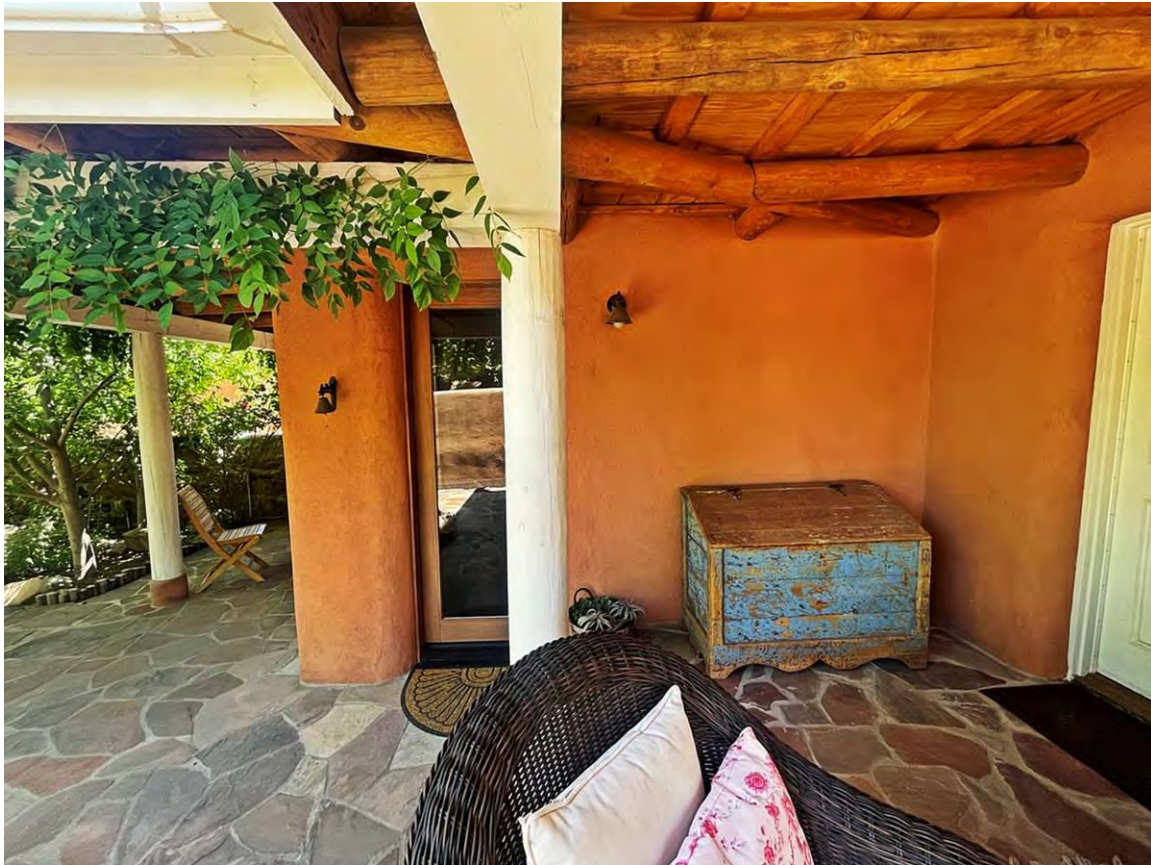
**Photo 8: South elevation, southwest corner. Camera facing north.**

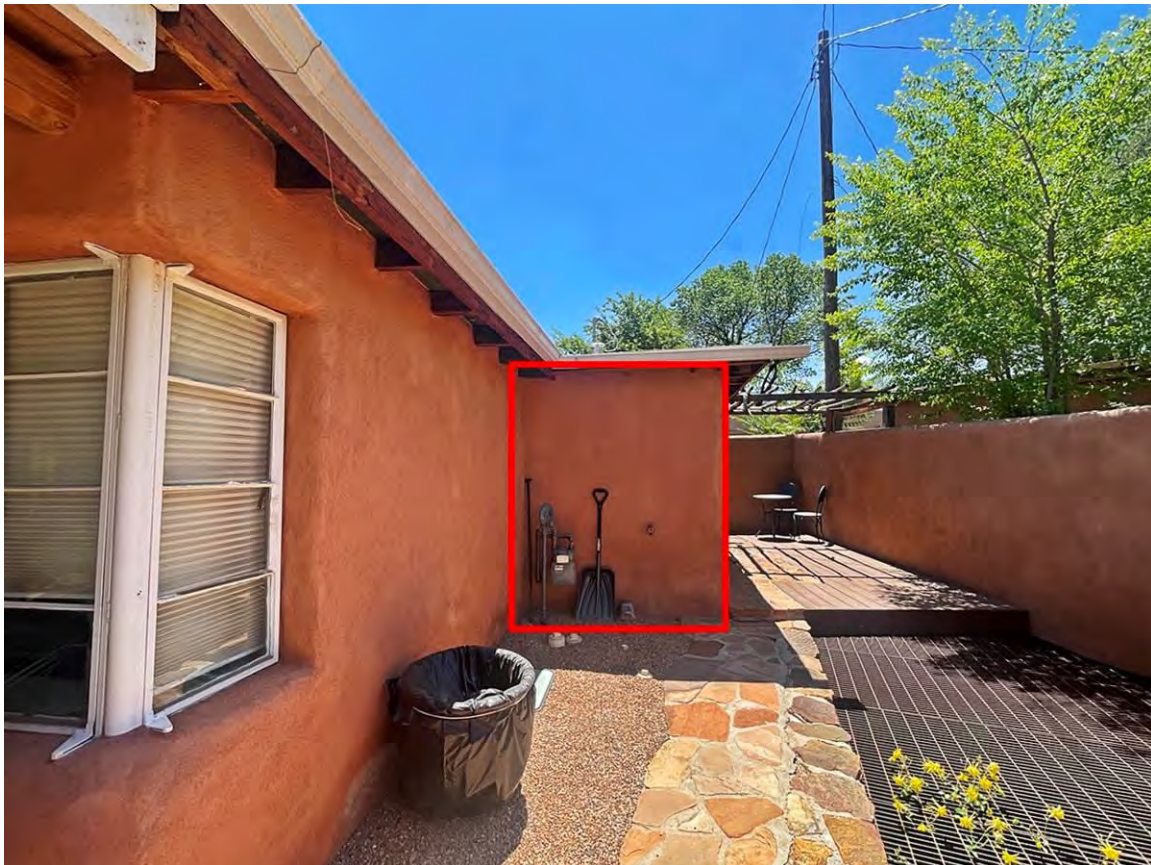
**Photo 9: South elevation oblique. 1970s bump-out highlighted. Camera facing east.**

Facing the acequia, a 1970s addition holding a bathroom dominates this façade (Photo 9). The nearly windowless volume has a shed-like feel to it (Photo 10 & 11). The east end is characterized by altered fenestration and the solid wall of a 1970s closet addition (Photo 12).

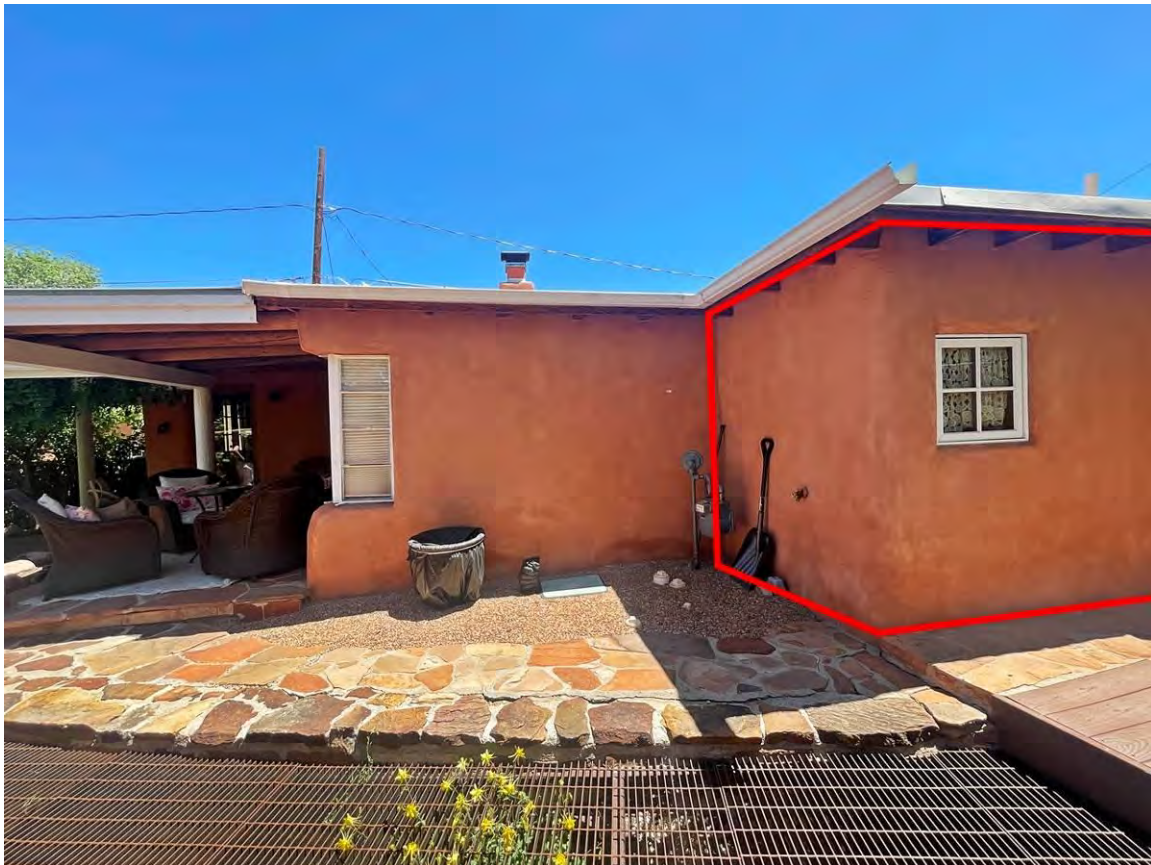
**Photo 10: South elevation, west end. 1970s bump-out highlighted. Camera facing north. Note grated acequia.**

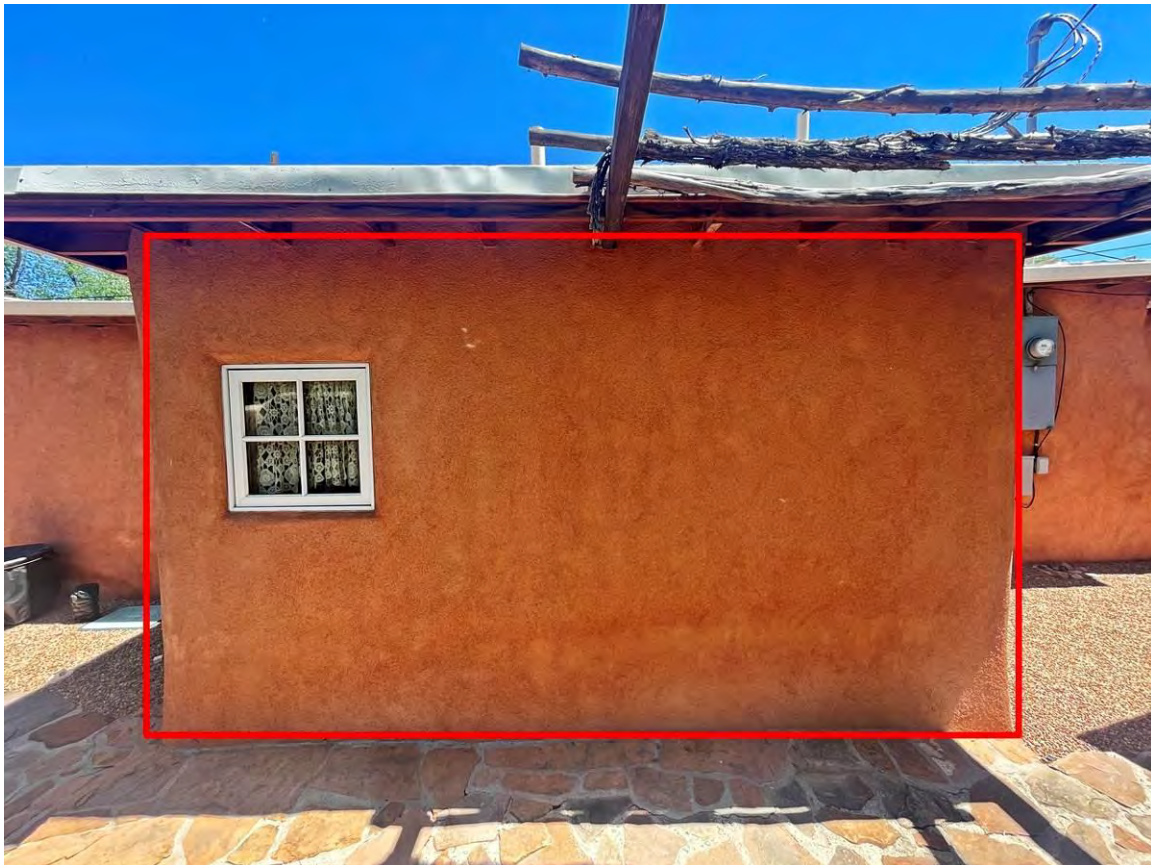
**Photo 11: South elevation, middle section. 1970s bump-out highlighted. Camera facing north.**

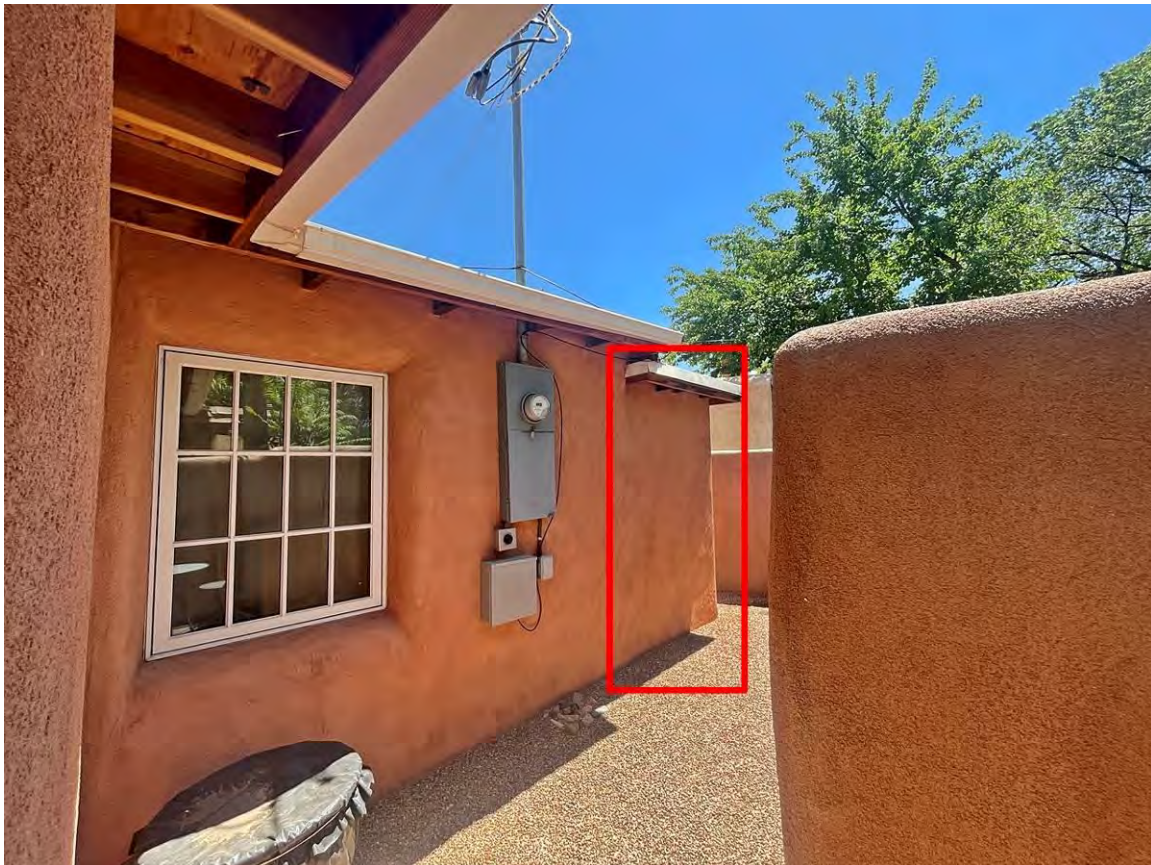
**Photo 12: South elevation, east section oblique. 1970s closet addition highlighted. Note single sash casement at left.**

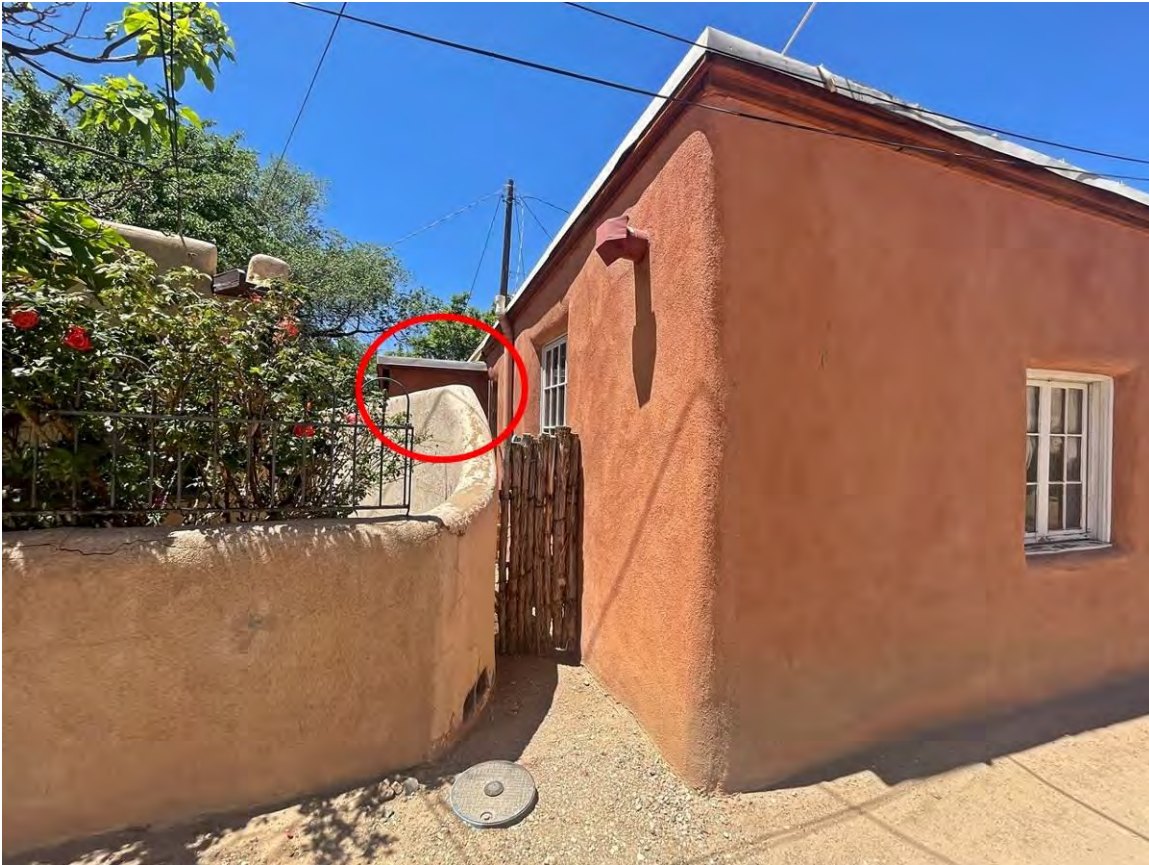
**Photo 13: East elevation oblique. Camera facing southwest. 1970s closet addition highlighted. Note single sash casement at center.**

The north end of this short elevation has two openings holding 12-light clad casements (Photo 13). Based on the north façade openings and a Google Street View, the east elevation openings held paired 6-light wood units (Fig. 13). The 1970s closet addition crowds its southwest corner (Photo 14).

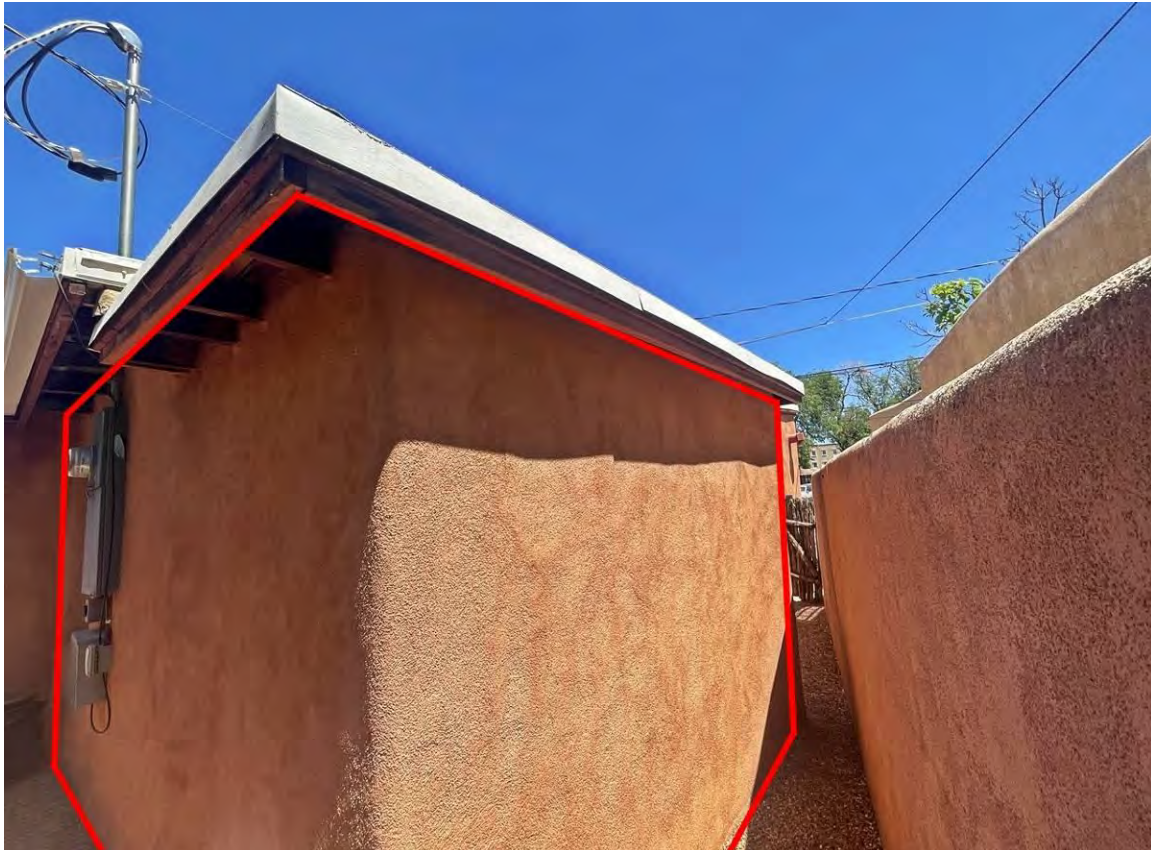
**Photo 14: East elevation. 1970s closet addition highlighted. Camera facing northwest.**

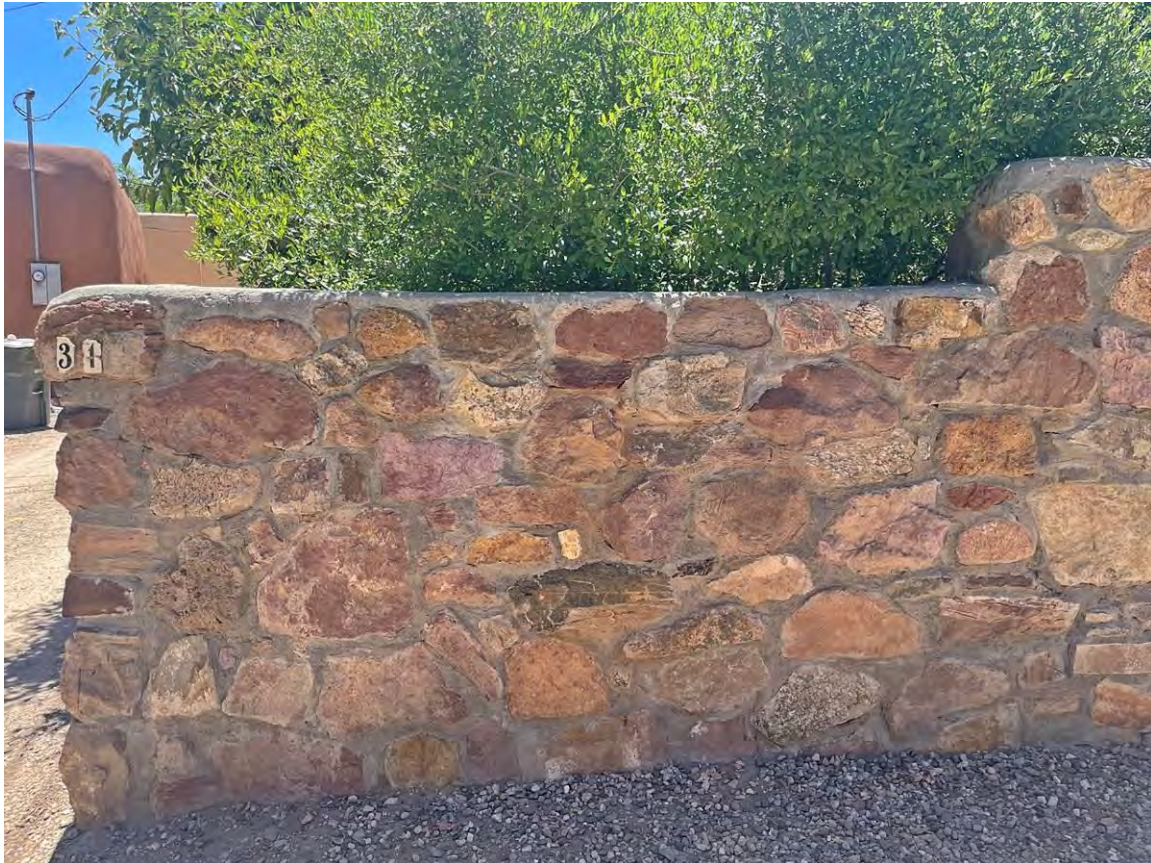
**Photo 15: Recently constructed stone wall section, west elevation. Camera facing east.**

While the stone wall was shortened in length and artificially reconstructed across its west exposure, there is enough left of it to be considered a Contributing resource. With this in mind, the recommendation is to amend the status to include only the surviving north section.

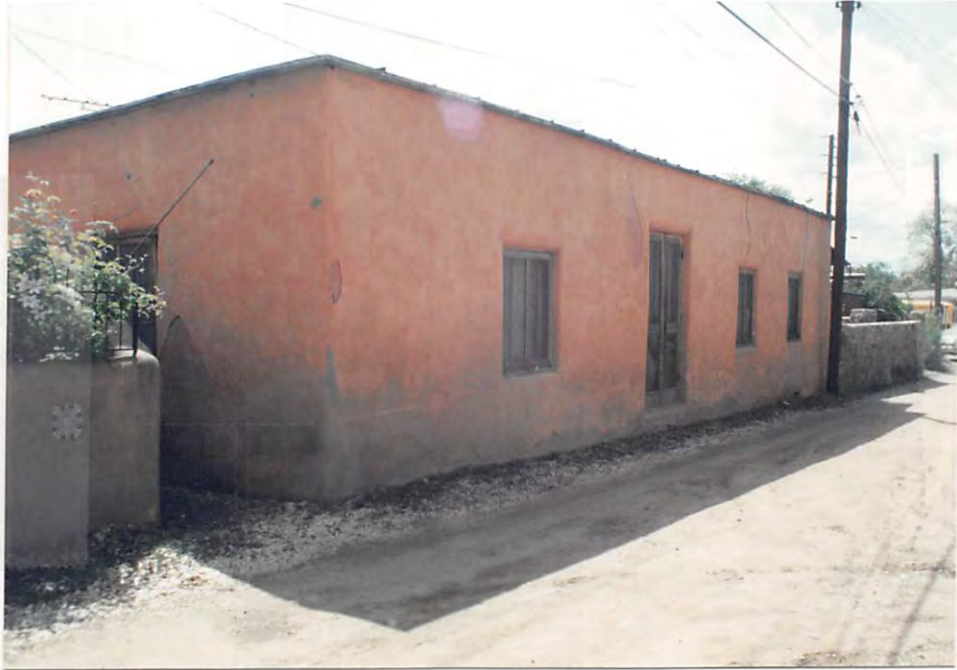
312 PINO

N + E ELEVATION
