Historic Cultural Properties Inventory (HCPI) Base Form (FORM 1)

1. Name of property: Librado and Plácida Ortiz House	2. Location: 1295 Cerro Gordo Road Downtown and Eastside Historic District — Santa Fe	3. Local Reference Number: Santa Fe ID: H-1372 4. County: Santa Fe Parcel # 11916416

8. Name of Project: HDRB Status Evaluation		
9. Lat/Long: 35.6834109,-105.9154025		
10. Photo Information: Jim Rodman, photographer. Photo 1: View of south (front) elevation. Camera facing northwest.

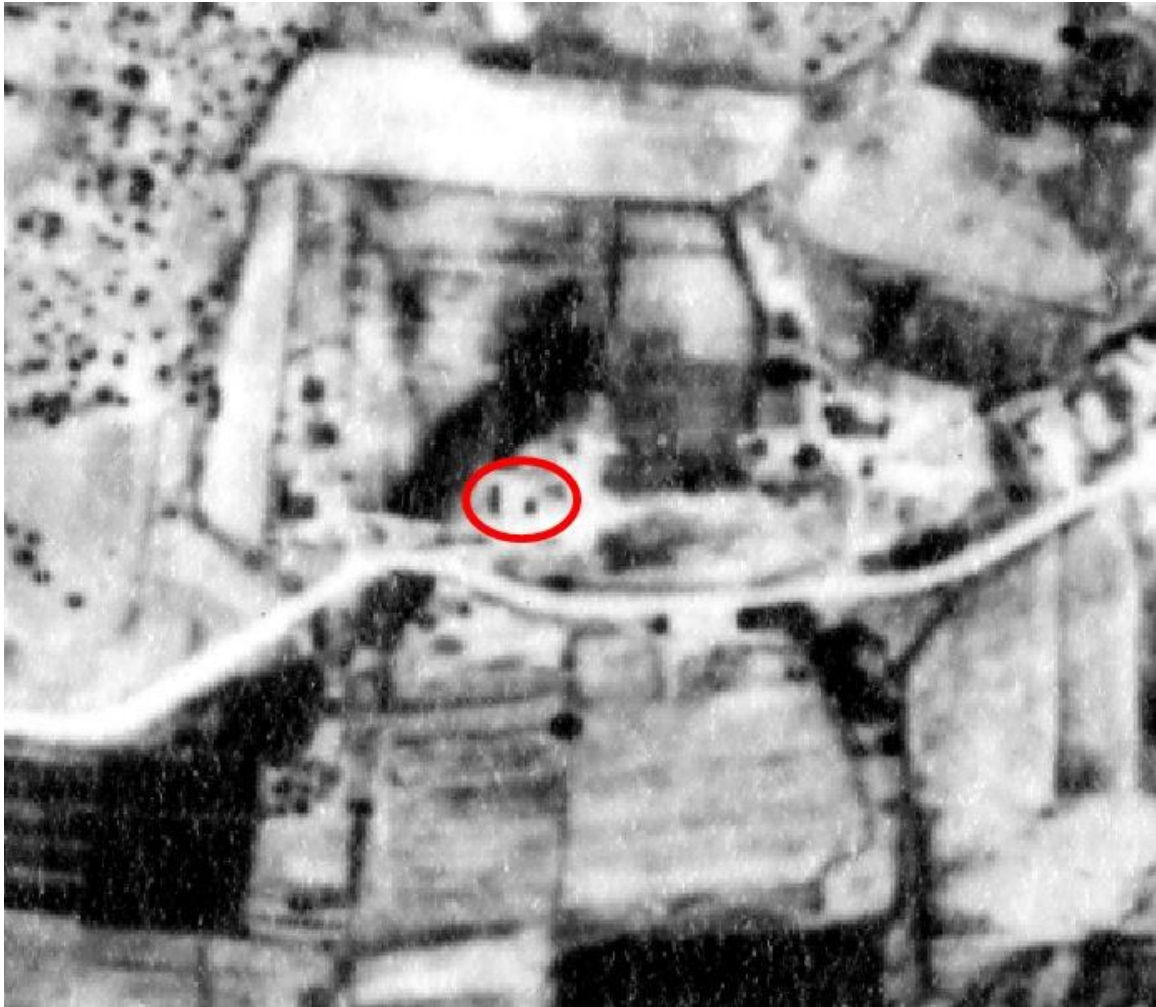
Figure 2: 1935 aerial photograph. United States Soil Conservation Service, NM 133, Sheet # 1009. Subject house circled.

The description, employing traditional terminology and measurement, reflects the continued subdivision of a larger family landholding using informal boundaries and access routes rather than surveyed lots. A 1935 aerial photograph indicates that a

building was present on the site by the mid-1930s (Fig. 2). The 1940 census recorded a similar household and neighborhood composition as before the Great Depression.

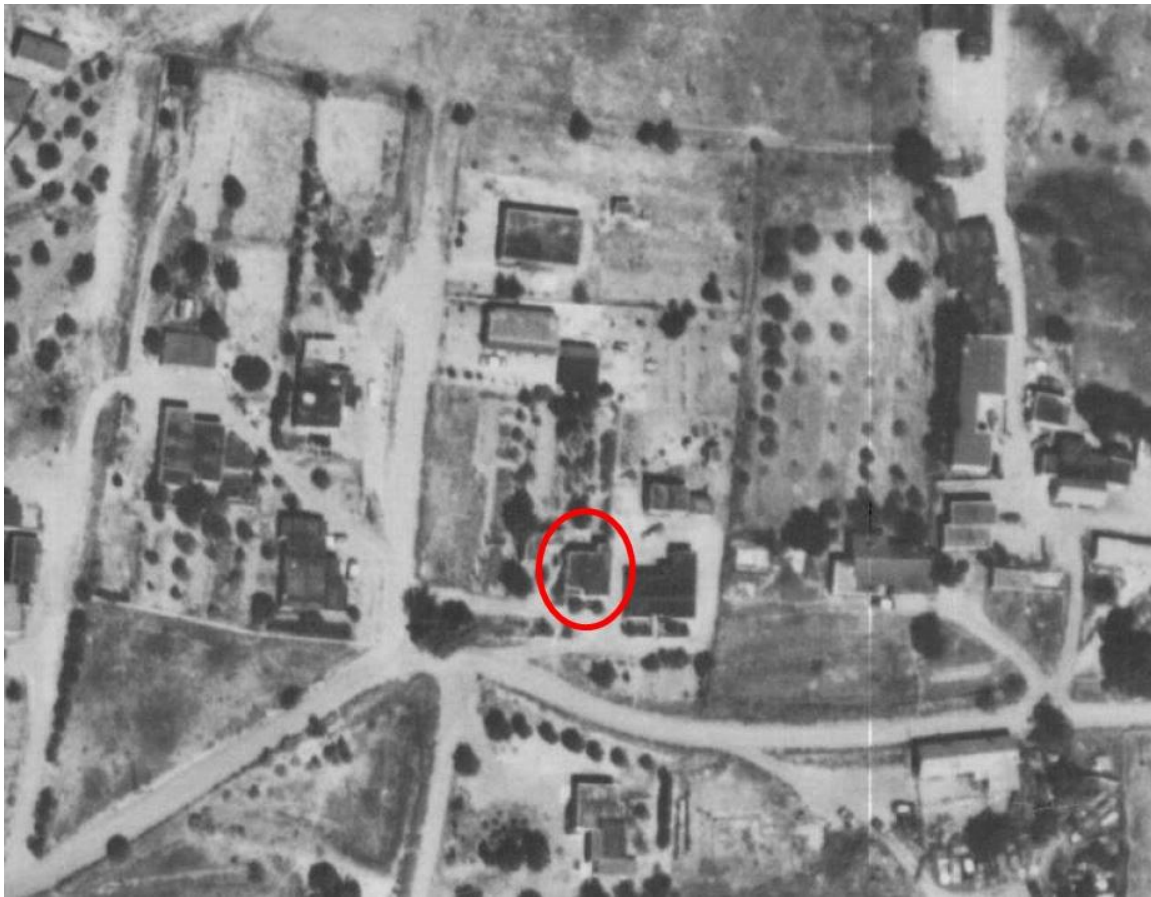
Figure 3: September 25, 1960, aerial photograph. Subject house circled.

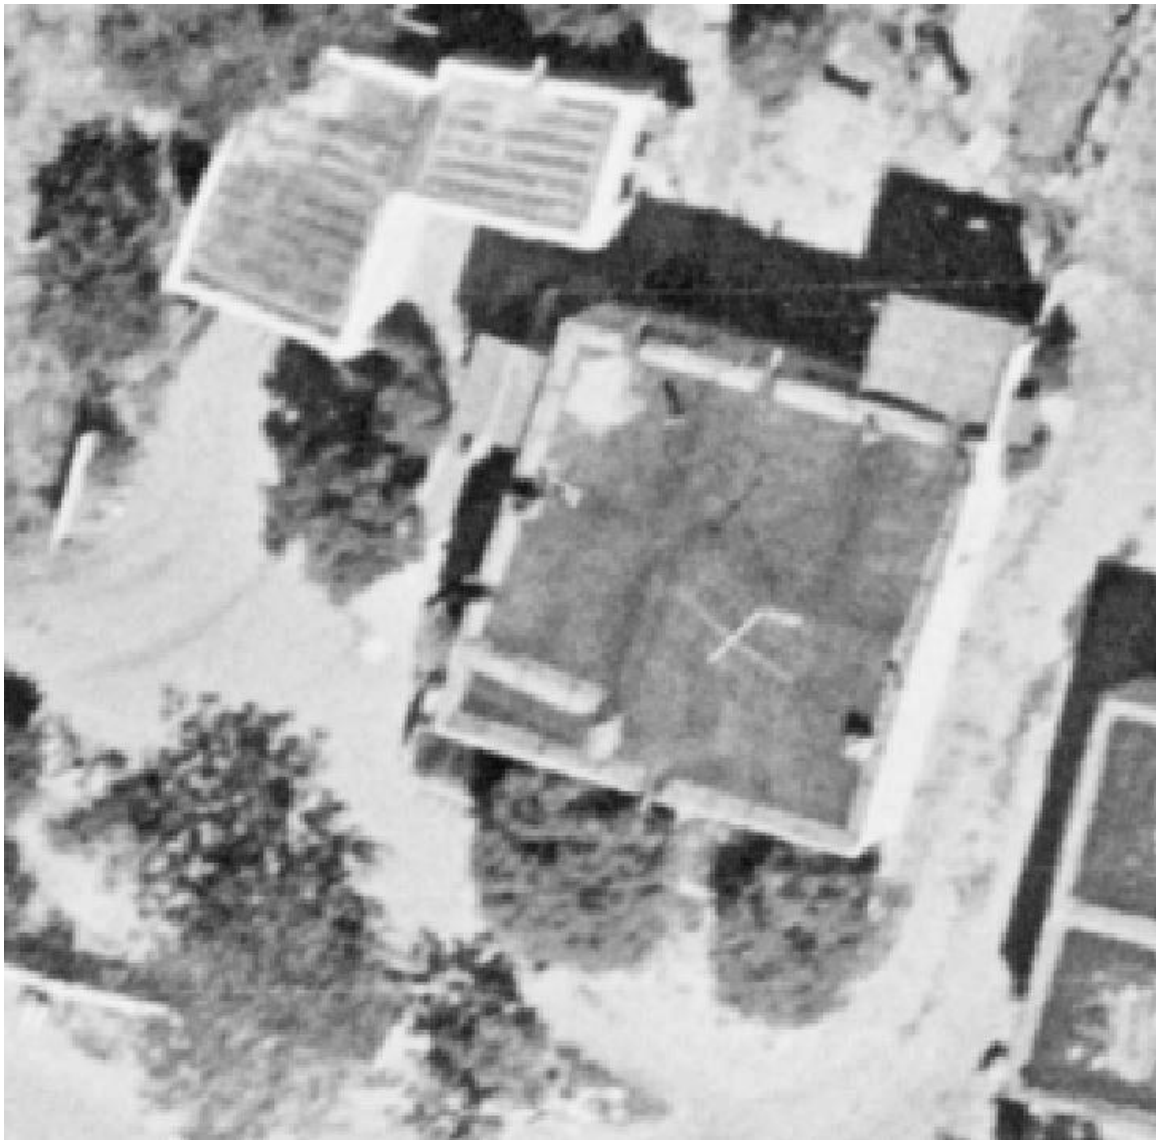
Figure 4: September 11, 1978, aerial photograph.

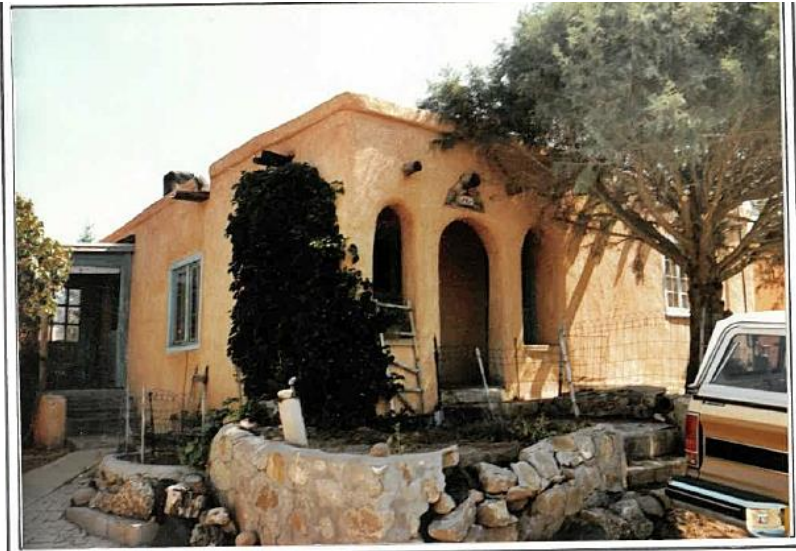
Figure 6: 1987 appraisal photographs.

Front of Subject

Rear of Subject

A photograph from a 1987 appraisal indicates that this entry was then of a different configuration, appearing semi-enclosed and incorporating a window (Fig. 6). Two metal *canales* of older vintage pierce the parapet, and a small stuccoed chimney stack rises above the roofline.

The north elevation opens onto a patio and represents the most altered façade of the house (Photo 6). A 1987 appraisal photograph indicates that it historically contained a small number of wood casement windows and a bumped-out section at the northeast corner, used as a laundry room (Fig. 6).

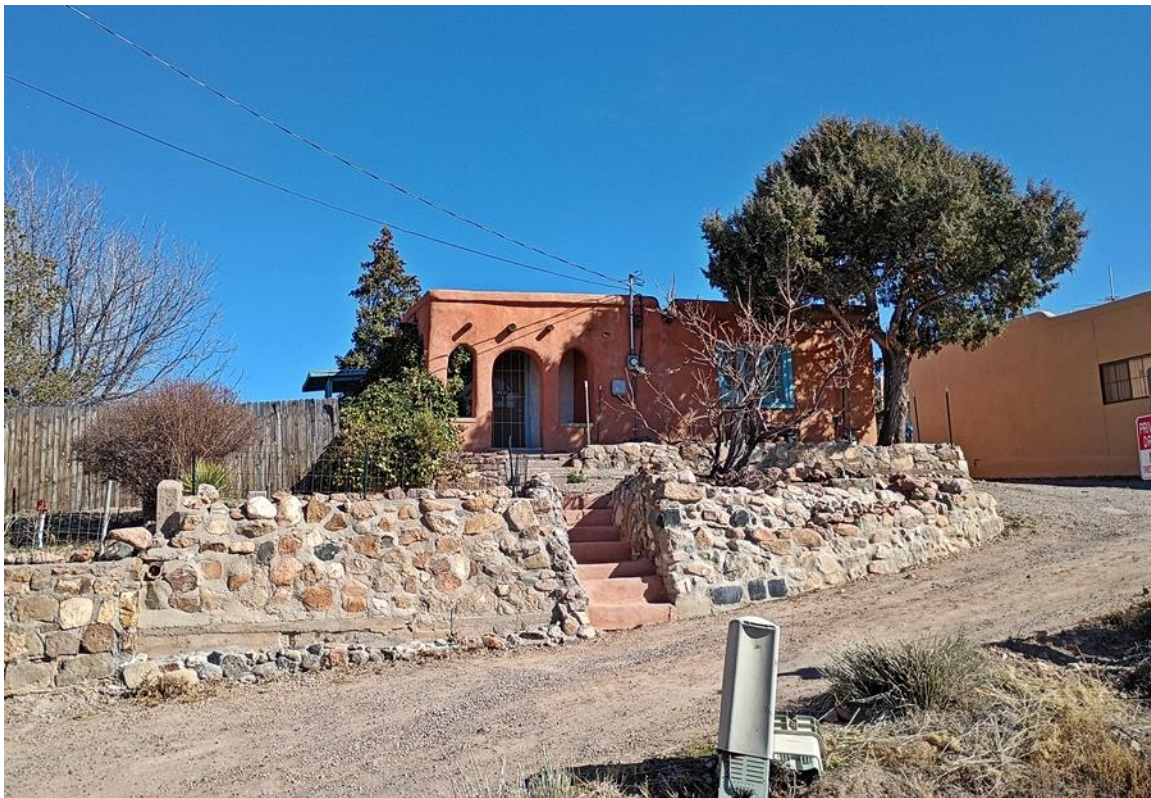
Photo 2: Setting. Camera facing north.

The property occupies an elevated lot above the road, defined by a substantial terraced retaining wall constructed of irregular fieldstone (Photo 2). A central concrete stair ascends from the street to a small landing and entry sequence. The 0.235-acre site is informally landscaped with gravel ground cover, scattered shrubs, and mature trees, including a mature character-giving juniper near the front of the building. In addition to the stone retaining walls, the site includes modern board fencing.

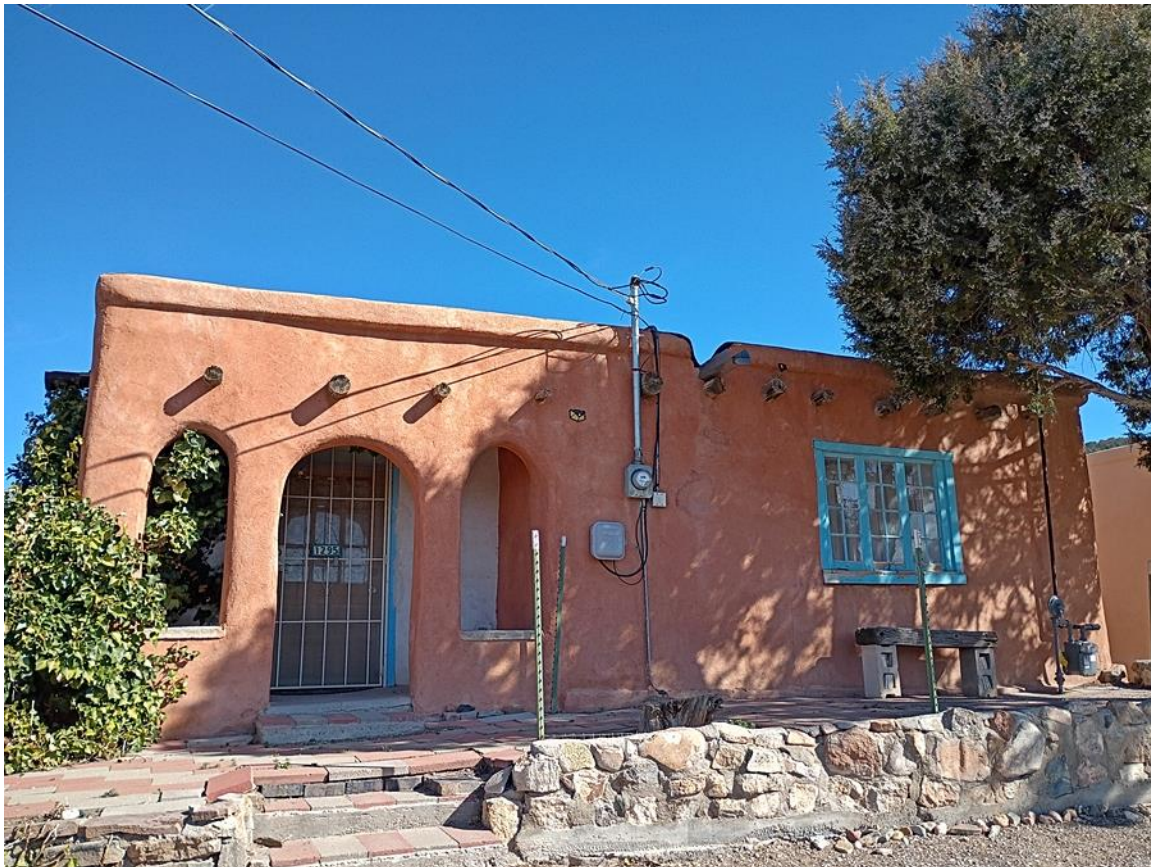
Photo 3: South (front) façade. Camera facing north.

The south (front) elevation occupies an elevated, terrace-like setting overlooking the Santa Fe River valley, an area historically associated with agriculture and with the family who constructed the house. The façade reflects two early phases of construction, comprising the original two-room core and a subsequent expansion (Photo 3). While the exact sequence is not fully clear, the east portion appears to represent the earlier construction.

An arched porch was added shortly thereafter in conjunction with the expansion to the west, which introduced two additional rooms. Differences in the diameter of the exposed viga ends along the façade indicate these phases. The later section is approached by a short run of concrete steps leading to the porch (Photo 3). Three arches define this space and shelter the primary entry, which contains a nine-light wood door.

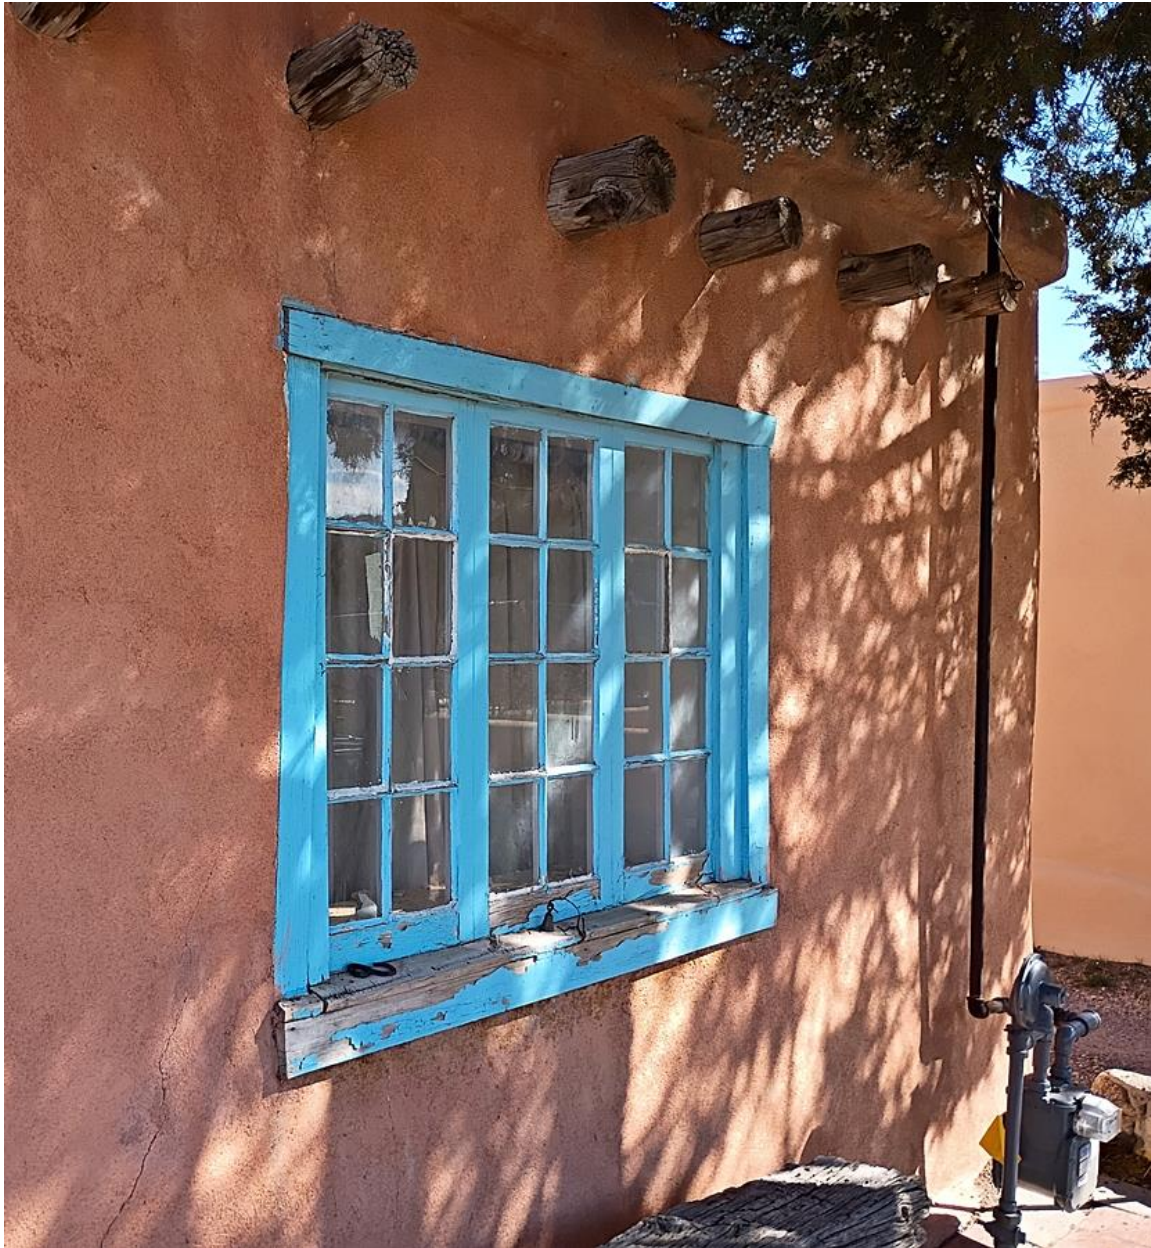
Photo 4: South (front) façade. Window detail. Camera facing northeast.

To the east, the earlier portion of the façade is fenestrated by a grouped set of eight-light wood fixed sash windows within a continuous opening (Photo 4). These are set close to the wall plane and framed by simple wood casings.

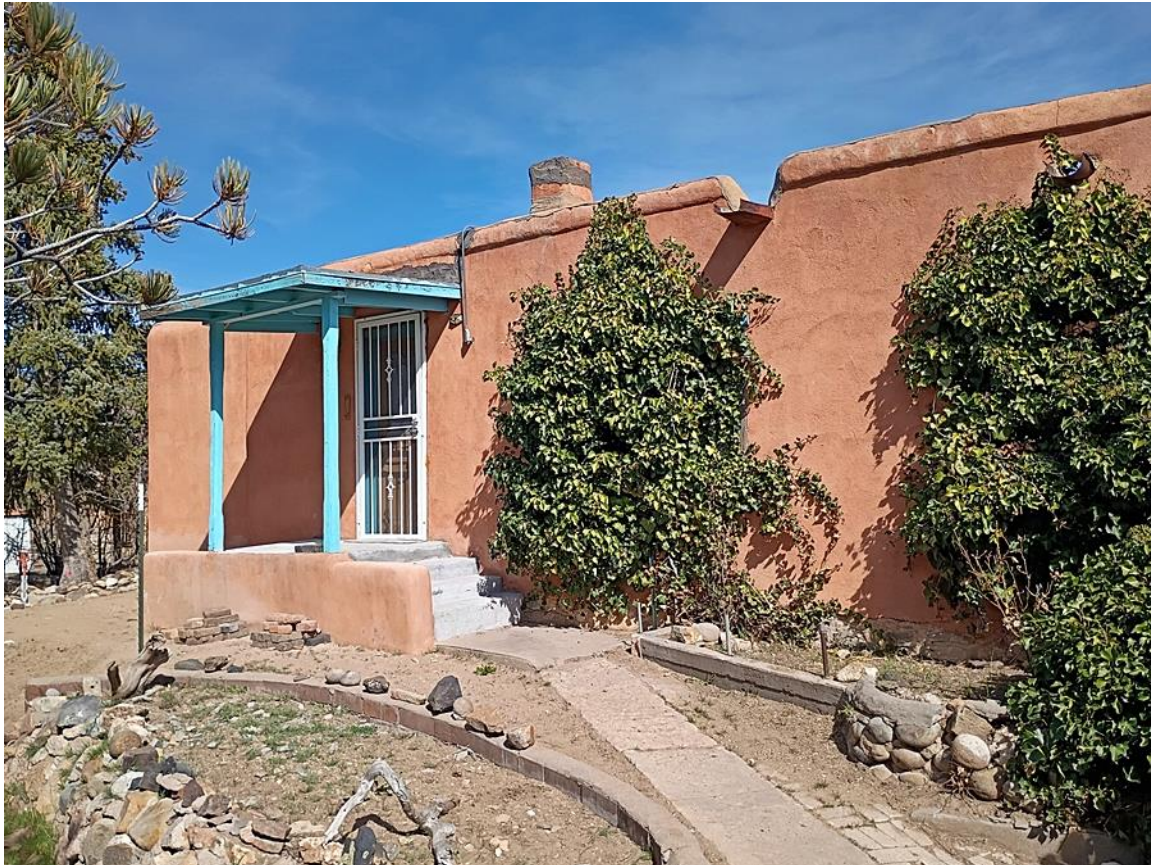
Photo 5: West elevation. Camera facing northeast.

The west elevation contains a secondary historic entry, which provided access to a small apartment during World War II. The façade includes a window with two six-light non-operable sash, now obscured by ivy (Photo 4). The entry is approached by concrete

steps leading to a small landing, sheltered by a non-historic shallow shed-roof canopy supported by square wood posts. Behind a security grille is a half-light over panel wood door of unknown vintage.

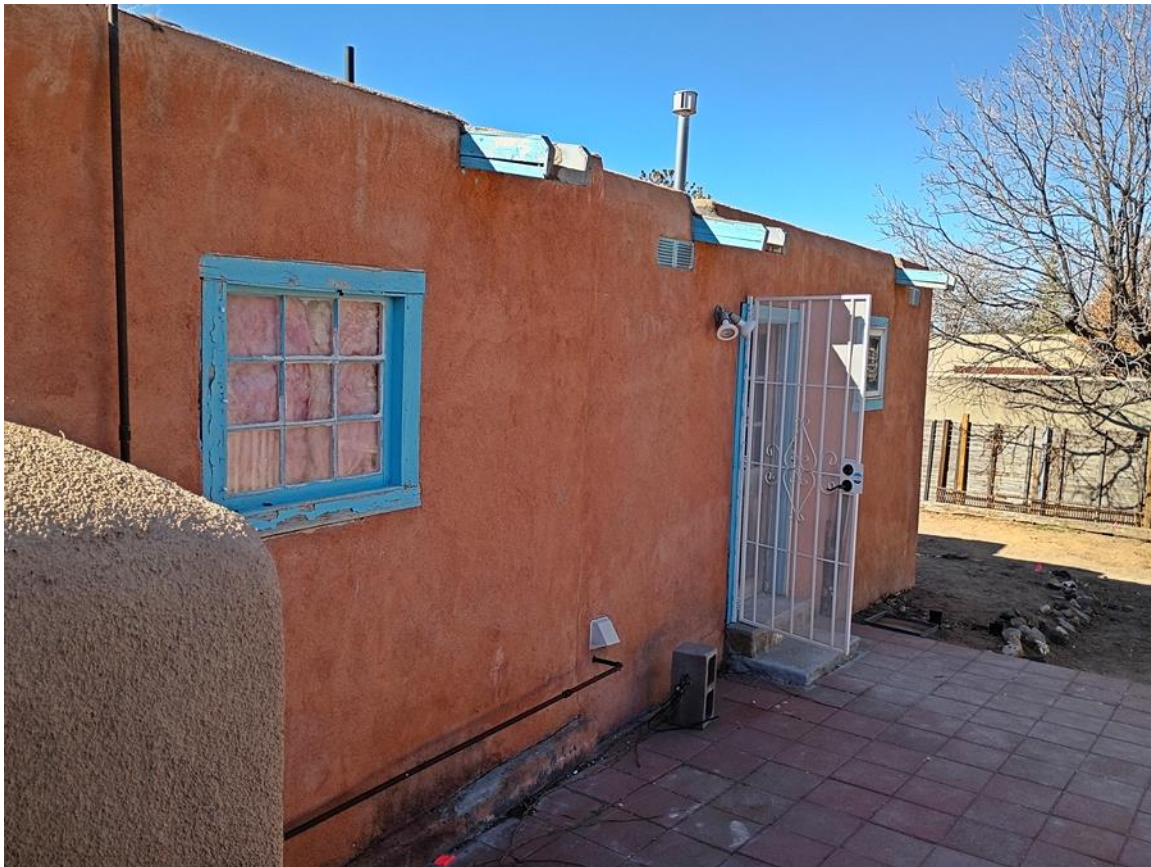
Photo 6: North elevation, Camera facing southwest.

In 1996, the then-owner received approval from the Historic Design Review Board to construct a two-room addition, extending the building approximately six feet north to align with the wall plane of the earlier projection. The addition is fenestrated with a door and a small casement window. The earlier extension retains its original six-light sash.

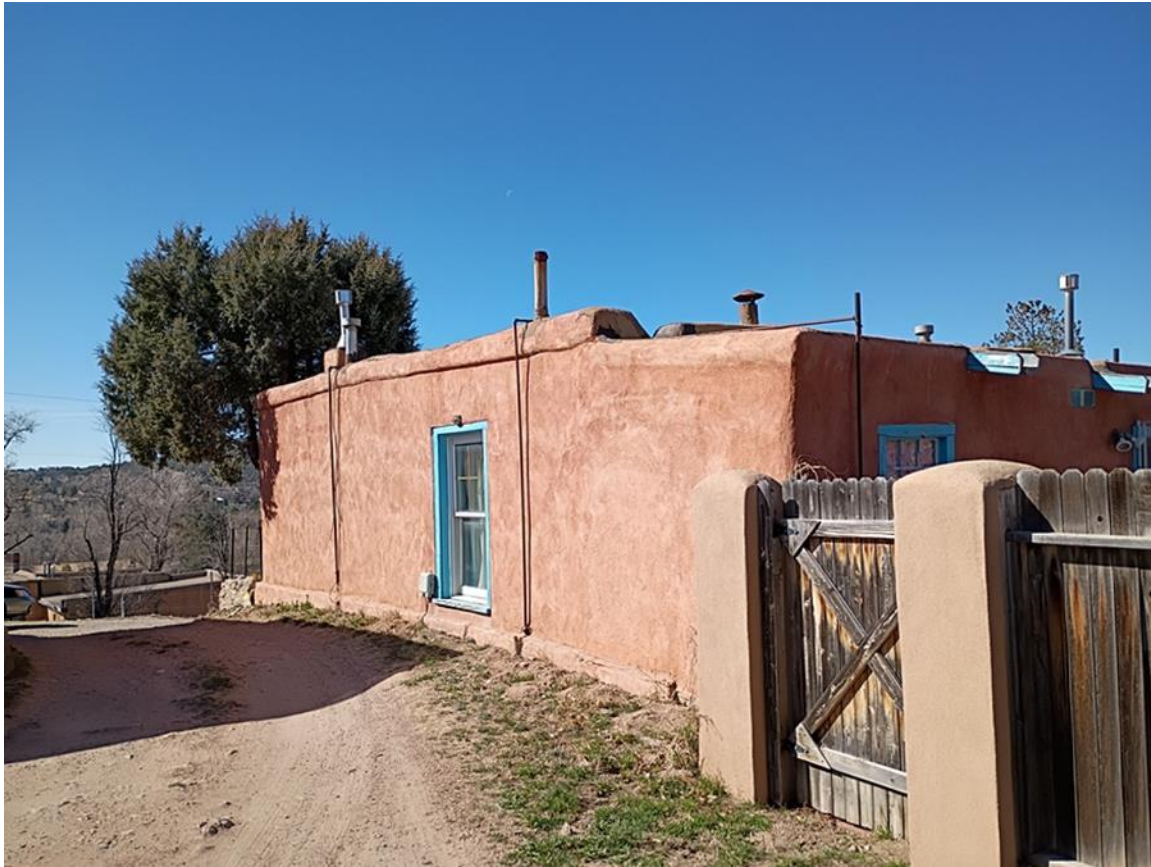
Photo 7: East elevation. Camera facing northwest.

This elevation has minimal fenestration, consisting of a single opening fitted with a clad one-over-one hung sash window (Photos 7 & 8). A line of *contrapared* is visible at the base of the wall. As with the other elevations, the parapet is thickened. Several vents and pipes rise above the roofline. A low stuccoed chimney stack is also present on this elevation and has been fitted with a modern stove flue.

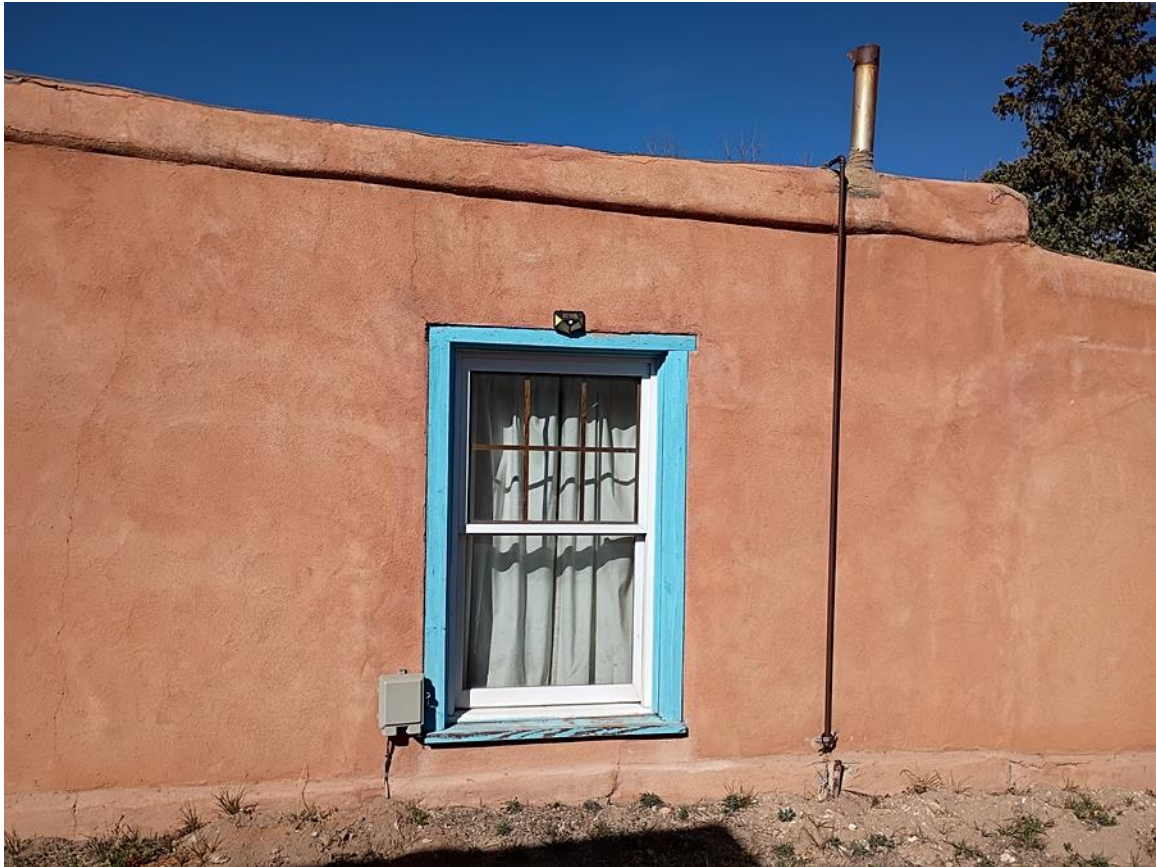
Photo 8: East elevation. Window detail. Camera facing west.
