**203 West Water Street**

# Historic Cultural Properties Inventory (HCPI) Base Form (FORM 1)

| 1. Name of property:<br><br>Livingston Furniture Company<br>Warehouse/ Scharf Gallery | 2. Location:<br><br>203 West Water Street<br>Downtown and Eastside Historic District -<br>Santa Fe | 3. Local Reference Number:<br>Santa Fe ID: H-3567<br><br>4. County: Santa Fe<br>Parcel # 99306890 |
| 8. Name of Project:<br>HDRB Status Evaluation | | |

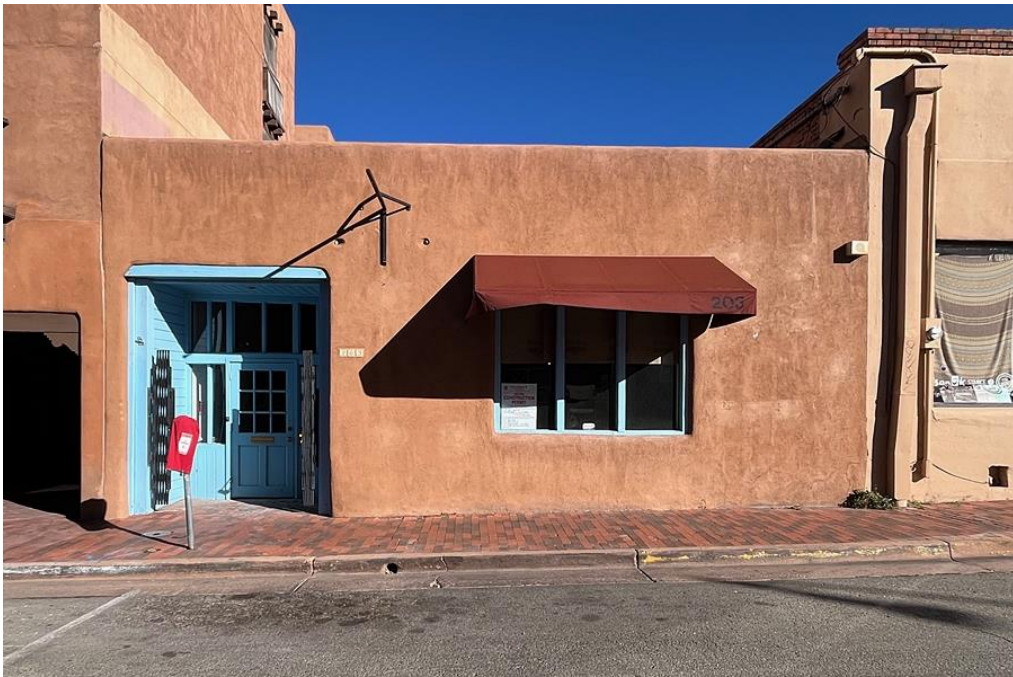
| 10. Photo Information: John W. Murphey, photographer. Photo 1: View of south elevation. Camera facing north. | | |

The building presents a single visible façade: a south-facing storefront oriented toward the former El Fidel Hotel. The approximately 32-foot-wide plane is divided into a recessed entry and a display window (Photo 1).

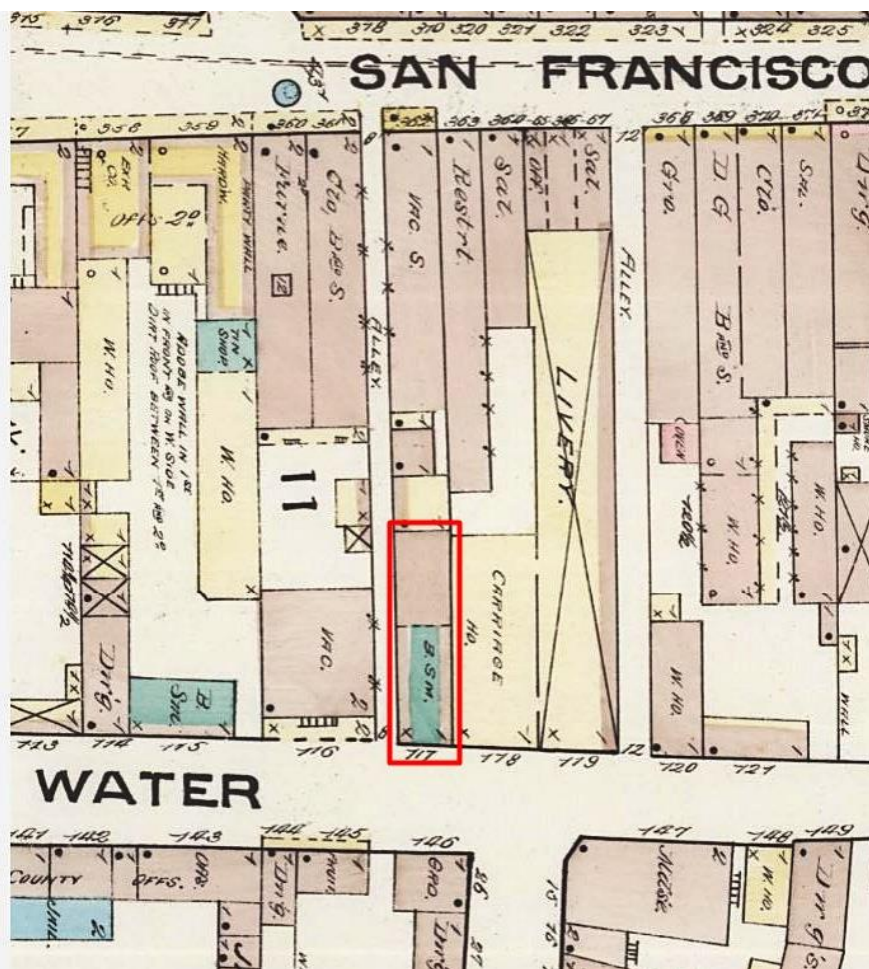
Figure 1: 1883 Santa Fe Sanborn Fire Insurance Company Map. Subject building highlighted.

The building’s first documented use was as a blacksmith shop, an essential component of this horse-powered economy, providing shoeing, wagon repair, and metalwork for both commercial and private clients. The first Sanborn Fire Insurance Map of 1883 depict the blacksmith shop (“B. Sm.”) as a partially masonry-constructed space (colored blue), set within a larger adobe (brown) building footprint (Fig 1). This distinction likely reflects the presence of a fire-resistant forge or work area within an otherwise earthen-walled structure, rather than a change in exterior finish. Such hybrid construction was common for blacksmith operations, where the risks associated with heat and sparks necessitated localized fireproofing.

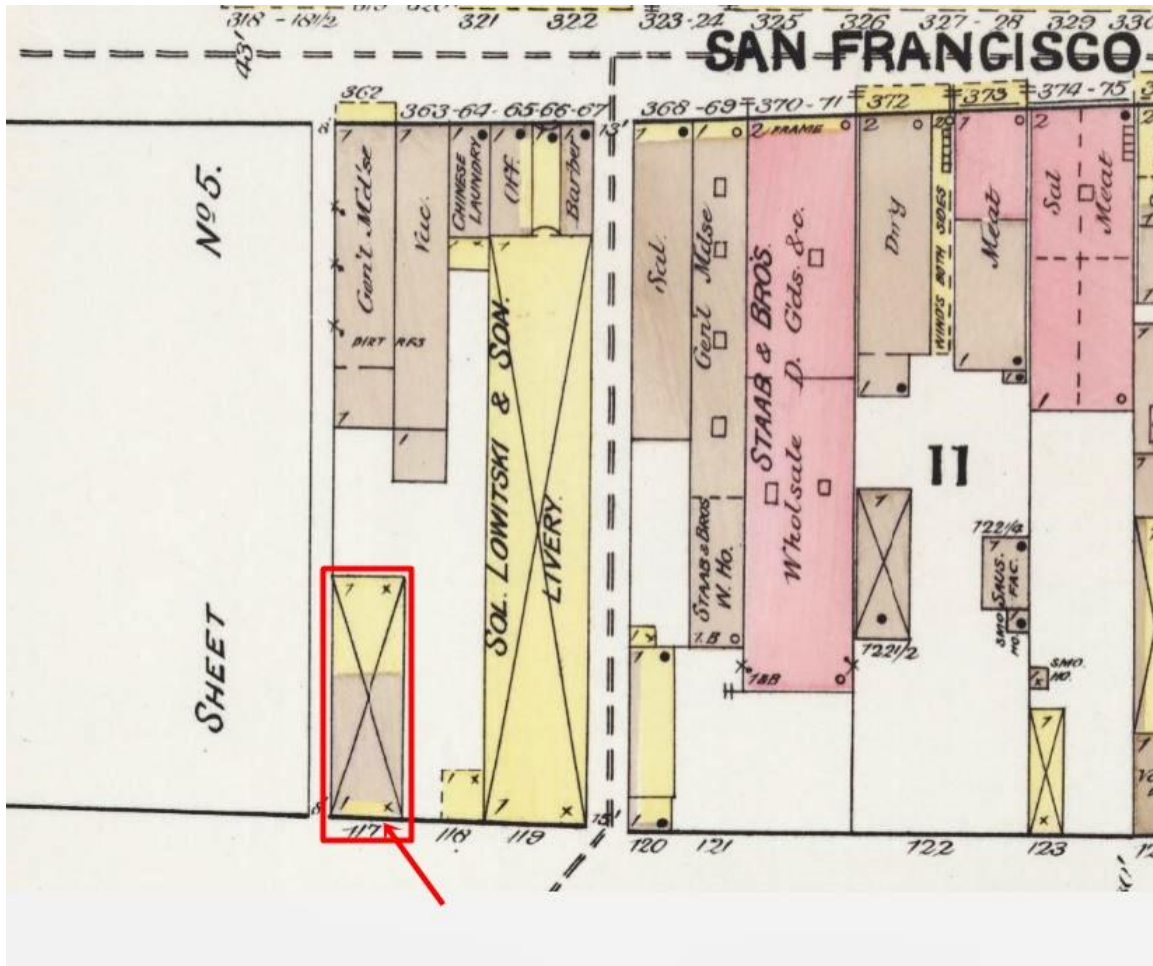
Figure 2; 1890 Santa Fe Sanborn Fire Insurance Company Map. Note introduction of wood-frame storefront (arrow).

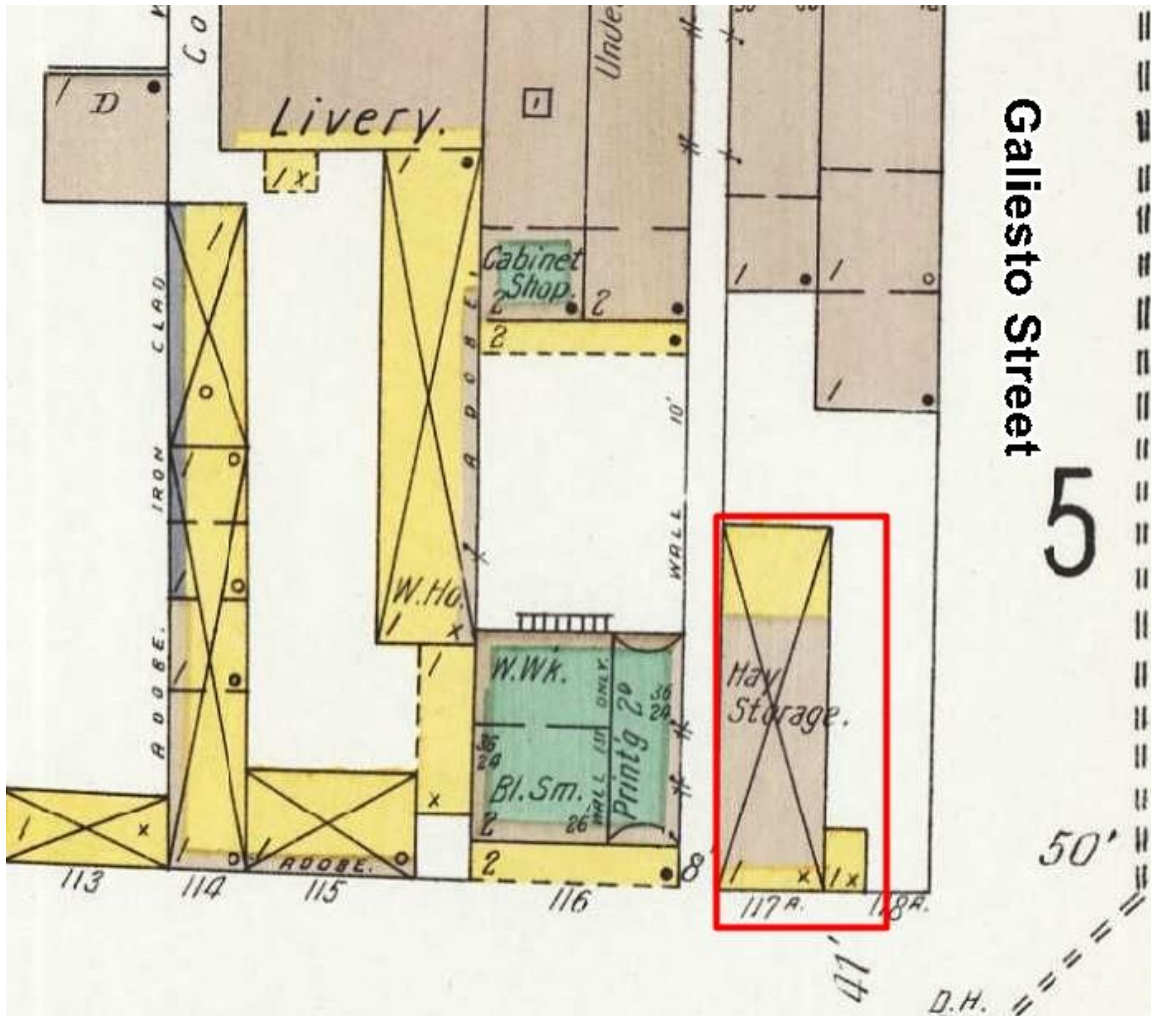
**Figure 3: 1902 Santa Fe Sanborn Fire Insurance Company Map. Note frame extension along east elevation.**

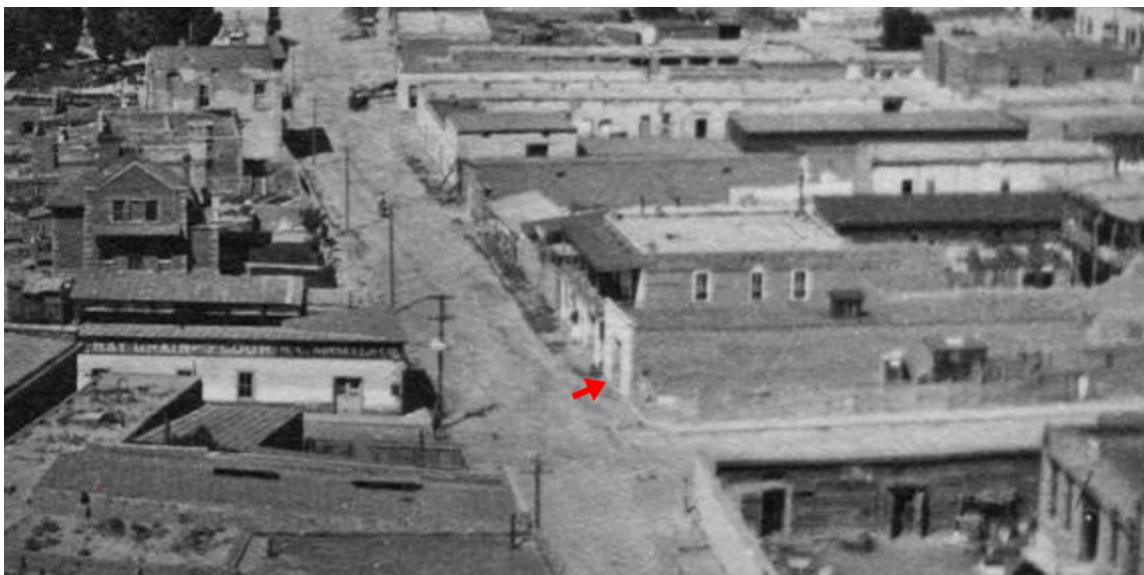
**Figure 4: Portion of c.1909 – 1910 view of Water Street, taken from power plant smokestack. Large wood entry to building indicated by arrow.**

Following Solomon's death, his widow Jennie Lowitzki retained ownership of the remaining parcel and adapted its use to reflect changing economic conditions. With the gradual decline of horse-based transportation already underway, she shifted toward to a retail-oriented enterprise, opening a general merchandise store along the West San Francisco Street frontage of the property. The building was captured in a birds eye view during this period, with a large entry spanning its façade (Fig. 4).

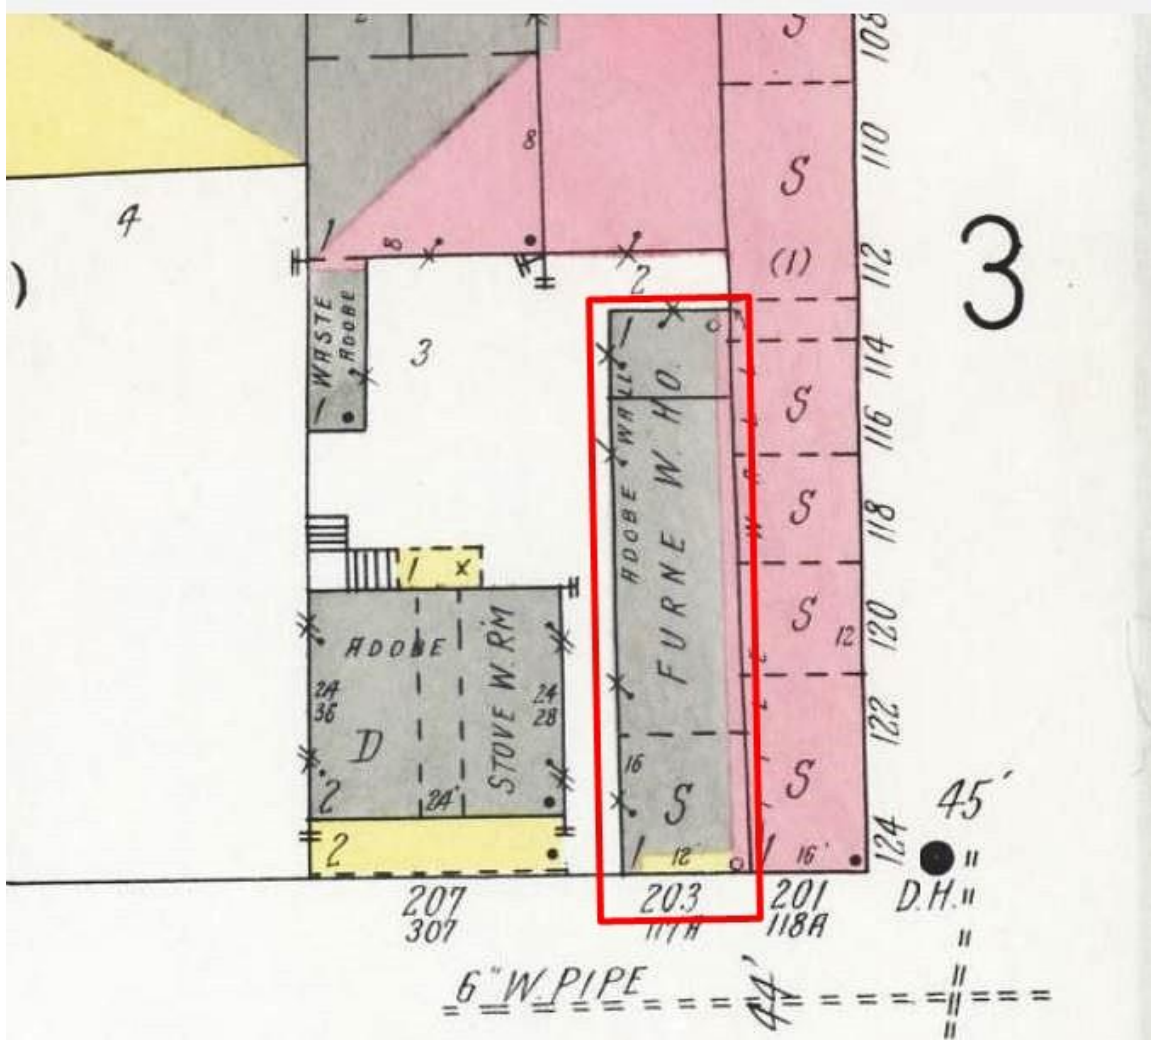
Figure 6: 1930 Santa Fe Sanborn Fire Insurance Company Map. Note removal of side entrance door and reinsertion of frame canopy or portal at Water Street in what is now a store "S" with a frame storefront reintroduced.

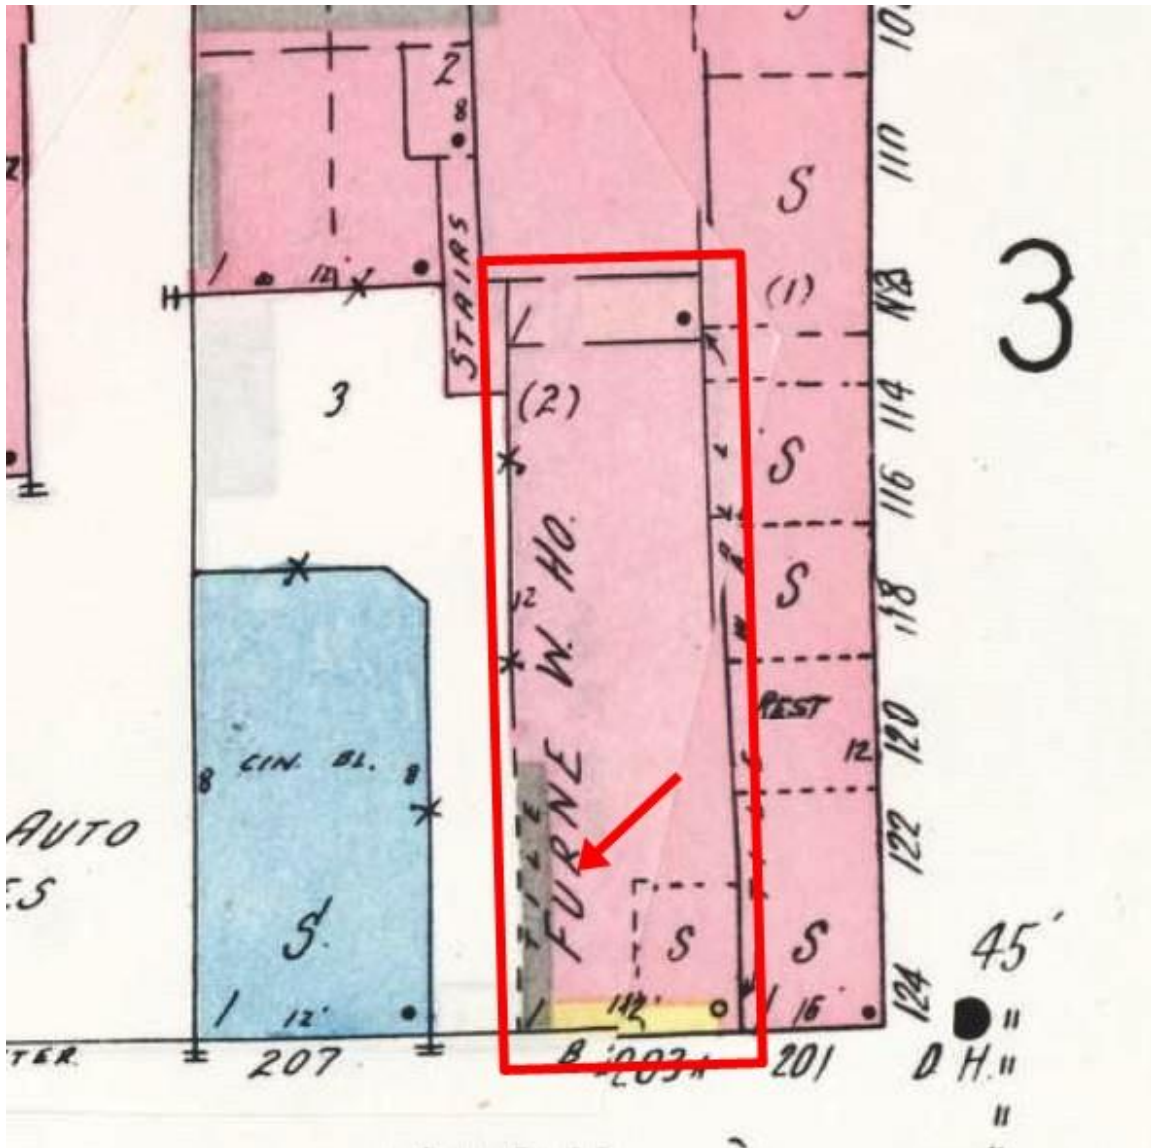
**Figure 7: 1948 Santa Fe Sanborn Fire Insurance Company Map. Note building has been reconstructed in with hollow clay tile walls (arrow).**

Taken together, the map and physical evidence suggest that the earlier adobe structure was either substantially rebuilt or entirely replaced between 1930 and 1948. This represents the most significant construction phase in the building's history, marking its transition into a more durable, fire-resistant commercial structure. It also established its historic appearance in the postwar period, until its renovation in the 1980s.

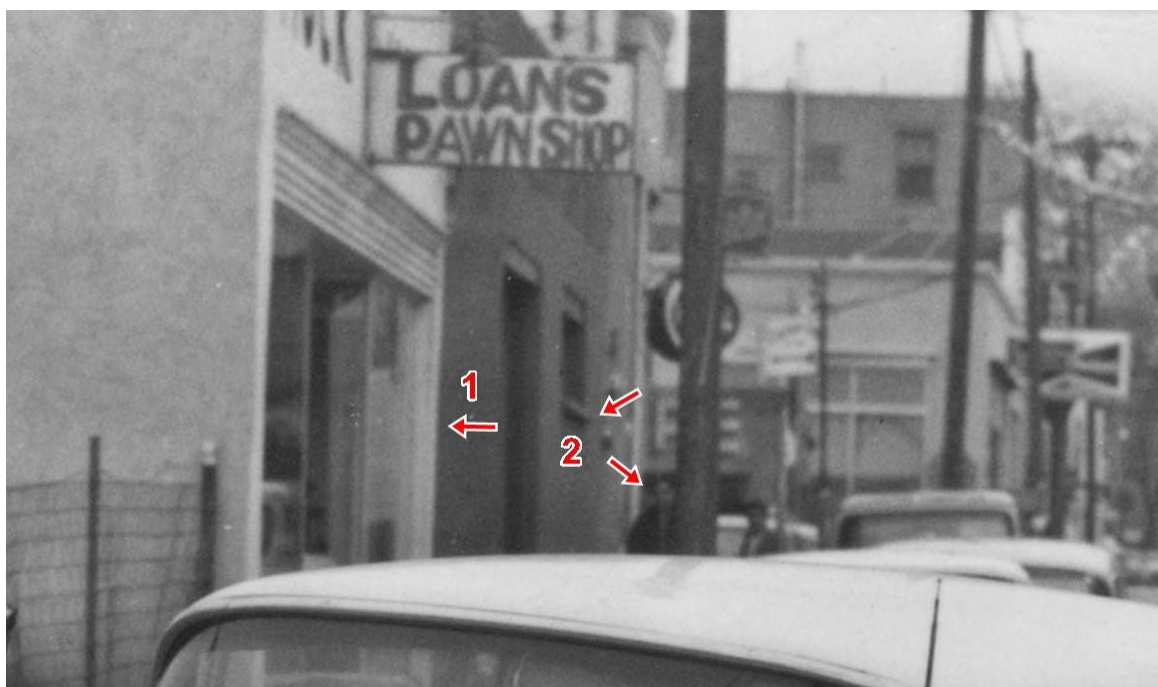
Figure 8: Portion of 1950s photograph of West Water Street.

1. Note that door opening is 3' to 4' east of current position of entry; and 2. Sill of window is much higher than current position, as evidenced by its location in relation to height of man below. The window also appears to be shorter in width and includes a lug sill.

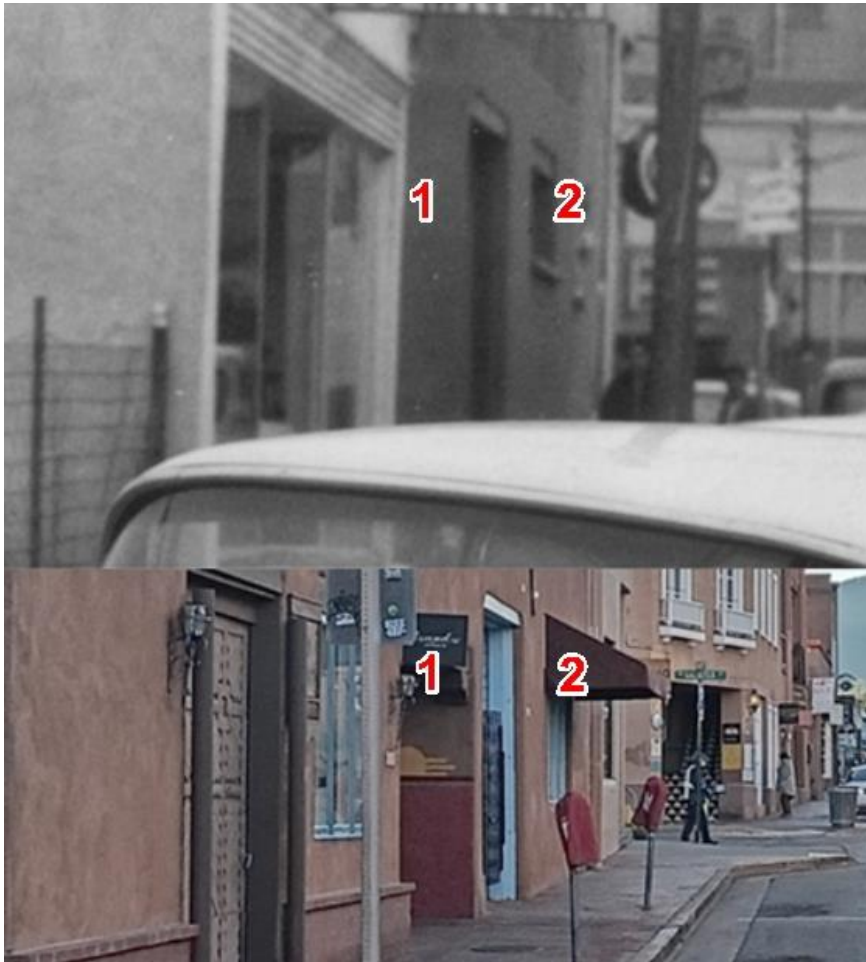
**Figure 9: Repeat photography. 1. Compare position of door in relation to west edge of building; and 2. Windowsill height and width of window.**

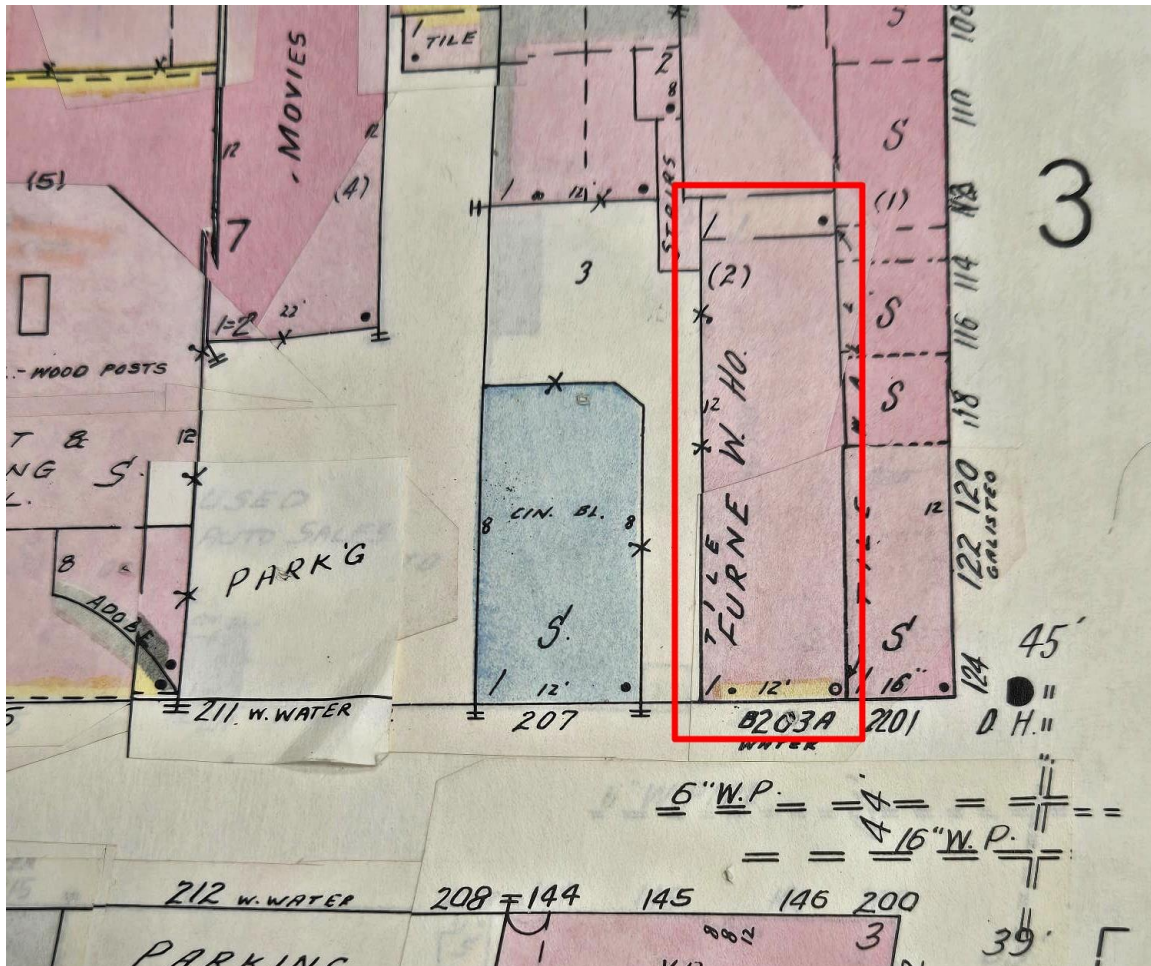
Figure 10: 1948 Santa Fe Sanborn Fire Insurance Company Map with 1968 paste over. Note west alley elevation is still visible public of right of way and includes openings. Courtesy of City Santa Fe Historic Preservation Division.

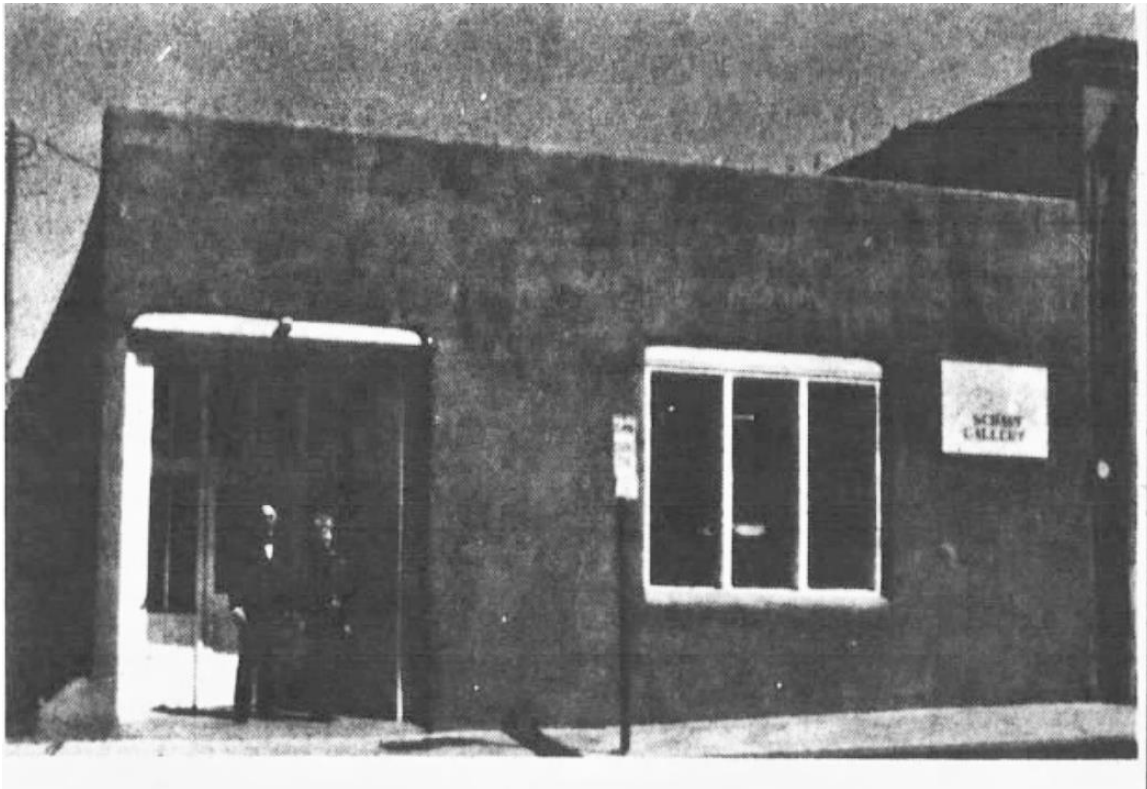
**Figure 11: Opening day advertisement for Scharf Gallery, October 1983. Source: Santa Fe New Mexican.**

An advertisement for the remodeled building described it—somewhat loosely—as an “old adobe building,” emphasizing interior wood floors and a “brick ramp entrance.”<sup>6</sup> The building reopened in late 1983 as the Scharf Gallery, a contemporary art gallery and small concert venue. Its opening advertisement included a photograph of what appears to have been the remodeled façade, incorporating a new window and a new entry (Fig. 11).

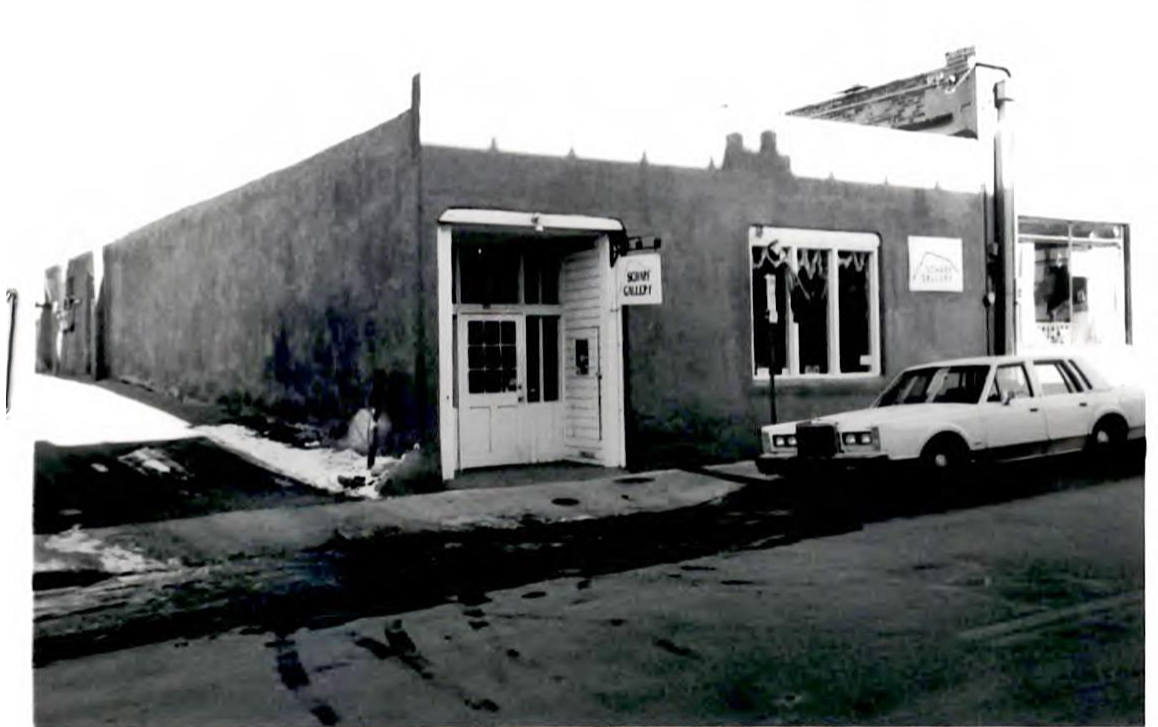
**Figure 12: December 6, 1984, HBI survey photo. Photographer, Harry Weiss. Note the west elevation is still visible from the public right of way and included a surviving window from the warehouse period.**

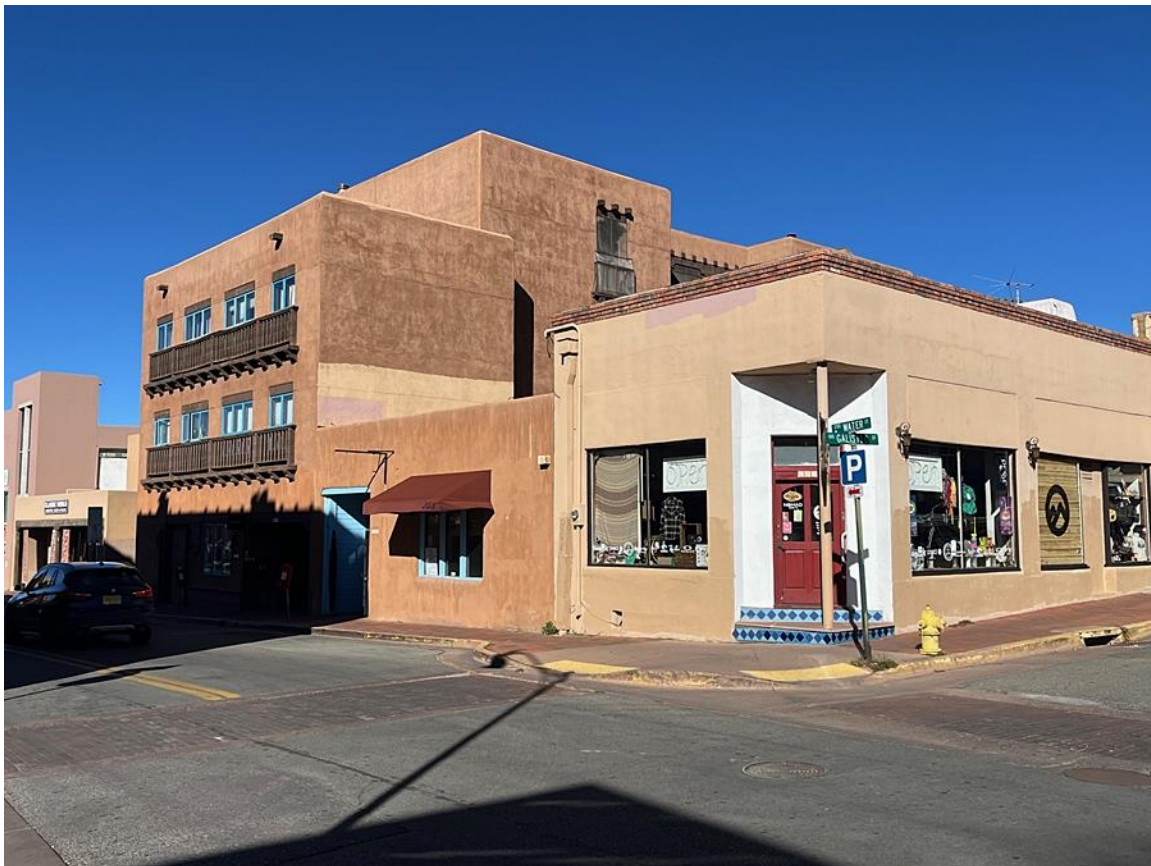
Photo 2: Setting. Camera facing northwest. December 2, 2025.

The subject building is situated between the 1928 Roberts & Salmon Building on Galisteo Street and the substantially taller 1980s Casita de los Cornell building to the west (Photo 2). It fronts onto a modern brick sidewalk. The structure is partially exposed along its west elevation, where a narrow passage separates it from the Casita de los Cornell building. The remaining elevations are not visible, as they function as party or partial party walls with adjoining buildings. Behind the parapet is a low-pitched roof.

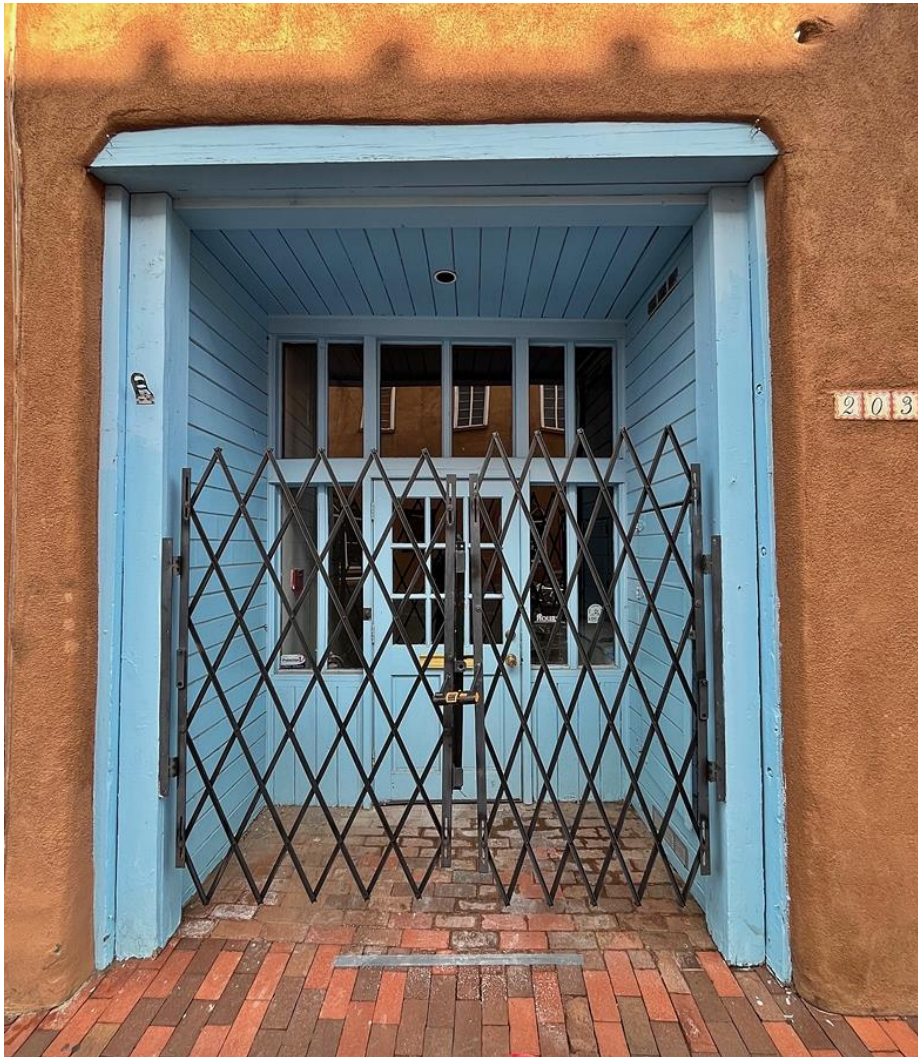
**Photo 3: Entry. Camera facing north. November 30, 2025.**

The entry is framed by wood boards painted blue (Photo 3). At its center is a non-historic nine-light wood door with modern components (Photo 4.). The tempered glass bears an etched certification mark referencing ANSI Z97.1–1975, indicating manufacture no earlier than the 1975 (Photo 5). Flanking sidelights of the same period complete the assembly, which is topped by a six-light fixed transom (Photo 6). The overall entry configuration is consistent with the early 1980s renovation (Fig. 11). Behind the door, a seven-foot-wide ramp rises to a floor level elevated approximately four feet above the street.

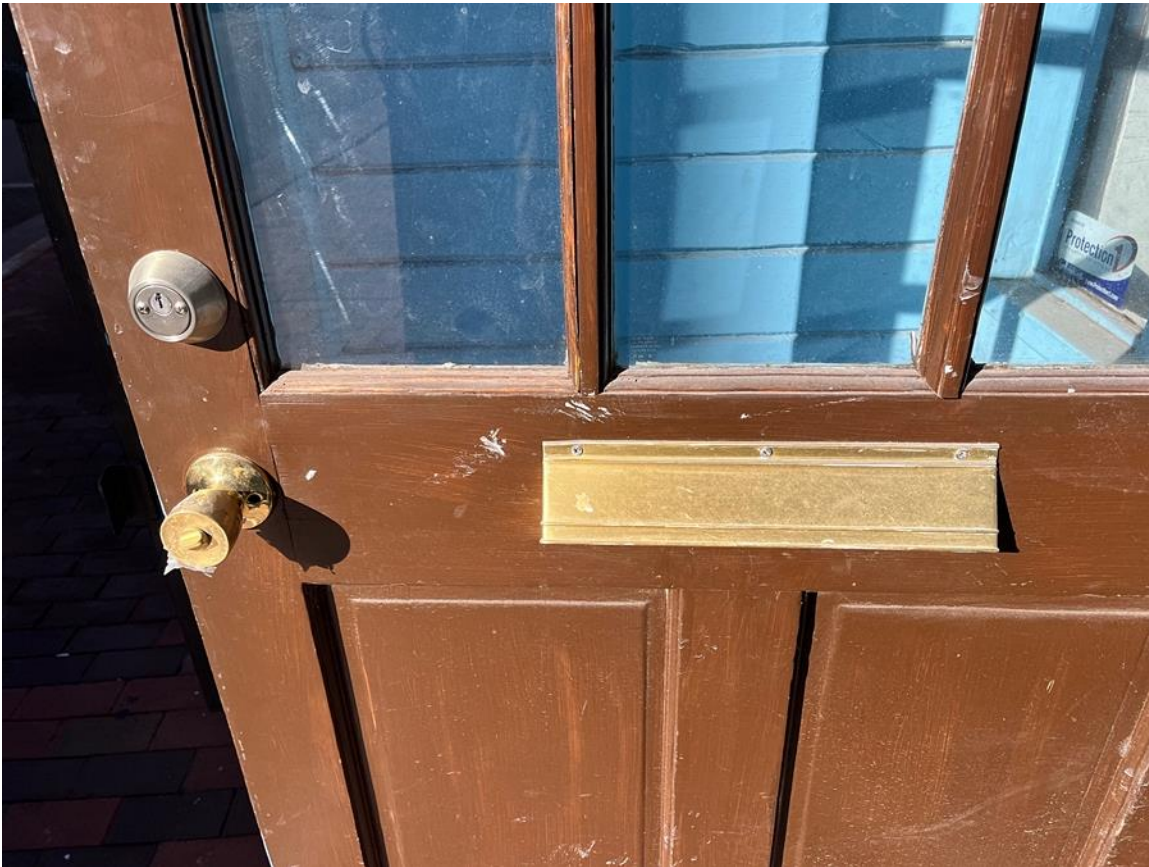
**Photo 4: Entry door. Camera facing down and west. December 2, 2025.**

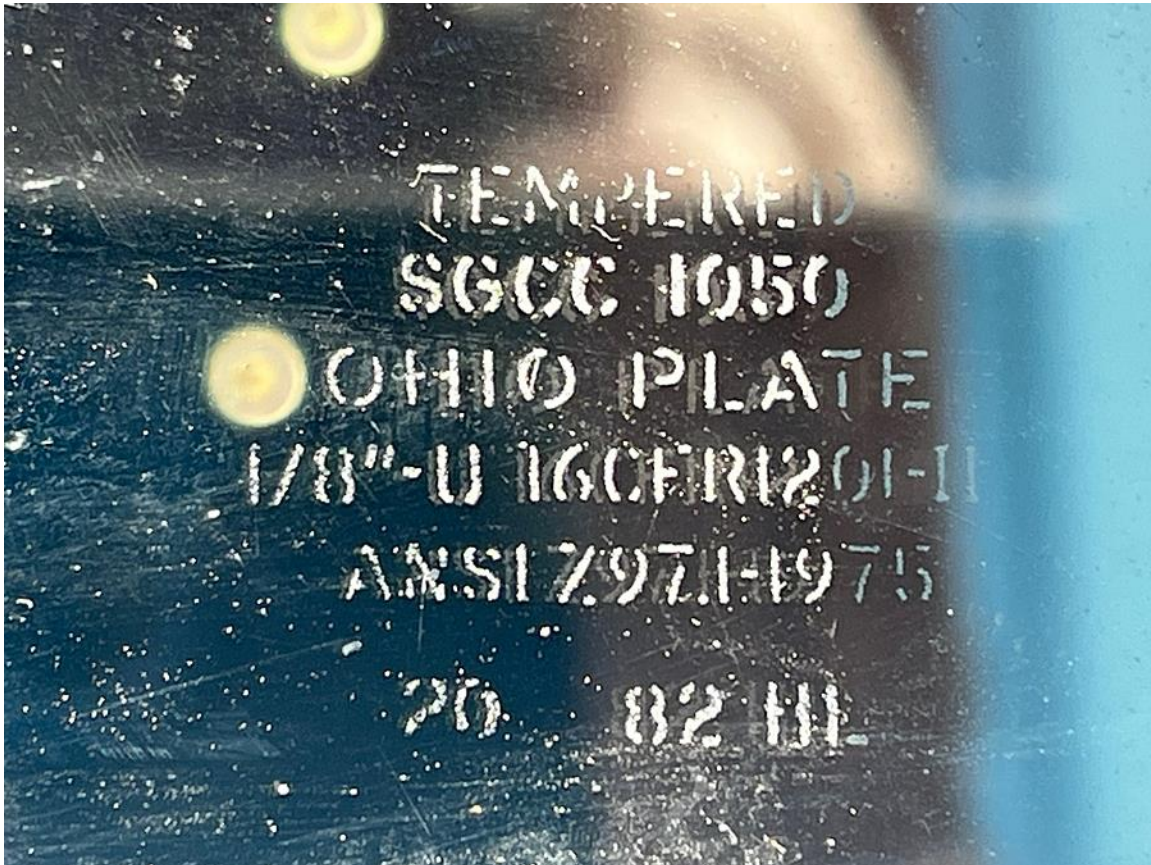
**Photo 5: Detail of entry door glazing mark. December 2, 2025.**

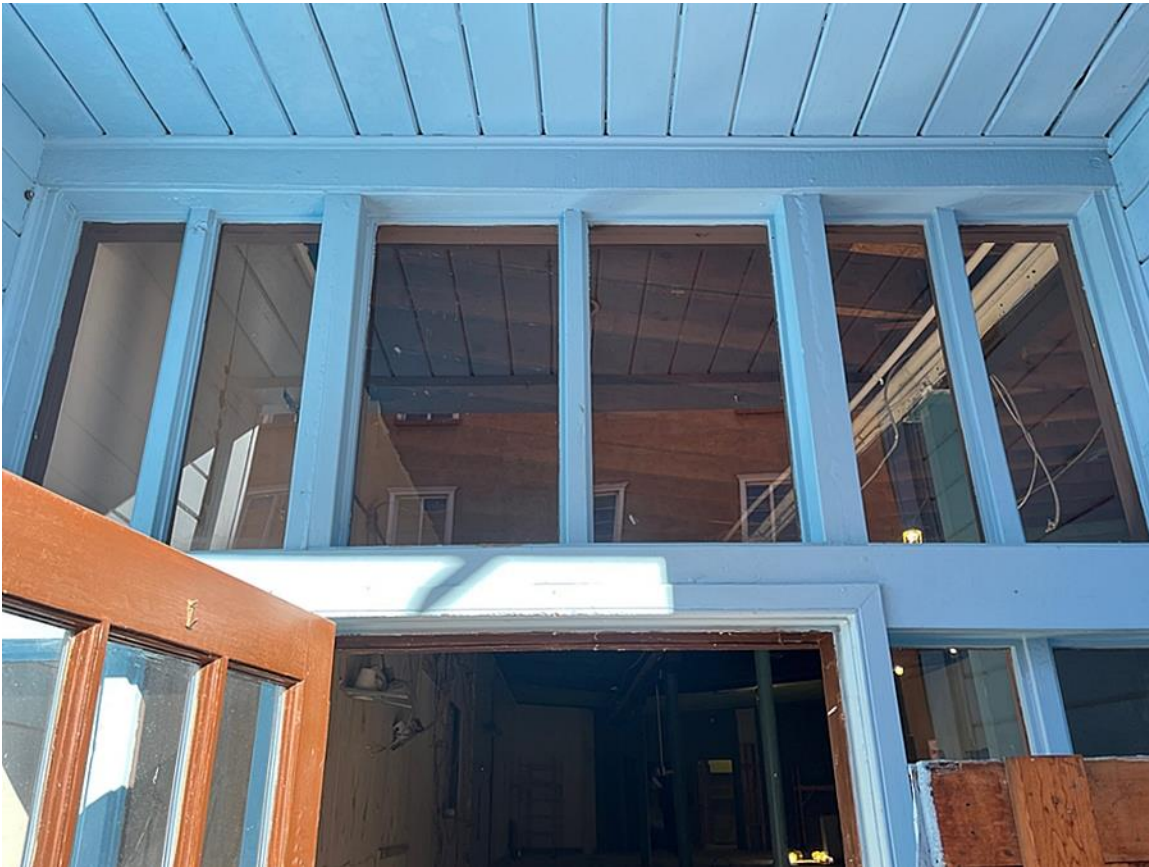
**Photo 6: Transom. Camera facing up. December 2, 2025.**

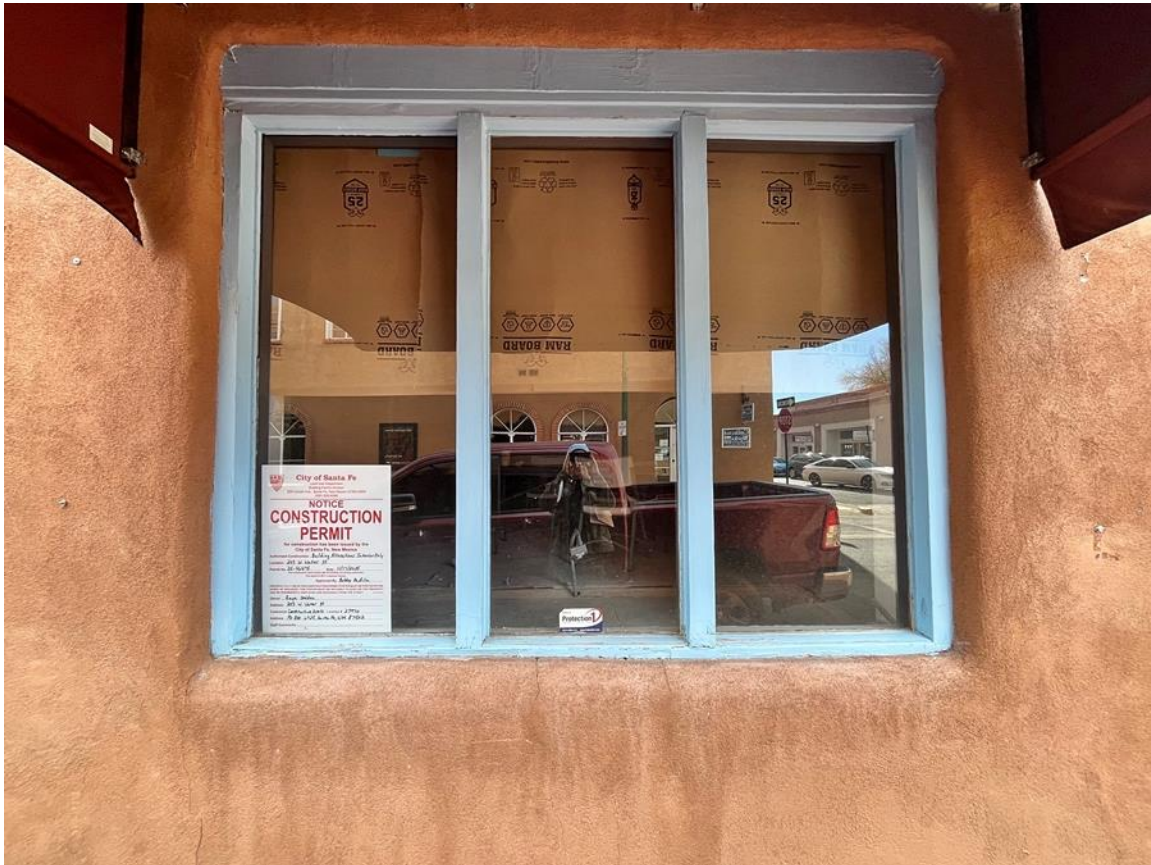
**Photo 7: Display window. Camera facing north. November 30, 2025.**

To the east is an approximately 6-by-8-foot opening containing a wood-framed display window. Likely field-built, it consists of three glass panels separated by 3¾-inch-wide mullions (Photo 7). None of the window components appear to be historic, and the frame and casing exhibit a single layer of paint (Photo 8). The opening rests on a 38-inch-high bulkhead and aligns at approximately shoe level within the interior. A fabric awning, approved by the City of Santa Fe Historic Preservation Division in the early 2010s, shades the window.

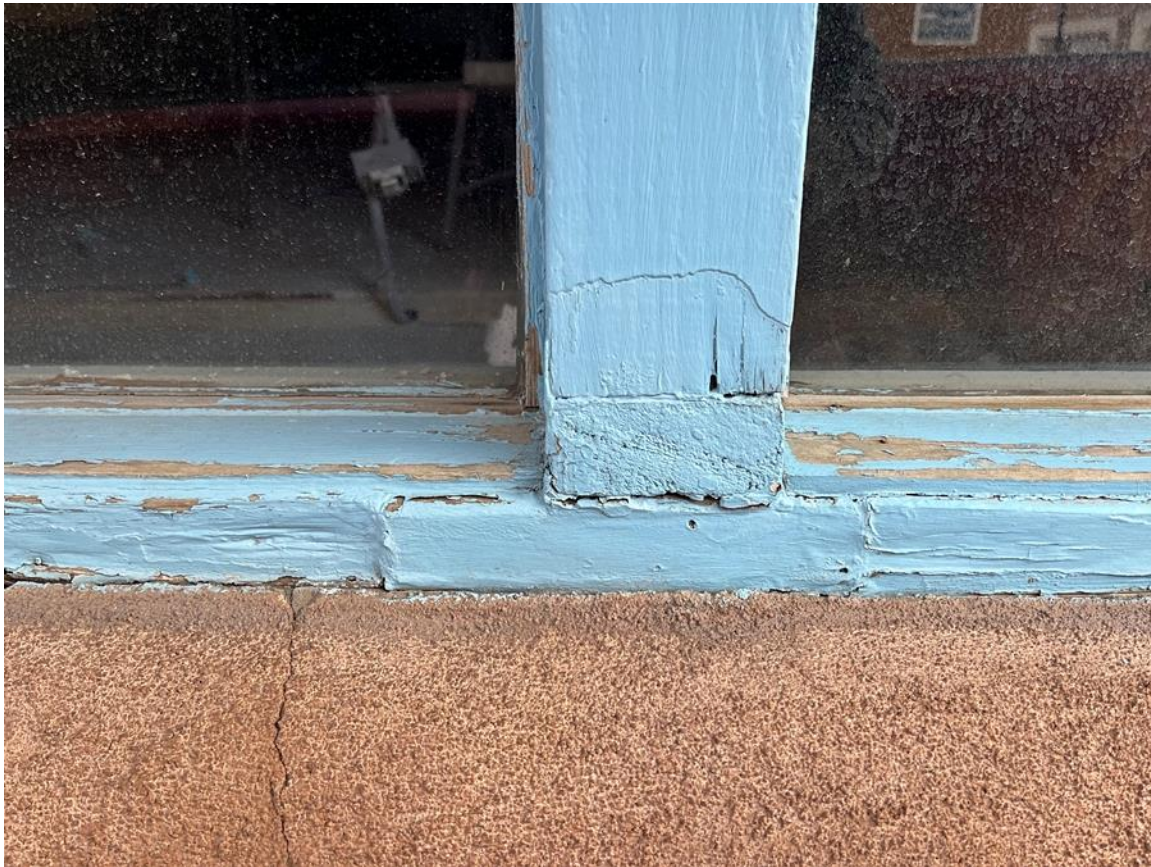
**Photo 8: Display window, detail. Camera facing down. November 30, 2025.**

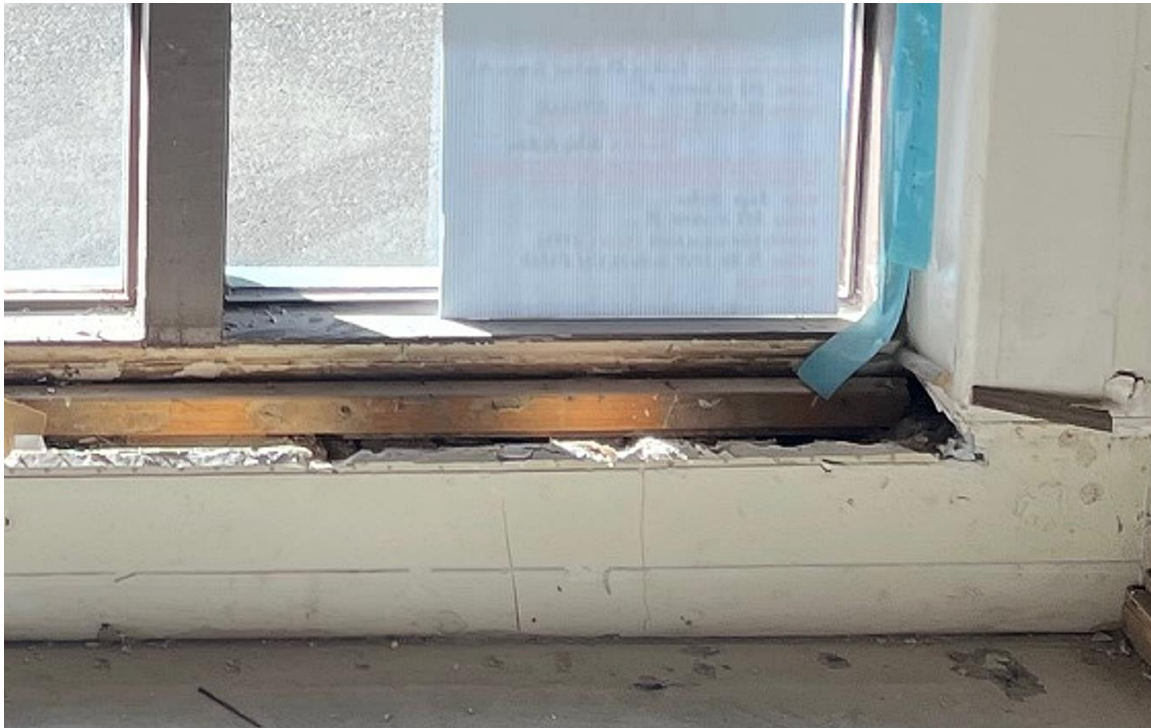
**Photo 9: Display window from interior. Camera facing south. December 2, 2025.**

Exposure of the wall assembly at the interior indicates that the display window was cut into an earlier wall and framed within it, rather than being part of the original construction (Photos 9 & 10).

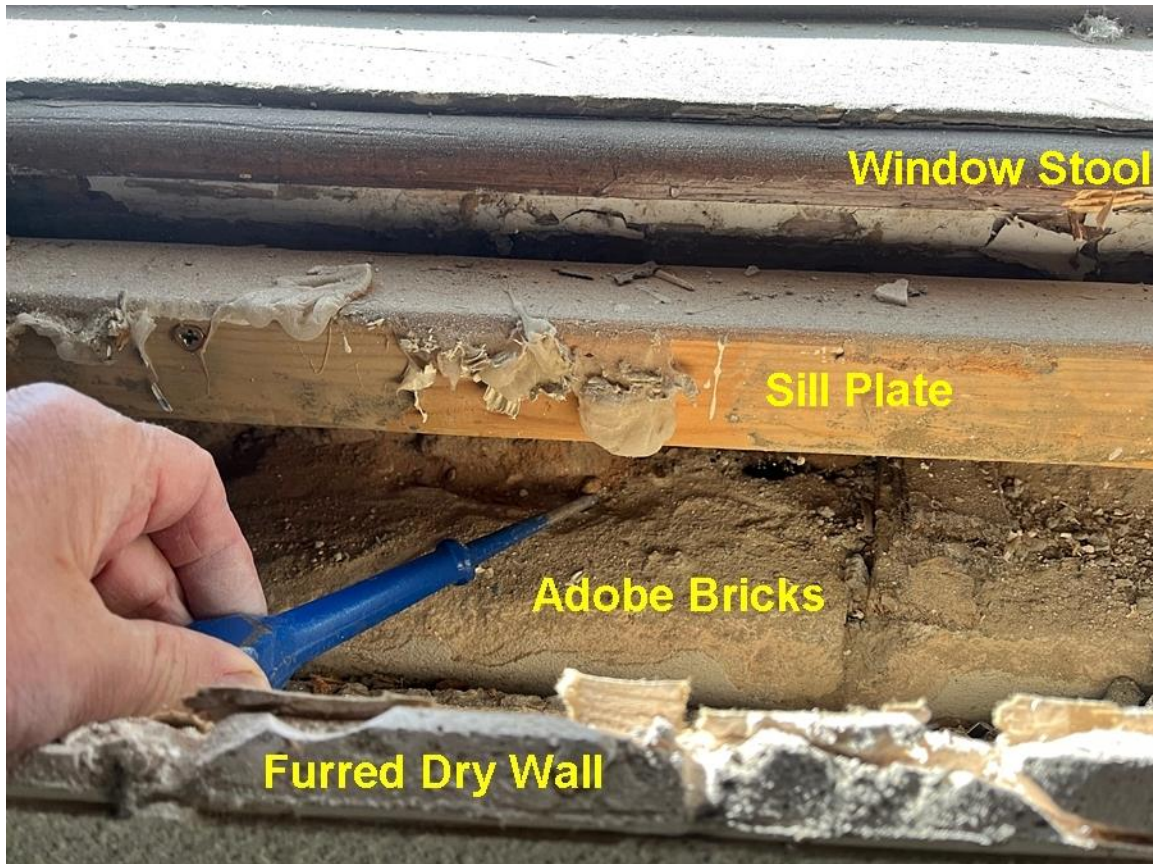
Photo 10: Detail of display window construction from interior. Camera facing down. December 2, 2025.
