**203 West Water Street**

# Historic Cultural Properties Inventory (HCPI) Base Form (FORM 1)

| 1. Name of property:<br><br>Livingston Furniture Company<br>Warehouse/ Scharf Gallery | 2. Location:<br><br>203 West Water Street<br>Downtown and Eastside Historic District -<br>Santa Fe | 3. Local Reference Number:<br>Santa Fe ID: H-3567<br><br>4. County: Santa Fe<br>Parcel # 99306890 |
| 8. Name of Project:<br>HDRB Status Evaluation | | |

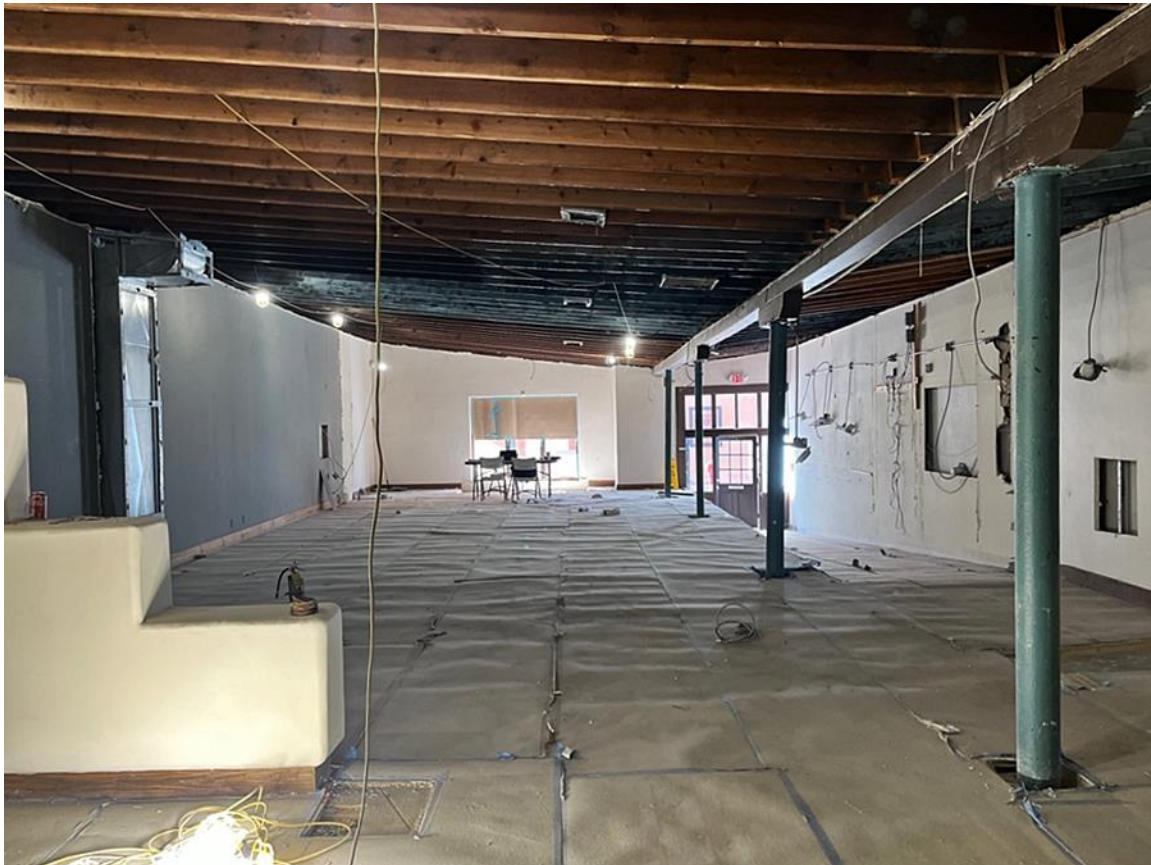
**Photo 11: Interior. Camera facing south. December 2, 2025.**

The interior reflects a combination of earlier structural elements and later finishes associated with the 1983 conversion to retail use (Photo 11). At the time of the site visit, portions of the building were undergoing exploratory demolition, revealing brick and hollow clay tile construction behind furred plastered walls. In areas where the dropped ceiling has been removed, wood trusses are exposed; one section exhibits blackened members, possibly evidence of a 1958 fire. At the rear of the building is a small kitchenette and bathroom, spaces introduced during the 1980s renovation.
