Historic Cultural Properties Inventory (HCPI) Base Form (FORM 1)

1. Name of property: Tobias and Gumecinda Lujan House and Shed	2. Location: 1525 Upper Canyon Road (1525 Canyon) Downtown and Eastside Historic District – Santa Fe	3. Local Reference Number: Santa Fe ID: H-1205 4. County: Santa Fe Parcel # 11452800
---	---	---

8. Name of Project:
 HDRB Status Evaluation

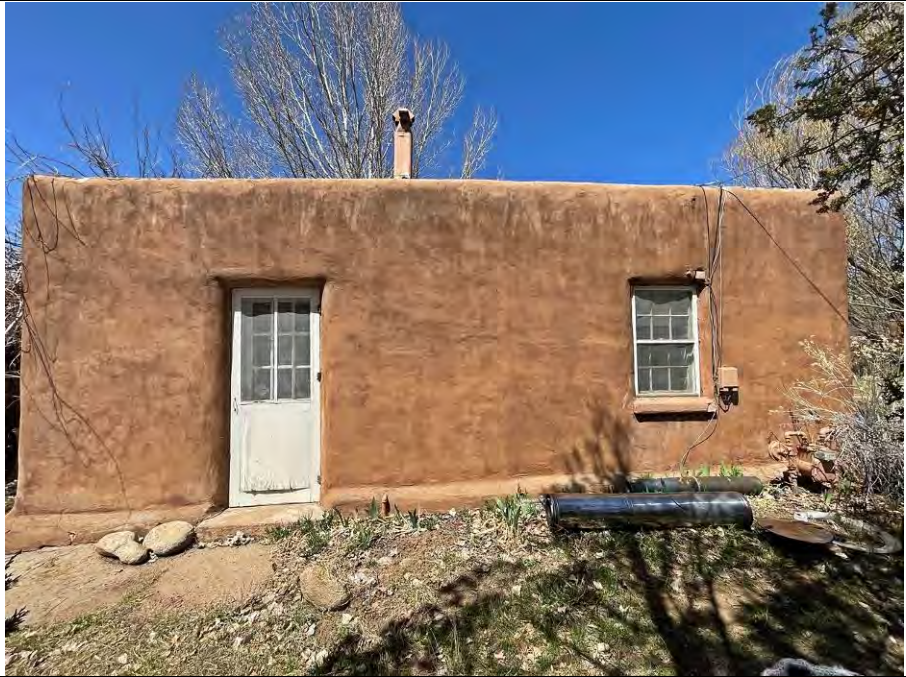
10. Photo Information: Giulia Caporuscio, photographer. Photo 1: View of south (main) façade. Camera facing north.

Sitting on an overgrown lot about 2.5 miles southeast of the Plaza are two undistinguished adobe buildings. They are set close together. The front building is an approximately 980-square-foot dwelling holding a single bedroom and a bath. It was constructed in the 1930s, with its back porch enclosed and roof raised after 1969. Next to it is a 575-square-foot shed/garage erected after 1966. Both are of crude construction and in poor condition.

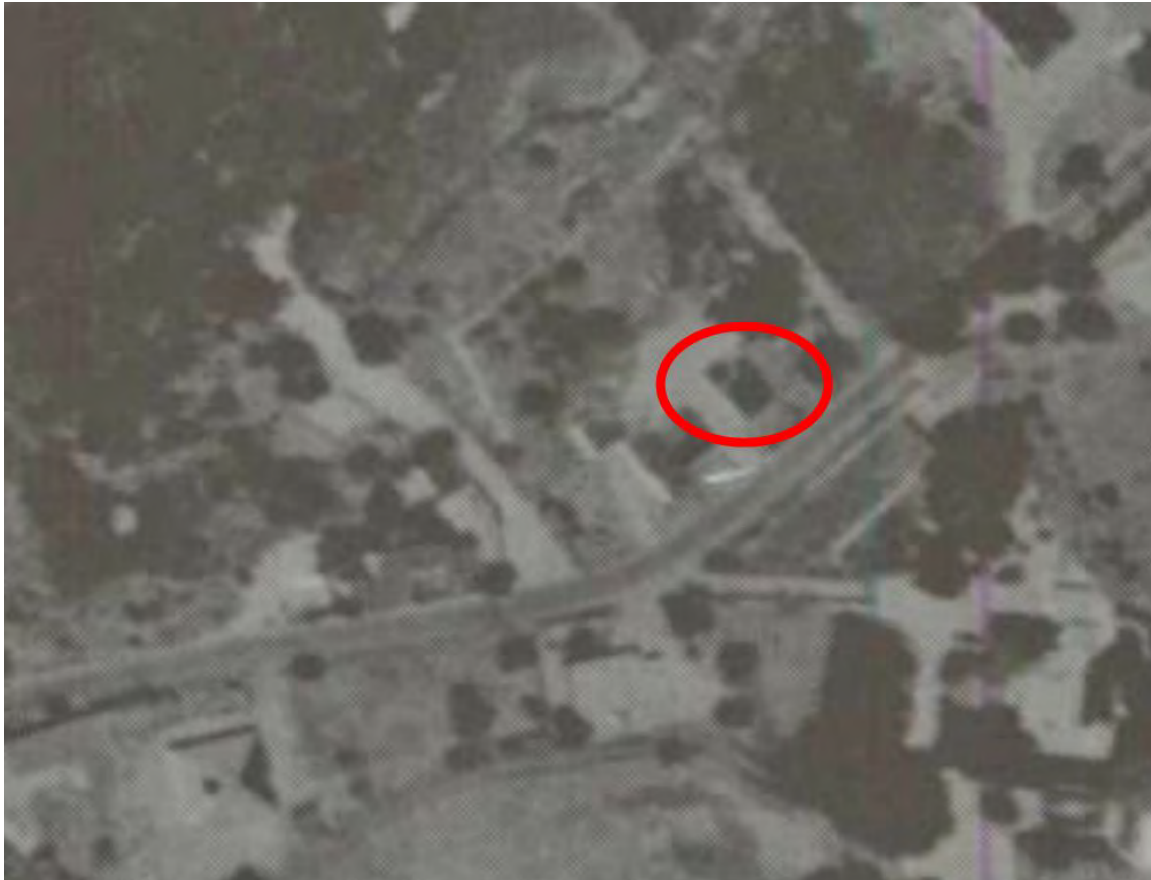
Set close to the home’s northeast corner is a structure the county assessor has designated a utility shed. The building, made of adobe, is arranged on a roughly east-west axis and composed of two distinct parts. However, it encloses only one room. Based on aerial photographs, it was erected between 1966 and 1969 (Figs. 5 & 6).

Figure 5: 1966 aerial photograph. Subject house outlined. Note the shed is not present.

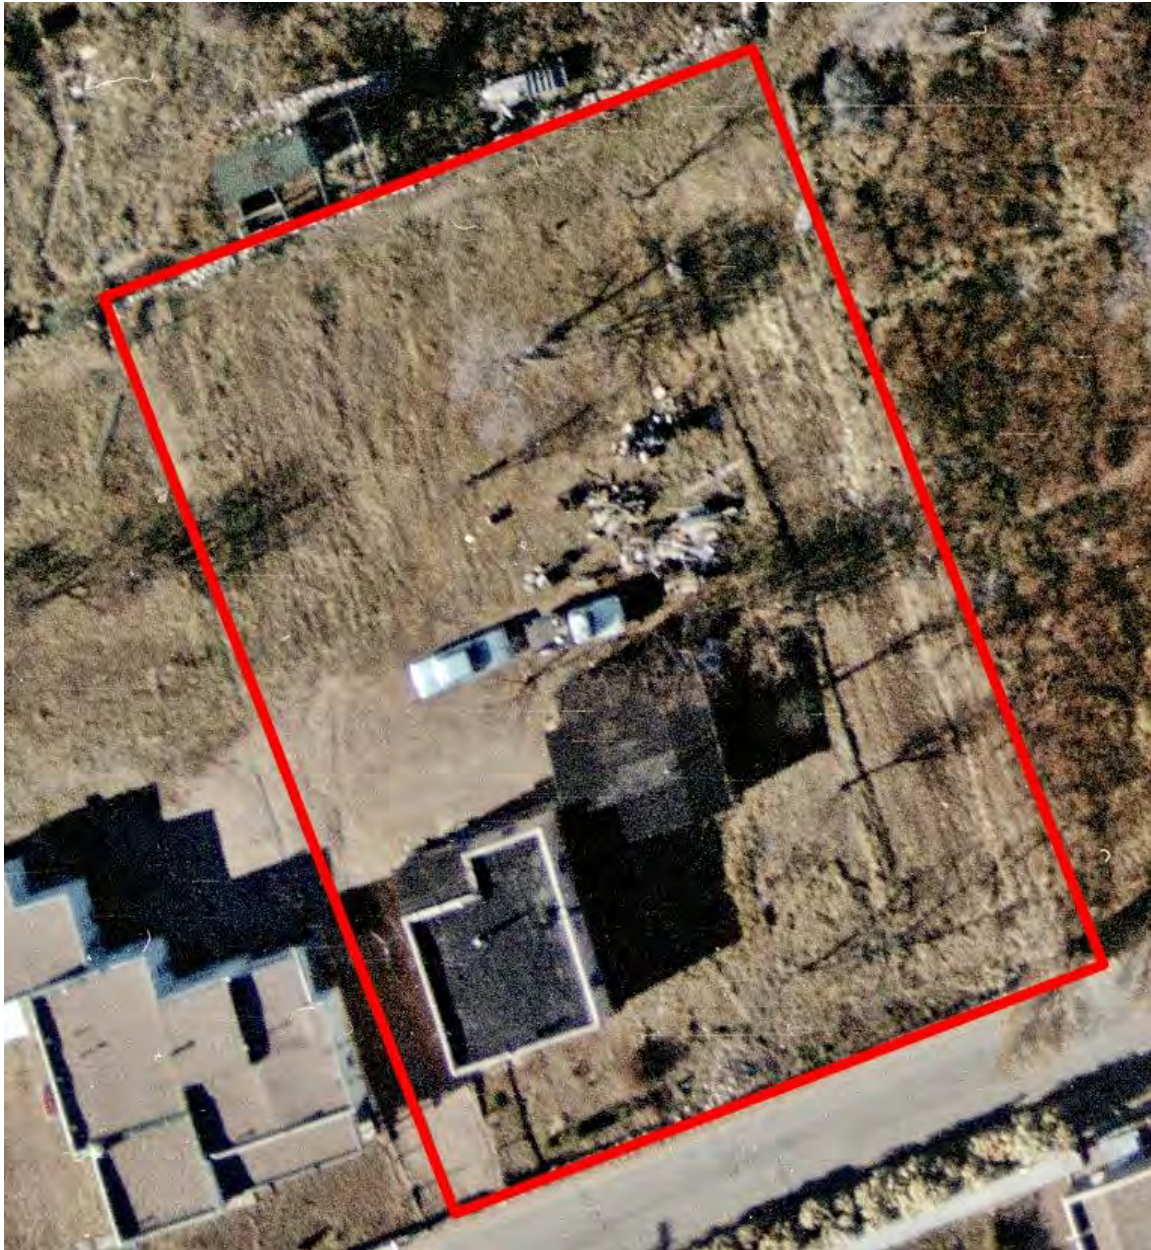
Figure 6: 1969 aerial photograph. Note indent at northwest corner of house and presence of shed.

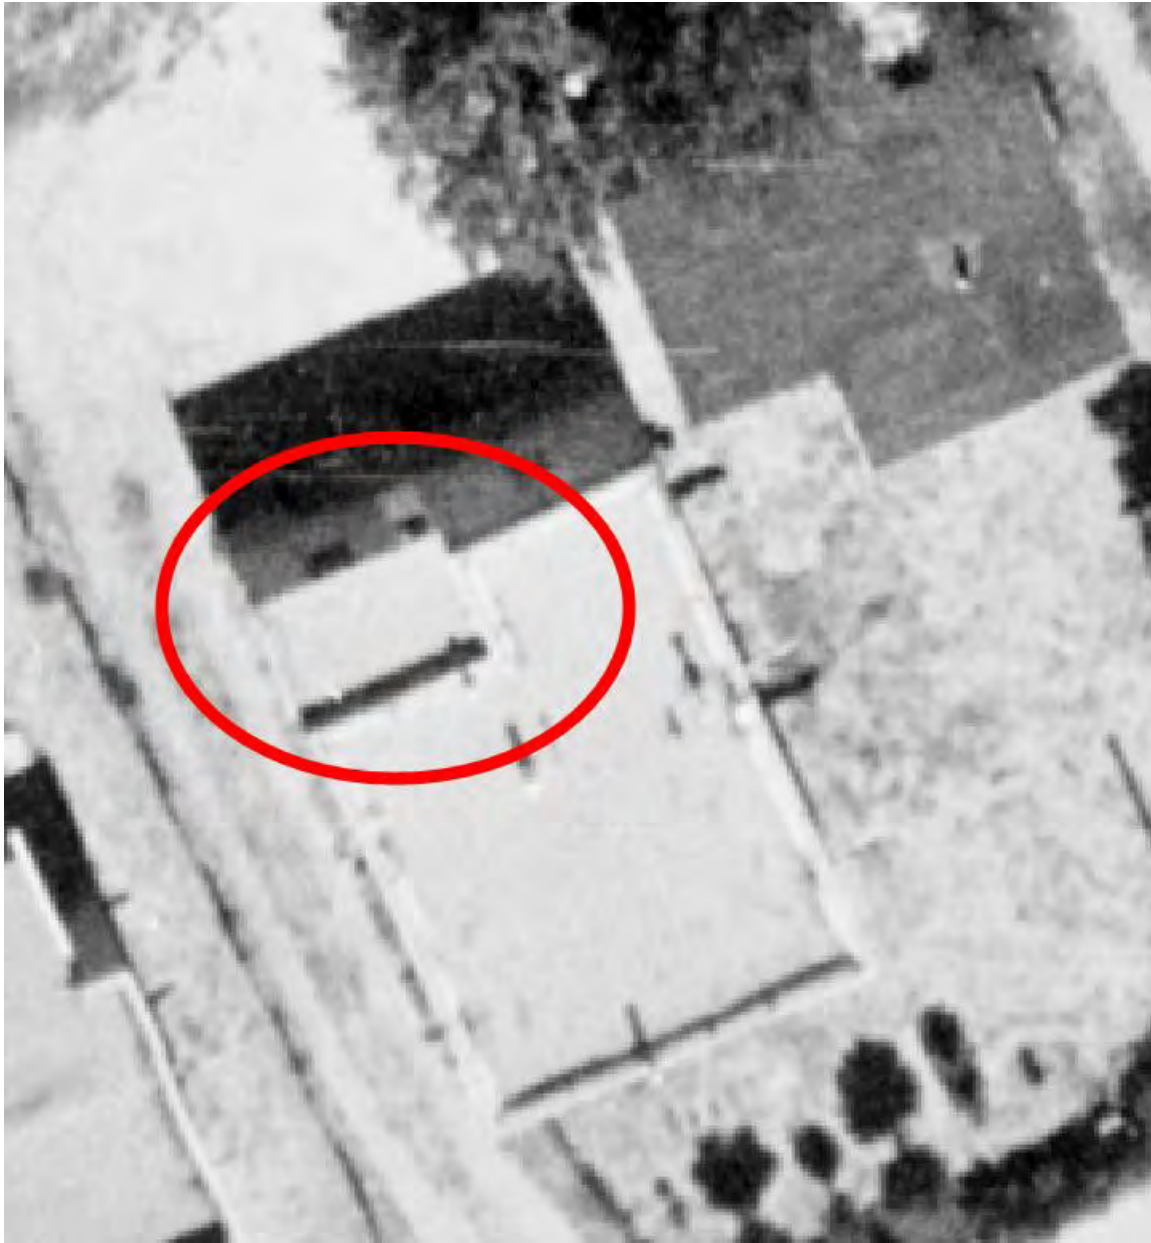
Figure 7: 1978 aerial photograph. Note raised roof of northwest corner.

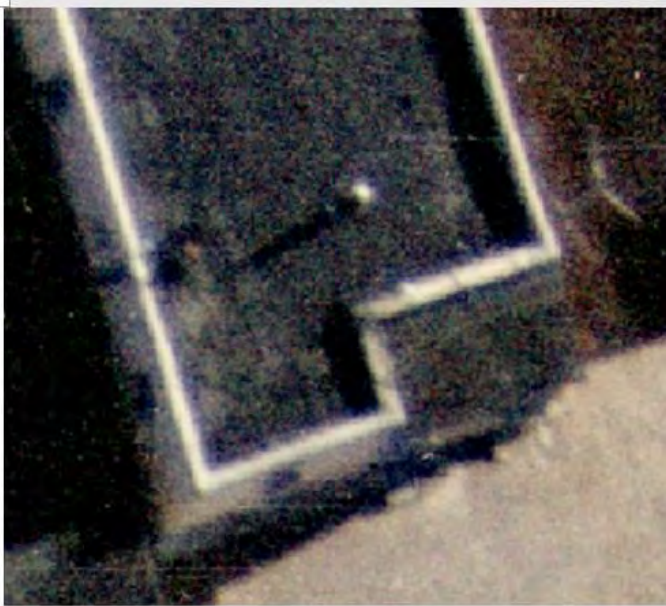
#1 Date: c.1966-69; enclosure, raising roof, and adding at northwest corner of house; aerial photographs and physical and visual evidence

**Figure 8: Alteration of northwest corner: 1969 (top) to 1978 (bottom).
 Alteration included raising the roof, and likely enclosing an existing porch and adding new windows and shifting the location of the entry door.**

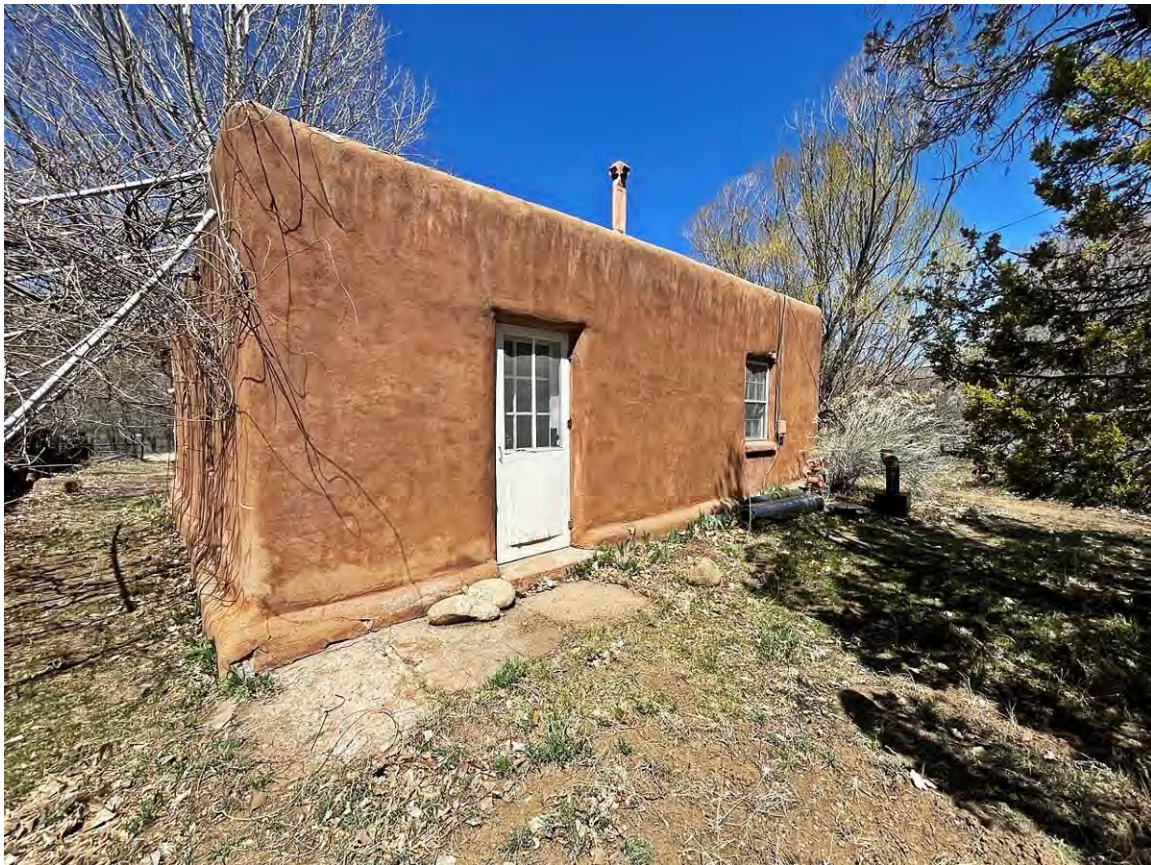
The south elevation has two openings: one holding a door, the other a window. Both are set deep into the wall (Photo 2). The ¾-light wood door appears to be older. The window is a 6/6, double-hung wood sash. Its mullion style and window locks place it in the vintage category. It and other windows around the house are covered with storm units (Photo 3). A heavy concrete sill terminates the opening.

Photo 2: South elevation. Camera facing northeast.

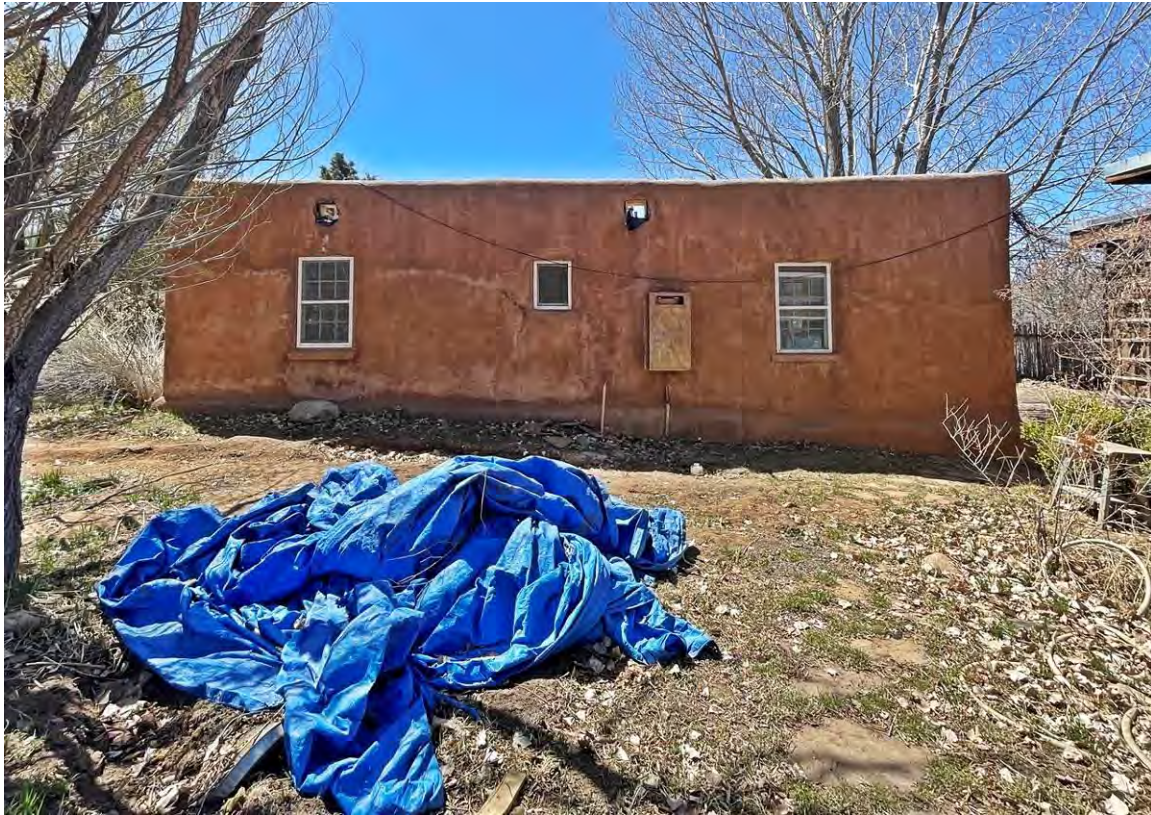
The long east elevation has two 6/6 windows bookending a small window in the bathroom (Photo 4). Like the south façade, the windows have crude concrete sills. Of interest are the square openings in the parapet, serving as drains.

Photo 4: East elevation. Camera facing west.

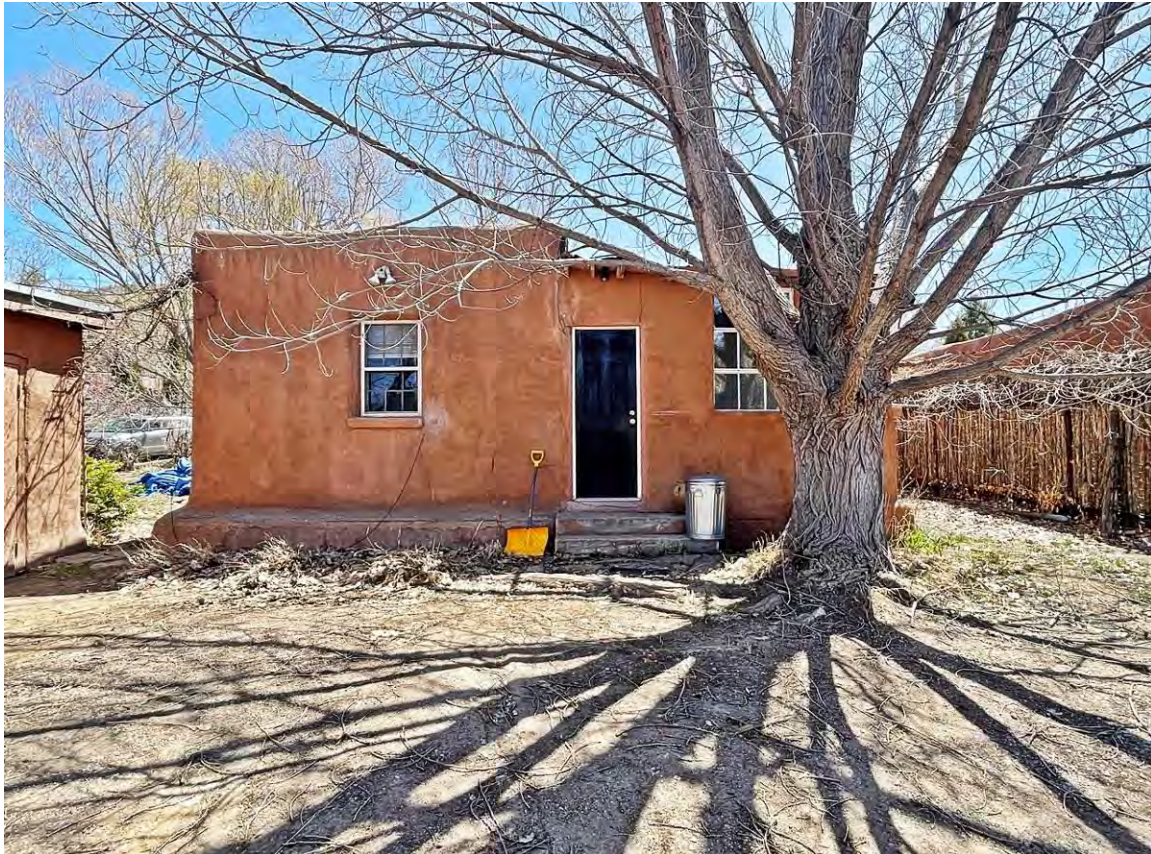
The north elevation, once facing farm fields, shows the greatest alteration — principally due to a post-1969 porch enclosure (Photo 5). The unaffected east side of the elevation has an opening at the bedroom fitted with a 6/6 window. The change occurs to the west

with a relatively new wood panel door giving entry to an enclosed porch. This space has a slightly lower roof and is fenestrated with recycled windows.

Photo 5: North elevation. Camera facing south.

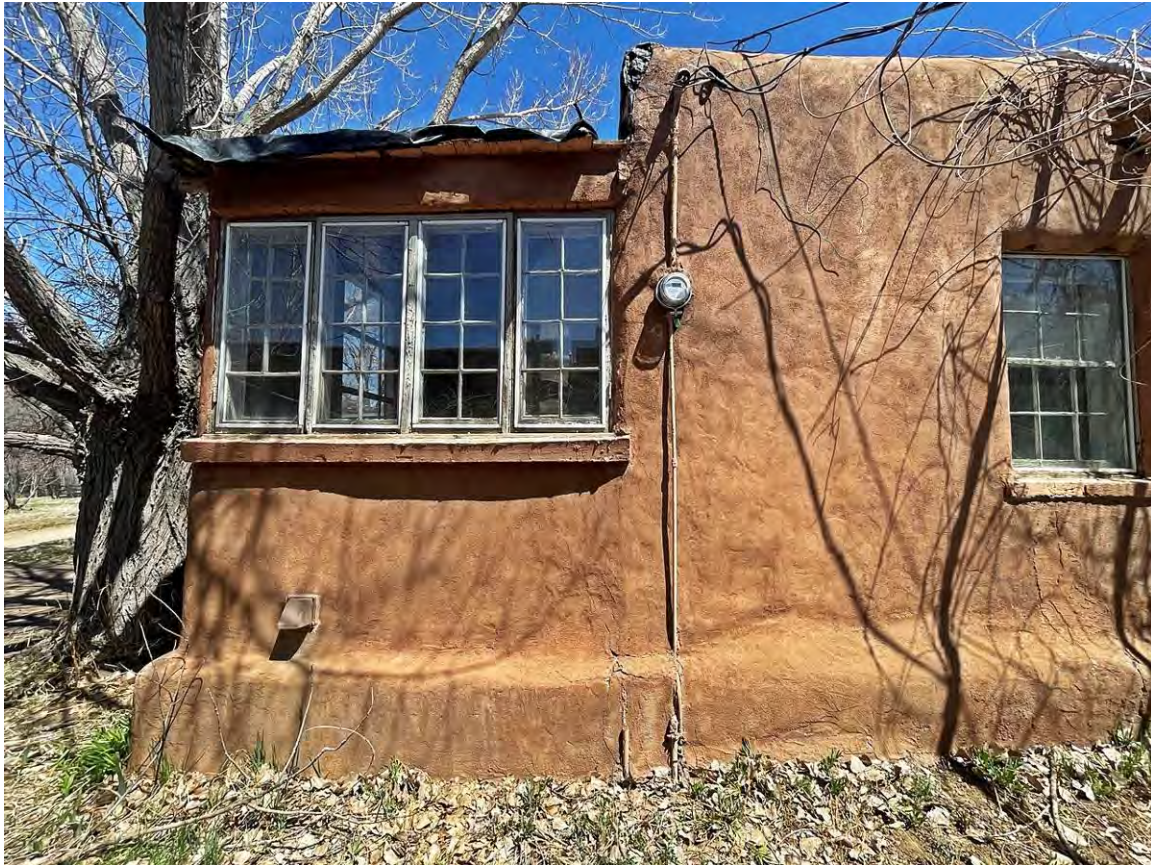
Rounding the corner is a continuation of the porch enclosure (Photo 6). Four repurposed 8-light sash arranged in a wood frame and covered with storm units draw light into the room. The corner windows hang on barrel hinges and may have once been operable. The remainder of the elevation is penetrated with two 6/6 double-hung wood sash windows (Photo 7).

**Photo 6: North end of west elevation. Post-1969 porch enclosure at left.
Camera facing east.**

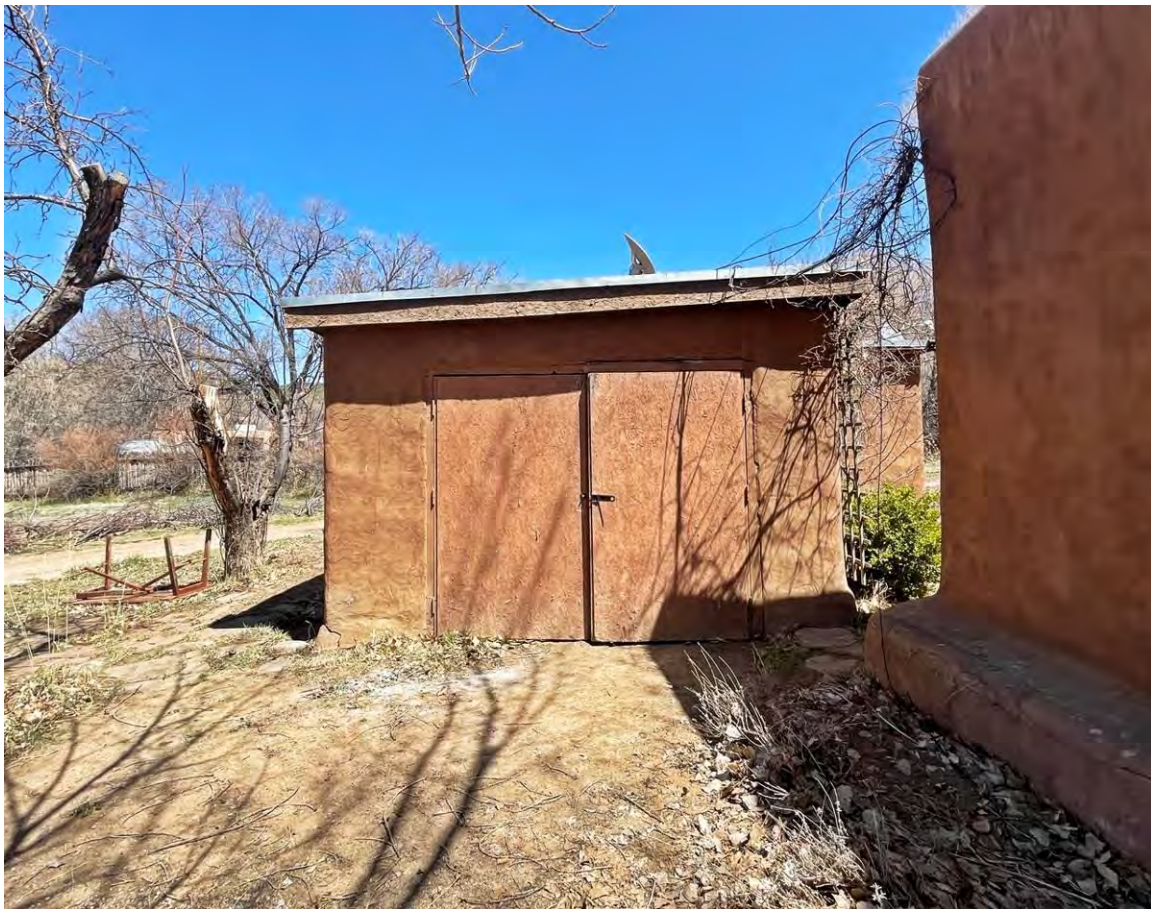
The west elevation is closest to the house and holds a small one-car garage (Photo 8). Swinging doors made of Oriented Strand Board open to this space. A separate wall with a wood entry door is set back approximately 9' from the garage (Photo 9).

Photo 8: West elevation. Camera facing east.

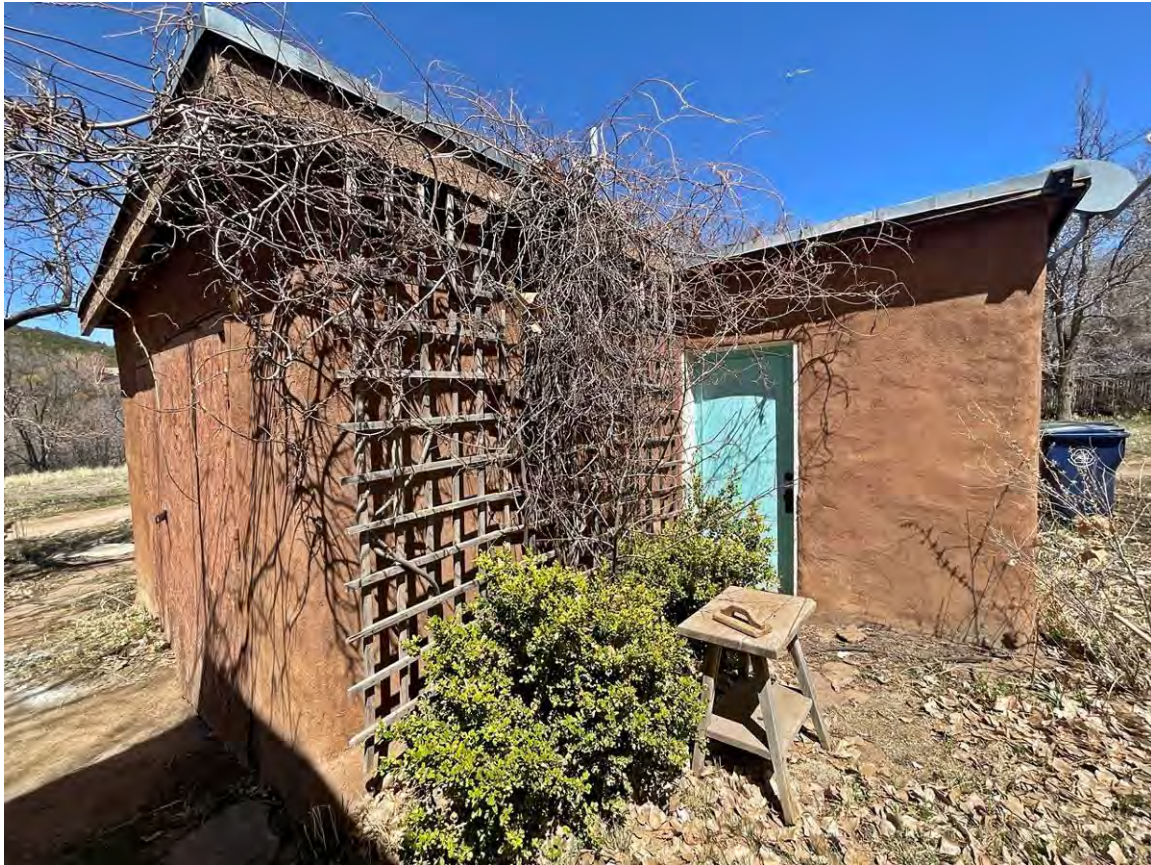
Photo 9: West elevation. Camera facing northeast.
