Re: Status Review of 127 Duran Street Rear

Gayla Bechtol, AIA

Historic Cultural Properties Inventory (HCPI) Base Form (FORM 1)

1. Name of property: 127 Duran Street, Rear House Guadalupe and Simonia Chavez House Martha J. Baca House	2. Location: 127 Duran Street (Rear) Westside-Guadalupe Historic District – Santa Fe	3. Local Reference Number: Santa Fe ID: Old # 051613057 4. County: Santa Fe Parcel # 10446175

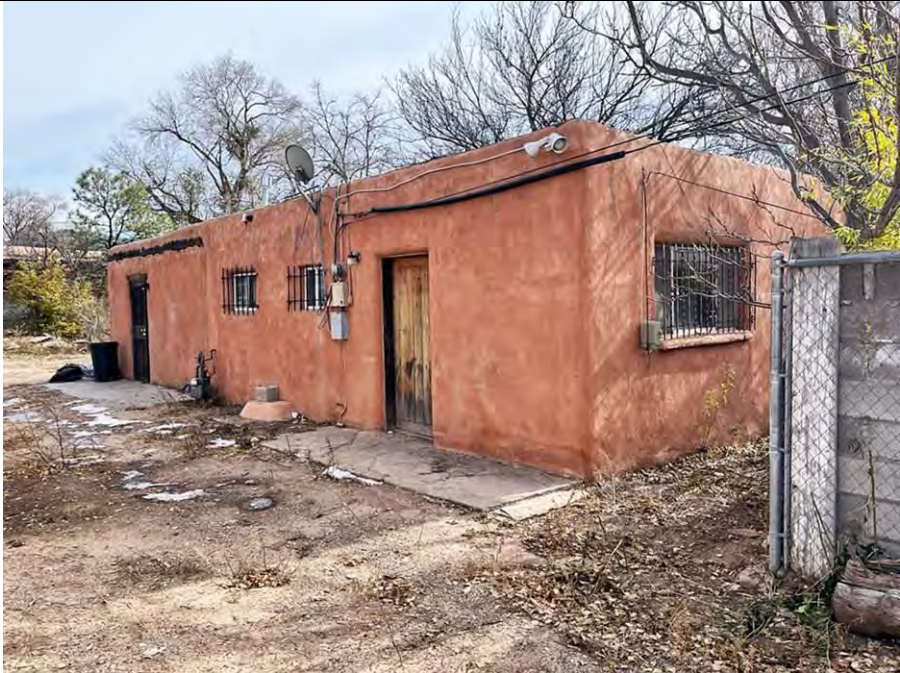
8. Name of Project: HDRB Status Evaluation		
9. Lat/Long: 35.690543, -105.946678		
10. Photo Information: John W. Murphey, photographer. Photo 1: North (front) elevation. Camera facing southeast, November 25, 2024

The building faces north with mostly a blank façade (Photos 1 & 5). The west half is the earlier constructed dwelling, consisting of four rooms. Separated by an expansion joint is the 1980s addition holding a dining room and living room (Photo 5). The west side is constructed of adobe and rests on a low foundation, though it is too low to be considered a crawl space. Its walls are roughly 12" thick. The construction of the addition is unclear.

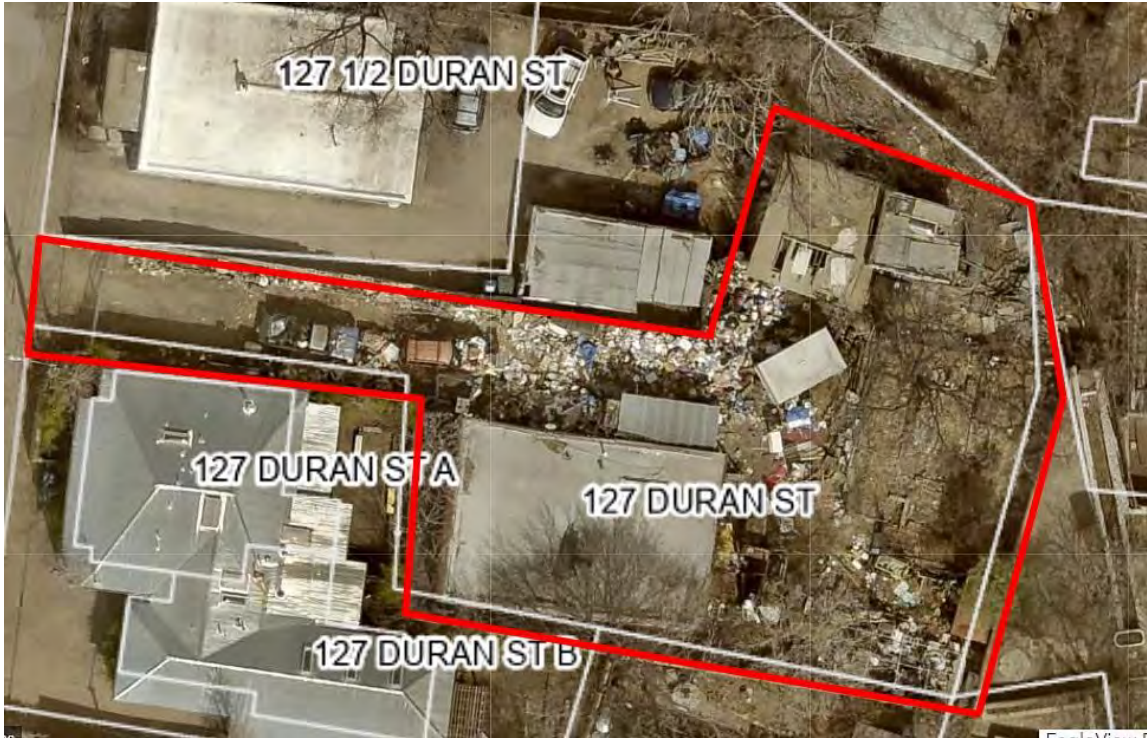
16. Additional Perspective: (Photos, drawing, footprint, etc., indicate north arrow when possible)

Source: Office of the Santa Fe County Assessor
parcel lines are not accurate; above interpretation made by author based on fence lines, etc; see Field # 19, survey plat.

Baca fell into financial difficulties, leading the City of Santa Fe and the State of New Mexico to place multiple liens on the property.¹² The property deteriorated significantly over the years. Aerial photographs reveal what began in the early 2000s as a line of parked cars down the driveway and escalated into a lot cluttered with trash (Field 16). A neighbor recalled that Martha struggled with hoarding.¹³

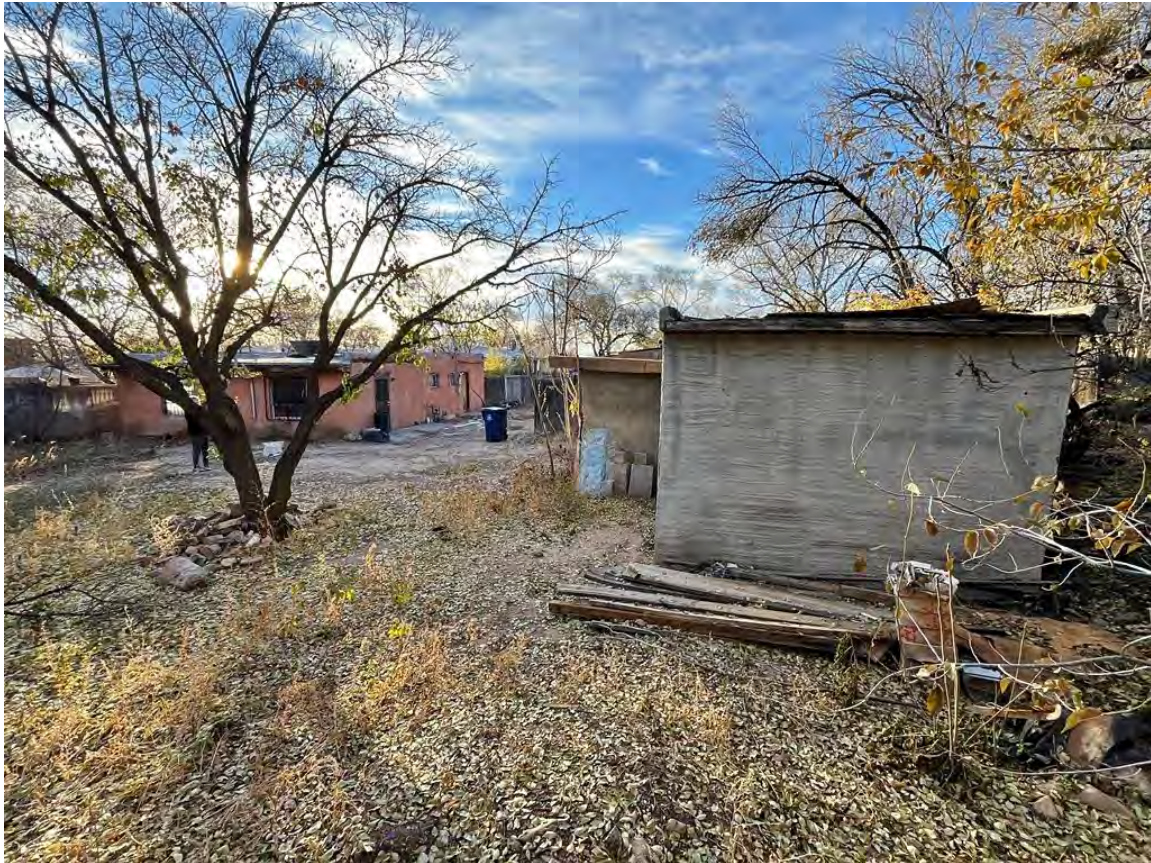
The property includes a post-1978 concrete block shop and storage room, both of which are of substandard construction. Once used for farming, the level lot has two mature apricot trees and several invasive ailanthuses. There is no formal landscaping. A relict acequia, thought to be part of the *Acequia Publica*, courses across the east edge of the property (Photo 4).

Photo 3: View of property facing southwest. Non-historic shop at foreground right.

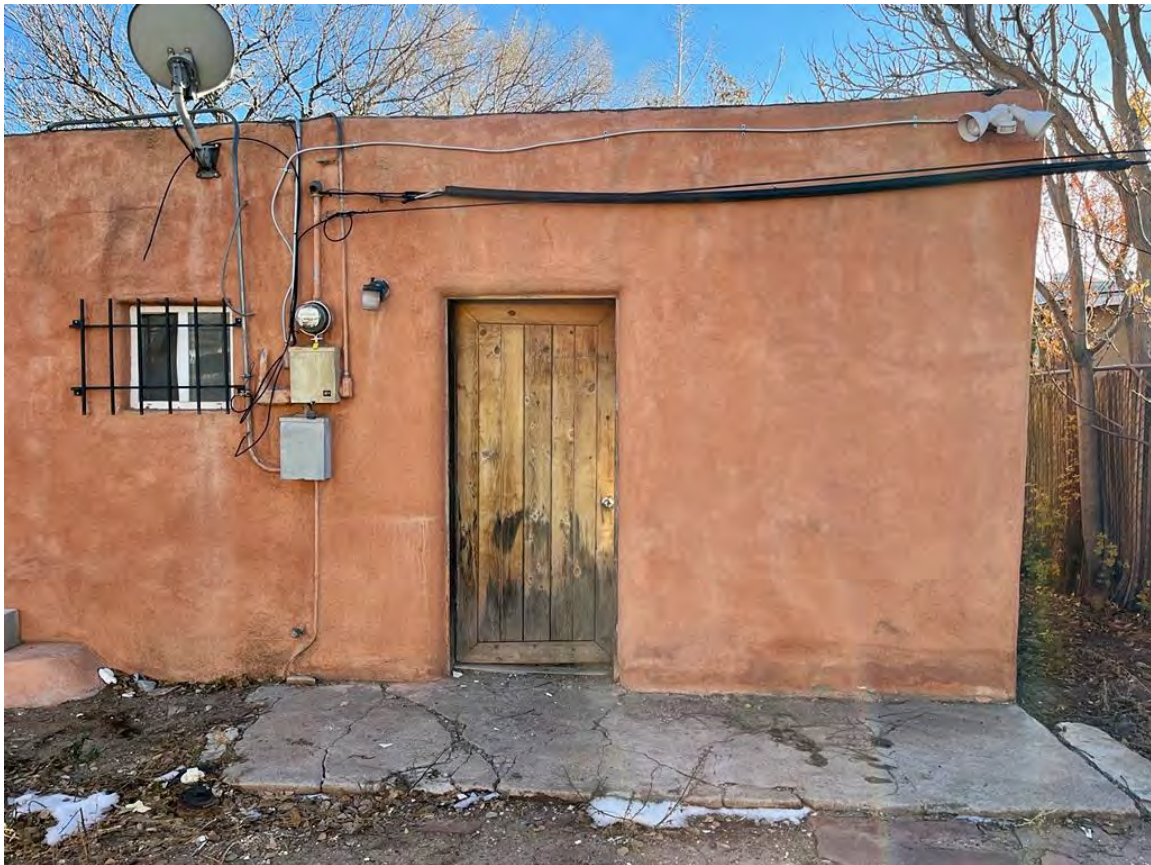
Beginning at the west end is a non-historic faux plank door (Photo 6). Next, still representing the original core, are sliding vinyl windows at the bathroom and kitchen (Photo 7). These windows, like the rest of the units along the portion of the building, are set 3½" to 4½" deep into the wall.

**Photo 6: North elevation representing the northwest room of the original core.
Camera facing south.**

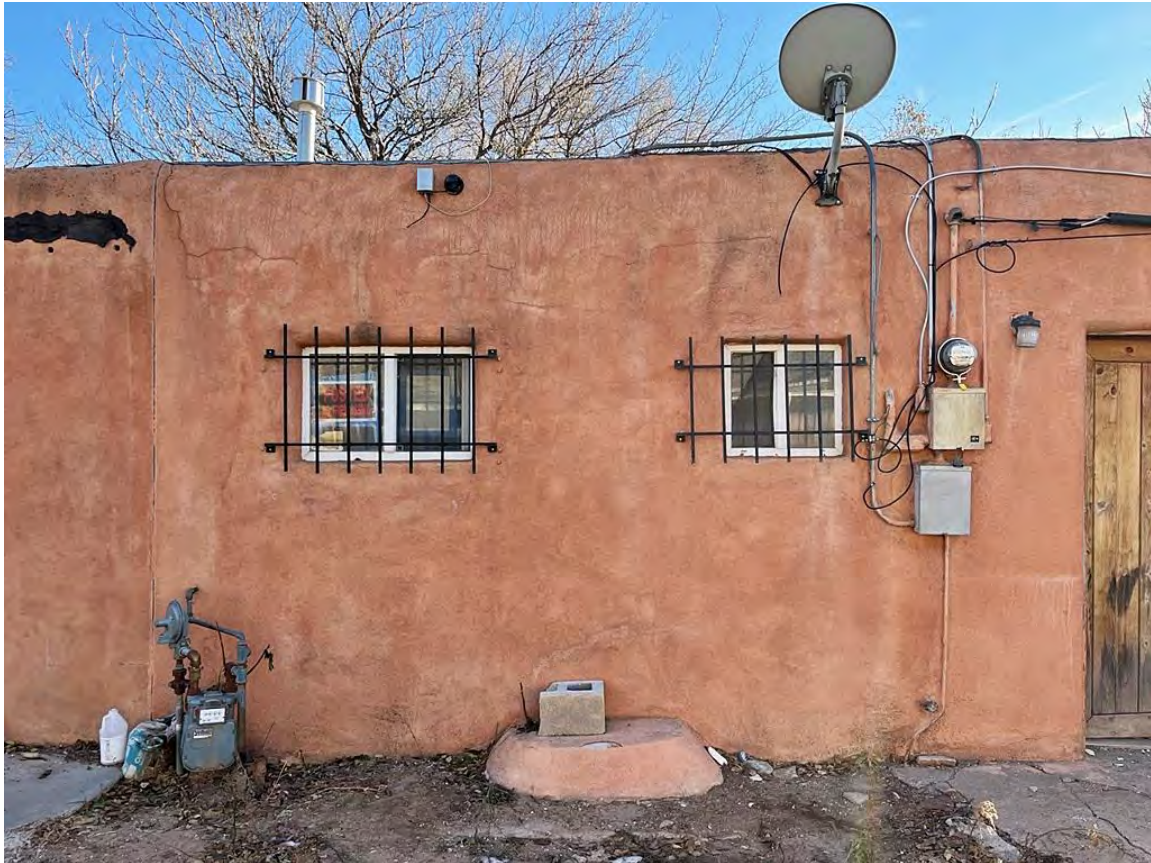
Photo 7: North elevation fenestration representing the kitchen (left) and bathroom (right) of the northeast room of the original core. Camera facing south.

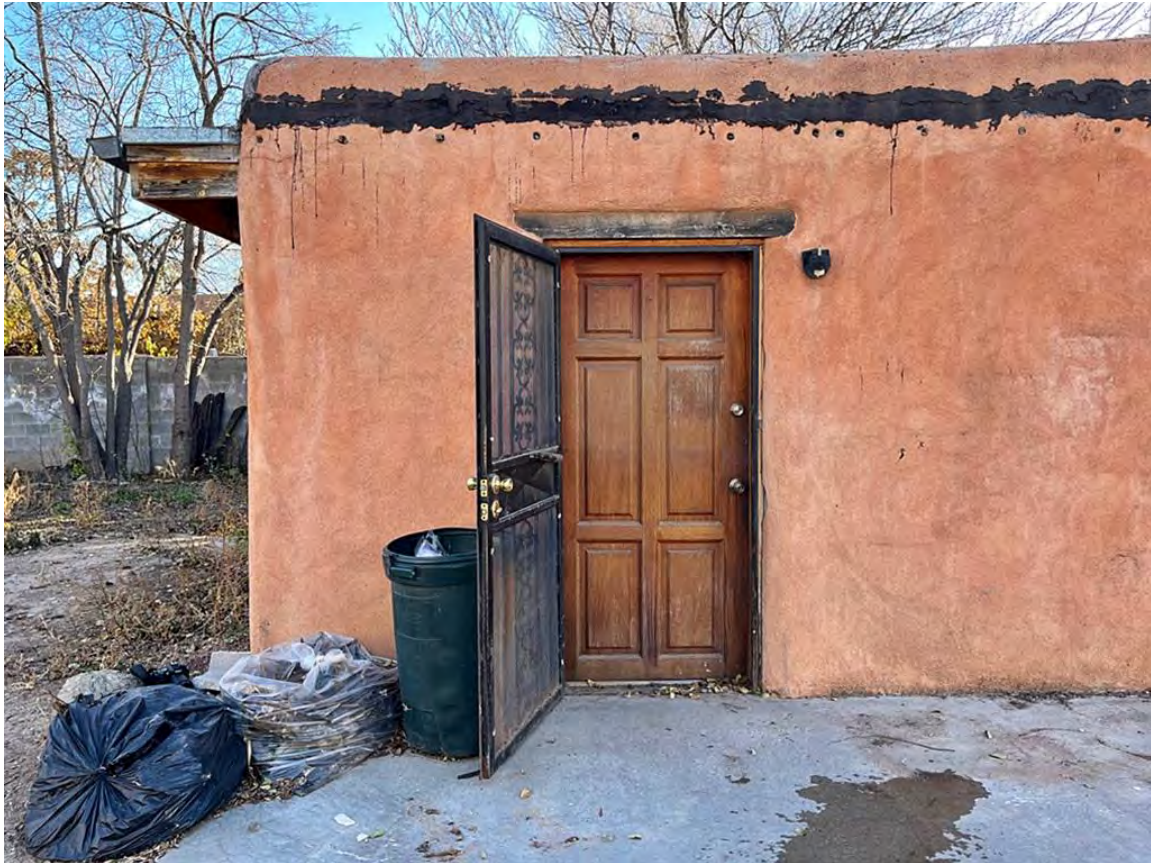
The remaining 14' of the façade represents the non-historic addition, which is entered by a six-panel wood door (Photo 8). Tar stains above the doorway indicate the presence of a porch that was recently removed.

Photo 8: North elevation at east end addition. Camera facing south.

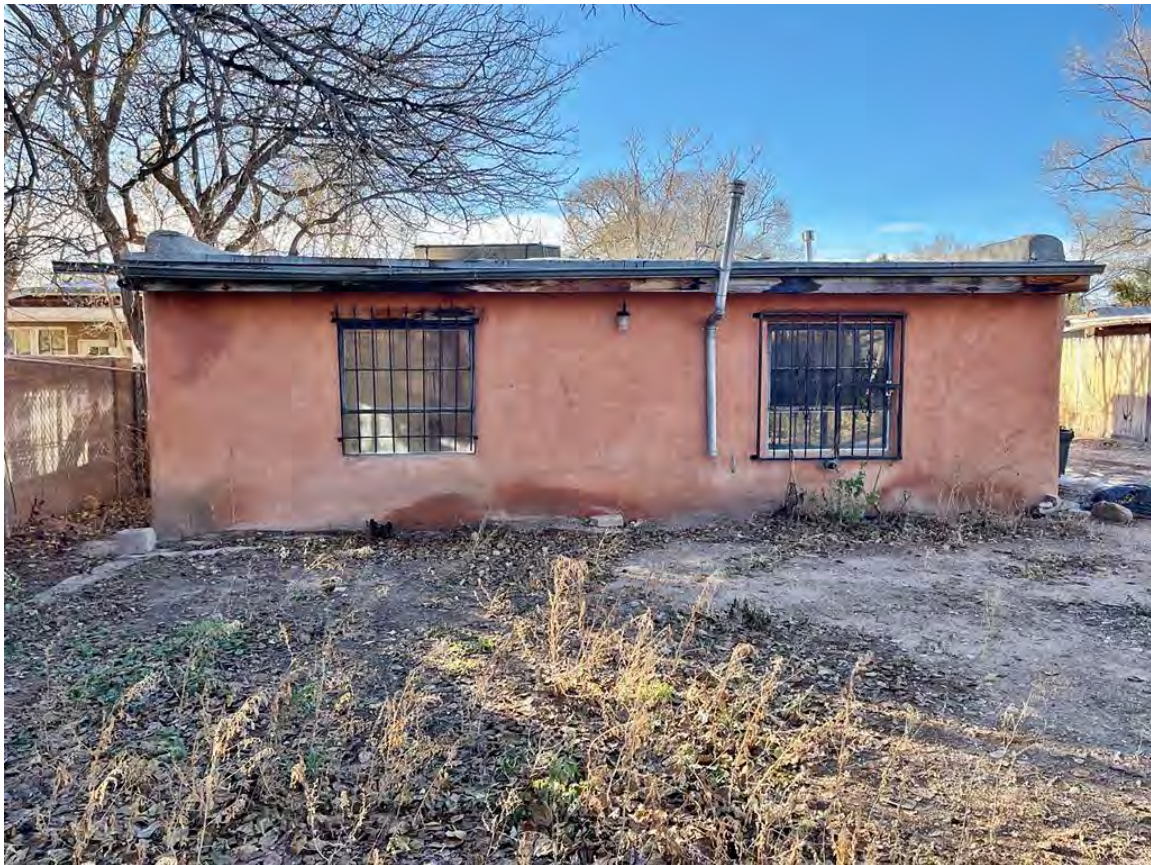
An overhang, which helps drain the roof, traces the east elevation (Photo 9). This portion of the building represents the addition and encloses a large room which is divided into living and dining spaces. The windows on this and the west elevation of the addition are metal fixed units (Photo 10). They are placed nearly flush with the wall.

Photo 9: East elevation representing 1980s addition. Camera facing west.

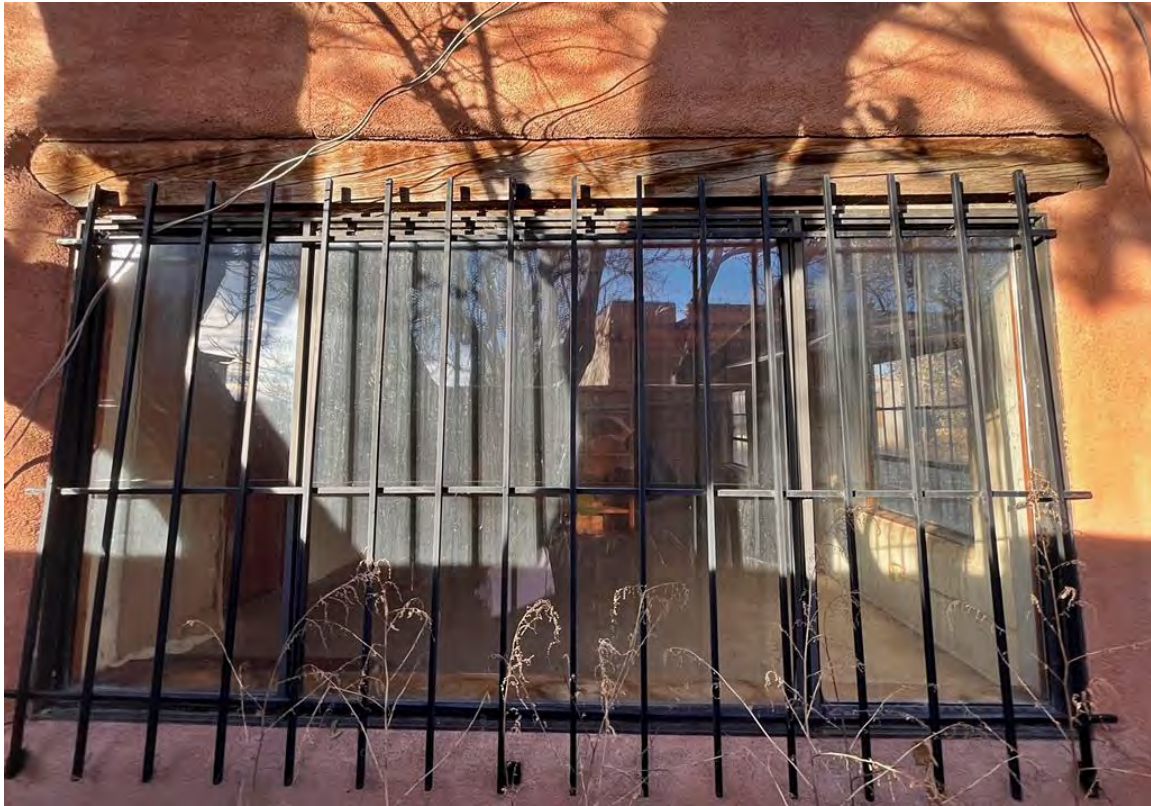
The south side of the building sits close to a block wall (Photo 11). Here stands one of two of the property’s apricot trees. It begins at the east end with a large window at the living room (Photo 12). An expansion joint signals the shift between the addition and the original building (Photo 13). The remaining windows of the façade are large aluminum sliding units with slanted concrete sills (Photos 14 & 15).

Photo 12: South elevation at 1980s addition. Window at living room. Camera facing north.

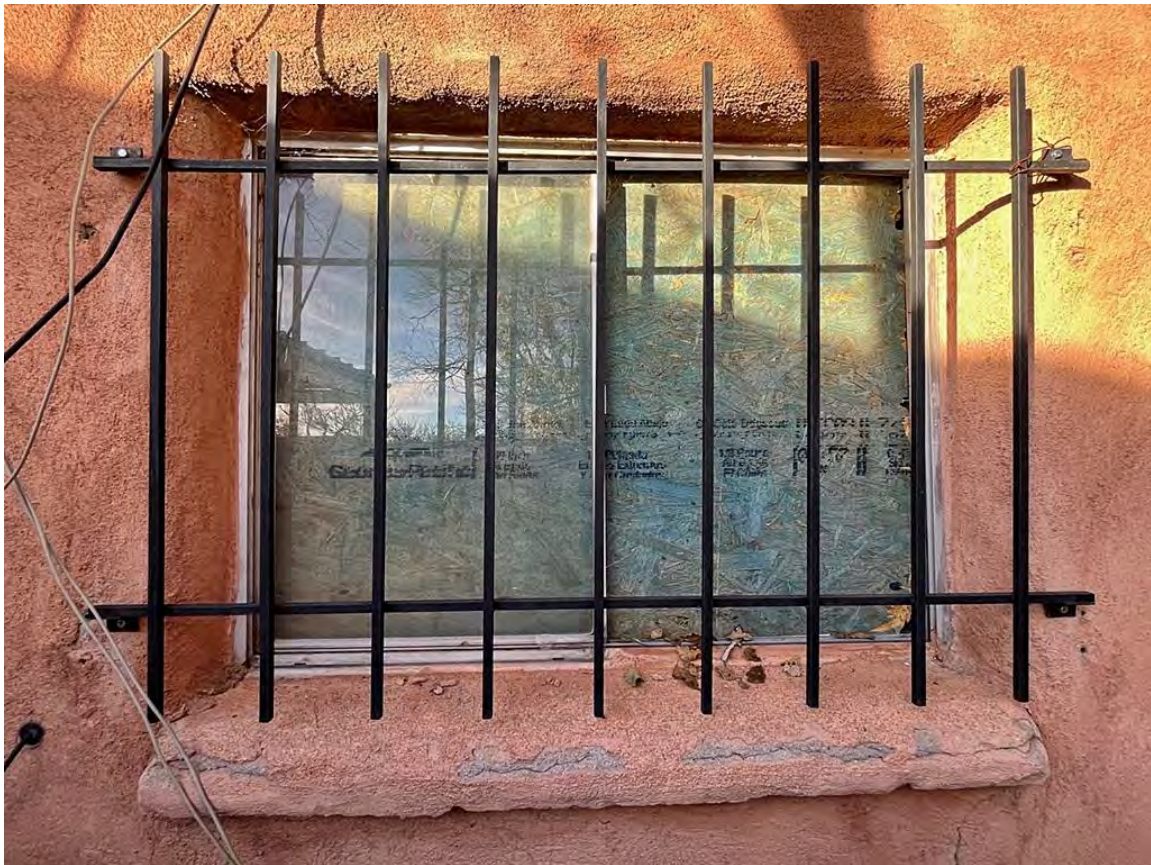
Photo 14: South elevation. Window of southeast room of the original core. Camera facing north.

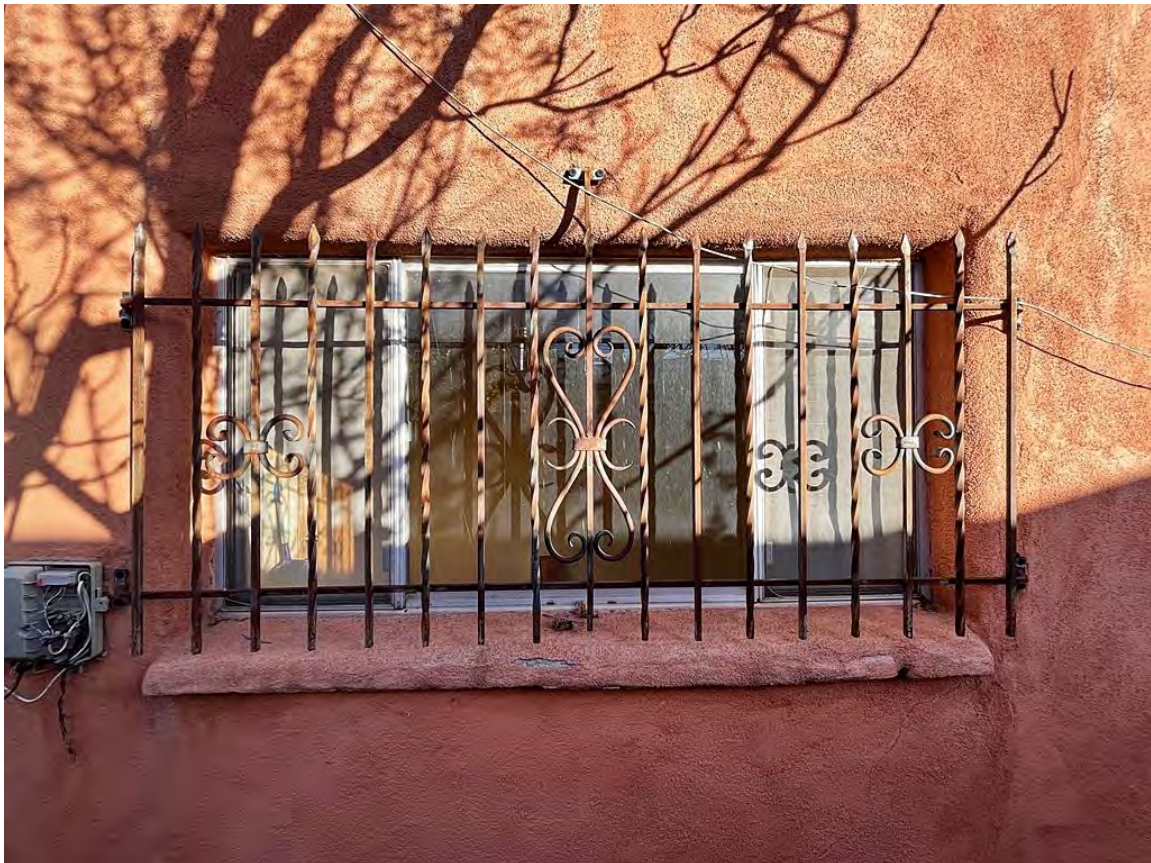
Photo 17: West elevation. Window of northwest room of the original core. Camera facing east.

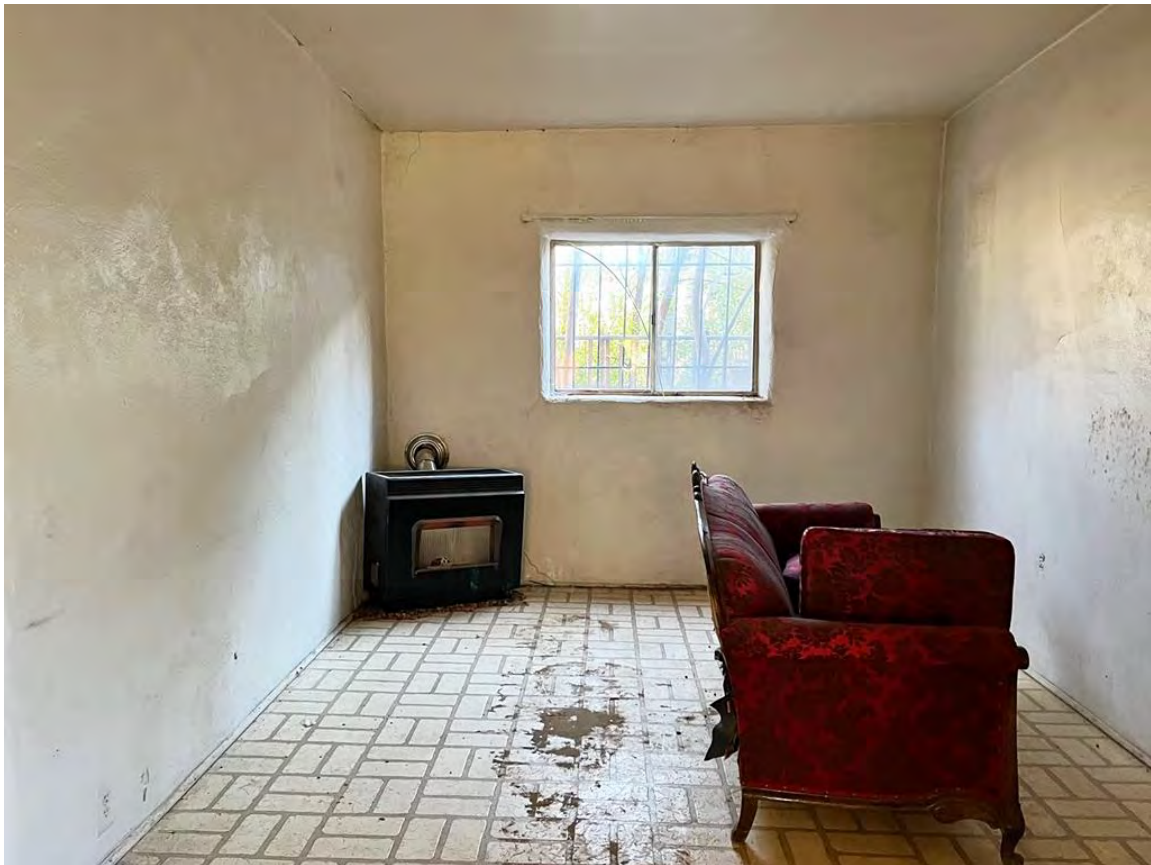
The interior of the older adobe section has four rectangular rooms that are connected by shared doorways rather than a hallway. The ceiling heights vary, with the tallest ceiling measuring 8’ 6” in the northwest entry room (Photo 18). The rooms are spare, lacking moldings or closets, and are all covered with non-historic flooring materials (Photos 18-20). Each room was heated with a stove. The fourth room, located in the northeast corner, is divided into a small bathroom and a kitchen (Photo 21).

Photo 19: Southwest room of the original core. Camera facing south.

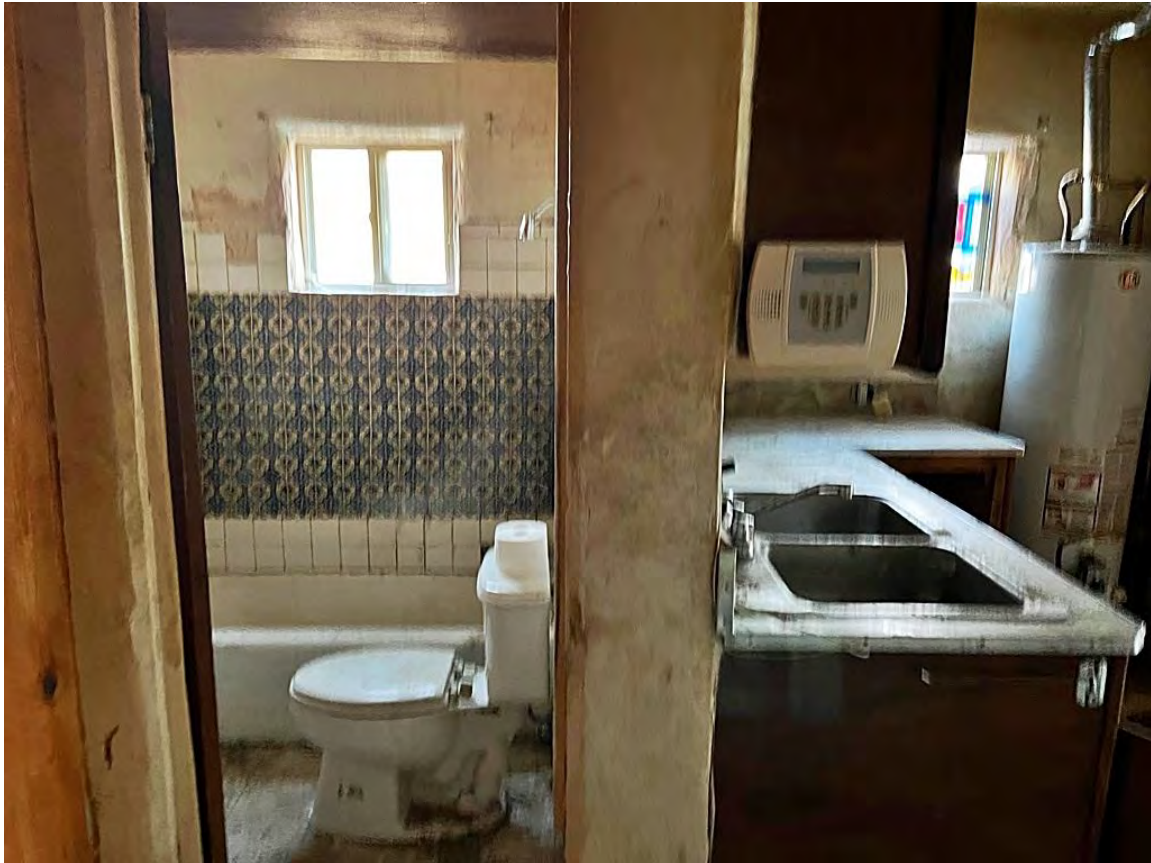
Photo 21: Northeast room of the original core, combining bathroom and kitchen. Camera facing north.

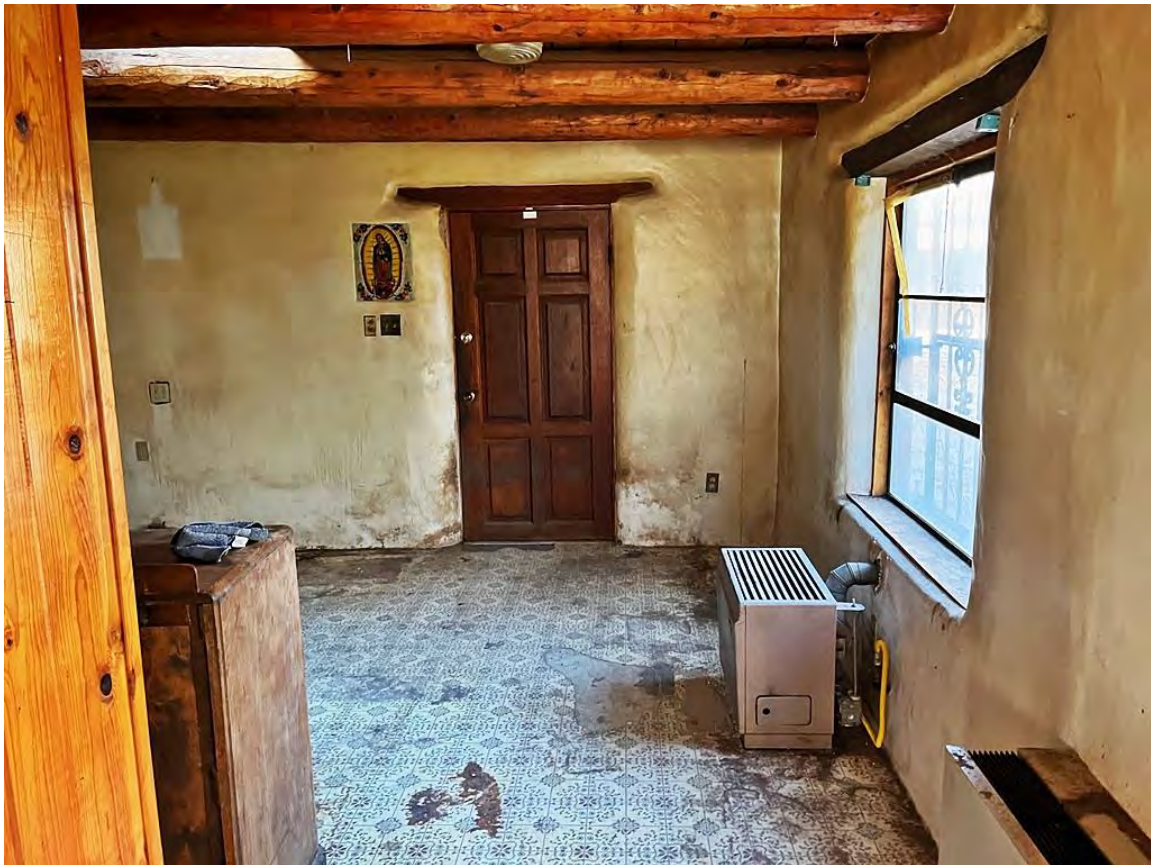
The addition has a plywood floor covered with vinyl tiling and a viga-spanned ceiling, interrupted by a skylight (Photo 22).

Photo 22: 1980s addition. Camera facing north.

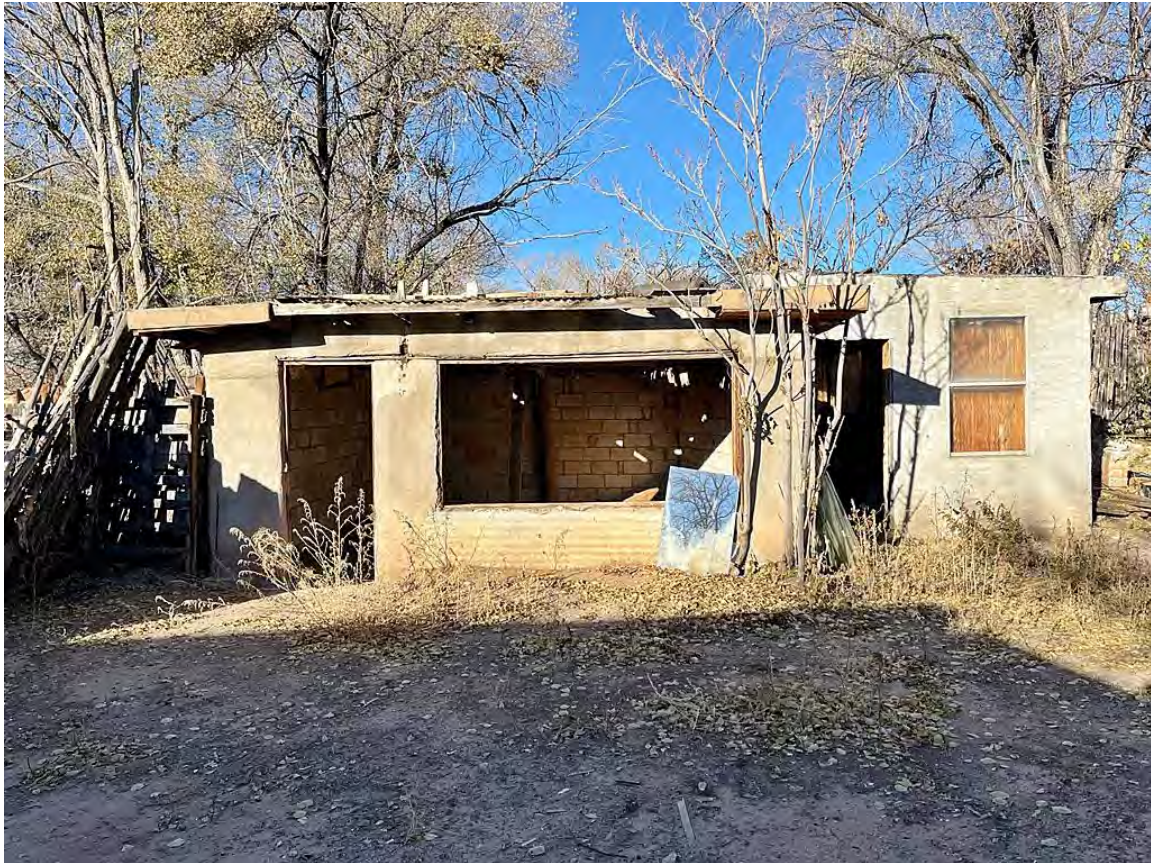
Standing at the northeast corner of the property is a shop — perhaps potentially first used as a garage — and an attached storage room (Photo 23). Constructed of concrete masonry units, the shop has a rectangular, dirt-floor room (Photo 24). Its frame roof structure rests precariously on two poles, supported by tilting posts. An adjacent frame storage room is covered with gray coat stucco (Photo 25). Essentially a lean-to, its structure is even more precarious (Photo 26).

Photo 23: Shop. South elevation. Camera facing north.

Following the original survey, the recommendation is to maintain Non-Contributing status. The house holds little architectural or historical significance. In addition, the 1985 extension increased its footprint by 34%. The shop and its addition appear to postdate 1978 and are poorly constructed.

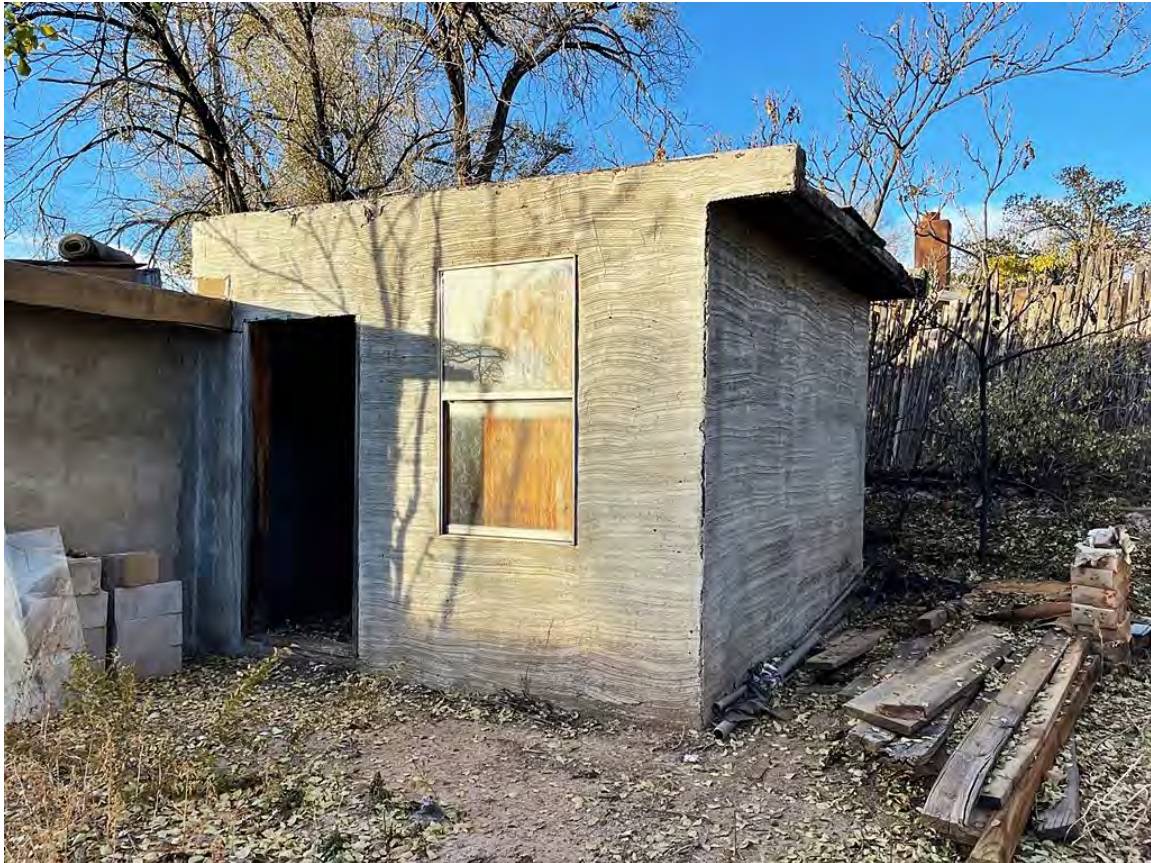
Photo 25: Shop. Addition. Camera facing northwest.

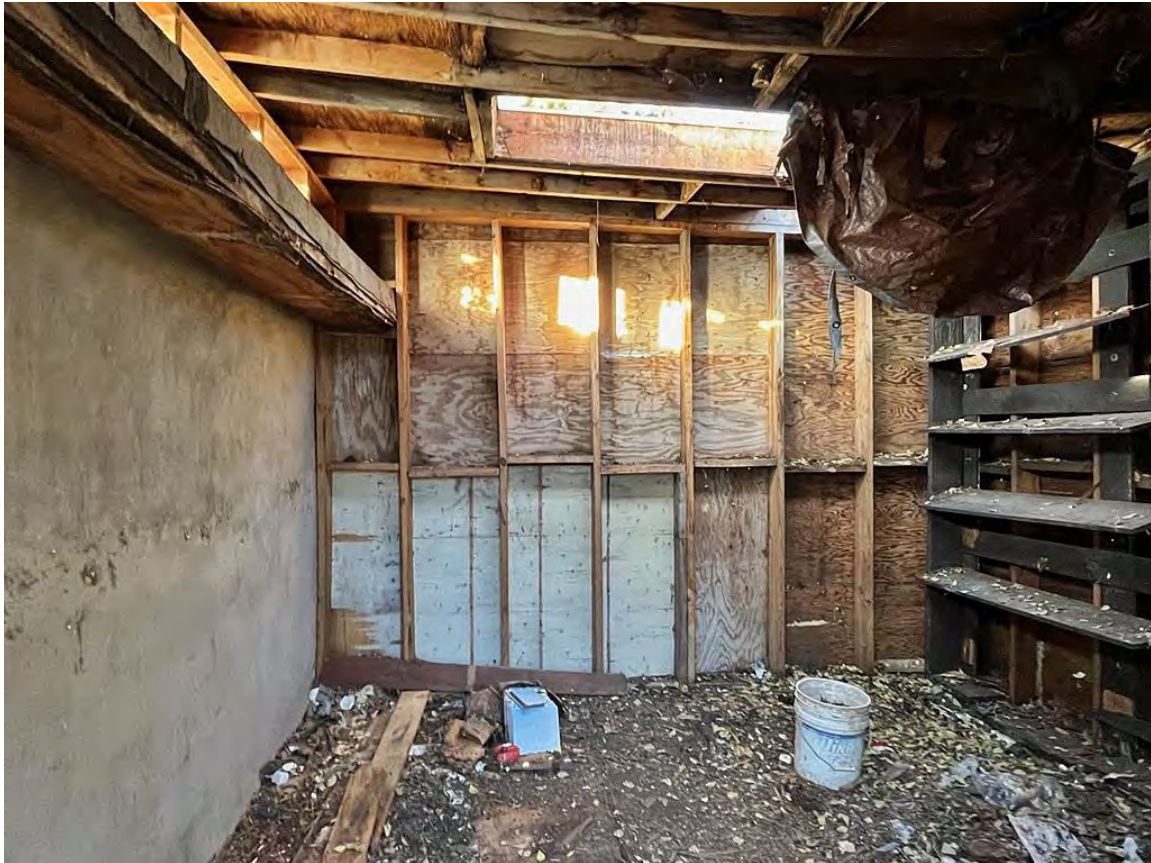
Photo 26: Photo 25: Shop. Addition, interior. Camera facing north.
