# City of Santa Fe

**Plan Number:** 2024-009372--HDRB

**Project Description:** 2024-009372-HDRB, 1182 Cerro Gordo Rd., Downtown & Eastside Historic District, Contributing and no-historic status, High Desert Contractors LLC, agent for Lanalee Lewis Rev. Trust, owner, requests a status review with primary façade designation, if applicable, for an accessory structure.

**2024-009372-HDRB, 1182 Cerro Gordo Rd., Downtown & Eastside Historic District, Contributing and no-historic status, High Desert Contractors LLC, agent for Lanalee Lewis Rev. Trust, owner, requests a status review with primary façade designation, if applicable, for an accessory structure.**

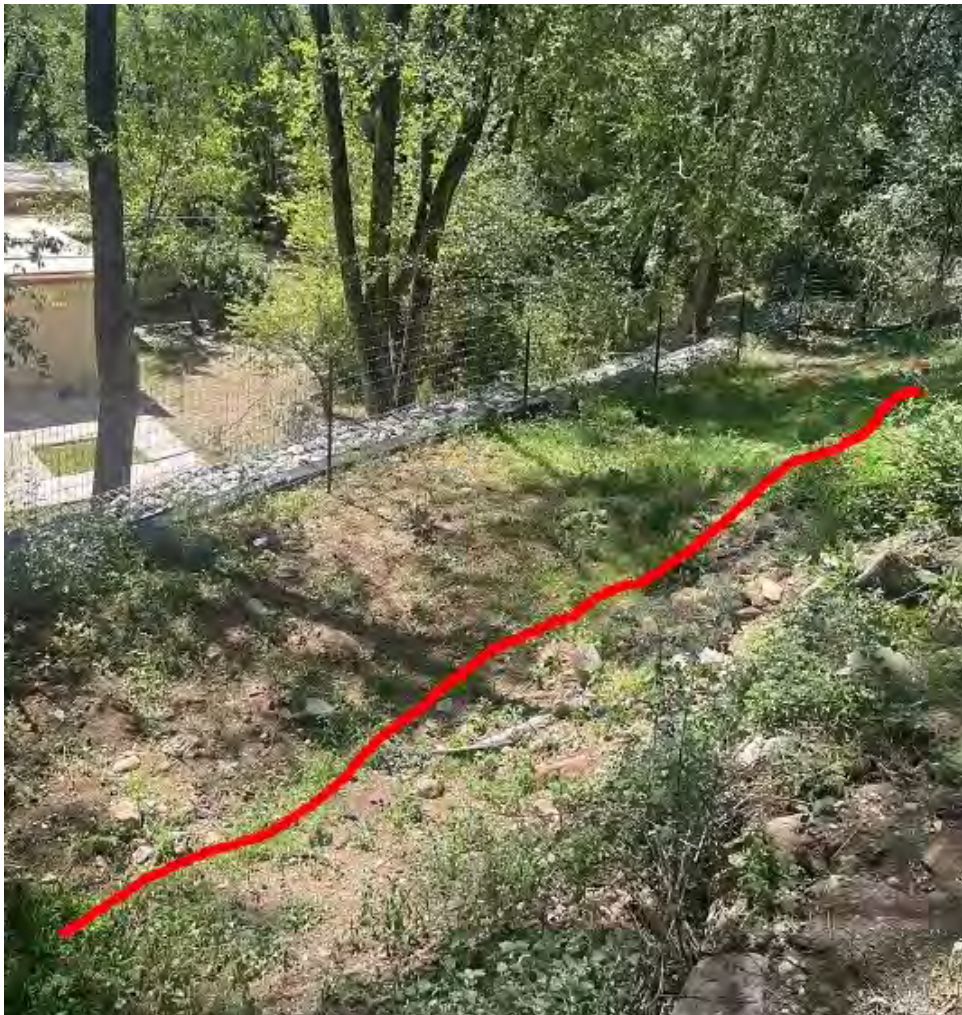
Figure 1: Remnant of *Acequia de la Muralla* with retaining wall to the right

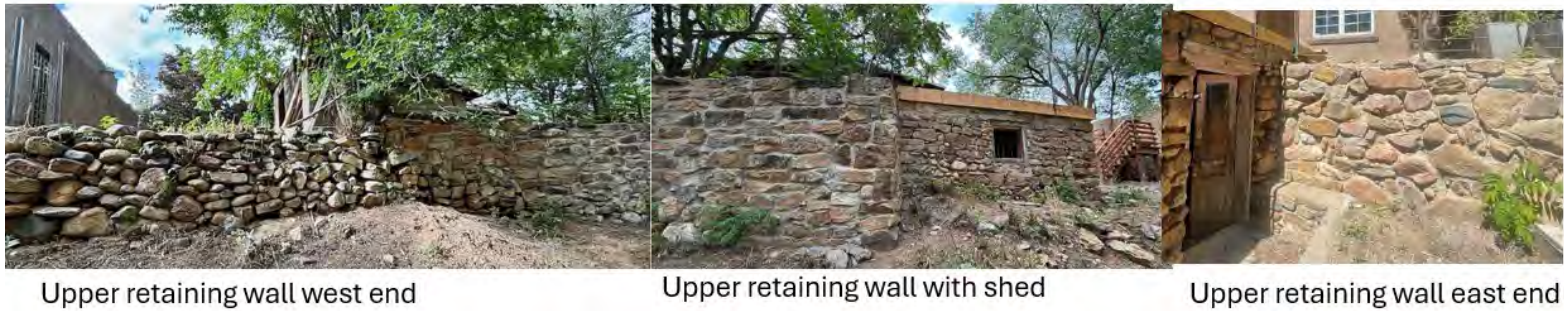
To the rear of the residence there are several sections of stone retaining walls holding back the slope upon which the house sits. The most extensive of these is 80 linear feet roughly 6' high wall section located directly below the house. The east section is built with local, undressed stone, mostly quartzite, laid in random courses. The exposed mortar is made of cement. The west section, which is situated lower on the slope, consists of more uniform, block-like stones arranged in regular courses at its east end. This section appears to be of heavier construction, with supporting end piers, and has been repointed with cement mortar. This portion does not appear on the 1978 aerial. The end of the wall at the west consists of dry-laid river cobbles. Part of the upper retaining wall is visible in a 1960 aerial photograph. The origin of the other walls is unclear.

Figure 2: Upper retaining wall which shows in the 1960 aerial photograph

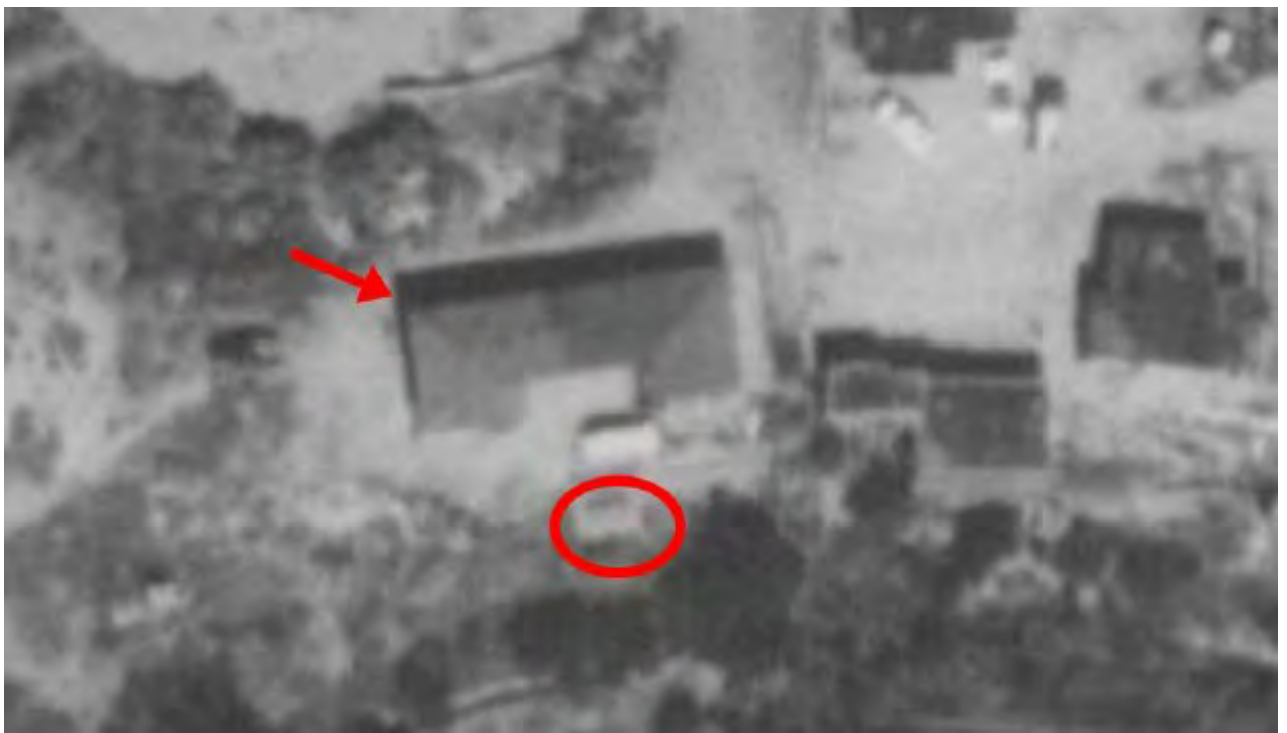
Attached to the upper retaining wall is a three-walled stone accessory structure of indeterminate age, designated on plat maps as the “Rock Shed.” The stone structure does not appear in the 1948 aerial photograph, however a structure in this relative location is shown on the 1960 aerial.

Figure 3: 1960 Aerial showing the shed structure location

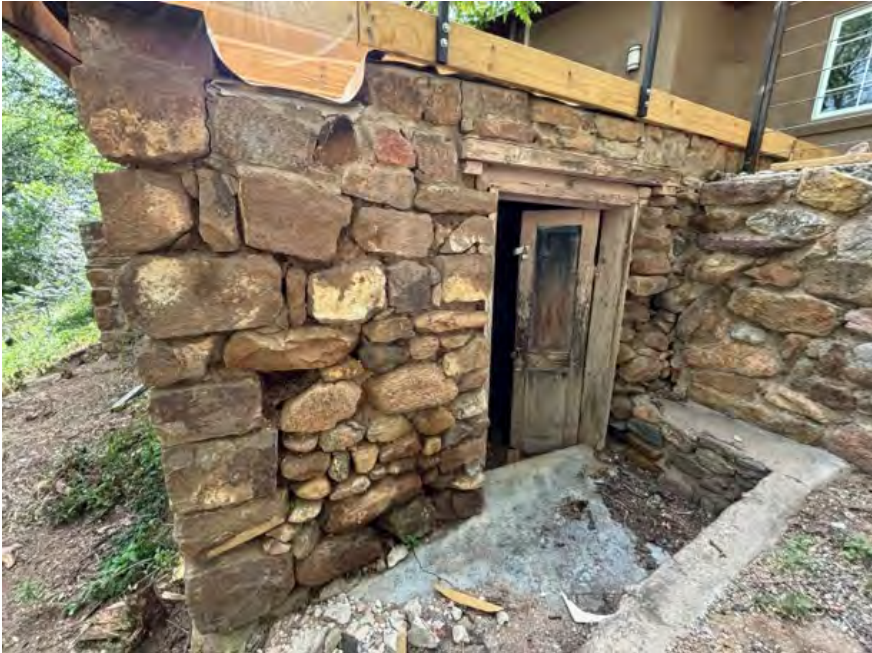
The structure, which is roughly 84 square feet, is made of quartzite and other local and imported stones. The main pattern consists of medium-sized flat and oblong stones with smaller rocks filling the gaps between them. These rest on a base of smaller rocks and cobbles. The stones are laid in mud mortar with cement patching at the window and top of the wall. The southeast corner is made of much larger stones, arranged almost like cornerstone supports. The rocks of the upper courses near the roofline are from a different source and are tabular. The entrance to the structure is on the east through double wood doors of an older vintage. The interior is one room with an earthen floor and a new wood joist ceiling created by a deck above it. Staff notes this deck is the subject of a red tag issued on the property for work without a permit. The roof previous to the recent deck

structure was constructed of red metal. The walls are partially mud-plastered, with sections that may be reconstructed or shored up with additional stones.

Figure 4: Exterior of the Shed

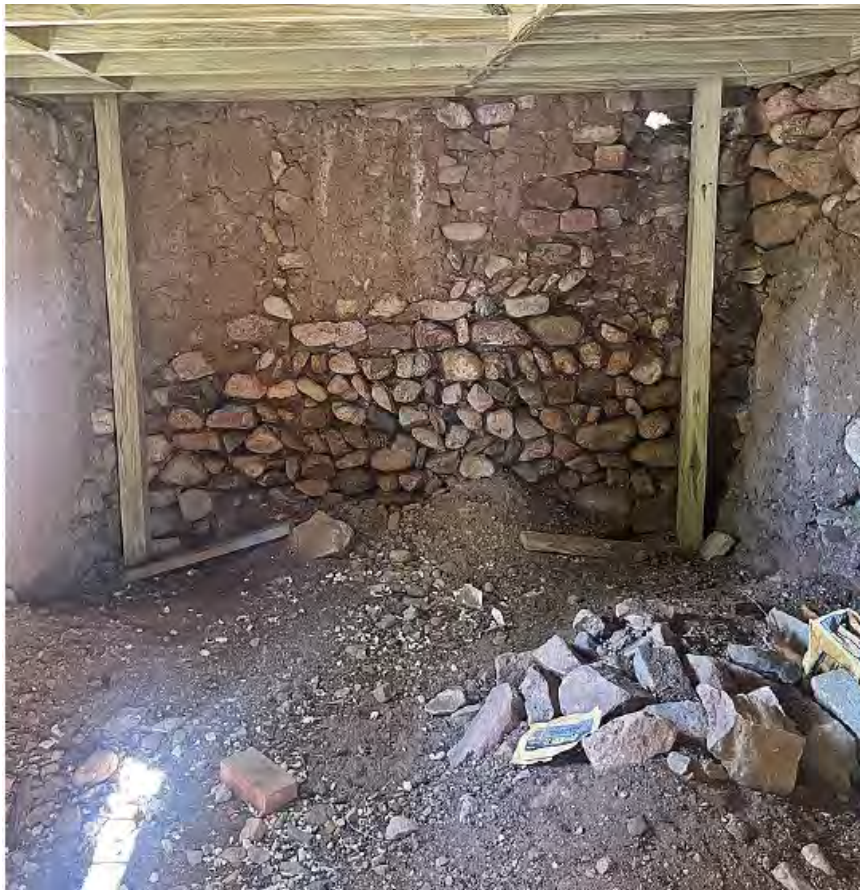
Figure 5: Stone shed structure interior

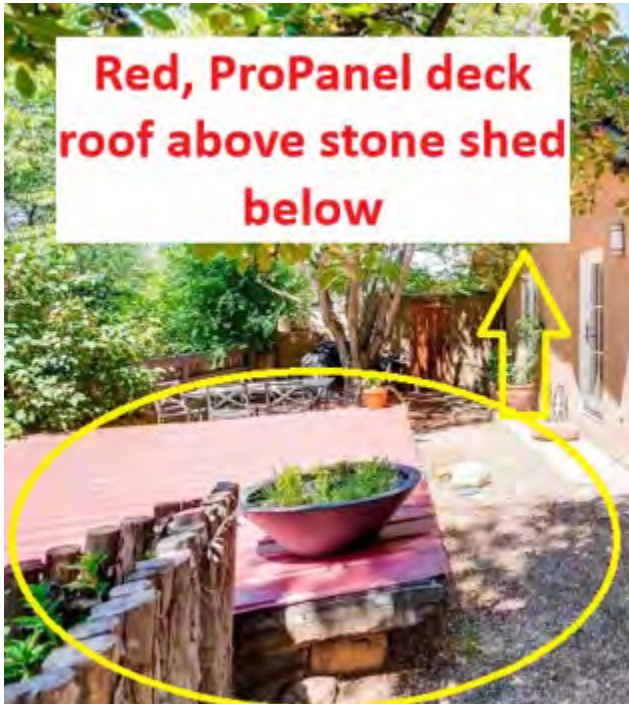
Figure 6: Previous red panel roof on the shed

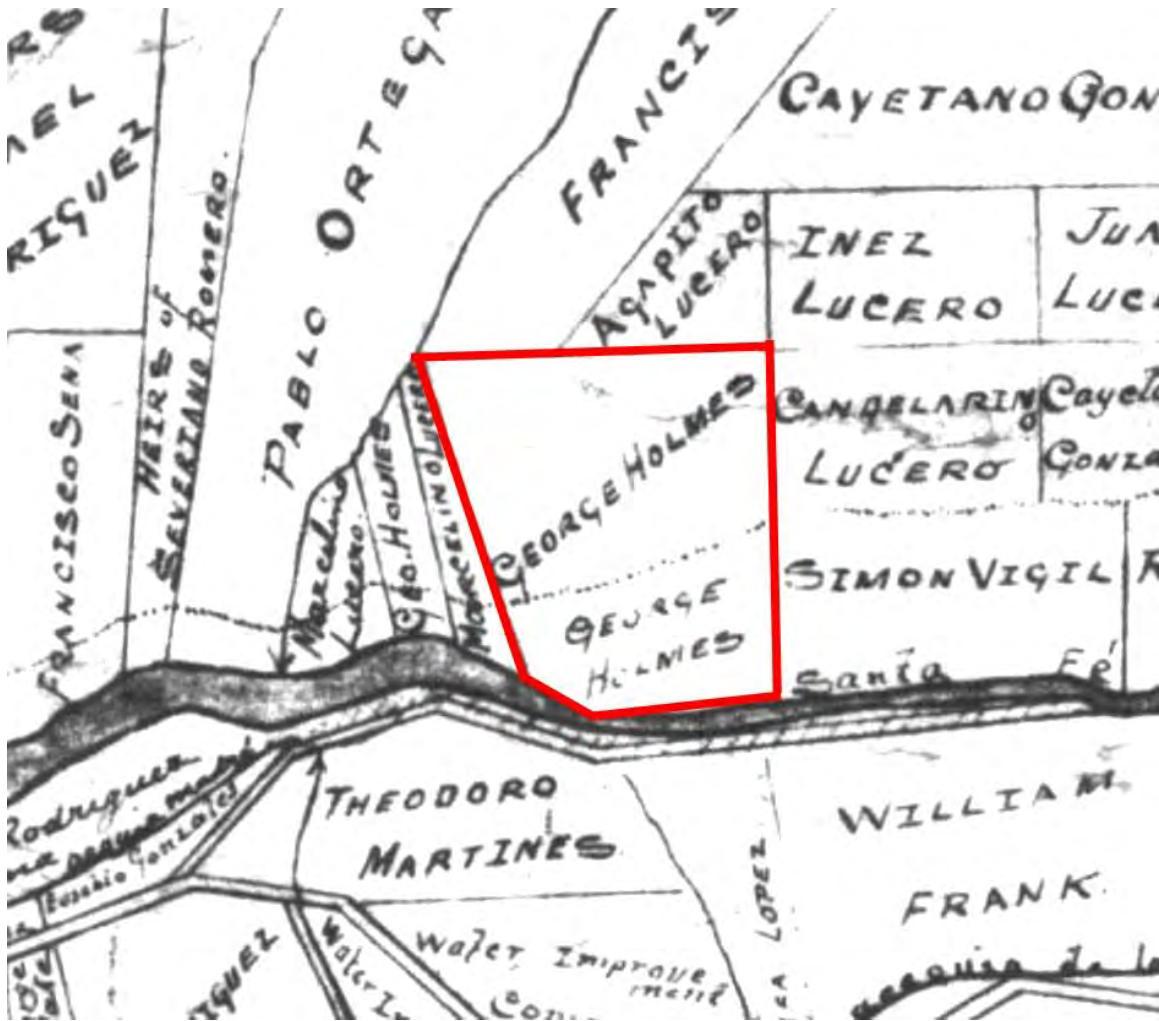
**Figure 2: 1897-98 map showing the larger parcel under the ownership of George Holmes. Source: William White, "Owners of Land Within the Santa Fe Grant Outside the City Limits," 1897-98.**

Starting in the 19th century, the former Lucero grant was divided into smaller tracts worked primarily as farmland (Fig. 2). By the late 19th century, most of the area south of Cerro Gordo Road near its junction with Lorenzo Road was owned by George Holmes, an Irish immigrant and stonemason. His land, as shown on the 1897-98 White’s map, stretched from the Santa Fe River northward to the south edge of Cerro Gordo Road (Fig. 2). The south portion of his land was irrigated by Ditch No. 8 (*Acequia de la Muralla*), a remnant of which exists on the property.

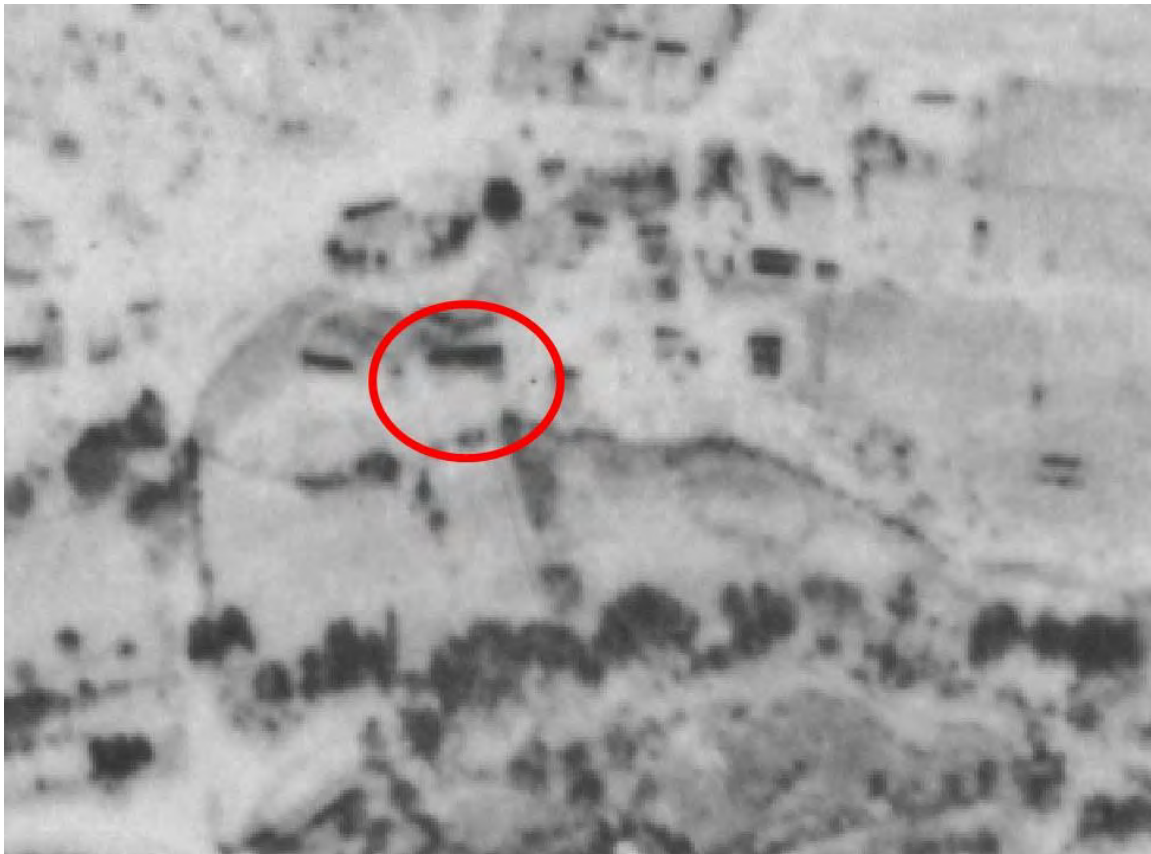
**Figure 5: October 25, 1948, aerial photograph. Note stone structure is not shown.**

The stone structure does not appear on the 1948 aerial photograph (Fig. 5). A structure in this relative location is shown on the 1960 aerial but is smaller and narrower (Fig. 6). It achieved its current size and shape by 1966 (Fig. 7).

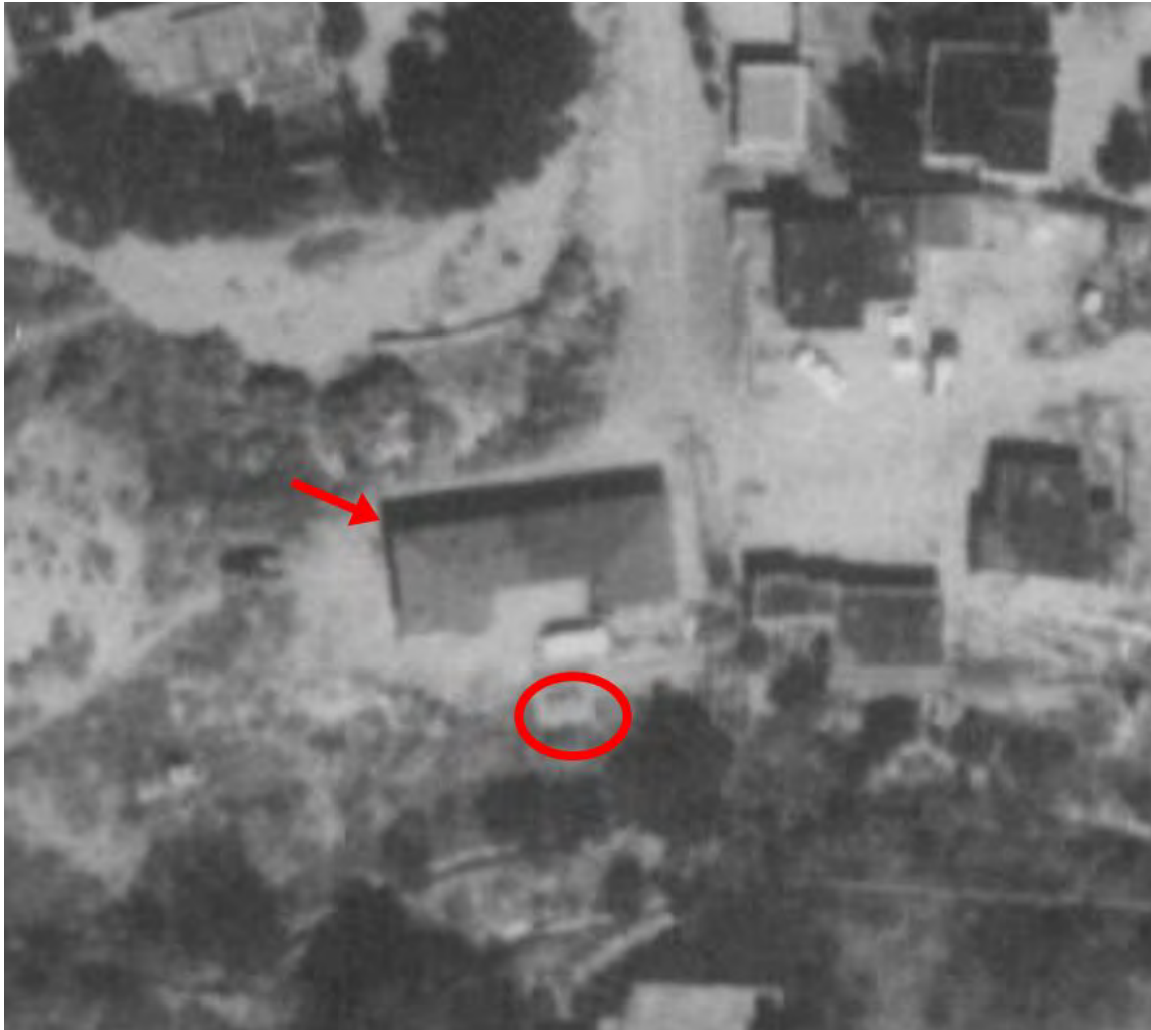
**Figure 6: September 25, 1960, aerial photograph. Note hipped gable connection (arrow) and presence of a structure near the current day stone building (circle). Upper retaining wall and acequia are visible.**

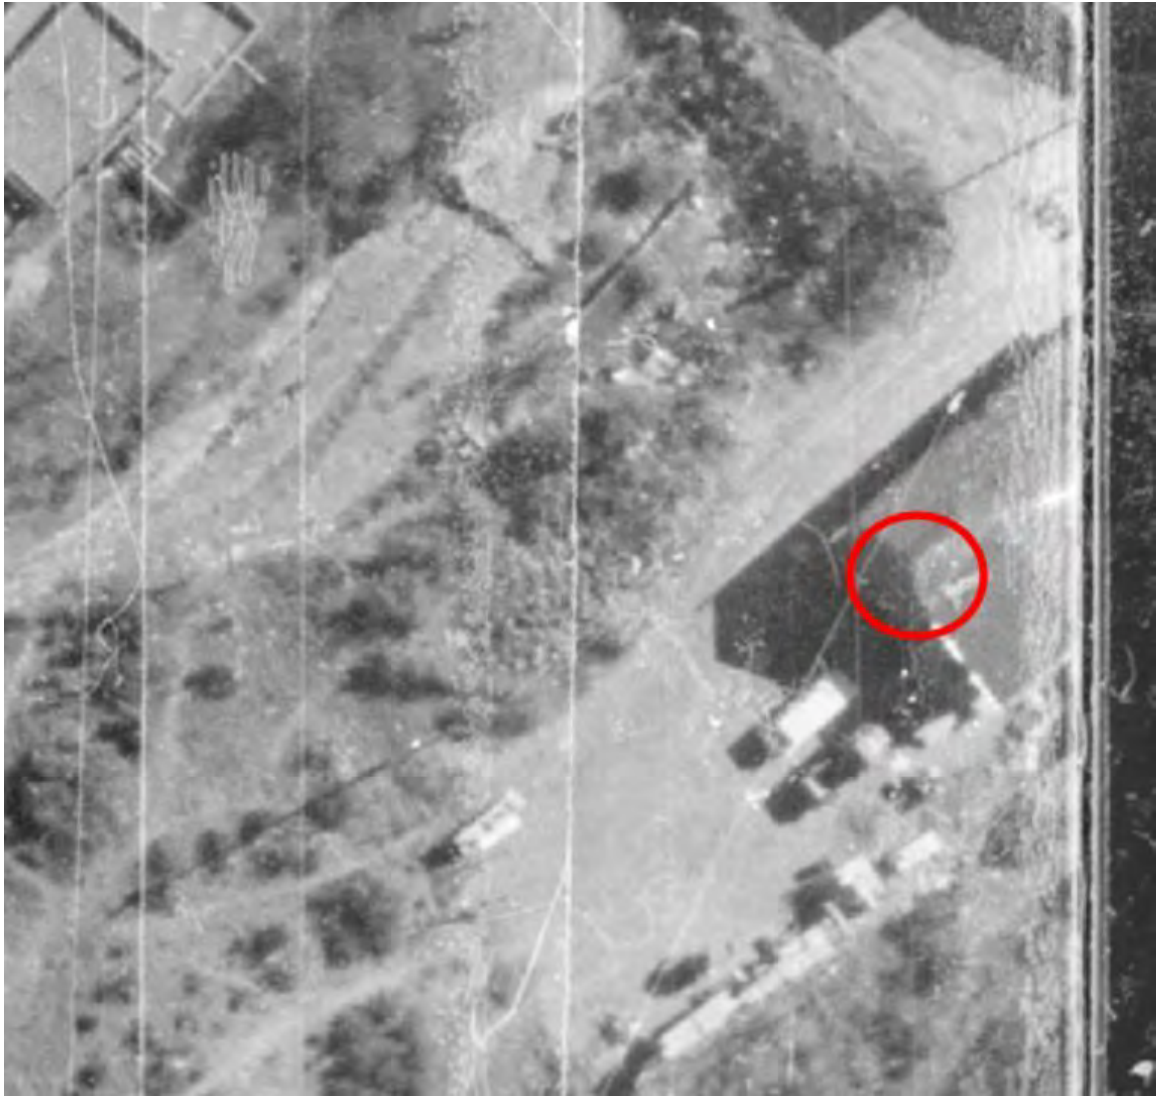
**Figure 8: May 11, 1973, aerial photograph. Note the west connection has been simplified to a gable end (circle).**

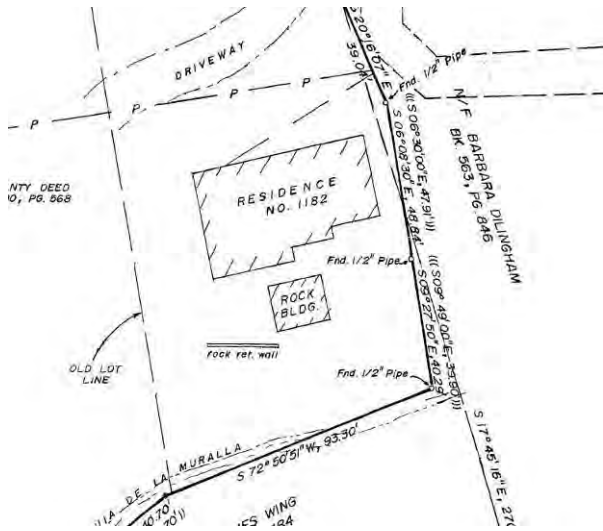
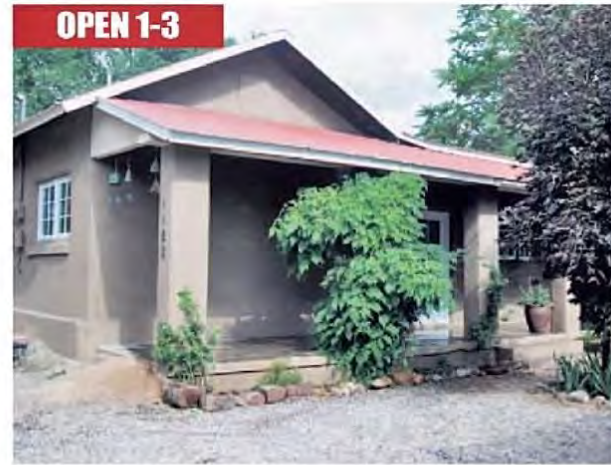
**Figure 11: Left, 1998 survey plat, without a porch across the west elevation; right, 2011 real estate advertisement, showing recent west elevation porch addition.**

Between 1998 and 2005, a portal was installed across the west elevation, introducing a non-historic Craftsman element to the vernacular home (Fig. 11 & Field 19). In 2007, all of the house’s fenestration was changed.<sup>1</sup>

A recent porch defines the west elevation (Photos 3 & 4). The 238-square-foot structure, spanning the entire façade, was constructed between 1998 and 2011 (Fig. 11). With its bulky square posts and shed roof, it gives the feeling of a Craftsman-style house. A glass door and paired casement windows penetrate the wall (Photo 5). Neither are original.

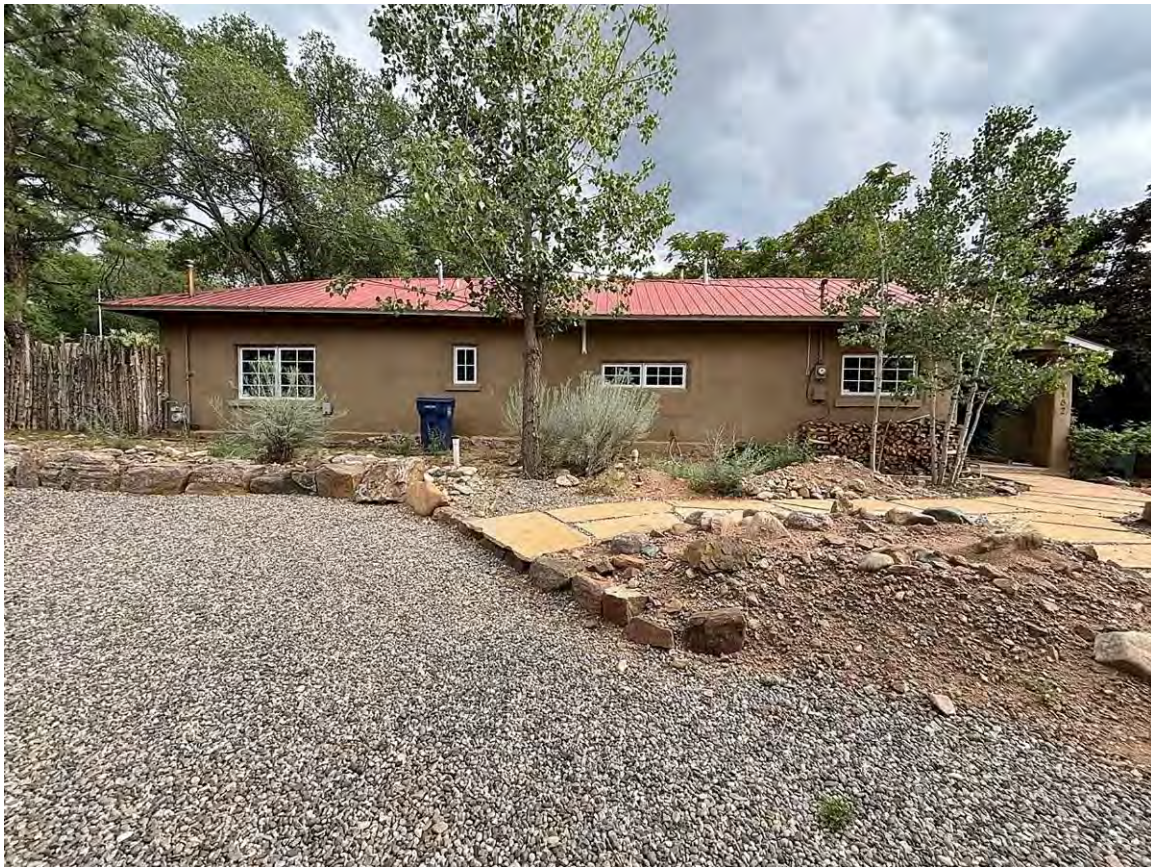
**Photo 2: North elevation. Camera facing south. M. Kay, August 14, 2024.**

If the Board determines that the house still qualifies as a Contributing property, it is recommended to designate the north elevation as the primary façade, as it has undergone the least amount of change (aside from the plain east elevation).

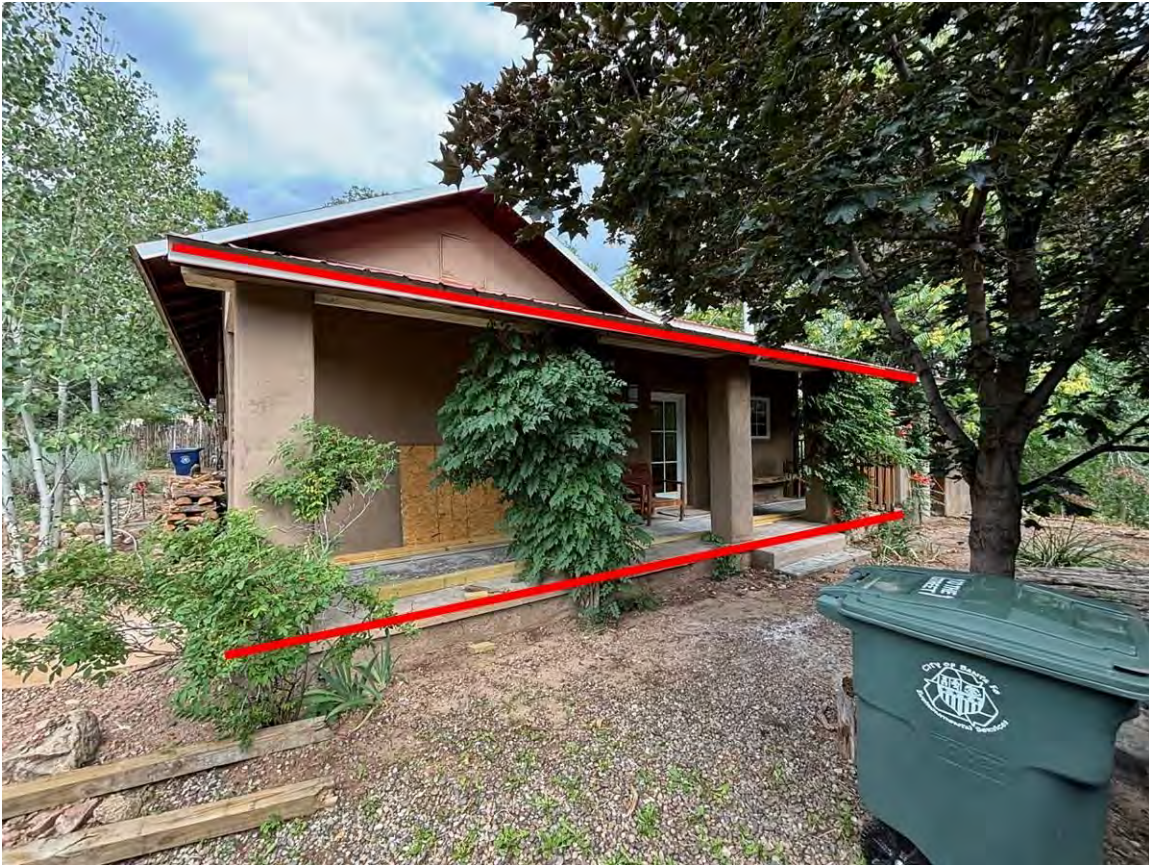
**Photo 3: West elevation. Camera facing southeast. Craftsman-style porch (highlighted) postdates 1978. M. Kay, August 14, 2024.**

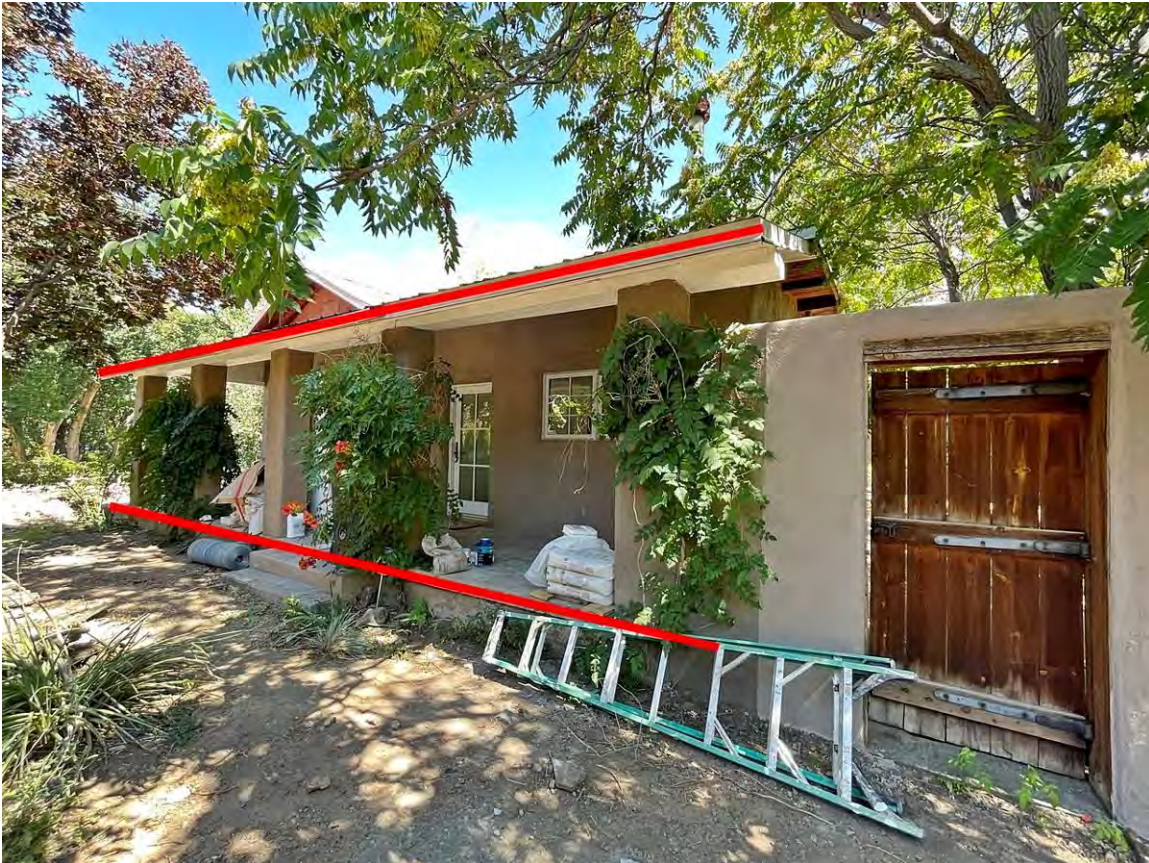
**Photo 4: West elevation. Camera facing northeast. Craftsman-style porch (highlighted) postdates 1978.**

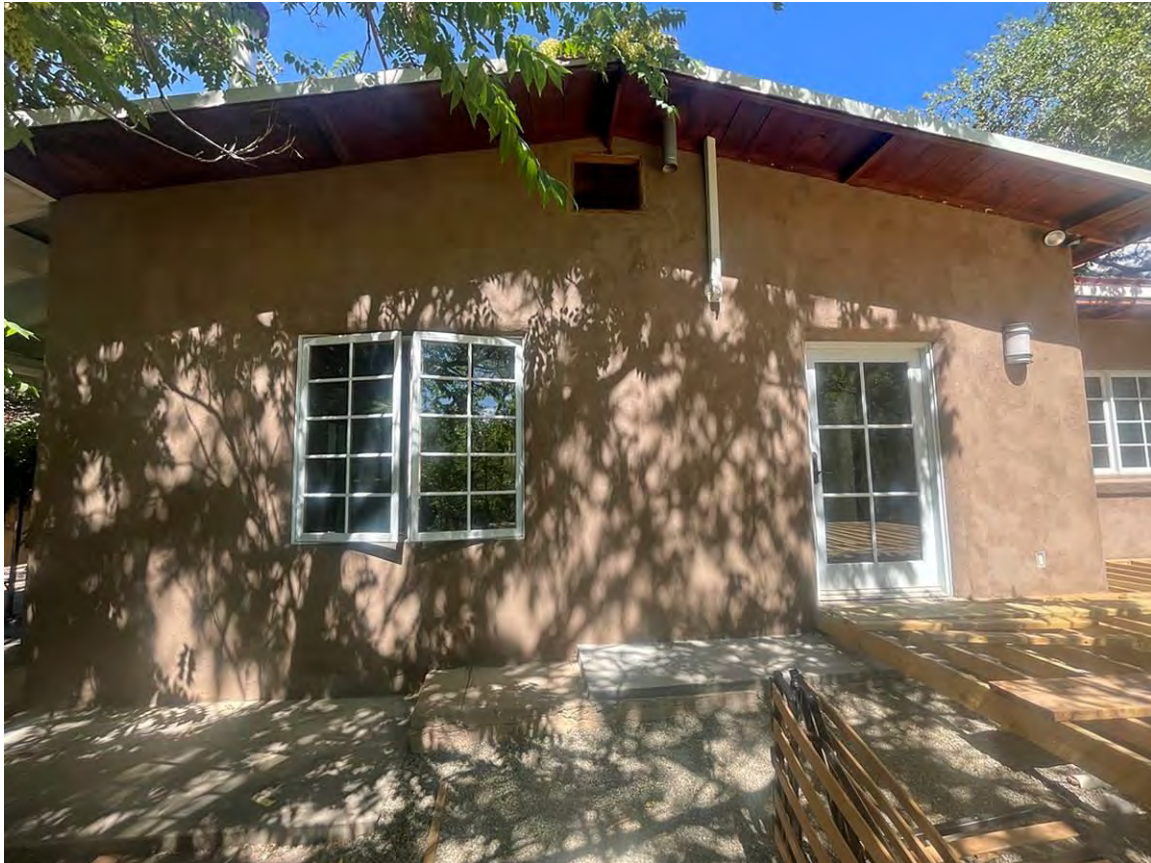
The south elevation, perched at the top of the slope, has experienced more change. It begins at the west end with a projected gable (Photo 6). Somewhere between 1973 and 1978, the original west wing was widened and extended southward, creating this façade (Figs. 8 & 9). This alteration removed the last vestige of the historic patio. Moving eastward, one encounters a flat-roof addition constructed between 1960 and 1966 (Photos 7 & 8). It has a pronounced overhang and the same white-clad windows found elsewhere in the house.

**Photo 6: South elevation. Circa 1973-78 extension of west arm of historic C-shape plan. Camera facing north.**

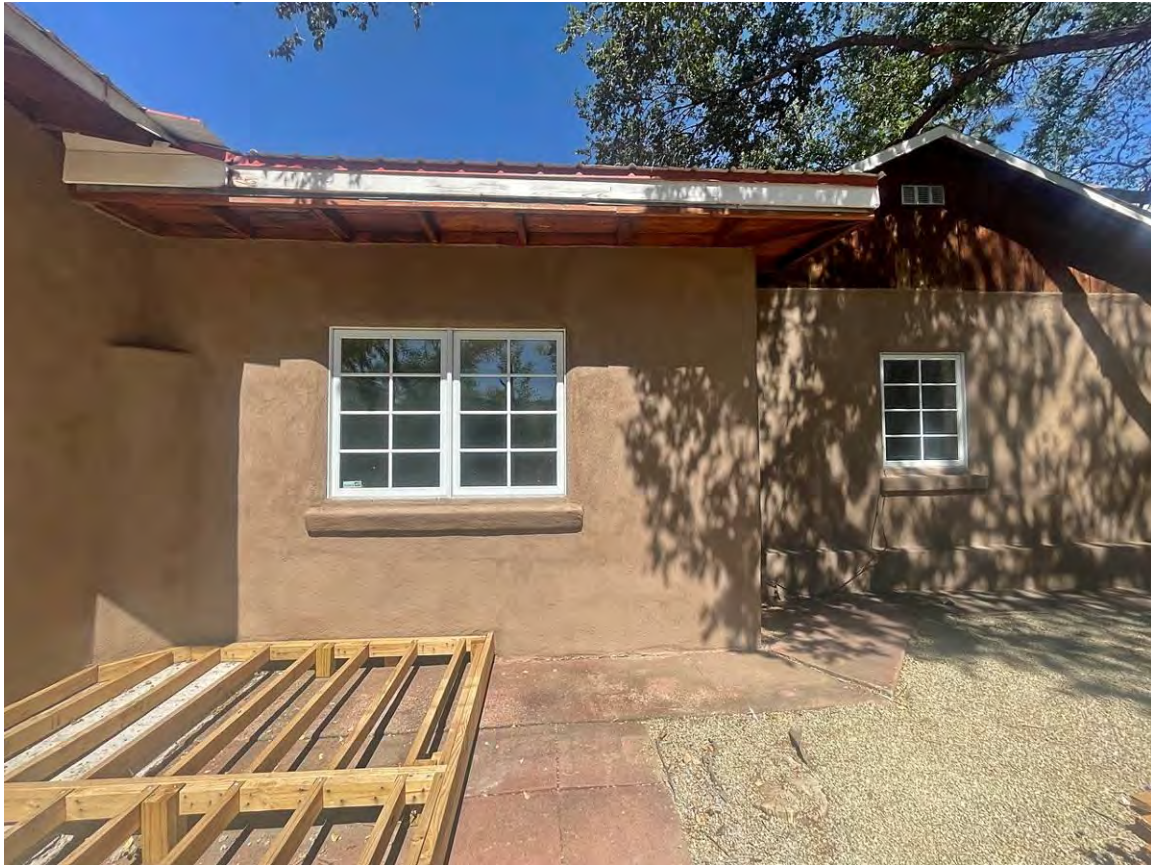
**Photo 7: South elevation. Circa 1960-66 addition built across courtyard at center. Camera facing north.**

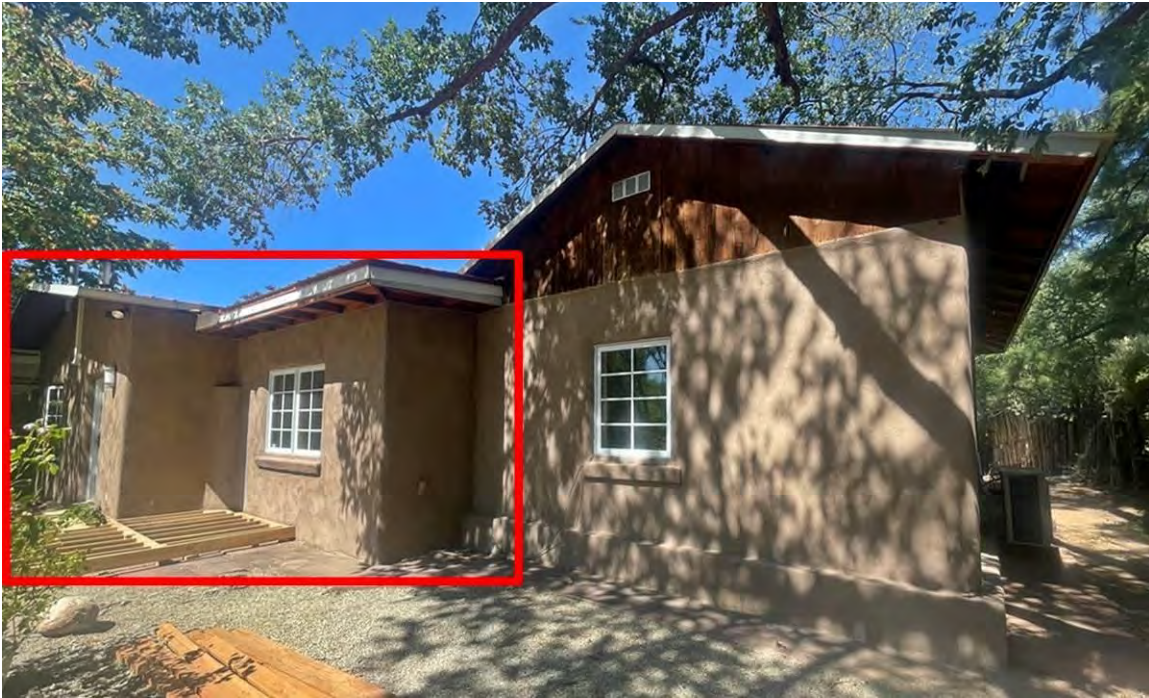
**Photo 8: South elevation. The highlighted area represents 1960s and '70s additions filling in the historic patio area. Camera facing northwest.**

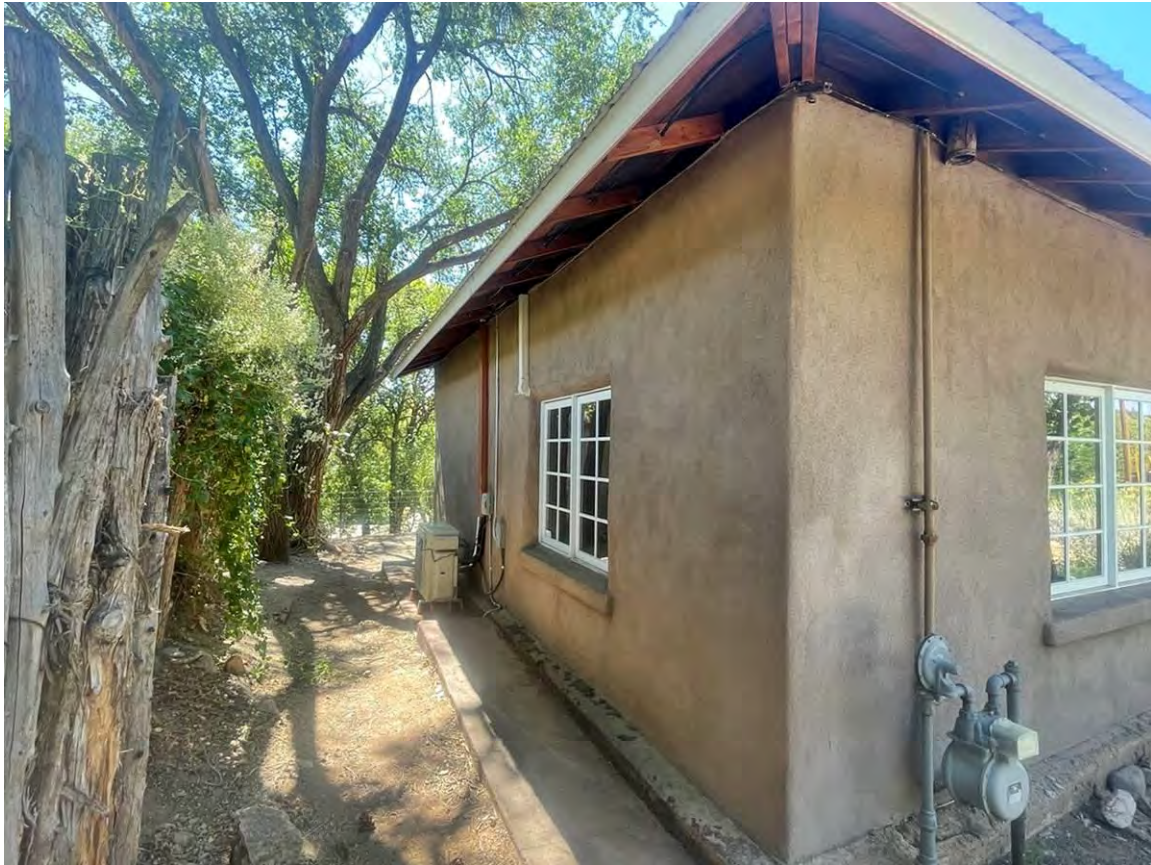
**Photo 9: East elevation oblique. This façade likely represents original, unaltered construction. Camera facing southwest.**

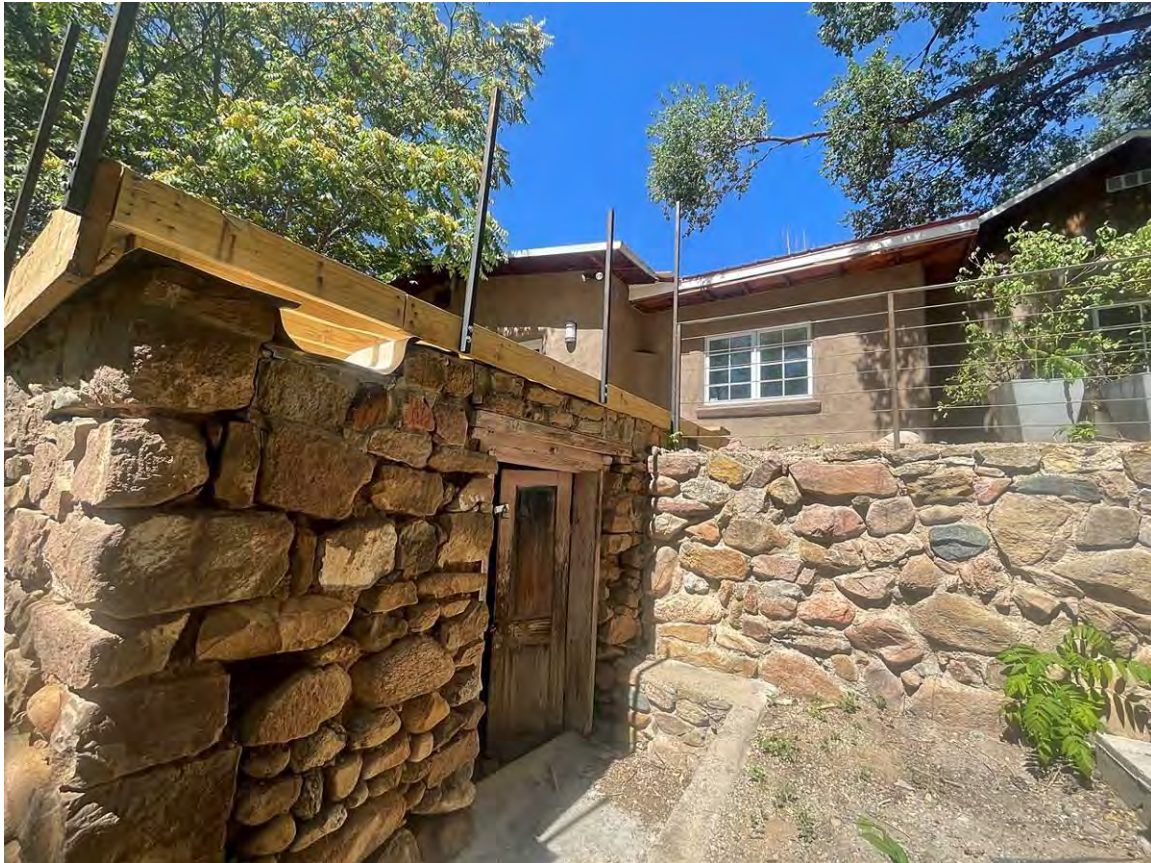
**Photo 10: Stone structure (left) and upper retaining wall (right). Camera facing northwest.**

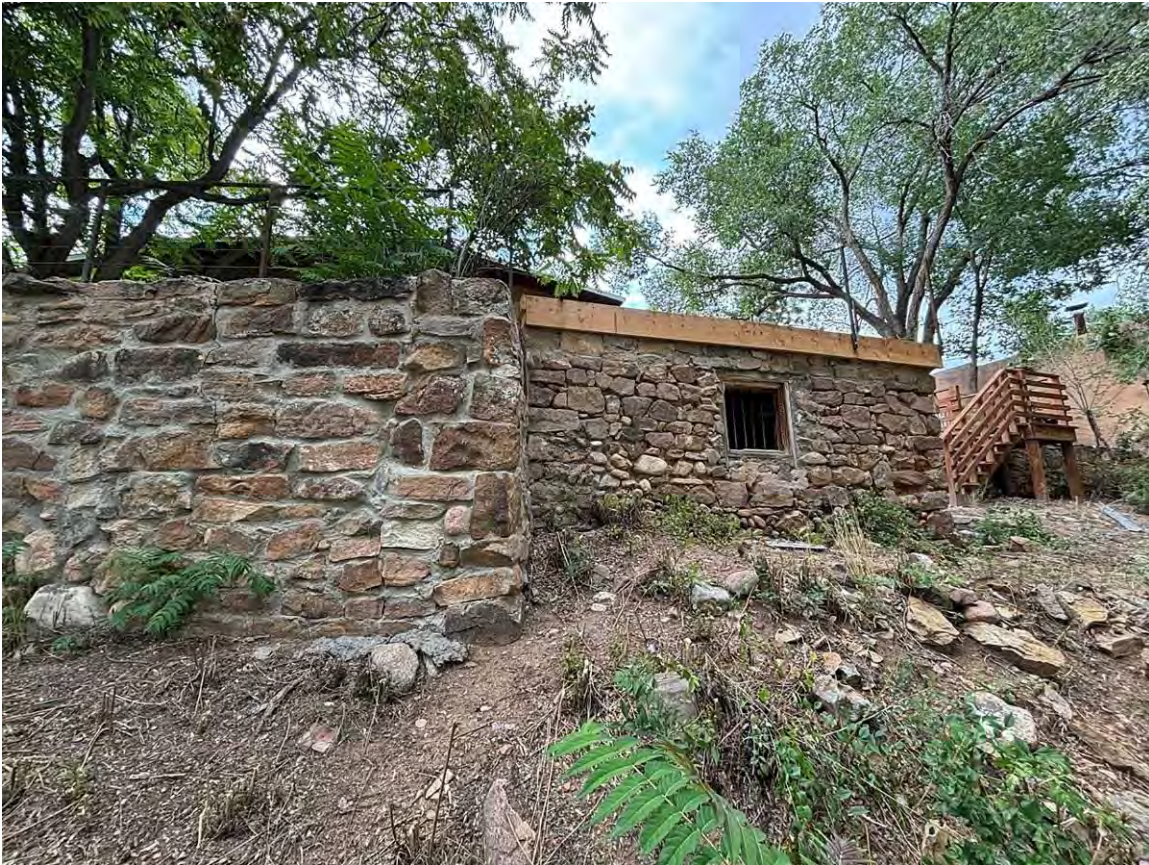
**Photo 11: Upper retaining wall (left) and stone structure (right). Camera facing northeast. M. Kay, August 14, 2024.**

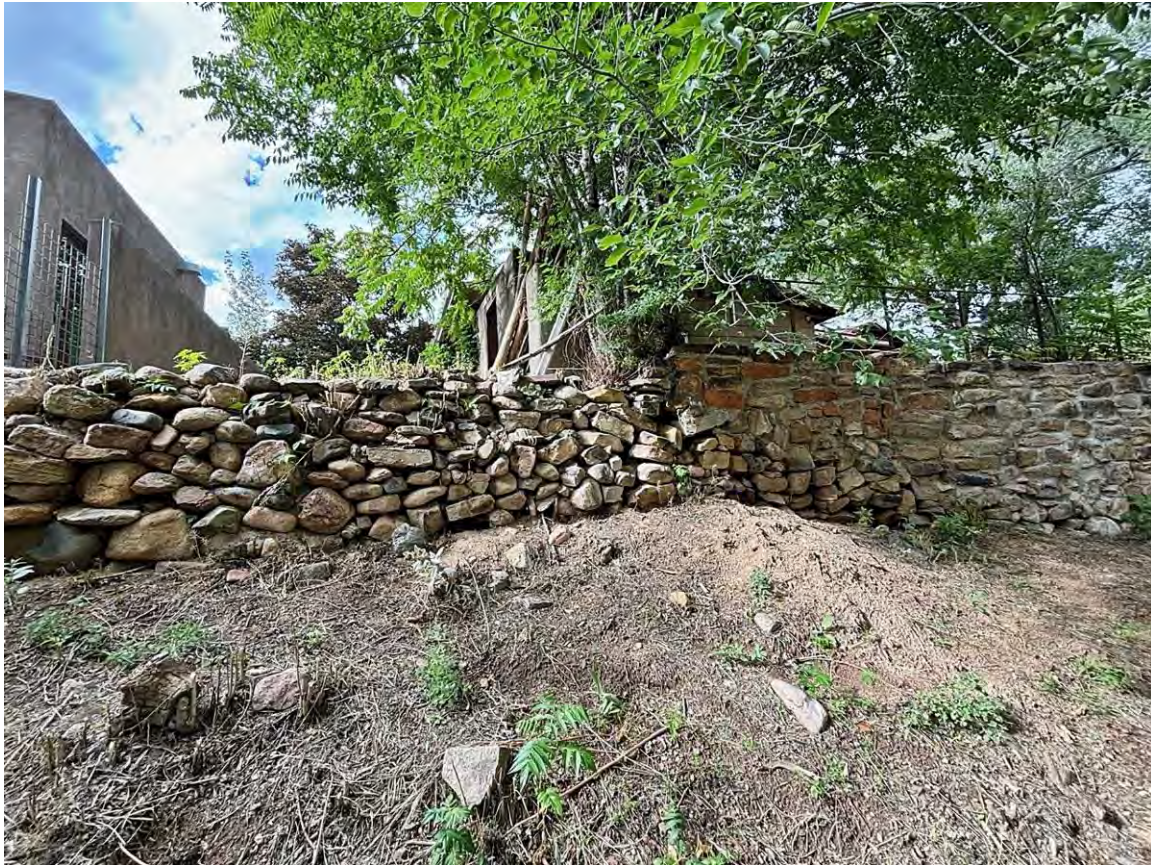
**Photo 12: Upper retaining wall at west end. Camera facing north. M. Kay, August 14, 2024.**

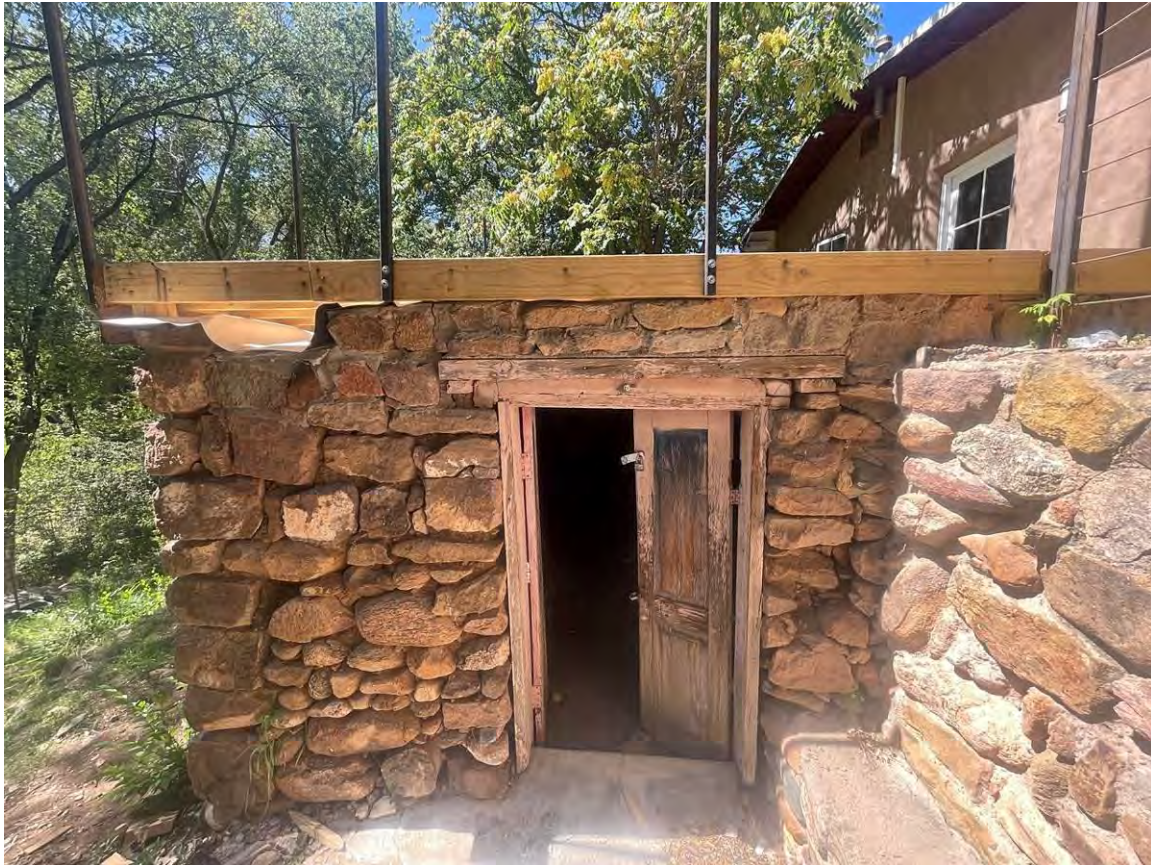
**Photo 13: Stone structure. East elevation. Camera facing west.**

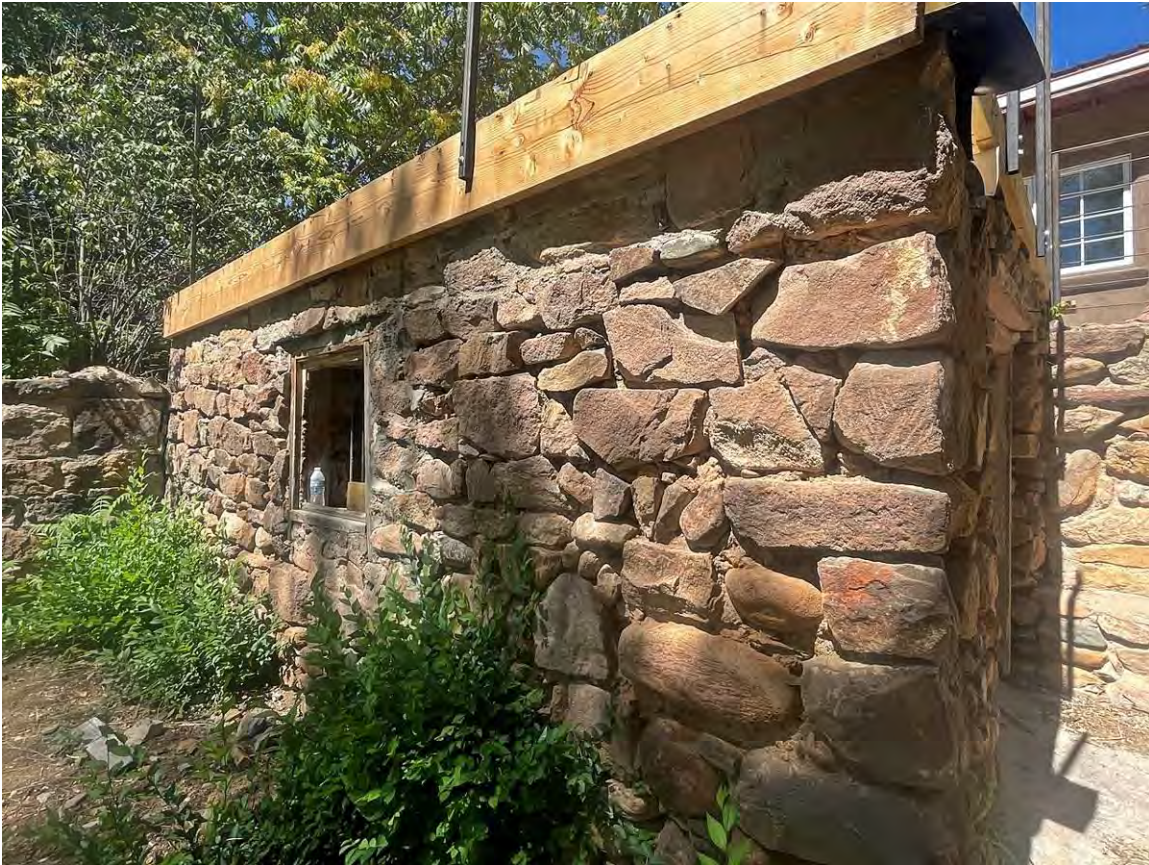
**Photo 14: Stone structure. South elevation. Camera facing northwest.**
