# City of Santa Fe

**Plan Number:** 2024-009372--HDRB

**Project Description:** 2024-009372-HDRB, 1182 Cerro Gordo Rd., Downtown & Eastside Historic District, Contributing and no-historic status, High Desert Contractors LLC, agent for Lanalee Lewis Rev. Trust, owner, requests a status review with primary façade designation, if applicable, for an accessory structure.

**2024-009372-HDRB, 1182 Cerro Gordo Rd., Downtown & Eastside Historic District, Contributing and no-historic status, High Desert Contractors LLC, agent for Lanalee Lewis Rev. Trust, owner, requests a status review with primary façade designation, if applicable, for an accessory structure.**

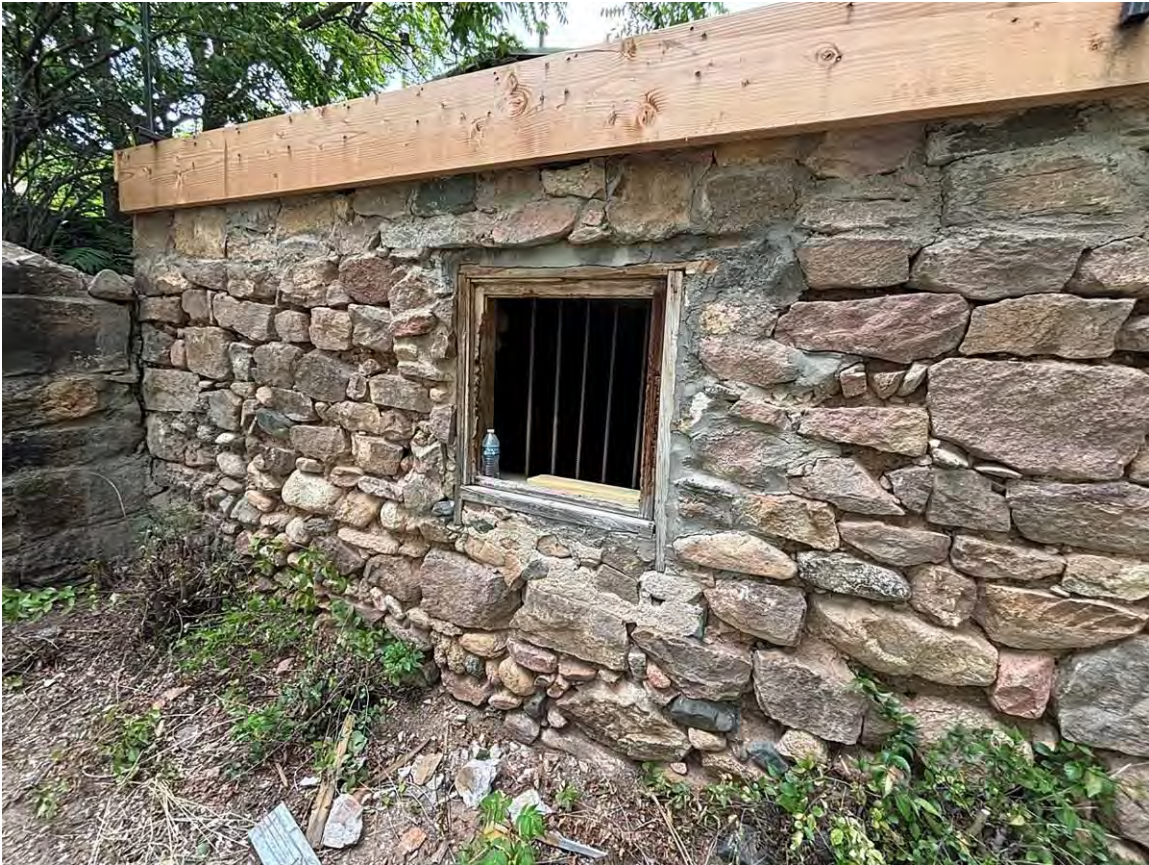
**Photo 15: Stone structure. South elevation. Camera facing northwest. M. Kay, August 14, 2024.**

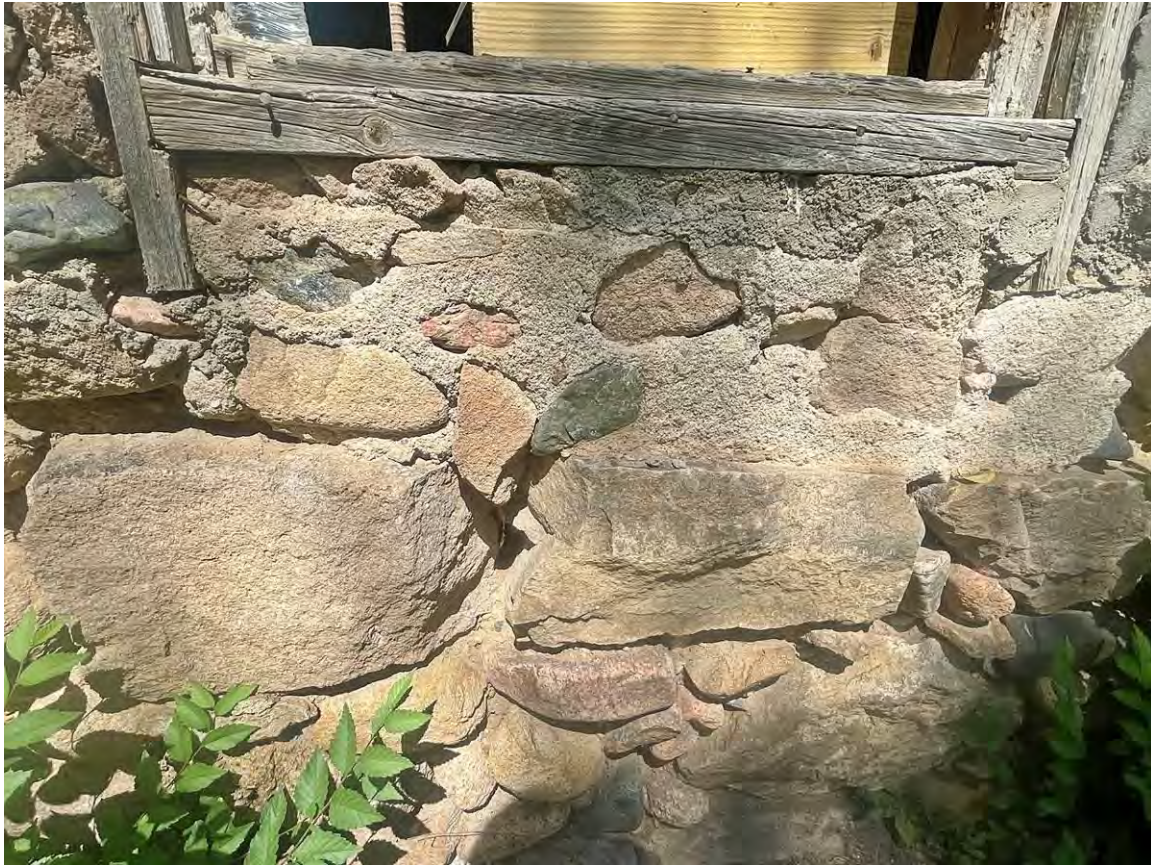
**Photo 16: Stone Structure. Mortar at window opening. Camera facing north.**

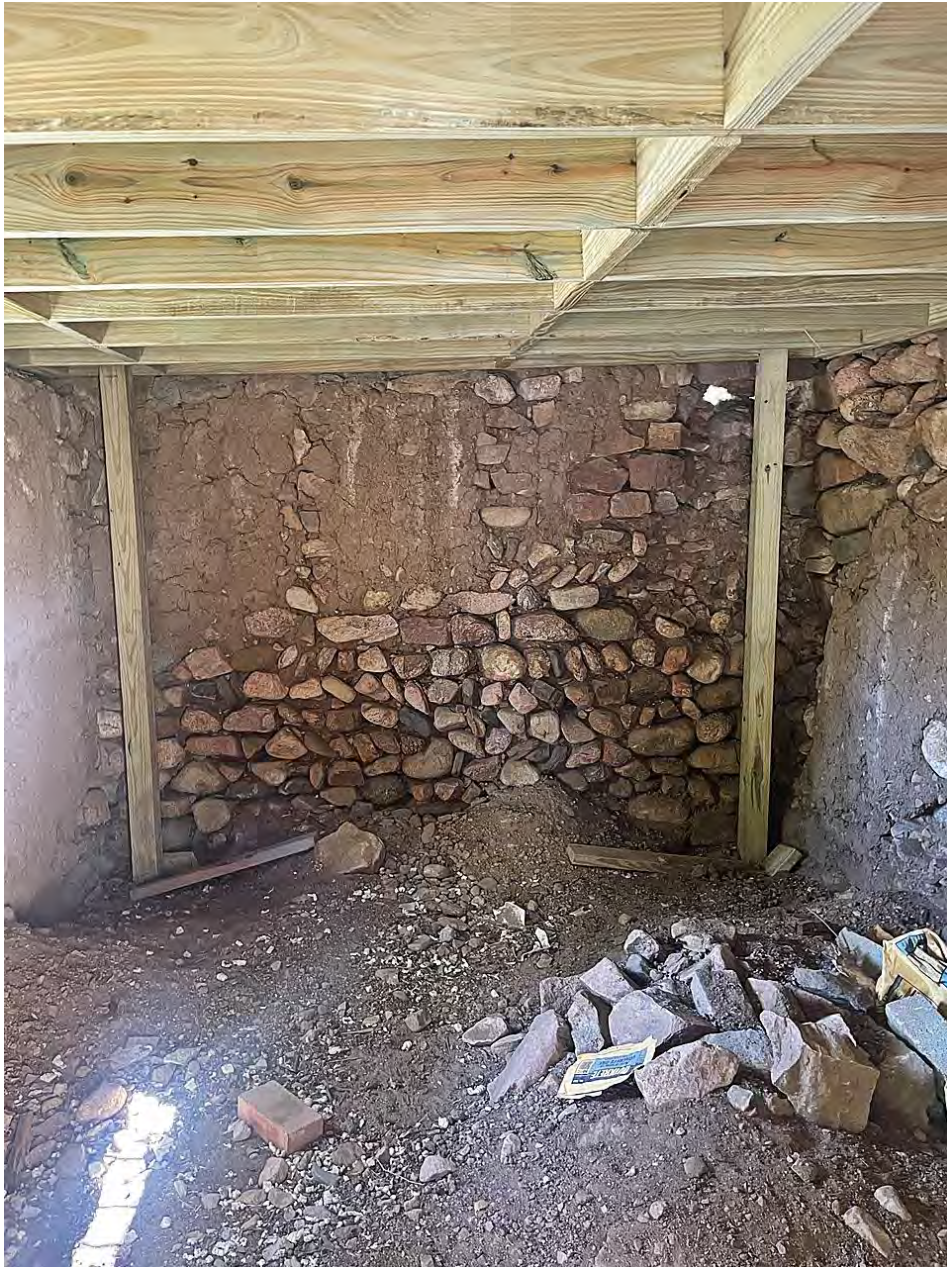
**Photo 17: Stone structure. Interior. Camera facing west.**

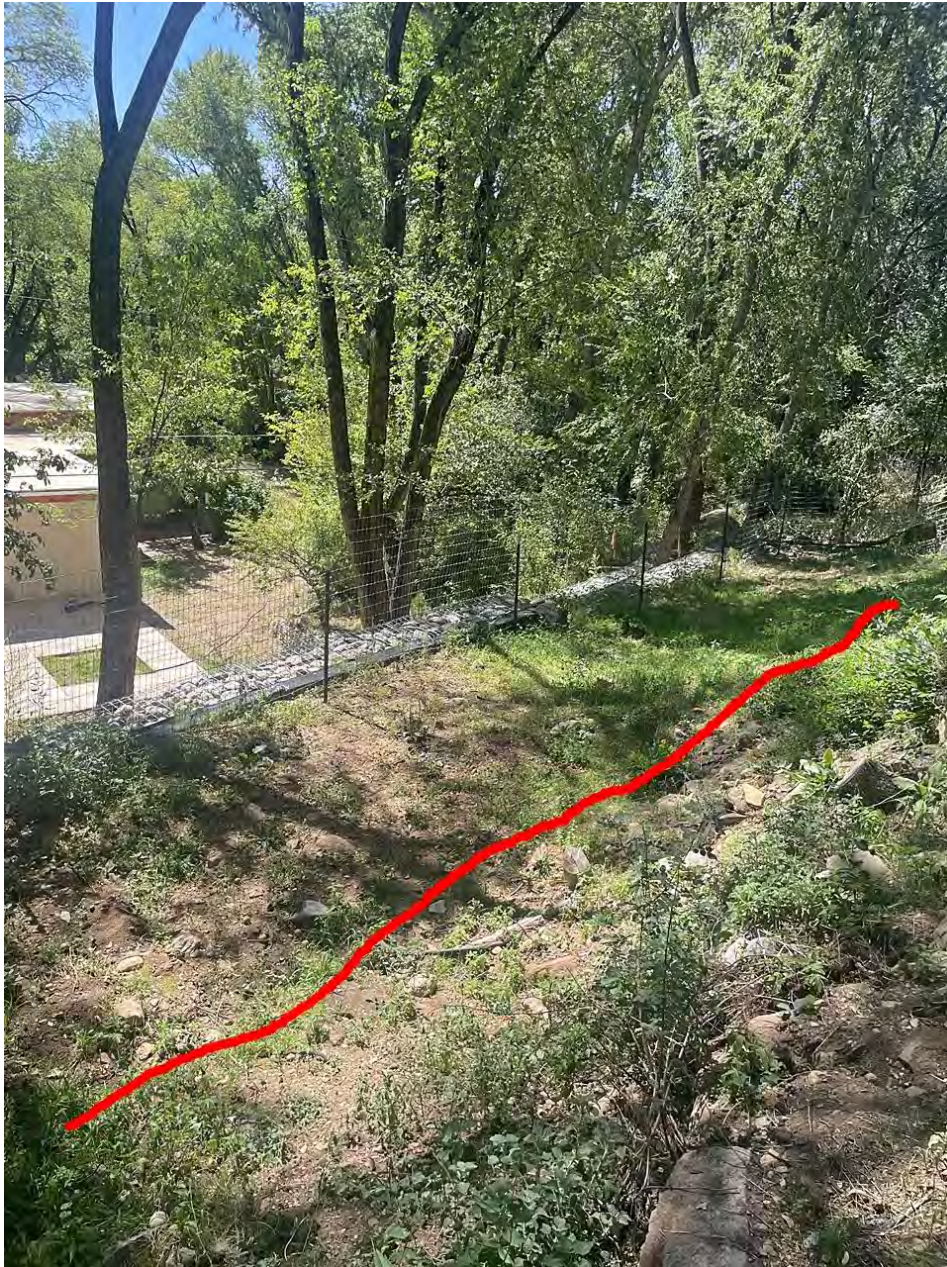
**Photo 18: Remnant of *Acequia de la Muralla* or Ditch No 8. Camera facing southwest.**

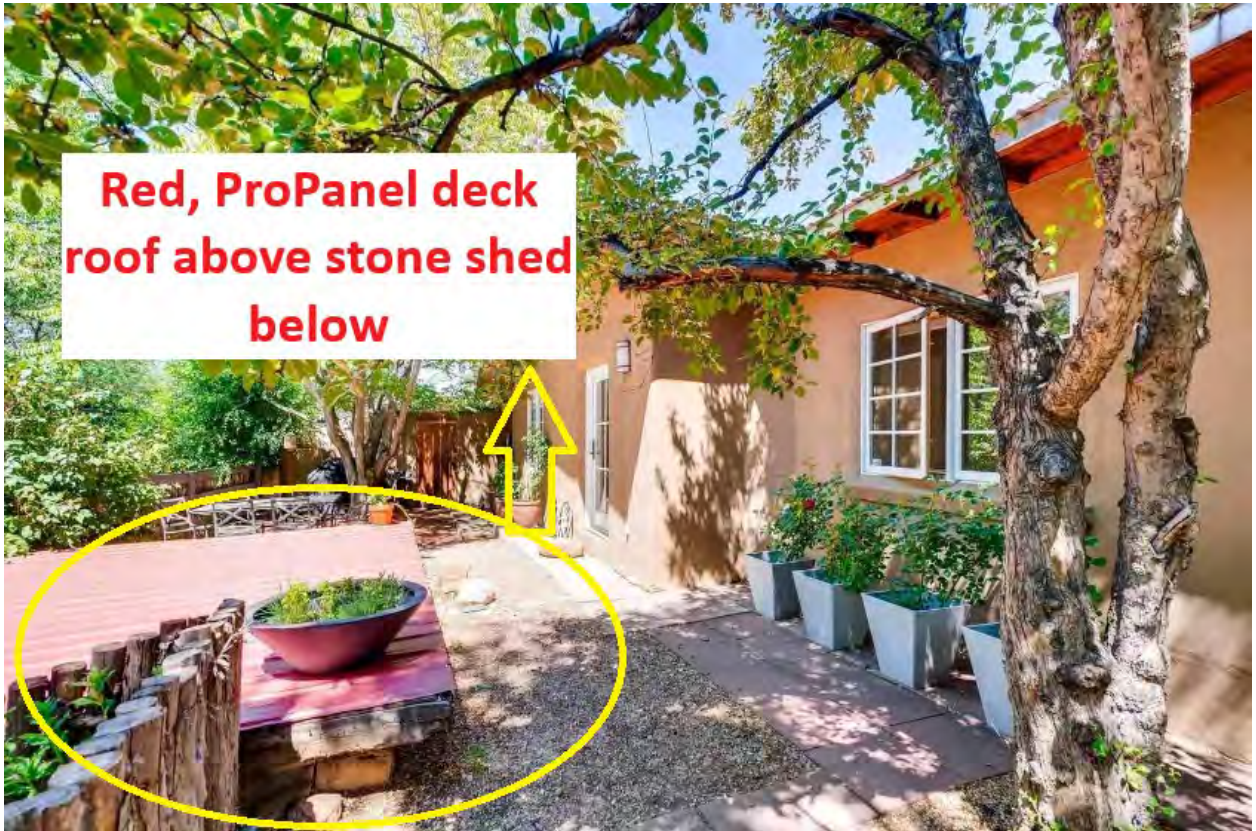
This is a picture of the south elevation from Zillow. This shows what the Backyard area looked like before Lisa Andree Falls took over ownership. The Red propanel material served as the stone shed's roof prior.

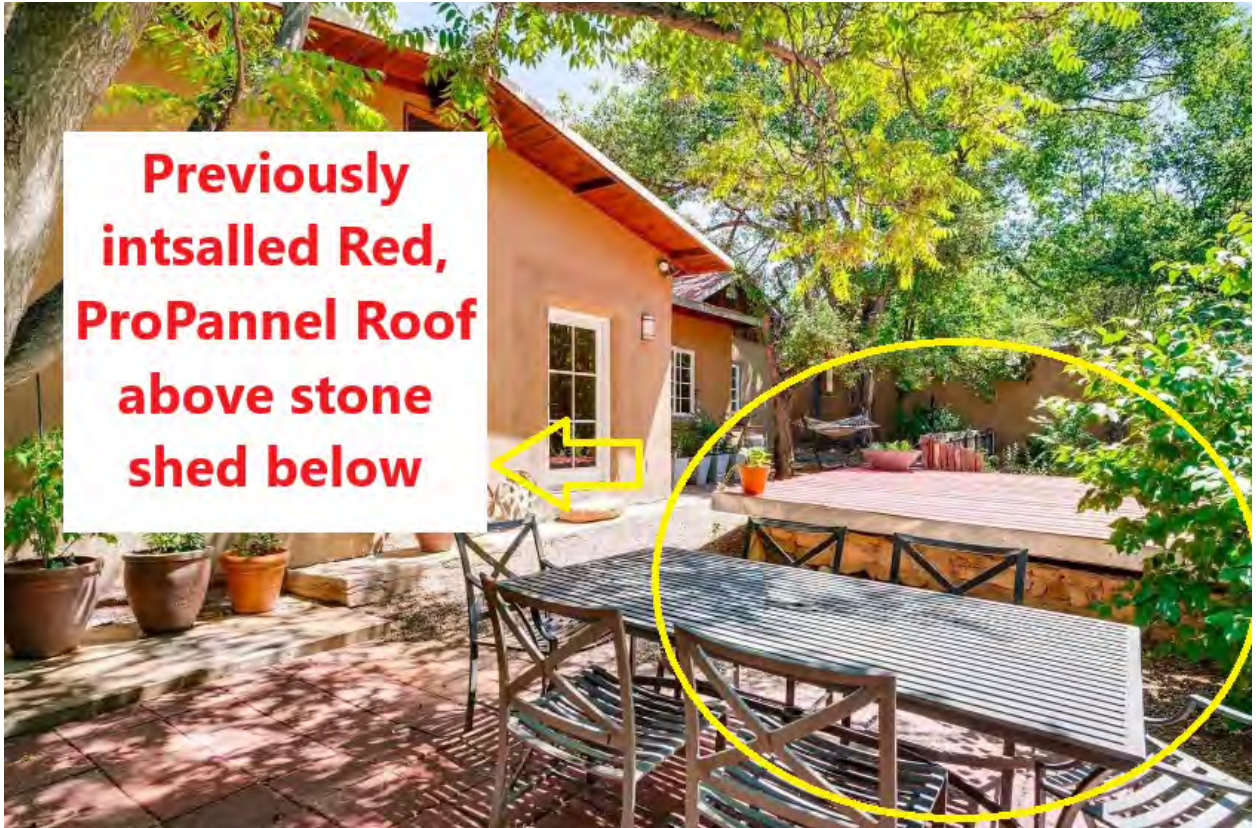
**Previously  
installed Red,  
ProPanel Roof  
above stone  
shed below**

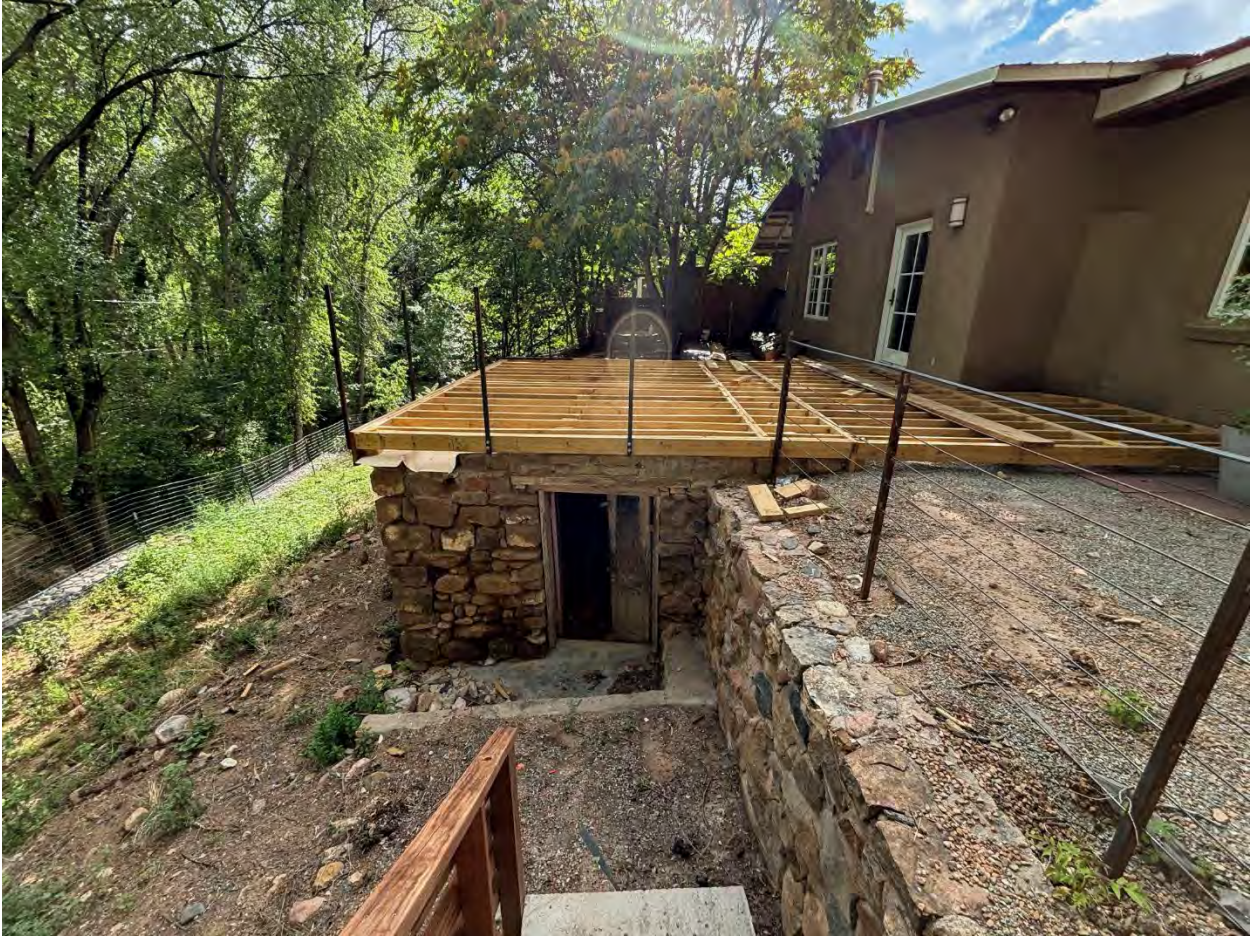
Another picture of the deck floating above the shed

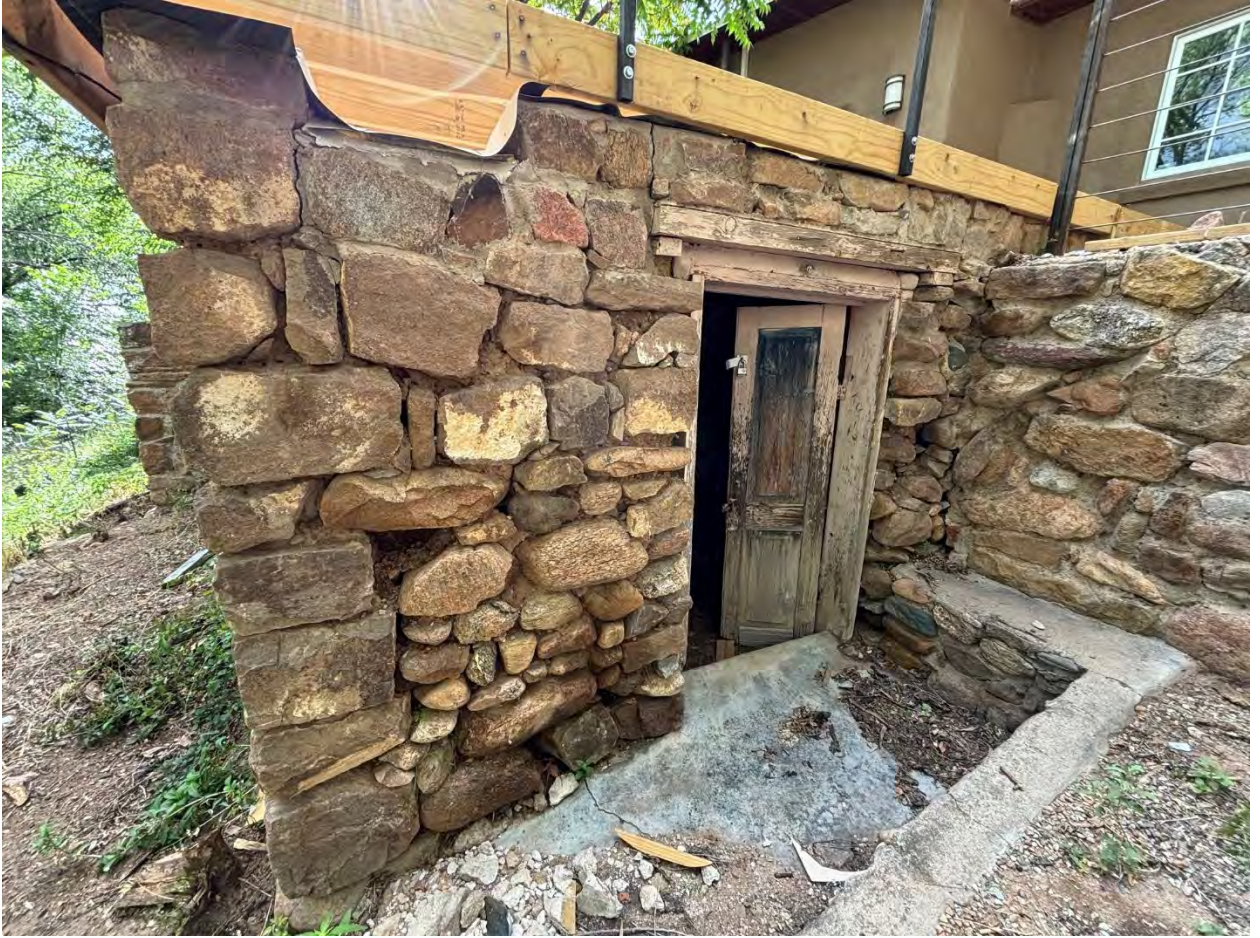
Shed

The wall extends 80 feet across the property from east to west. It is divided into two sections, with a stone structure or shed located roughly in the middle. The wall has an average height of 6 feet. The east section is built with local, undressed stone — mostly quartzite — laid in random courses (Photo 10). The exposed mortar is made of cement. The west section, which is situated lower on the slope, is constructed differently. It consists of more uniform, block-like stones arranged in regular courses at its east end (Photo 11). This section appears to be of heavier construction, with supporting end piers, and has been repointed with cement mortar. This portion does not appear on the 1978 aerial (Fig. 9). The end of the wall at the west is of different construction, consisting of dry-laid river cobble (Photo 12).
