Historic Districts and Historic Landmarks

Design Standards and Signage Exception Criteria

This is a request to allow the replacement of a previously existing pro-panel roof over a rustic rock shed found to be a contributing historic structure with a bitumen roof that is covered (and hidden) by a deck that is of a similar color to the original red pro-panel roof. The project address is 1182 Cerro Gordo Road.

Request for Exception to replace roof “not in kind” on a contributing structure.

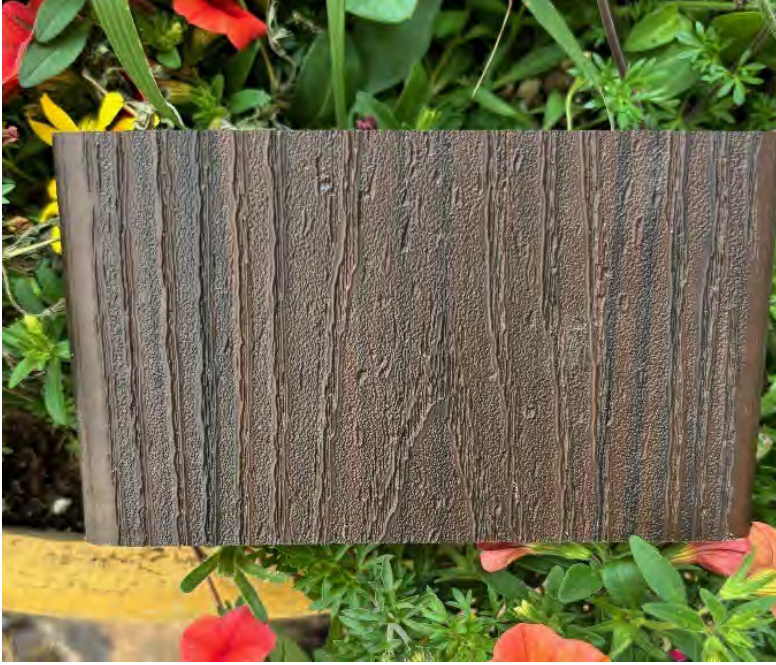
Figure 3: This is the Trex decking color that we propose will be used over the roof as deck space.

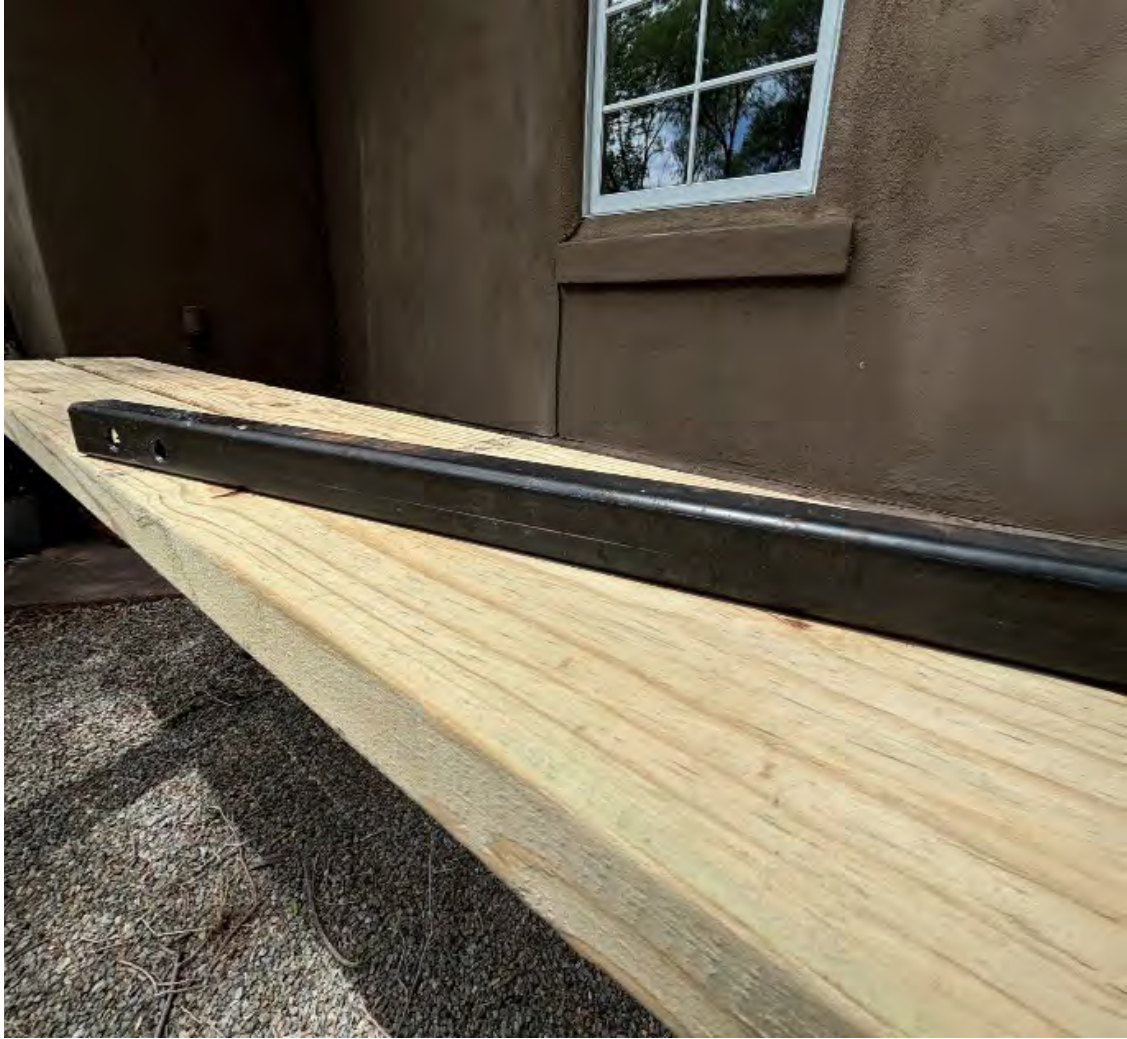
Figure 4: Example of proposed square steel to be used as a the railing

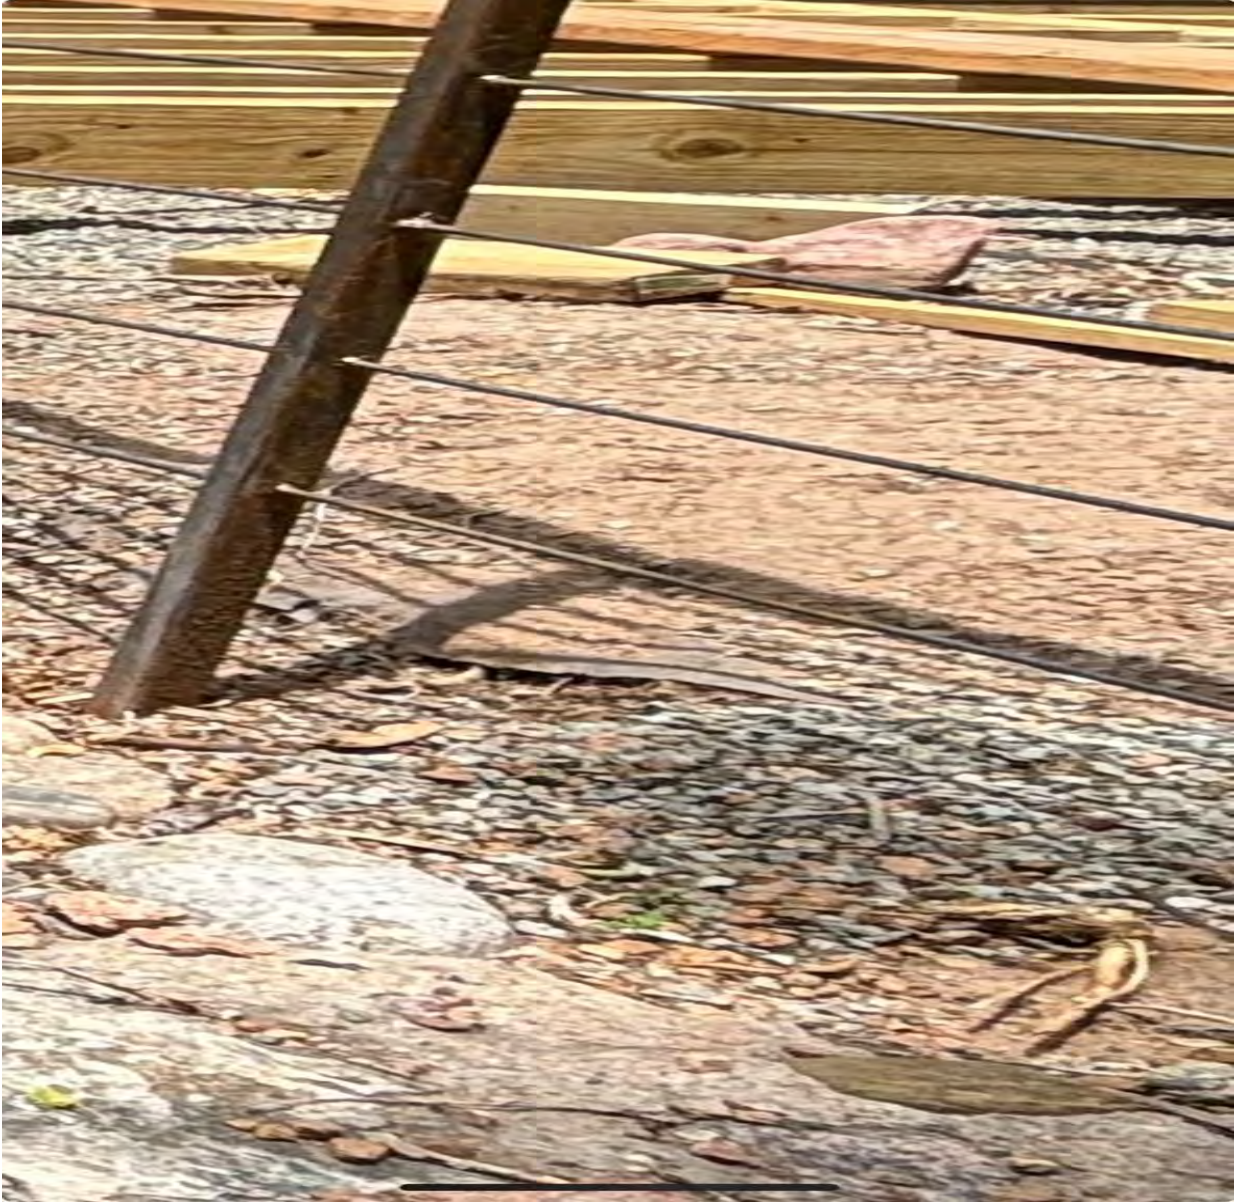
Figure 12: Example of proposed round steel to be used as railing

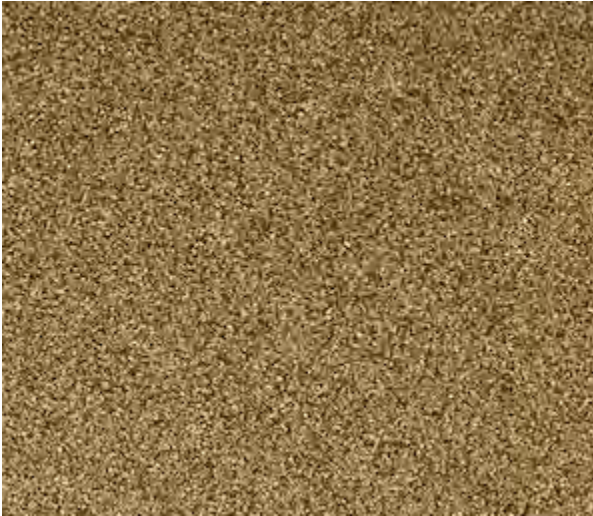
Figure 2: BRAI roof color “Tan” is what we are proposing we use as the roof of the stone structure.

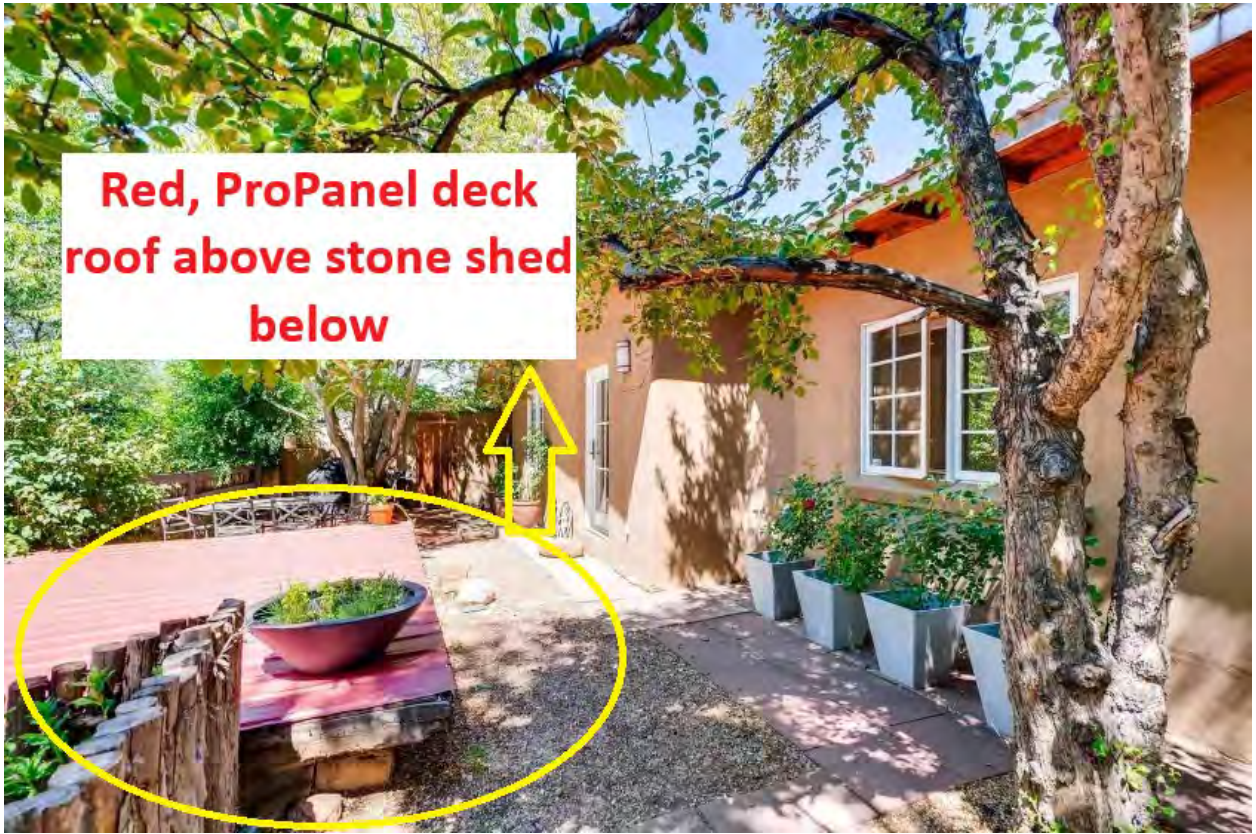
This is a picture of the south elevation from Zillow. This shows what the Backyard area looked like before Lisa Andree Falls took over ownership. The Red propanel material served as the stone shed's roof prior.

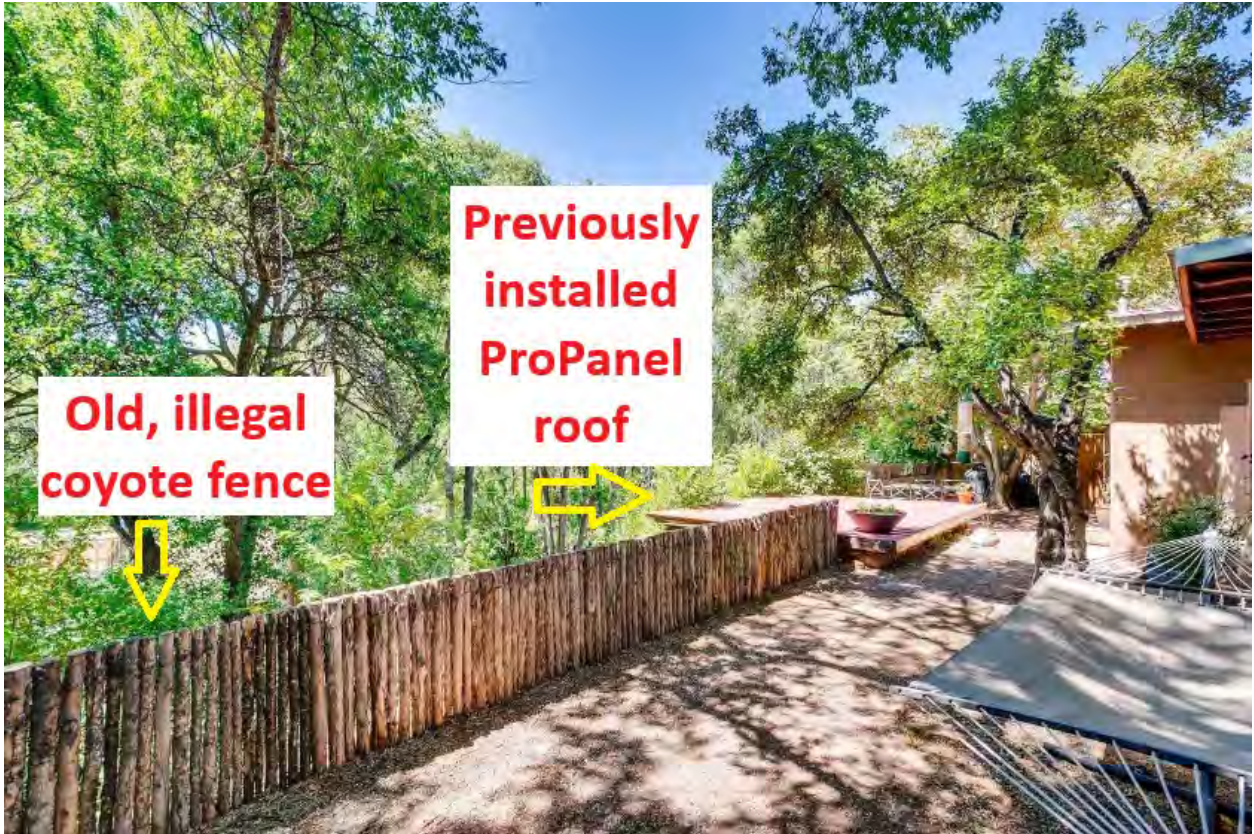
This is a picture of the south elevation from Zillow. This shows what the Backyard area looked like before Lisa Andree Falls took over ownership. Old, illegal coyote fence lines the backyard area. Its illegal because this fence is only 30 feet tall and poses a risk of injury or death. Also in this picture is another view of the propanel material used as a roof for the stone shed below.

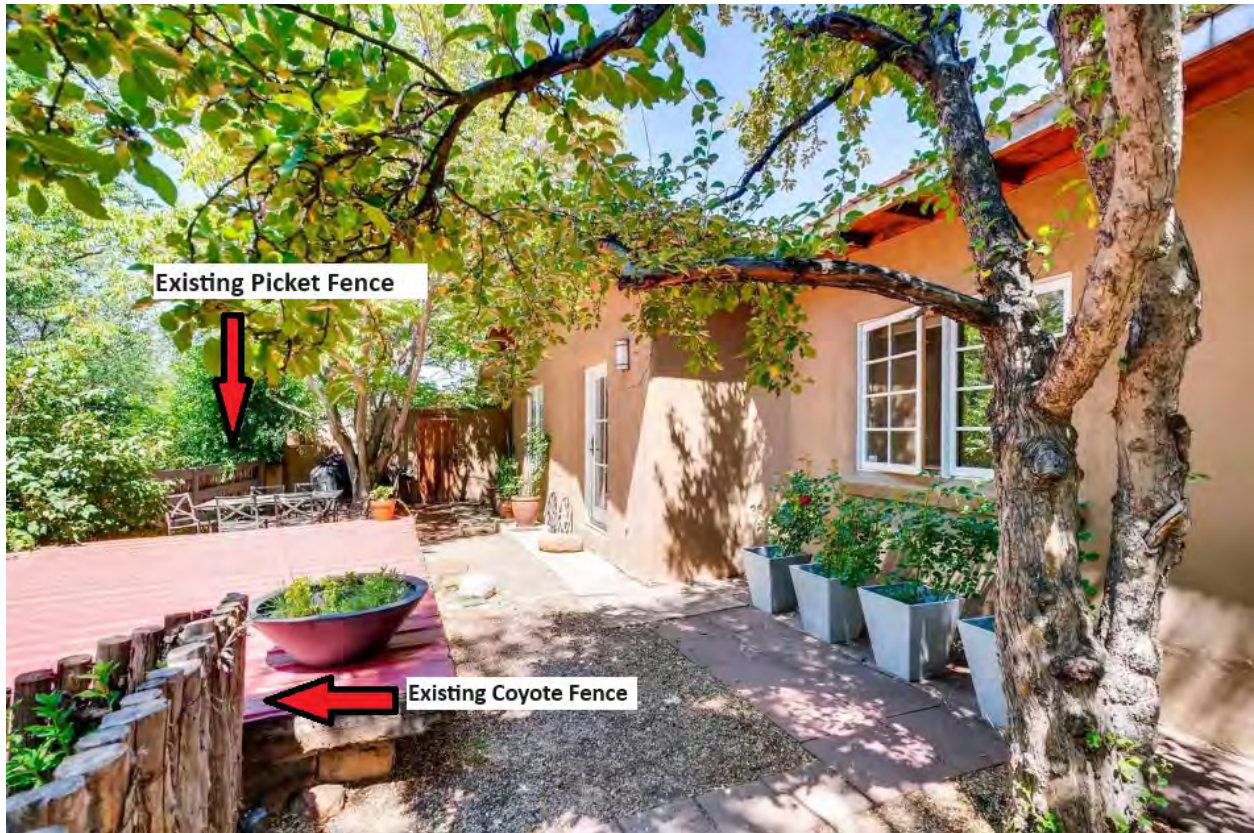
Figure 18: This is a picture of the south elevation from Zillow. This shows what the Backyard area looked like before Lisa Andree Falls took over ownership. In this picture is another view of the ProPanel material used as a roof for the stone shed below. Also the red arrows point out where the fencing used to be. Both picket and coyote fence were used. Both sections of fence were 30" tall

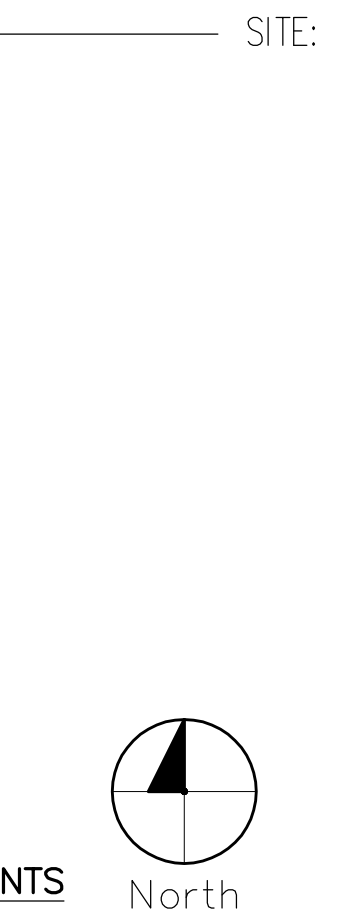
IMPROVEMENT LOCATION REPORT

- Springs, streams, rivers, ponds or lakes located, bordering on or through said premises.
Acequia crossing through property as shown.
- Evidence of cemeteries or family burial grounds located on said premises.
None noted.

- Overhead utilities, poles, anchors, pedestals, wires or lines overhanging or crossing said premises and serving other properties.
As shown.
- Joint driveways or walkways, joint garages, party walls of rights of support, steps or roofs in common.
None noted.

- Specific physical evidence of boundary lines on all sides.
As shown.
- Is property improved?
Yes.
- Indications of recent building construction, alterations or repairs.
None noted.

- Approximate distance of structure from lot line or building setback lines.
As shown.
