**City of Santa Fe  
Historic Districts Review Board  
Findings of Fact and Conclusions of Law**

**Case # 2024-8452-HDRB**

**Address** – 216 Old Santa Fe Trail

**2024-008452-HDRB. 216 Old Santa Fe Trail. Downtown & Eastside Historic District. Non-contributing.** John Padilla, agent for Lewis West, owner, requests a historic status review with primary facade(s) designation if applicable.

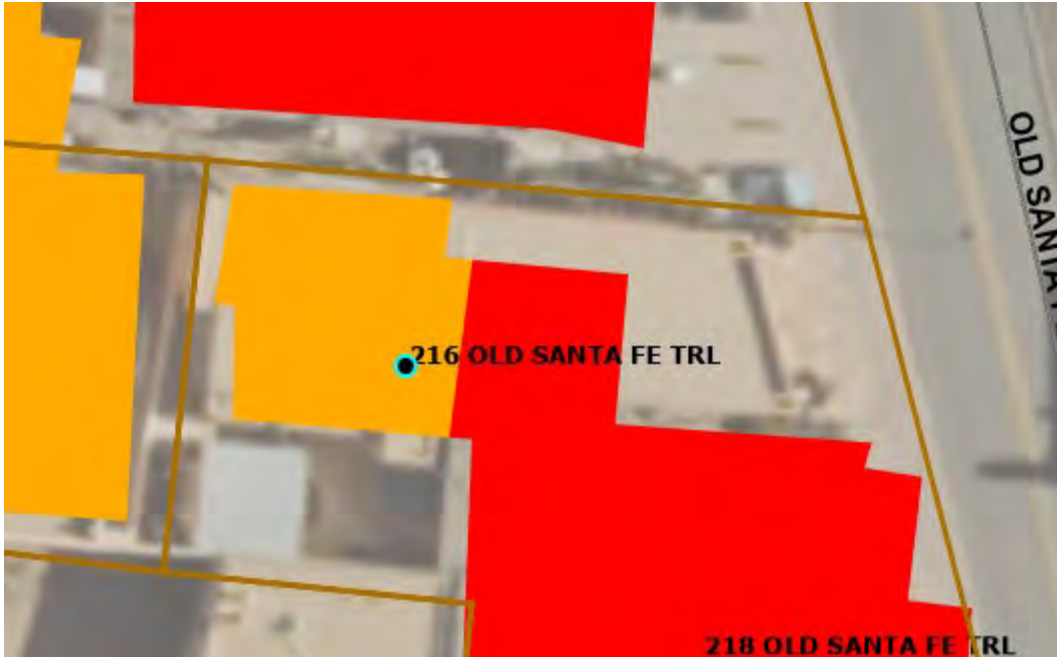
Figure 1: Status designation map

216 Old Santa Fe Trail is a non-residential structure located in the Downtown and Eastside Historic District. The status map shows that the front portion of the structure is contributing while the rear portion is non-contributing.

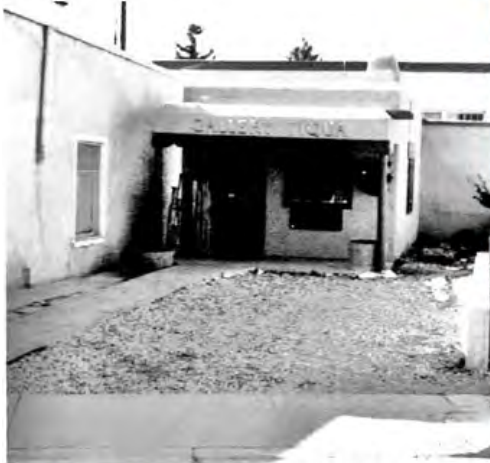
Figure 1: December 20, 1984, HBI survey photo. Harry Weiss. Courtesy NMCRIIS.

The structure was constructed in a vernacular manner between 1956 and 1958. The 1984 HCPI form provides no information about the structure. The 2024 HCPI reflects the changes that were made without permit or approval from the HDRB in 2023.

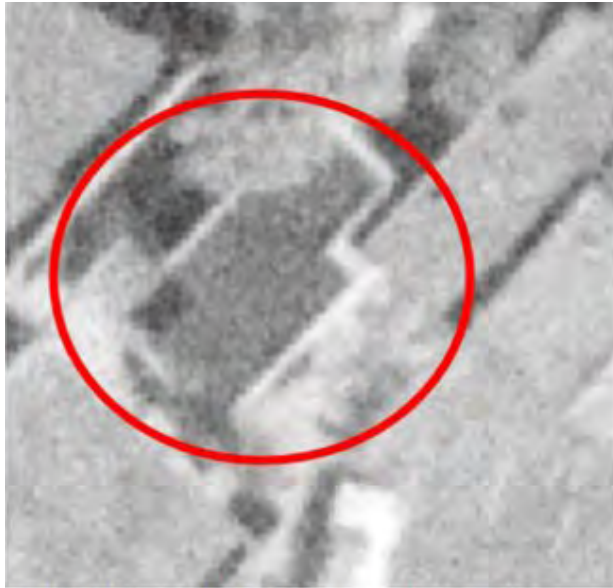
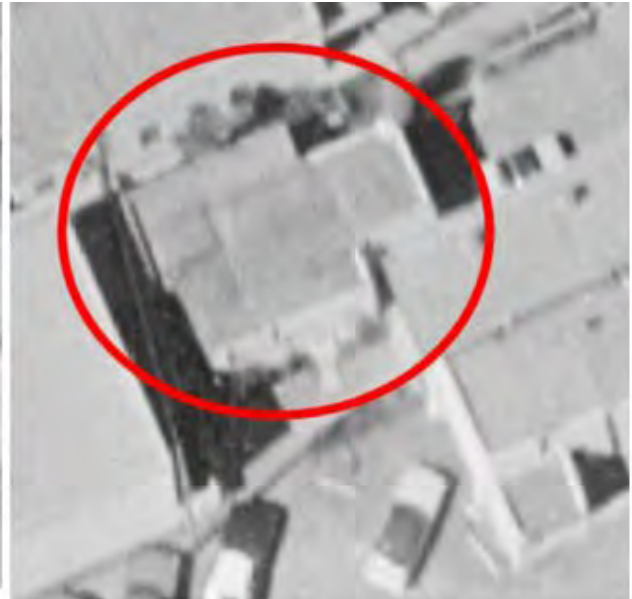
Figure 3: Aerials from 1958 and 1978

Aerial photography shows the structure in 1958 and with additions in 1978. The 1984 structure was entirely to the rear of the lot and still appeared as the original residence. A building permit for a detached family residence was issued in 2005 (BLDR-2005-3137), however there is no indication that a second structure was ever built as there is not a second structure in any aerial or photo including the street image from Google Maps in

Figure 6: November 10, 1958, aerial photograph.  
Note presence of small house.

Figure 7: September 11, 1978, aerial photograph.

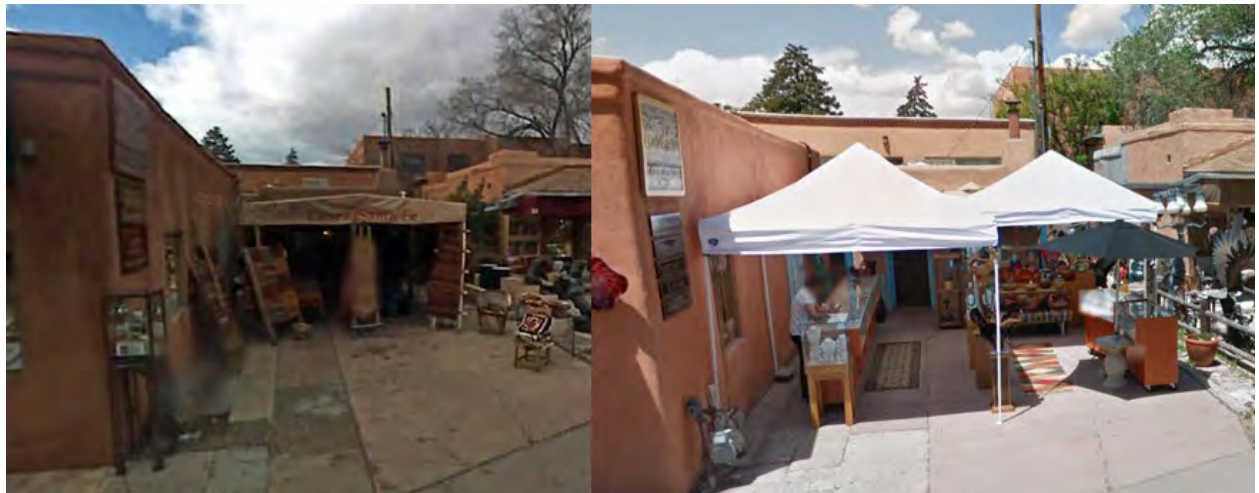
Figure 4: Store front in 2005 and 2015

2007. A tent structure is in this image and may be the permitted structure from 2005. This structure was still in use in 2014 but is missing by 2015.

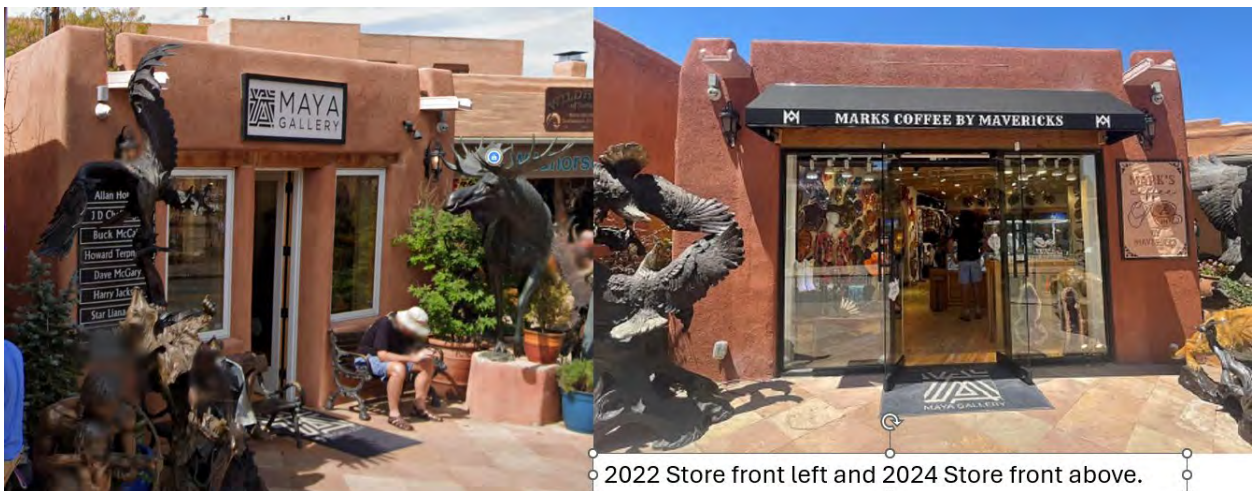
Figure 6: Store fronts in 2022 and 2024

Additional work on the property in 2017 altered the face of the structure by enclosing windows and increasing the size of fenestrations to create the store front as it appears in 2022.

The structure as it exists today has no fenestrations on either the north or south elevations. The east façade was altered again in 2023 creating a glass front and while the single header from the 2016 conversion is still present, it is obscured by a new awning.

2022 Store front left and 2024 Store front above.

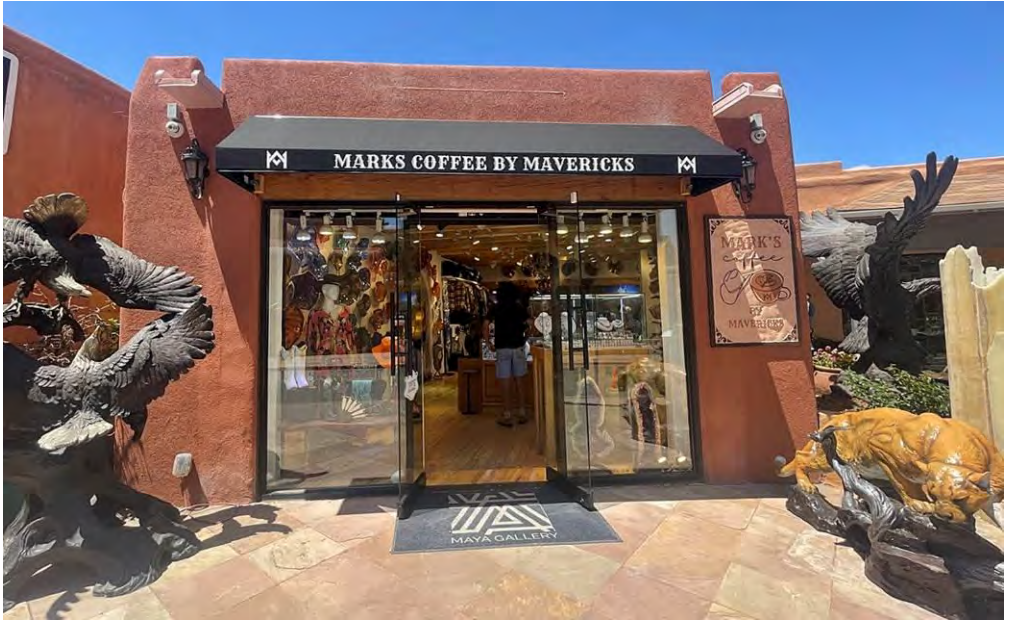
8. Name of Project: HDRB Status Evaluation		
9. Lat/Long: 35.6854116,-105.9405717		
10. Photo Information: Giulia Caporuscio, photographer. Photo 1: View of east façade. Camera facing northwest.

The building faces Old Santa Fe Trail with a recently modified façade (Photo 1). As shown on Google Street View (Fig. 2), the 2016 addition had a centered door bracketed by small display windows. Spanning the openings was a continuous wood lintel recessed into the stucco. The fenestration has been replaced with a modern storefront with pivot glass doors. The lintel remains but is now obscured by an awning.

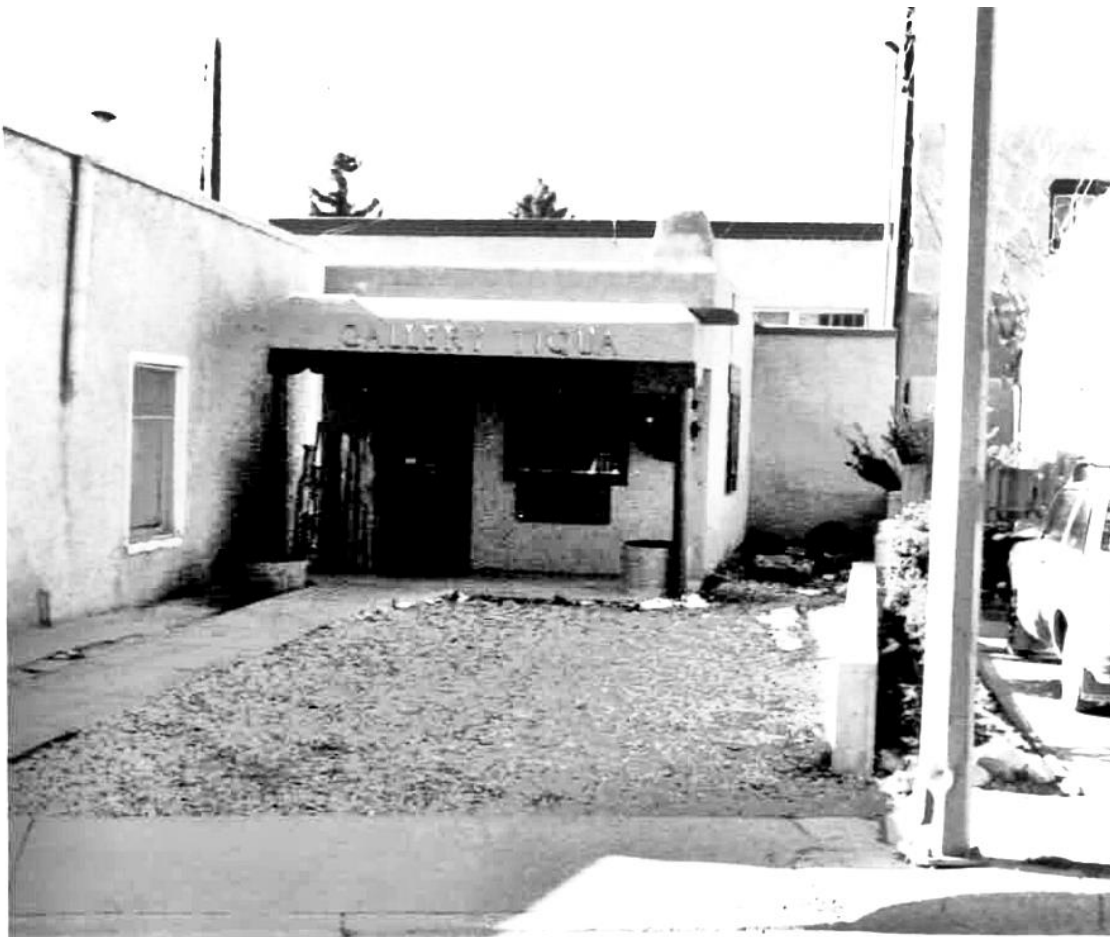
**Figure 1: December 20, 1984, HBI survey photo. Harry Weiss.  
Courtesy NMCRIIS.**

Responding to the completion of the Inn at the Loretto in 1975, the former house again became a shop, housing jewelry stores. In the mid-1980s, it turned into Gallery Tigua (Fig. 1) which sold Native American and Hispanic paintings and sculptures. Until recently, it held the Maya Gallery. It is now crammed with purple quartz crystals, stitched cowboy boots, knife sets, and the like.

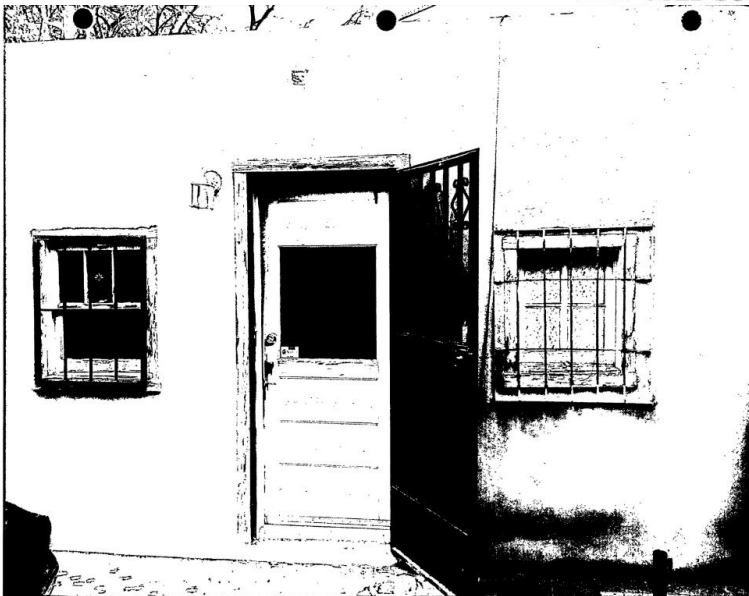
**Figure 9: Illustrations from February 15, 2017, administrative approval covering the southeast corner of the building.**

**PROPOSED SOUTH ELEVATION**
