## RPA & ASSOCIATES | WINDOW & DOOR CONDITION AND INTEGRITY CODES

## RPA & ASSOCIATES | 329 OTERO STREET

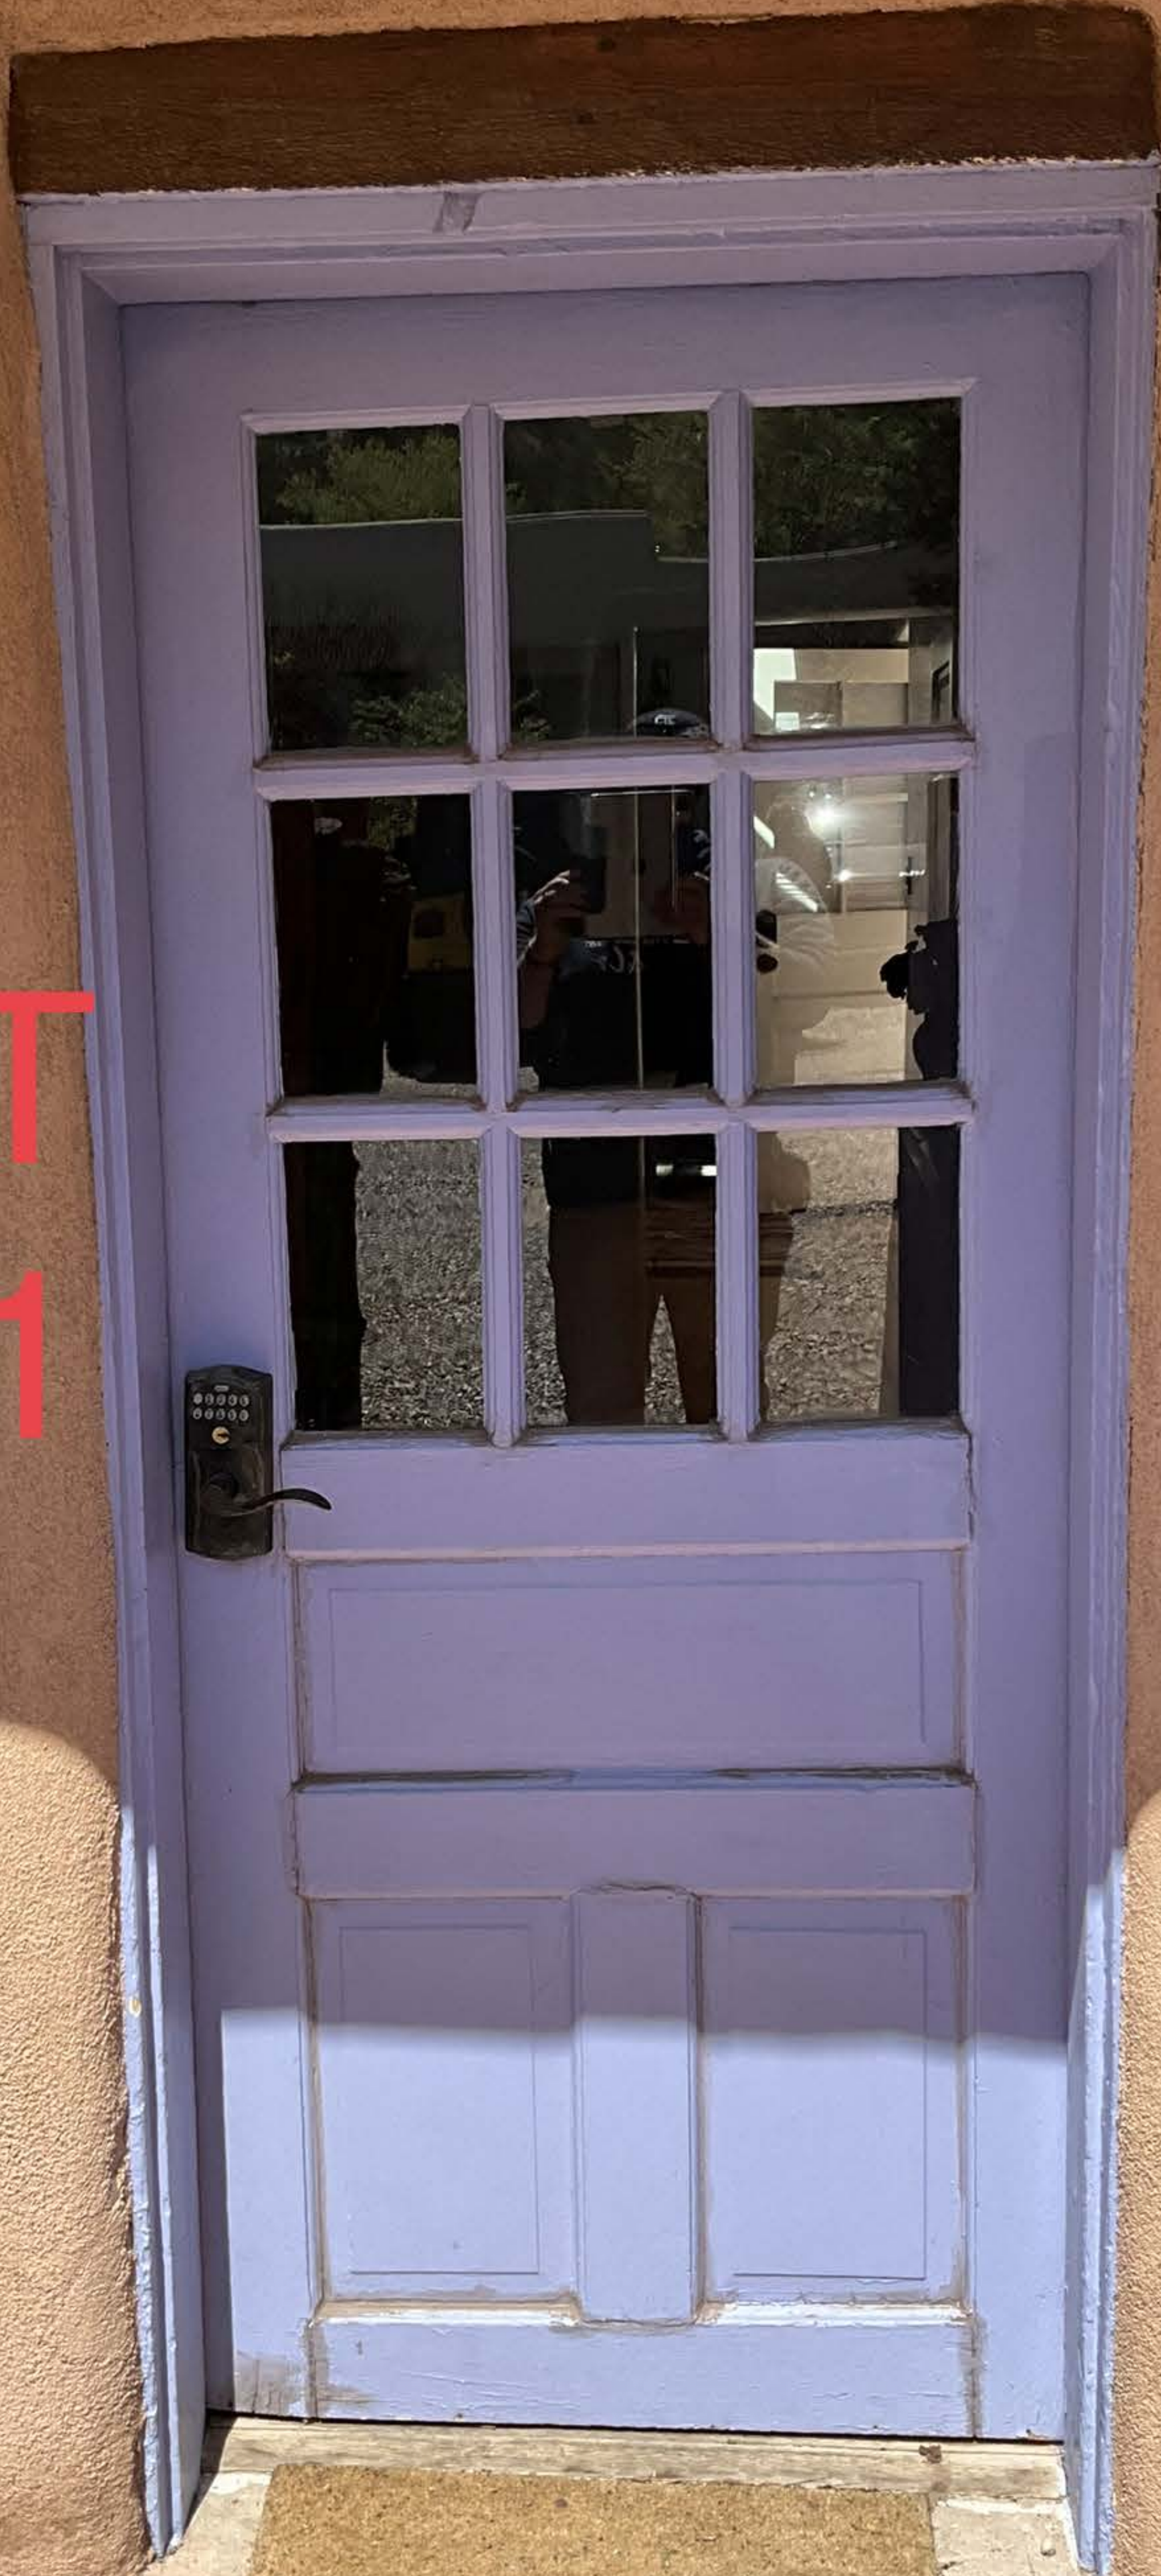
EAST  
DR#1

LABEL	WINDOW & DOOR DESCRIPTION	CONDITION & INTERGRITY CODE	HISTORIC/NON-HISTORIC - AGE
EAST – DR #1	32 x 76 RH DOOR	S	NON-HISTORIC – SIMPSON CUT DOWN DOOR WIDE 1990's MUTTON
EAST – A	36 x 49 DOUBLE HUNG 8/8 INSULATED GLASS	S	NON-HISTORIC – JELDWEN (2001)
NORTH – B	26 x 33 DOUBLE HUNG 1/1	S	NON-HISTORIC – SHOP MADE SASHES 1-LT WITH MECHANICAL NAILS (1990's)
NORTH – DR # 2	32 x 80 RH DOOR 4-LT/3-PANEL WOOD STOP – PLYWOOD PANEL	S	NON-HISTORIC – SIMPSON DOOR (1990's)
NORTH – C	25 x 37 DOUBLE HUNG 3W1H/1-LT	F	HISTORIC
WEST – D	25 x 49 ½ DOUBLE HUNG 3W1H/1-LT	S	HISTORIC
WEST – DR #3	34 x 78 LH 3W2H/2-PANEL	S	NON-HISTORIC – SIMPSON DOOR (1990's)
WEST – E	25 x 49 ½ DOUBLE HUNG 3W1H/1-LT	S	HISTORIC
SOUTH – F	54 x 42 TWIN DOUBLE HUNG 1/1-LT	F	NON-HISTORIC – SHOP MADE SASHES (1990's)
SOUTH – G	54 x 42 TWIN DOUBLE HUNG 3W1H/1-LT	F	HISTORIC
SOUTH – H	26 x 49 ½ DOUBLE HUNG 3W1H/1-LT	F	HISTORIC
SOUTH – I	54 x 42 TWIN DOUBLE HUNG 3W1H/1-LT	F	HISTORIC
