City of Santa Fe, New Mexico

DATE: May 27, 2025

2025-010295-HDRB, 234 Irvine St, Westside-Guadalupe Historic District, contributing, Samantha Greenberg, agent for Edan Kark, owner, requests a status review with primary façade designation, if applicable, for a residential structure and requests a status downgrade for an accessory structure.

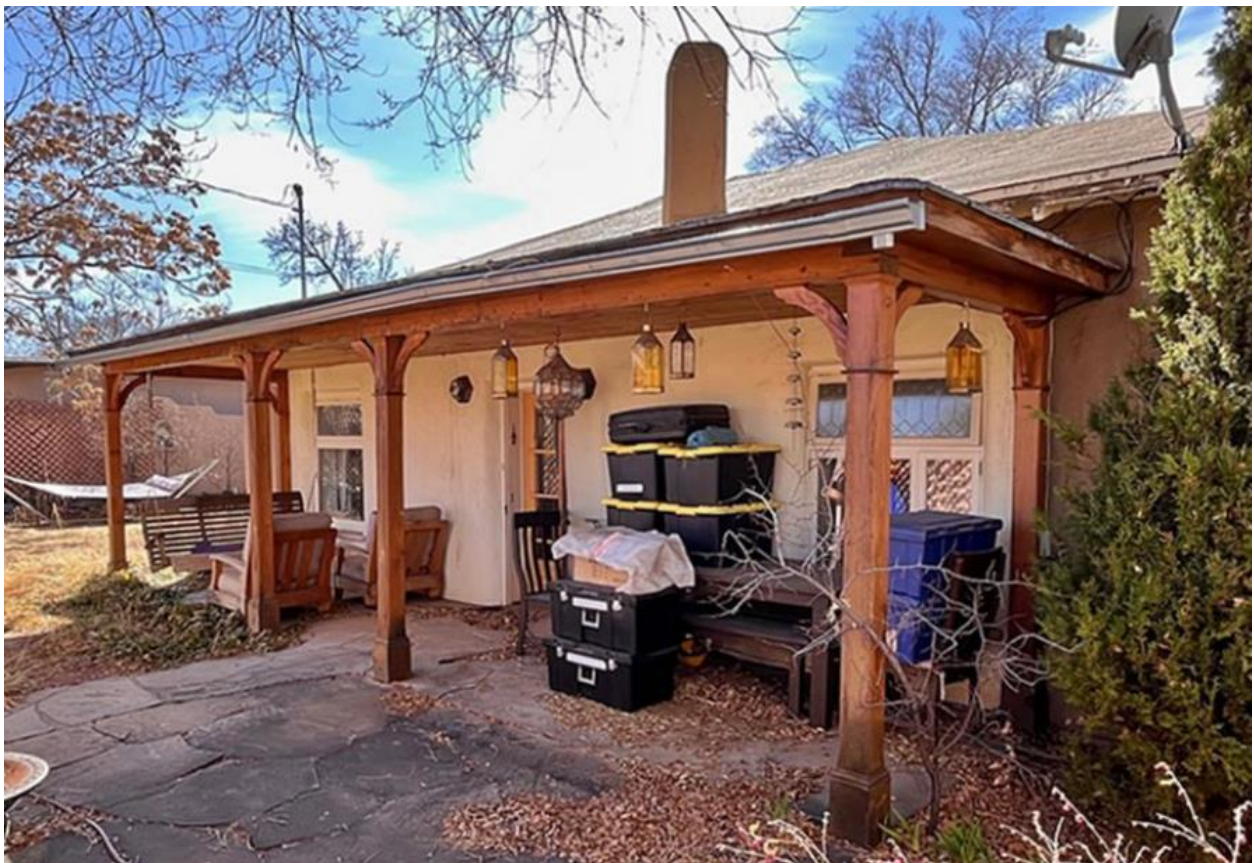
Figure 1: East elevation 2025

The 1,796 sq. ft. main residence was constructed prior to 1928 of adobe with a hip roof. The house features deep inset wood windows with the exception of four which are clad (2), aluminum and metal. According to the 2025 Historic Cultural Properties Inventory (HCPI), several of the windows appear to have been repaired with non-historic components and many windows contain lead lozenge décor in the upper sashes (Figure 3). The rear or west facade features a recent porch addition. Sometime after 1978, the original rear porch was enclosed and extended west off the

Staff recommends the historic status of the residential structure be retained as contributing with the primary façades designated as the north, east, and south facades (facades 5, 6, and 7 respectively). While some modifications have been made, these three (3) facades hold the original footprint and historic details of the residence, including the inset wood windows with lead lozenge

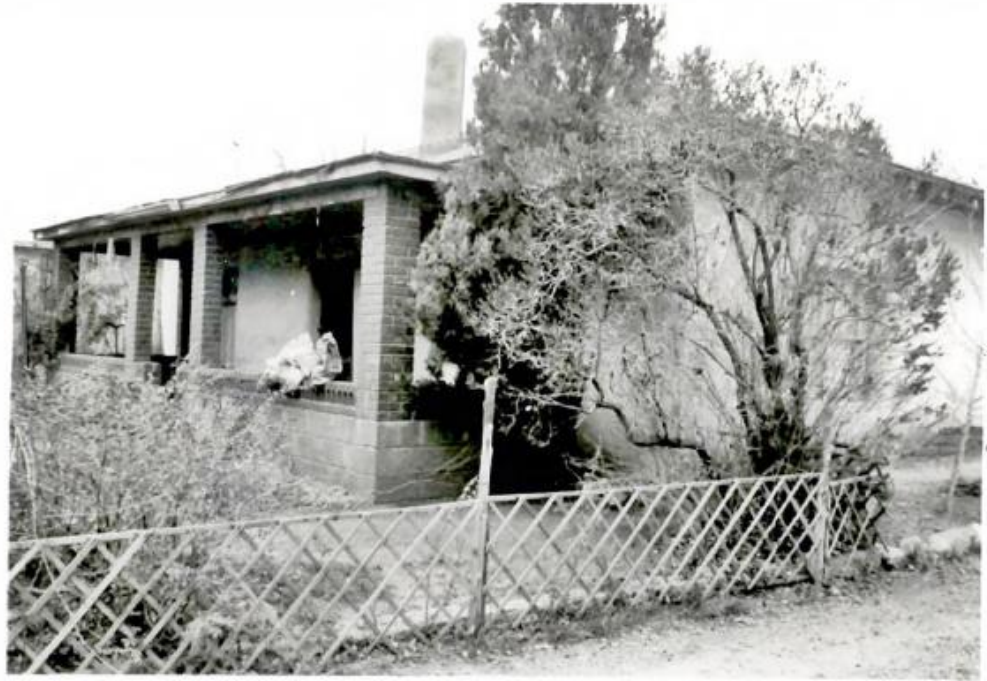
Figure 2: Historic front porch

A distinctive characteristic of the historic front porch was the construction of brick columns, which has been found in other parts of Santa Fe, including the significant structures at 718 and 721 Old Santa Fe Trail, which were constructed roughly at the same time as the subject house.

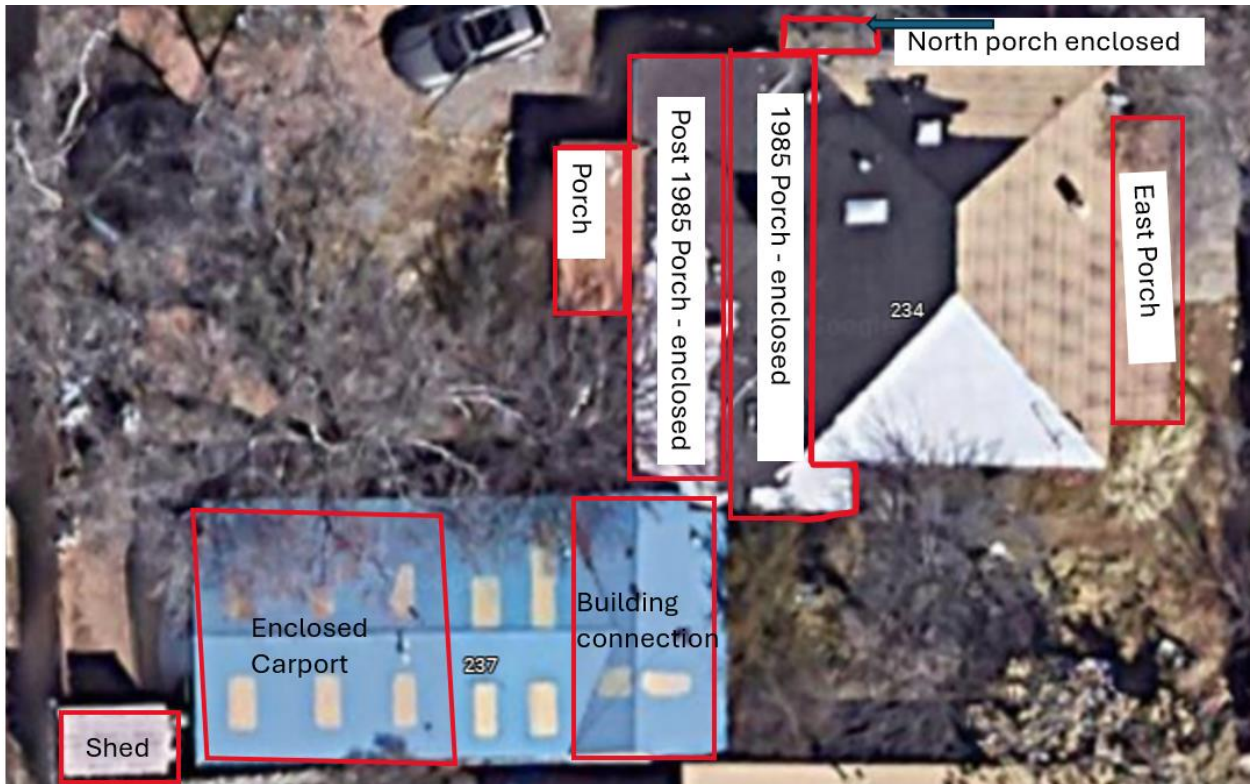
Figure 4: Unpermitted work on the property.

back of the house. Other modifications to the main residence include a mechanical room addition on the north elevation, as well as a recent porch mudroom addition, all of which were established after 1978 (Figure 4).

As of 2025, the unpermitted work on the property includes the following modifications:

1. Installation of the shed at the southwest corner.
2. Enclosure of accessory structure carport (subject of the 2019 red tag).
3. Construction of a porch on the west side of the contributing house between 2008 and 2014.
4. The enclosed porch area on the west side of the house (shows as a porch in 1985 HCPI), the second enclosed porch on the west side of the house added and enclosed after the 1985 HCPI.
5. Alterations to the front porch area on the east façade (brick with shed roof in 1985 HCPI and wood frame in 2007).
6. An addition/enclosed porch on the north elevation,
7. Connection between the two residences of unit A (per 2010 drawing), and
8. Increase of the wall height.

Please refer to Figures 4-10 for a visual representation of the progression of development on the property. Per section 14-5.2(C)(2)(f) *If a property owner makes changes to a structure without the proper city approvals which result in the lowering of the structure's status, staff or the board may require the property owner to restore the structure such that its former status is restored.*

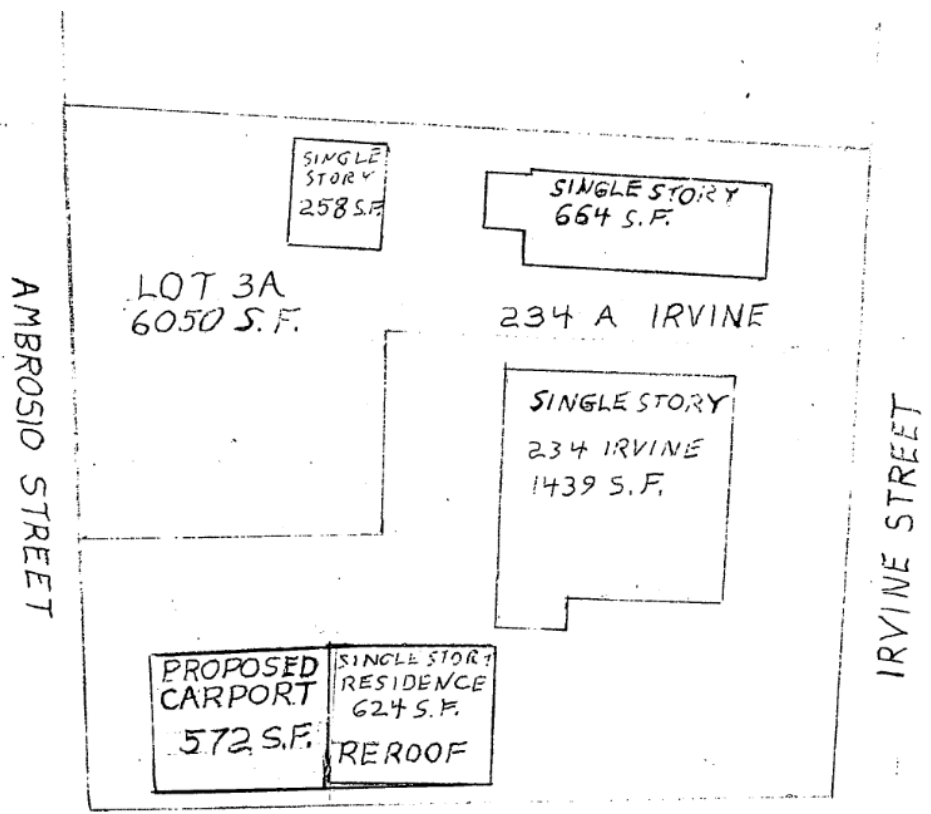
Figure 5: 2010 Site Plan from case H-10-006

The carport addition is the subject of case H-10-006 which was approved for a 572 sq. ft. carport with a height of 11 feet on the non-contributing shed structure. Since 2010, there have been no cases for the property, with the exception of the 2019 case initiated due to the red tag violation.

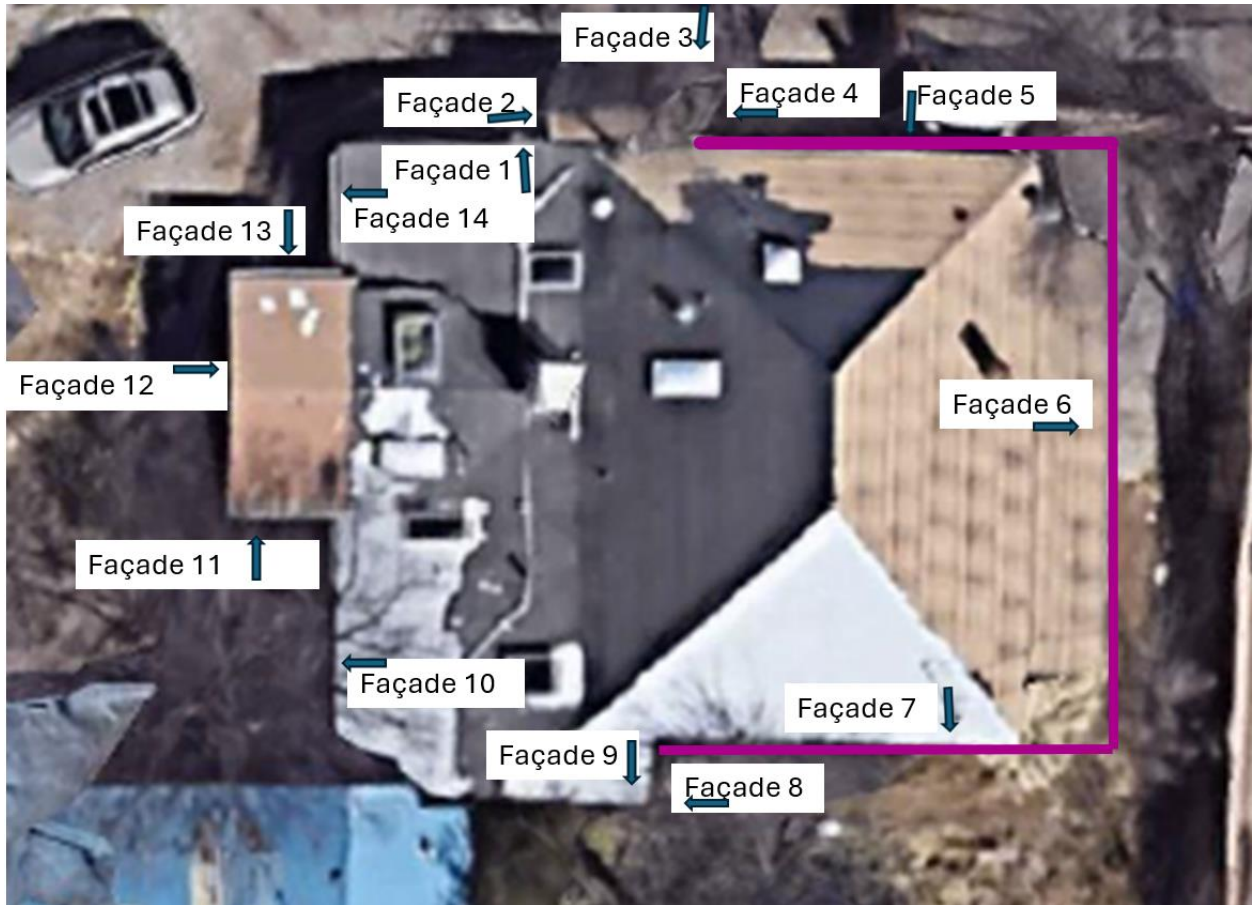
Figure 11: Façade Map

Staff recommends the main residence be maintained as contributing. While the structure has been modified and altered over the years, several of its distinctive historic properties are preserved, particularly on the north, east, and south facades. Per the HCPI, the property is part of the late 19th century, 1887, “Irvine Addition” which was the first subdivision on the west side of Santa Fe. The core of the residence remains distinctive, particularly the inset windows and the pitched hip roof on the adobe structure. Staff recommends the primary façades as the north, east, and south facades (facades 5, 6, and 7 respectively) which hold the original footprint of the residence, the inset wood windows with lead lozenge patterns and the original roof line of the building with the exceptions of the non-historic doors and windows and the non-historic east elevation porch.

patterns and the original roof line of the building. Staff recommends excluding the non-historic doors and windows and the non-historic east elevation porch from the designation.
