NEW MEXICO HISTORIC BUILDING INVENTORY FORM

H2426

HIPPED COTTAGE

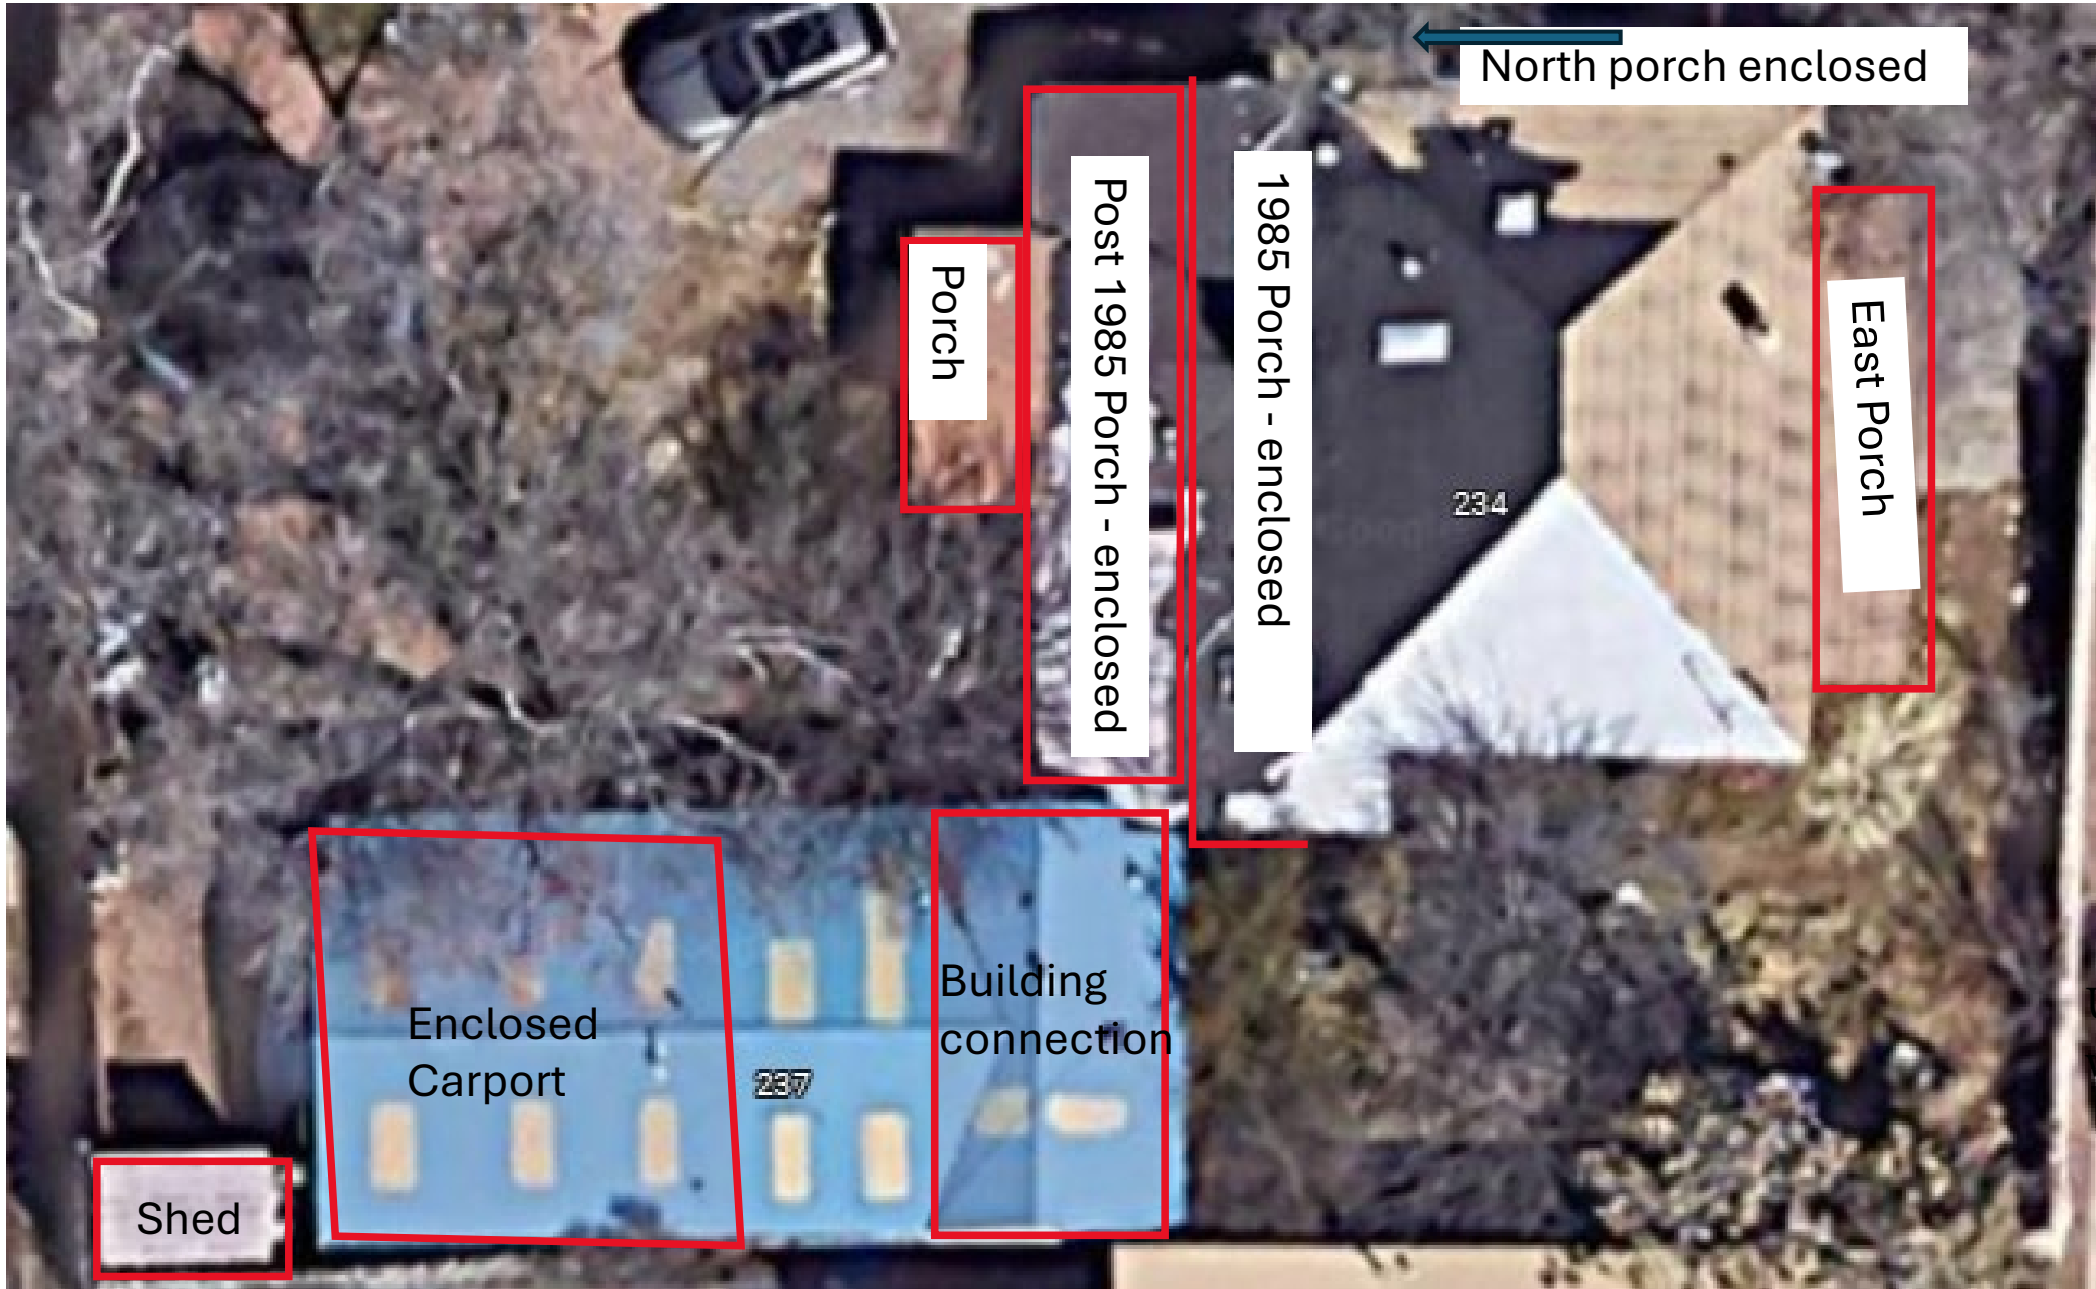
North porch enclosed

East Porch

1985 Porch - enclosed

Post 1985 Porch - enclosed

Porch

Building connection

Enclosed Carport

Shed

Unpermitted work
