Historic Cultural Properties Inventory (HCPI) Base Form (FORM 1)

6. Date of Survey: March 6, 2025		
7. Previous Survey Date(s): <input type="checkbox"/> Yes: <input checked="" type="checkbox"/> No:		
8. Name of Project: HDRB Status Evaluation

1. Name of property: José and Rosalia Ortiz Property Shed	2. Location: 248 Rodriguez Street Downtown and Eastside Historic District – Santa Fe	3. Local Reference Number: Santa Fe ID: N/A

Illustrations

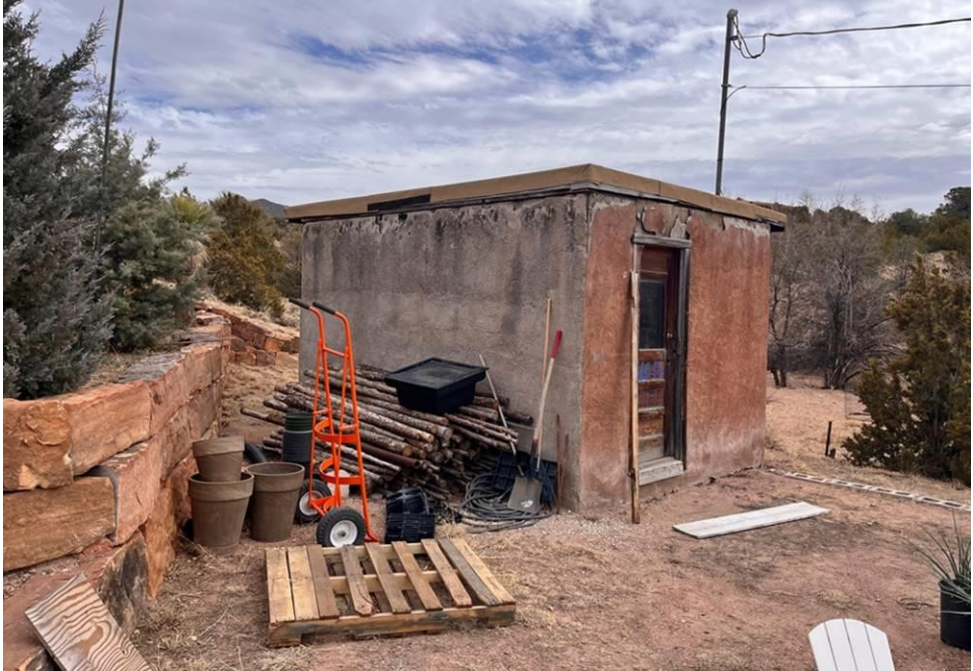
9. Lat/Long: 35.6872741,-105.9260488		
10. Photo Information: Giulia Caporuscio, photographer. Photo 1: View north and west elevation, facing northeast

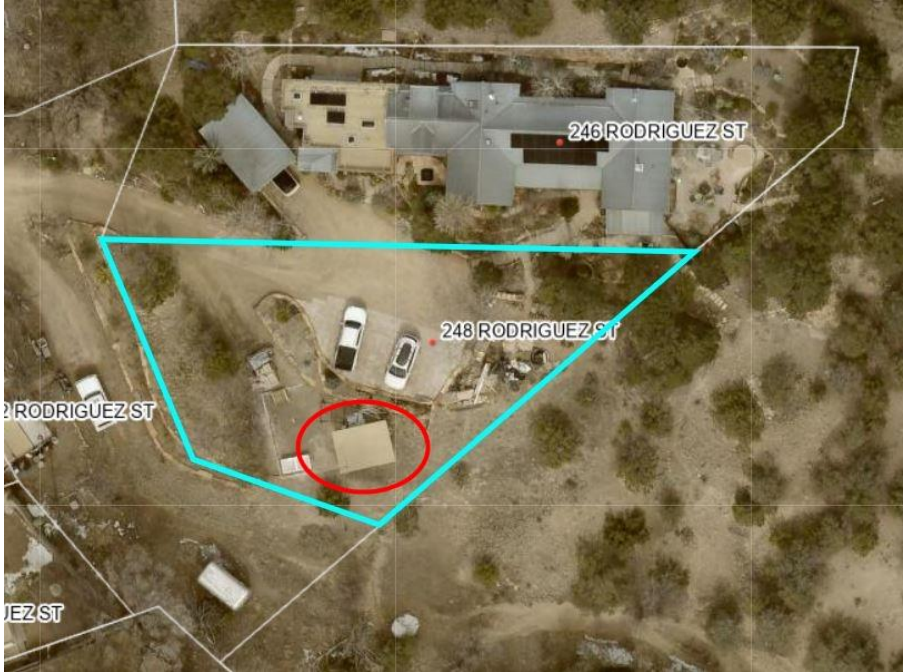
16. Additional Perspective: (Photos, drawing, footprint, etc., indicate north arrow when possible)

Source: Office of the Santa Fe County Assessor
Blue parcel lines are not accurate

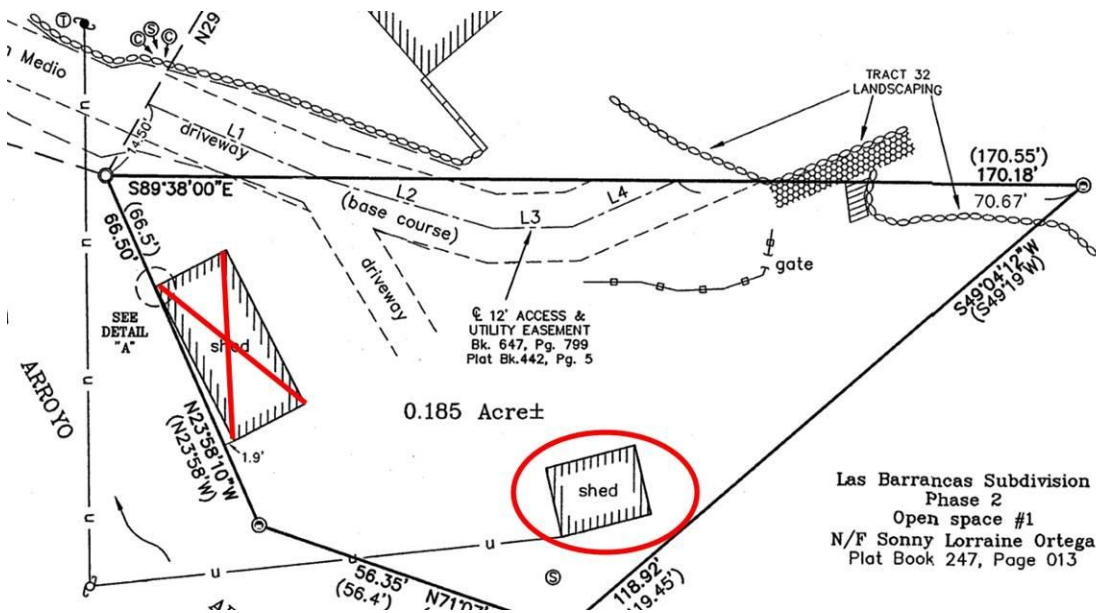
19. Site Plan: Portion of 2018 survey plat. Courtesy of Zia Surveys.

Las Barrancas Subdivision
 Phase 2
 Open space #1
 N/F Sonny Lorraine Ortega
 Plat Book 247, Page 013

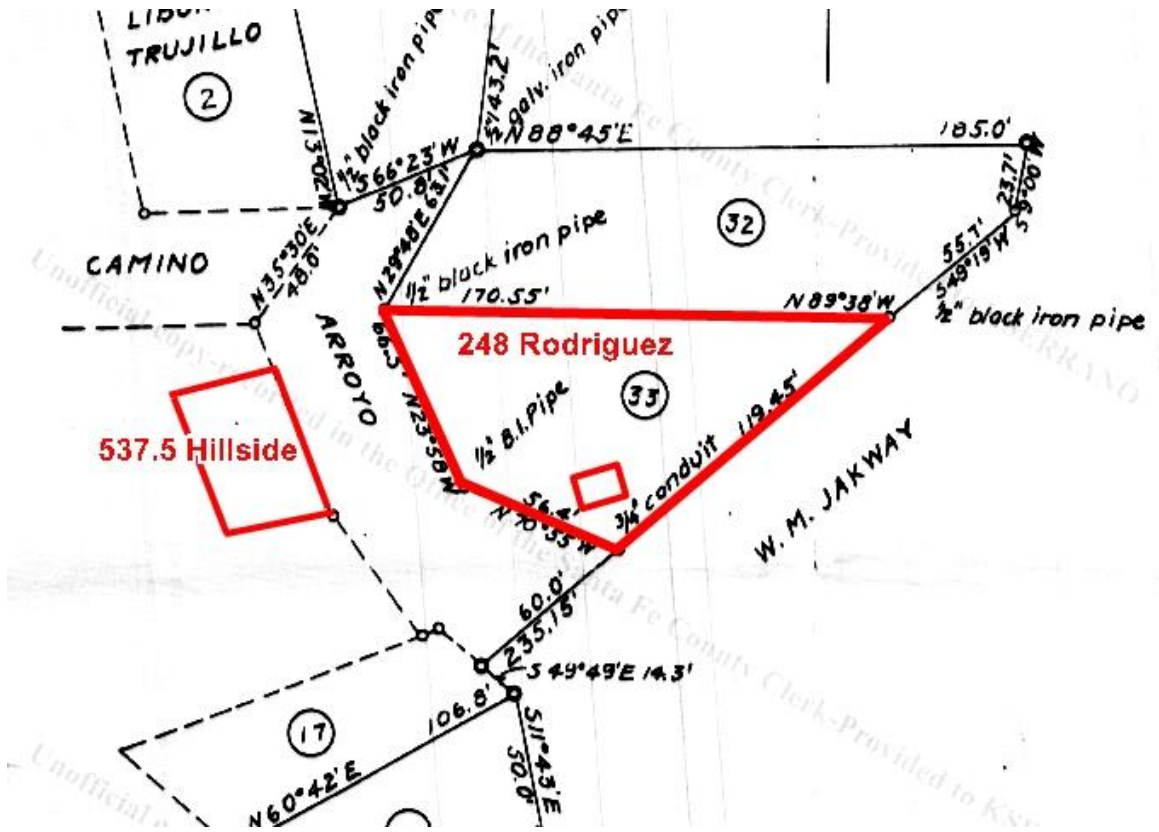
Figure 2: Subject tract highlighted in relation to the Ortiz residence.
 James C. Harvey, "East Portion' of Tract of Land Subdivided for Felix A. and J. A. Armijo," October 5, 1953.

The first evidence of the parcel holding the shed comes from a plat made for Felix A. Armijo in 1953 (Fig. 2). The tract that would later hold the subject structure was acquired in 1960 by José and Rosalia (Rose) Ortiz, who lived in the home across the arroyo, addressed at the time as 527 Hillside Street. The deed was recorded three years later.²

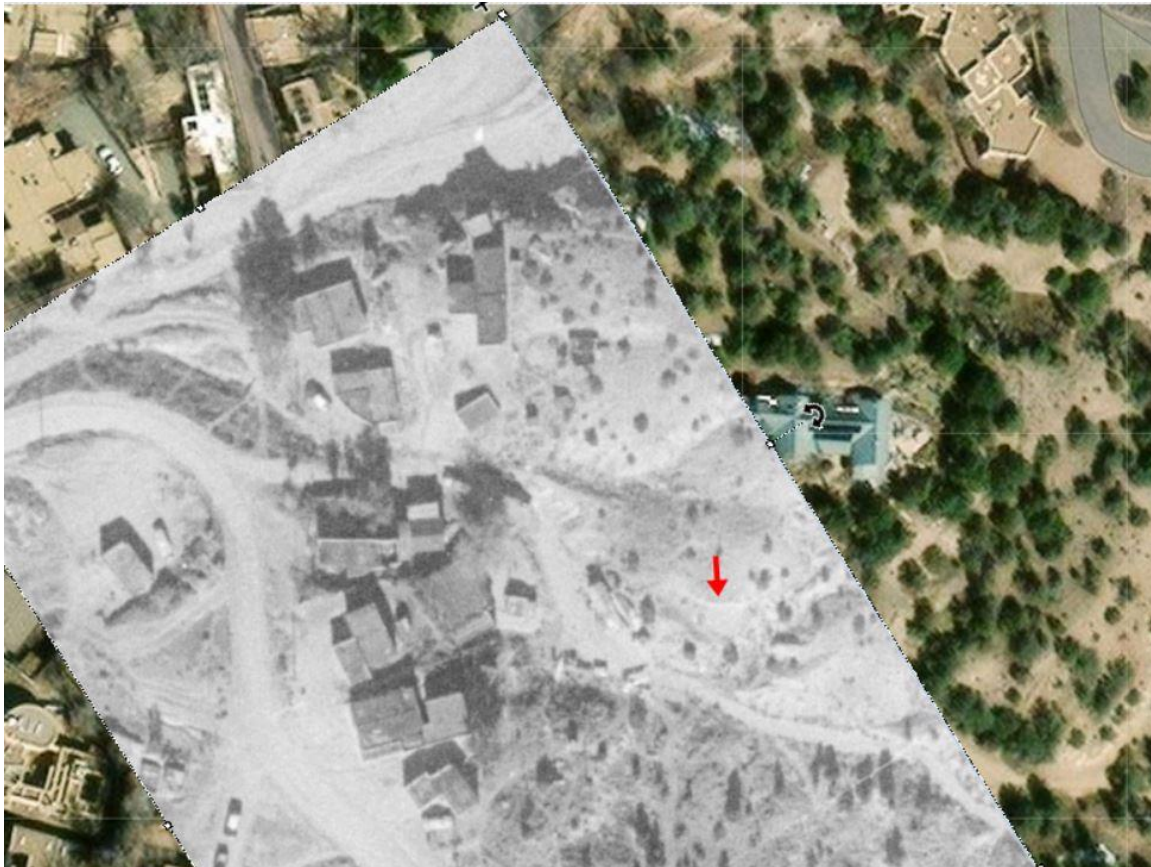
Figure 3: Overlay of November 10, 1958, aerial photograph on current satellite map. Note shed is not present.

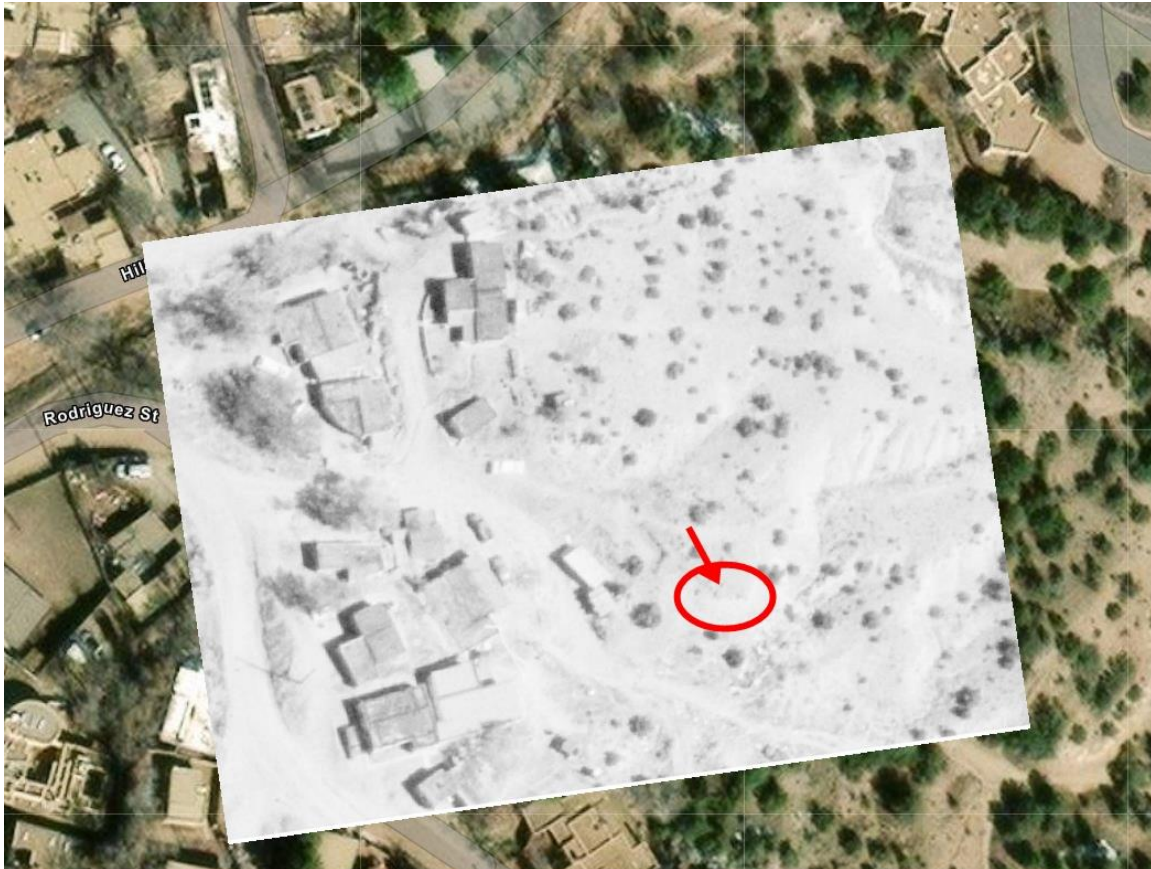
Figure 4: Overlay of May 2, 1966, aerial photograph on current satellite map. Note shed is not present.

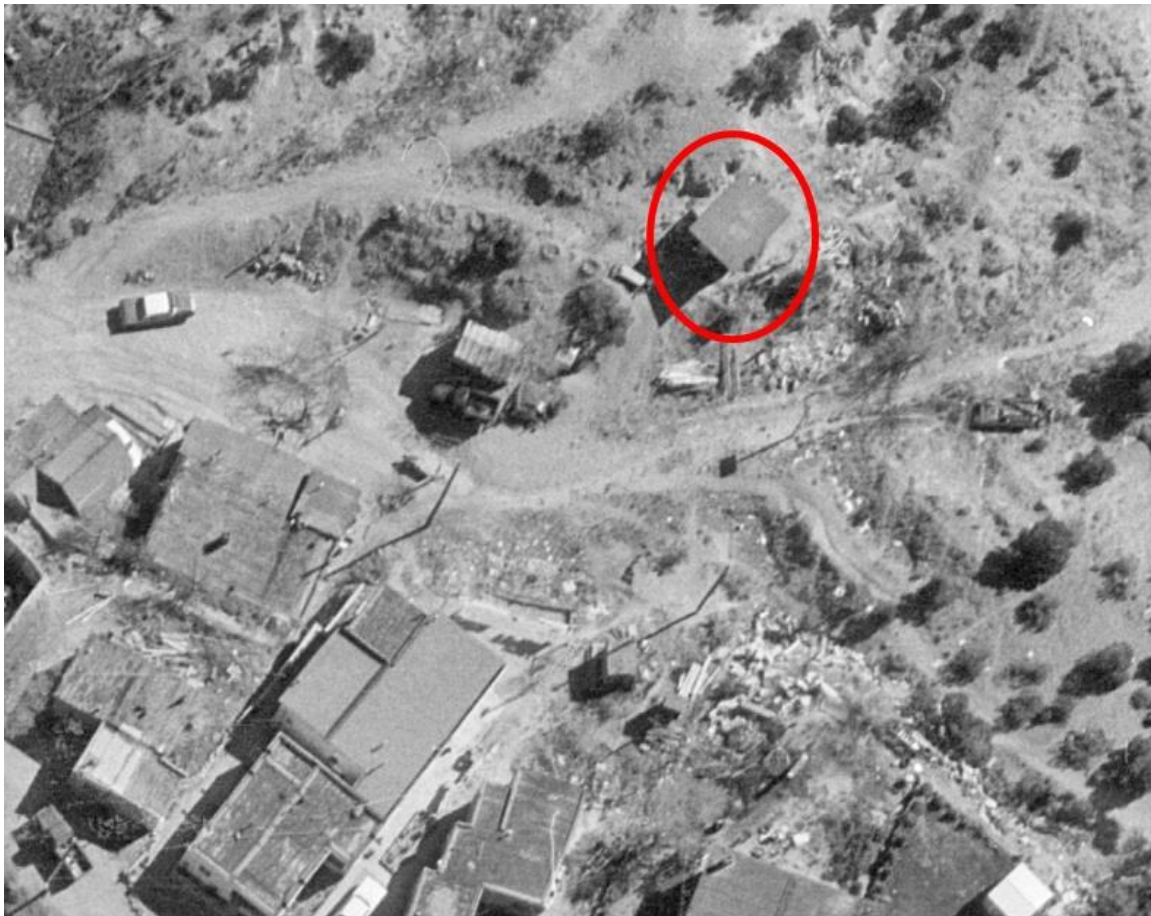
**Figure 5: May 11, 1973, aerial photograph.
Note presence of shed.**

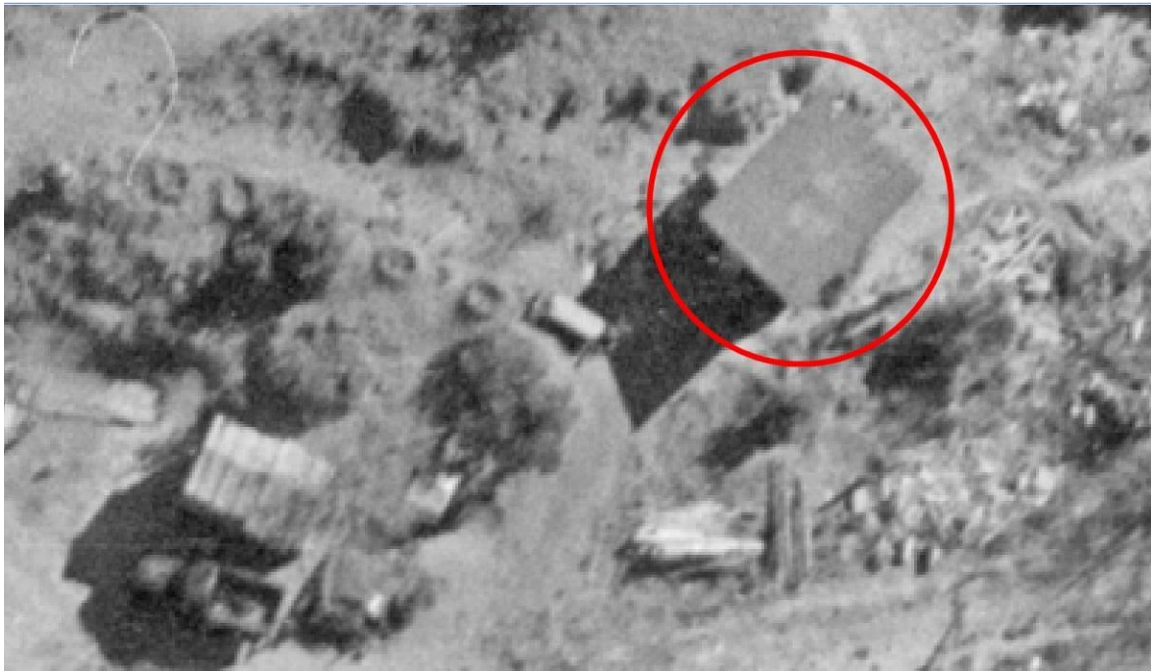
Figure 6: Close-up of 1973 aerial.

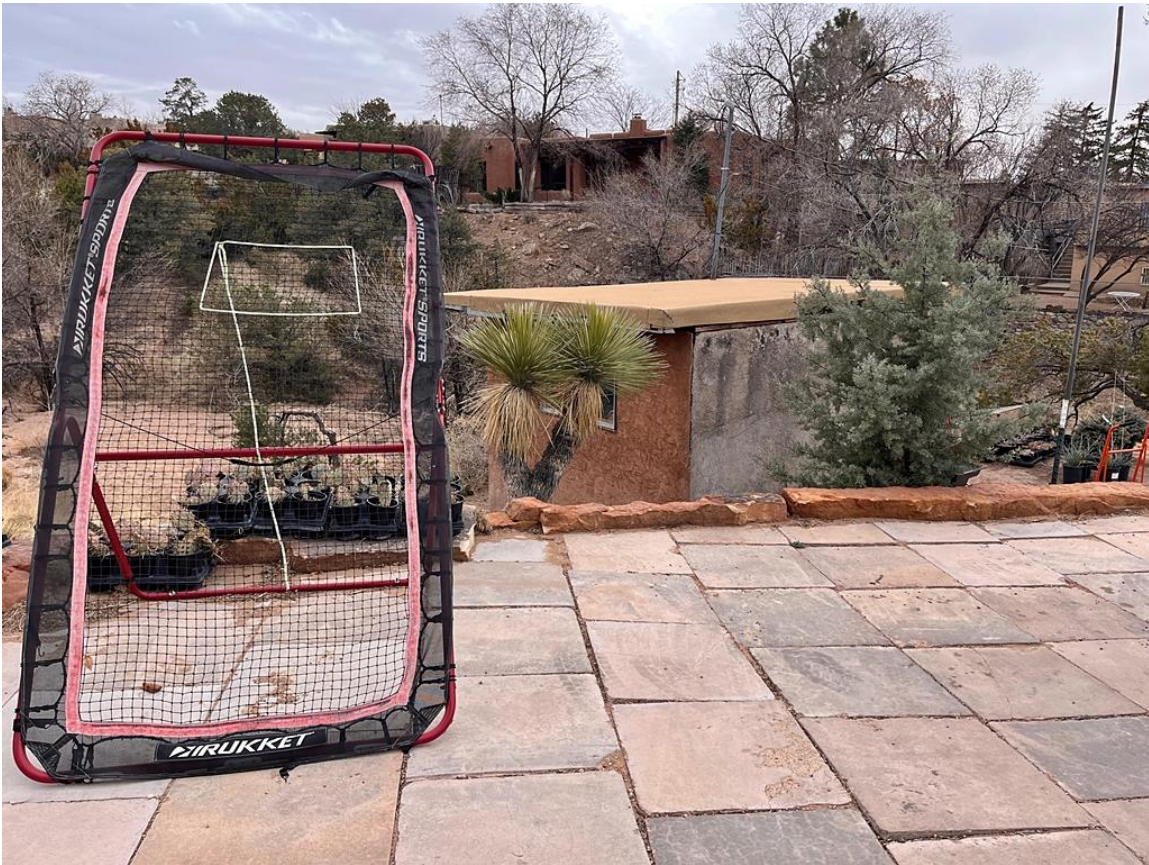
Photo 2: View from parking court of 246 Rodriguez Street. Camera facing south.

The structure rests on a graded pad on a 30° slope, above a sand wash that drains into Arroyo Saiz. It sits below a modern Northern New Mexico-style house (246 Rodriguez Street), constructed in the 1980s with additions made in the 2000s (Photo 2). It is accessed by a graded gravel drive which also serves as storage for materials used in a landscaping business (Photos 3 & 4).

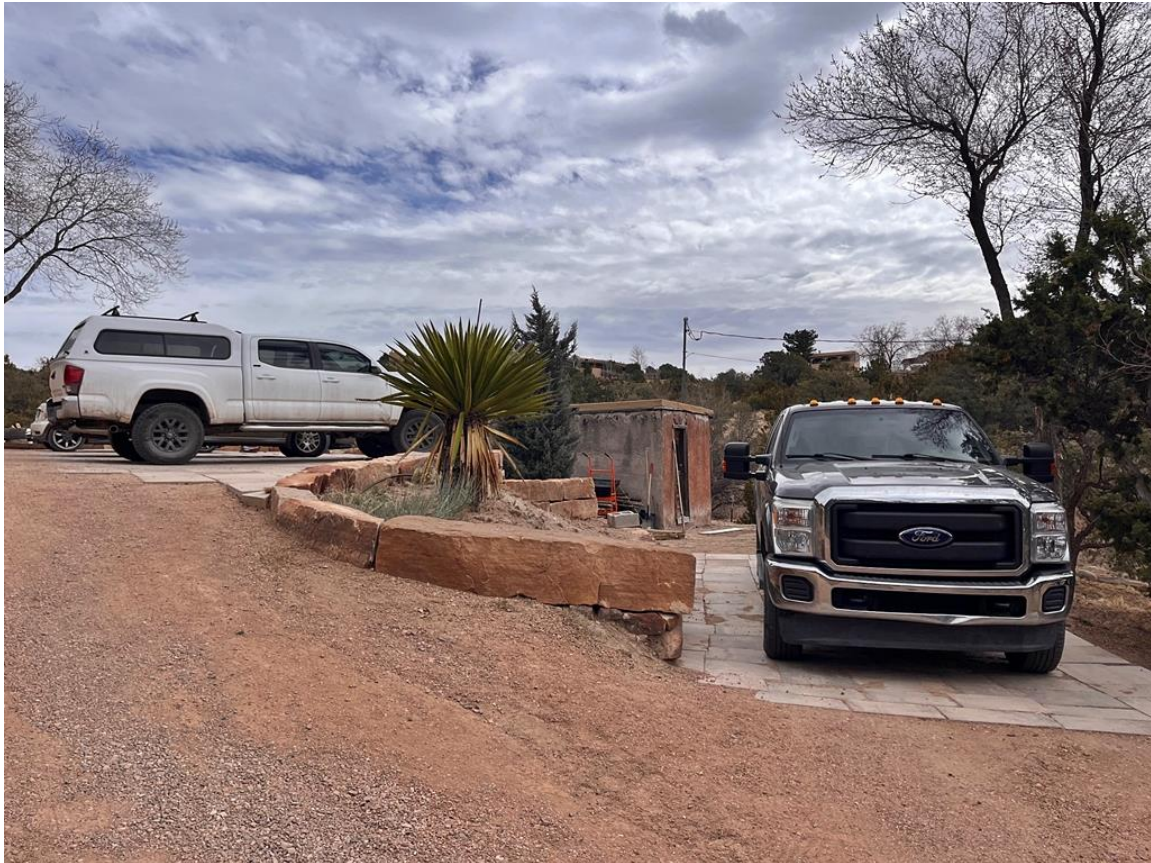
Photo 3: View from driveway of 246 Rodriguez Street. Camera facing southeast.

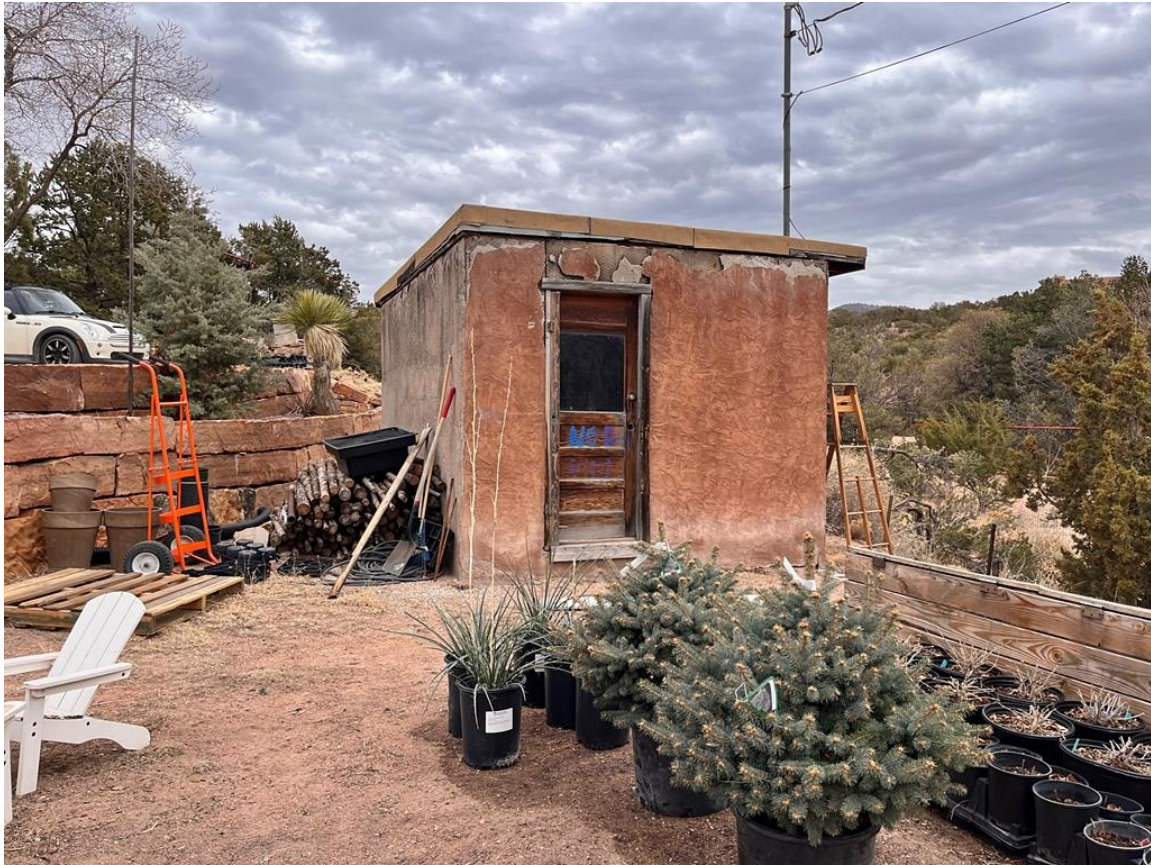
Photo 4: West elevation and immediate setting. Camera facing northeast.

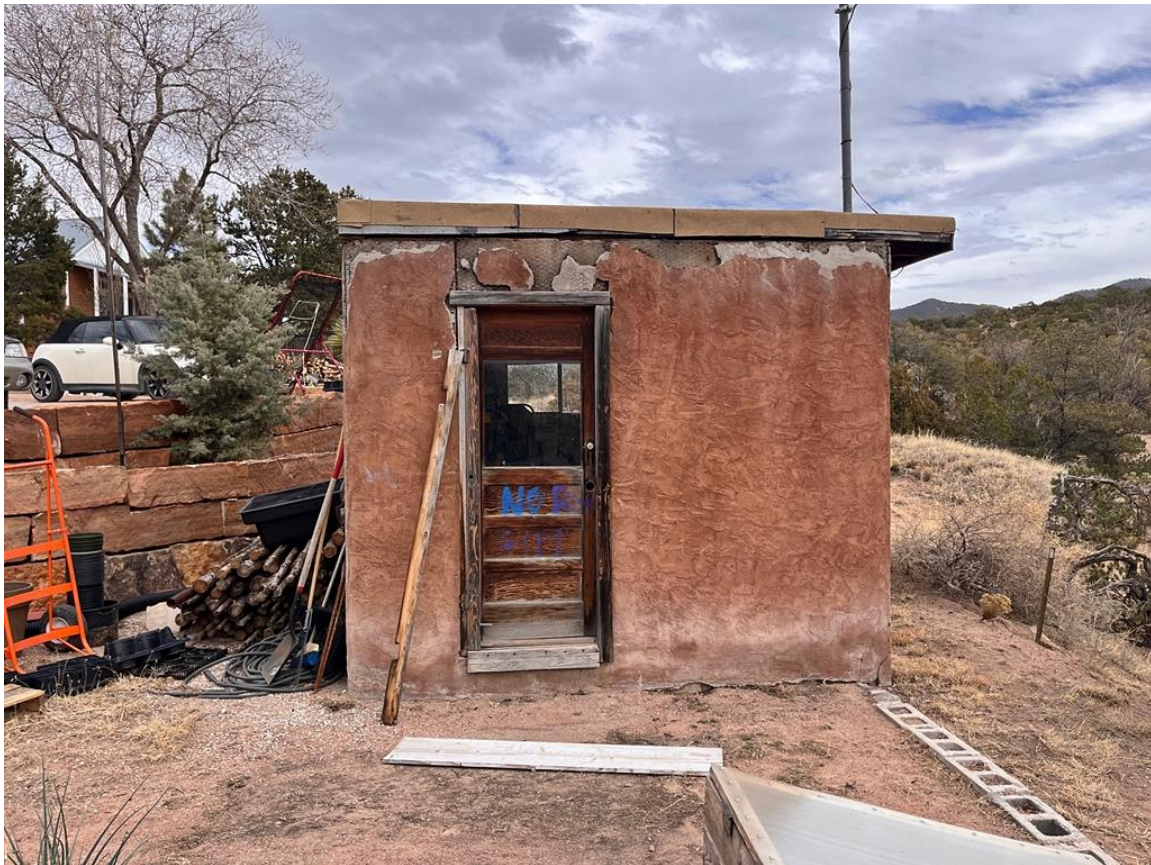
The shed is oriented 255° southwest, with its only entry on the west elevation (Photo 5). The roughly 104-square-foot building is constructed with a frame structure sheathed in fiberboard and finished with stucco, showing a time-diagnostic brocade texture.

Photo 5: West elevation. Camera facing northeast.

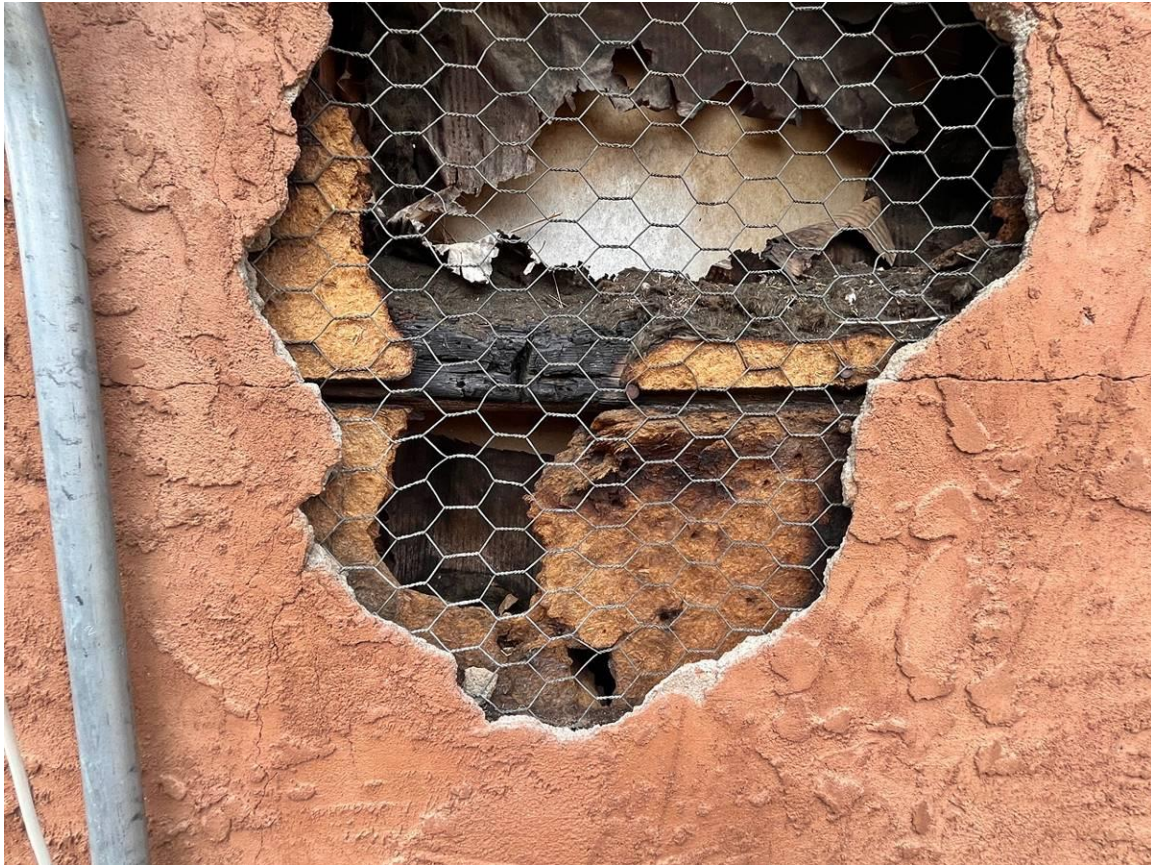
The construction technique is visible through a cut on the south elevation (Photo 6). It consists of a layer of fiberboard nailed to the studs, covered by a metal lath to hold the stucco. There is no indication of insulation. The layering suggests it was constructed on a small budget and not intended for human habitation.

Photo 6: Break in south elevation revealing construction technique. Camera facing north.

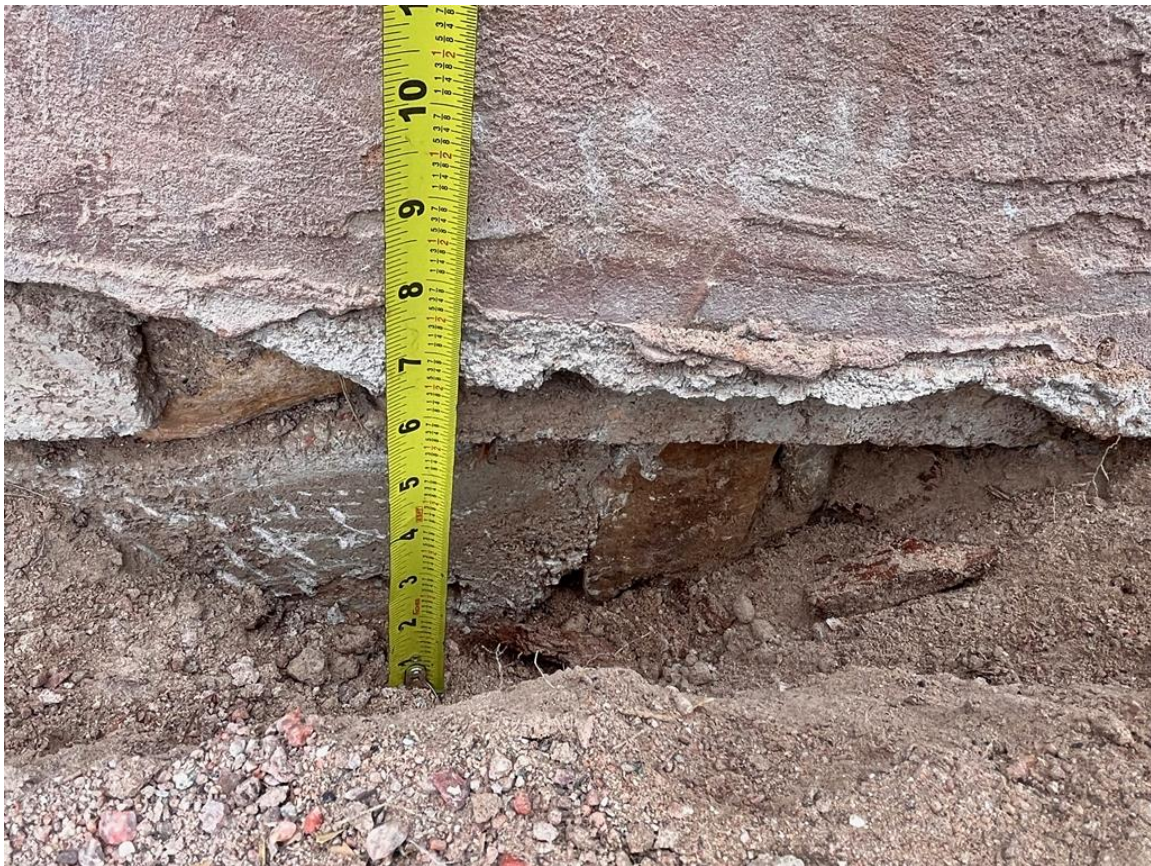
Based on an exploration 6" below ground level, the shed sits on a mixed poured concrete and rubble stone foundation (Photo 7).

Photo 7: Exposure of foundation, consisting of poured concrete and rubble.

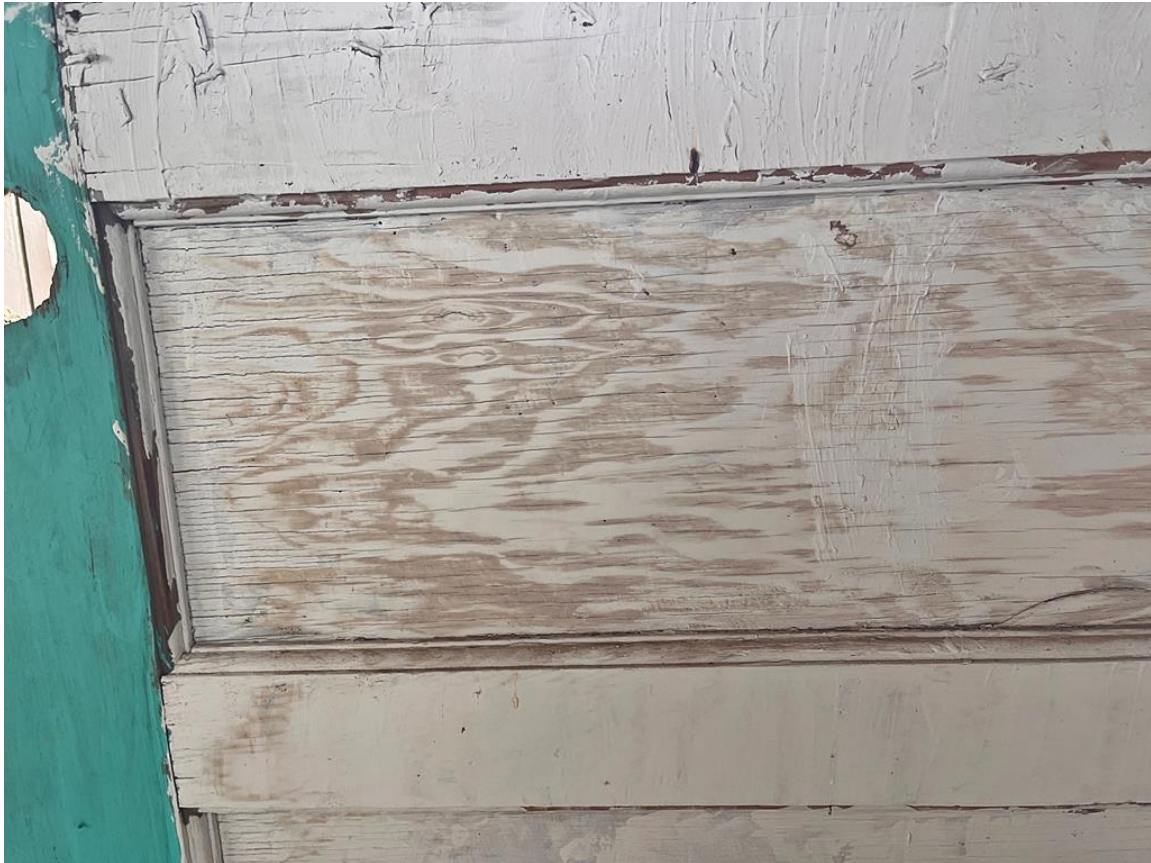
The west elevation is fenestrated with a 32-inch-wide glass and four-panel wood door. While the door appears old due to weathering, the interior reveals that the panels are made of plywood (Photo 7). This door model was still being sold by Sanbusco (No. F-117) in the 1960s.¹ The remnants of a screen door suggest an effort toward human comfort.

Photo 7: Interior of west door.

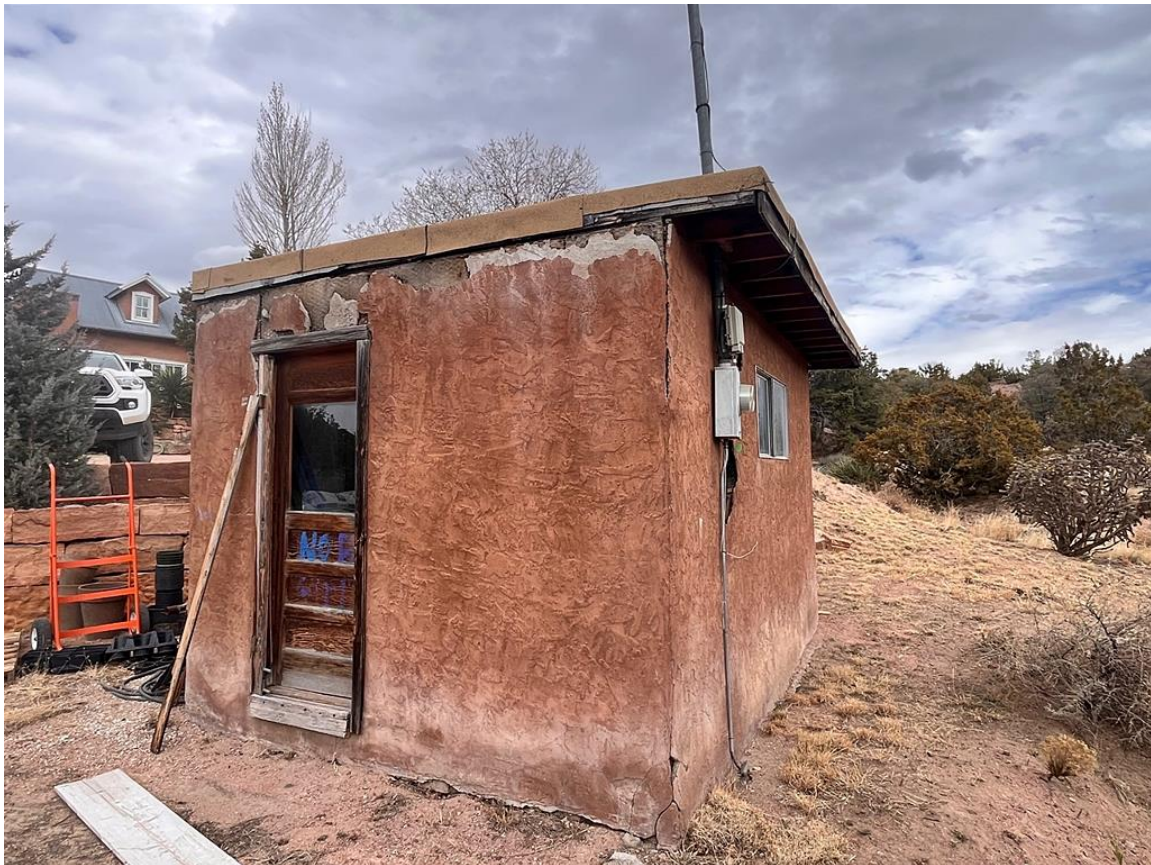
The roof extends over the south side, providing protection for a window (Photo 8). The window is a horizontal sliding aluminum unit, which is diagnostic of the shed's construction period (Photo 9). The elevation has the aforementioned damaged area, along with a round opening holding a modern wall thimble, suggesting the shed was once used for human habitation.

Photo 8: West and south elevations. Camera facing northeast.

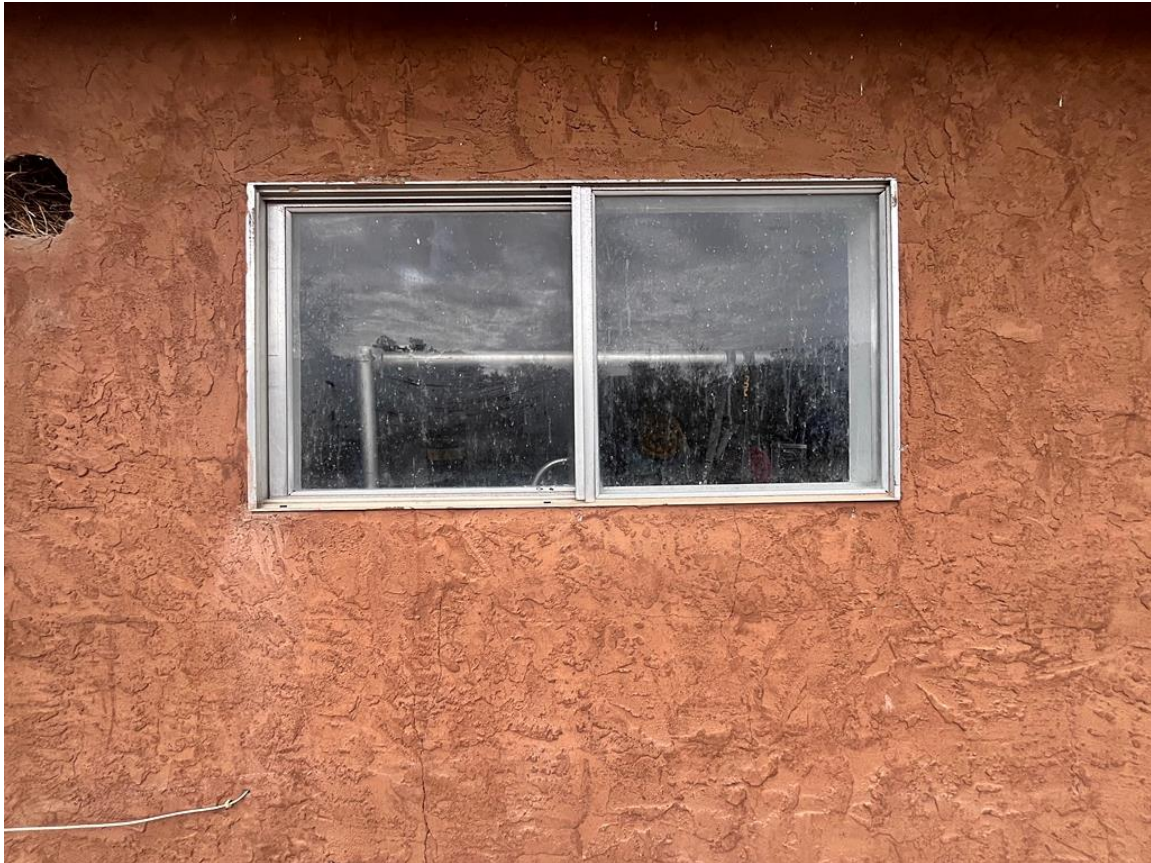
Photo 9: Aluminum sliding window on east elevation. Camera facing northwest.

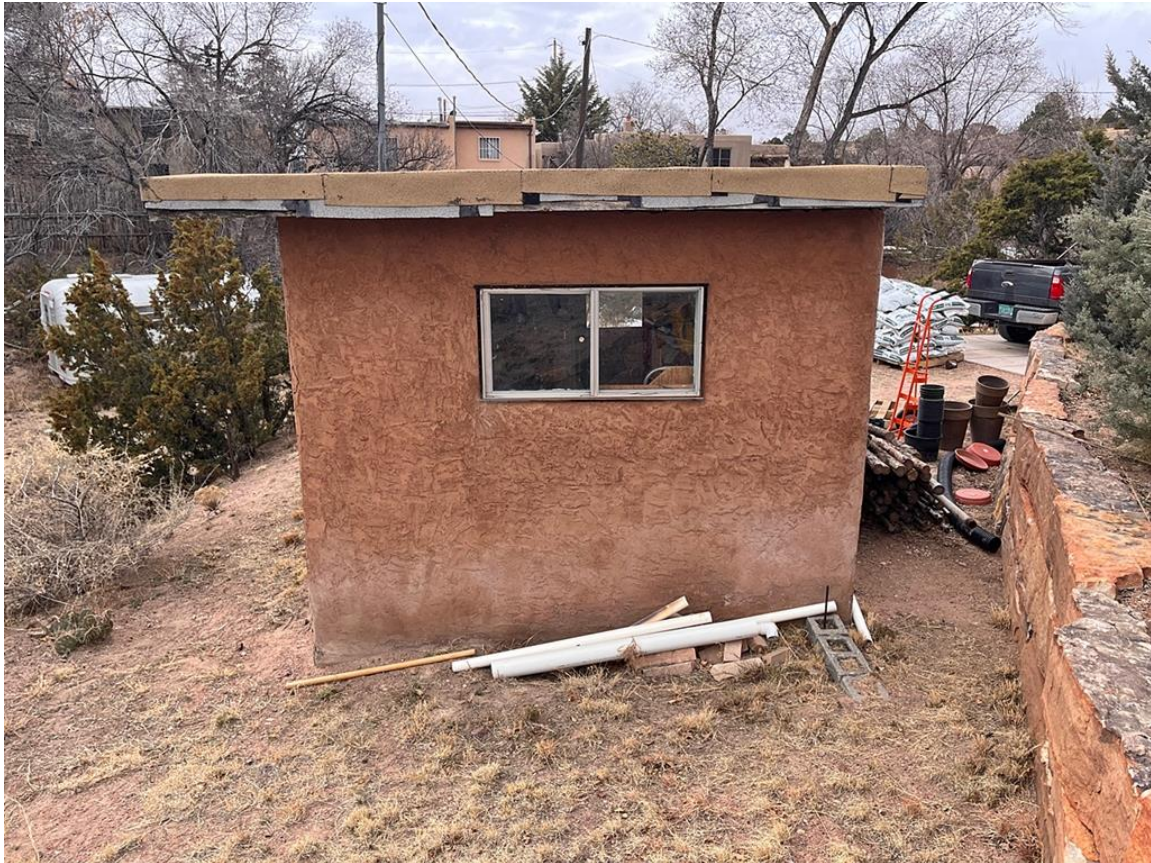
The east side of the building has a shallower overhang than the south side and has a similar aluminum sliding window (Photo 10).

Photo 10: East elevation. Camera facing southwest.

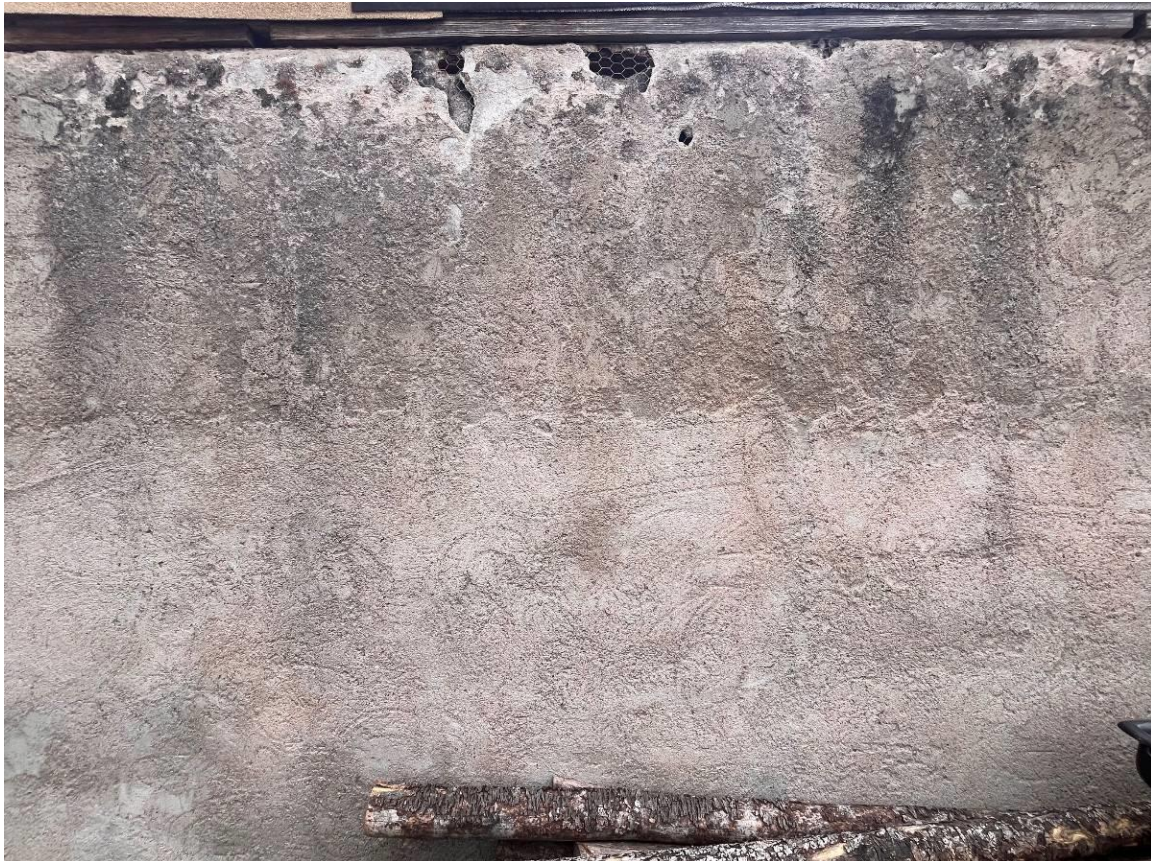
The north elevation faces the slope and has no fenestration. It is covered with a rough gray coat of stucco, suggesting that this side of the building was not intended to be visible at the time of construction (Photo 11). Ironically, it is now the most visible side of the building.

Photo 11: North elevation. Camera facing southeast.

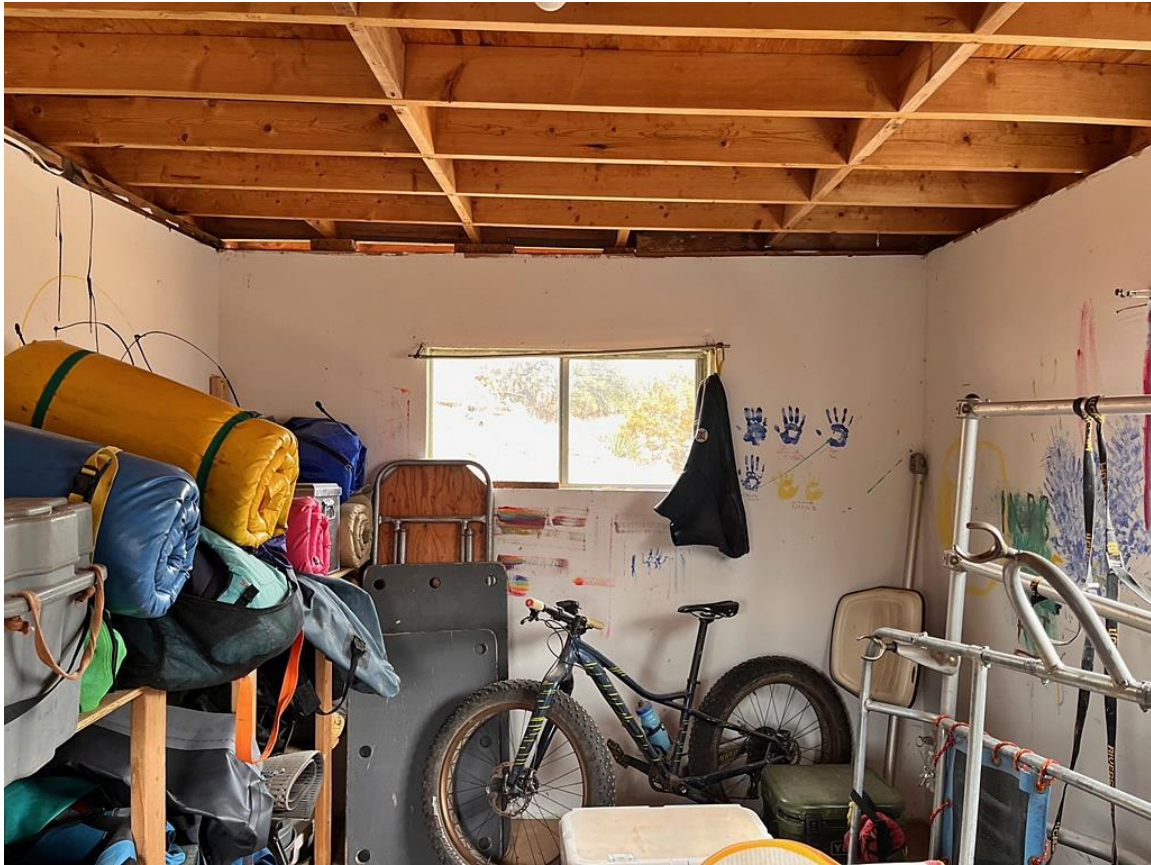
The interior is one space currently for storage. It has no ceiling, and the roof construction is exposed (Photo 12). The room is spanned by 1 ½" x 5 ¼" joists arranged at 16" on-center. Sheets of plywood create the decking. Recent white drywall is tacked to the studs; there is no source of electrical lighting. Recently installed white drywall has been attached to the studs.

Photo 12: Interior of shed. Camera facing northeast.

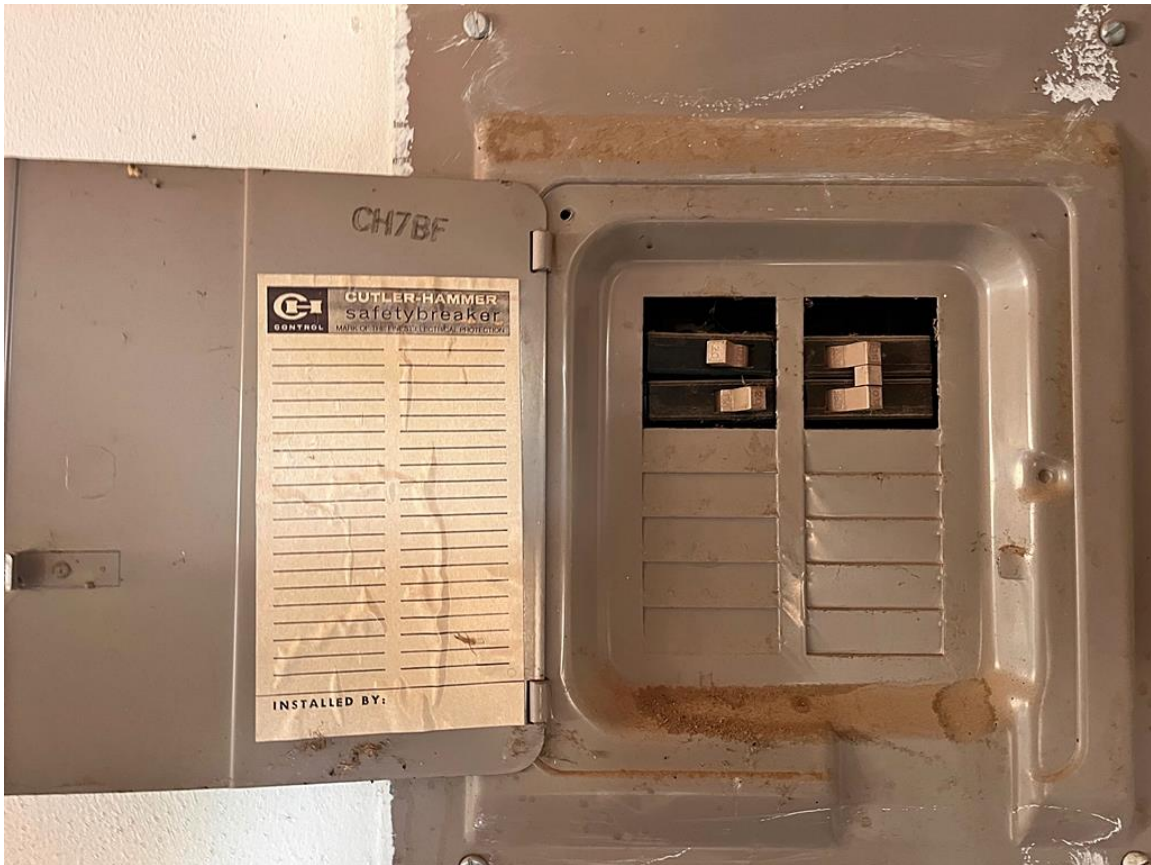
A notable feature is the circuit breaker box located in the southeast corner (Photo 13). Cutler-Hammer "Safety Breaker" box panels were introduced in the mid-1960s. The minimum number of breakers suggests that the structure had only basic electrical needs, likely consisting of a single light and an outlet suitable for powering a radio or small heater.

Photo 13: Breaker box on east wall.

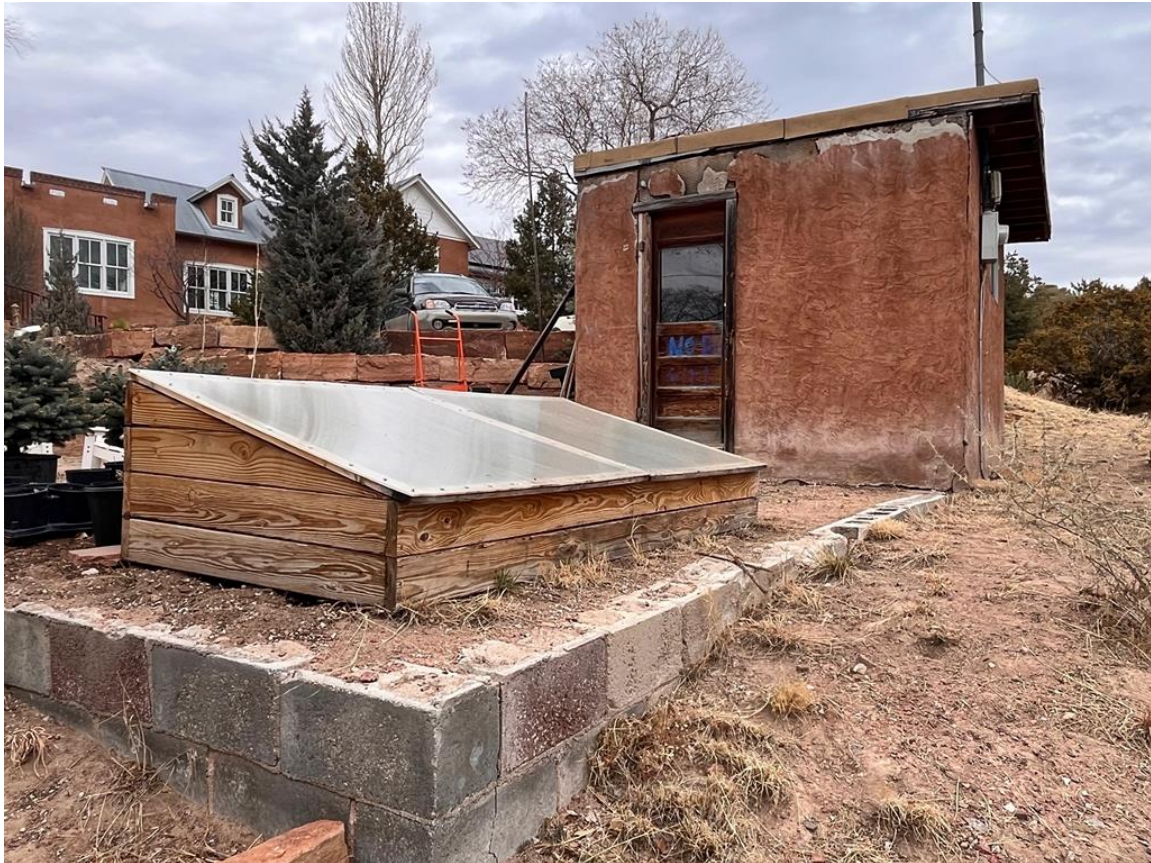
The site features several segments of CMU blocks that are exposed at ground level. The purpose of these blocks is unclear (Photo 14). Ground debris along the south elevation includes broken window glass, fragments of planting pots, and aluminum pull-tabs — a possible time indicator of the shed’s construction era (Photo 15).

Photo 14: Low foundation wall. Camera facing northeast.

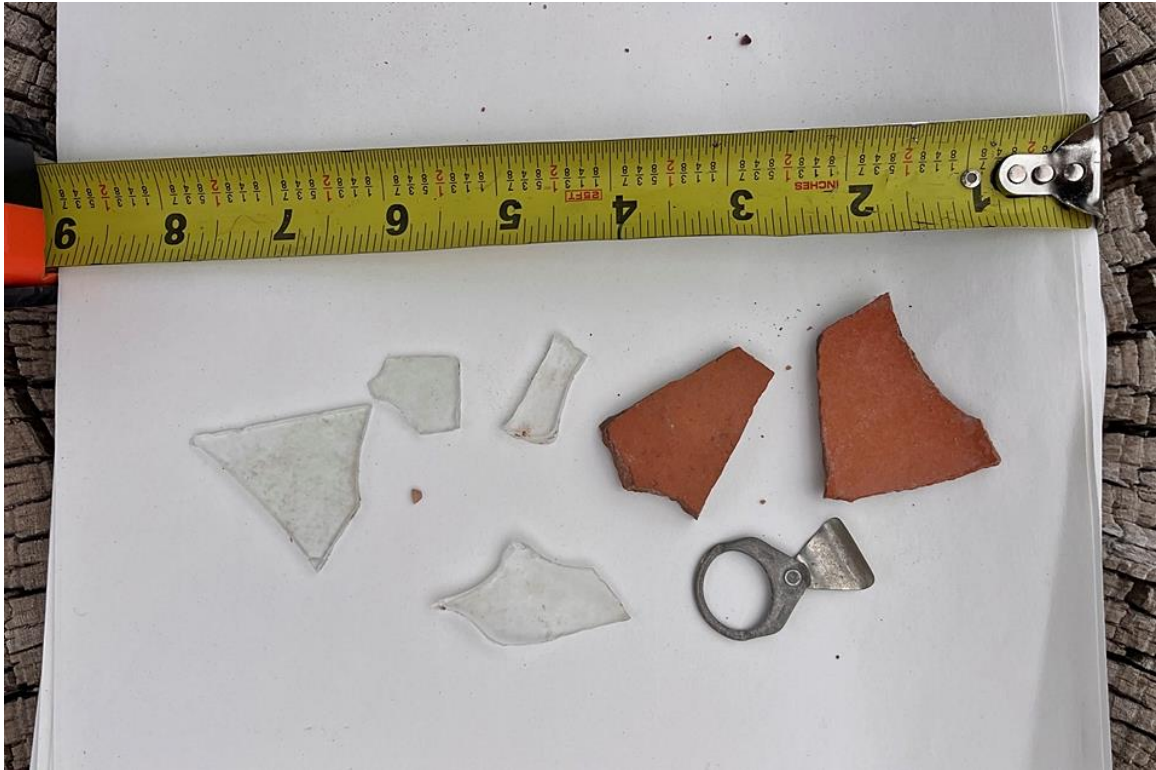
Photo 15: Surface debris found around shed.
