Historic Cultural Properties Inventory (HCPI) Base Form (FORM 1)

6. Date of Survey: March 6, 2025		
7. Previous Survey Date(s): <input type="checkbox"/> Yes: <input checked="" type="checkbox"/> No:		
8. Name of Project: HDRB Status Evaluation

1. Name of property: José and Rosalia Ortiz Property Shed	2. Location: 248 Rodriguez Street Downtown and Eastside Historic District – Santa Fe	3. Local Reference Number: Santa Fe ID: N/A

Illustrations

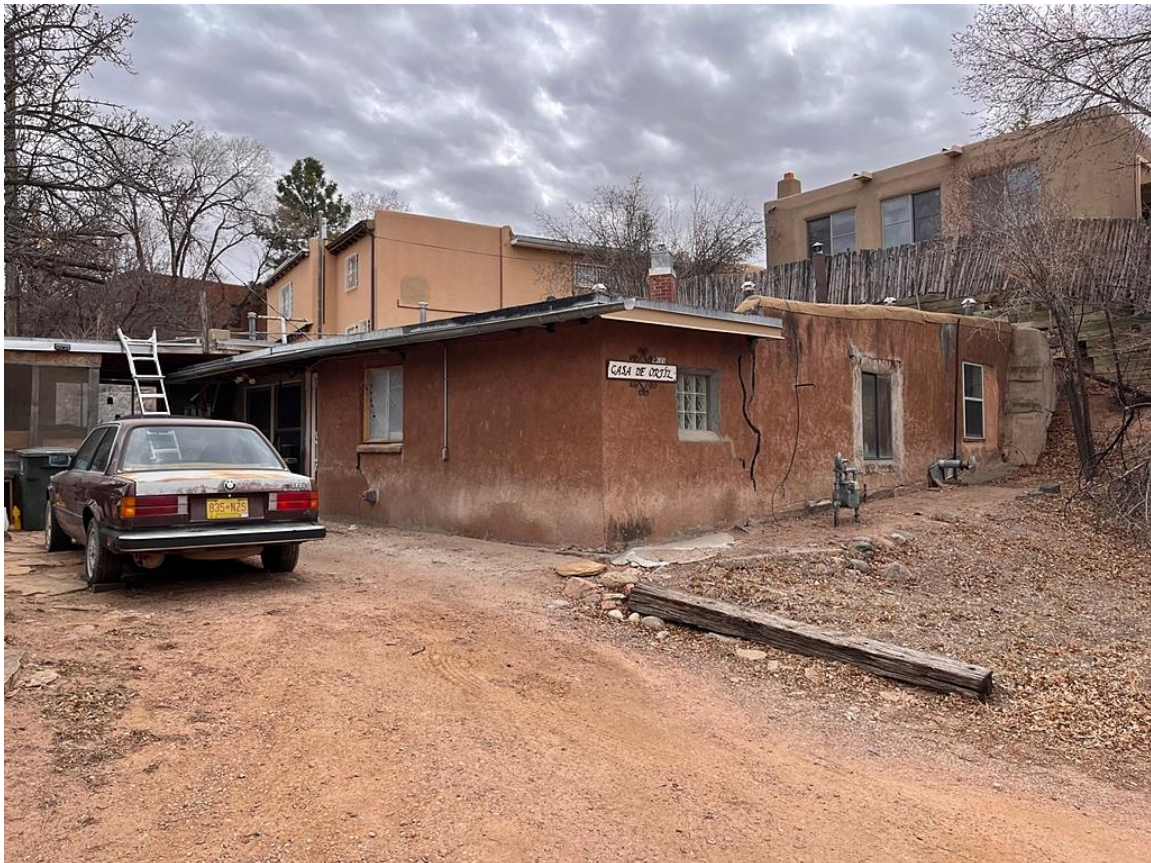
Photo 16: 537 ½ Rodriguez Street, the former José and Rosalina Ortiz House. Camera facing southeast.

José Valentino Ortiz was born in 1915 to Policiano and Gregorita Ortiz. Census records show he grew up in Rio en Medio, a traditional Hispanic community along the river of the same name in northern Santa Fe County. He married Rosalia Trujillo, a resident of Rio en Medio, in the early 1940s, and the couple relocated to Santa Fe a decade later. By the mid-1950s, they and their seven children were in the house across the arroyo, which was deeded to them in 1957 (Photo 16). The family would grow to eleven children.

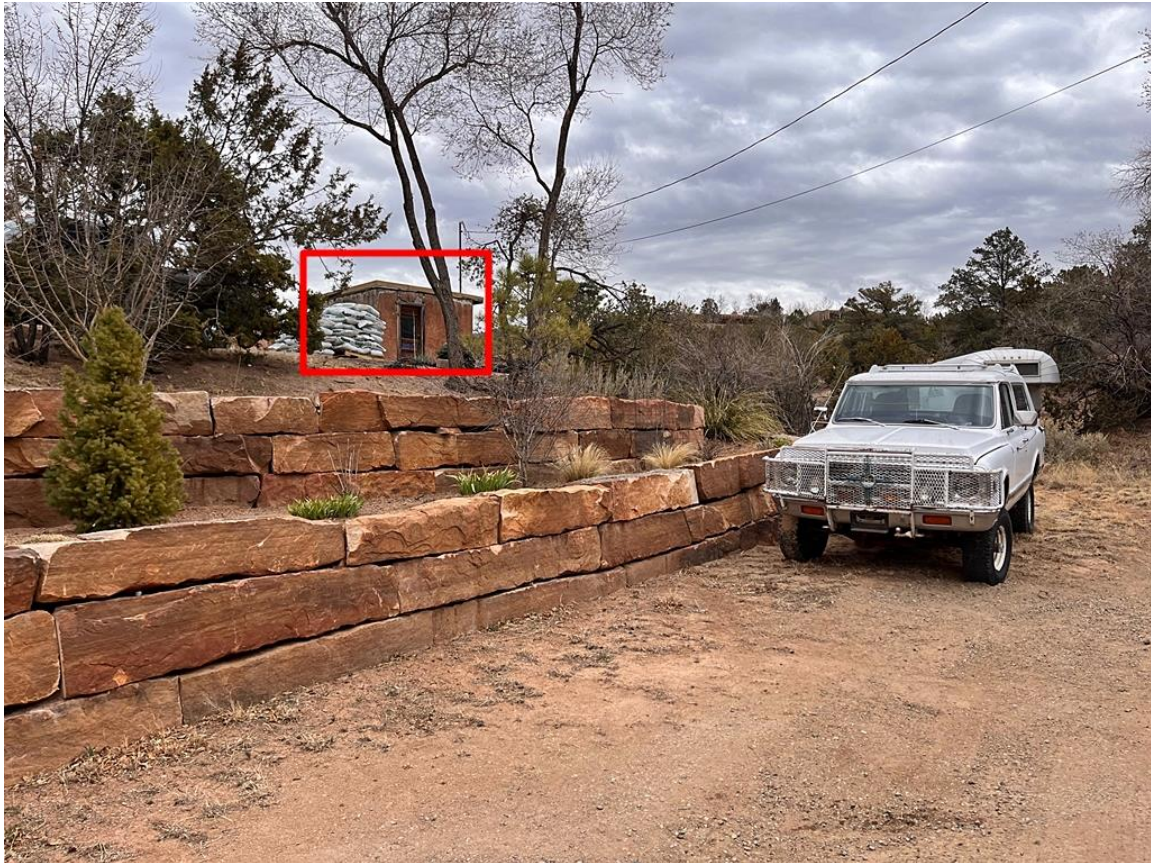
Photo 17: View of shed from the arroyo near the 537 ½ Rodriguez Street. Camera facing southeast.
