City of Santa Fe

Plan Number: 2024-009321--HDRB

Project Description: 2024-009321-HDRB, 1 Plaza Fatima, Downtown & Eastside Historic District, Contributing, Mark Lopez, agent for Mark Kreloff, owner, requests primary facade(s) designation for a residential structure.

2024-009321-HDRB, 1 Plaza Fatima, Downtown & Eastside Historic District, Contributing, Mark Lopez, agent for Mark Kreloff, owner, requests primary facade(s) designation for a residential structure.

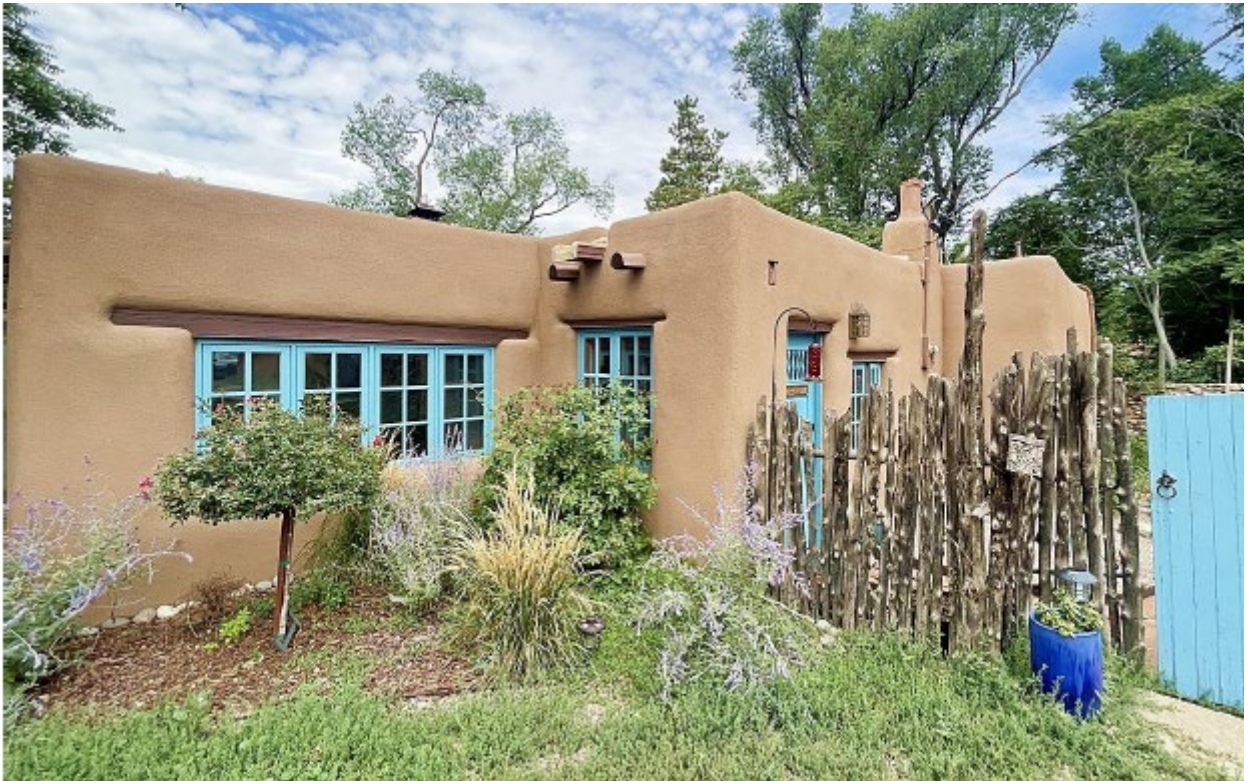
The east elevation consists of cubic offsets that appear in its original design with 6-lite wood casement windows painted turquoise. The units have a geared, “crank-out” operation. The windows sit deep within the wall, contrasting with the 1970s addition. A “tucked” wood lintel sits above the opening (See Figure 1). It is unclear if this or the other lintels are original.

Inside the fence is the primary entrance to the house. It has a wood door with a decorative window at the top. Affixed to the door is a carved wood plaque reading “1 Plaza Fatima.” Beyond the entry façade is a projection cut with one opening holding paired 6-light casements.

Figure 1: East elevation

Staff recommends the historic status of the structure be maintained as contributing and the east elevation and southeast corner be designated as the primary facades, per 14-5.2(C) Designation of Significant and Contributing Structures.

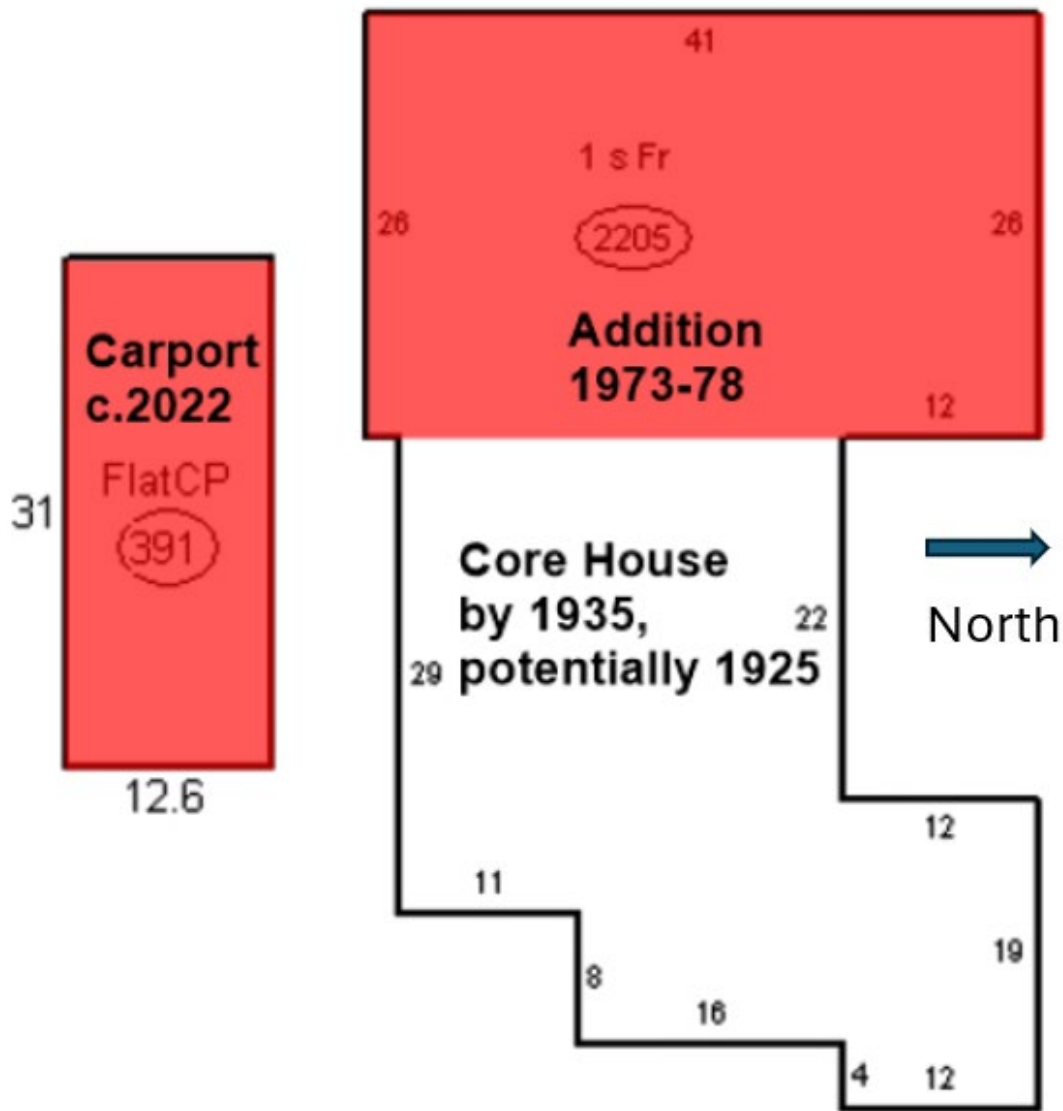
West of the altered portion of the south elevation, begins the 1970s addition. The addition was constructed between 1973 and 1978. The roughly 1,066-square-foot appendage has similar wood casement windows but set closer to the edge of the outer wall. The addition is entered through an ornamental wood door. This addition was roughly 48% of original footprint of the building.

Figure 2: Additions diagram courtesy of 2024 HCPI

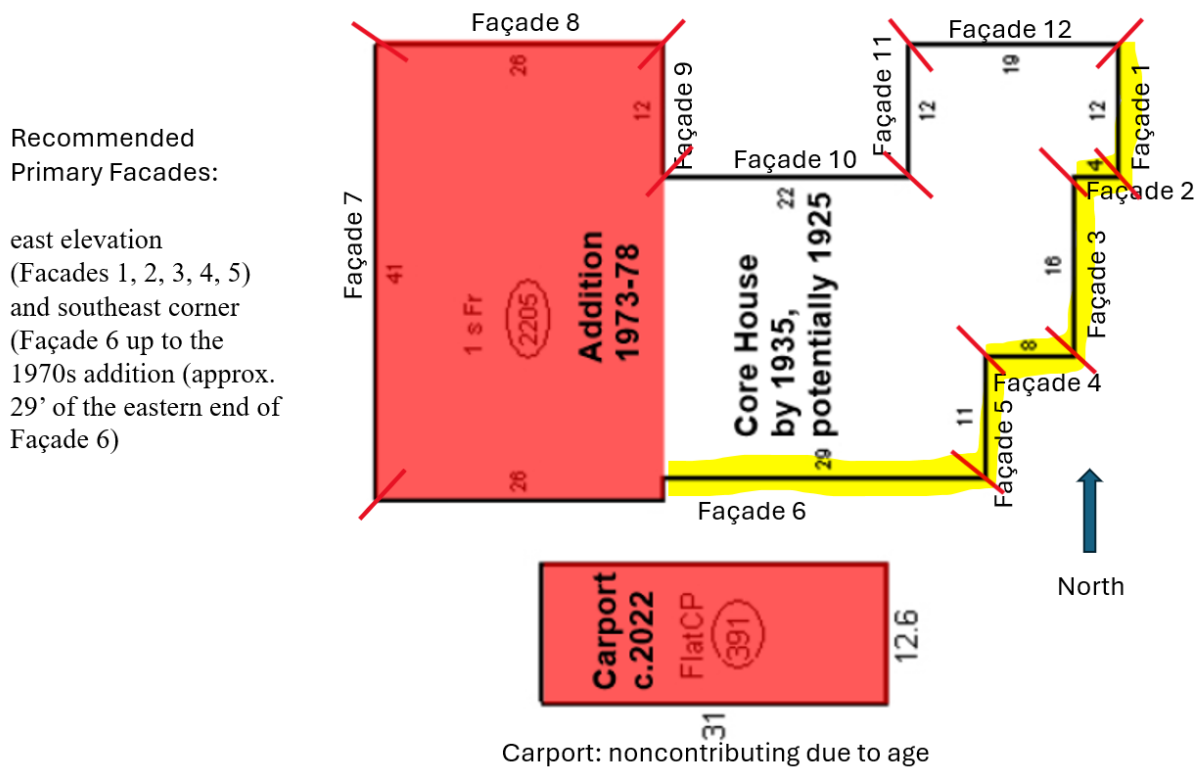
The house has historical significance for its association with Rosa Margaret Curtis, who developed Plaza Fatima. Compromising this association is the 1970s addition, which changed the overall design of the 1930s house, as evidenced by aerial photographs. The addition lost much of the integrity aspects of design, materials, feeling, and association, the house conveys of the Curtis period. However, the east façade and southeast corner still represent this period. The additions are likely to be historic in their own right as they may have been constructed prior to 1975.

Figure 3: Façade Diagram

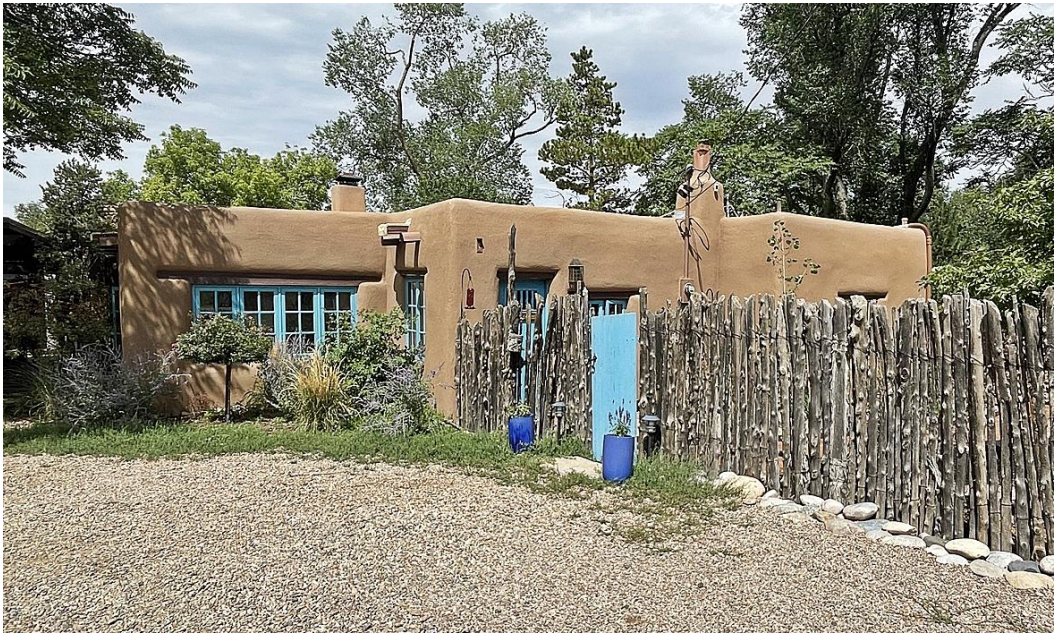
8. Name of Project: HDRB Status Evaluation		
9. Lat/Long: 35.6814763,-105.9328179		
10. Photo Information: Giulia Caporuscio, photographer. Photo 1: View of east elevation, facing northwest.

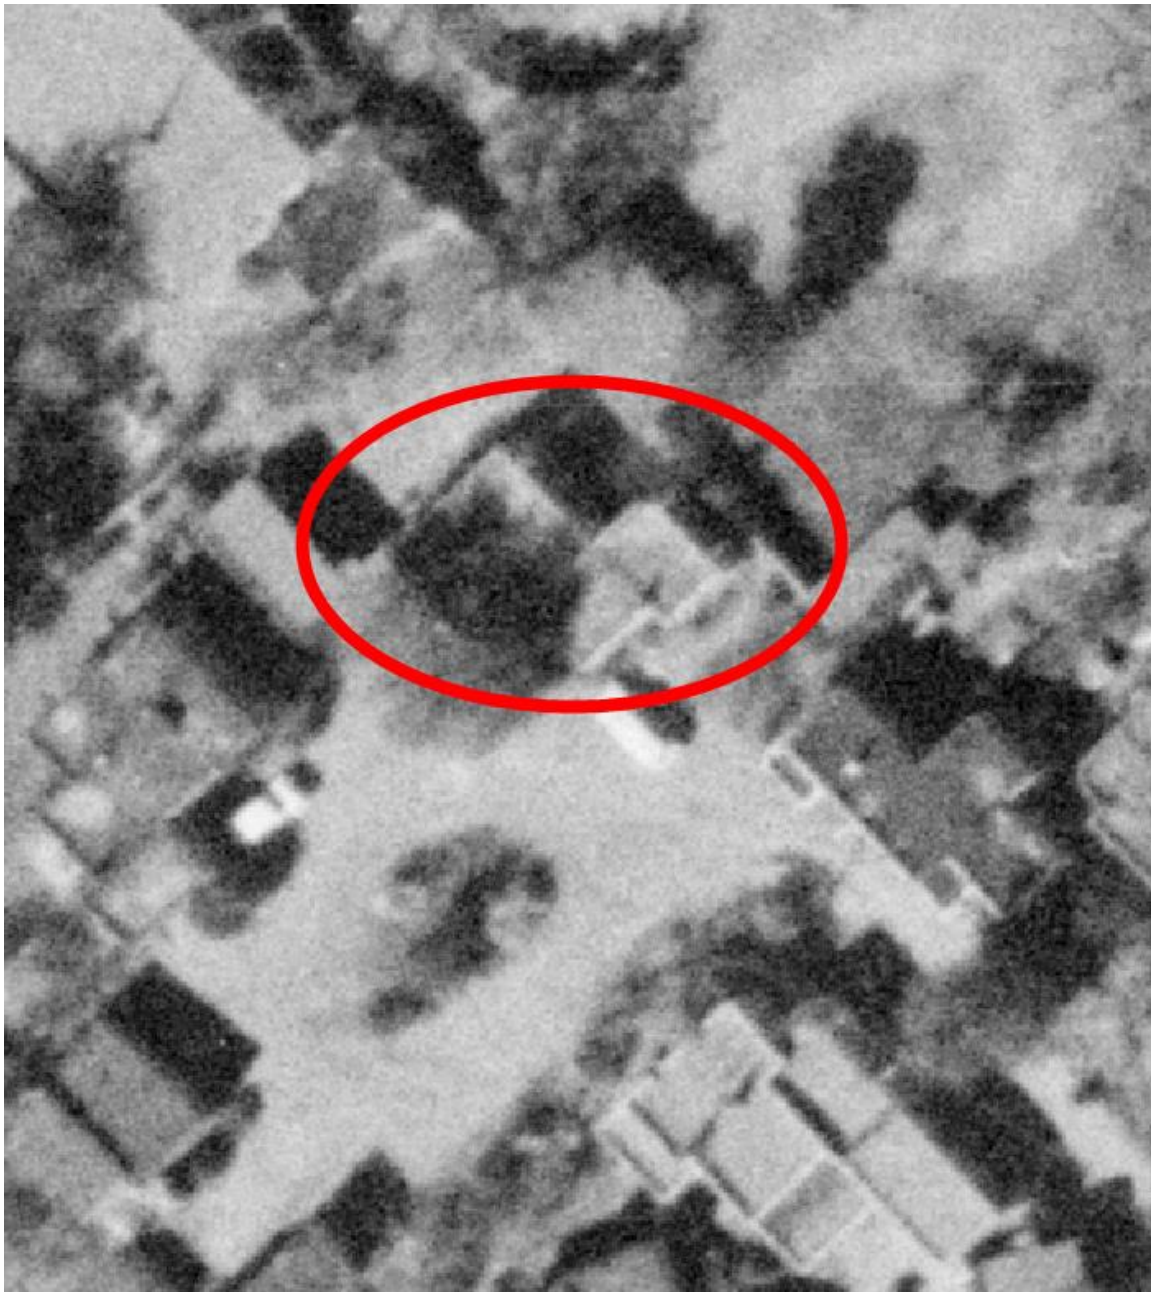
Figure 6: November 10, 1958, aerial photograph. Subject house highlighted. Note presence of an earlier carport.

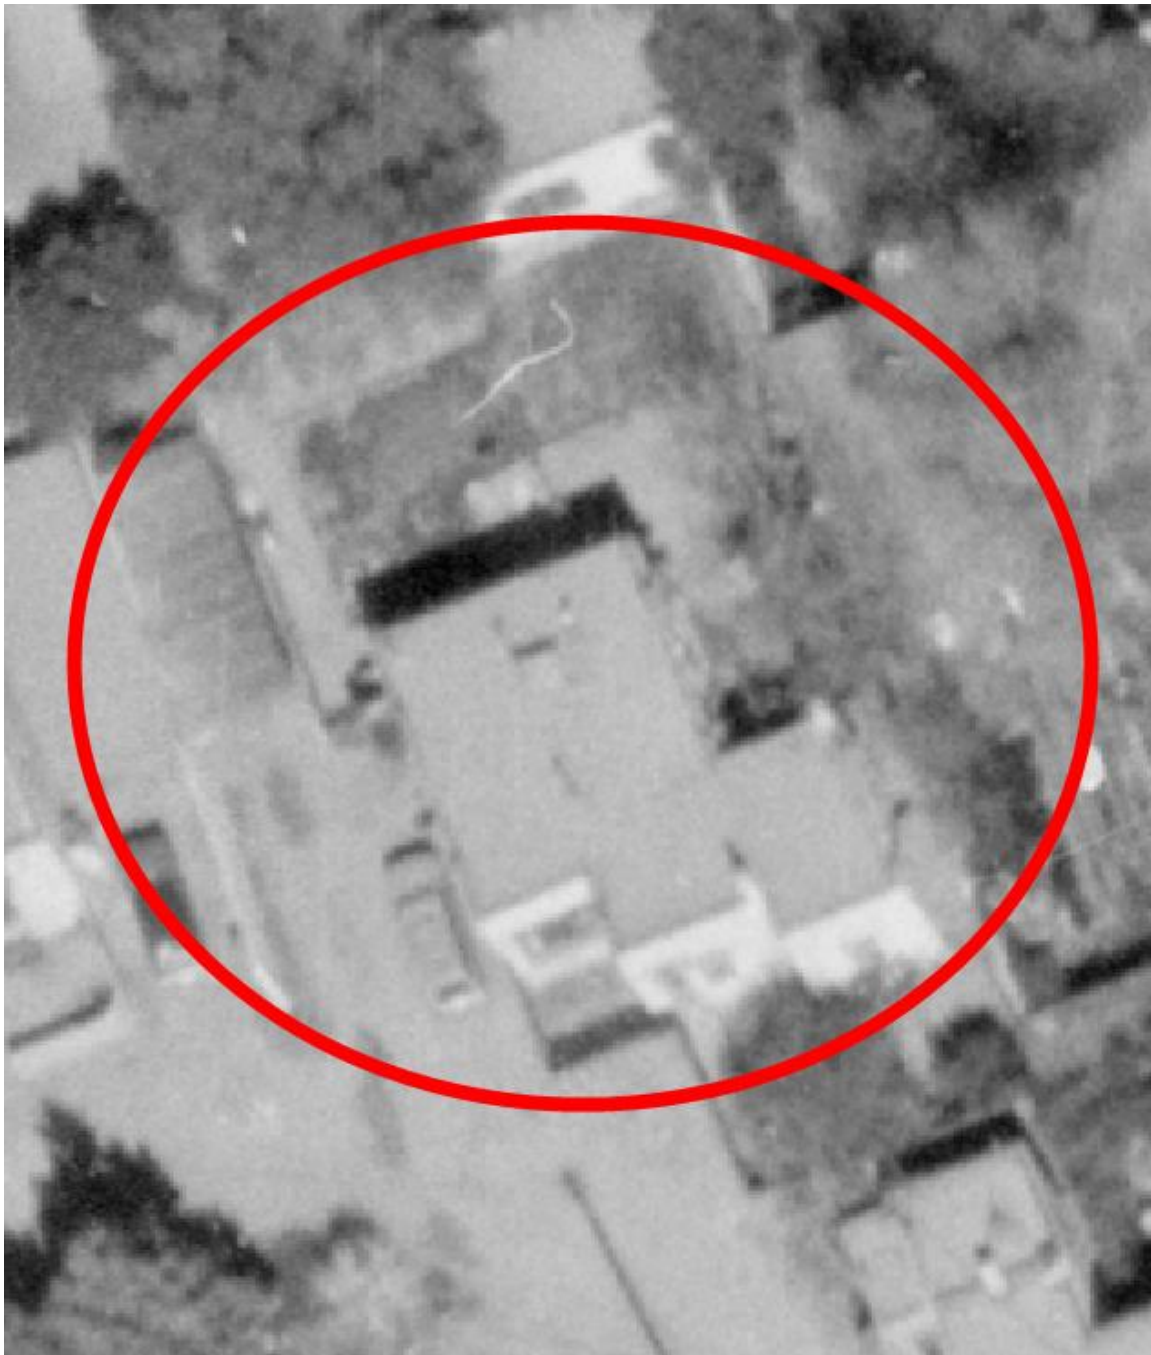
Figure 7: May 11, 1973, aerial photograph. Subject house highlighted.

The first available aerial, from 1935, shows the core house. It involved a simple compound ground plan that likely started with a single room (Fig. 2). This structure is not shown on the 1912 King’s map (Fig. 1), so the assumption is that the core building dates to the 1925 period. Its distinguishing feature was its east façade, but it had several setbacks. This core plan remained through the early 1970s, as evidenced by a 1973 aerial (Figs.6 & 7). Between 1973 and 1978, a significant rectangular addition was appended to the back of the house, significantly increasing its square footage and changing its design (Figs. 7 & 8). In 2022, the Board approved a project to build a new carport.

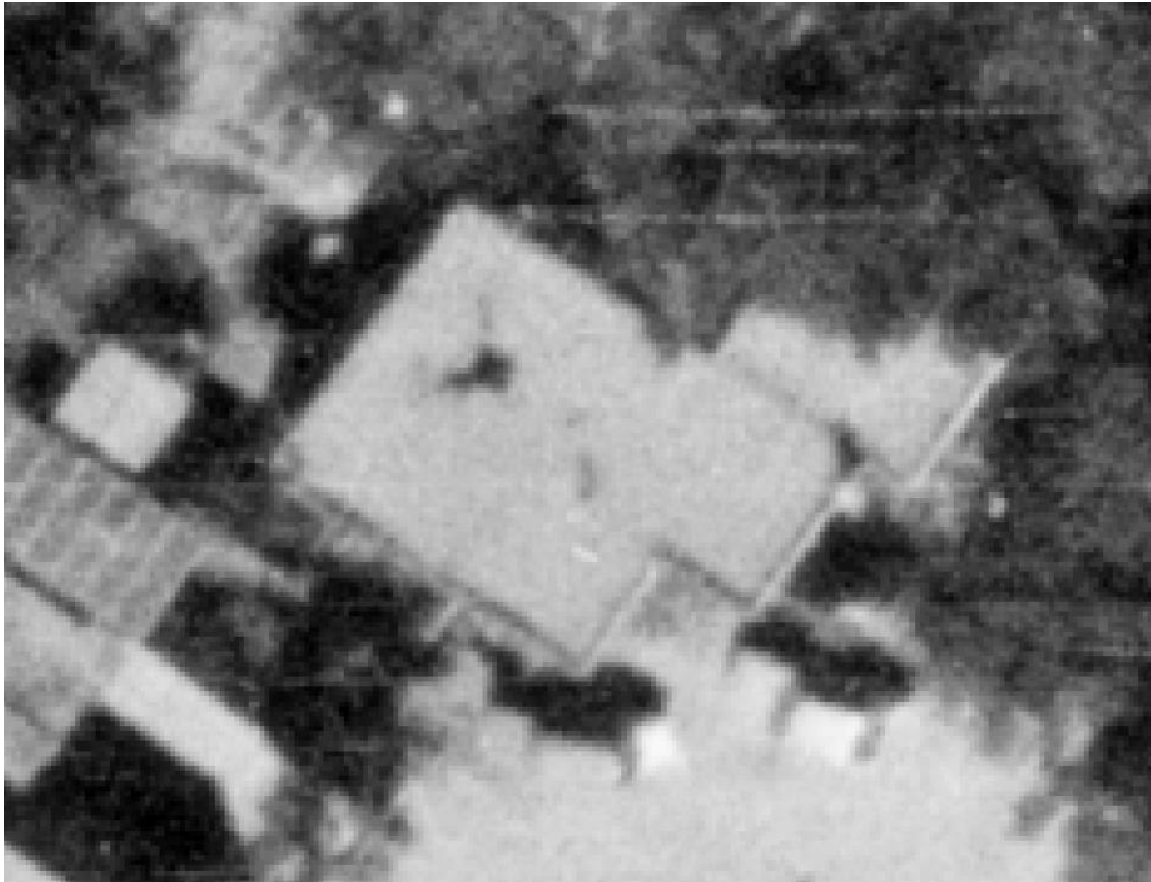
Figure 8: September 11, 1978, aerial photograph. Note absence of present west addition.

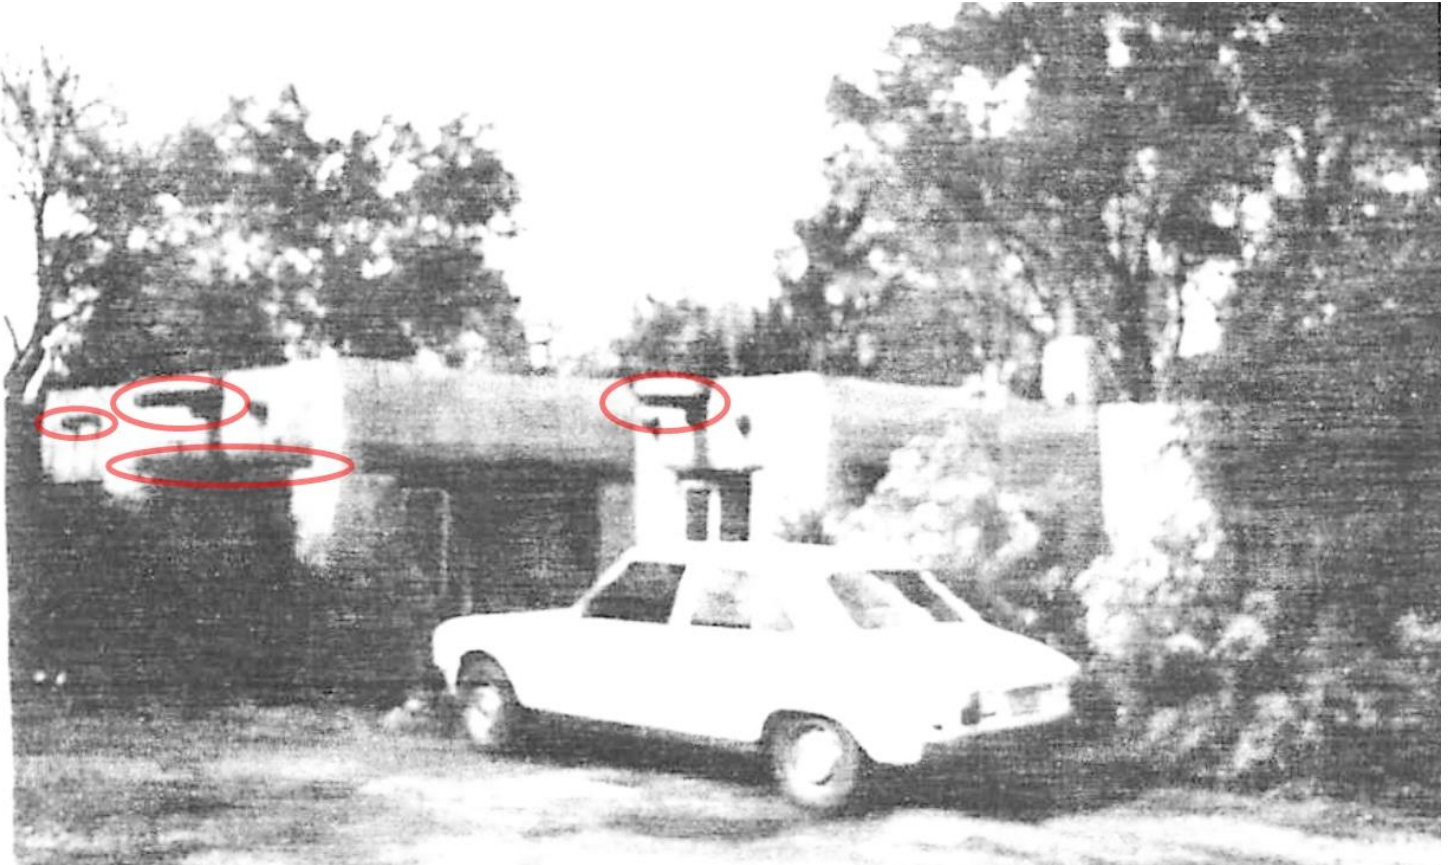
Comparing the current façade with the 1984 survey photo reveals change (Fig. 9). The lintels in the 1984 photo are fully exposed lumber, with the current tucked element calling into question the treatment given to the other headers across the house. In addition, new *viga* ends have been attached to the façade, and the stylized stepped canales were replaced with off-the-shelf trough units.

Figure 9: Copy of October 26, 1984, HBI survey photograph. Michael Belshaw. Note stylized canales, lack of vigas across south elevation, and squared lintels over south elevation window.

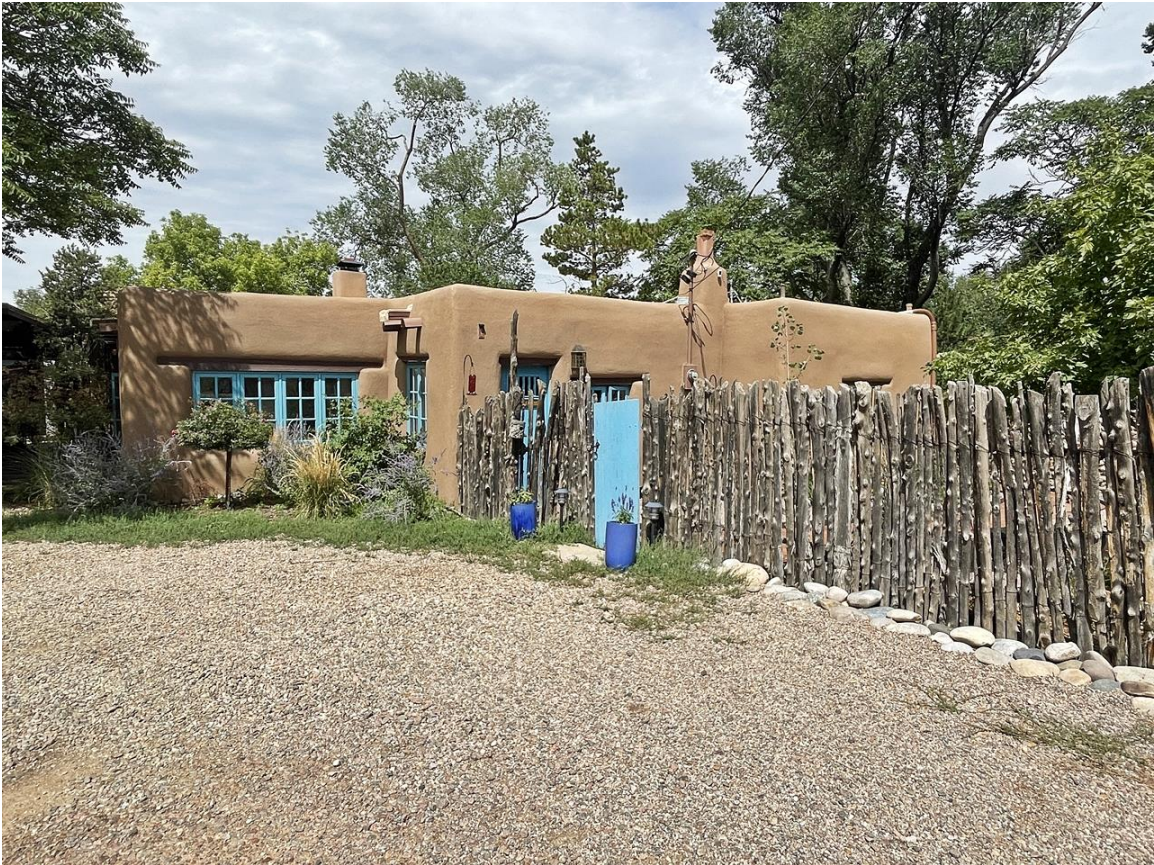
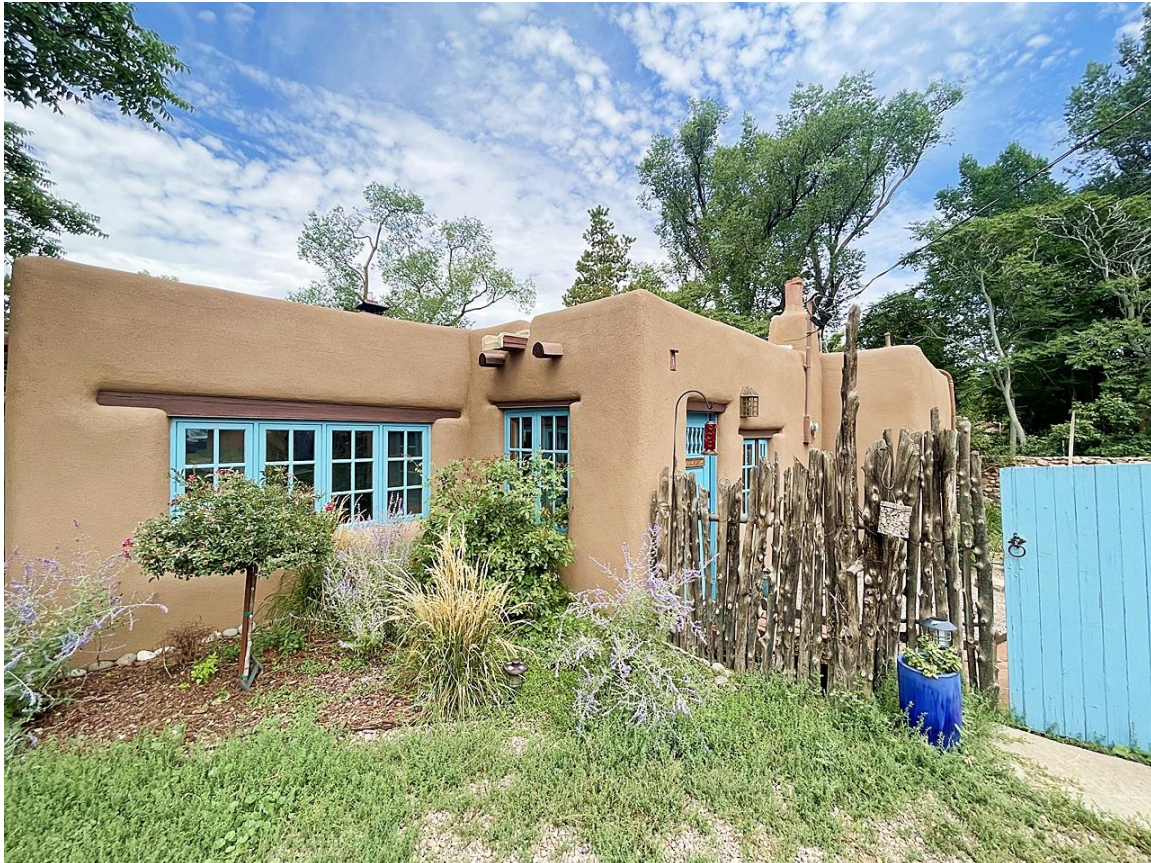
Most of the façade sits behind a coyote fence, creating a private yard. It presents a composition of cubic offsets that appear in its original design (Photos 3 & 4). A bank of four 6-light wood casement windows painted turquoise is visible to the public. Like all windows in the house, these are replacement units. They are modern with a geared, “crank-out” operation. The windows of this portion of the house sit deep within the wall, contrasting with the 1970s addition. A “tucked” wood lintel surmounts the opening. It is unclear if this or the other lintels are original.

Photo 3: 1 Plaza Fatima. Setting and east elevation. Camera facing northwest.

Photo 4: East elevation oblique. Camera facing northwest.

Given the Board’s decision about whether the 1970s addition damaged its design, the house could remain Contributing. In this case, the east elevation and southeast corner would be recommended as the primary facades, with the provision that the changed fenestration, including all windows and doors, would not be part of the designation.

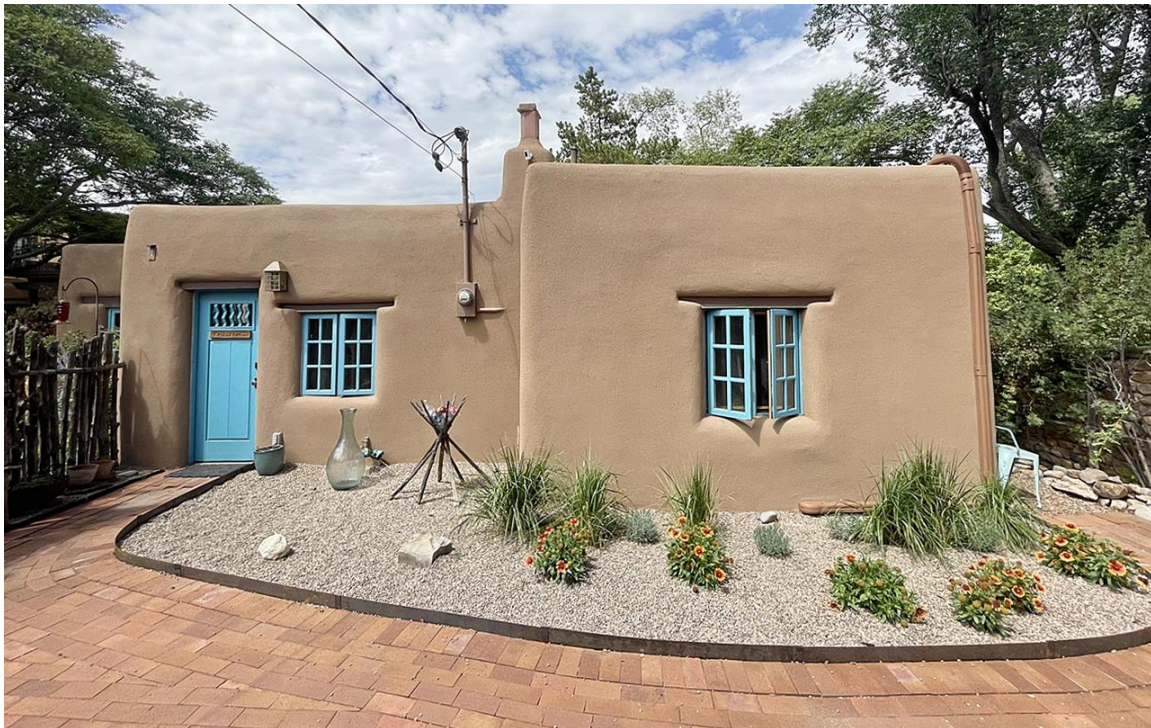
Inside the yard is the primary entrance to the house. It has a wood door with a lightning-bolt “window” (Photos 5 & 6). Affixed to the door is a carved wood plaque reading “1 Plaza Fatima.” The door’s vintage is unclear, but it doesn’t appear to be historic. Beyond the entry façade is a projection cut with one opening holding paired 6-light casements (Photo 5).

Photo 5: East elevation at entry. Camera facing west.

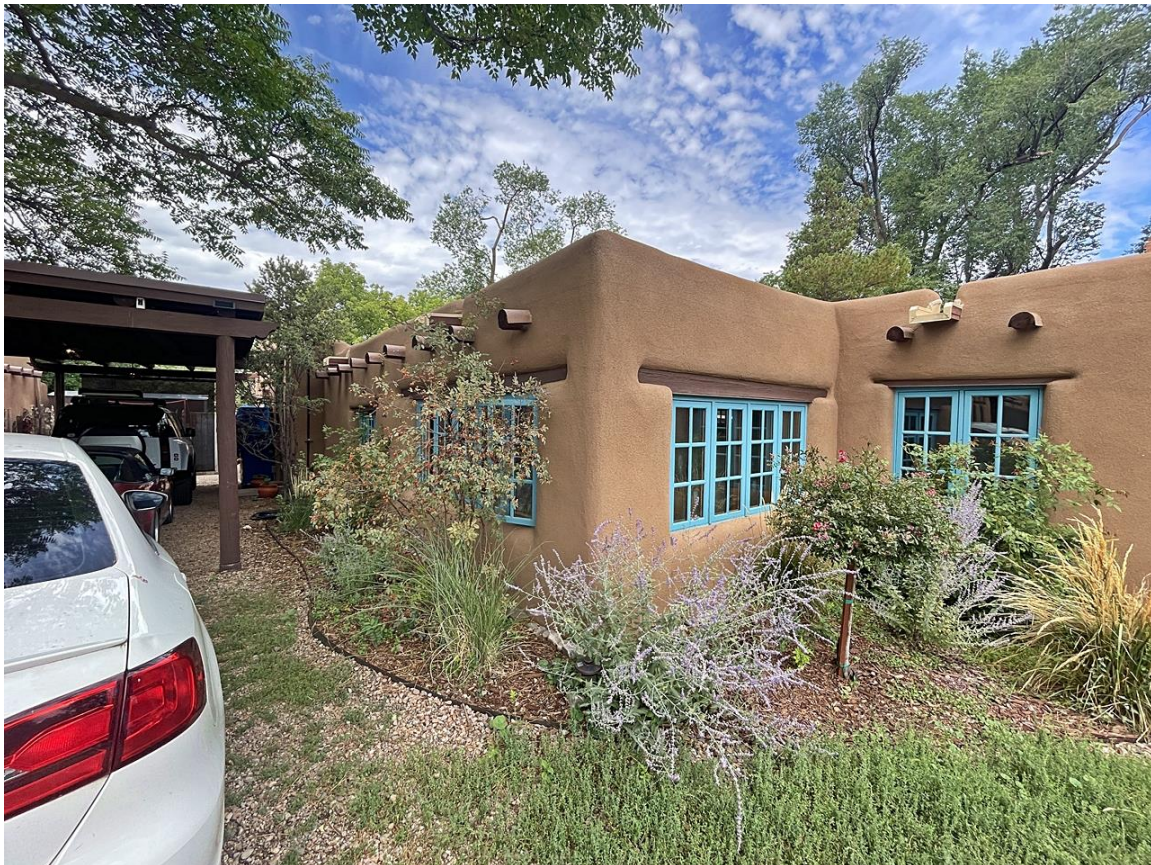
This elevation faces a gravel parking area, protected by a c.2022 HDRB-approved carport (Photo 7). The east end shows what is likely the original fenestration openings, beginning with a ribbon of five 6-light casement windows (Photo 8). These, too, are replacements.

Photo 7: South elevation oblique and recent carport at left. Camera facing northwest.

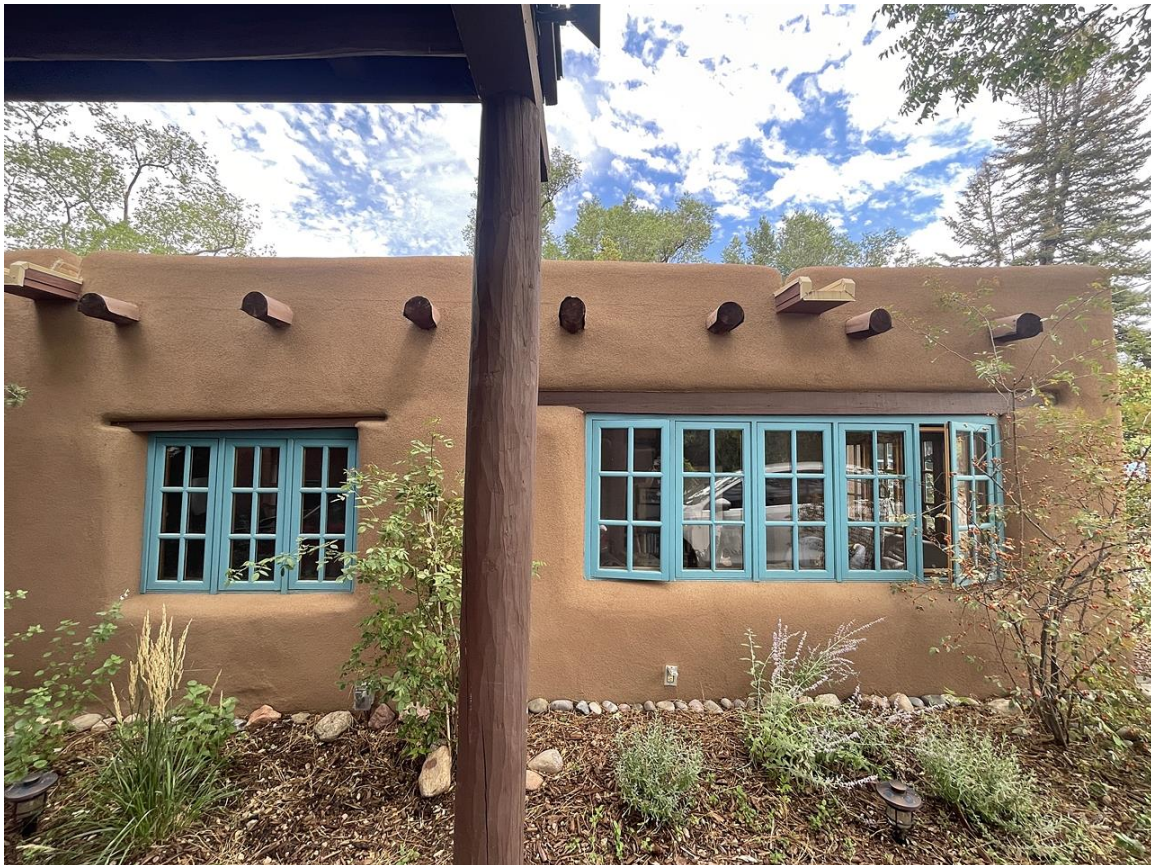
Photo 8: South elevation. Original portion of building after renovation. Camera facing north.

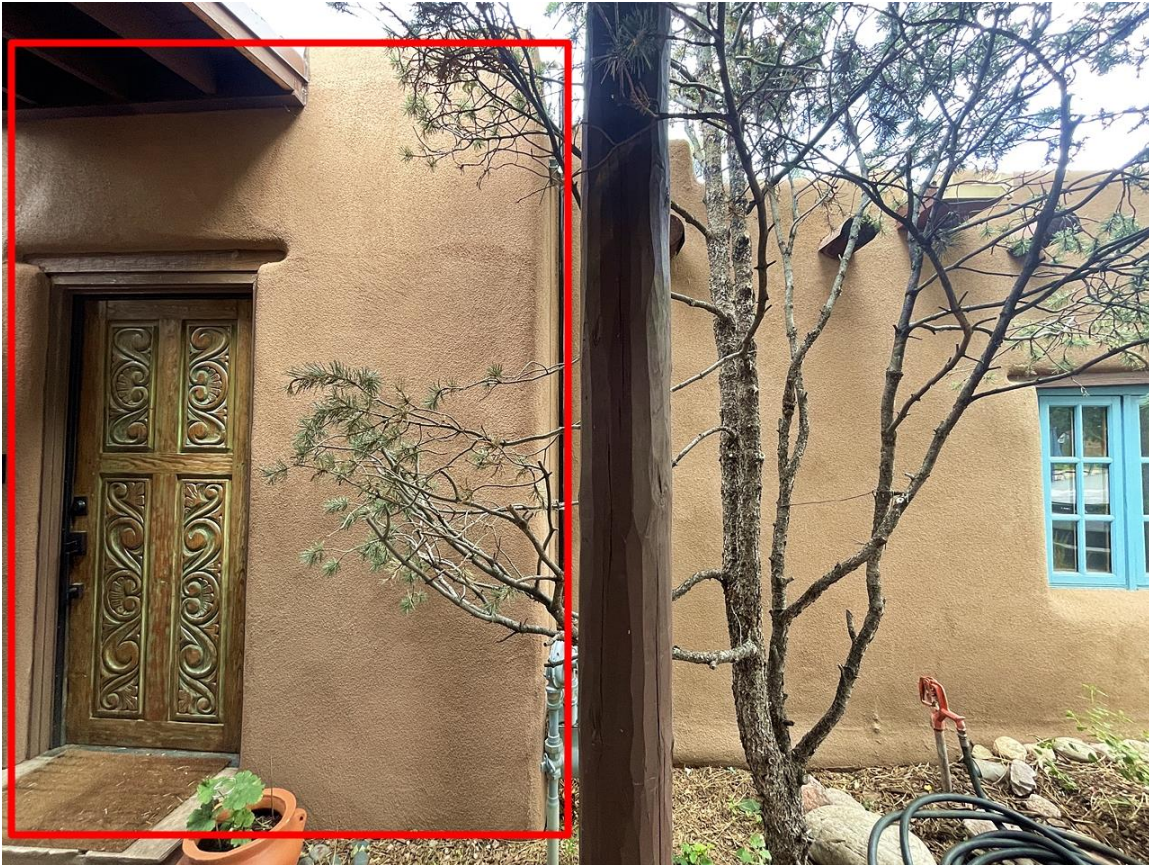
Photo 9: South elevation. Mid-1970s addition highlighted in red. Camera facing north.

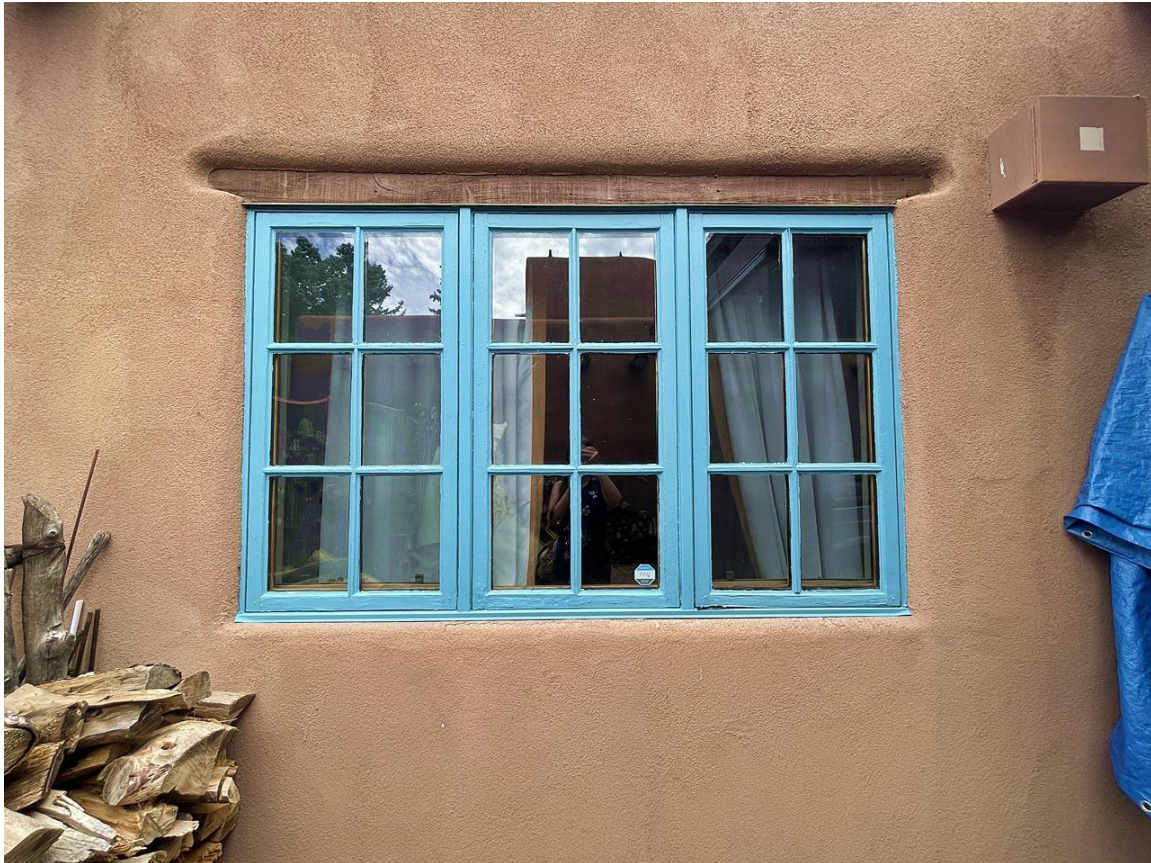
Photo 10: South elevation. Mid-1970s addition, window detail. Camera facing north.

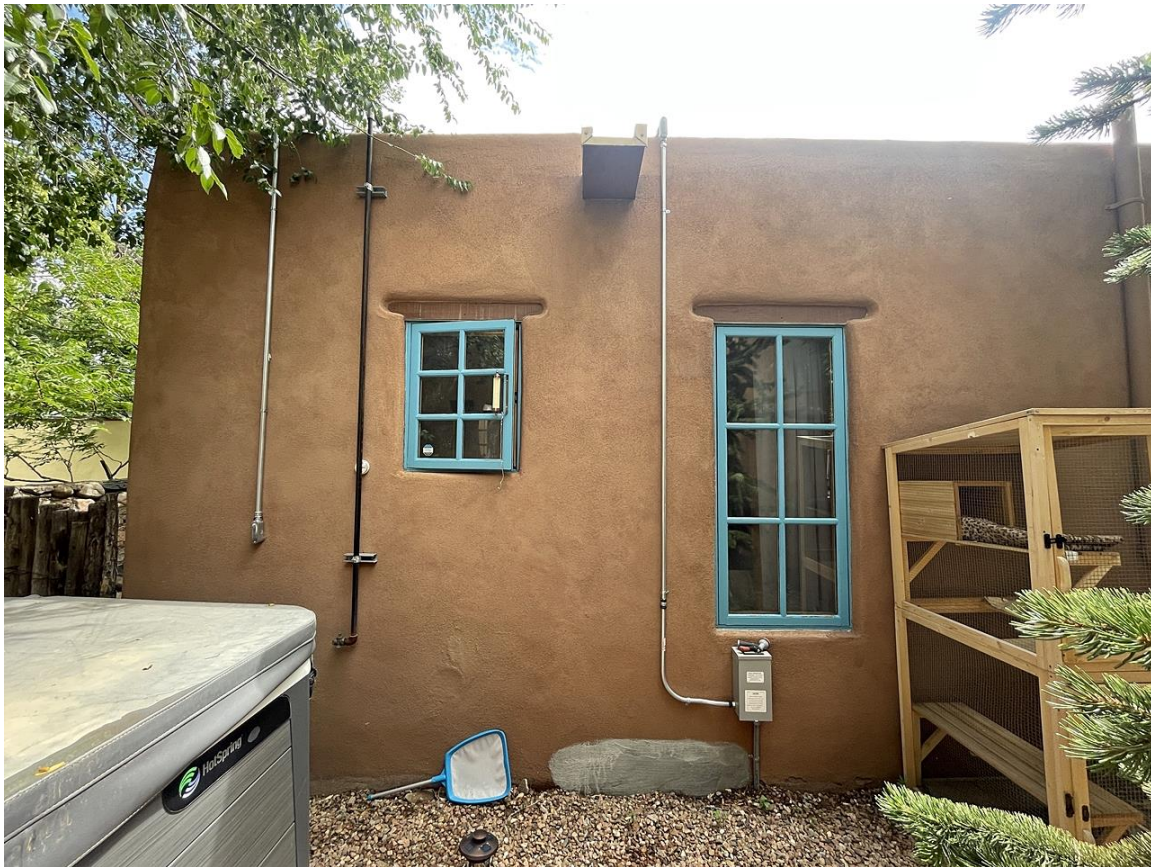
The west elevation is entirely made of the 1970s addition. It has three openings fitted with casement windows topped with tucked lintels (Photos 11 & 12).

Photo 11: West elevation. Mid-1970s addition, north end. Camera facing east.

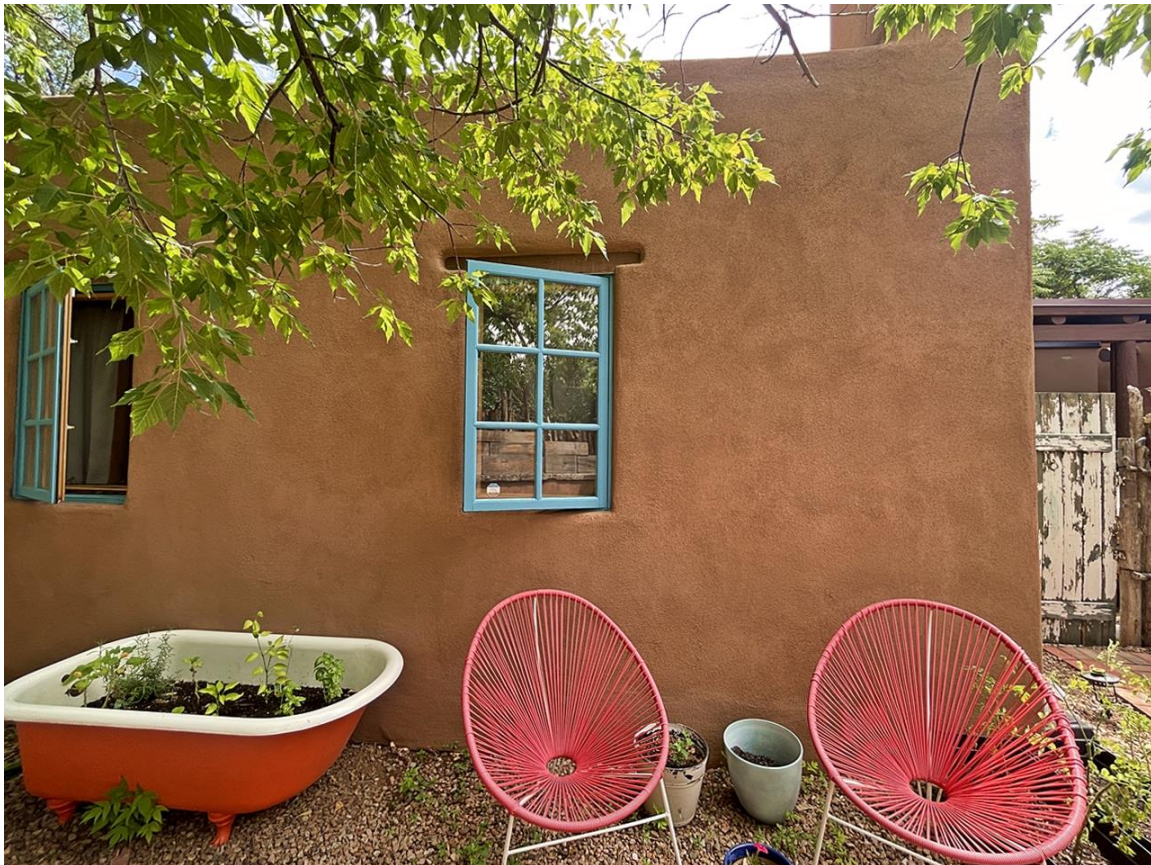
Photo 12: West elevation. Mid-1970s addition, south end. Camera facing east.

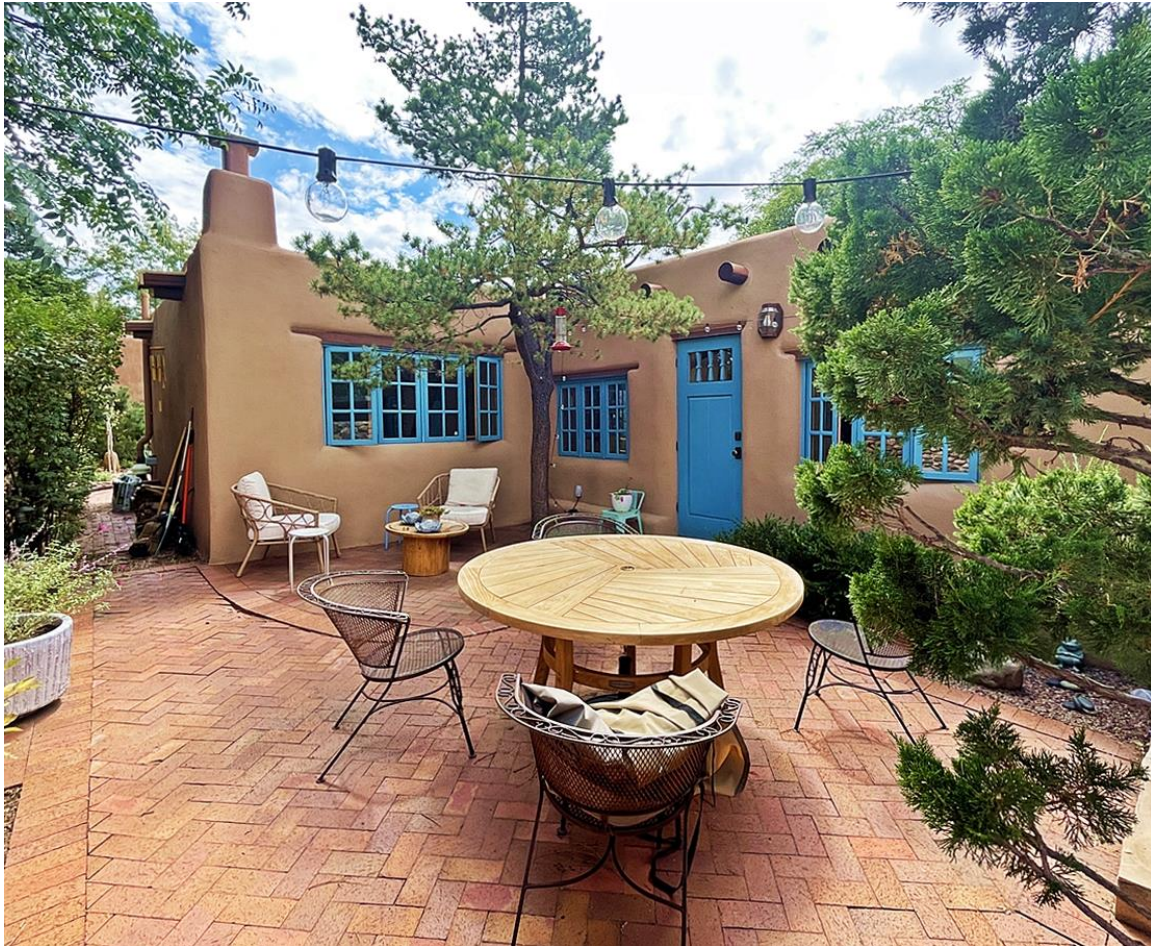
The back of the side of the building is enhanced by a private courtyard around an indent created by the 1970s addition. The original building, forming the east and north sides of the courtyard, has similar fenestration to other façades of the house (Photo 13). The courtyard's west wall represents the addition and has French doors (Photo 14). The east end of the original building has no openings (Photo 15); the west end includes a single opening holding 6-light casements (Photo 16).

Photo 13: North elevation at courtyard. Original portion of building. Camera facing southeast.

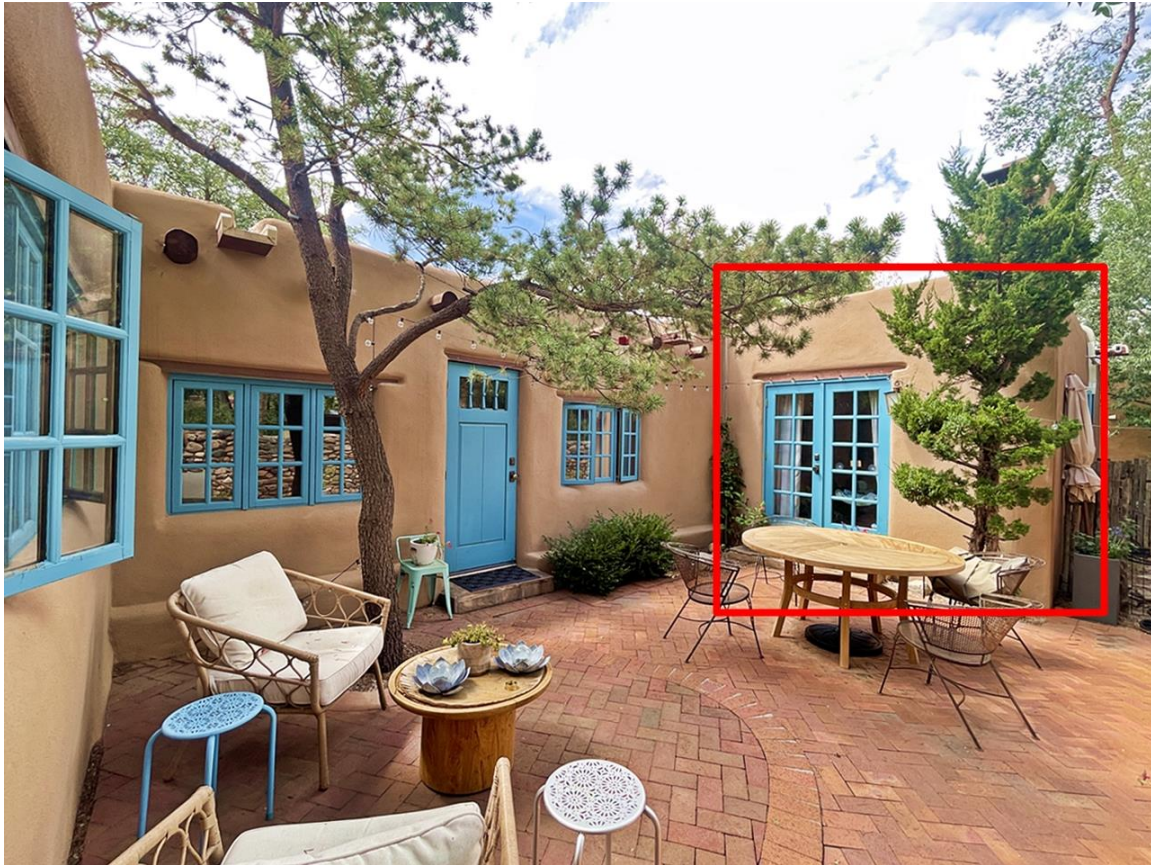
Photo 14: North elevation at courtyard. Mid-1970s addition highlighted in red. Camera facing southwest.

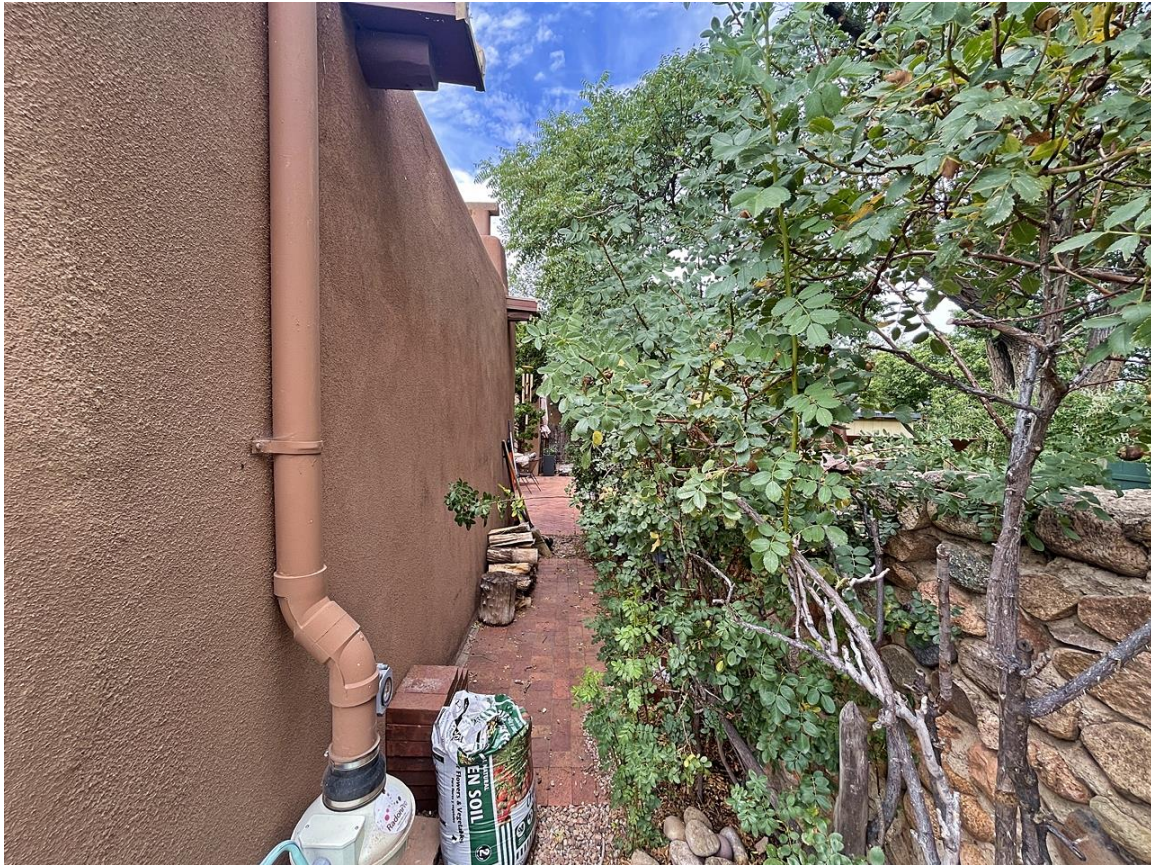
Photo 15: North elevation. Original portion of building. Camera facing west.
