City of Santa Fe

Plan Number: 2024-009321--HDRB

Project Description: 2024-009321-HDRB, 1 Plaza Fatima, Downtown & Eastside Historic District, Contributing, Mark Lopez, agent for Mark Kreloff, owner, requests primary facade(s) designation for a residential structure.

2024-009321-HDRB, 1 Plaza Fatima, Downtown & Eastside Historic District, Contributing, Mark Lopez, agent for Mark Kreloff, owner, requests primary facade(s) designation for a residential structure.

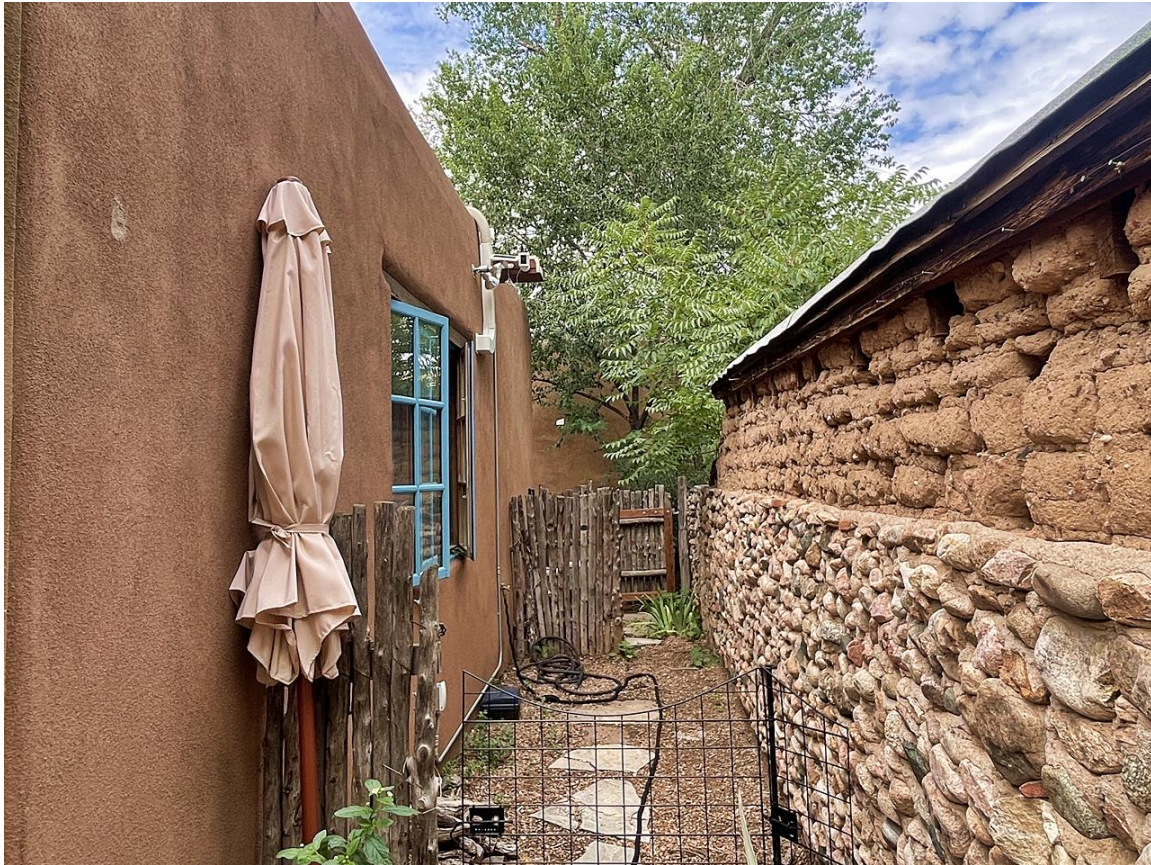
The back of the side of the building is enhanced by a private courtyard around an indent created by the 1970s addition. The original building, forming the east and north sides of the courtyard, has similar fenestration to other façades of the house (Photo 13). The courtyard's west wall represents the addition and has French doors (Photo 14). The east end of the original building has no openings (Photo 15); the west end includes a single opening holding 6-light casements (Photo 16).

Photo 16: North elevation. Mid-1970s addition. Camera facing west.
