Historic Cultural Properties Inventory (HCPI) Base Form (FORM 1)

1. Name of property: Carlos and Virginia Romero/ William and Emily Romero House	2. Location: 140 Romero Street Westside-Guadalupe Historic District – Santa Fe	3. Local Reference Number: Santa Fe ID: H-3192 4. County: Santa Fe Parcel # 12306560

8. Name of Project: HDRB Status Evaluation		
9. Lat/Long: 35.6838508, -105.9522312		
10. Photo Information: John W Murphey, photographer. Photo 1: View of east elevation, facing northwest. February 27, 2025.

Historic Cultural Properties Inventory (HCPI) Detail Form (FORM 2)

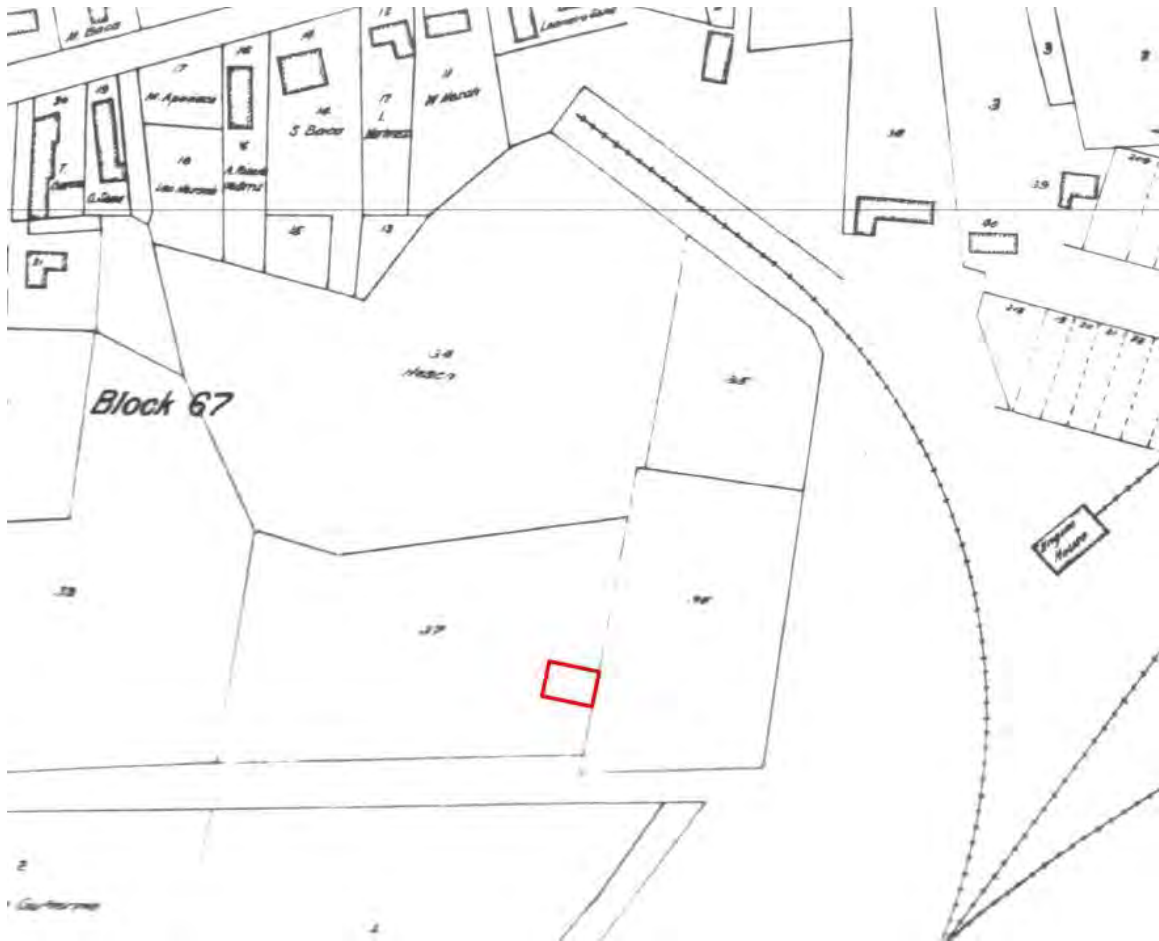
**Figure 1: N. L. King, “Map of the City of Santa Fe,” 1912.
 Approximate location of future subject lot highlighted in red.**

It is unclear when Hanley acquired the Manhattan Road land, but in 1910, he hired the city land surveyor John L. Zimmerman to create a plat. This plat is likely the bounded area shown on the 1912 King’s map as Lot 37 (Fig. 1). Following a probate of his estate, his executors, consisting of three family members from Lynn, began selling off the Manhattan Road land. Each deed indicates the parcel was part of Lot 37. In this way, the original land was subdivided into seven smaller lots, one of which involves the subject parcel (Fig. 3).

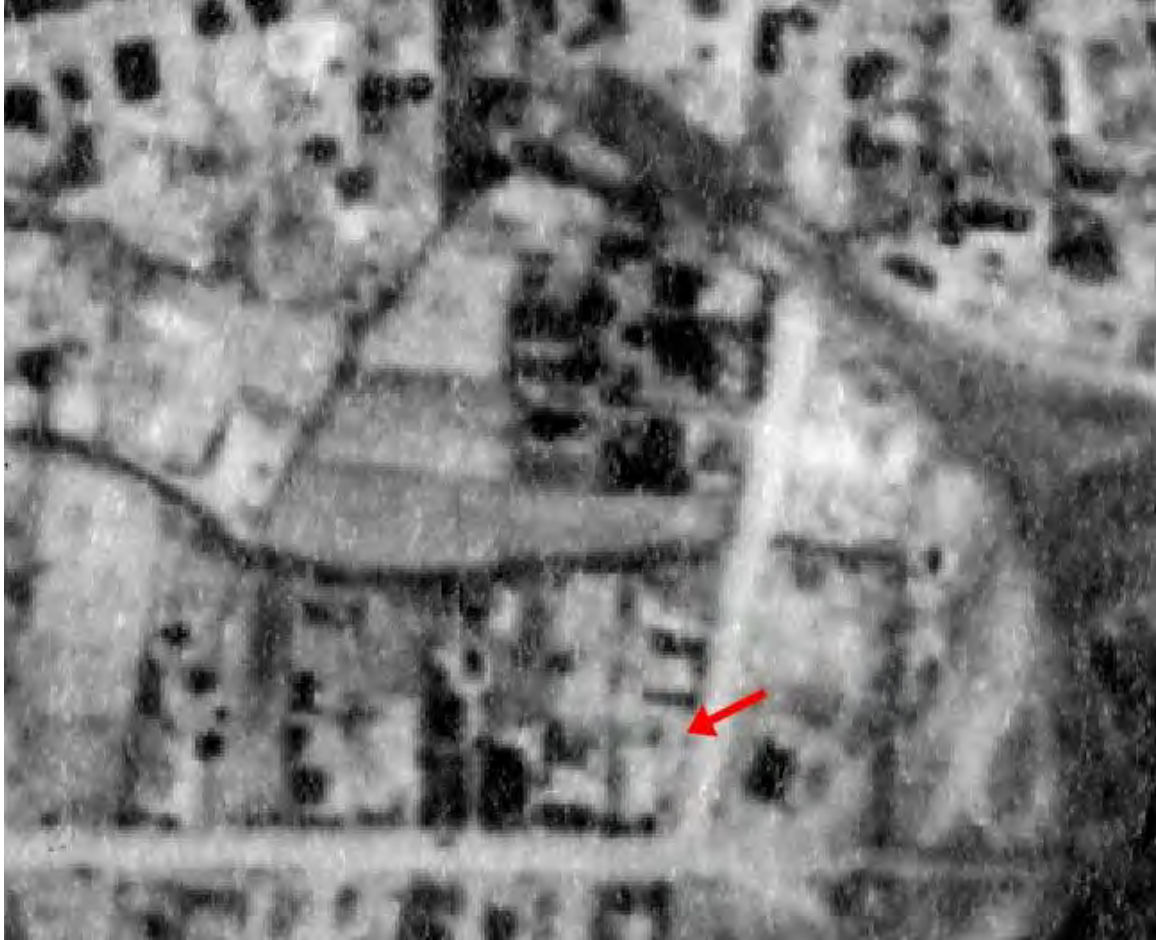
Figure 2: 1935 Soil Conservation Service aerial photograph.
Note the current house is not present but the property may include a structure.

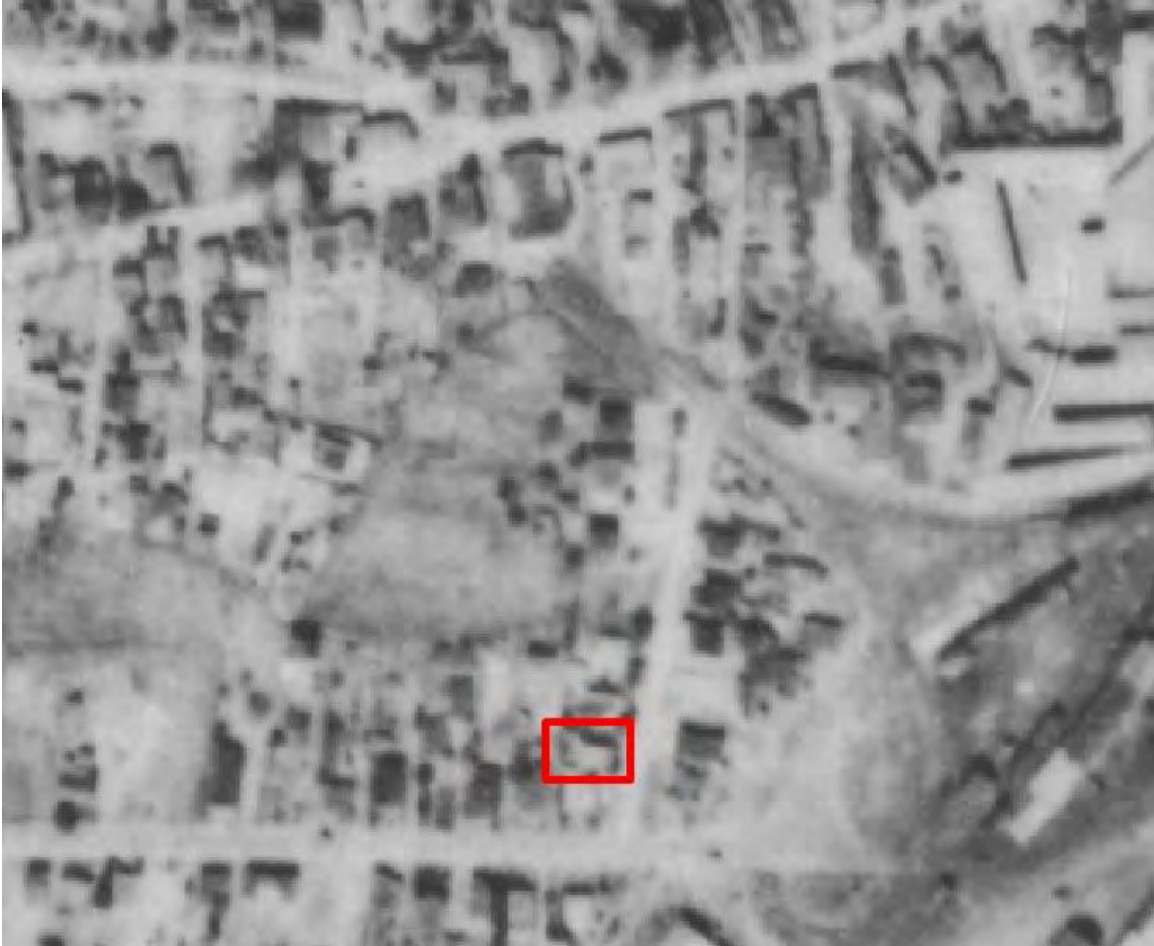
Figure 4: October 25, 1948, aerial photograph.
Note rear addition appears to extend into neighboring property to the north.

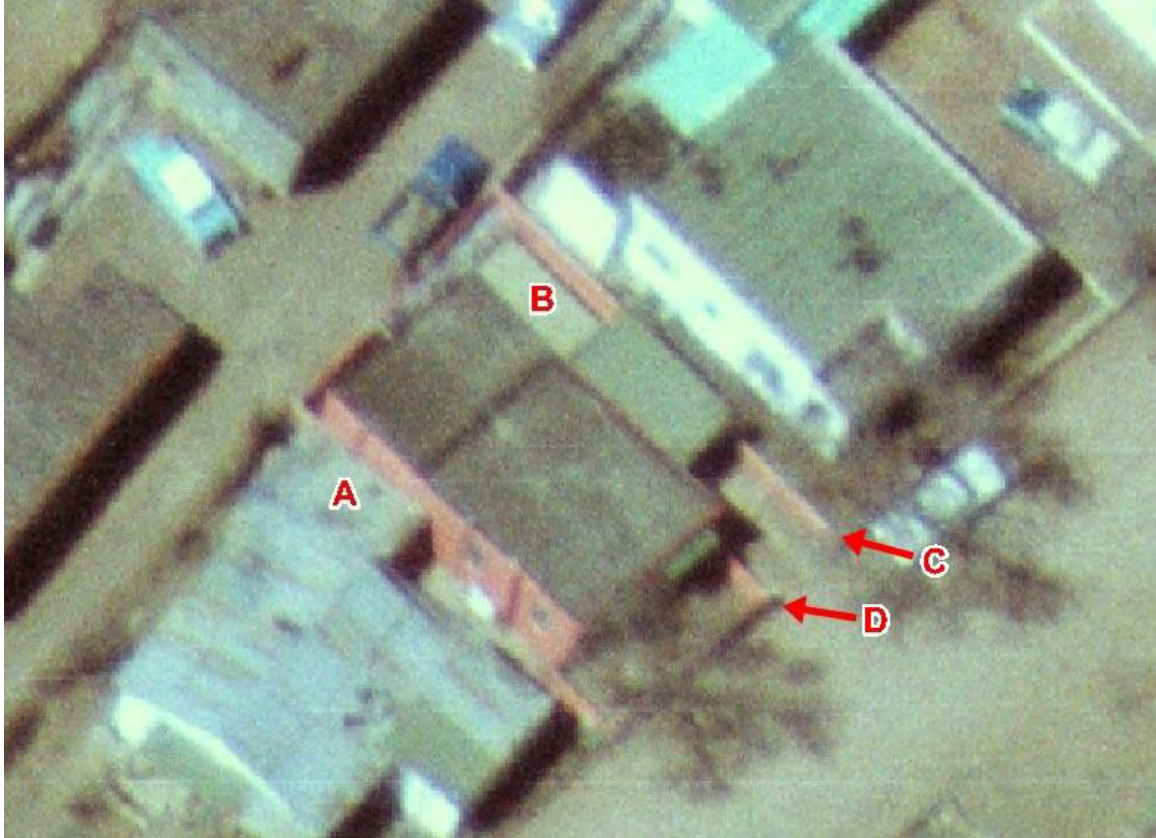
Figure 6: February 27, 1969, aerial photograph.
A. Garage at neighboring property appears to be attached to subject house; B. porch has been added; C. north property wall at lower height; D. front yard wall present.

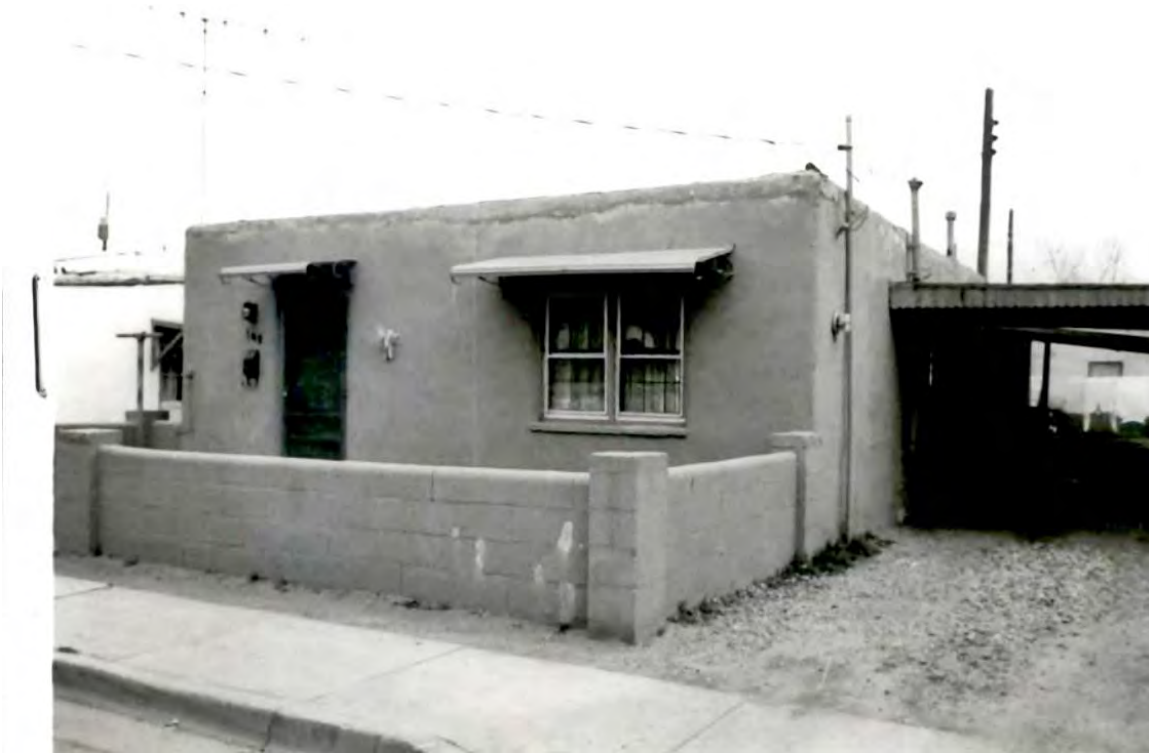
The opening to the north encloses a recently installed clad sliding unit (Photo 5). Its lintel has been altered. The 1985 survey shows that it historically held two 6/6 hung sash with a mullion bar and a stuccoed sill (Fig . 8). Both the entry and windows had awnings in 1985.

**Figure 8: August 1985 Historic Building Inventory photograph. Harry Weiss, photographer. Courtesy of NMCRIS.
 Note paired 6/6 windows, unstuccoed yard wall, and open carport and porch.**

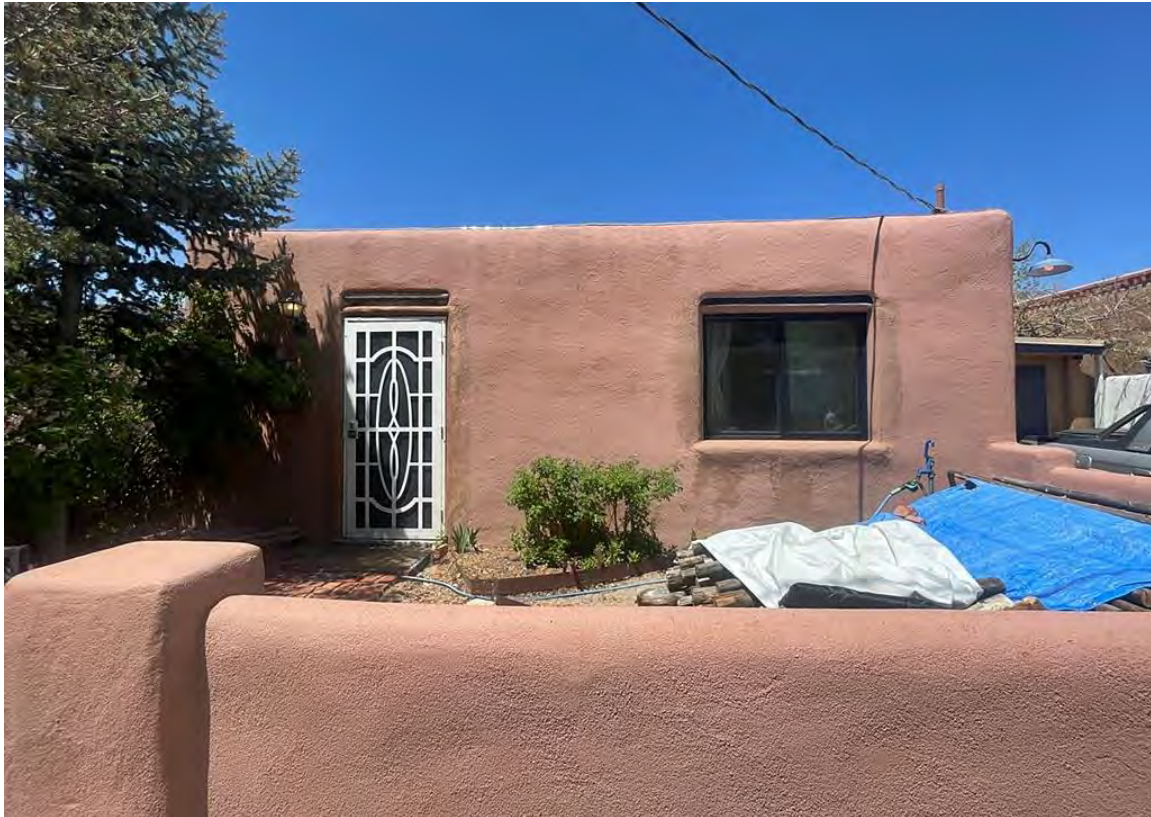
Photo 2: East (front) elevation. Camera facing west.

The front façade presents to the street an uncomplicated arrangement of two openings (Photo 2). The façade is flat, with no articulation other than these openings. The south opening holds a non-historic door obscured by a decorative metal security grate. The door behind the security door is a pre-hung colored glass door (Photo 3). A piece of wood that appears to be hand-carved is sunk into the stucco above the door (Photo 4). This flourish is not original.

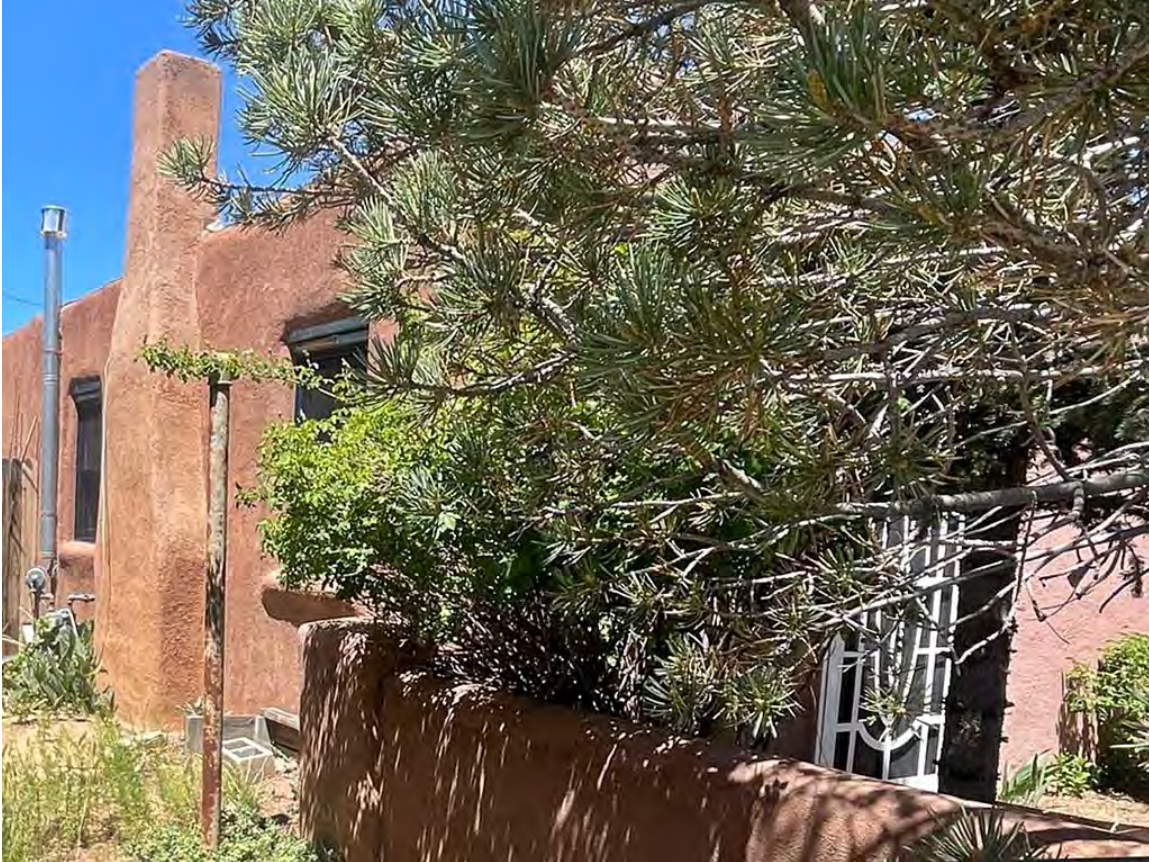
Photo 6: South elevation. East end representing original house. Camera facing northeast

home has a balanced façade of a stuccoed tapered chimney flanked by two windows (Photo 6). The 1/1 clad windows are recent replacements. The remaining part of the façade comprises the addition and has no fenestration or architectural detail (Photo 7).

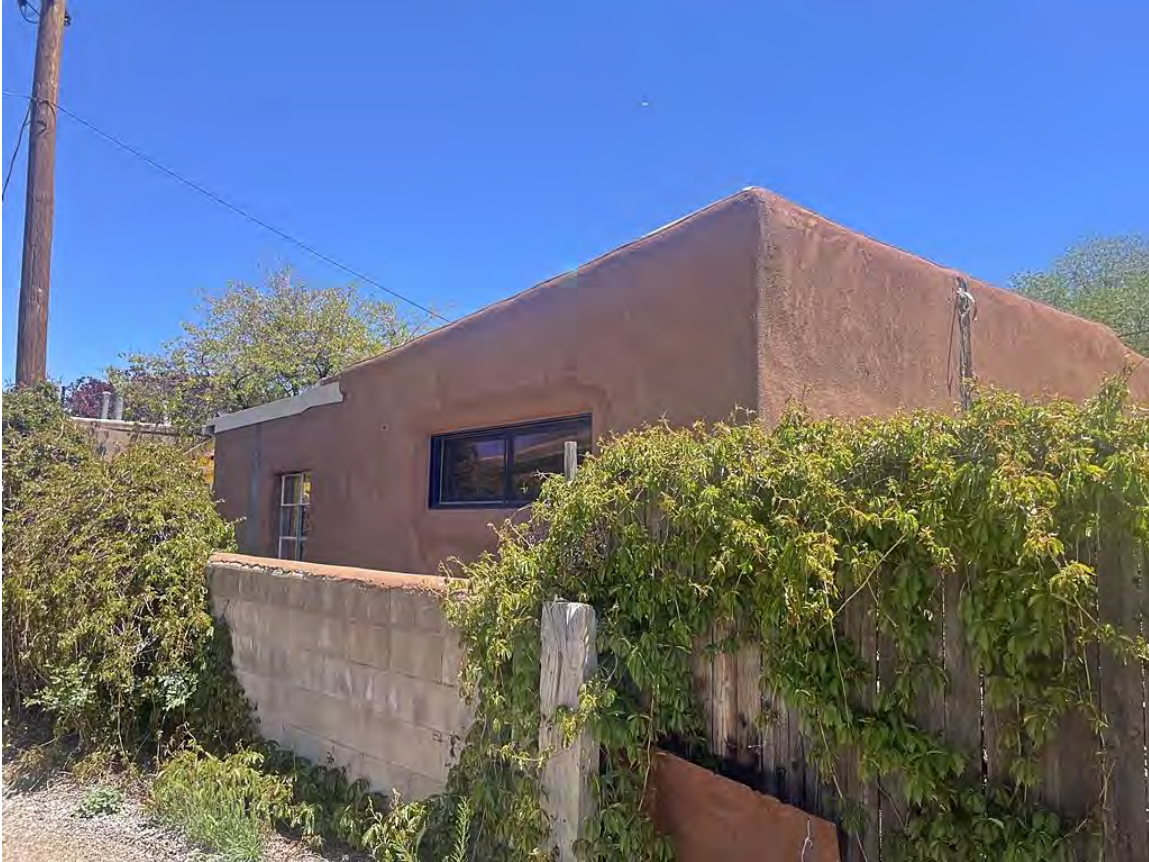
Photo 8: West elevation representing addition and enclosed porch. Camera facing northwest.

The west side of the home is made entirely of the addition and the enclosed porch (Photo 8). It faces an access alley for several homes off West Manhattan Avenue. It contains two windows. Spanning the south end is a long ribbon window comprising a recent aluminum sliding unit (Photo 9). A much smaller 6-light steel window stands at the opposite end, delivering light into what was historically a porch (Photo 10).

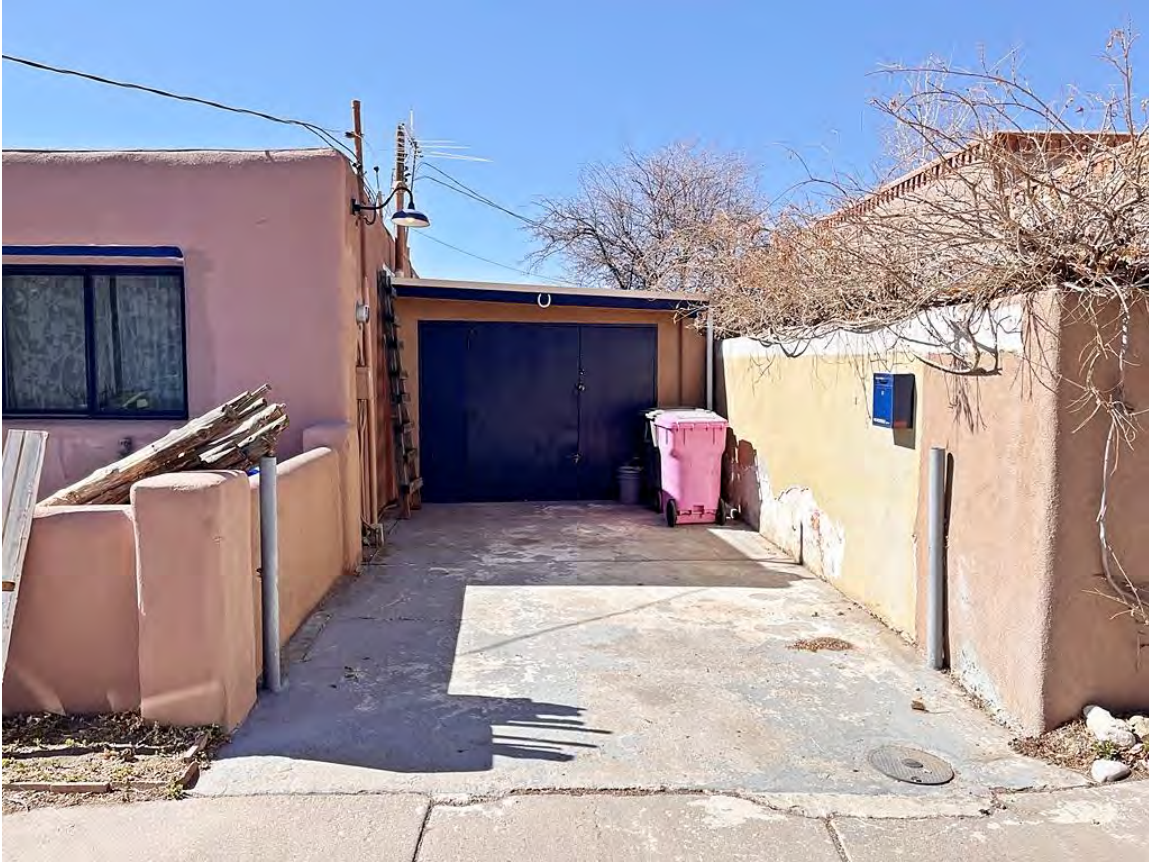
Photo 11: North elevation. Enclosed carport. Camera facing west. John W. Murphey, February 27, 2025.

This elevation includes an attached garage (formally an open carport) and an enclosed porch extending off the addition (Photo 11). The roughly 220-square-foot garage is set back from the street and is attached to the house and the north property wall. Its east and west walls are of frame construction.

It appears in the 1958 aerial photograph as a lower, flat roof carport. Its current roof slopes northward, suggesting an alteration which was likely an intervention to improve drainage. Painted plywood fills its opening, including a cut to create a swinging door (Photo 12). It was still an open carport when photographed in 1985 (Fig. 8). There is a non-historic pedestrian door on the west side of the garage along with a recent window (Photo 13). The garage is sealed and works as an auxiliary room to the house.

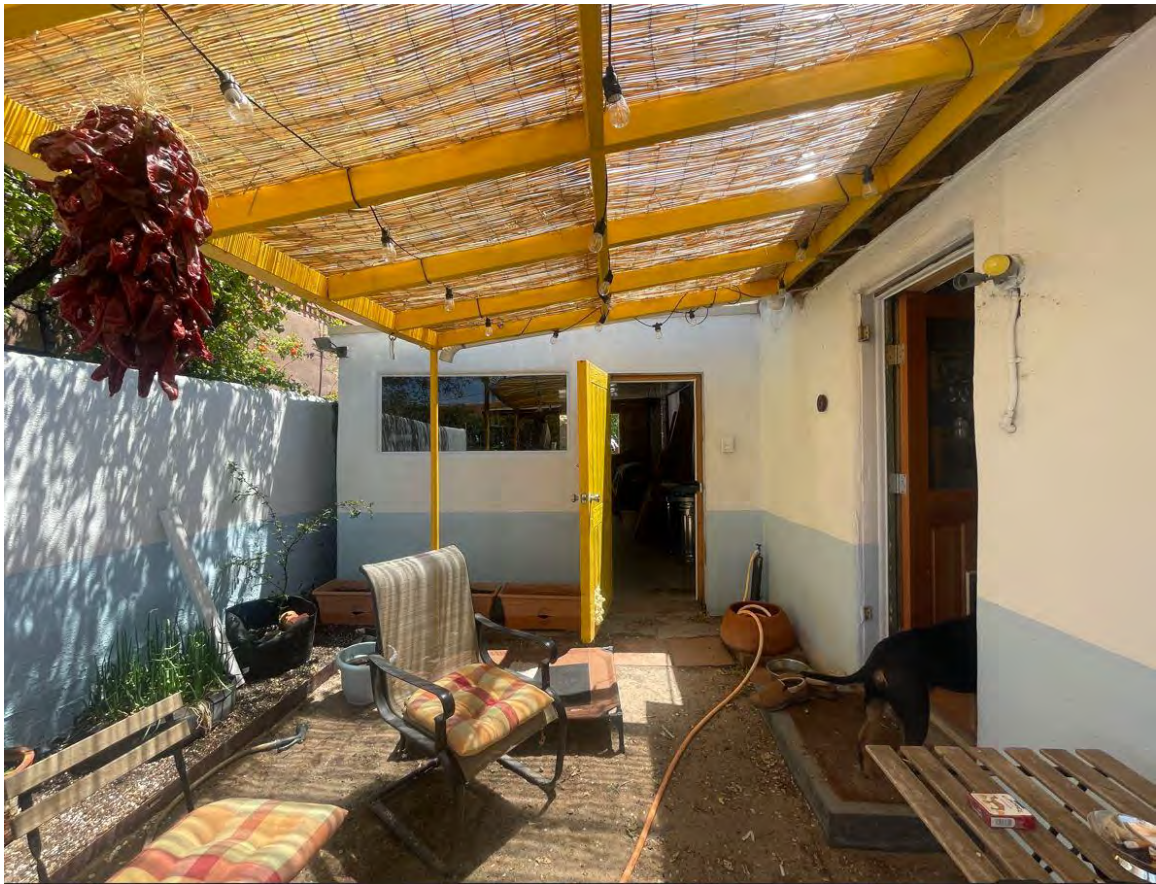
Photo 13: West elevation of enclosed carport. Camera facing east.

The west end of the façade comprises the enclosed porch (Photos 13 & 14). A non-historic decorative wood door opens to the primary bedroom (Photo 14). A single steel window is situated at the west end. An informal ramada painted yellow shades the area.

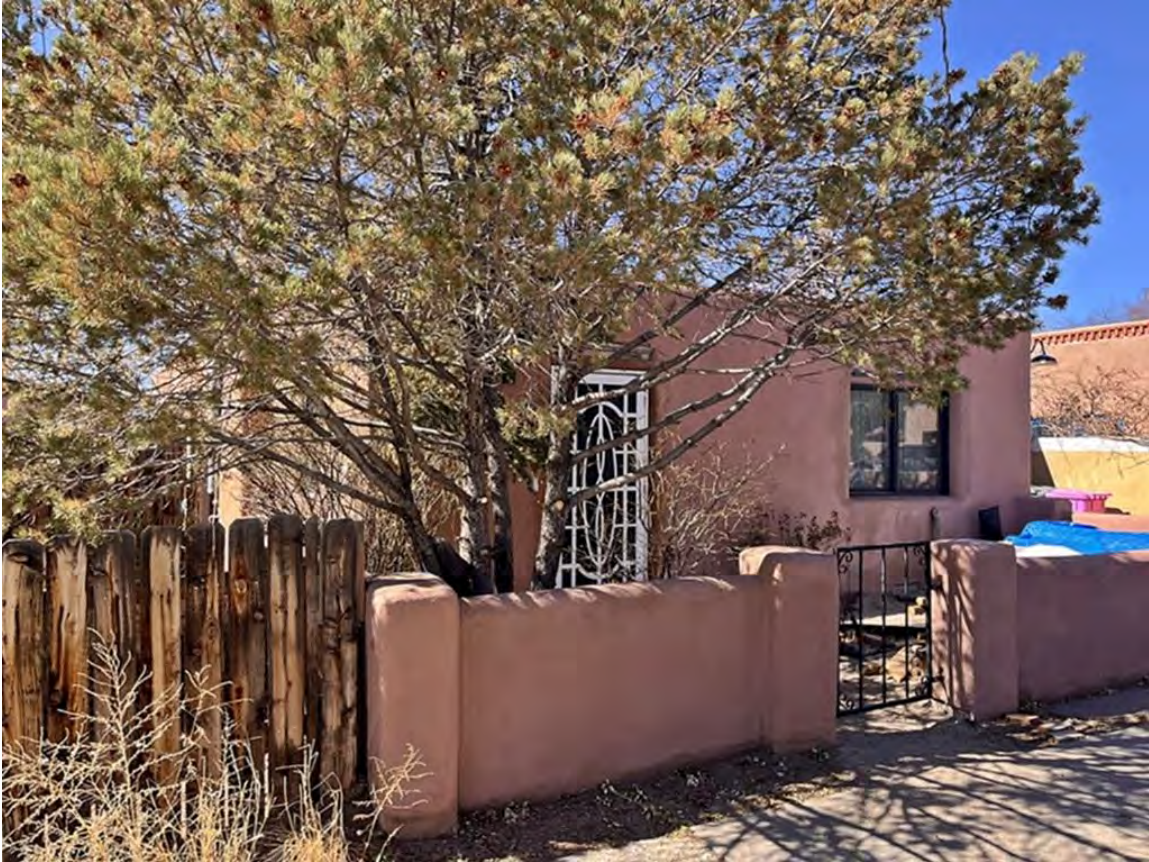
Photo 15: Front yard wall. Camera facing northeast. John W. Murphey, February 27, 2025.

A short stucco-on-block wall defines the home’s front yard. It is composed of sections of walls set off by stout, square posts. There is an opening near the south end holding a steel gate (Photo 15). The wall continues for a short distance along the driveway, tying into the house. It does the same at the south end.

Although the front yard wall likely dates to the 1960s, it was modified after 1985 with a Pueblo Revival-style treatment, including stucco surfacing and softened, rounded edges. This makeover is not in keeping with the house’s vernacular character and introduces a stylistic inconsistency. For these reasons, the wall is recommended as Non-contributing.

The construction is cinderblock, chicken wire, and stucco covered with elastomeric or other latex paint which has aged in the sun to a slightly pinkish brown color.
