# memo

**DATE:** July 8, 2025

2025-010666-HDRB, Shelby St. Foot Bridge, Downtown & Eastside Historic District, no status, Wonderstone Consulting LLC, agent for City of Santa Fe, owner, requests a historic status review for the pedestrian bridge.

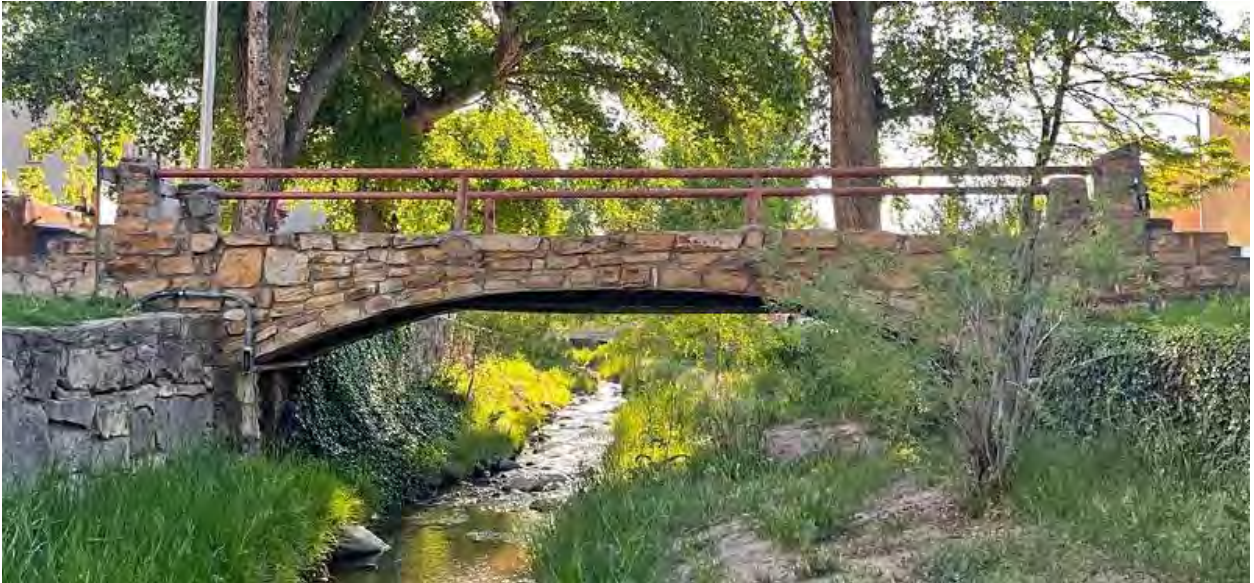
Figure 2: Side view of Shelby Street Footbridge

The Shelby Street Footbridge was constructed in 1968, most likely as a replacement for a timber bridge that was constructed in the 1930s as part of the Civilian Conservation Corps project. The 1968 bridge is constructed of concrete slabs with timber and stone abutments and concrete girders (see figure 4 for parts of a bridge), and a steel pipe railing. An additional concrete beam was placed between the girders for added support at an unknown date. The exterior of the girders is embedded with sandstone blocks set into a concrete bed, which gives the footbridge an appearance of rock construction in an arch. The entrance to the bridge is bordered on each side by low sandstone parapets about 12" in height, and the metal railing is embedded in square masonry end posts at about 18" in height. The entrance on the north of the bridge has curved stone walls up to four feet in height flanking the approach to the bridge. These walls connect to the masonry end posts. The south entrance has had stones removed to accommodate the widening of the pedestrian path.
