Historic Cultural Properties Inventory (HCPI) Base Form (FORM 1)

1. Name of property: Shelby Street Footbridge	2. Location: Over Santa Fe River Downtown and Eastside Historic District – Santa Fe	3. Local Reference Number: Santa Fe ID: N/A 4. County: Santa Fe Parcel # 910017966
--	--	---

5. Property Type: <input type="checkbox"/> Buildings: <input checked="" type="checkbox"/> Structures: Bridge <input type="checkbox"/> Site <input type="checkbox"/> Object	 
6. Date of Survey: May 20, 2025	
7. Previous Survey Date(s): <input type="checkbox"/> Yes: <input checked="" type="checkbox"/> No:	
8. Name of Project: HDRB Status Evaluation	
9. Lat/Long: 35.6850349, -105.9392324

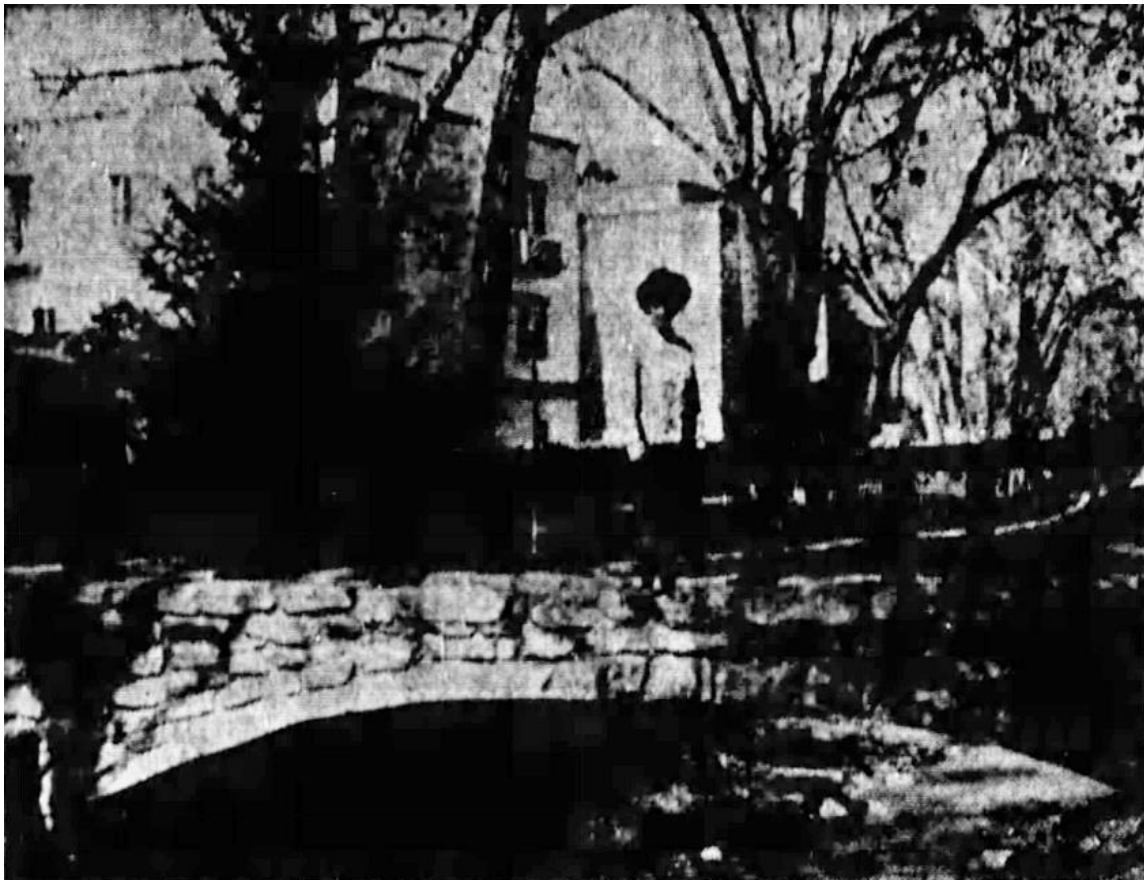
Figure 1: Lela Wilson stands at the center of the recently completed Shelby Street Footbridge, April 1968. Courtesy of the Santa Fe New Mexican.

Its completion was marked with a photograph in the local newspaper (Fig. 1), although the project went unmentioned in the State Parks and Recreation Department’s internal newsletter. It did, however, appear in the background of two promotional films produced in the late 1960s to advertise New Mexico’s state parks (Fig. 7).

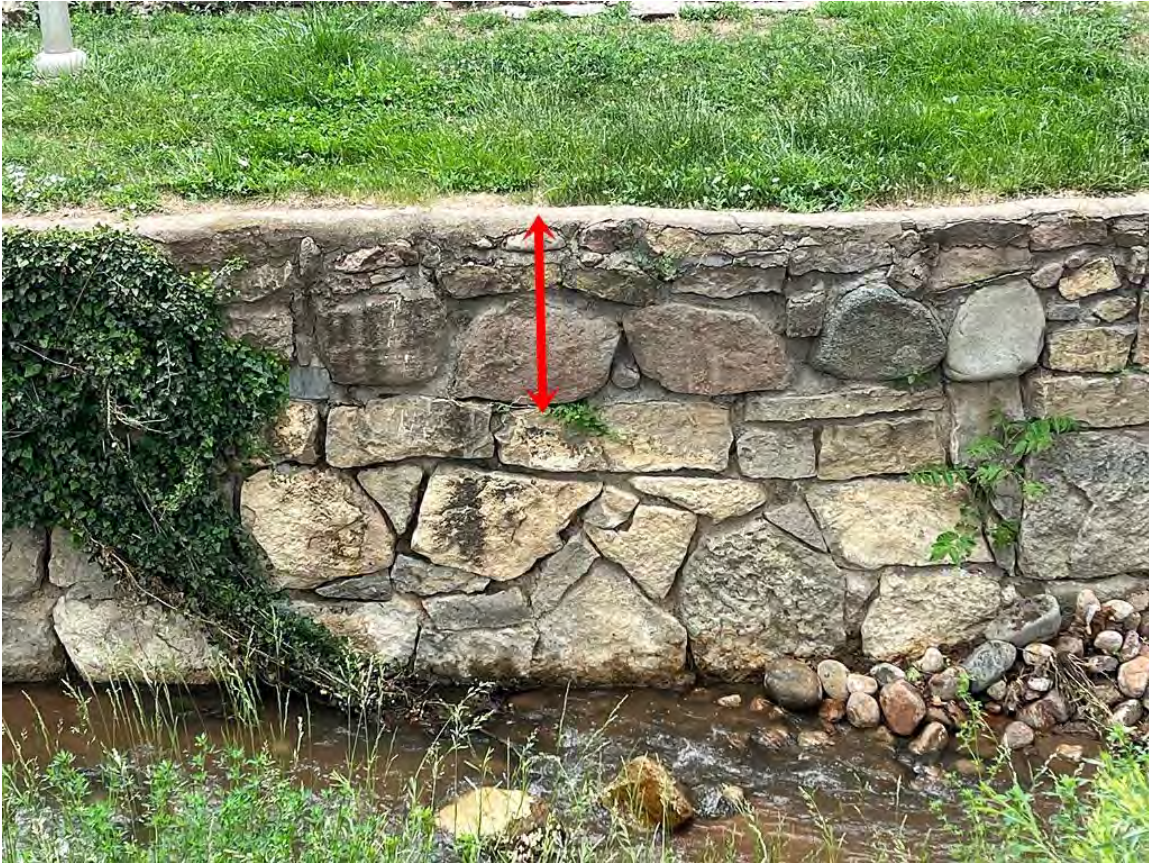
Following the park’s official designation, a series of additional improvements were undertaken. The stone retaining walls were raised to accommodate more fill (Fig. 4), new picnic areas with concrete tables and benches were added, turf was planted throughout, footpaths were laid, and signage installed—including an Official Scenic and Historic Marker framed in rustic brown logs. None of the archival sources reviewed—including newspaper accounts and records from the State Parks and Recreation Commission—mention the replacement of the original CCC-built log bridge.

Figure 4: Contemporary photograph showing where the river retaining walls were extended in the early 1950s to create the Santa Fe River Park.

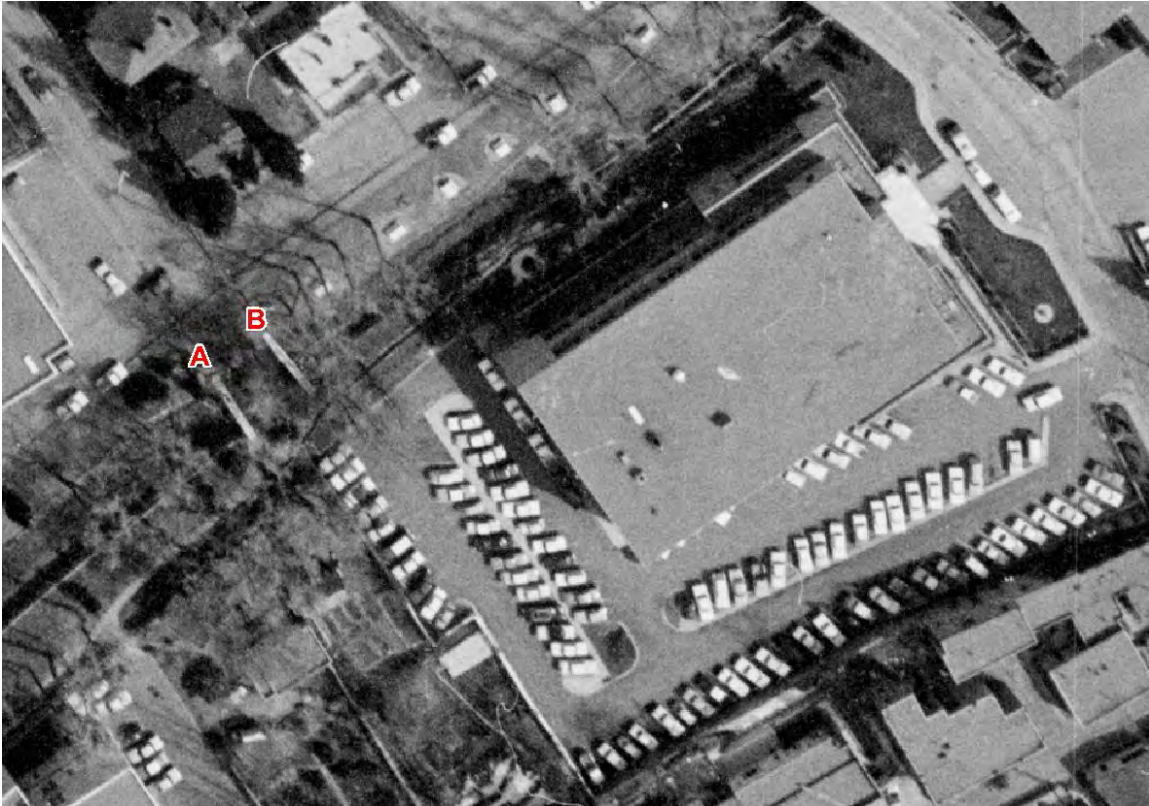
Figure 5: February 2, 1968, aerial photograph showing two bridges at the Shelby Street crossing. A. is the bridge erected 1968; B. is likely the CCC -constructed built in 1934.

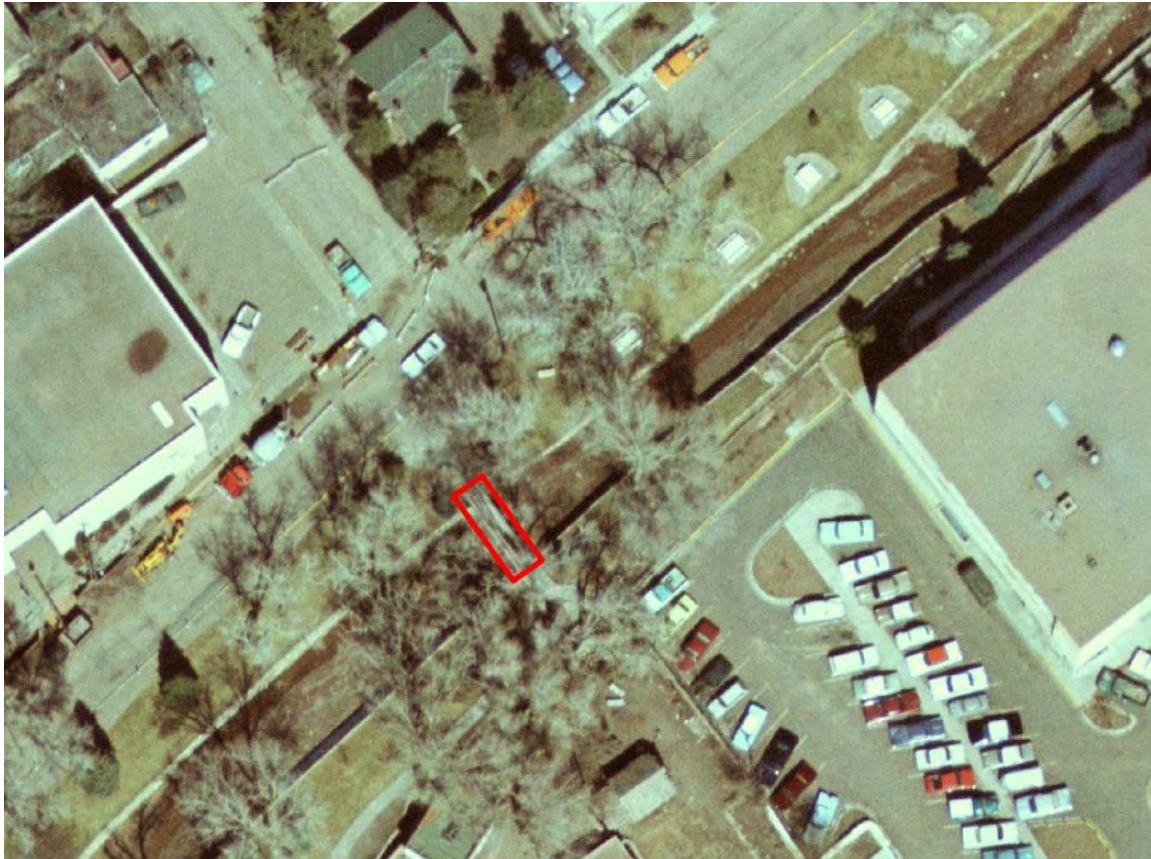
Figure 6: February 27, 1969, aerial photograph, showing the completed current bridge.

The current footbridge was constructed in early 1968, likely replacing an earlier structure—possibly the original timber span built during the CCC era. A February 1968 aerial photograph shows two footbridges crossing the river at the foot of Shelby Street (Fig. 5). By the following year, only the present bridge remained (Fig. 6). The bridge was erected by park personnel under the supervision of Joe B. Rodriguez, then the area supervisor for Northern New Mexico.

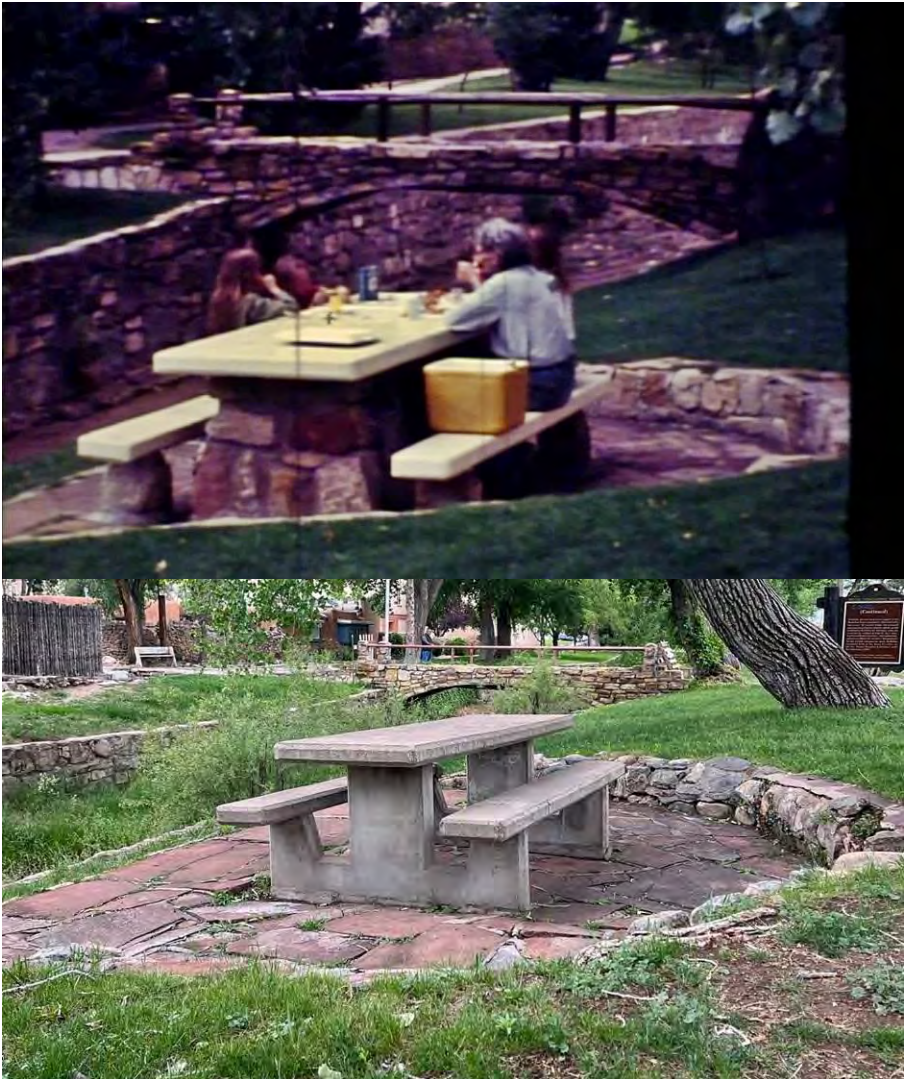
Figure 7: Still taken from late 1960s State Parks and Recreation Areas Commission promotion film with Shelby Street Footbridge in the background. Repeat shot taken June 1, 2025. Original photograph of the Courtesy of the New Mexico State Archives Records Center.

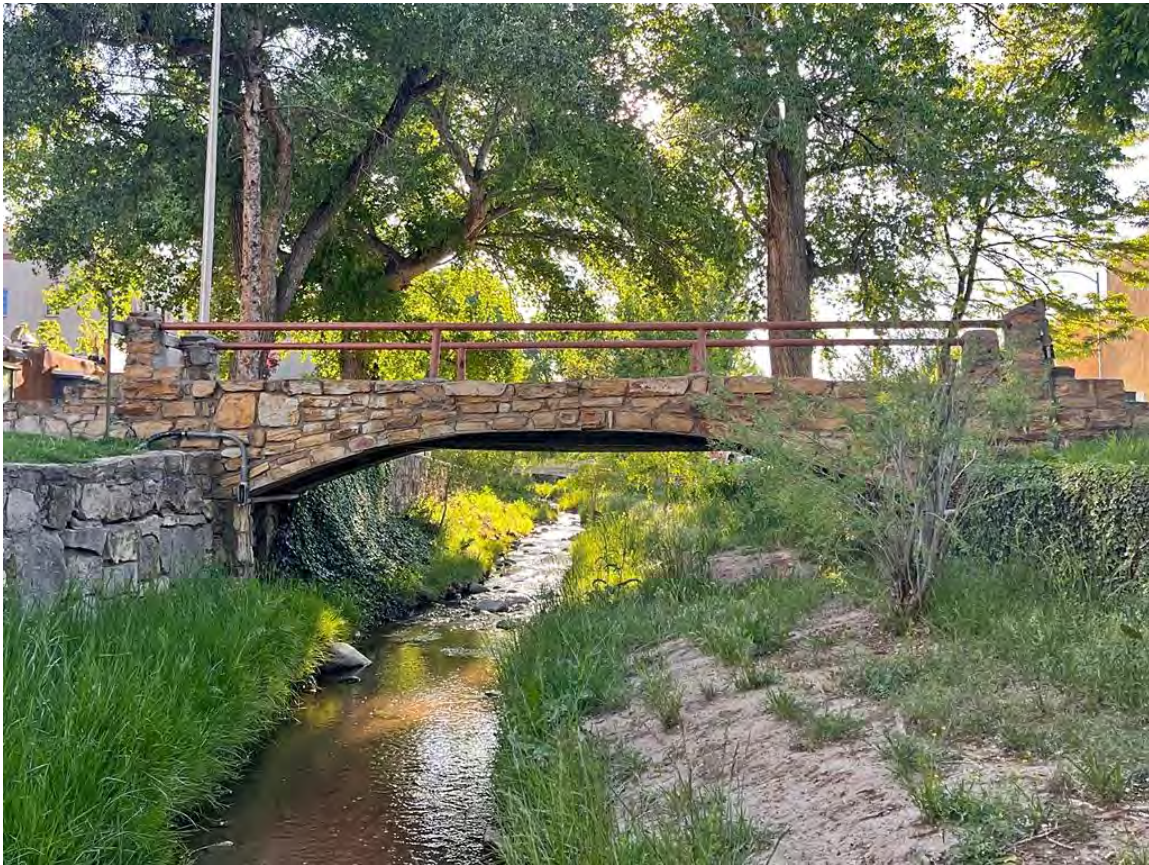
The bridge lies within a modified riparian corridor where the river has been straightened and channelized. The surrounding context includes a mix of commercial and governmental buildings, reflecting the area’s urbanization from the mid to late 20th century. Mature cottonwoods, willows, and other riparian vegetation provide shade and visual relief, reinforcing the river’s presence as a natural element in an increasingly dense built environment (Photo 3).

Photo 3: River and channel context. Camera facing west.

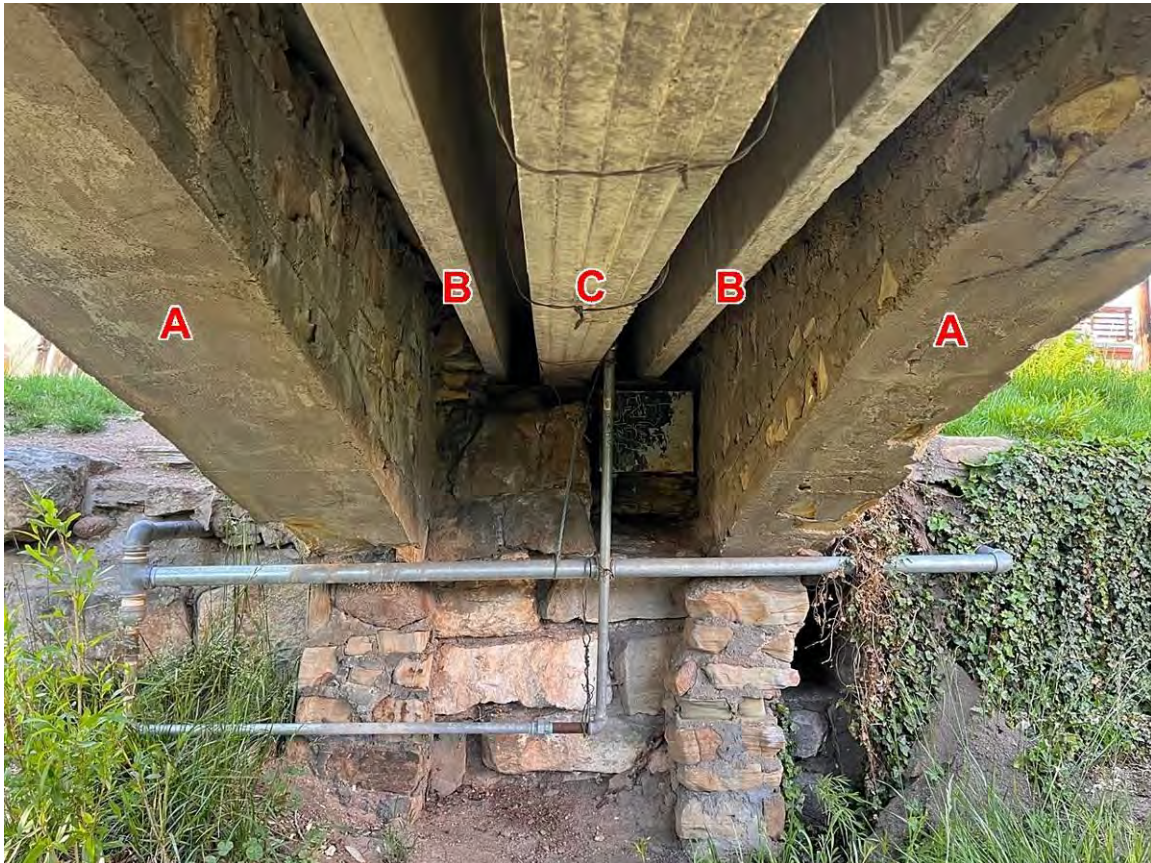
The bridge consists of two precast concrete girders supporting a cast-in-place or integrally cast slab deck (Photo 4). Each girder measures approximately 3 inches wide by 11½ inches high and is T-shaped, flanged into the slab. A later addition—a concrete beam measuring approximately 8½ inches wide by 9¾ inches high—was installed between the girders for supplemental support; however, the beam exhibits noticeable deflection at mid-span. The bridge spans the river at 26 feet, with a total length of approximately 38 feet including approaches.

Photo 4: Bridge superstructure: A: exterior false spandrel walls, B. girder-slab beams C. reinforced center beam. Camera facing north.

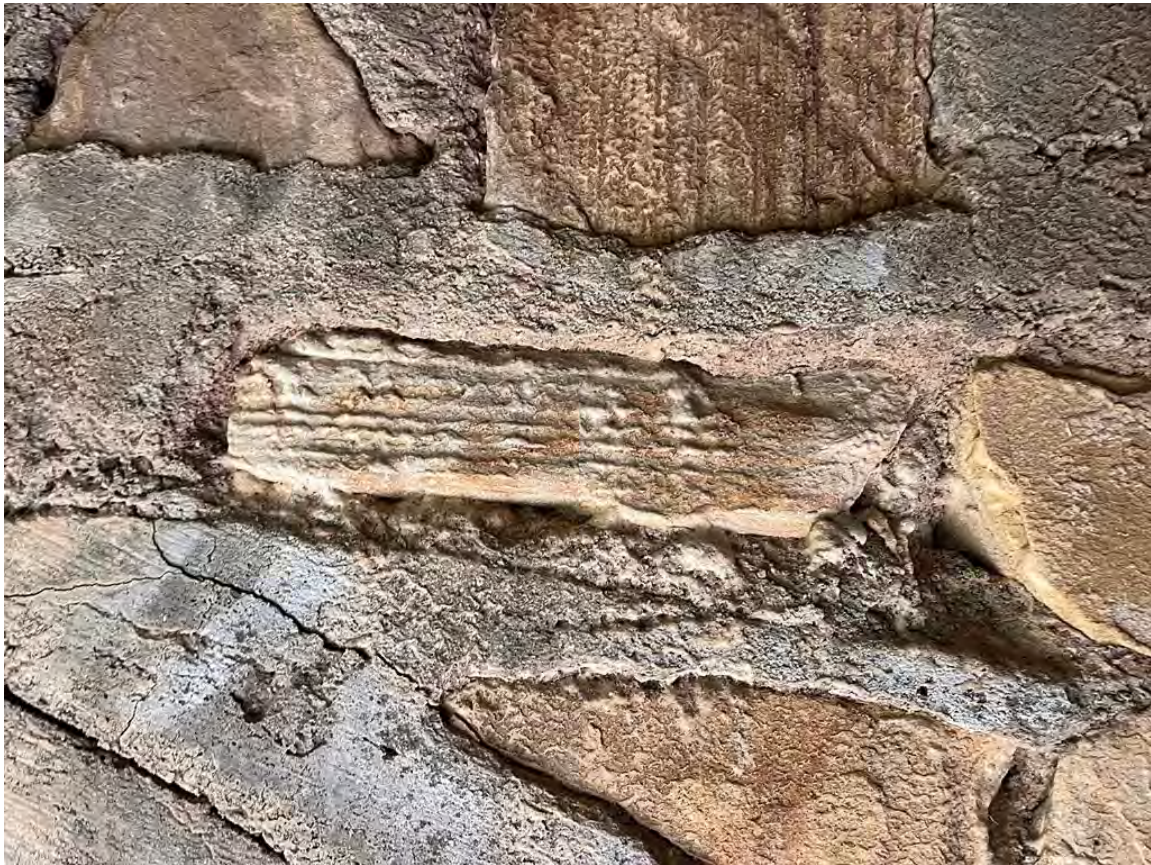
The exterior features non-structural concrete curtain walls with a false arch profile. It is clad in local sandstone likely intended to mimic a closed-spandrel masonry arch (Photo 1). These false spandrel walls measure approximately 3 inches wide with a variable height and consist of sandstone blocks set into a concrete bed (Photo 5). The blocks exhibit pronounced horizontal striations or bedding planes that visually differ from the limestone channel walls below (Photo 6).

Photo 5: Interior stonework of false spandrel wall.

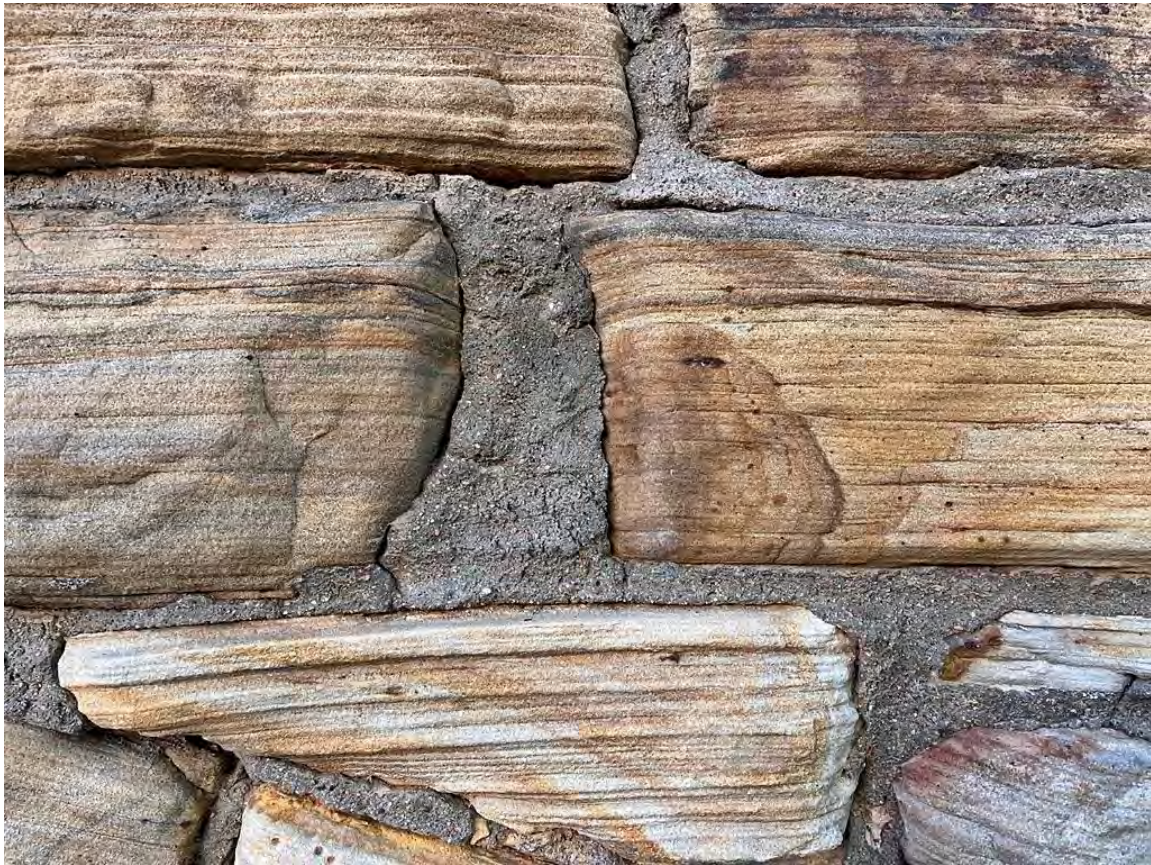
Photo 6: Exterior stonework of false spandrel wall.

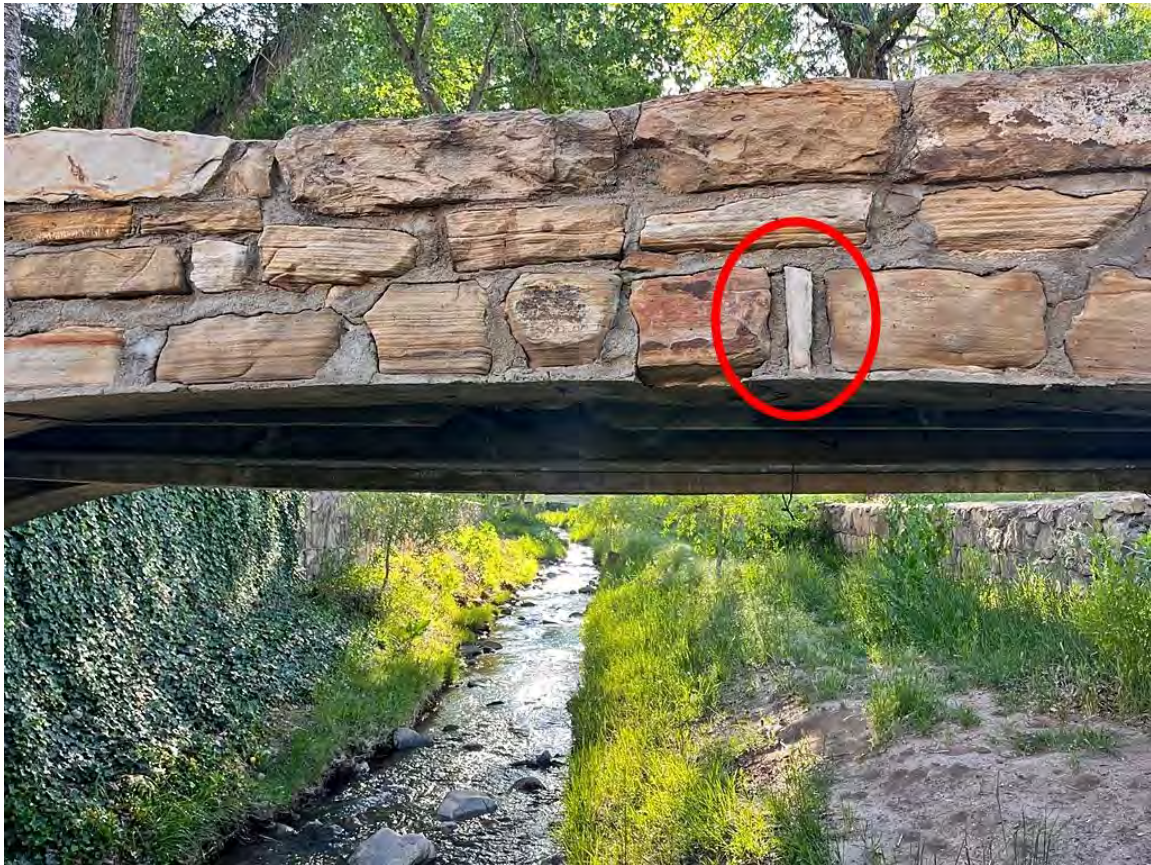
Similar to a true masonry arch, the false spandrel walls taper toward the center, narrowing from 4 feet at the base to approximately 20 inches at the “keystone”—a small vertical block located at the bridge’s midpoint (Photo 7). This keystone is decorative and non-structural.

Photo 7: Crown of false spandrel wall with “keystone” highlighted.

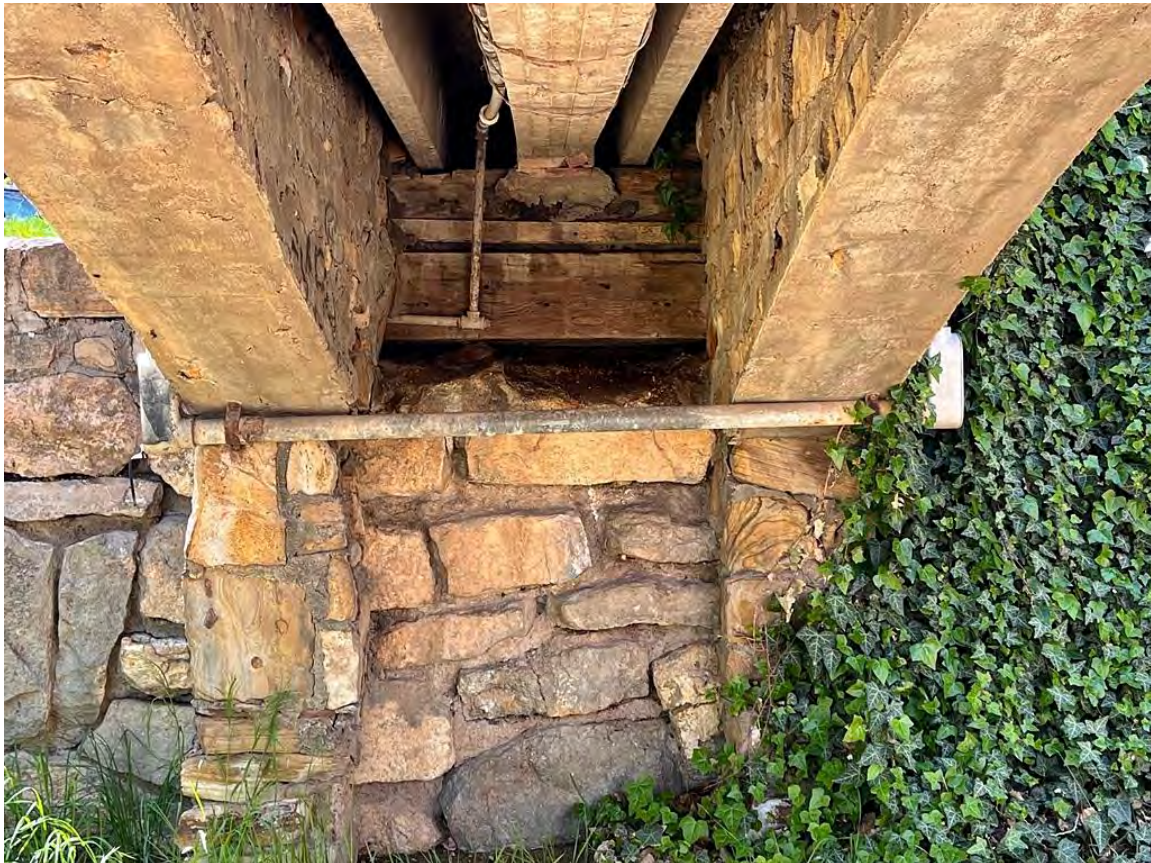
The bridge rests directly on the river embankment, supported by large timber blocks that serve as both abutments and bridge seats.¹ This rudimentary substructure reflects minimal engineering, relying largely on soil mass and timber resistance for lateral stability. The lower abutments and bridge seats are faced with stone for visual effect (Photo 8).

Photo 8: Substructure at south embankment stone abutment and bridge seat, and what appears to be timber support. Camera facing south.

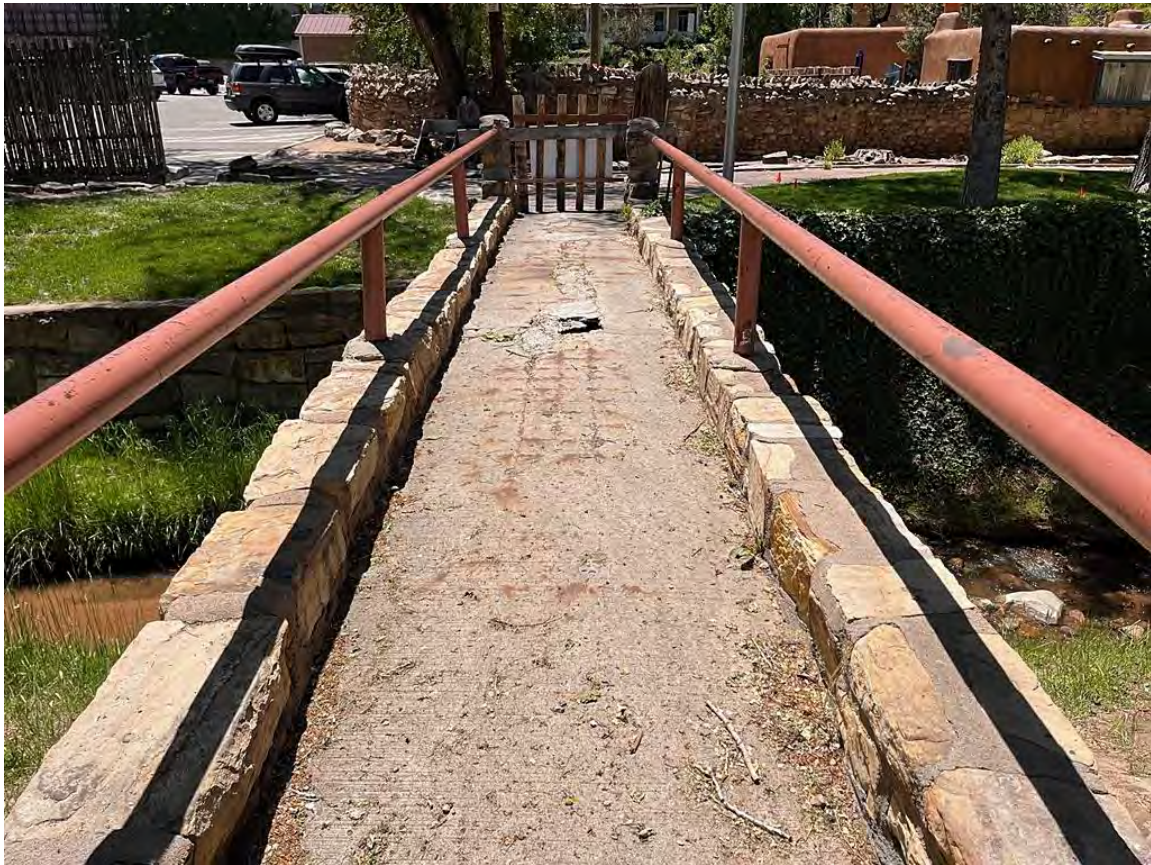
The 4-foot-wide walkway is bordered on both sides by low sandstone parapets that rise approximately 12 inches above the deck surface (Photo 9). A painted metal pipe railing runs along the edges of the deck, terminating at each end in square masonry end posts approximately 18 inches high, which visually anchor the span.

Photo 9: Deck and railing. Camera facing south.

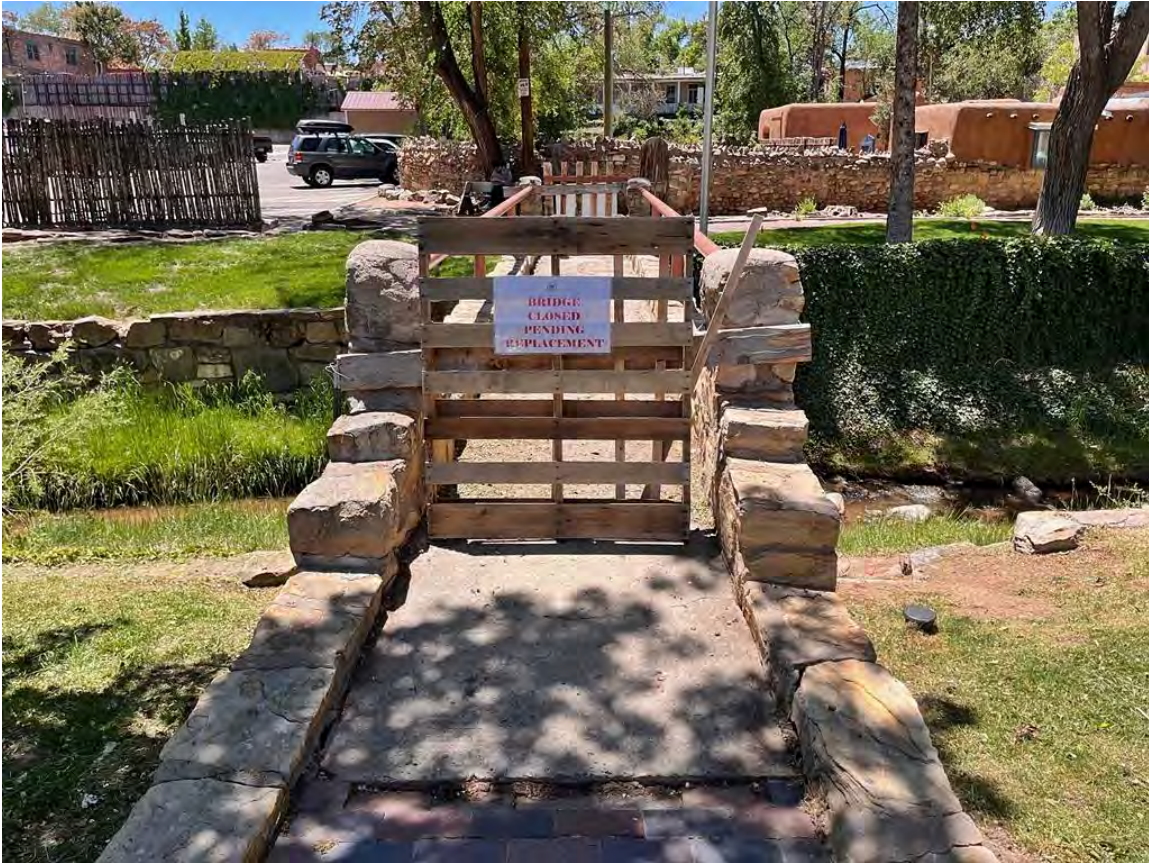
On the north side, the bridge is approached by a continuation of the concrete slab (Photo 10). Curving stone walls flank this approach, rising from ground level to approximately four feet where they connect with the masonry end posts. On the south side, the original approach was removed to accommodate the widening of the pedestrian path (Photo 2).

Photo 10: North approach. Camera facing south.

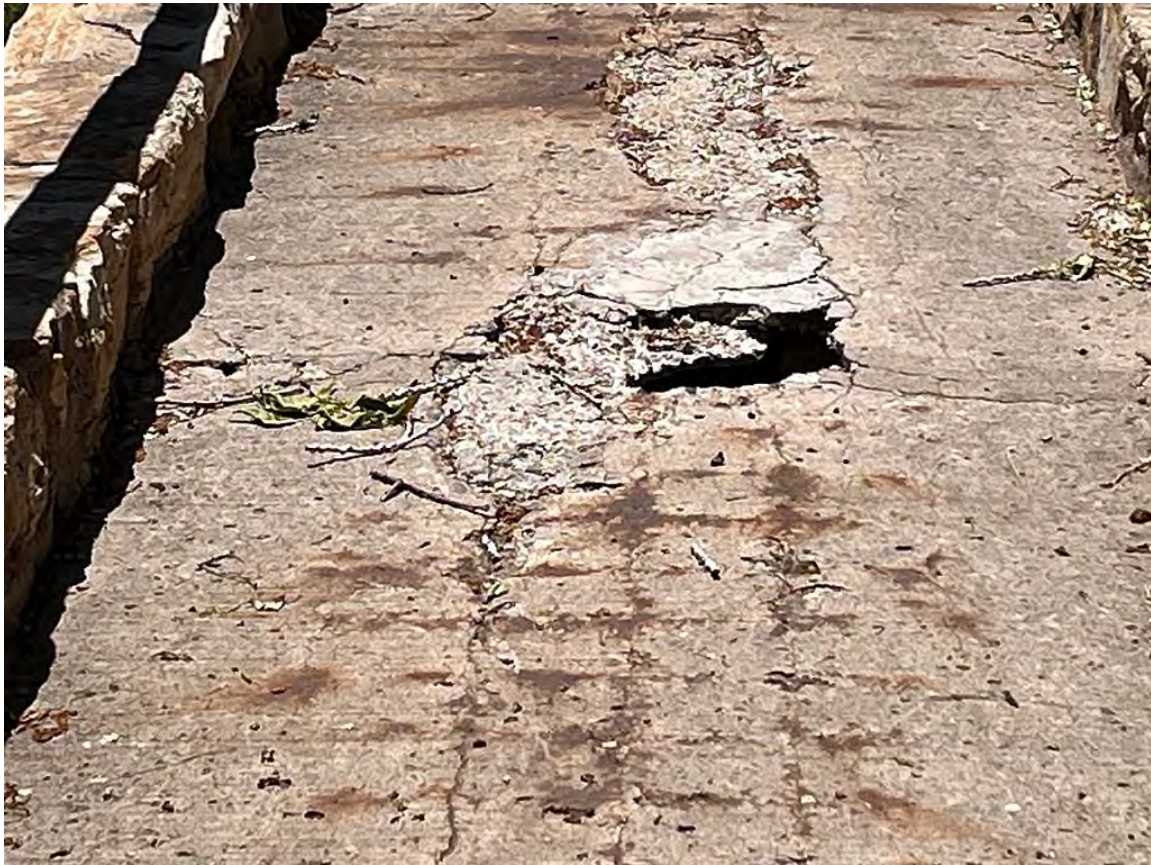
The bridge’s deck is formed by the concrete slab. Over time, surface deterioration has exposed the reinforcing steel mat. Near the center of the span, a punch-through has developed, accompanied by widespread concrete delamination.

The bridge is currently in poor condition and shows multiple signs of structural distress. A large punch-through in the deck reveals corroded reinforcing steel (Photo 11). Significant delamination has weakened the concrete surface, and cracks are evident both longitudinally and transversely beneath the deck (Photo 12). Efflorescence—white mineral deposits indicating moisture infiltration—is visible across the underside (Photo 12). These combined issues have compromised the structural integrity of the bridge, leading to its closure by the City of Santa Fe in 2022.

Photo 11: Deck showing punch-through, delamination, and exposed rebar mat.

In November 2024, the Santa Fe Governing Body approved the use of \$240,000 in state capital outlay funds to design a new structure to replace the aging and structurally deficient bridge.²⁷ This HCPI is a step in the process of replacing the bridge.

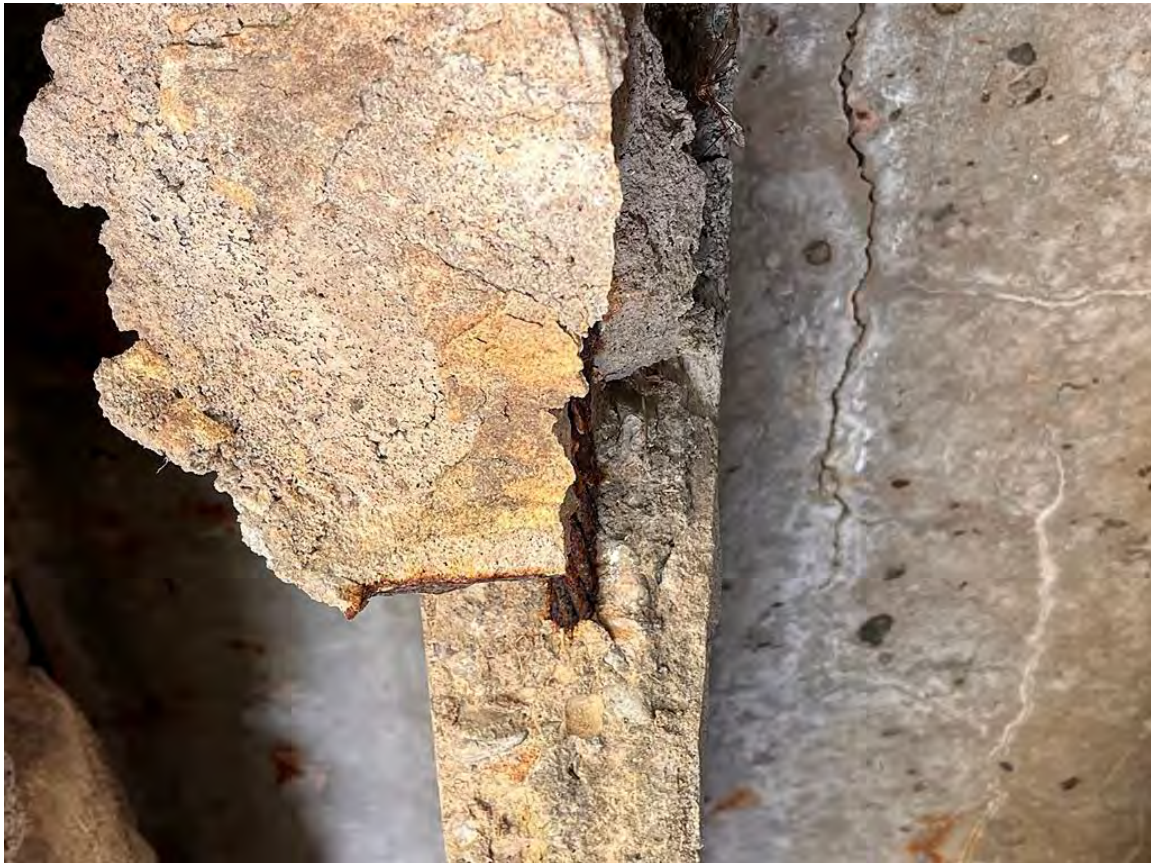
Photo 12: Deterioration to structural members, including severe delamination and exposed rebar on the beam, along with longitudinal cracking and efflorescence across the slab.
