# City of Santa Fe, New Mexico

# memo

**2025-010870-HDRB, 549 ½ Agua Fria St.**, Westside Guadalupe Historic District, Not Surveyed, Robert Kreger, agent for Catherine Wynne, owner, requests status review with primary façade designation(s) if applicable.

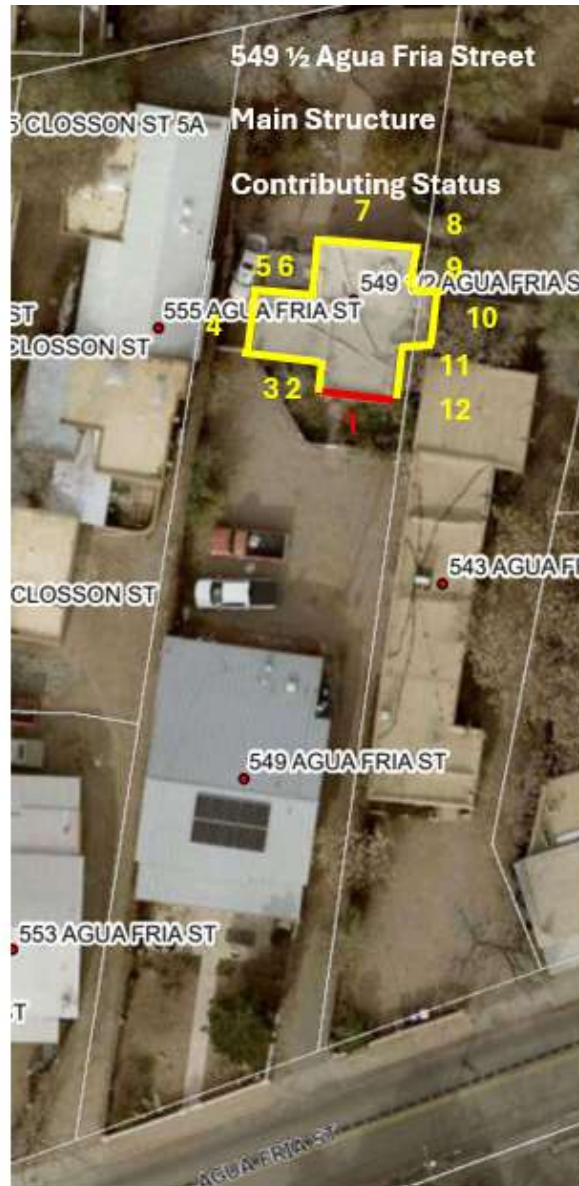
Figure 1: Proposed Façade Diagram for Contributing Status at 549 ½ Agua Fria Street.

Primary Façade: ———

Non-primary Façade: ———

Staff recommends the historic status of the structure be upgraded to contributing and designate the south elevation as the primary façade identified as number one on the Proposed Façade Diagram, exclusive of non-historic windows, per 14-5.2(C) Designation of Significant, Contributing or Noncontributing Status Within Historic Districts.
