City of Santa Fe, New Mexico

memo

2025-011043-HDRB, 528 and 530 Calle Corvo, Downtown and Eastside Historic District, Non-contributing, Ju Tan, agent for Susan Lamden, owner, requests status review with primary façade designation(s) if applicable.

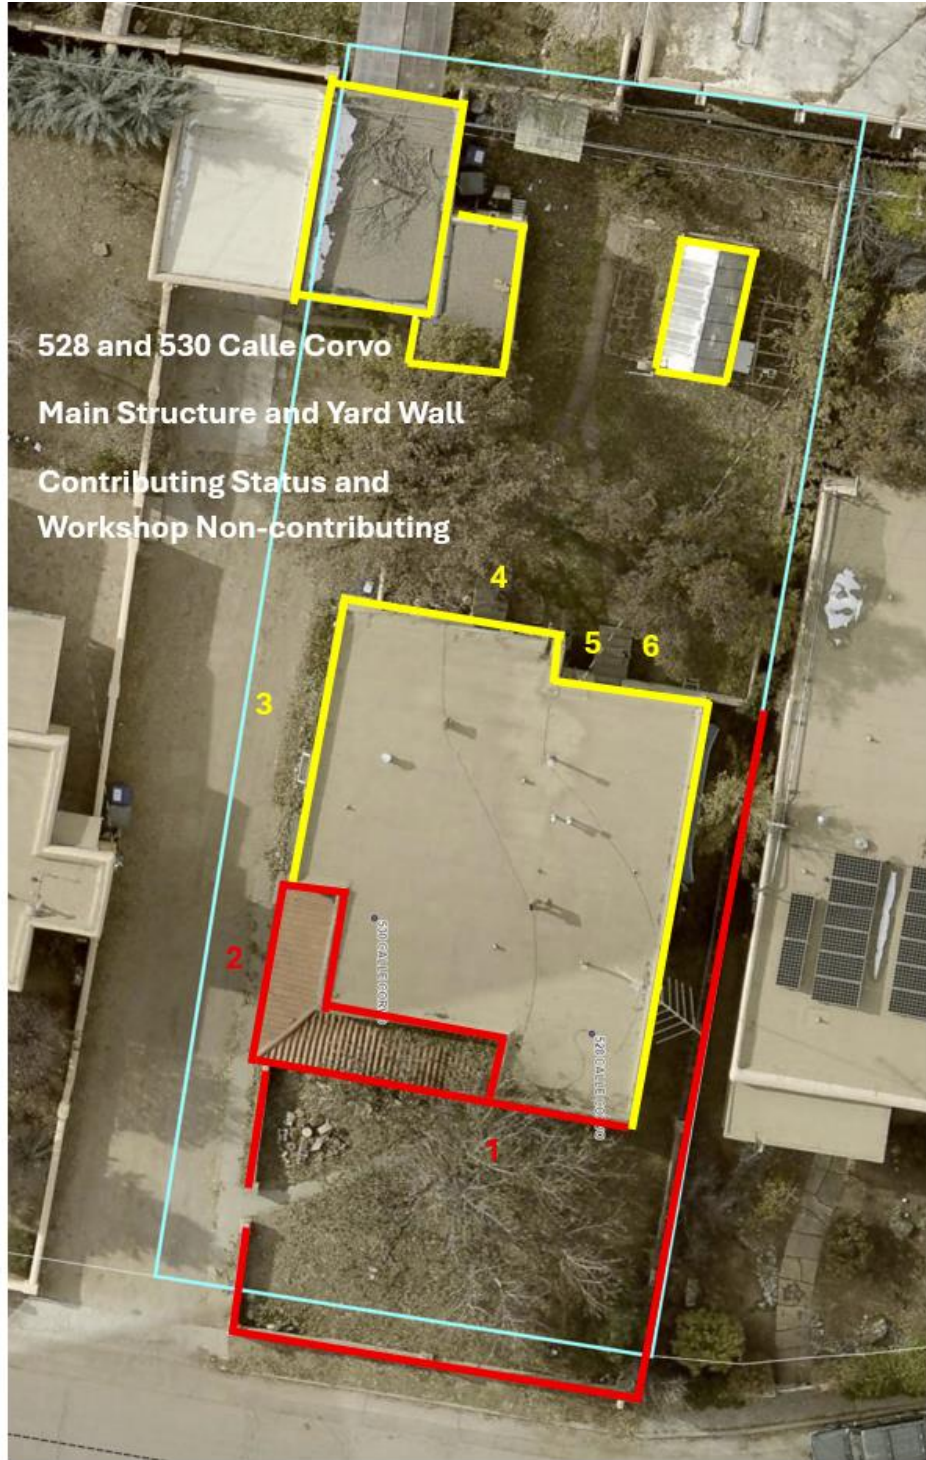
Figure 1: Proposed Façade Diagram for 528 and 530 Calle Corvo.

Primary Façade: ———

Non-primary Façade: ———

Staff recommends the historic status of the main residence and yard wall be upgraded to contributing, designate the east and southeastern façades including the portal and excluding non-historic doors and windows as the primary façades (numbers one and two on façade drawing), and designate the workshop as non-contributing per 14-5.2(C) Designation of Significant, Contributing or Noncontributing Status Within Historic Districts.

- a. In case 2025-011043-HDRB, for 528-530 Calle Corvo, upgrade the main residence, as contributing, designating facades (numbers one and two from façade diagram) as primary façade(s).
- b. In case 2025-011043-HDRB, for 528-530 Calle Corvo, retain the main residence as non-contributing.

- a. In case 2025-011043-HDRB, for 528-530 Calle Corvo, upgrade the workshop, as contributing, designating facades (number one from façade diagram) as primary façade(s).
- b. In case 2025-011043-HDRB, for 528-530 Calle Corvo, retain the workshop as non-contributing.
