RE: 222 Polaco Street Status Review Buildings A, B, C

# Historic Cultural Properties Inventory (HCPI) Base Form (FORM 1)

# Historic Cultural Properties Inventory (HCPI) Detail Form (FORM 2)

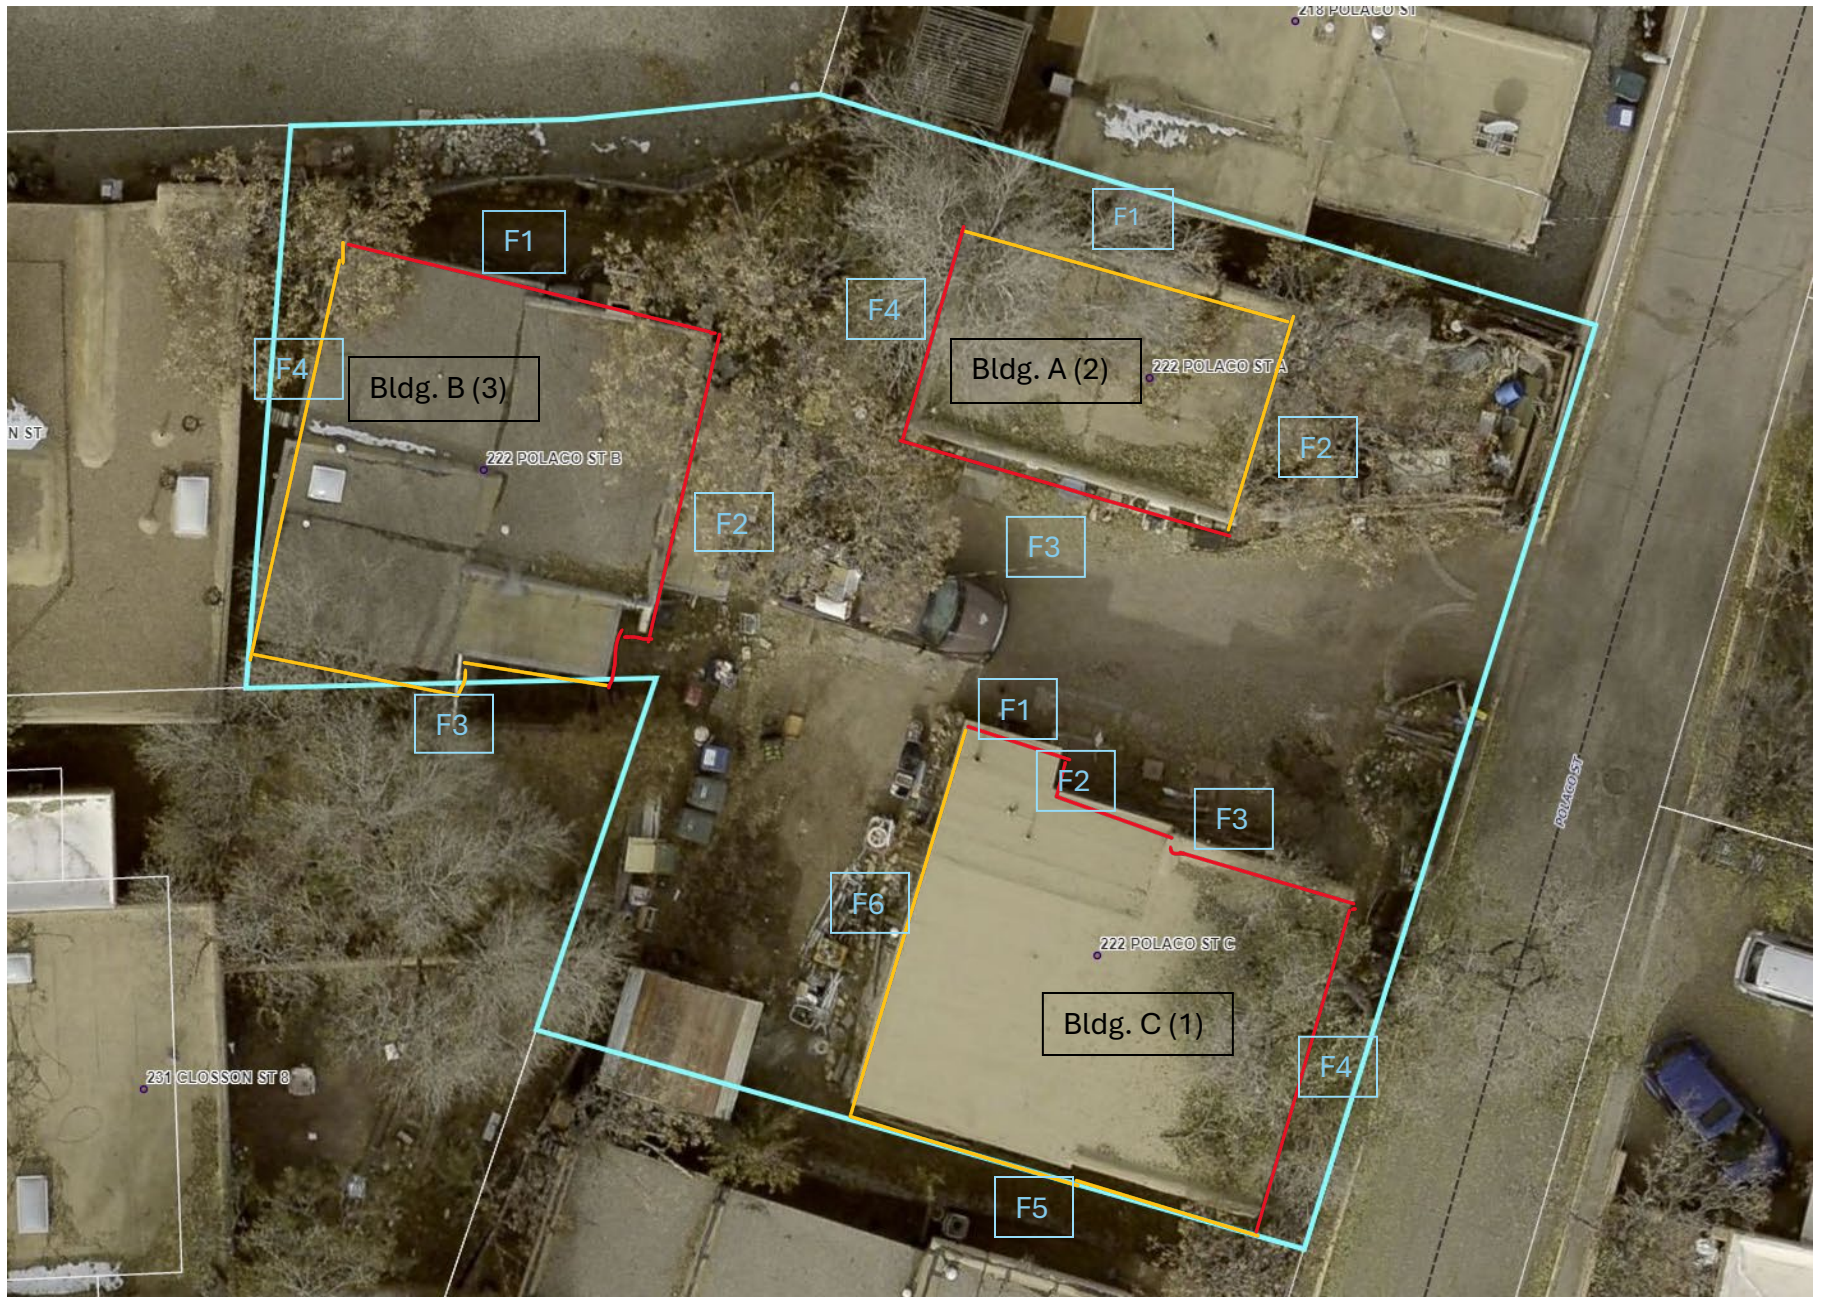
Figure 1. Façade Diagram

Primary

Non-Primary

- ***Building #C/ #1 in HCPI*** we request *Primary elevation designation.*
- ***Building #A/#2 in HCPI*** is recommended as *Contributing*, with the south and west elevations identified as the *primary façades.*
- ***Building #B/ #3 in HCPI*** is recommended as *Contributing*, with the original portions of the east and north elevations identified as *primary façades*, and the understanding that *non-original design elements and materials are excluded.*

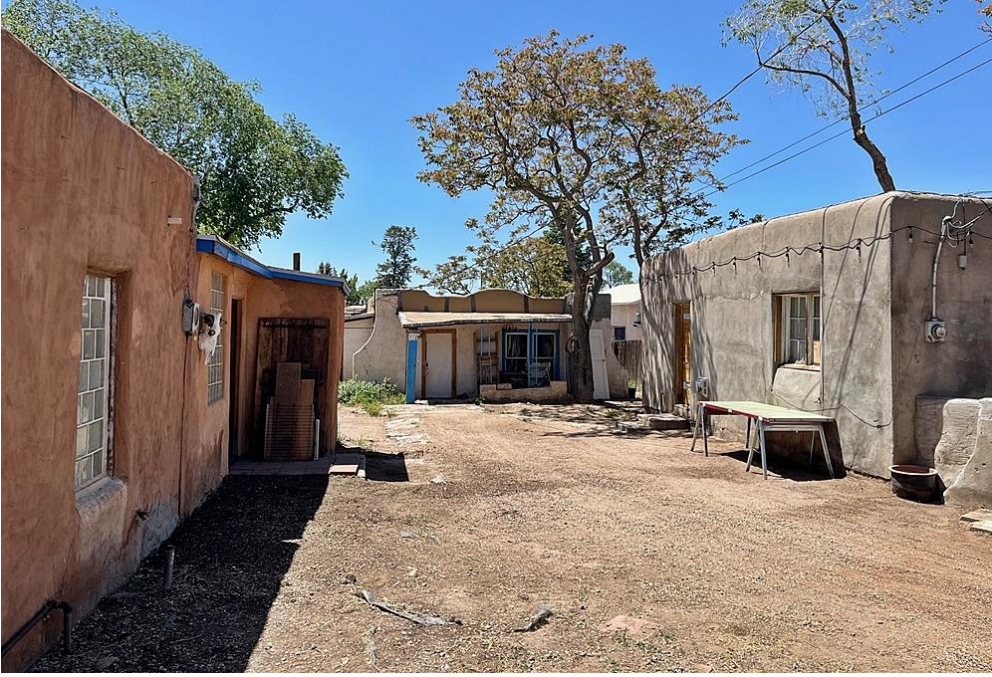
<b>10. Photo Information:</b> John W. Murphey, photographer. Photo 1: View of Rivera Family Compound. Camera facing northwest.		
<b>11. Brief Description of the Property:</b>  The former Rivera Compound comprises three dwellings arranged on a roughly 0.15-acre lot on the west side of Polaco Street (Photo 1). The lot's irregular, seven-sided shape deviates from other parcels along the street and may suggest that the area containing Building #3 had a different origin, possibly predating the subdivision that created Polaco Street. Each house incorporates some form of adobe wall construction. The core of each building is visible on a 1958 aerial photograph. Aside from Building #2, the footprints of the buildings expanded over the years with various additions, most of which were completed by the late 1970s, as shown in a 1978 aerial photograph. All three are listed as Contributing structures to the Westside-Guadalupe Historic District.  <i>Continued on Page 5.</i>

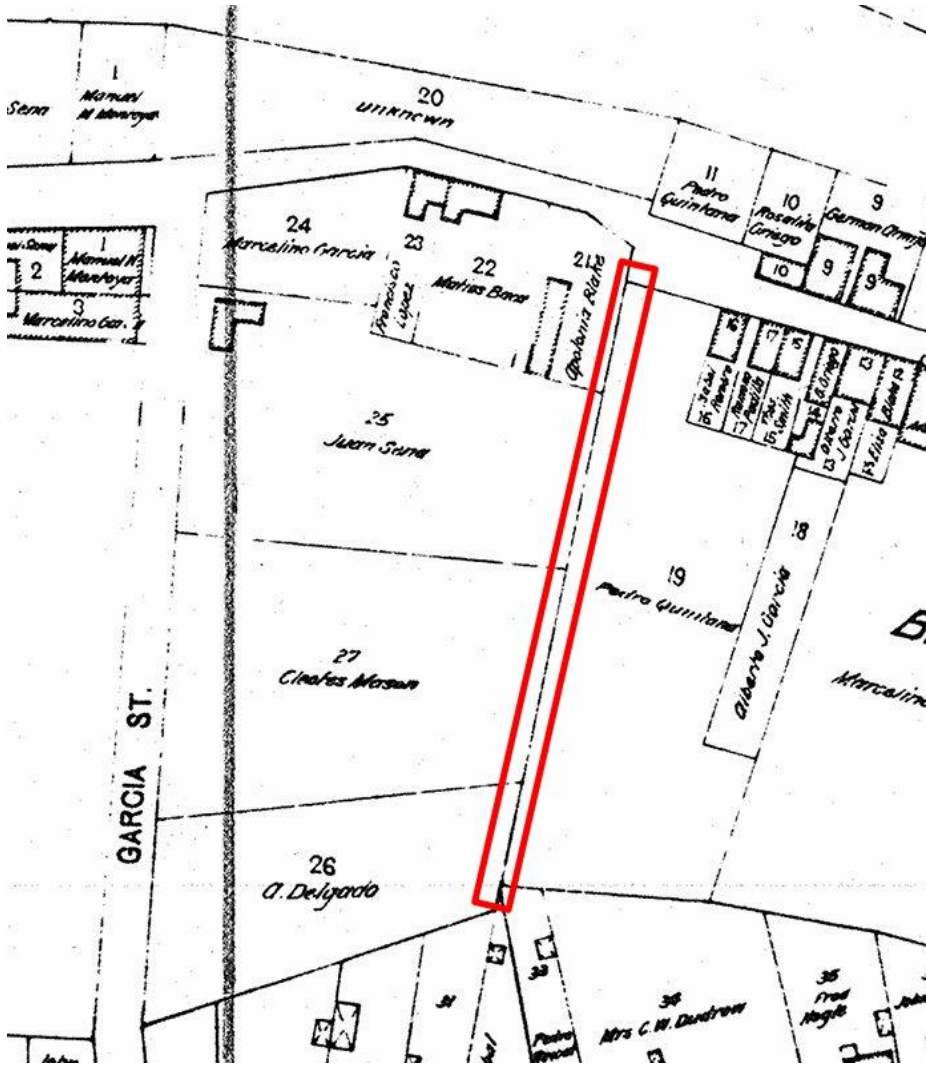
Figure 1: N. L. King, "Map of the City of Santa Fe," 1912.  
 The highlighted property line indicates approximate future course of Polaco Street.

The 1912 King’s map shows the future course of Polaco Street as a line separating the Quintana family property to the east from those of the Sena family and others to the west (Fig. 1). This north-south property line would eventually become known as Quintana Alley.

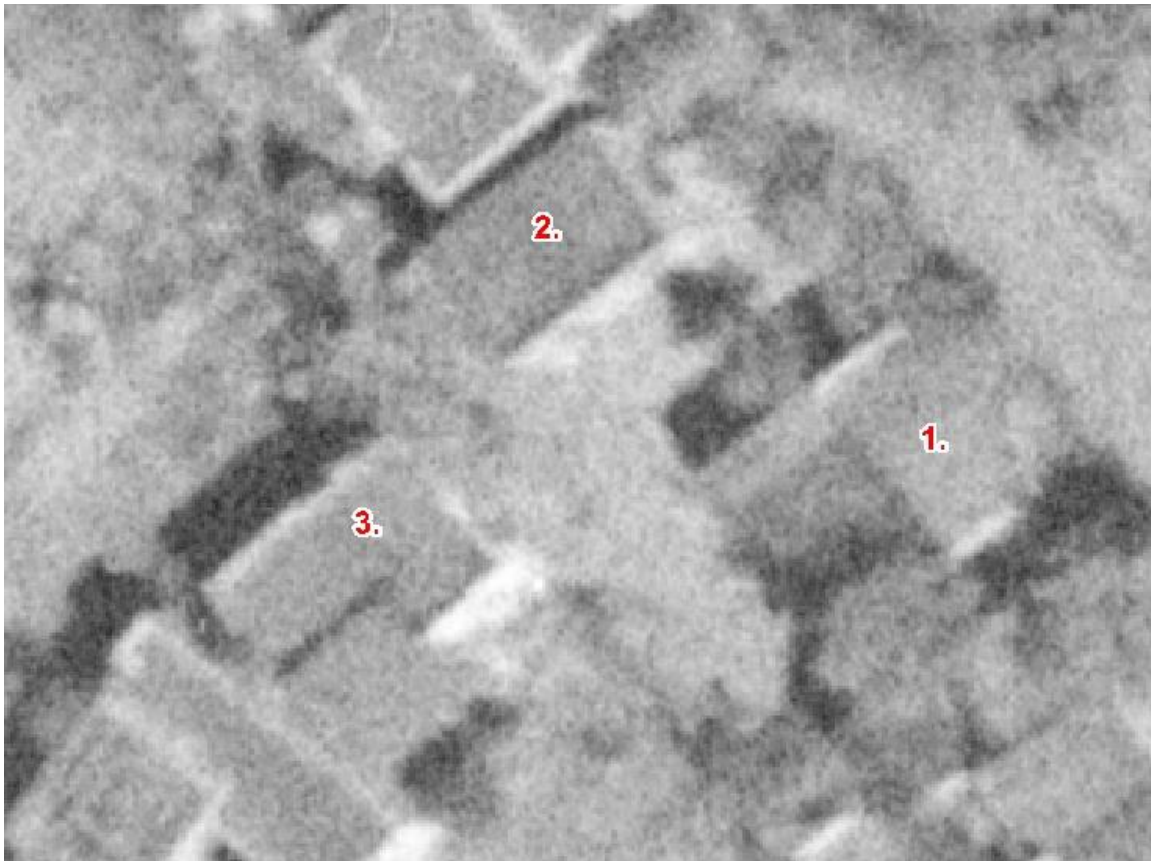
**Figure 4: November 10, 1958, aerial photograph. Rivera Family Compound dwellings.**

The arrangement of the three dwellings is evident in a 1958 aerial photograph, which shows all three units clearly. At that time, Buildings #1 and #2 did not yet have the additions they now hold (Fig. 4).

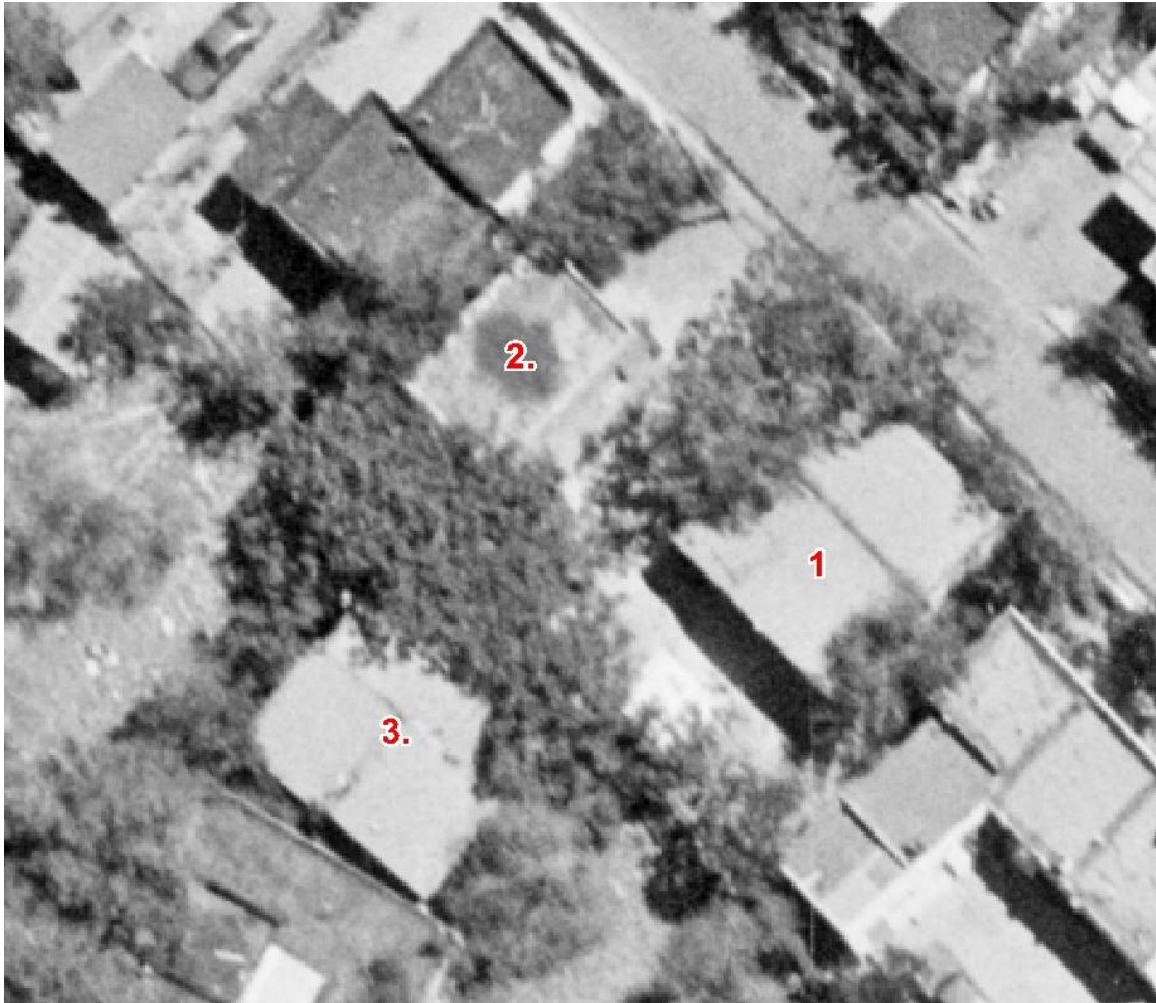
**Figure 5: September 11, 1978, aerial photograph. Rivera Family Compound dwellings. Note most of the additions are in place by this time.**

Family ownership of the property shifted in 1977, when both Luciano and his mother died within a few months of each other. By this time, Building #1 and Building #2 had had received their additions, as evidenced by a 1978 aerial photograph (Fig. 5).

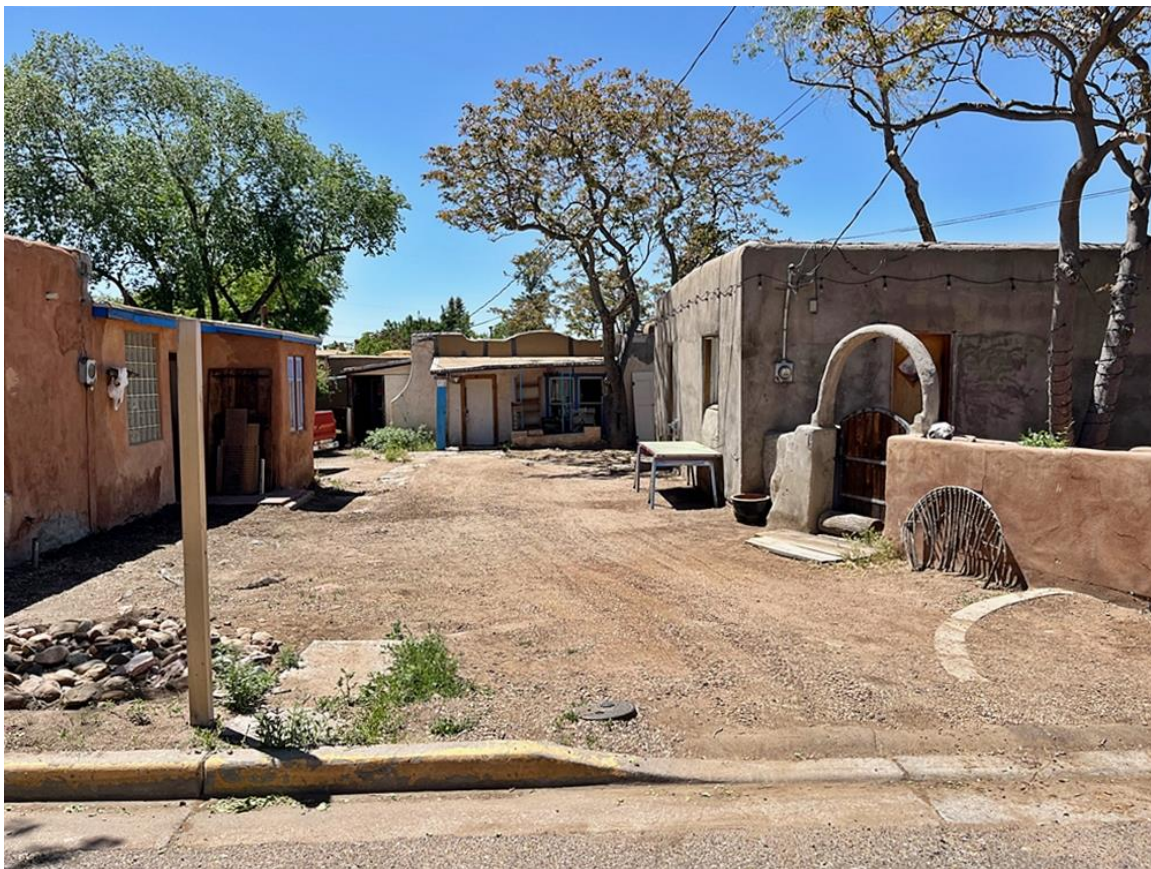
Each building of the compound reflects construction practices shaped by limited means (Photo 2). The structures appear to be owner-built and likely do not meet current code standards. Deterioration and structural deficiencies are readily observable.

**Photo 2: Setting of Rivera Family Compound. Camera facing west.**

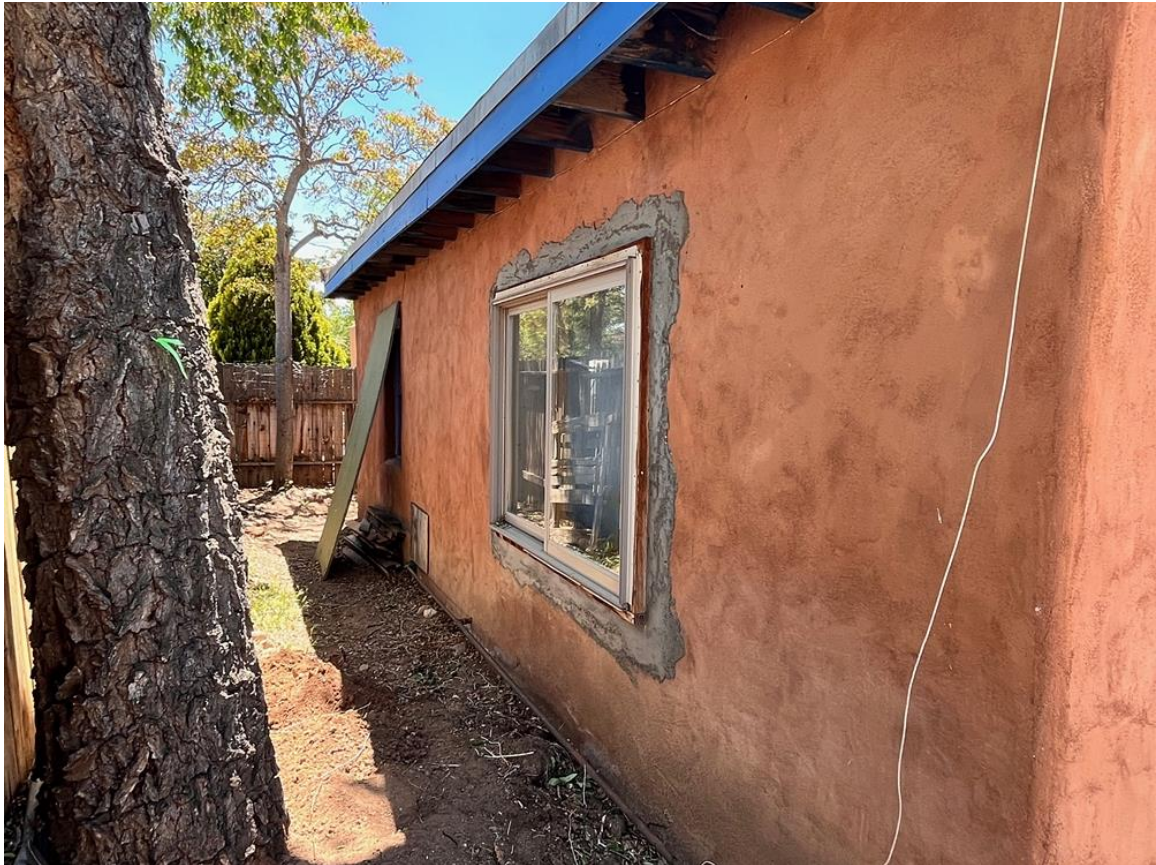
The east elevation, facing Polaco Street, is penetrated by two window openings (Photo 3). The south unit is a 1/1 hung-sash wood window in poor condition (Photo 4). The north window is an aluminum sliding unit jammed into the wall (Photo 5). Wood rafters project from the wall, and tacked onto them is a recent fascia with a metal cap. An owner decided to give the roof some flair by adding a faux Pueblo parapet constructed of cement laid over chicken wire (Photo 6).

**Photo 3: Building #1. East elevation. Camera facing southeast.**

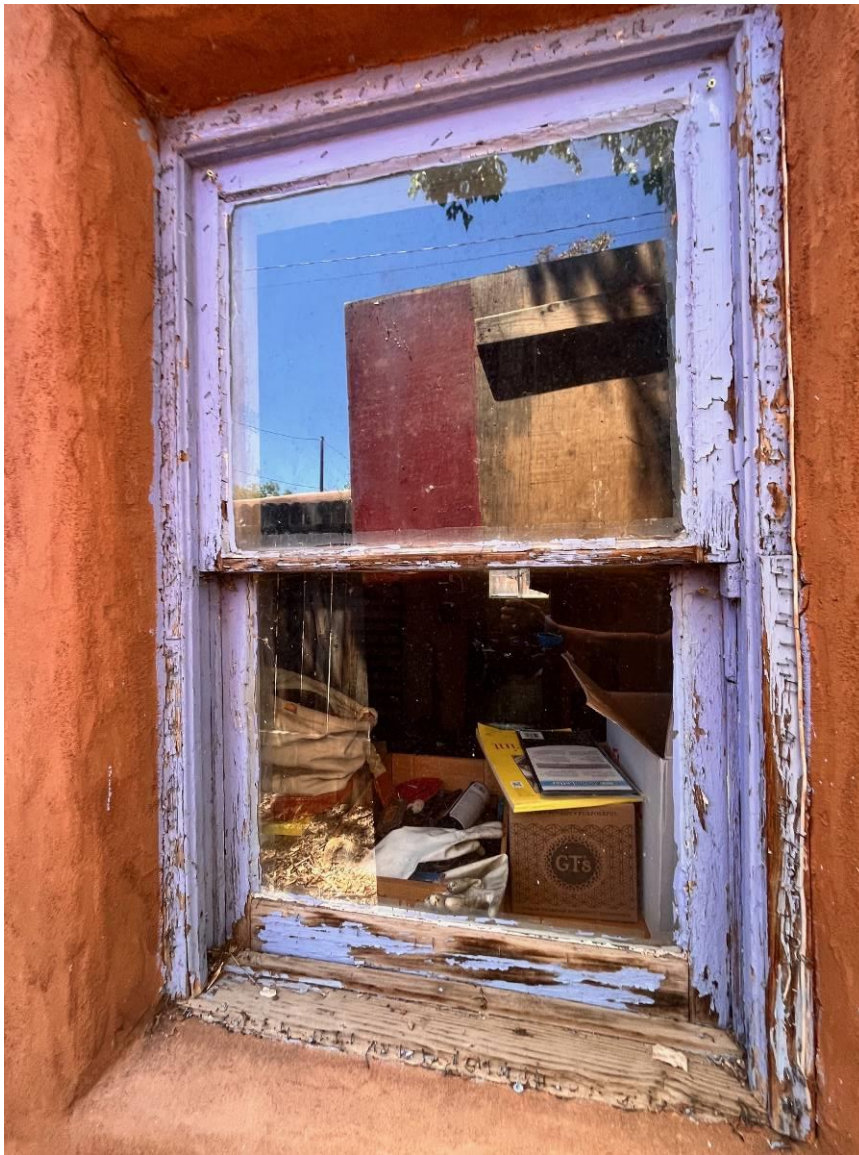
**Photo 4: Building #1. East elevation. South window. Camera facing southeast.**

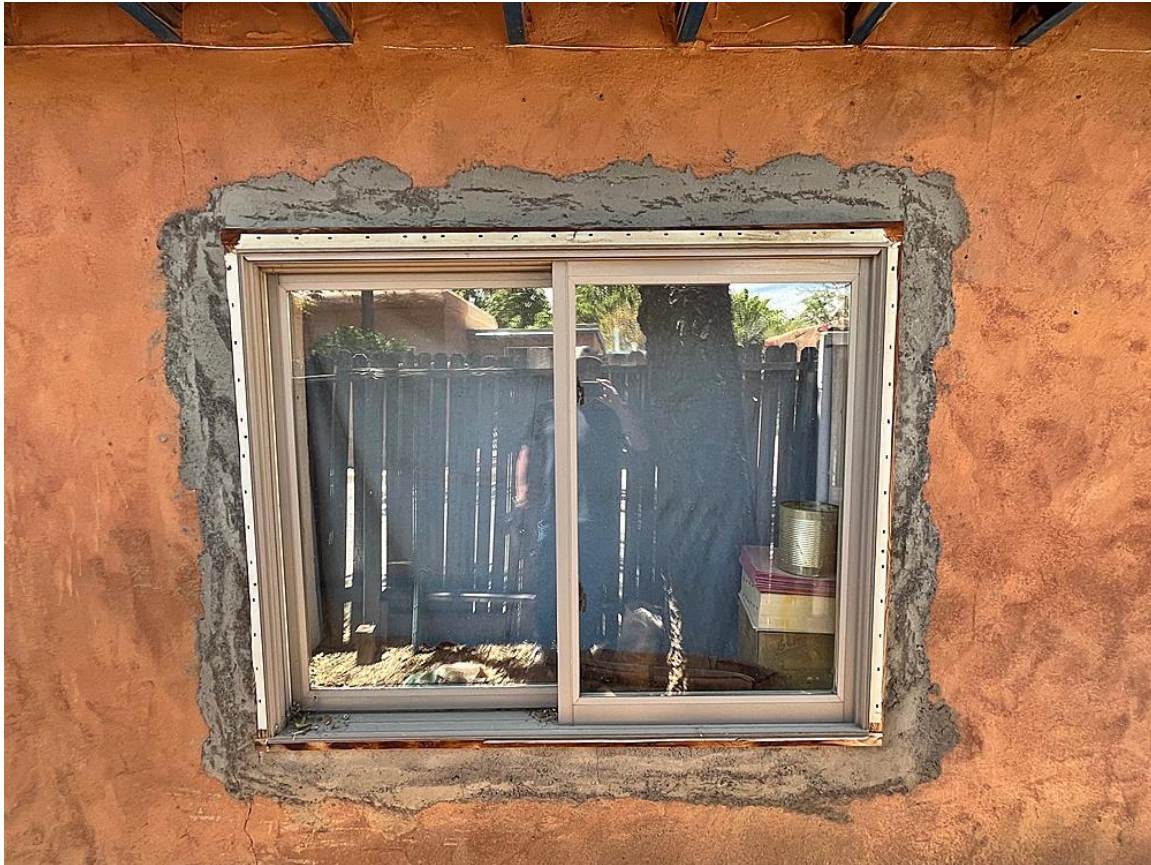
**Photo 5: Building #1. East elevation. North window. Camera facing west.**

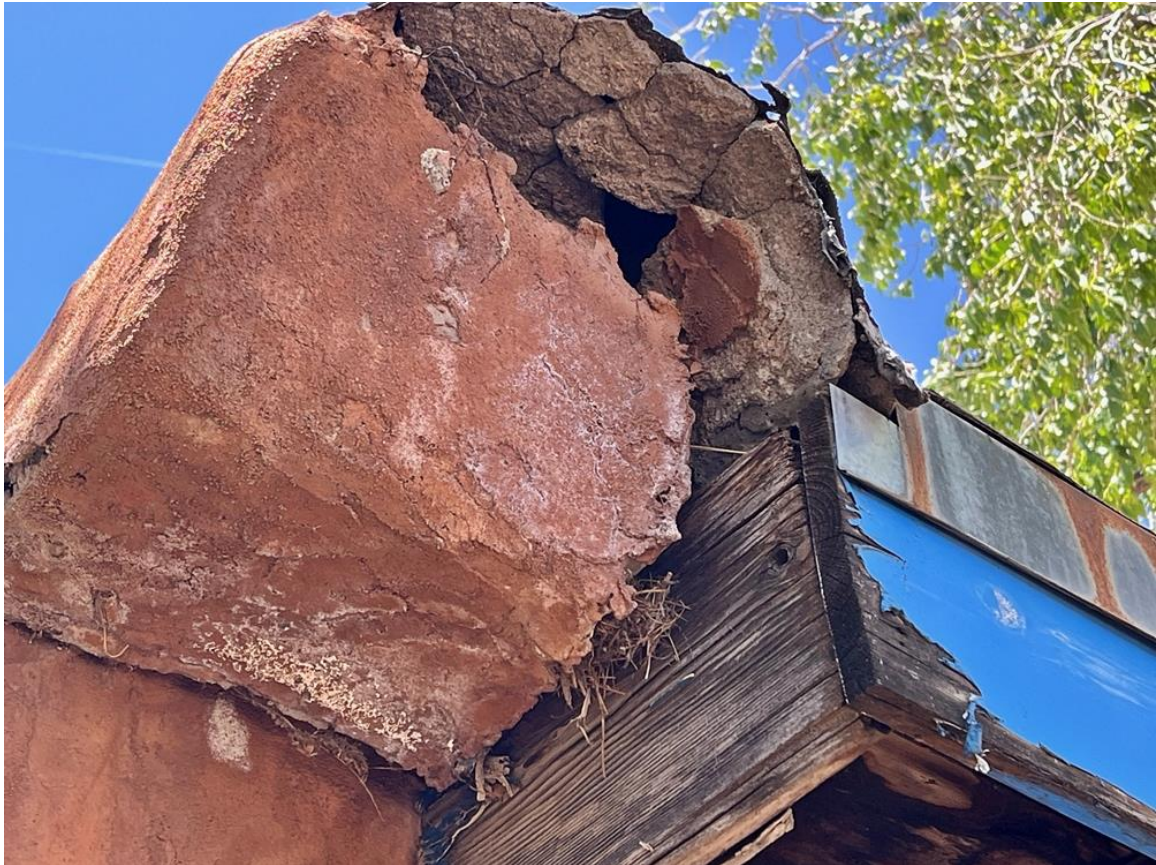
**Photo 6: Building #1. False parapet. Camera facing up.**

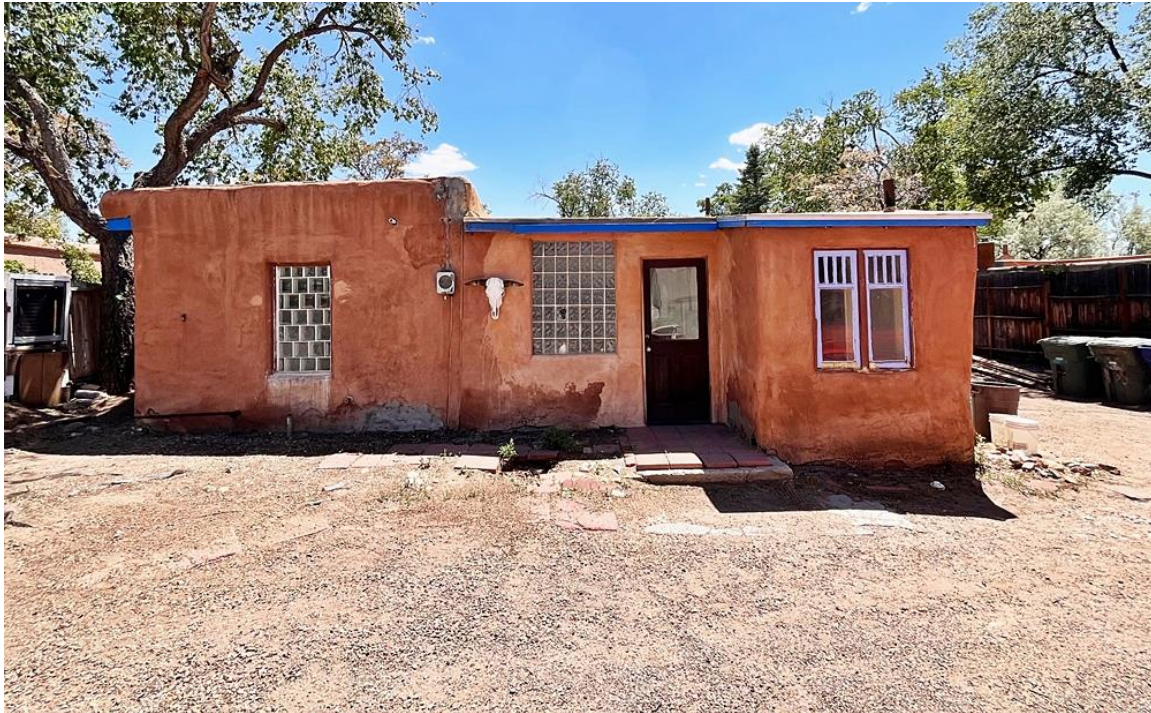
This elevation, facing the driveway, is the most altered. The long façade reveals several additions made to the core block (Photo 7). Rectangular and oriented toward the driveway, the core block contains an opening now filled with glass blocks; based on its dimensions, this opening may have originally held a door. An enclosed porch is adjacent to the west. This section has another opening containing glass and a modern half-light wood door (Photo 8). This section and the next segment to the west have lower roof heights, indicating they are additions.

**Photo 7: Building #1. North elevation. Camera facing south.**

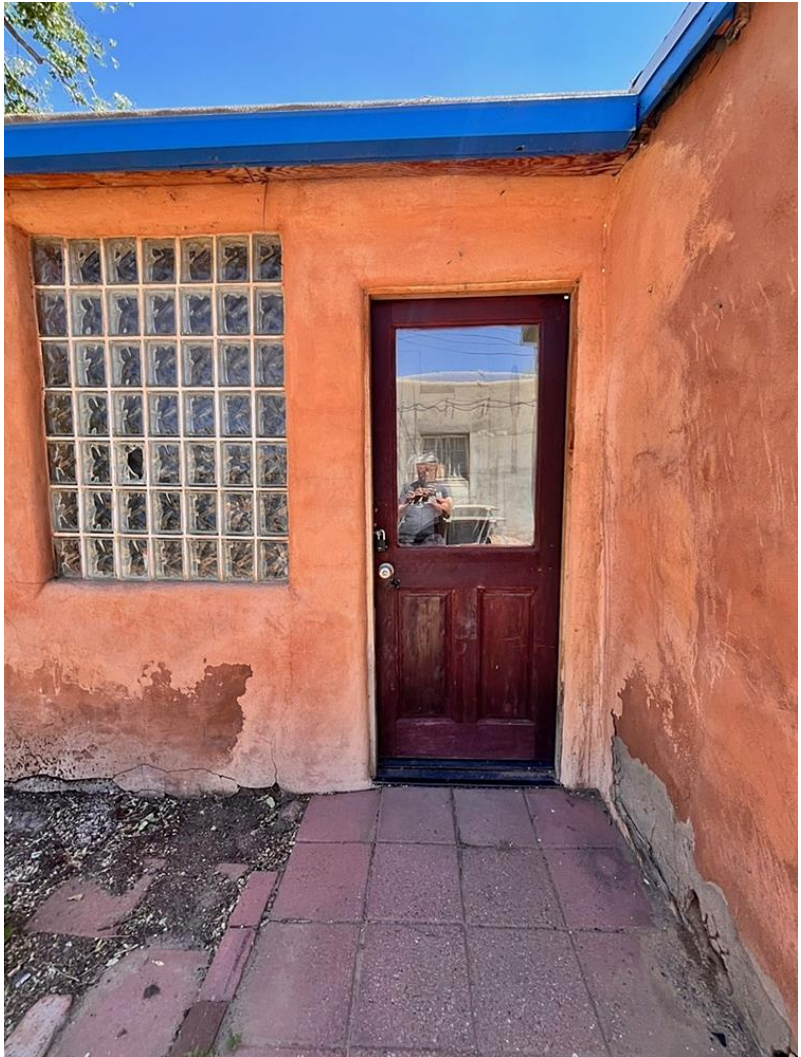
**Photo 8: Building #1. North elevation. Enclosed porch. Camera facing south.**

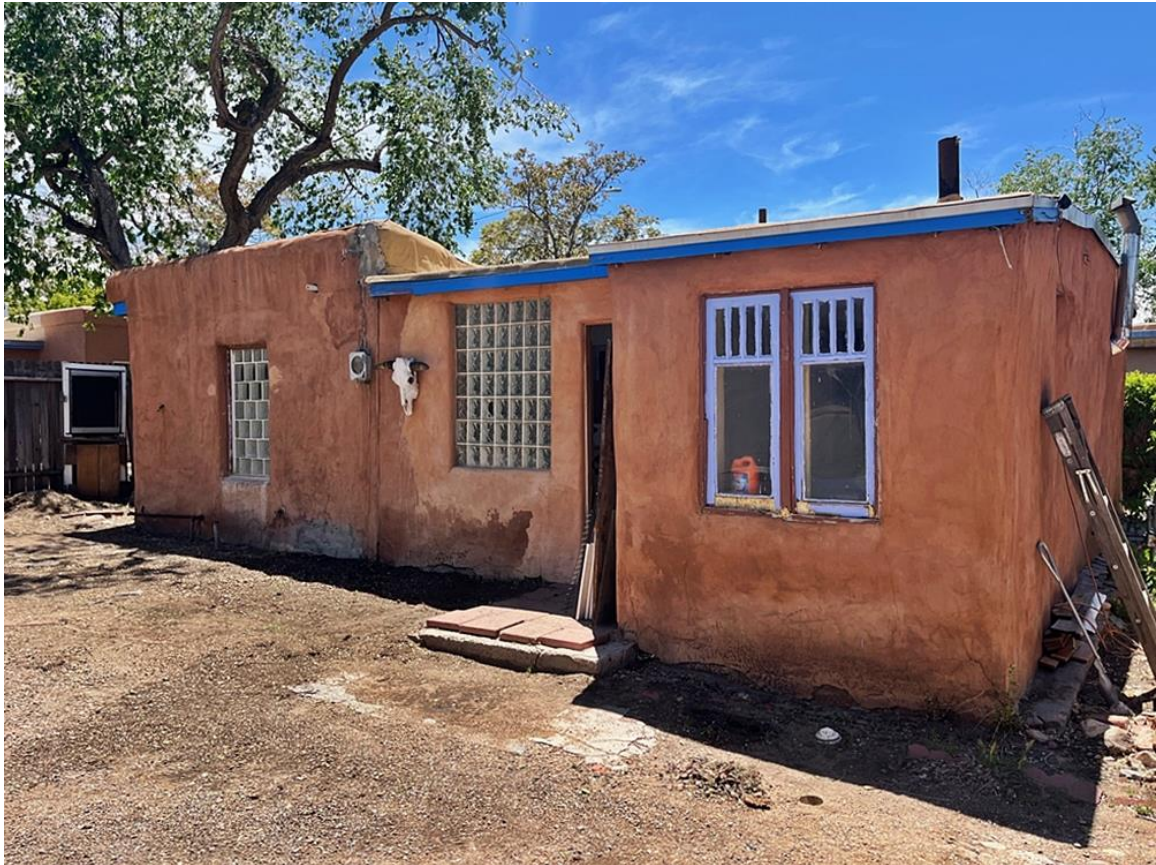
The final portion projects out from the filled-in porch and contains a bathroom (now demolished) and laundry area (Photo 9). Two tall, 5-light wood windows deliver sunshine to the bathroom hall (Photo 10). The windows, measuring 16½" x 48," were likely recycled. They are in poor condition, with their lower lights replaced with Plexiglas.

**Photo 9: Building #1. North elevation. Bathroom addition on the right. Camera facing northeast.**

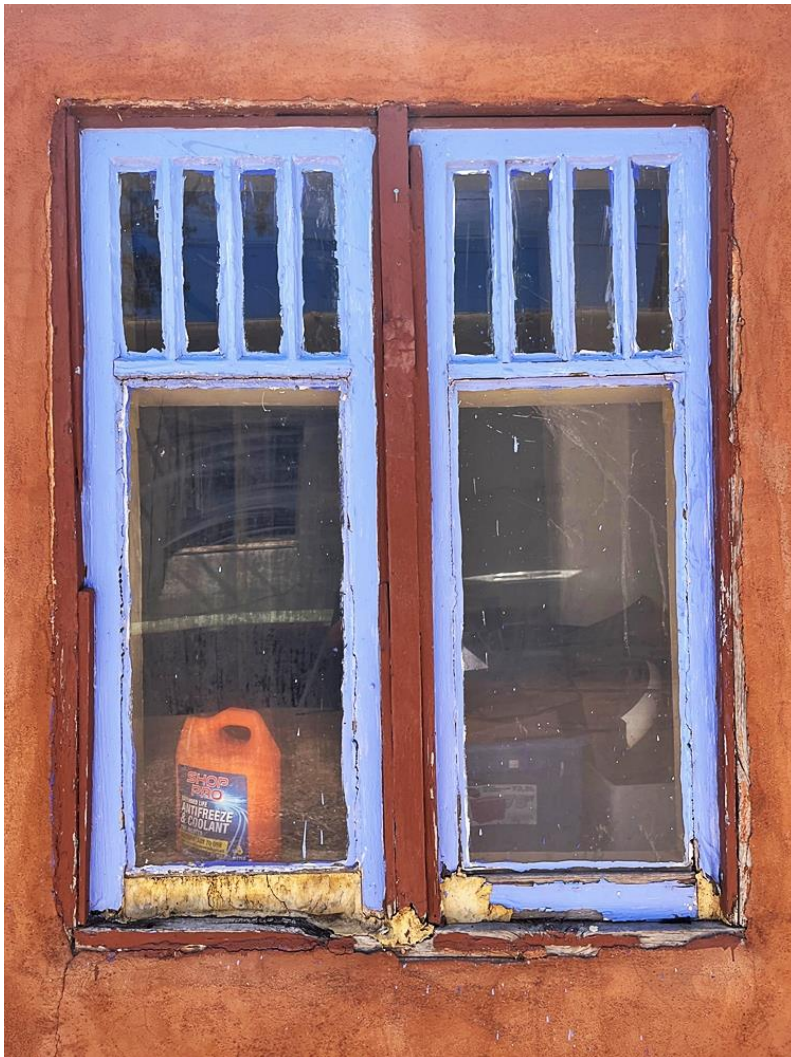
**Photo 10: Building #1. North elevation. Bathroom addition windows. Camera facing south.**

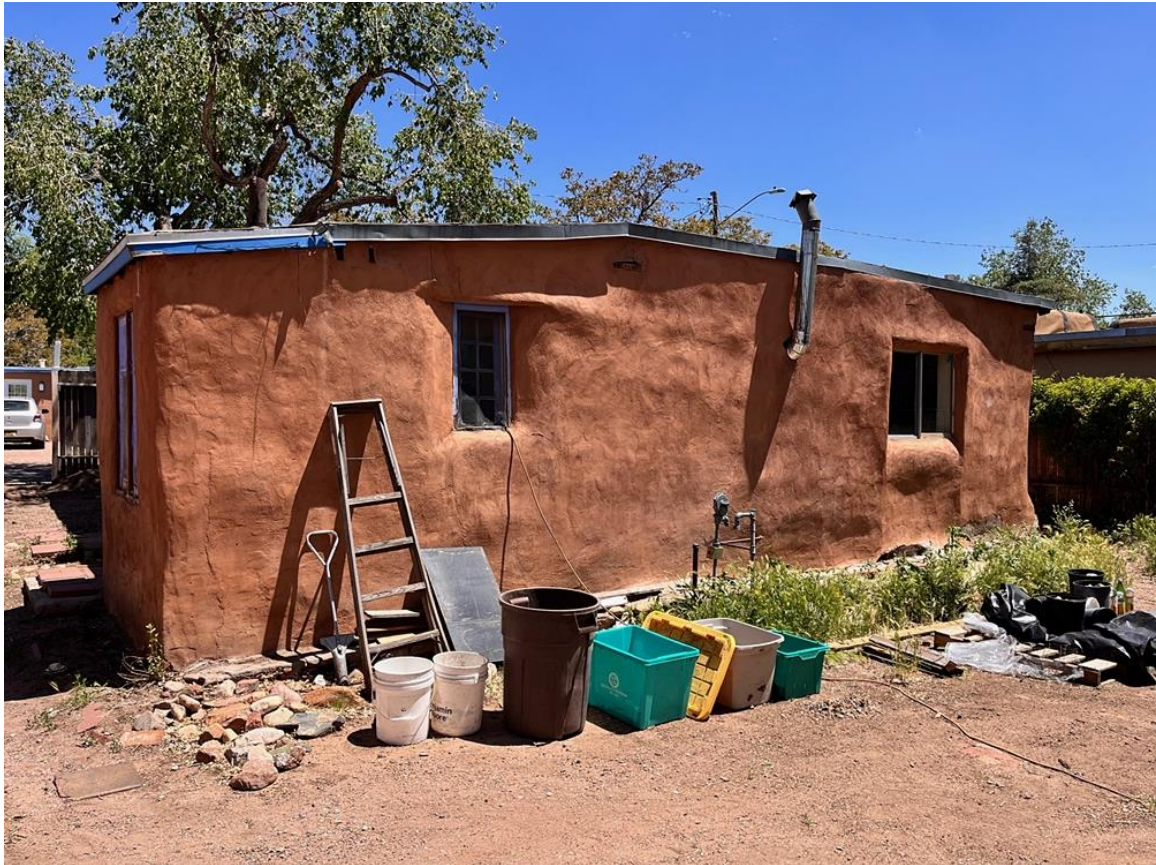
This elevation incorporates a post-1958 addition (Photo 11). It has lumpy stuccoed adobe walls and two windows: one an 8-light wood sash stuck into the stucco at the bathroom (Photo 12), and the other an aluminum sliding unit pillowed by a bed of stucco (Photo 13). The north section has a shed roof covering the bathroom addition. A stove pipe rises from the center of the façade, and a vent near the ground indicates it sits over a low crawlspace.

**Photo 11: Building #1. West elevation. Camera facing northeast.**

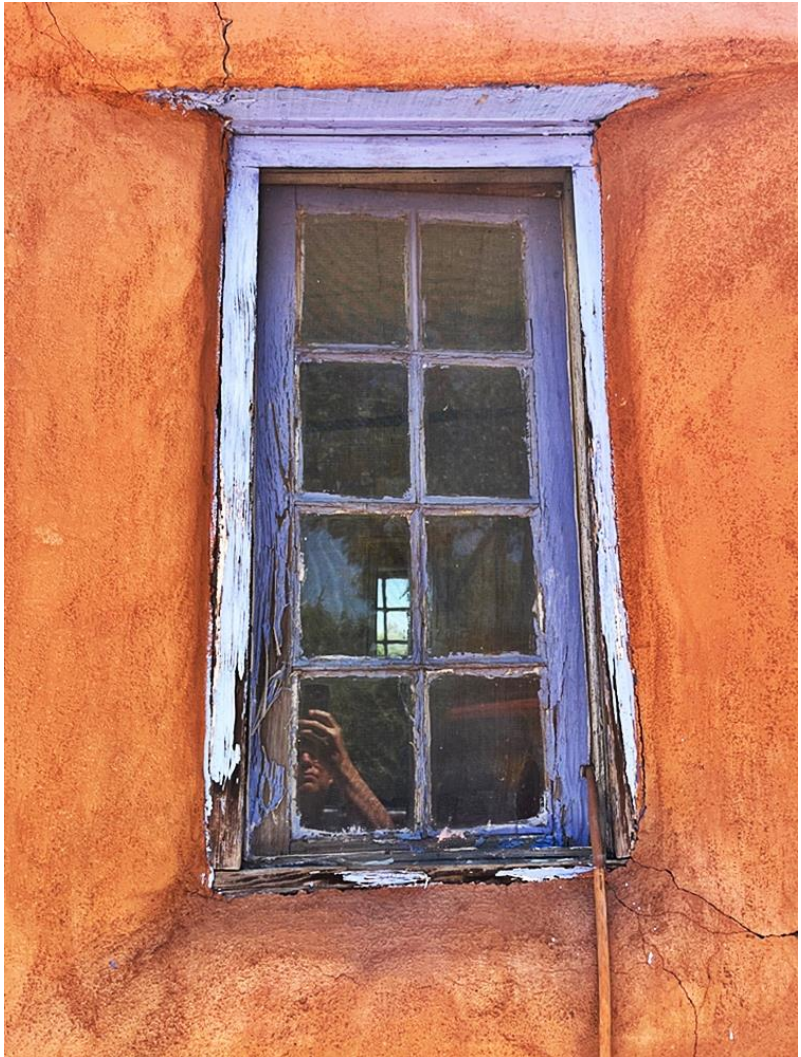
**Photo 12: Building #1. West elevation. North window. Camera facing east.**

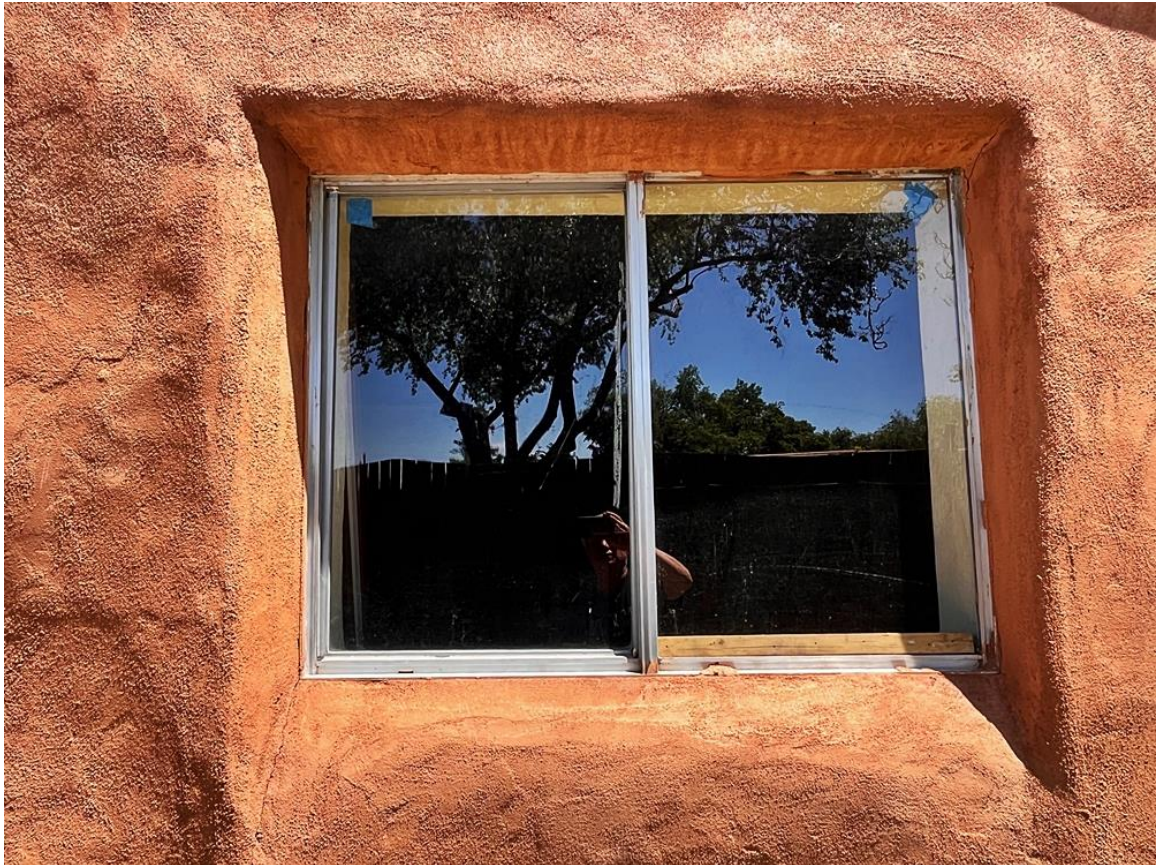
**Photo 13: Building #1. West elevation. South window. Camera facing east.**

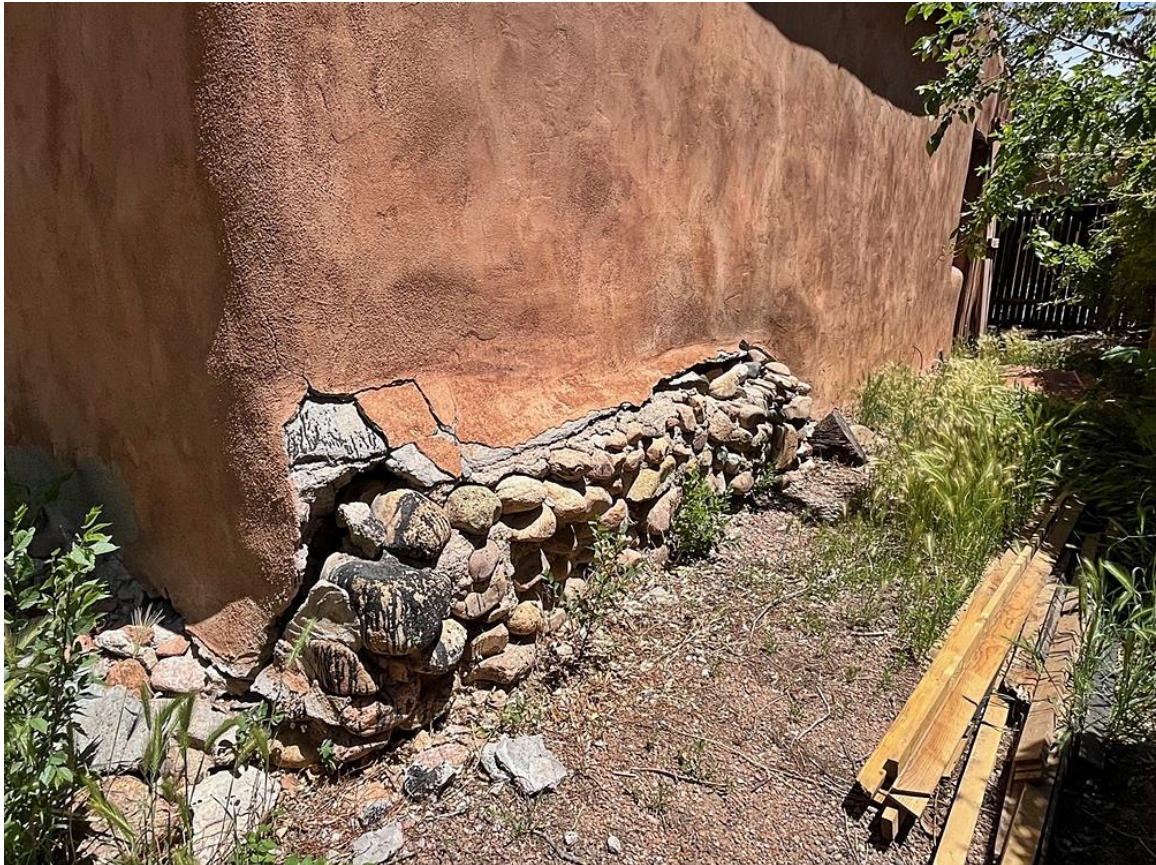
The south elevation faces the property line (Photo 14). It has only one opening near its east end. Roughly eight feet of rock is stacked near its west end, serving as a contrapared. The opening contains a 1/1 hung wood sash window in poor condition (Photo 15).

**Photo 14: Building #1. South elevation. Camera facing northeast.**

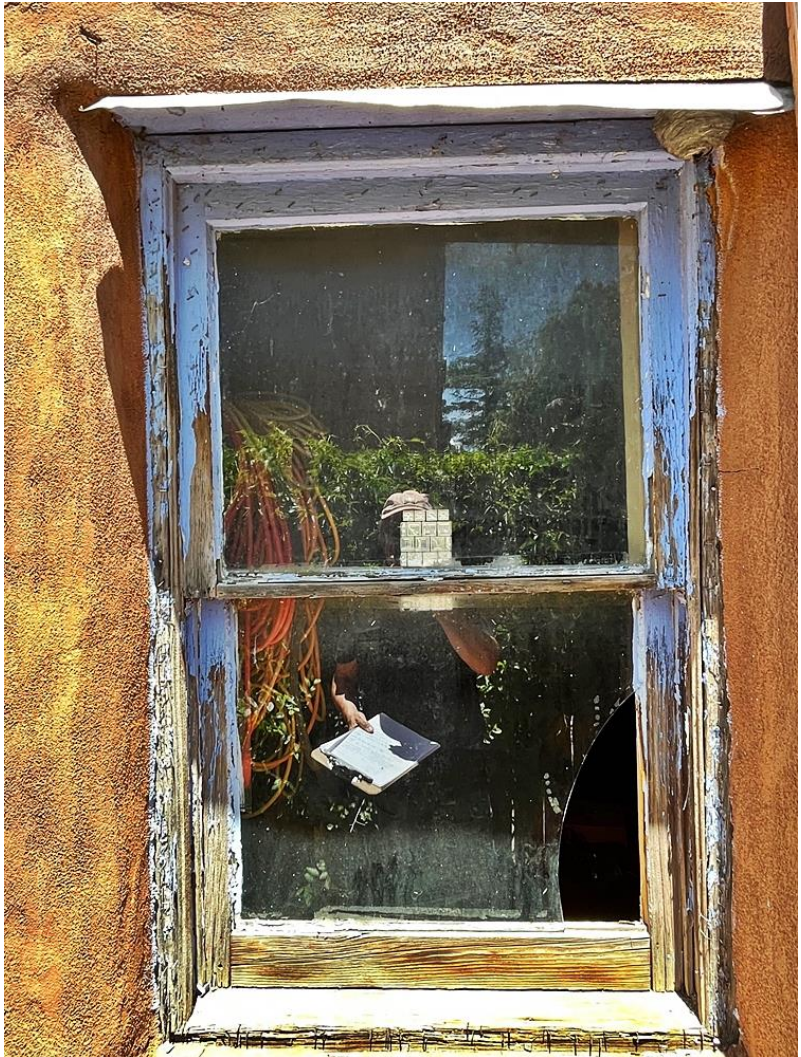
**Photo 15: Building #1. South elevation. East window. Camera facing north.**

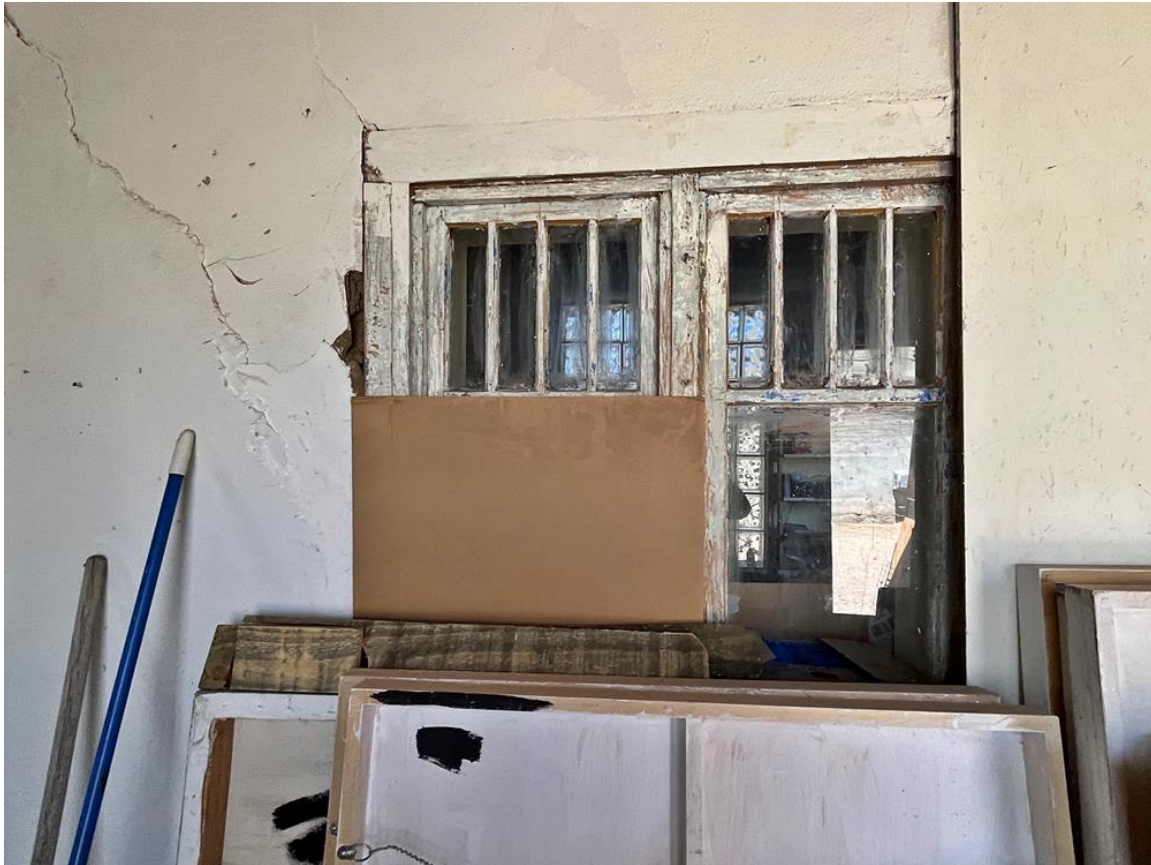
The entry vestibule represents the enclosed porch, which is evident by surviving windows which were once located on the exterior (Photo 16). There are several large rooms with exposed wood decking. A large 16' 10" x 17' 6" room at the southwest corner (Photo 17) reveals its adobe construction. It has a plank board floor with a few areas patched using homemade mending plates (Photo 18). A nicho is carved into the south wall (Photo 19). The bump-out containing the bathroom addition is nine inches above the adjacent room (Photo 19). It has a plywood floor painted yellow (Photo 20).

**Photo 16: Building #1. Interior of enclosed porch. Camera facing south.**
